5 CONDITION ASSESSMENT

5.1 Exterior

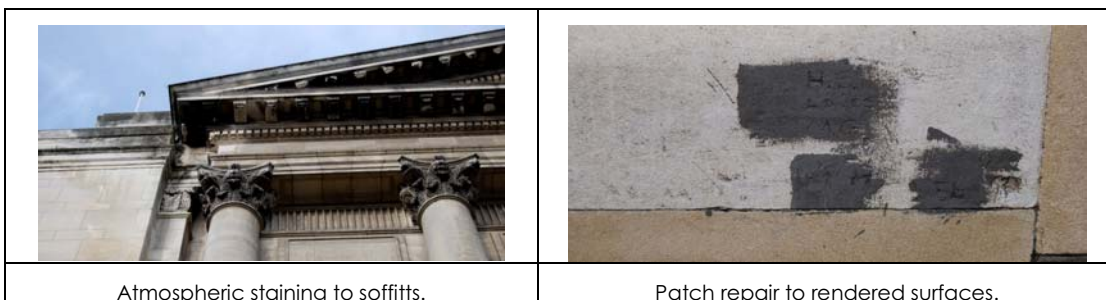
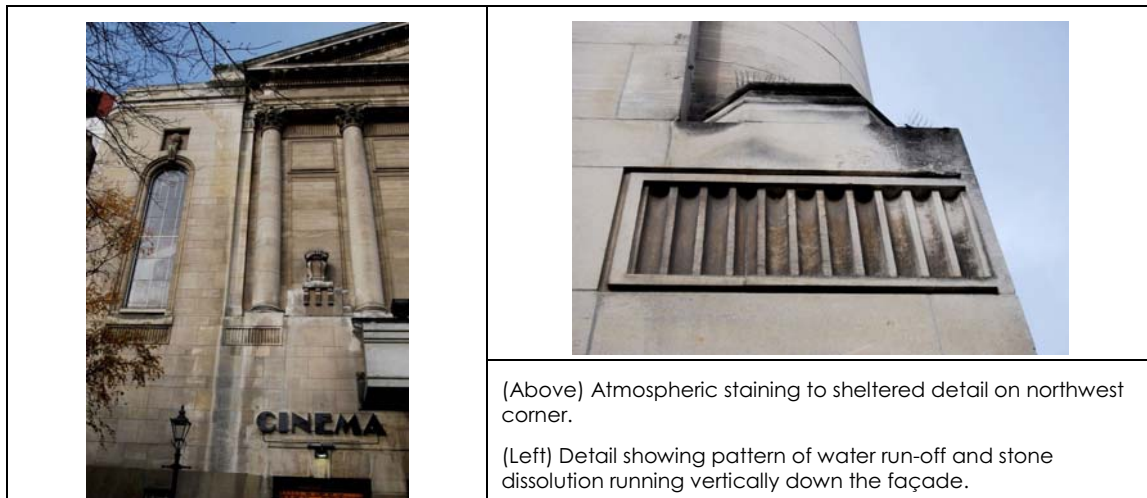
Delamination and dissolution of the Oamaru limestone is evident to the upper reaches of the elevation in particular, concentrated around the parapet and pediment, with noticeable areas of decay also evident to either side of the central portico, at junctures with the corner 'towers'. The latter appears to be caused by water pouring down the elevation in these locations and rainwater disposal solutions in these areas should be carefully investigated.

Salt growth (efflorescence) was noted to parapets on the northwest tower when these were inspected at close quarters. It was not possible to examine all parapets closely due to the height of the elevation however it would be sensible to assume the at least some degree of salt growth occurs and that this may be causing or accelerating the visible stone delamination.

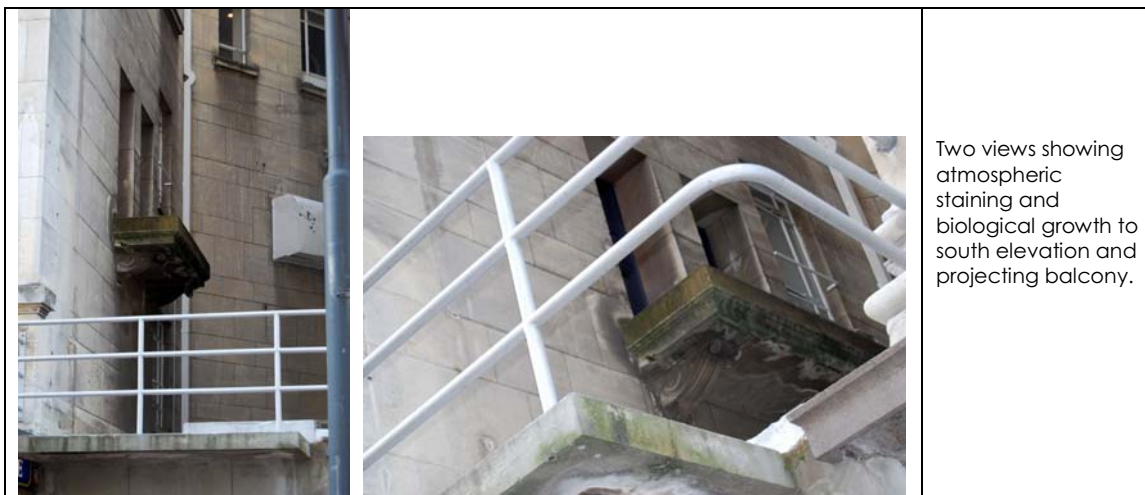
As noted in the Description above this is not a true elevation as such, however the one visible section does display a considerable degree of atmospheric staining, likely to be caused by its sheltered position. Some biological growth is also notable.

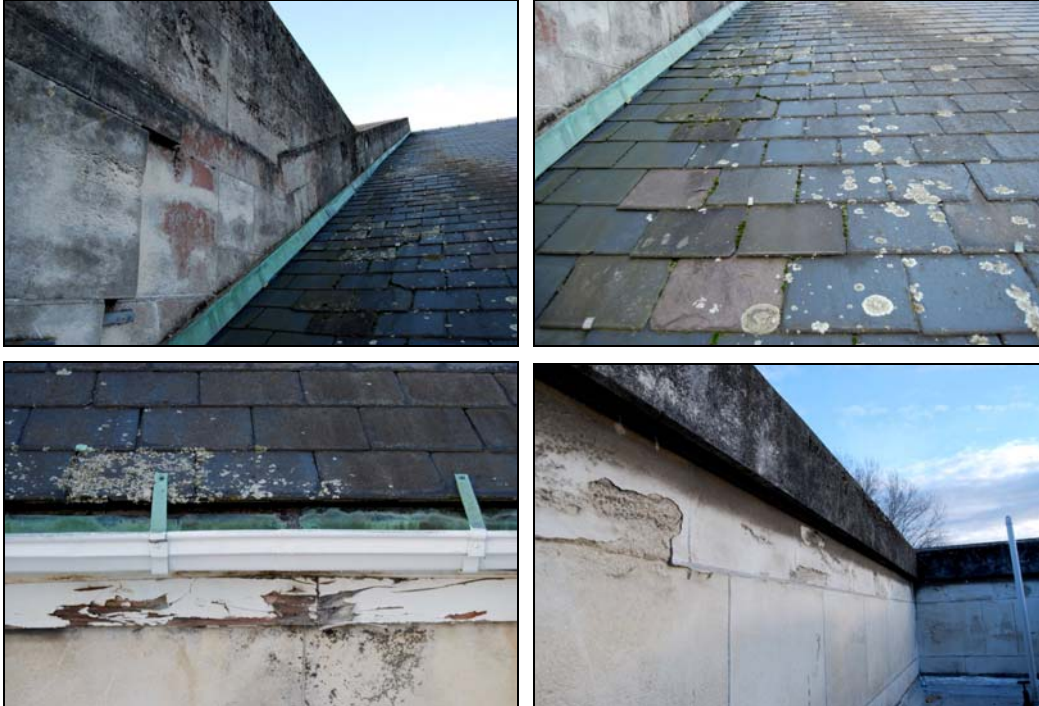
Extensive delamination and salt growth were noted to stone parapets in this area. This is likely to be exacerbated by the presence of concrete capping, which causes the more porous stone to act as a sacrificial layer, and may also be providing a source of salts.

Lichen growth was noted to several areas of slate roofing.

Gutters have pulled loosed from their supports in several places and there is some disintegration to timber fascia boards.

Roofing details showing (clockwise from top left): Delaminated stone and damp staining to north parapet; Lichen growth to slate surfaces; Damage to timber fascia; Delamination and salt growth to south parapet

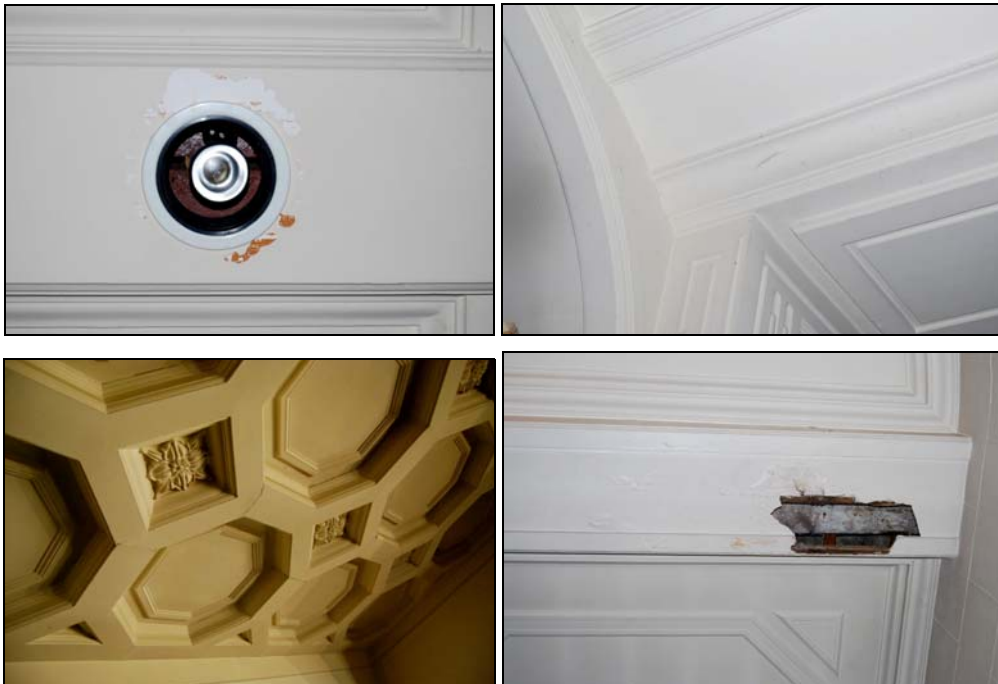
Moulded plasterwork throughout the building appears to be reasonably well preserved. However it should be noted that it was not possible to inspect much of this plasterwork at close quarters due to the height of ceilings in many spaces. General conditions noted include cracking and crazing around joins in the moulded motifs, peeling paint, minor damp staining, and general soiling. One area of particularly bad damage exists to the western corridor at first floor level.

Typical plasterwork details showing (clockwise from top left): Insertion of modern light fitting, with peeling paint revealing original terracotta paint beneath; hairline cracking and crazing; cracks along joins in heavier moulded pieces, missing section of plasterwork surrounded by damp staining.
