**PRESENTATION MATERIAL FOR PLAN CHANGE 1 SUBMISSION**  
**Patersons on behalf of Blue Sky Property 45 Beach Limited**

The DCC Heritage Assessment for the building at 45 Beach Street recommended that the entire external building envelope, excluding the carport and garage on Albert Street, was recommended for protection.

Patersons, on behalf of BlueSky, requests that the Scheduled Heritage Building BX046 feature, referring to the main building at 45 Beach Street be removed from PC1. This includes from the planning maps.

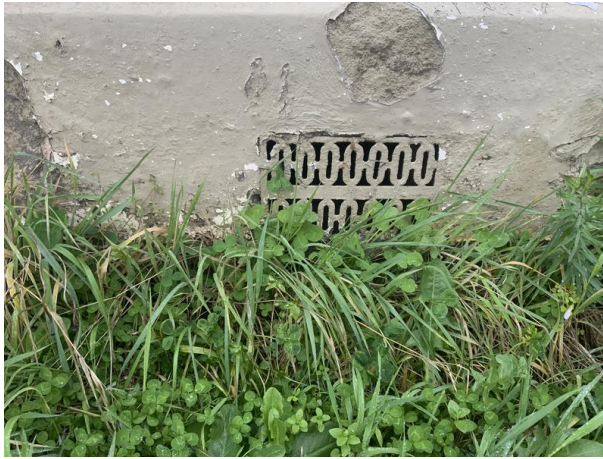
Photo 4

Cracking detected to East aspect foundation. Advise a structural engineer investigate the structural viability of the material as it presents as chalky and possibly beyond it's serviceable life.

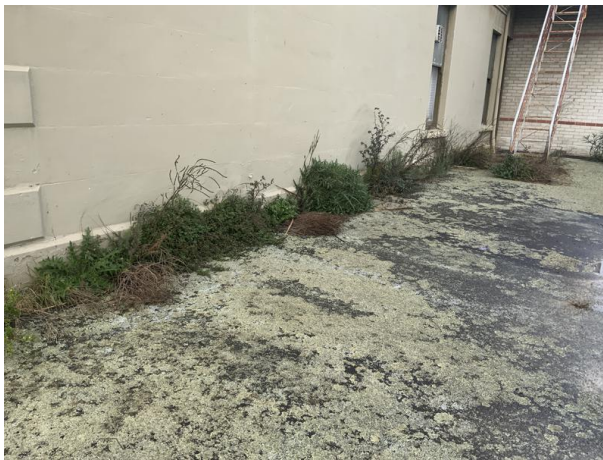
Photo 5

Vents viewed throughout foundation. Clearing of vegetation advised due to multiple vents blocked

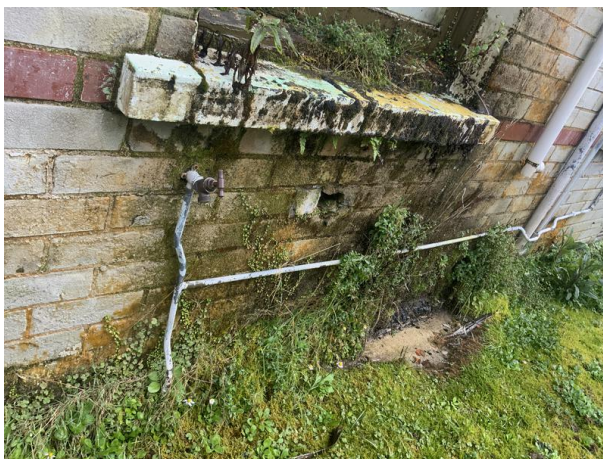
Photo 10

Moisture and dampness detected to SW aspect foundation. Repairing of stormwater system advised

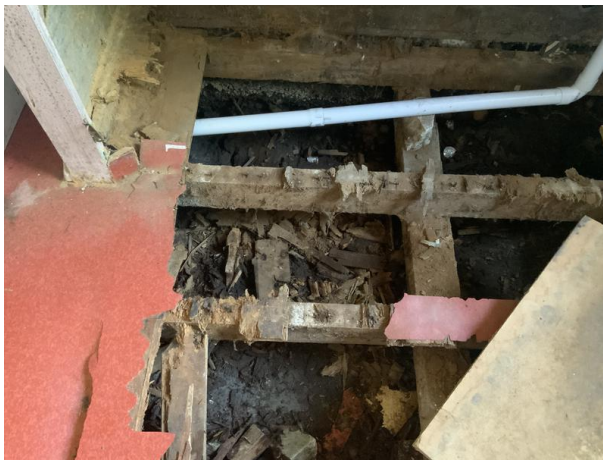
Photo 12

Subfloor bearers and joists in poor condition. Further investigation is required

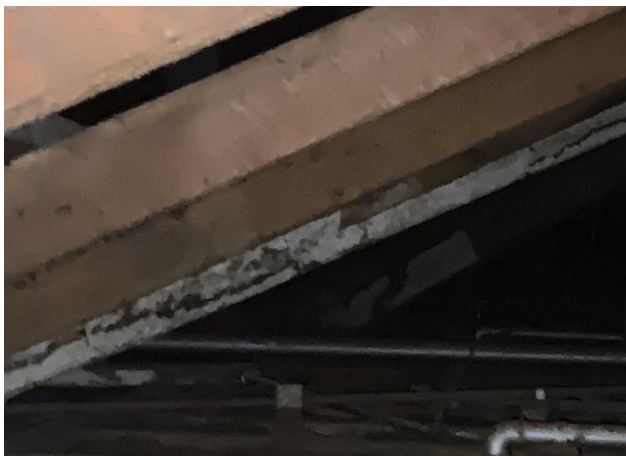
Photo 25

Indications of historical moisture damage detected to roofing rafter. A full roof inspection is advised

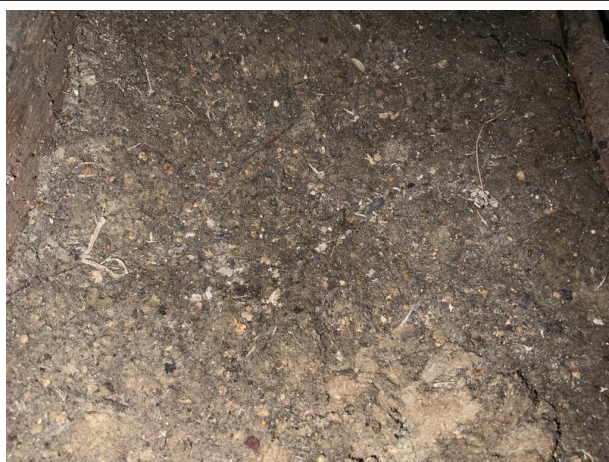
Photo 26

Wet insulation detected throughout the roof space area.

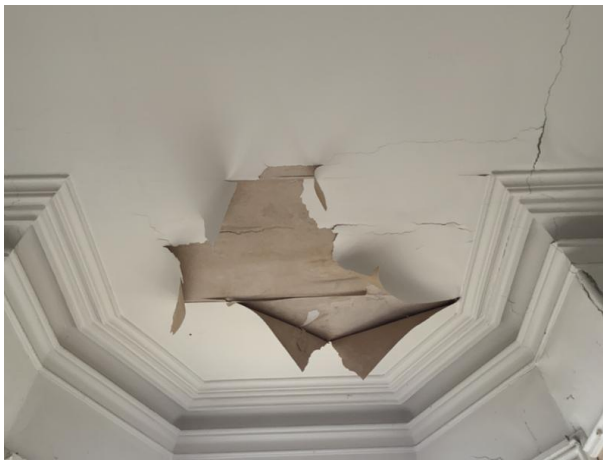
Photo 35

Damage and cracking detected to ceiling throughout rooms 29 and 30. Installation of a new ceiling advised

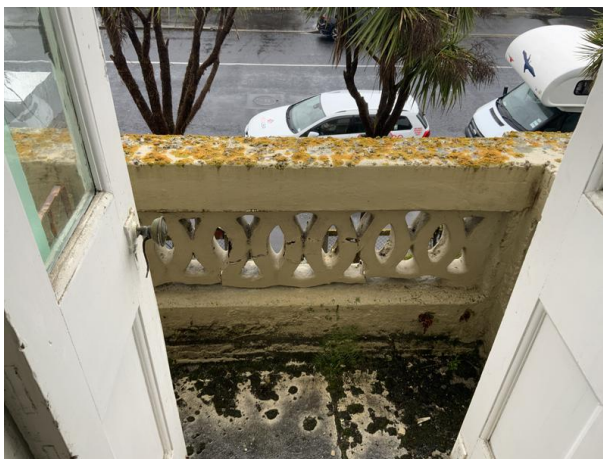
Photo 39

Room 29 balcony

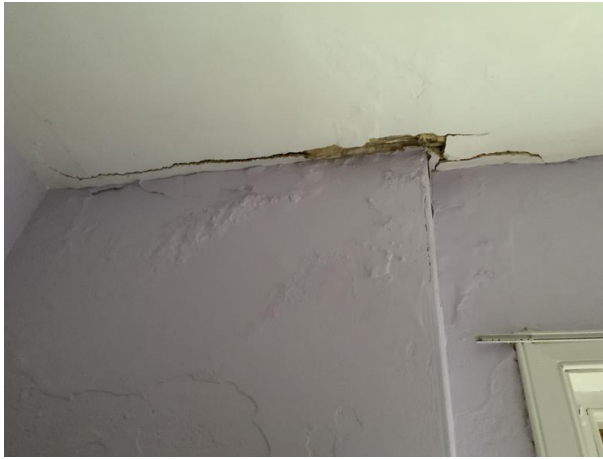
Photo 44

Cracking & moisture damage detected to bedroom 31 ceiling at wall junction. Possible structural issues to be investigated by a structural engineer

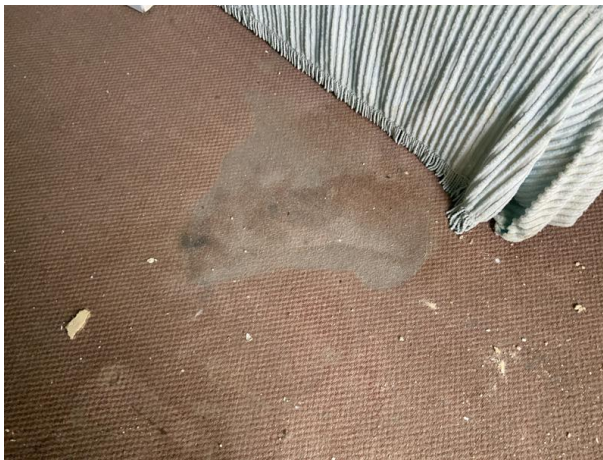
Photo 49

Moisture and mould detected to bedroom 32 carpet. Invasive inspection of timber flooring and floor framing advised

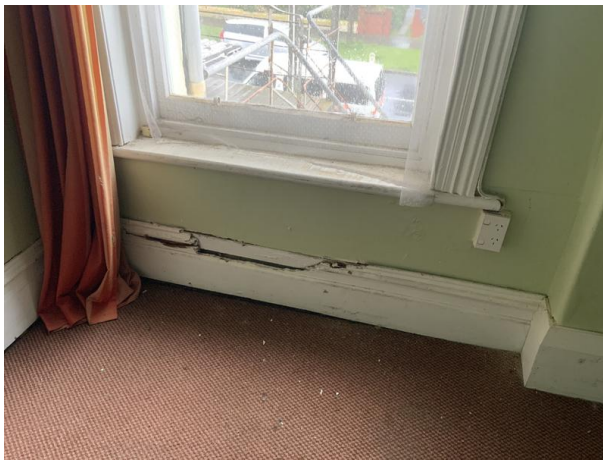
Photo 56

Damage detected to bedroom 33 skirting. Replacement of skirting advised and investigation into any structural issues

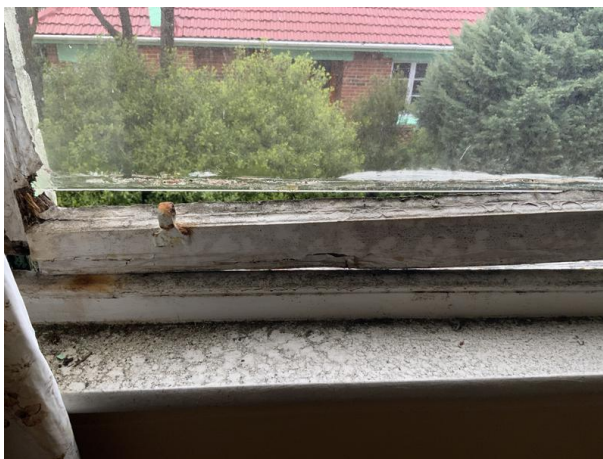
Photo 68

As a measure of safety window must be removed immediately

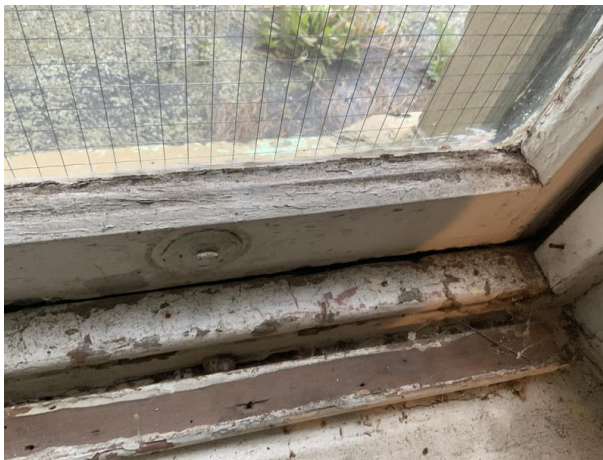
Photo 76

Damage & gaps detected to bedroom 35 opening window. Replacement advised

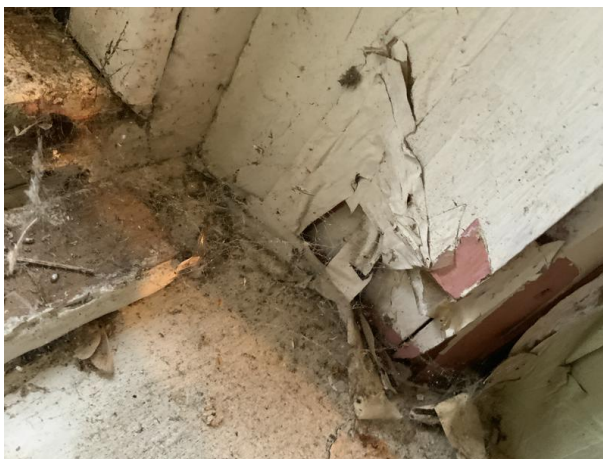
Photo 77

Damage detected to bedroom 35 window reveal. Replacement advised

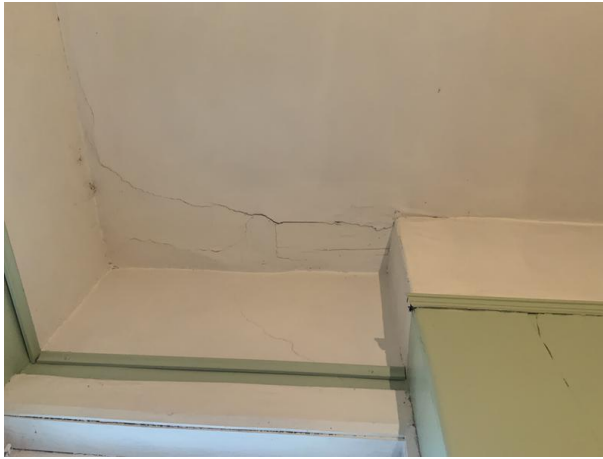
Photo 78

Cracking detected to bedroom 35 ceiling. Advise an internal plasterer for repairs

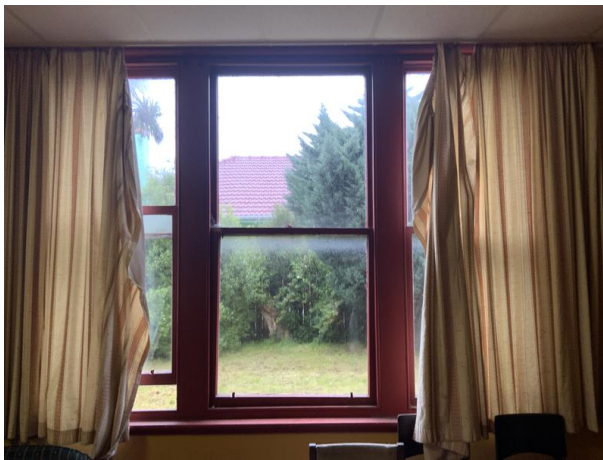
Photo 85

Lounge window set with only one opening window. Maintenance required to open all but one window

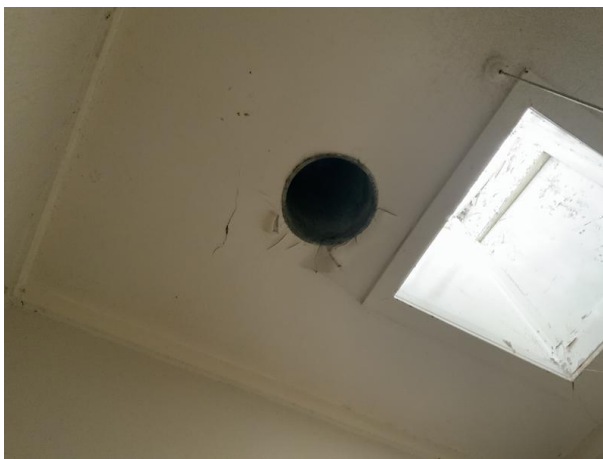
Photo 98

Bathroom ceiling damaged.  
Replacement of ceiling advised

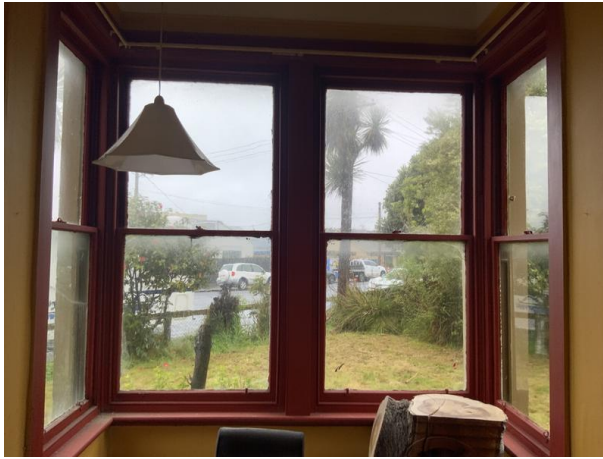
Photo 159

Office windows non-openable.  
Maintenance required to open

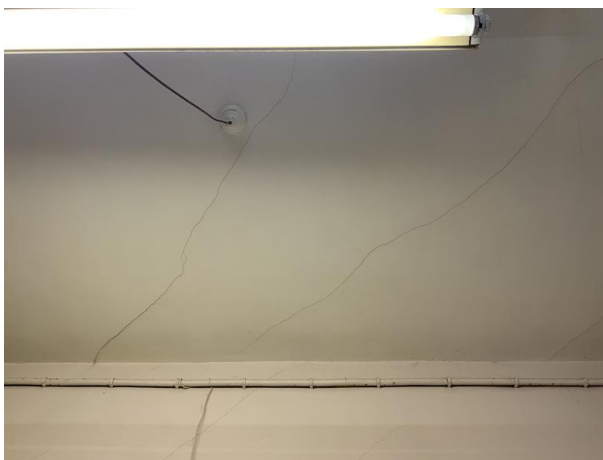
Photo 167

Cracking detected to dining room ceiling to a degree of beyond repair. Installation of a new ceiling advised

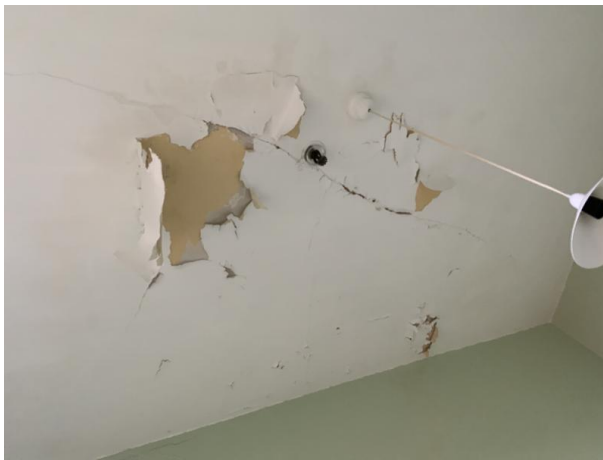
Photo 184

Flaking paint and cosmetic damage detected to bedroom 23 ceiling. Installation of a new ceiling advised

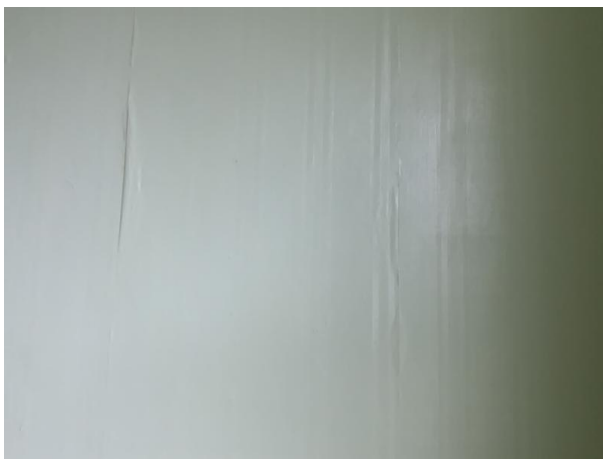
Photo 185

Cosmetic damage detected to bedroom 23 wall linings. Re-lining advised

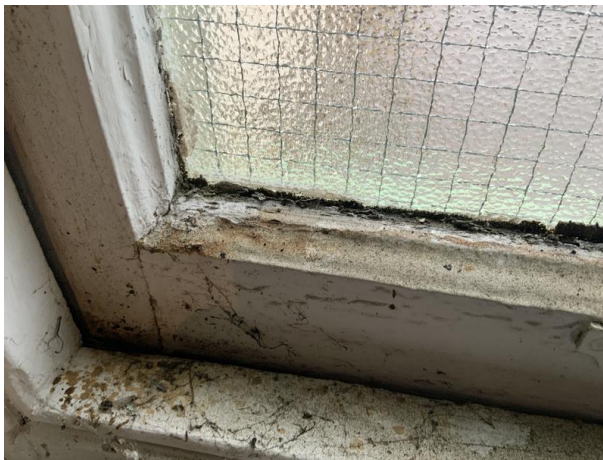
Photo 195

Condensation and damage detected to bedroom three window frame. Installation of a new window advised

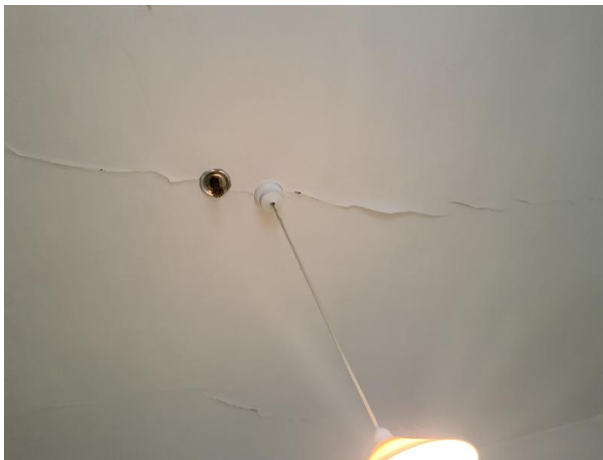
Photo 203

Cracking detected to bedroom 34 ceiling. Advise an internal plasterer for repair.

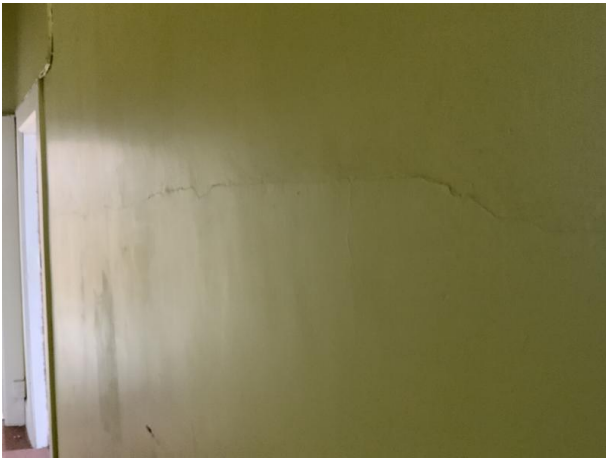
| <p>Photo 218</p> | <p>Cracking detected throughout level two hallway wall linings. Re-lining walls advised</p> |

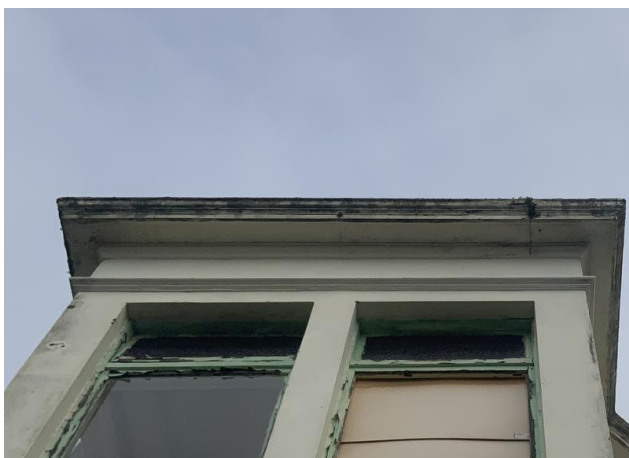
Photo 103

Cracking detected to soffits East aspect. Further investigation is required for safety reasons

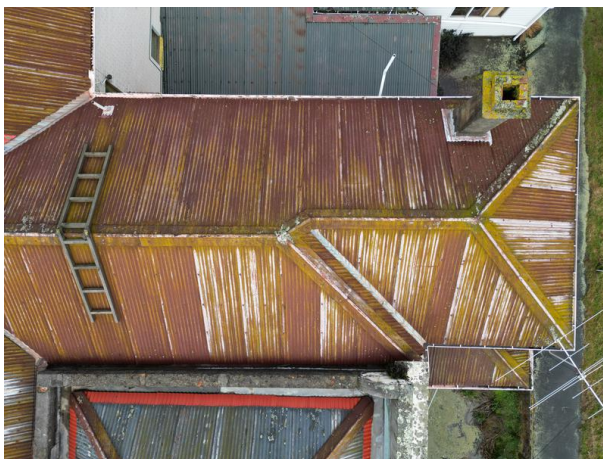
Photo 106

Corrosion detected throughout  
the roofing surface.  
Replacement of roofing is  
advised

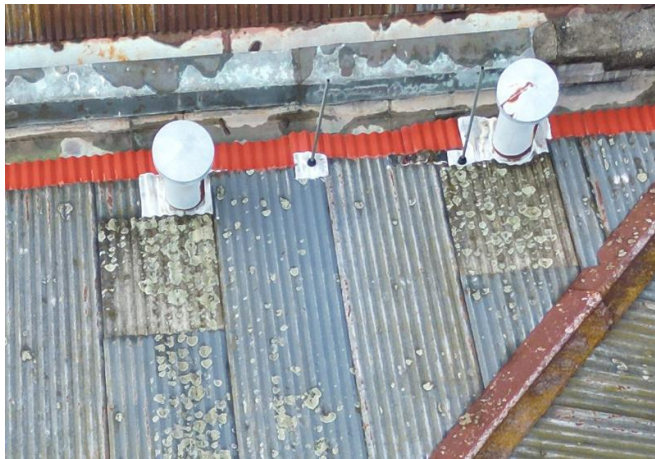
Photo 107

Vent & over-flow penetration flashings located North aspect. There is sealant on the roof flashings. This will need to be monitored as it does break down over time.

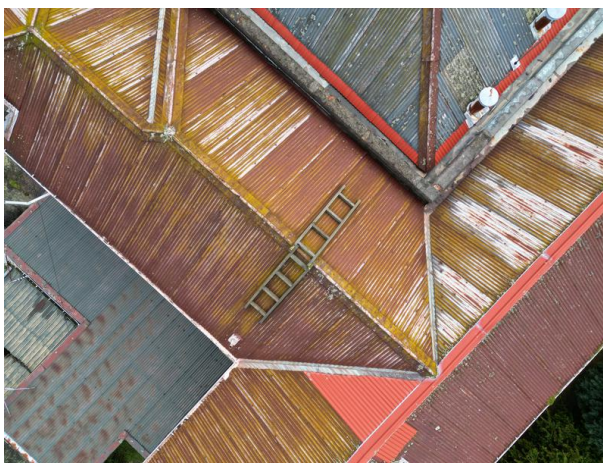
Photo 108

Roofing ridge apex with corrosion detected to cap flashings. Further investigation is required

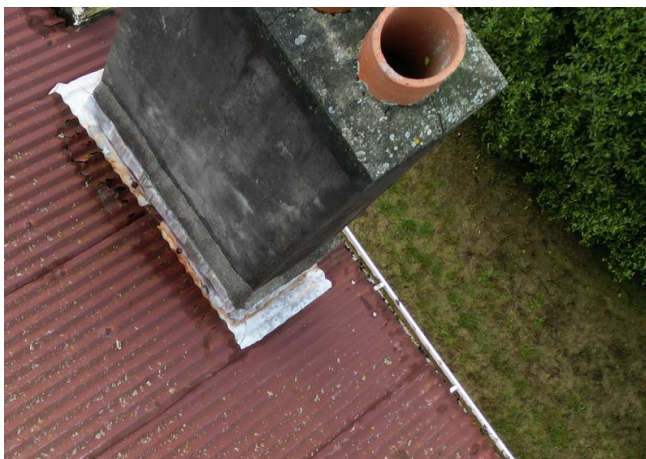
Photo 109

Flue penetration flashing West aspect with corrosion detected to the roofing iron. Subject to moisture ingress, Replacement of roof advised

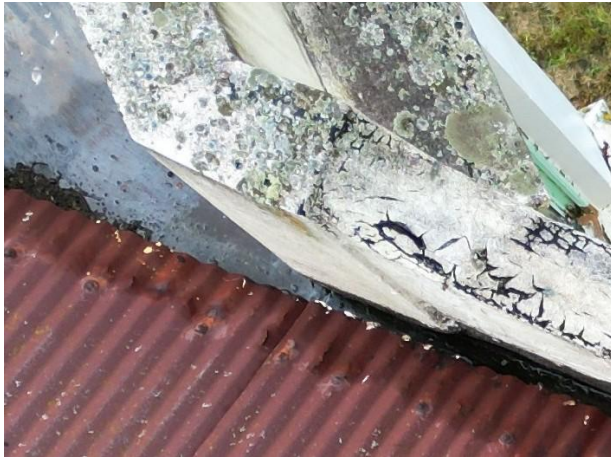
Photo 110

Corrosion detected throughout the entire roofing surface. Replacement is prudent

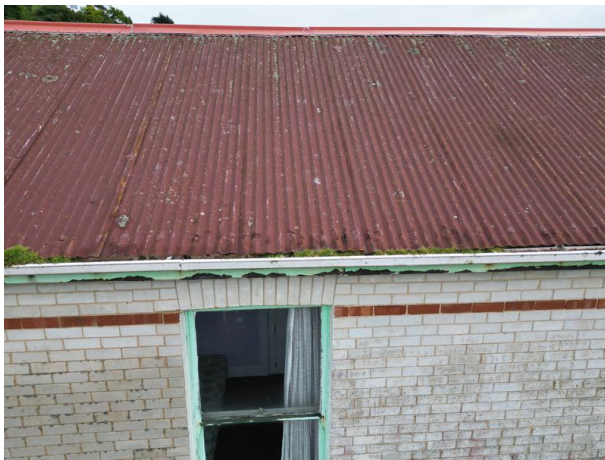
Photo 111

Vegetation detected throughout the entire gutter system. Removal and replacement of gutters advised

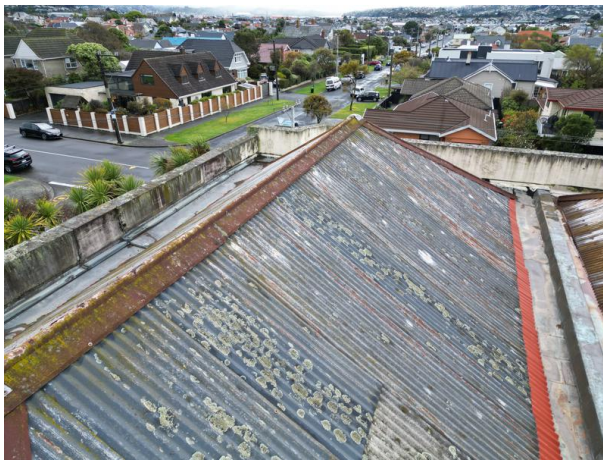
Photo 117

Lichen and moss detected throughout the roofing surface. Treatment and cleaning advised

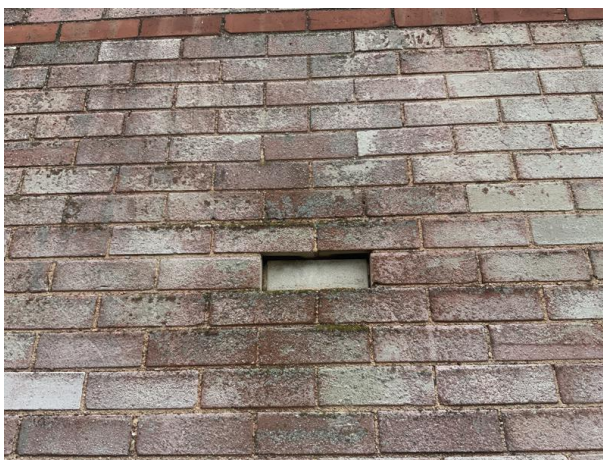
Photo 121

Loose brick detected to South aspect exterior cladding. Advise a brick layer for re-installation

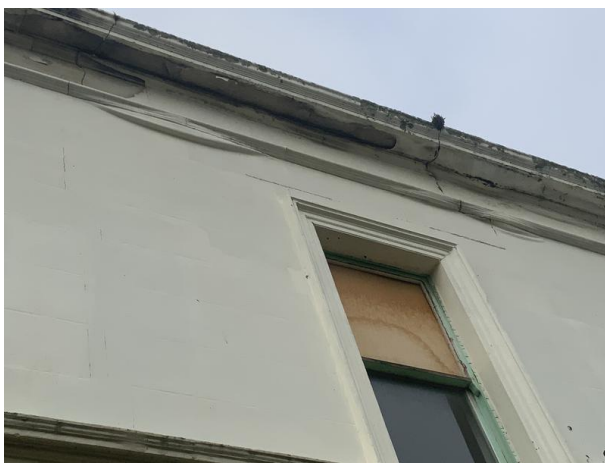
Photo 130

Upper North aspect exterior cladding with cracking detected below soffits. Further investigation is required to the structural integrity below the plaster system

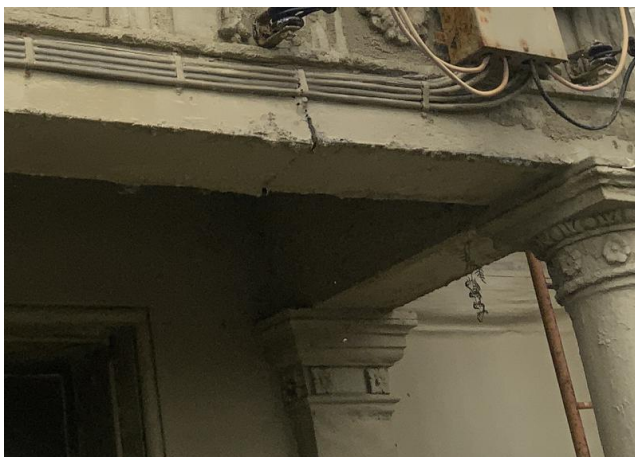
Photo 134

Cracking detected to lintel at entrance door. Further investigation is required to the structural integrity by an engineer

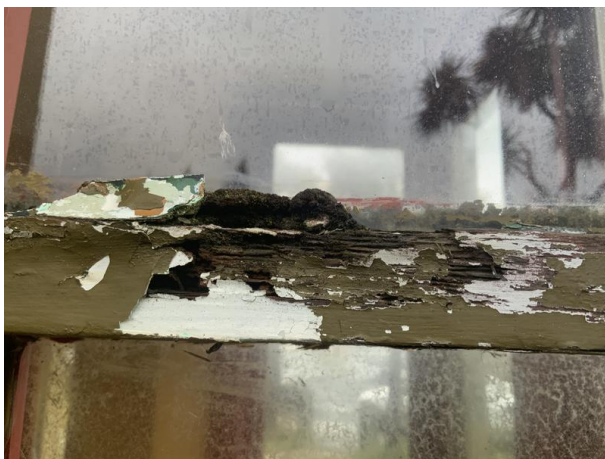
Photo 137

Typical sighting of rot to window framing throughout exterior joinery. Replacement advised

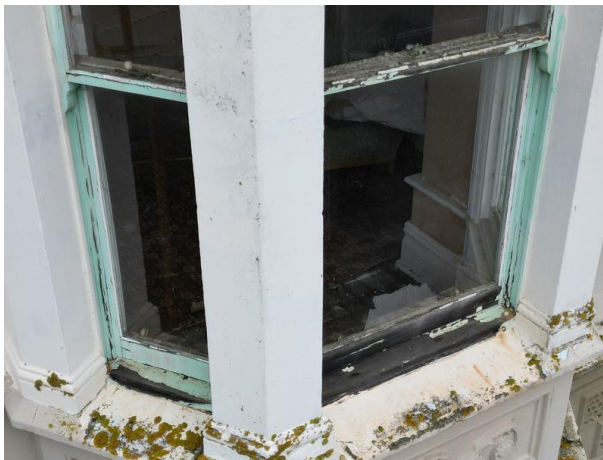
Photo 145

Rot detected to timber sills to all upper exterior joinery windows. Replacement advised

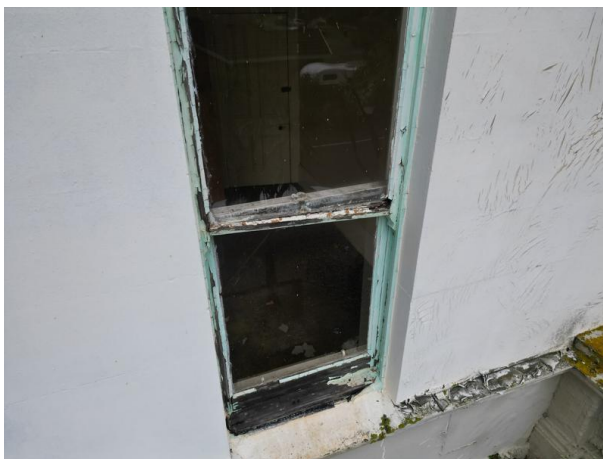
Photo 146

Advise boarding up all upper exterior joinery windows for safety reasons. Due to falling glass

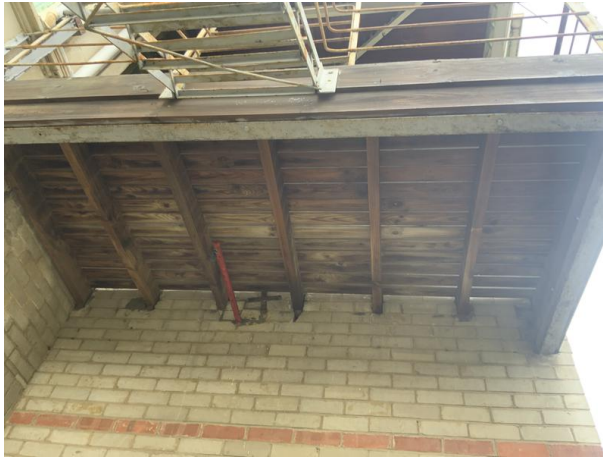
Photo 154

Subfloor view of balcony with deterioration of timbers visible. Further investigation is required to the structural integrity of the Northwest aspect balcony

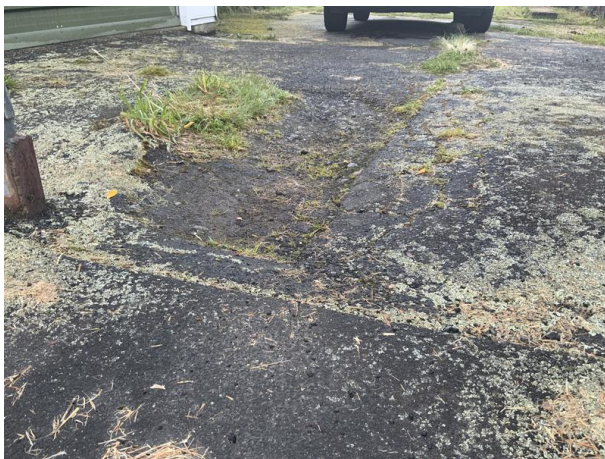
Photo 239

Cracking & sunken asphalt detected to driveway.  
Installation of a new driveway advised

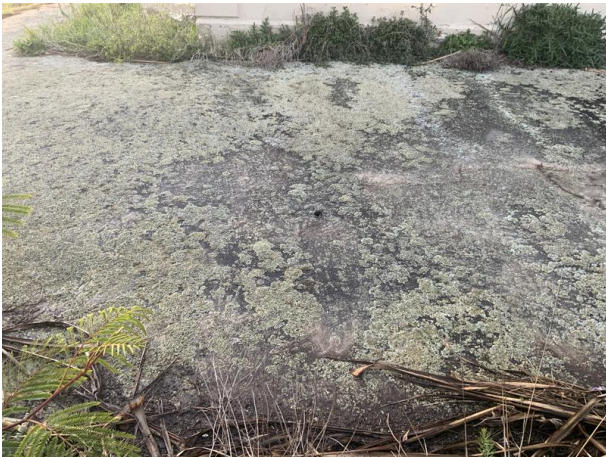
| <p>Photo 257</p> | <p>North aspect patio area completely covered in lichen. Treatment required</p> |

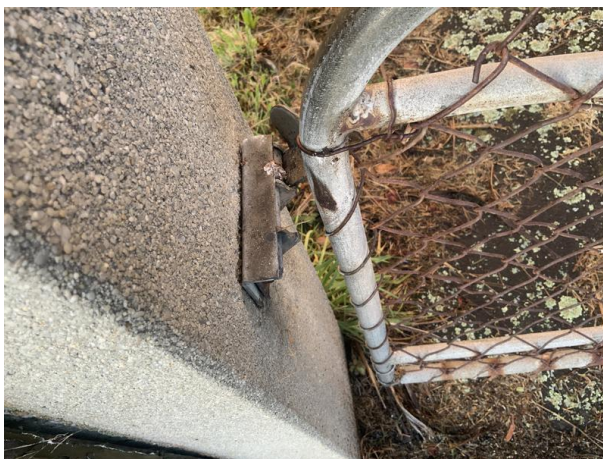
Photo 266

Front entrance gate latch missing latch piece. Installation of a new latch advised

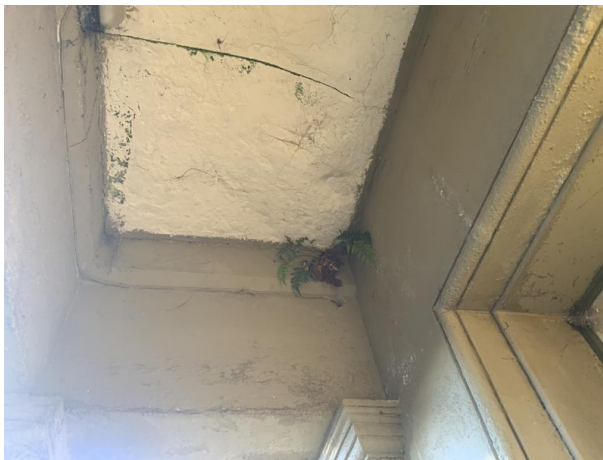
Photo 269

Vegetation growing out of verandah porch ceiling. Removal of vegetation advised

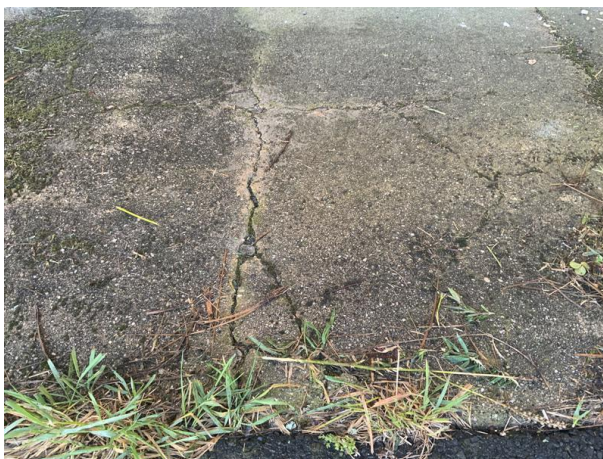
Photo 270

Cracking detected to veranda porch patio. Installation of a new patio advised

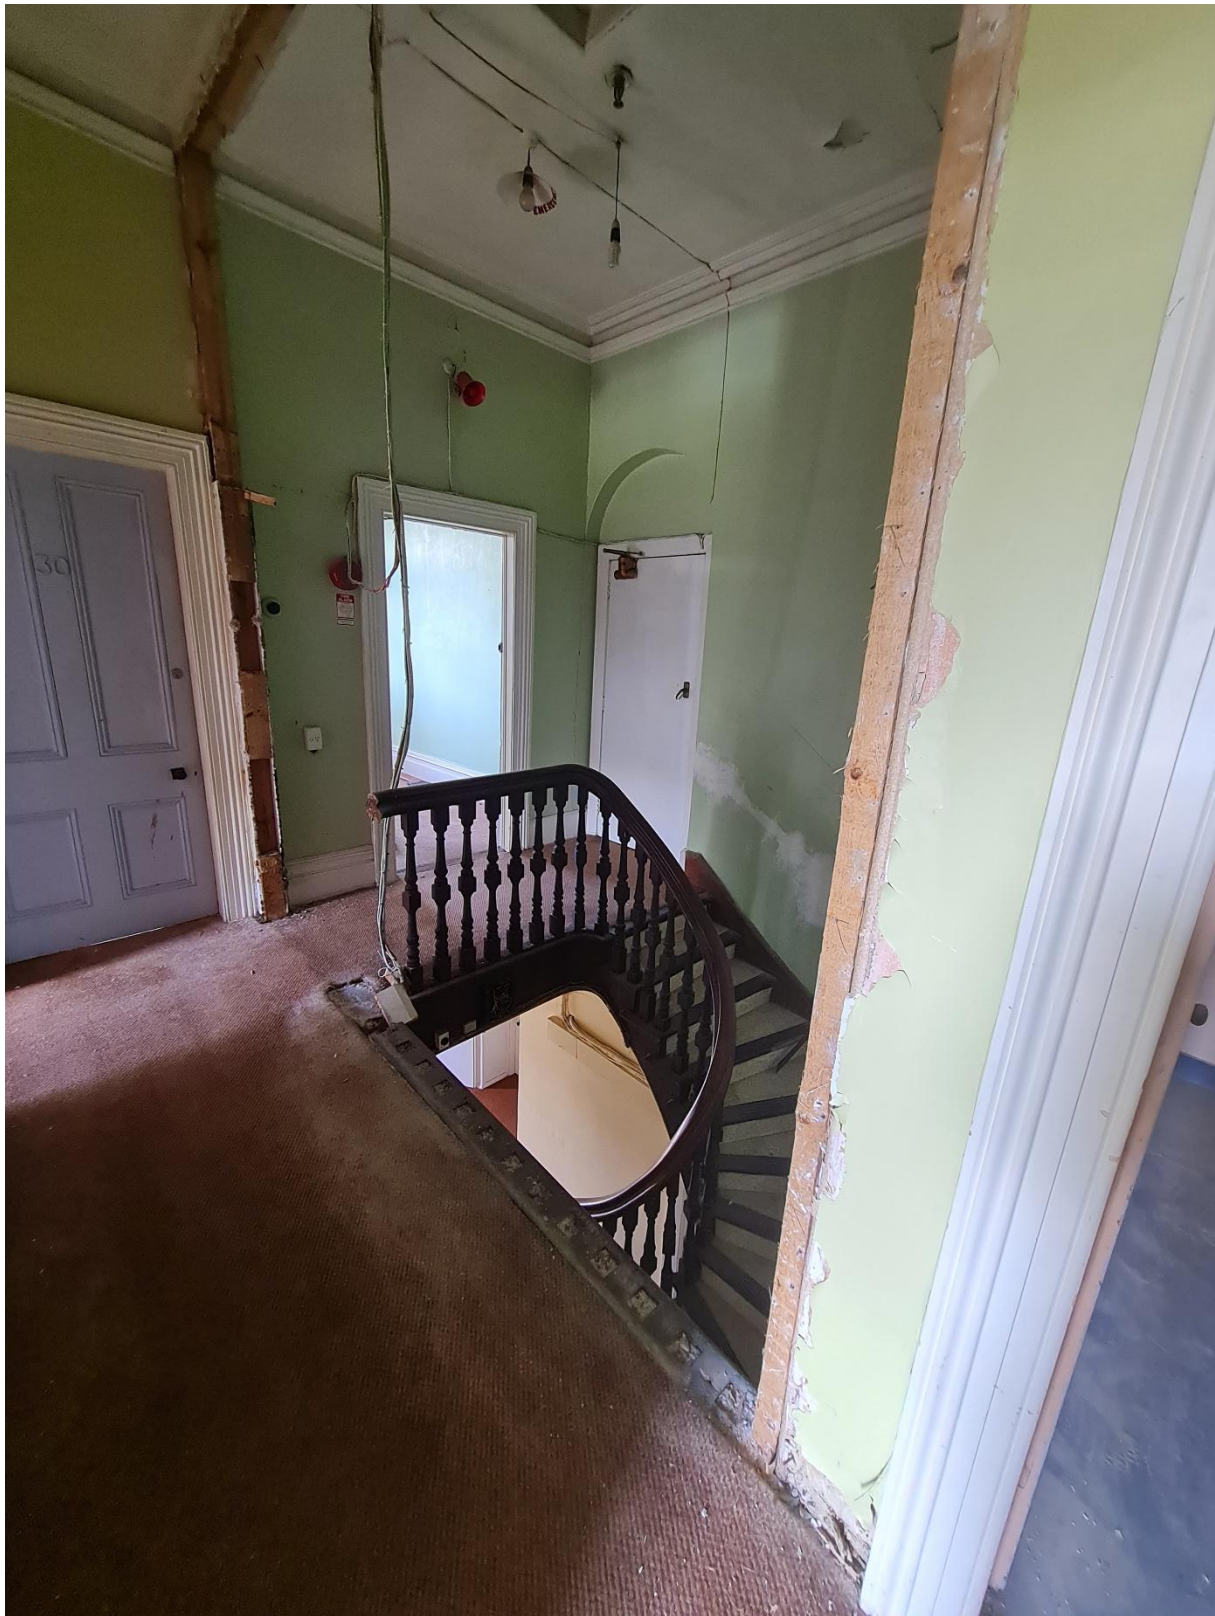
*Photo 2 - Removed wall / fall hazard at stair shaft*

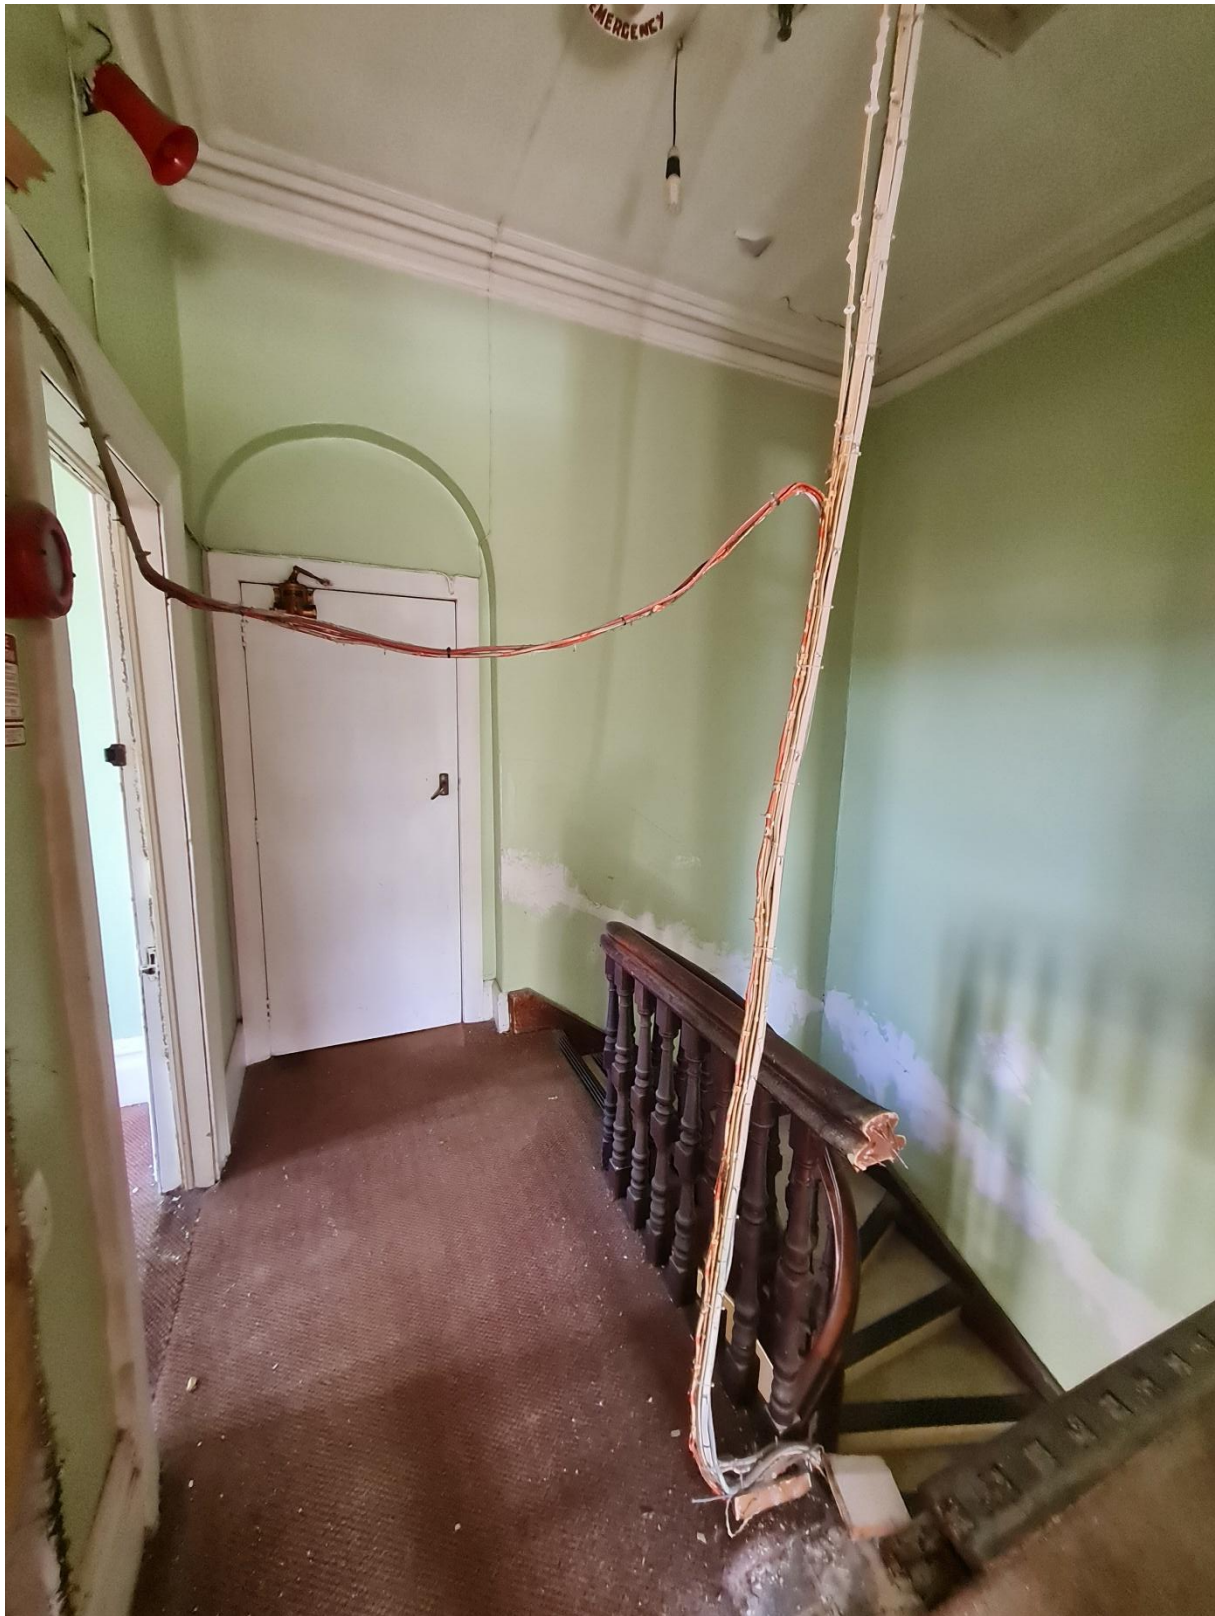
*Photo 3 - Exposed electrical wiring, upper level*

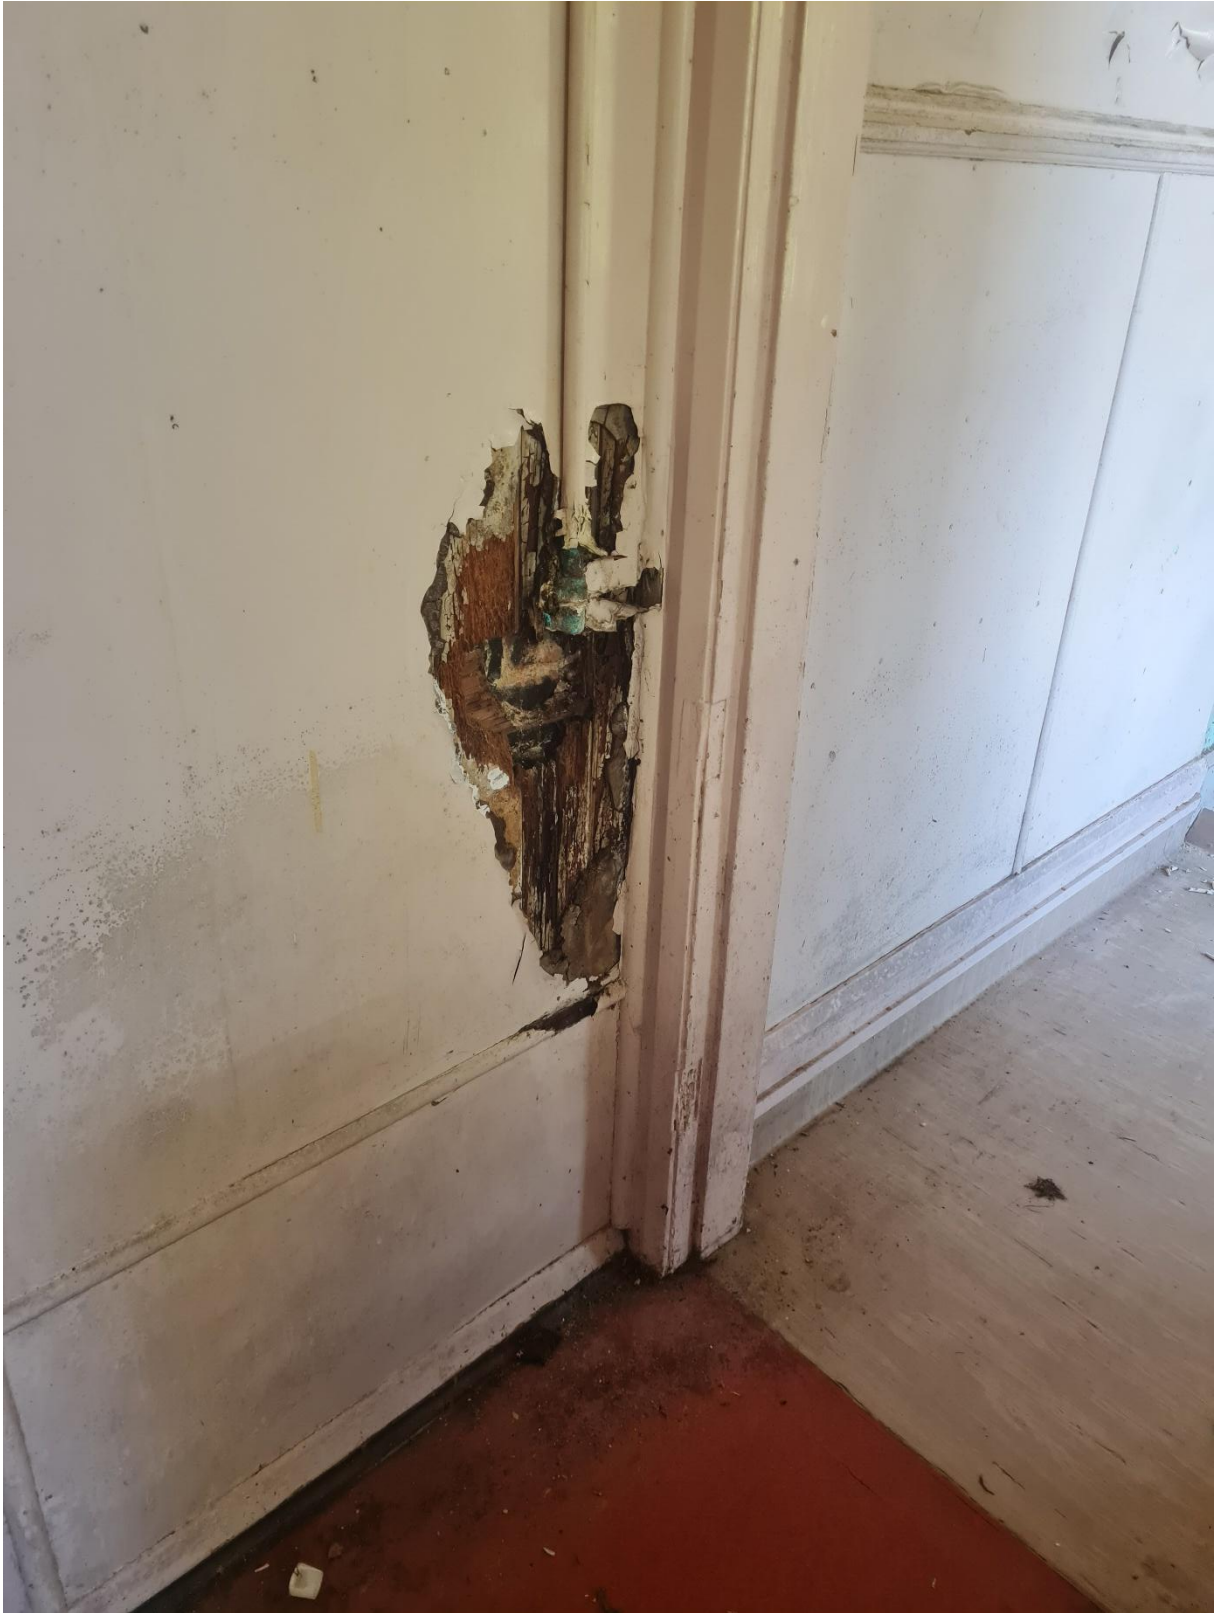
*Photo 5 - Water damage, ground floor wall*

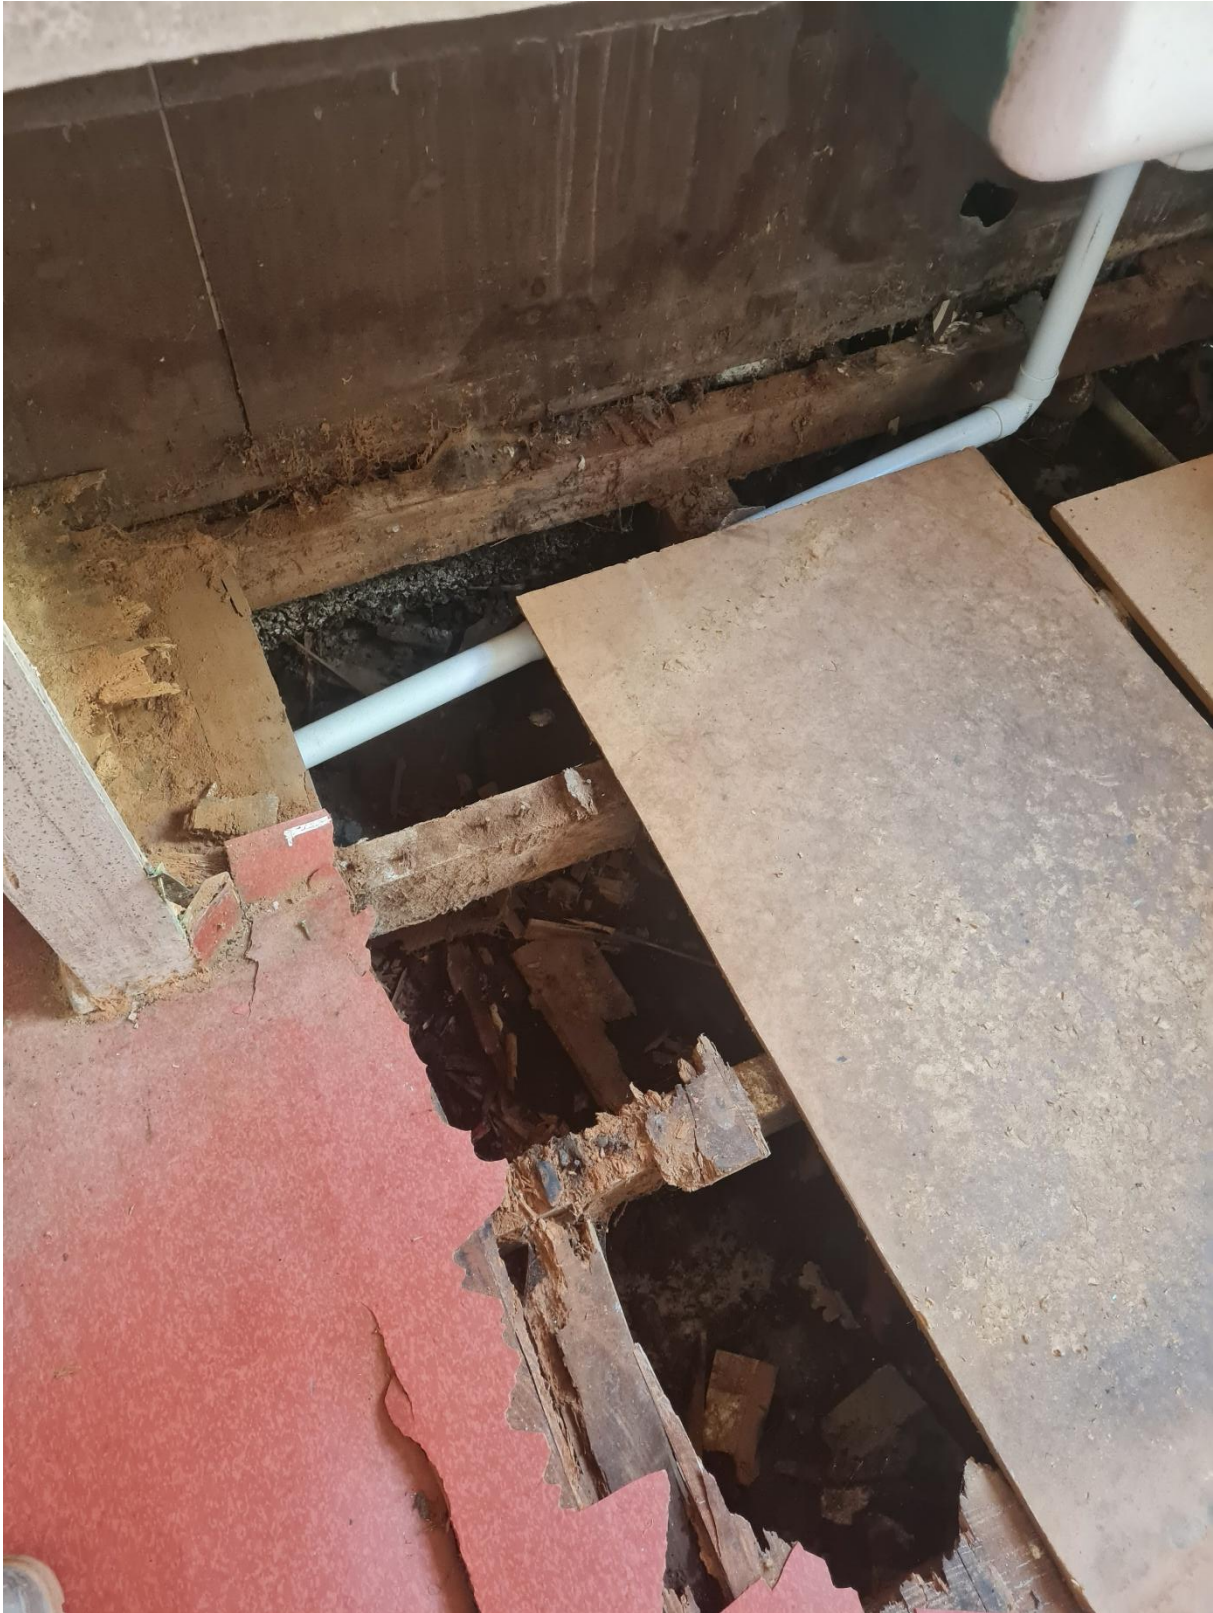
*Photo 6 - Rotted floor framing, ground floor*
