# Arboricultural Report

## LUC-2024-171 Application for work or the removal of a scheduled tree 27 King Street, Mosgiel

Prepared for: DCC Planning  
Prepared by: Roberts Consulting Ltd  
Date: May 27, 2024

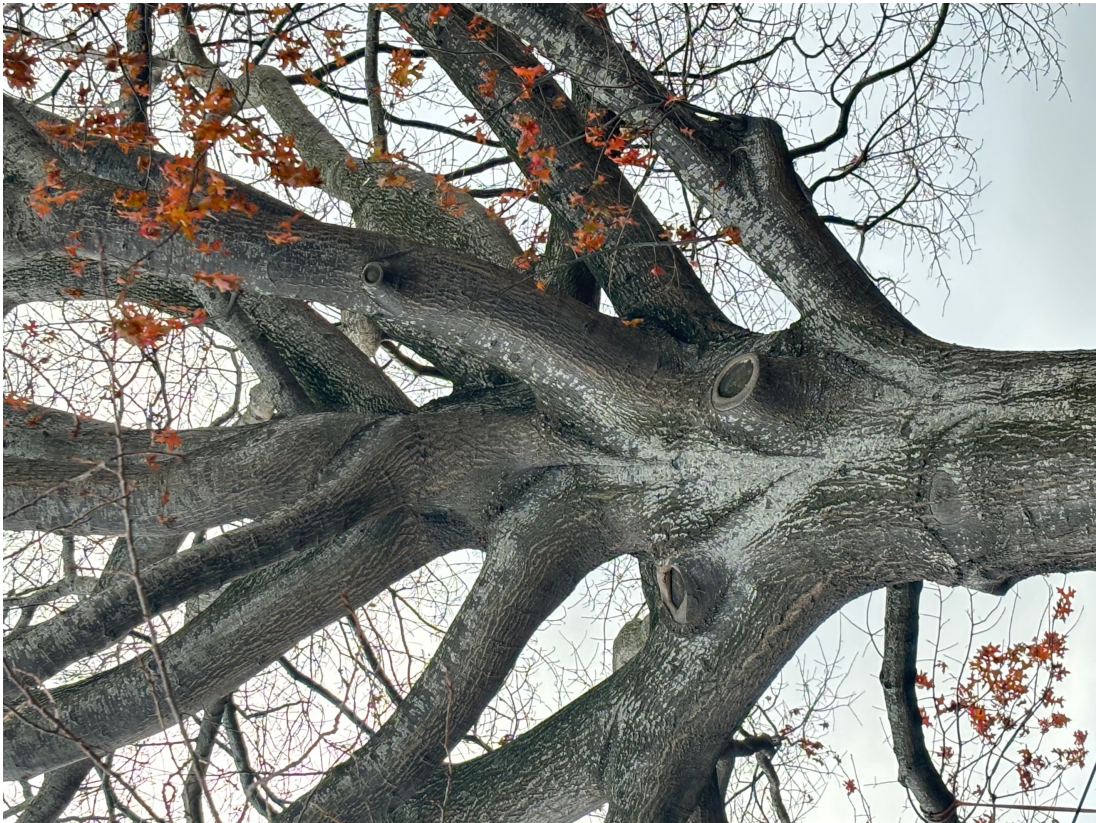
7.3.1 The callus wood around the edges of the pruning cuts was active, even, and well-formed

7.4 The main branch unions appear stable and well-formed (image one).

7.4.1 A good, or structurally stable branch union is considered to be one where the angle of attachment is wide and branch-bark-ridge on the upper side of the union is raised. I did not see branches with narrow angles of branch attachment or included bark.

**Image one:** Image showing branch structure of the main unions. Even rings of callus wood can also be seen around the old pruning cuts

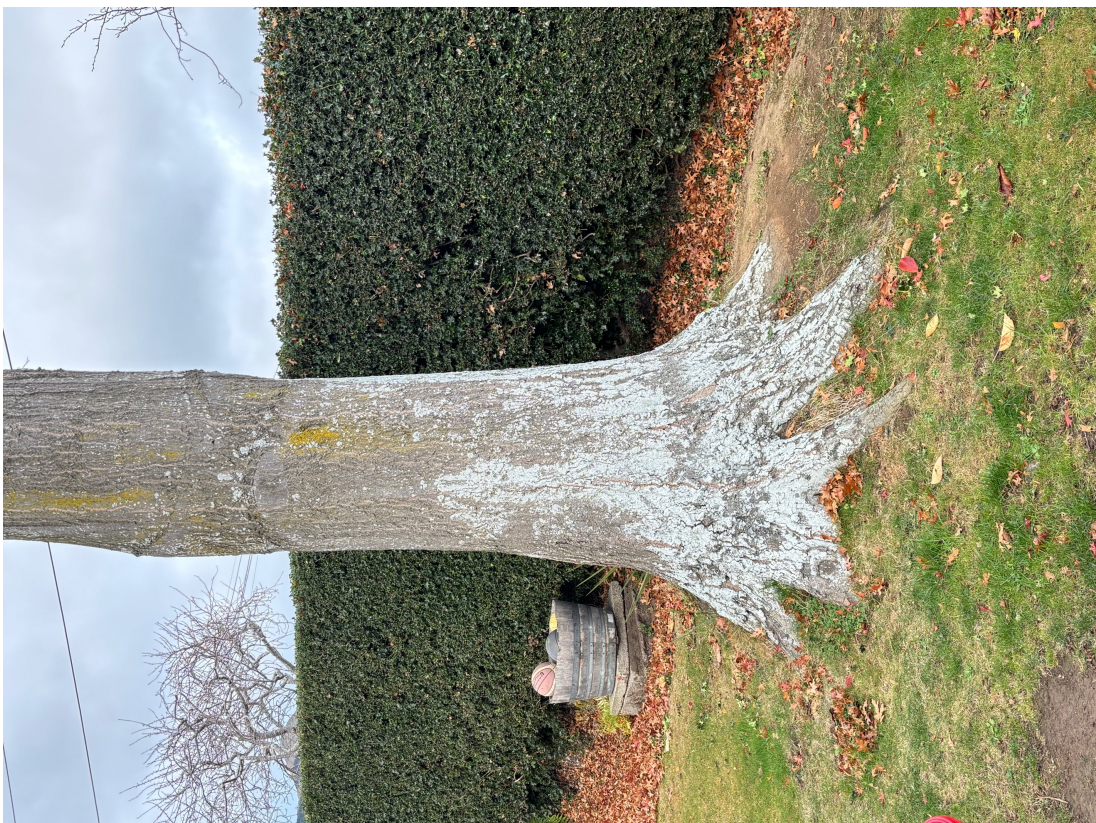
7.6 The root plate appeared to be stable, and I saw no indication of any recent movement or disturbance (image two).

- 7.6.1 I did not see any signs of symptoms or fungal pathogens, and there was nothing in or about the root plate to suggest or indicate the presence of root decay.

**Image two:** Image showing the base of the trunk and root plate.
