RE: LUC-2018-367 Application to remove significant tree T442

As per your July 10, email request, I have conducted a site visit to number 27 Falkland Street Dunedin, to inspect significant tree T442 listed on Schedule 25.3 as a Cedar (*Cedrus sp.*). The purpose of the visit was to assess the condition of the tree, specifically in relation Application LUC-2018-367 [to remove a significant tree T442 - Cedar].

Site Address: 27 Falkland Street Dunedin 9010 [Property No: 5016576]
Client: Lucy Collins, City Planning. Dunedin City Council
The Proposal: Assess tree T442 in relation Application LUC-2018-367
Assessment date: July 13, 2018

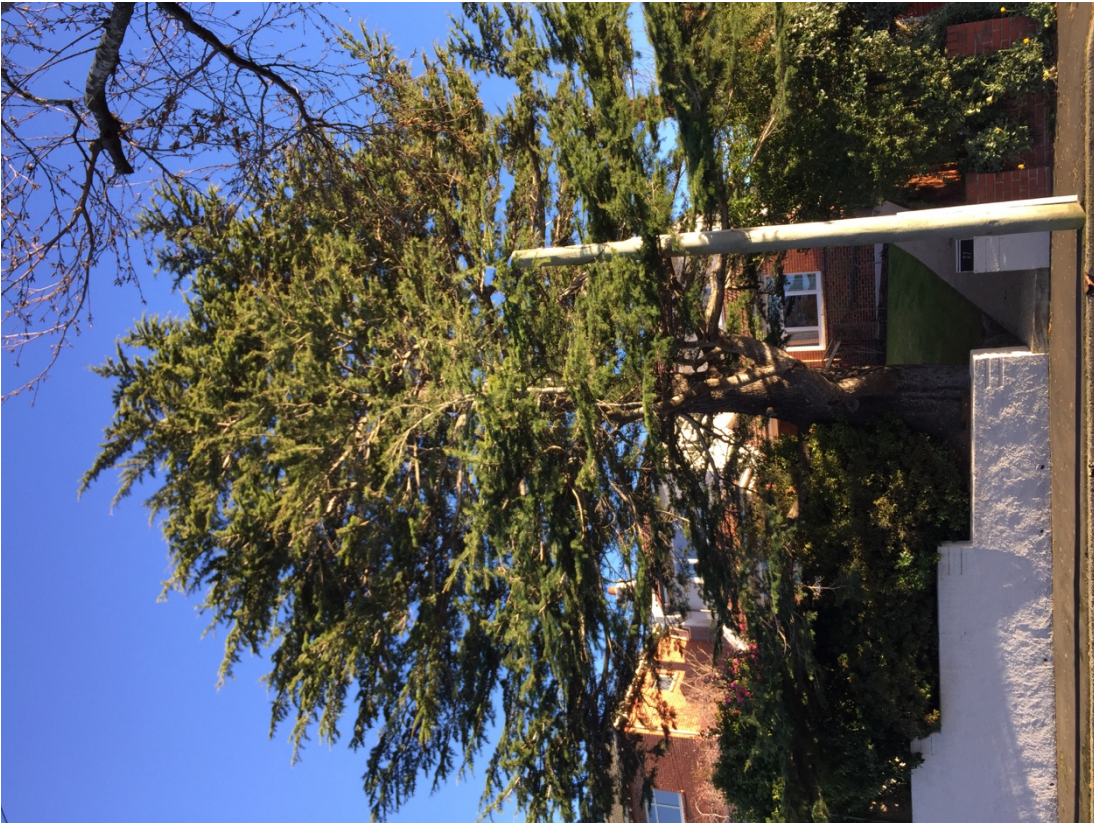
Image one: Image showing the relatively symmetrical canopy and branch habit of T442

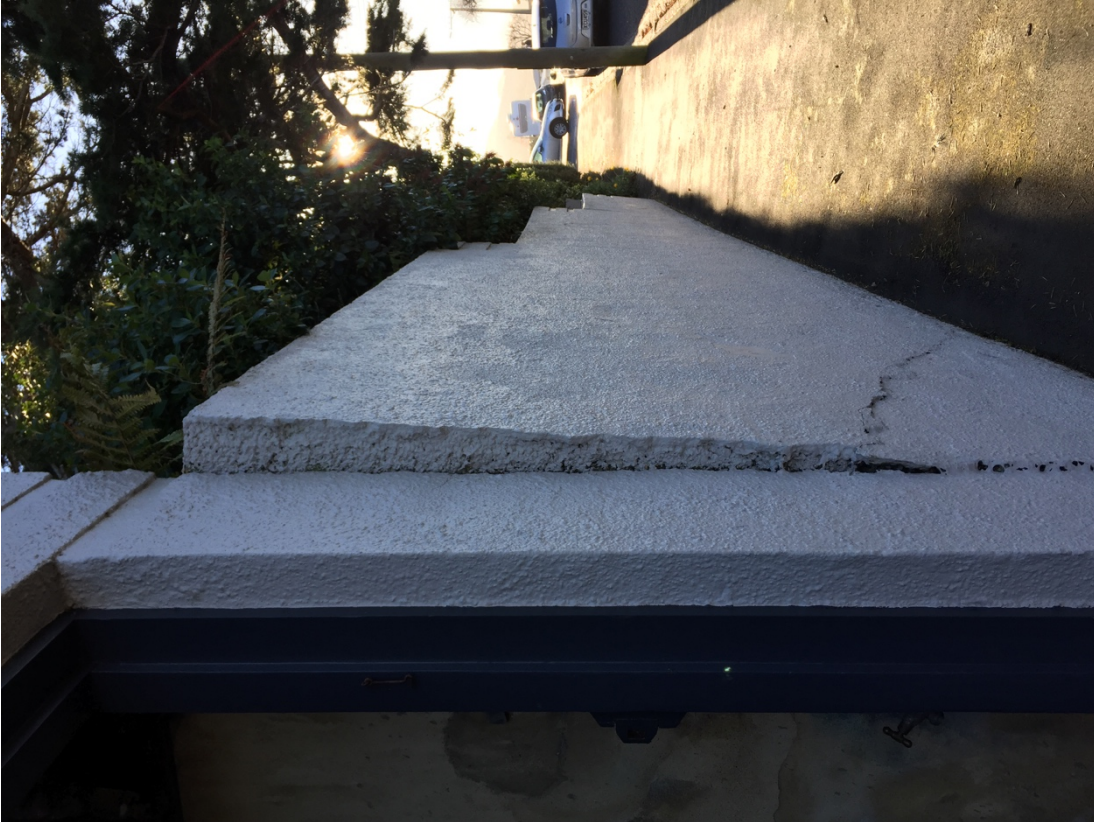
- 2.5 The applicant notes that; *'Of most concern... is that it has caused our retaining wall to lean over' the public footpath...'*
- 2.5.1 This is a factual statement

Image three: Image showing the front boundary fence / retaining wall at number 27 Falkland Street leaning out towards the footpath
