**Arborist Report from Valley Arboriculture Ltd**

# Arborist Report

27 King street, Mosgiel, Dunedin

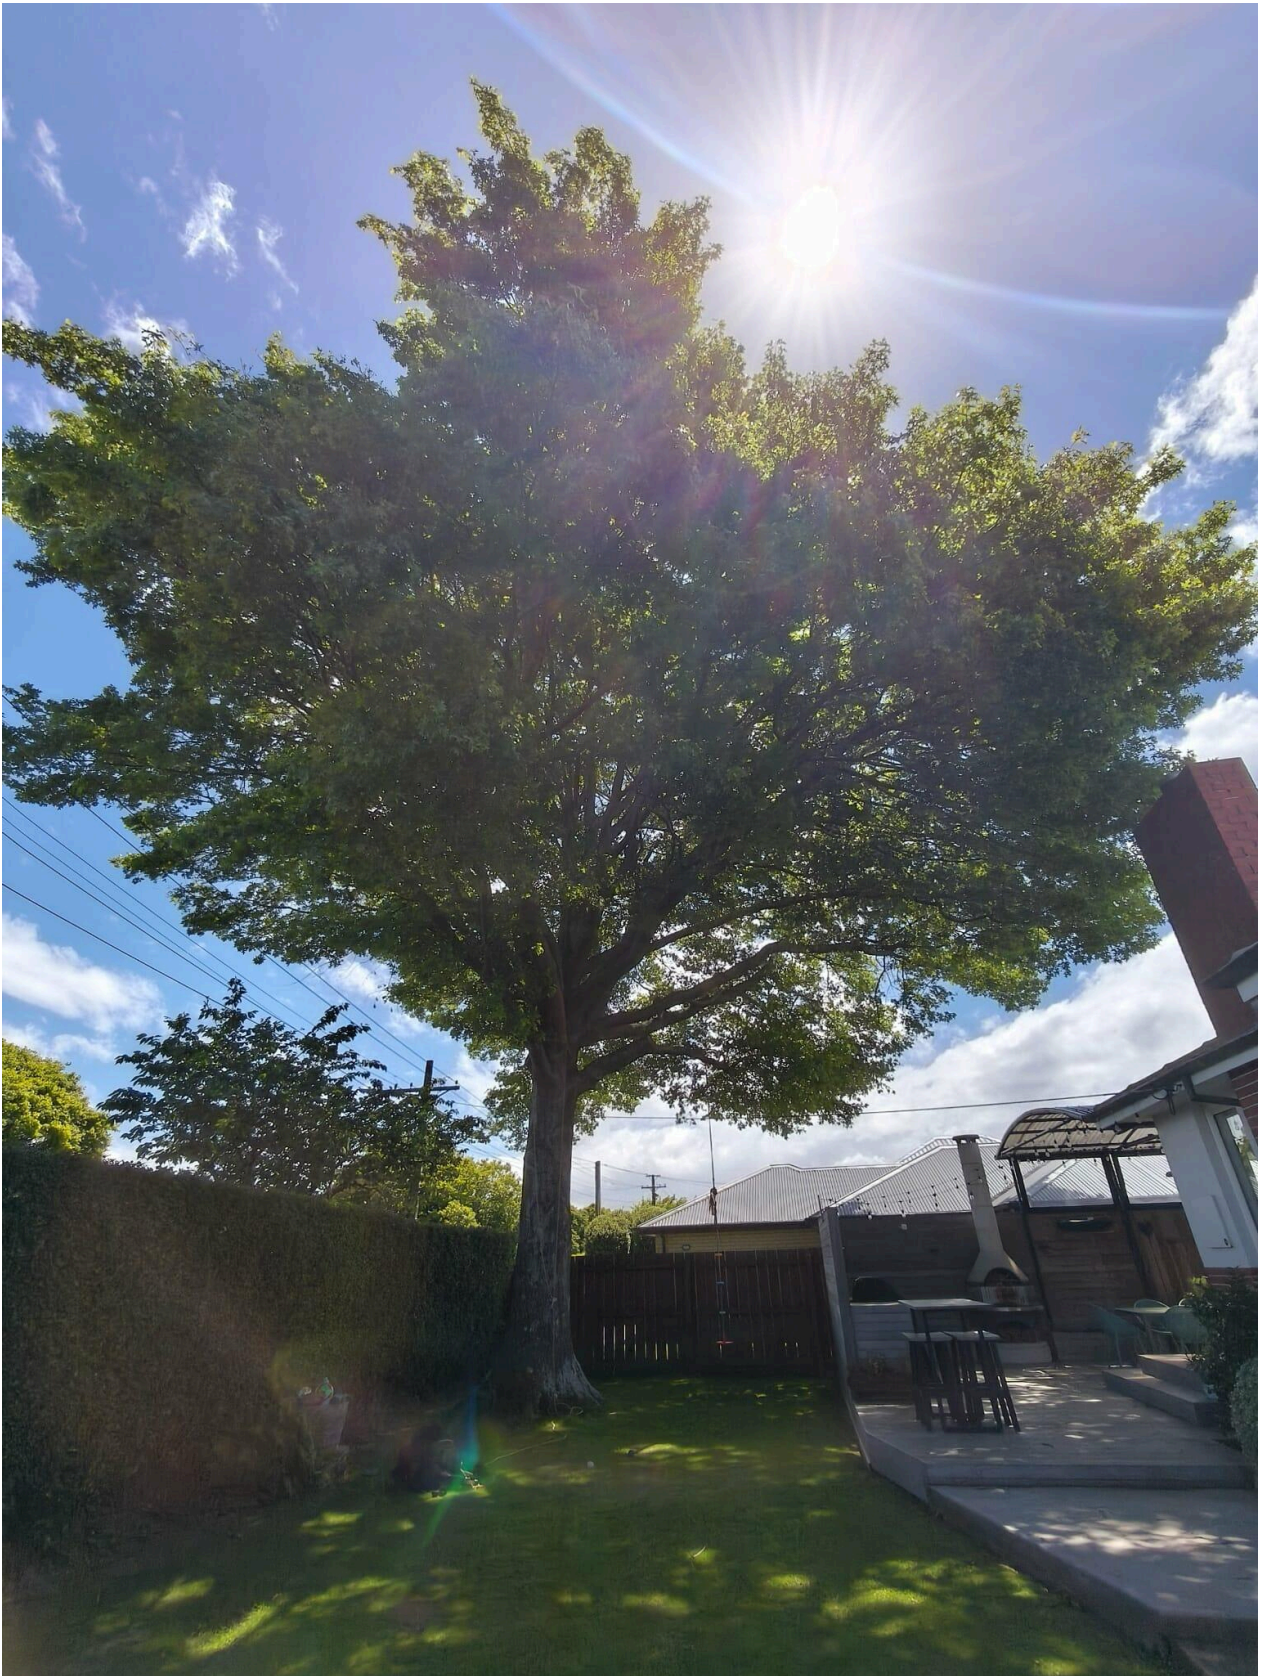
The inner canopy of the tree has been professionally pruned in the past for thinning, clearance of the powerlines, and removing select limbs growing towards the dwelling of 27 King street. Foliage in the canopy is of normal density and vitality with no defects, disease or insect damage visible at the time. There has been no signs of topping of the tree and previous pruning cuts show normal signs of reaction wood sealing over previous pruning cuts. There are very minor pieces of deadwood sporadically throughout the canopy which are too hard to see in photos but pose no risk to persons or property. The height of the tree is approximately 15M tall and the width of the canopy is approximately 12M across. Due to the powerlines being in close proximity of the tree it has been pruned more heavily on the western side to prevent the tree's growth from interfering with the lines. Due to this pruning the tree's canopy is slightly more dense on the eastern side but still maintaining a fairly asymmetrical vase form (figure 1).

Figure 1. The overhang of the tree to 27 King street dwelling.

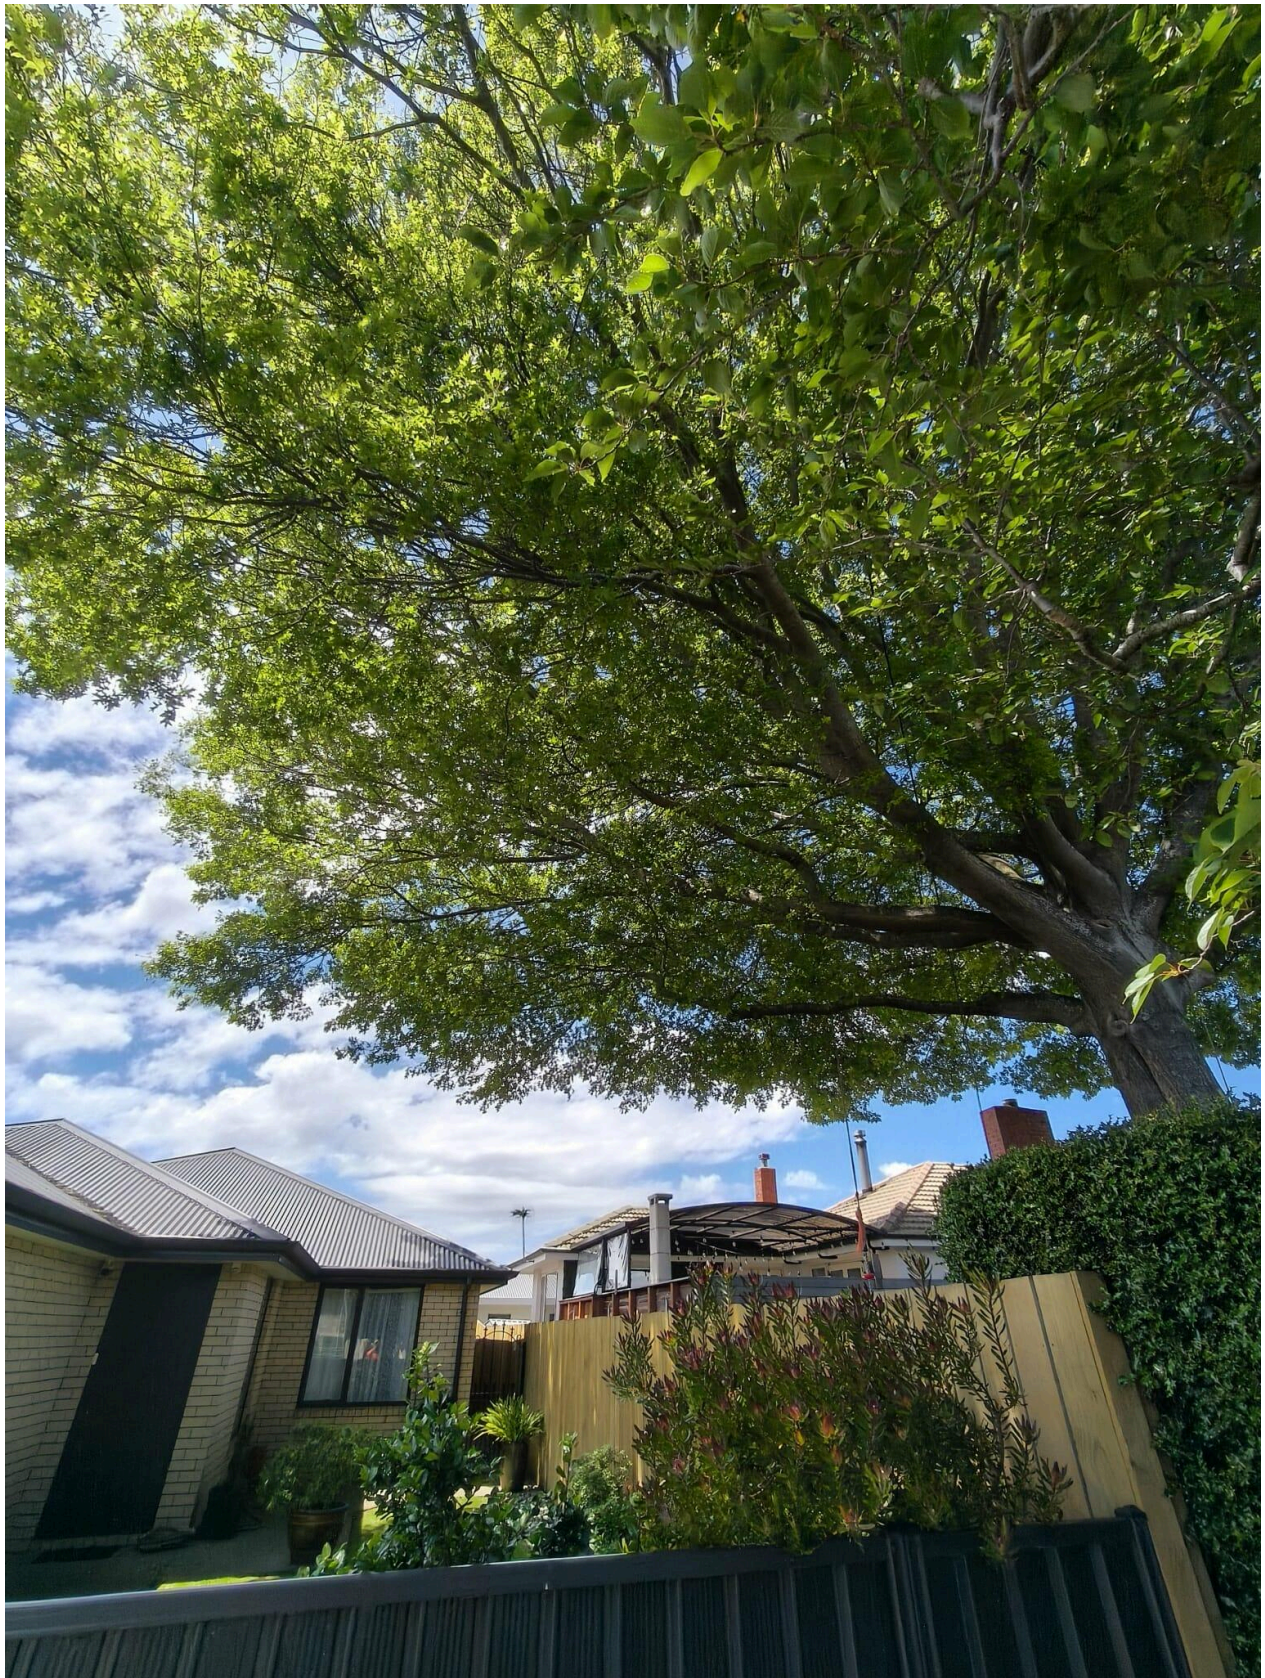
Figure 2. The overhang of the tree to 27A King street dwelling.

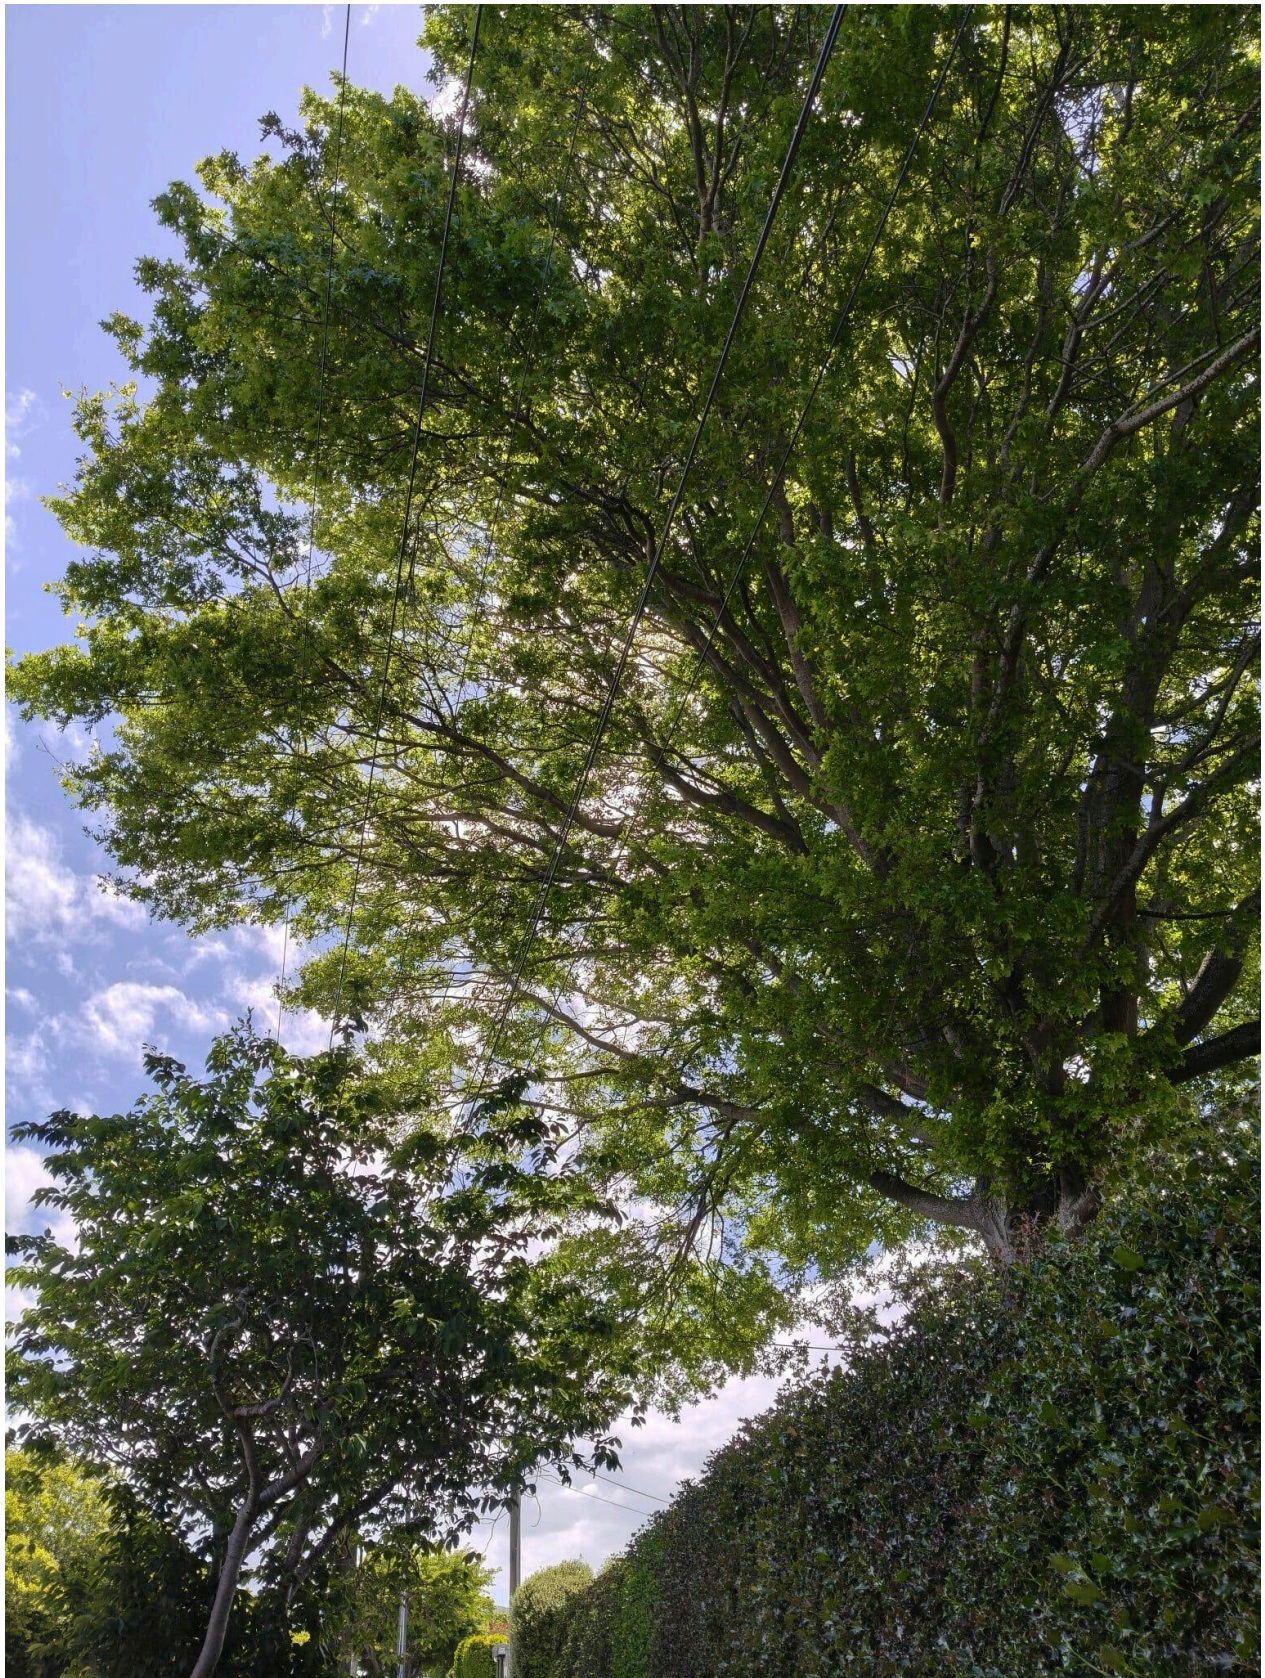
Figure 3. The tree's canopy extends above the power lines, footpath, and road. Although not in this picture the footpath is in between the cherry tree and holly hedge with the road running next to the cherry tree on the western side.

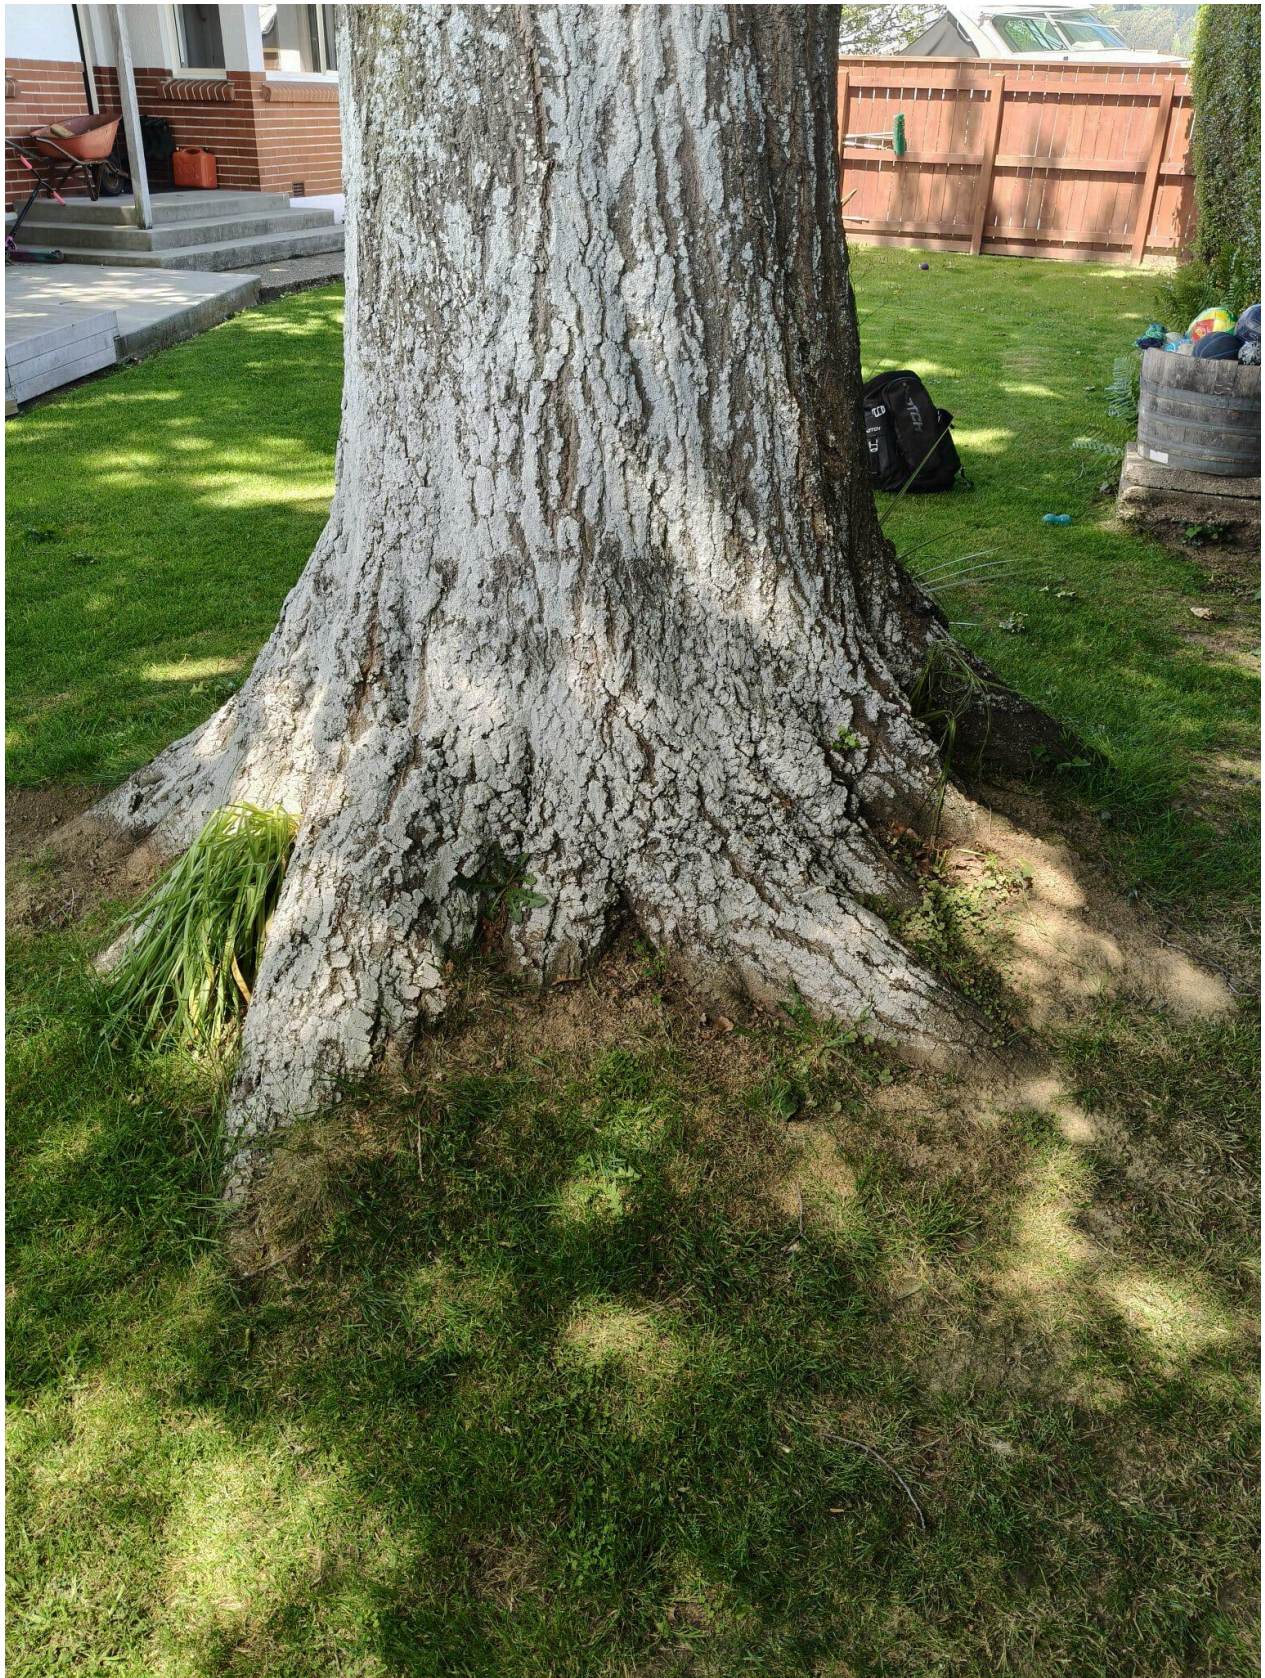
Upon initial inspection by the arborist, there is one tree in total identified on site therefore this report will be segmented for the singular tree only. The inspection for the tree was carried out on the 28th of November 2025 on a calm, sunny, cool day. The tree is in close proximity and overhangs the dwellings of 27 King street (figure 1) and 27A King street (Figure 2). Also directly underneath the tree is a fence that runs along the North side (figure1), a sidewalk along the north-western side, the road just inside the dripline of the tree, and finally powerlines (figure 3). There are no visible roots present above the surface of the ground with the sidewalk, road, and driveway of 27A King street possibly impeding the growth of the roots due to severe compaction. The root flare of the tree is present and in good health (figure 4).

Figure 4. A healthy rootflare at the base of the tree.

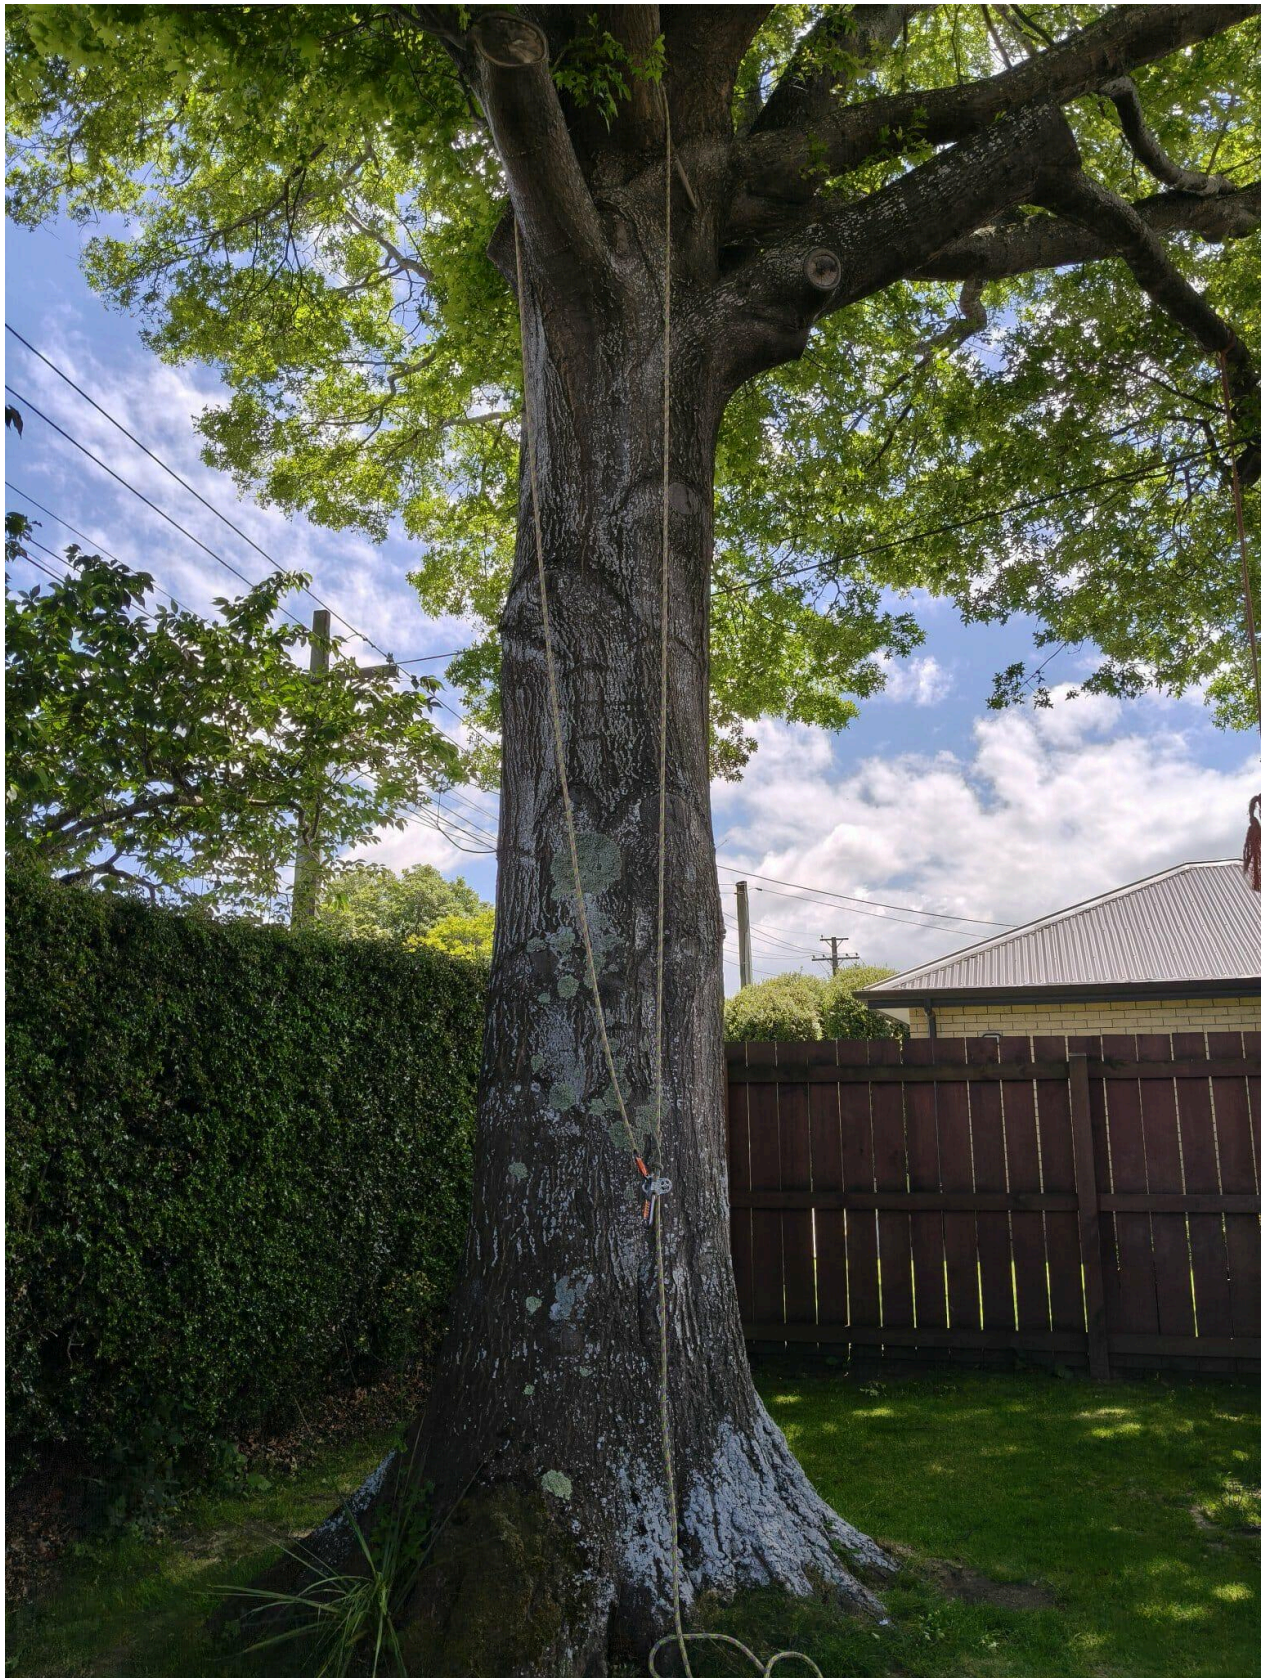
The trunk of the tree is a singular straight trunk roughly 4M up from the root flare (figure 5). On the north west facing side of the trunk there appears to be the presence of a torsional crack (figure 6) that reaches from the top of the root flare (figure 7) and stops just above a pruning cut near the top of the trunk (figure 8). The tree has sealed over the crack but is showing signs of a ram's horn developing at the top of the wound. There is also an indent mirroring the torsional crack on the south side of the trunk (figure 9). The tree has developed multiple stems above the main trunk (figure 10). The area in which the stems generate from is roughly 2M long from the top of the trunk to the last cluster of stems, because of this growth there is no main central leader present. There are multiple stems in this area that have developed with included bark (figure 11.1-11.6).

Figure 5. Trunk of the tree facing south.

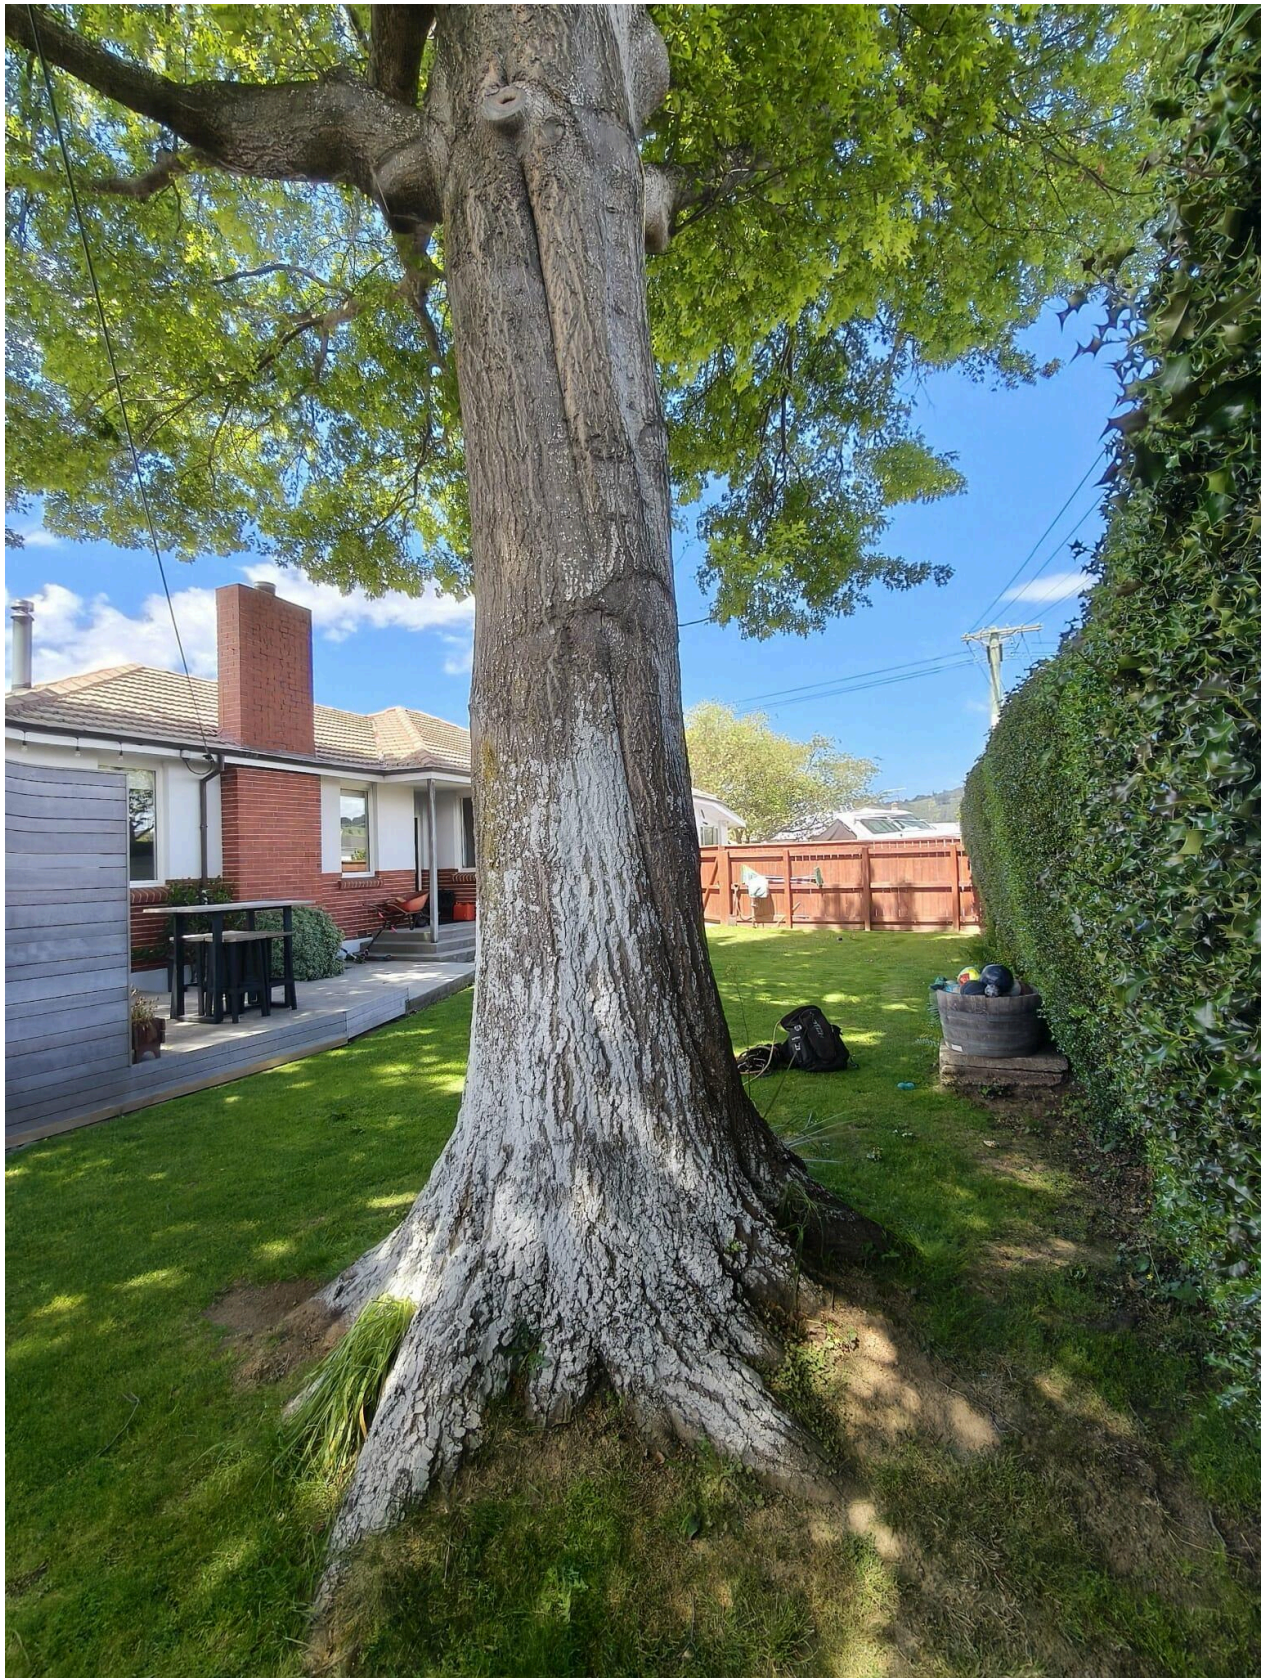
Whole tree failure does not appear imminent but the torsional crack on the north side of the trunk and mirrored seam on the south side does raise the concern of how structurally sound the trunk is. A torsional wound in the tree is normally caused by extreme weather events which twist the wood causing the fibres to shear apart. Because of the size of the tree's canopy there is a significant amount of weight and force being applied through the wound area which has the potential to create a whole tree failure stemming from the trunk of the tree.

Although we cannot see the full extent of the torsional crack we can use sonic tomography to determine the presence of significant cracking or decay in the area of the wound. There are alternative methods of determining the amount of damage in the trunk of the tree but they are invasive and not entirely reliable in this situation.

Figure 6. The overall length of the torsional crack on the north west facing side of the trunk.

Tree works will be performed by trained and qualified arborists only. There are two recommendations that I can suggest which can reduce the risk of failure. Firstly I suggest an aggressive but gradual retrenchment of the canopy in three pruning segments over the timespan of 6-8 years with each pruning segment reducing the overall canopy of the tree by 20%. After each reduction is made the tree should be monitored for the response growth and assessed the following year. If the tree responds well the pruning should commence again the following year and so forth. This option will reduce the windsail of the tree, reduce end weight of the limbs with included bark, and ease the pressure on the torsional wound in the trunk. Because this will be a very aggressive prune there will be a significant amount of epicormic growth as a defense mechanism from the tree. This new epicormic growth will have to be maintained frequently in the future to prevent overcrowding and improper canopy restructuring.

My second recommendation would be the complete removal of the tree. The client has voiced their concern and fear of being in their house while high winds are present. I cannot quantify their fear in a reporting format but it should be noted how the individuals are affected. By removing the tree we remove all risk associated with it. If the tree is to be removed I would also recommend a new tree suitable for the area to be planted in its place.

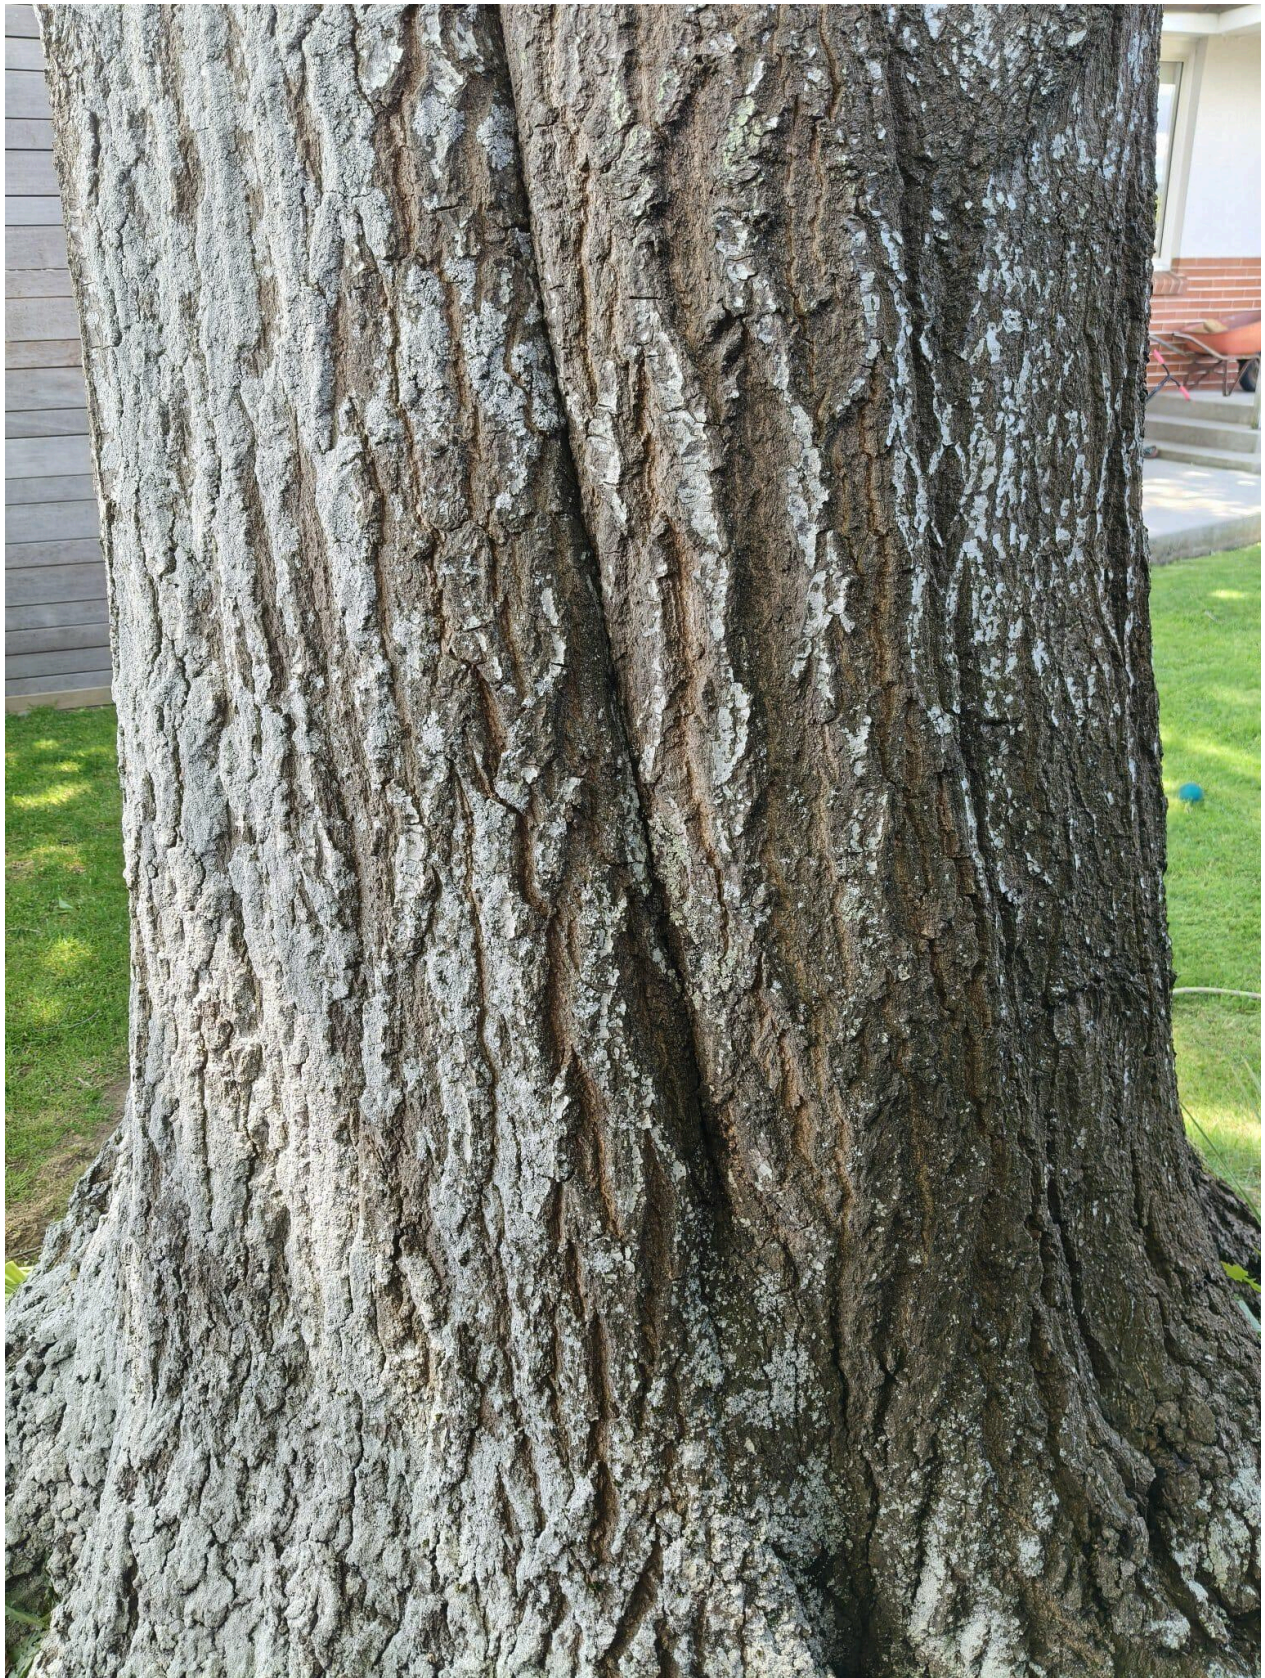
Figure 7. The bottom of the torsional crack.

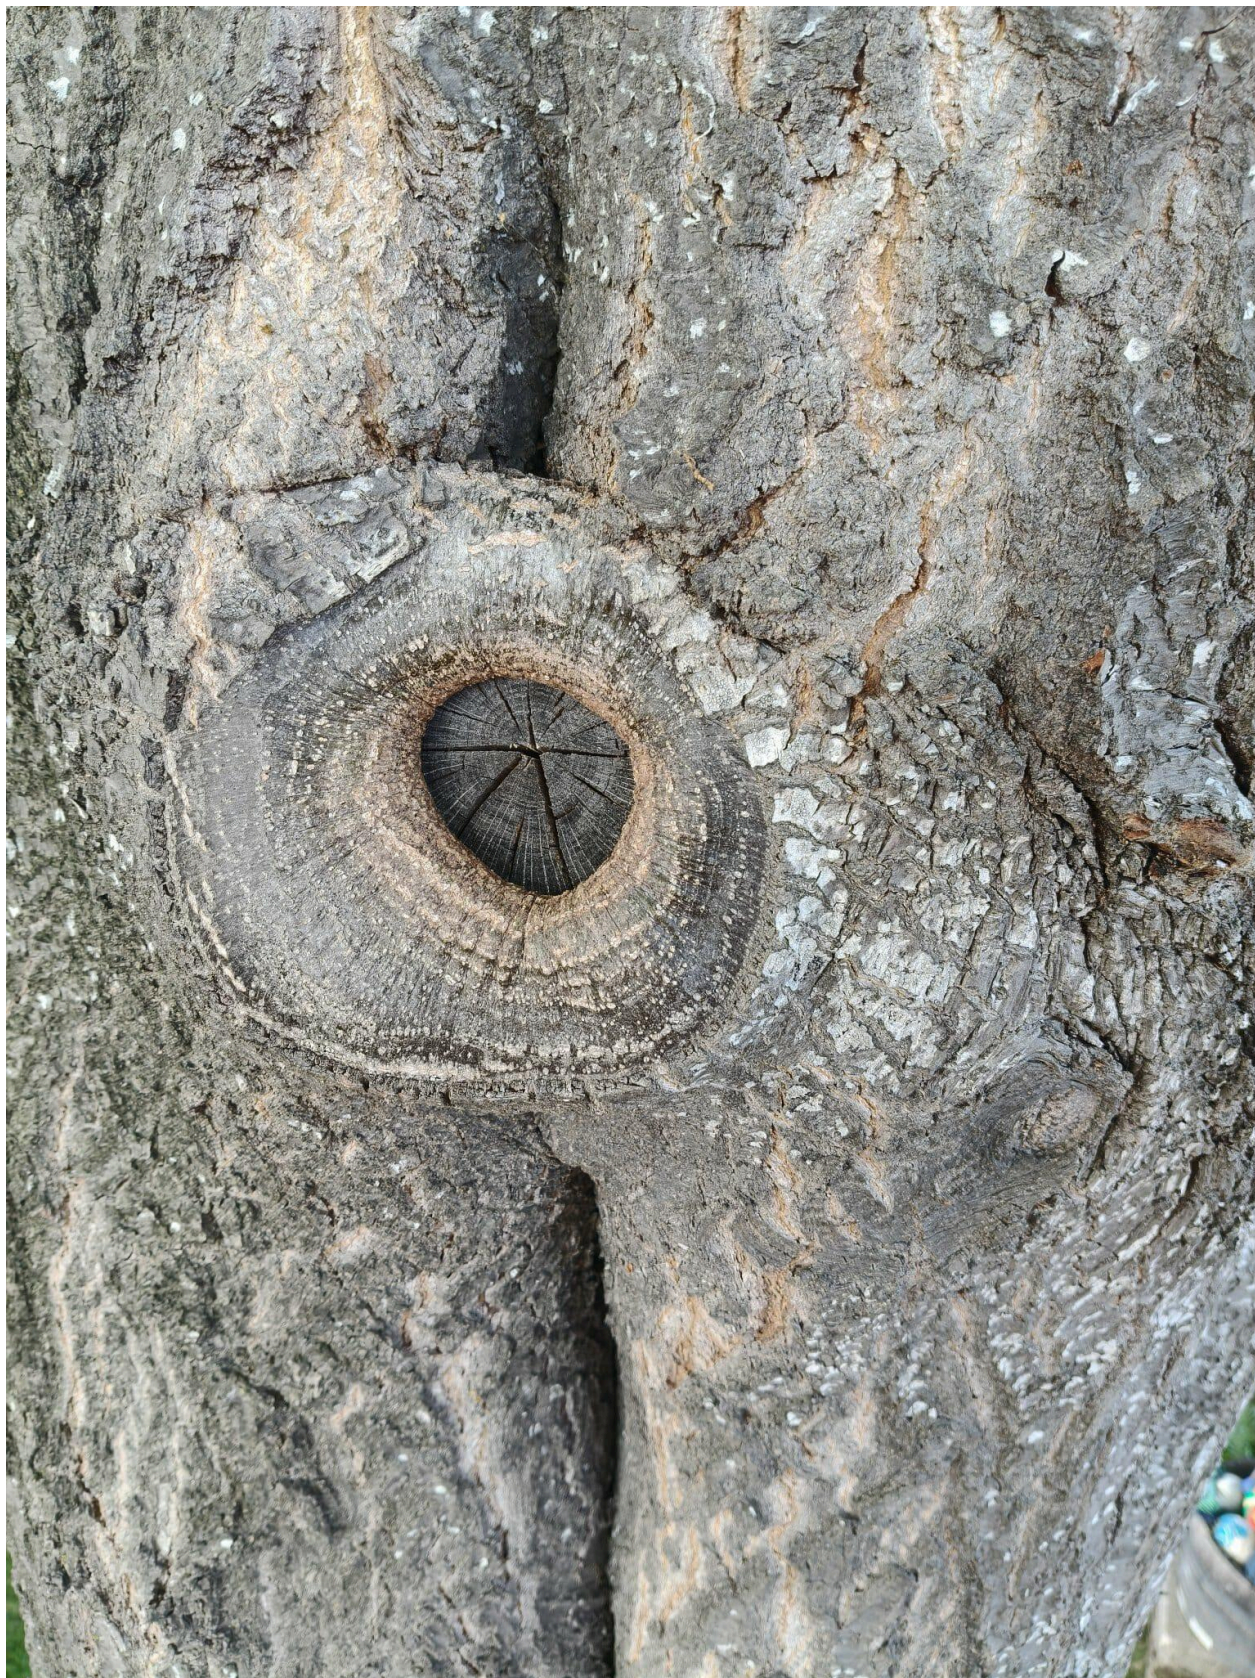
Figure 8. The top of the torsional crack.

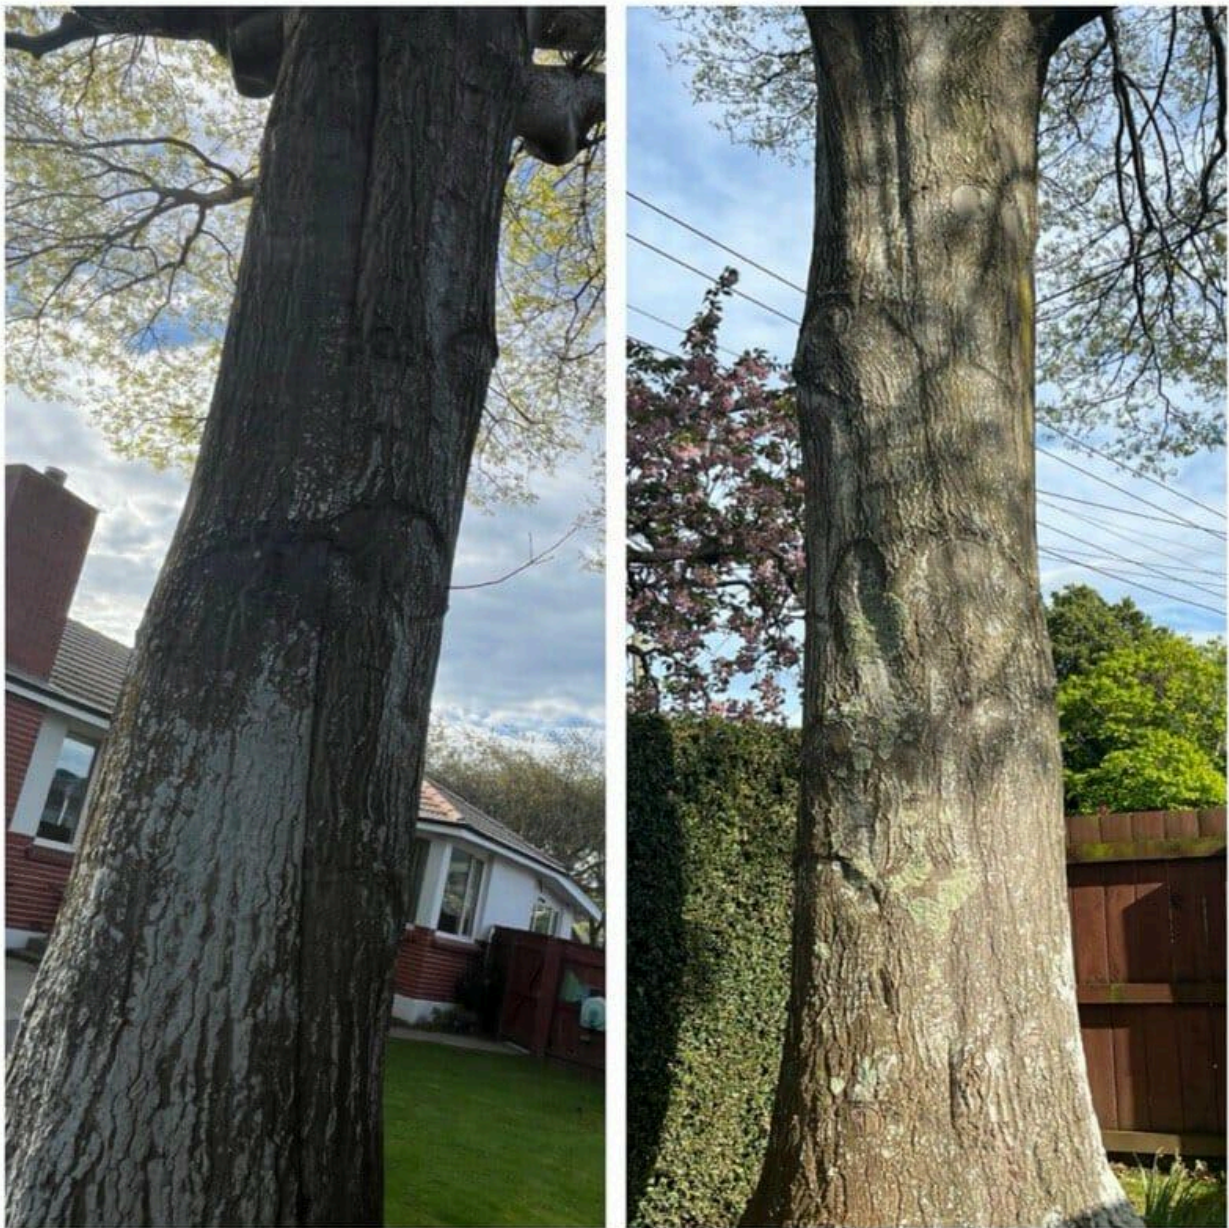
Figure 9. The torsional crack is shown in the left photo with the mirrored indent in the photo on the right.

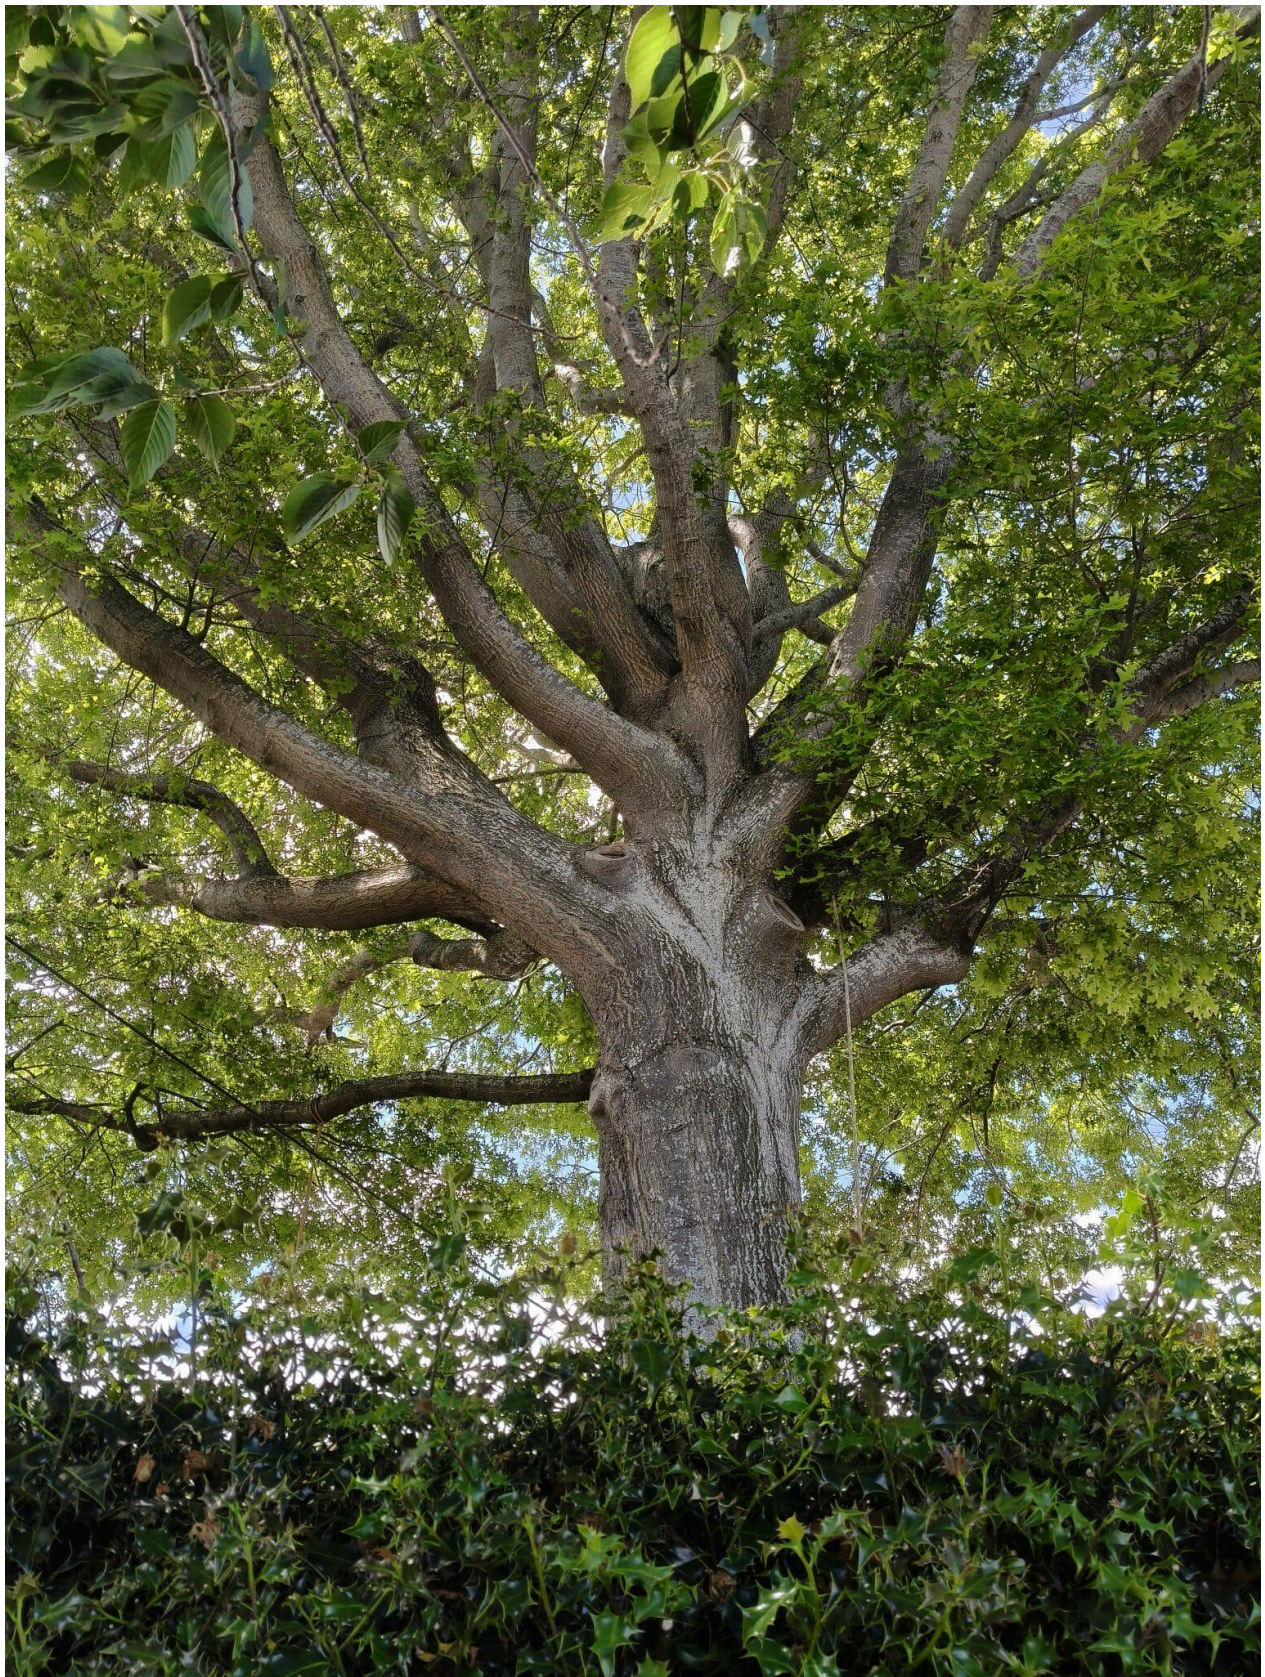
Figure 10. Multiple stems forming above the main trunk.
