**Arborist Report from Valley Arboriculture Ltd**

# Arborist Report

27 King street, Mosgiel, Dunedin

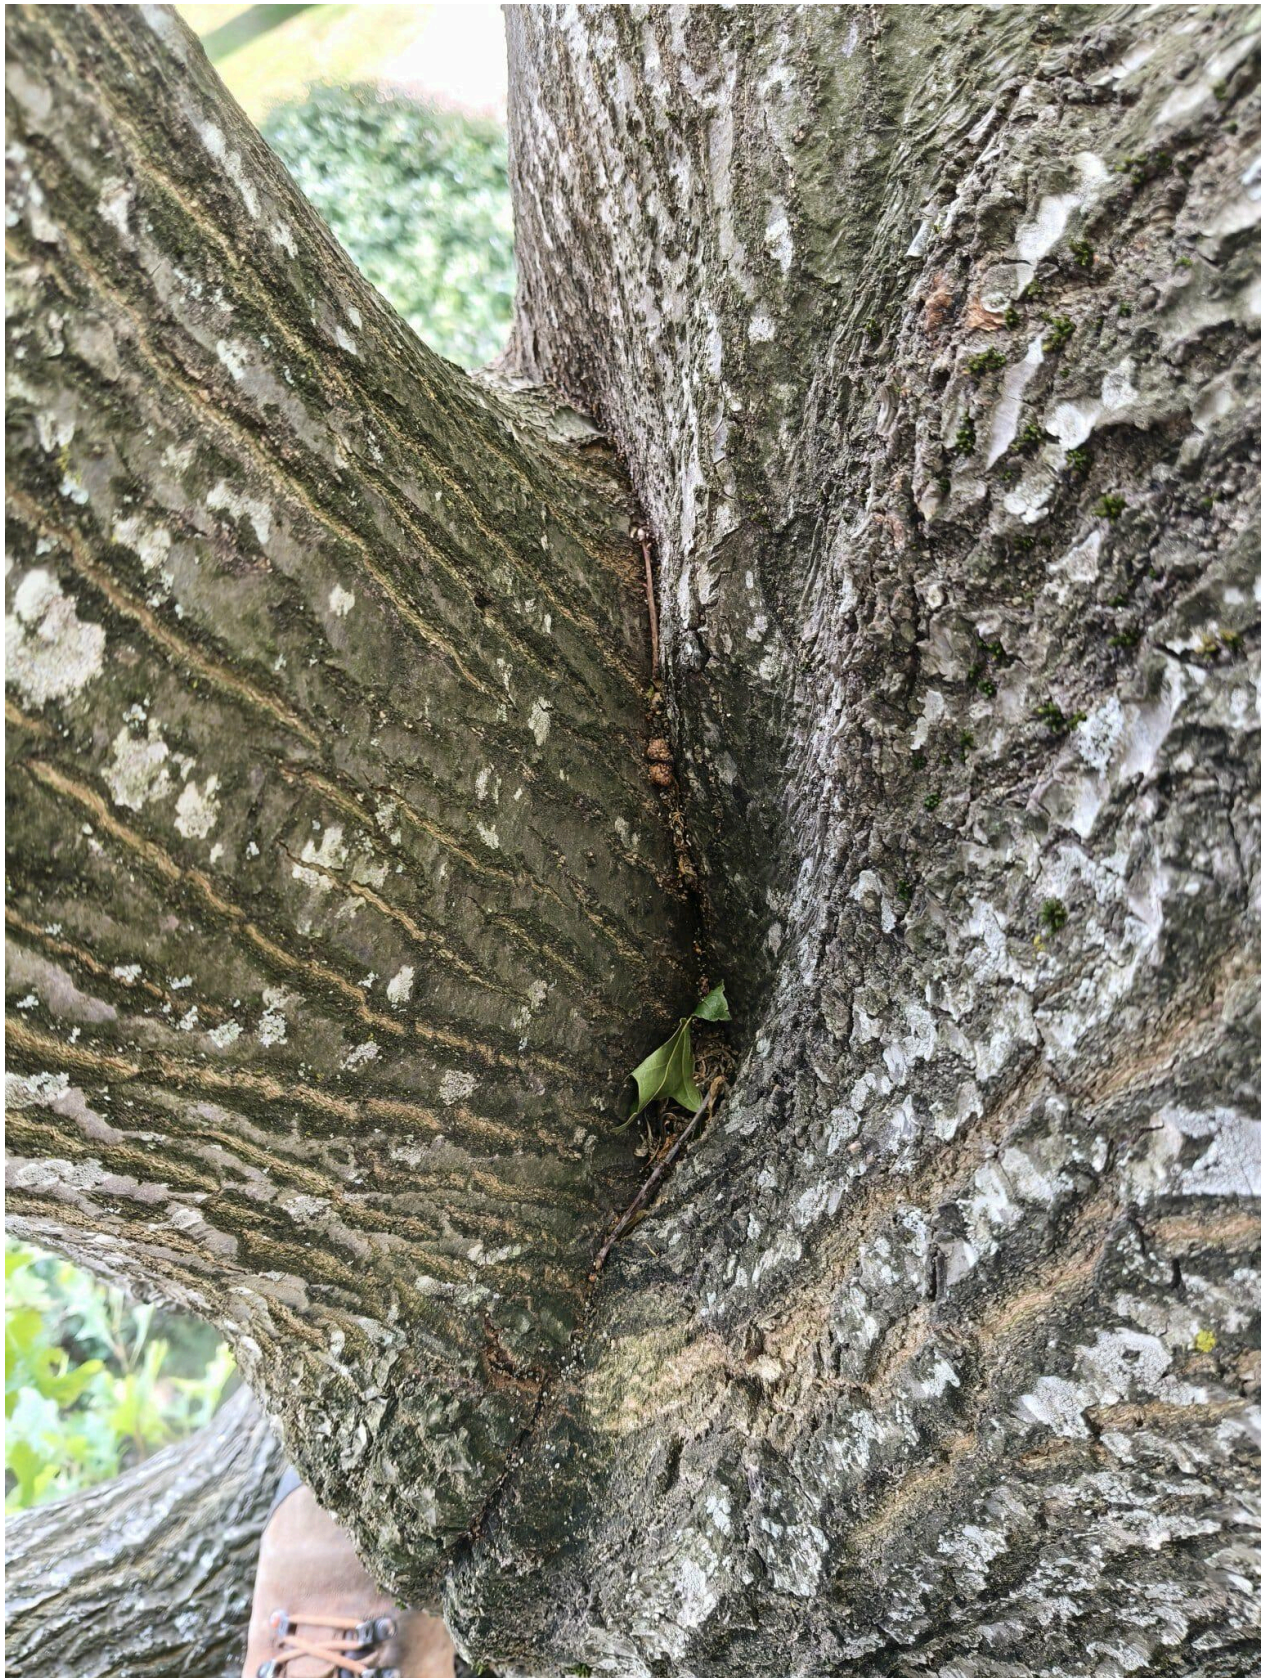
The trunk of the tree is a singular straight trunk roughly 4M up from the root flare (figure 5). On the north west facing side of the trunk there appears to be the presence of a torsional crack (figure 6) that reaches from the top of the root flare (figure 7) and stops just above a pruning cut near the top of the trunk (figure 8). The tree has sealed over the crack but is showing signs of a ram's horn developing at the top of the wound. There is also an indent mirroring the torsional crack on the south side of the trunk (figure 9). The tree has developed multiple stems above the main trunk (figure 10). The area in which the stems generate from is roughly 2M long from the top of the trunk to the last cluster of stems, because of this growth there is no main central leader present. There are multiple stems in this area that have developed with included bark (figure 11.1-11.6).

Figure 11.1. Included bark on the limb growing above powerlines.

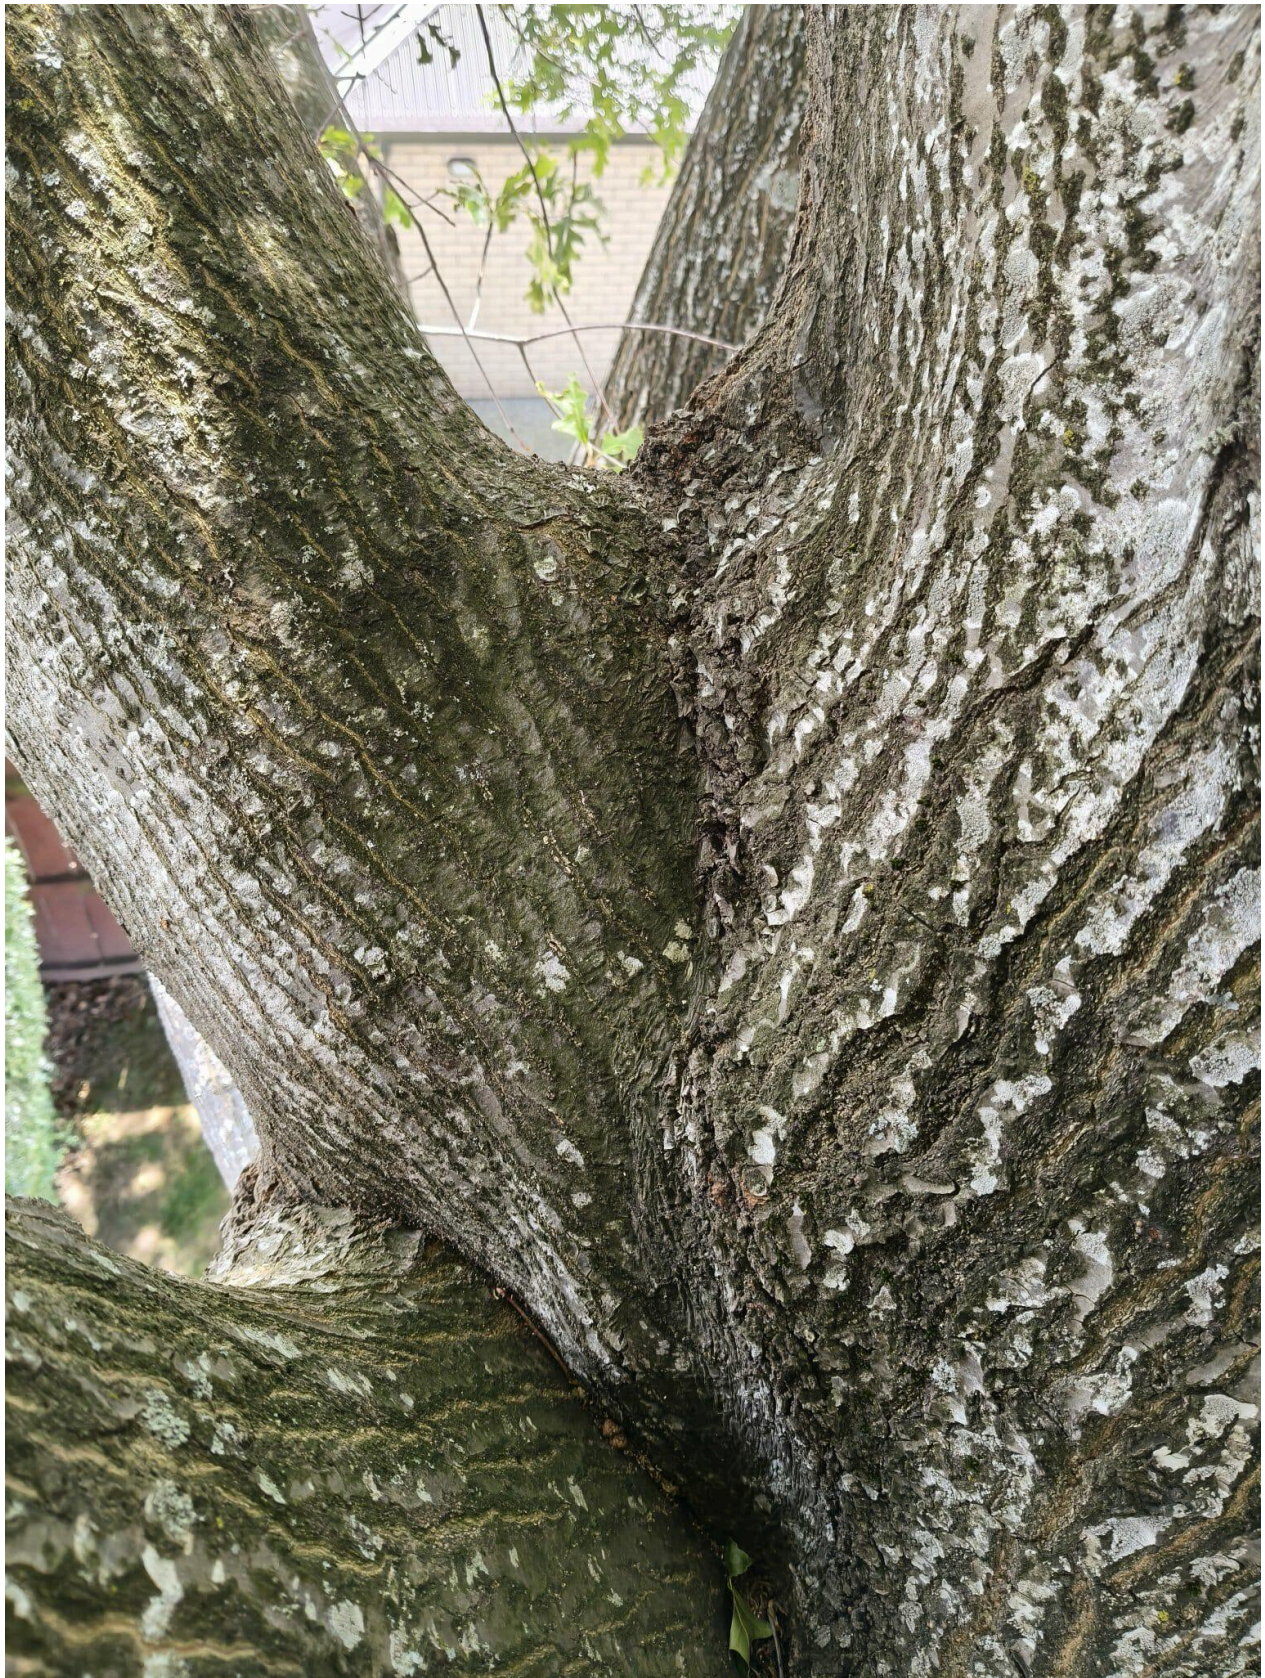
The trunk develops into a multi stemmed canopy which extends over multiple static and non static targets below and near the tree. The main concern for this area is that multiple stems have developed included bark in their attachment points to the main stem. Included bark is a structural defect in which the bark of the tree grows inward and becomes trapped between two limbs or stems instead of growing normally together and upwards to form a healthy union. There are two limbs that are affected with included bark which are above powerlines and in an event of a failure can cause significant damage to power lines, vehicles parked along the road and pedestrians along the sidewalk (Figure 11.1- 11.2). At the north side of the tree there is one stem with included bark and in an event of a failure can cause minimal damage to the lower canopy of the tree, dwellings of 27A King street, and the wooden fence (figure 3). Additionally there has been a small fresh crack along the top of a stem that grows towards 27A King street (figure 11.7) Along the east side of the tree there are two more stems with included bark that grow above the dwelling of 27 King street which in an event of a failure can cause moderate damage to the structures below (Figure 11.4-11.6). As these limbs continue to grow they will continue to push against each other which can cause failure at the unions (Figure 11.2-11.6).

Figure 11.2. Another limb with included bark growing towards the power lines. This photo shows how as the limbs grow in diameter they will continue to press against each other with no space to develop.

Tree works will be performed by trained and qualified arborists only. There are two recommendations that I can suggest which can reduce the risk of failure. Firstly I suggest an aggressive but gradual retrenchment of the canopy in three pruning segments over the timespan of 6-8 years with each pruning segment reducing the overall canopy of the tree by 20%. After each reduction is made the tree should be monitored for the response growth and assessed the following year. If the tree responds well the pruning should commence again the following year and so forth. This option will reduce the windsail of the tree, reduce end weight of the limbs with included bark, and ease the pressure on the torsional wound in the trunk. Because this will be a very aggressive prune there will be a significant amount of epicormic growth as a defense mechanism from the tree. This new epicormic growth will have to be maintained frequently in the future to prevent overcrowding and improper canopy restructuring.

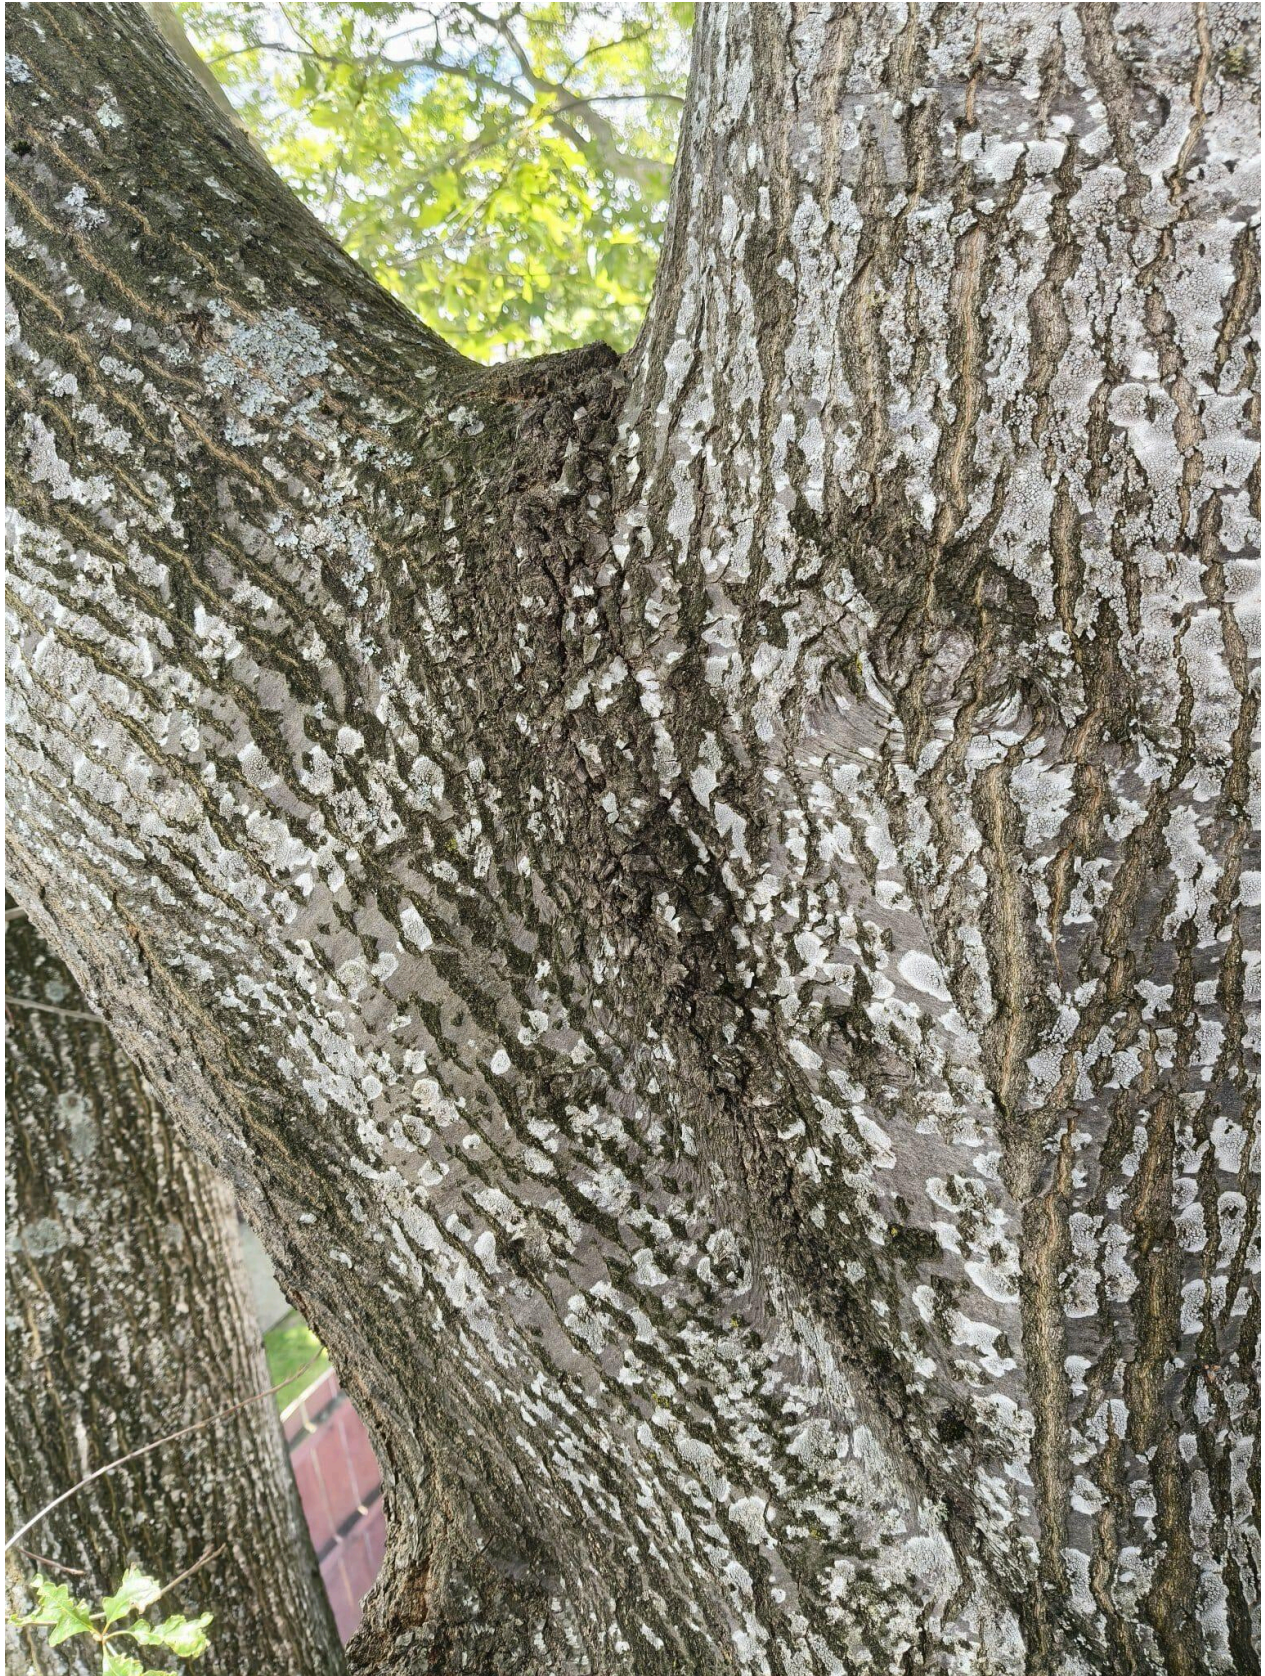
Figure 11.3. Included bark on two stems near the middle top portion of the lower canopy.

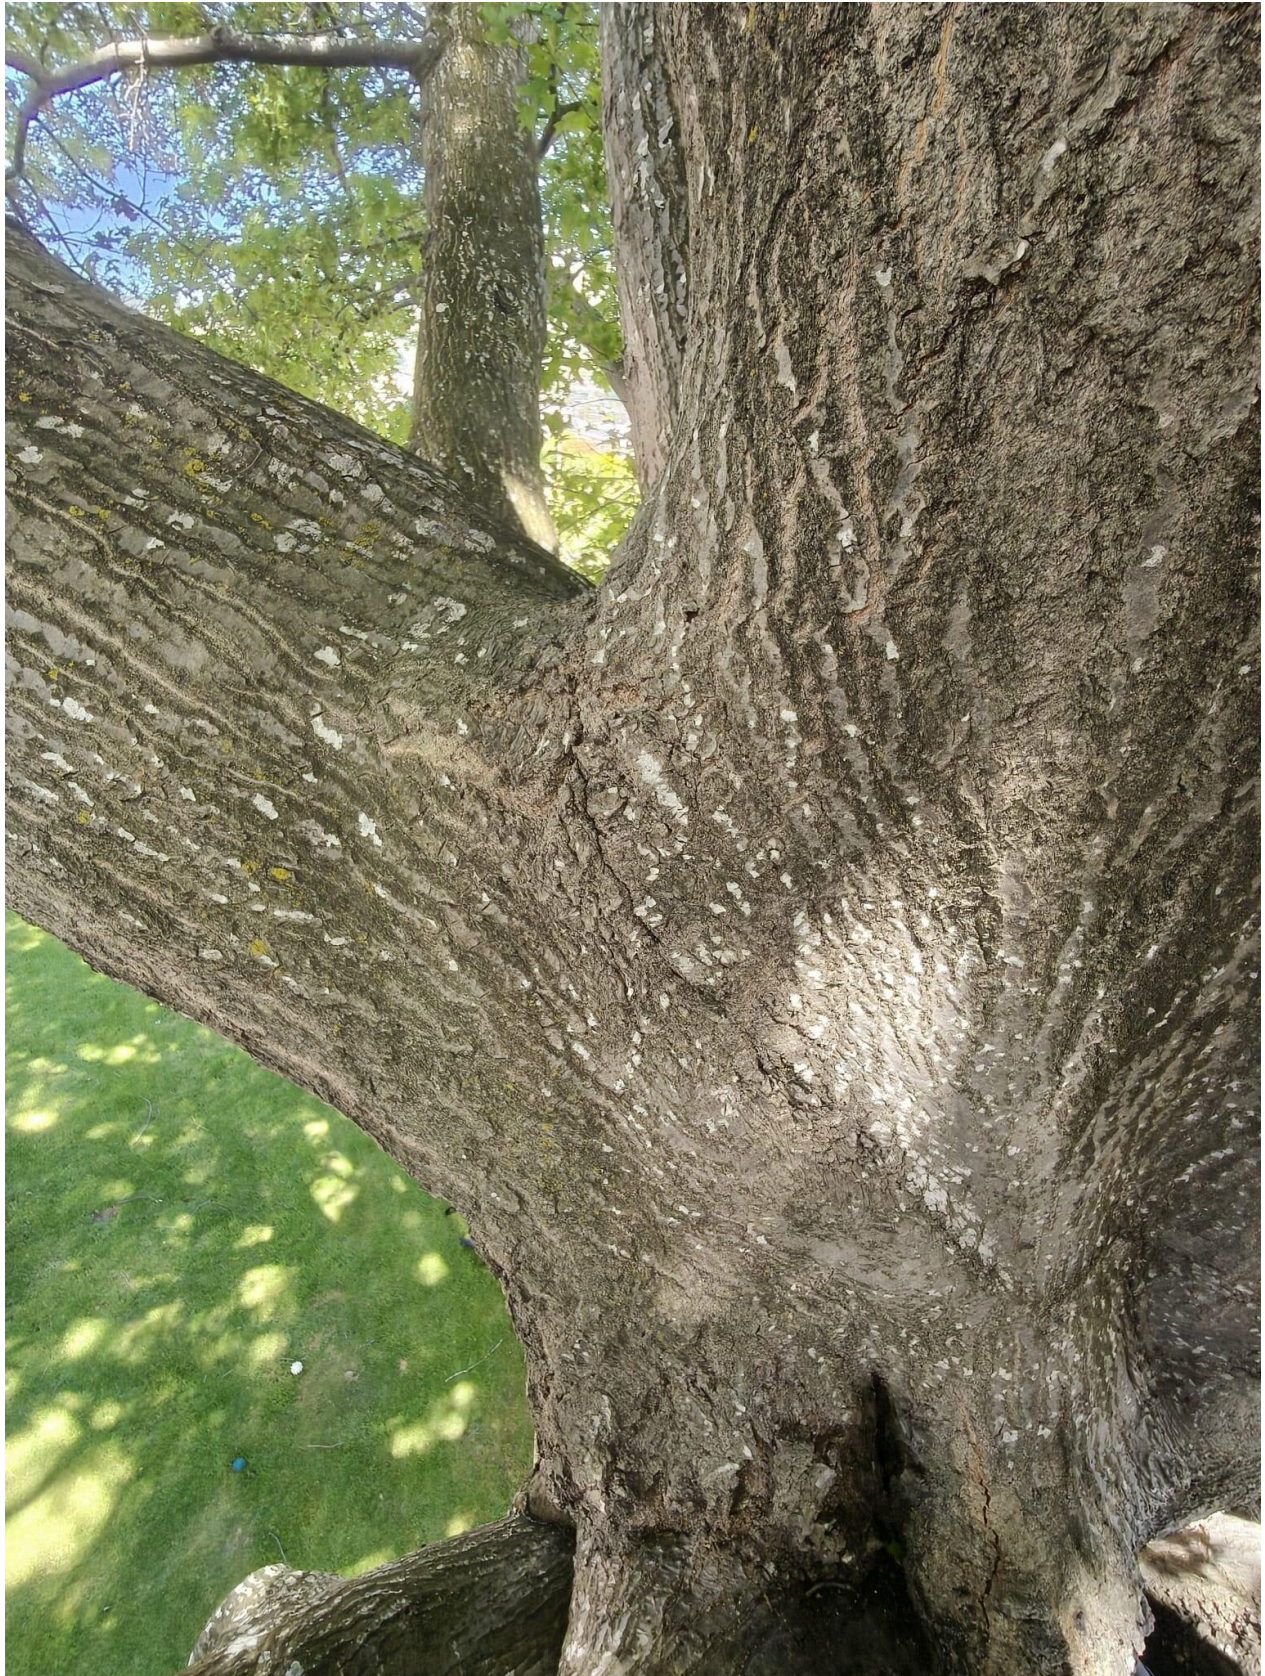
Figure 11.4. Large limb that grows towards the house with included bark.

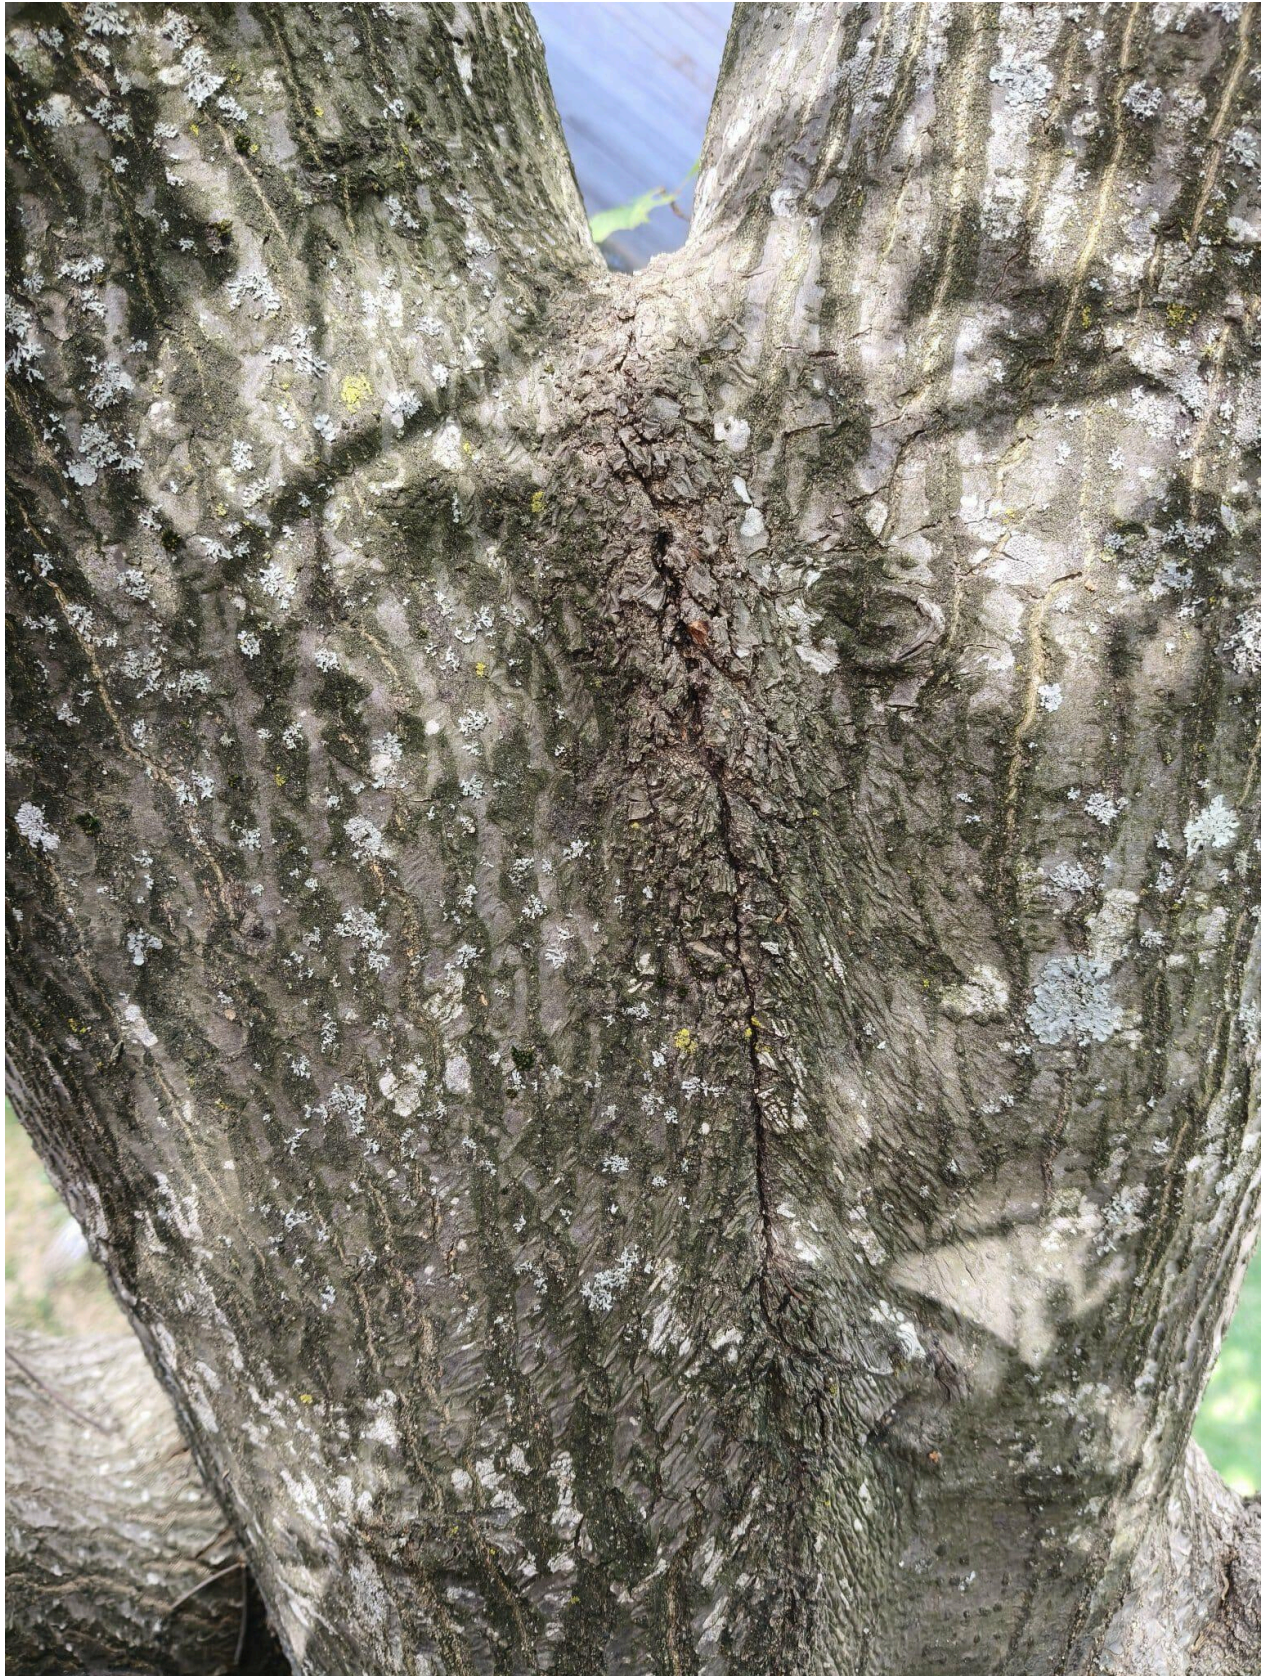
Figure 11.5. The highest stems of the tree have formed an included bark.

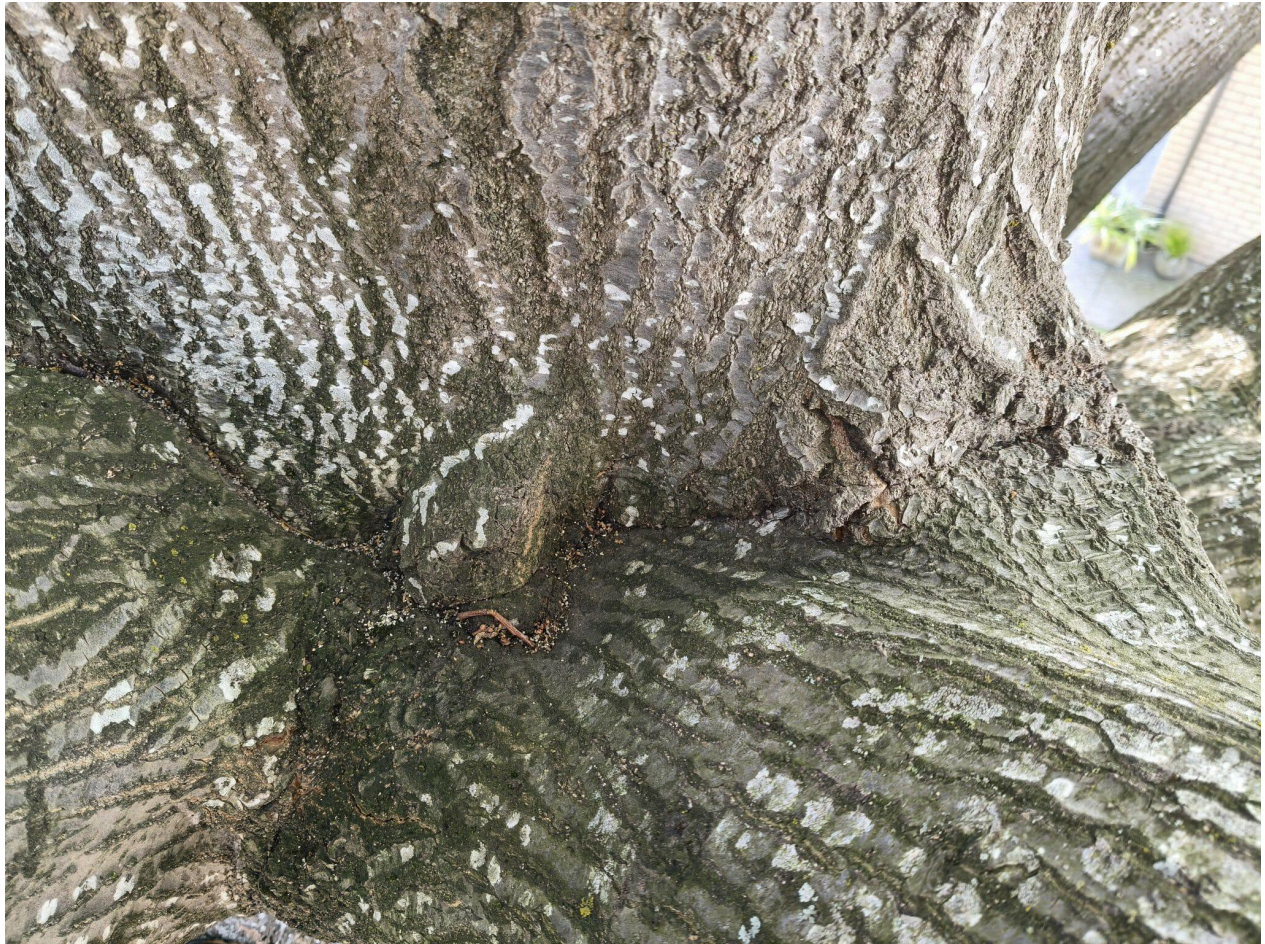
Figure 11.6. Another large limb growing towards the house with included bark. This photo shows how as the limbs grow in diameter they will continue to press against each other.

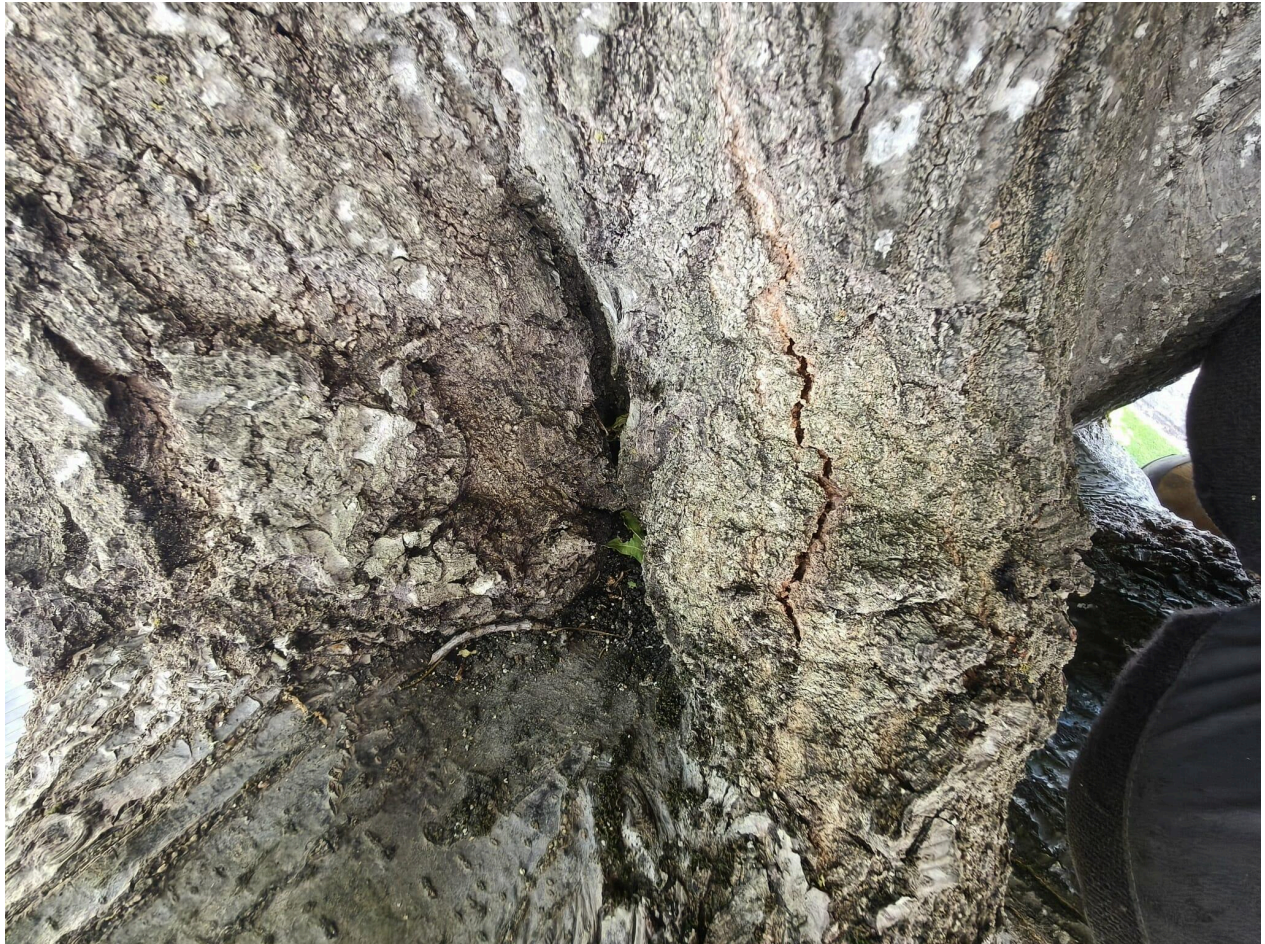
Figure 11.7. A small crack has formed above a limb.
