| <b>IN THE MATTER</b> | an application for resource consent<br>of LUC-2015-469 |
| <b>BY</b> | Blueskin Energy Limited<br><br>Applicant |

**BRIEF OF EVIDENCE OF VIRGINIA GAIL TOY**

# **Geological and Geotechnical Report on Porteous Hill Wind Farm Site**

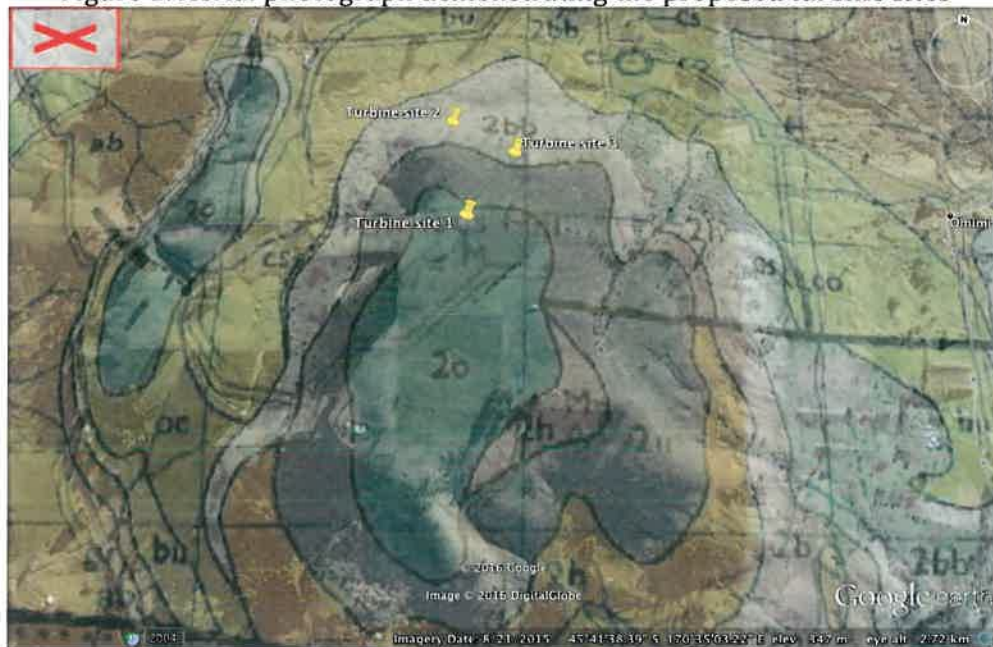
The site is underlain by basalts of the Dunedin Volcanic Group (Figs. 1, 2). These are solid volcanic rocks, ie. 'strong' to 'very strong' in the geotechnical sense (refer to classification in Appendix 1). They were deposited from 10-6 million years ago, and have since experienced substantial near-surface weathering, so now they are geotechnically 'highly-weathered' to 'completely -weathered' (App. 1). Weathering resulted in formation of a horizon of soil that is 'medium dense' to 'very dense' in the geotechnical sense (App. 1) with a thin veneer of topsoil (again, in the geotechnical sense, a soil containing substantial organic matter; App. 1). The soil contains numerous less weathered boulders of hard rock. These remnants can be observed outcropping at proposed turbine sites 1 and 2. The area around the immediate site is underlain by Tertiary sedimentary units (Fig. 2).

Figure 2: Geological map overlain on aerial photograph of the proposed turbine sites. The area covered is similar to that in Fig. 1. Geological units are either basalts ( 2o = olivine basalt; 2h = Waitati phonolite; 2m = mugearite; 2n = nepheline diorite); 2bb = basaltic breccia; or Tertiary sedimentary units (cs = Caversham sandstone; co = Concord greensand and Scroggs Hill limestone; br = Brighton formation limestone and shelly greensand; gr = Green Island loose sand; ab = Abbotsford mudstone). The Tertiary sediments are much more susceptible to landsliding than the basalts as they are comparatively unconsolidated.

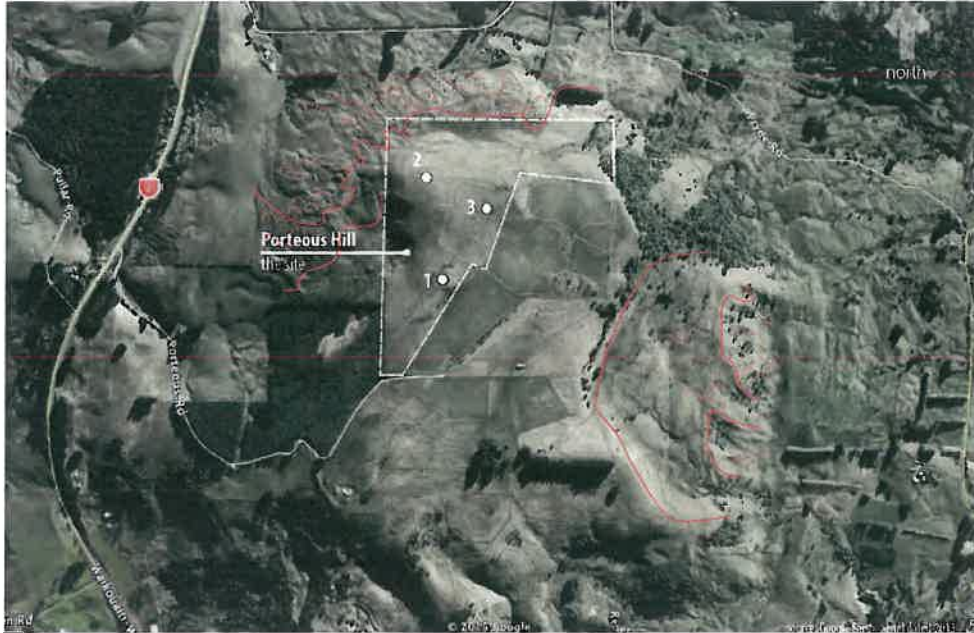
Figure 3: Aerial photograph of the proposed turbine sites with red annotations indicating typical topographic expression of landslides. Solid red lines are 'headscarps' - ie. the upslope limit of the slides; scallops indicate 'hummocky topography' typical of the slumped soil that has separated from the headscarp and slid downhill.

geomorphic expression of shallow-seated soil slides. In the Porteous Hill area, this landslide geomorphology is restricted to the slopes significantly downhill of the proposed turbine sites. There are no geomorphic signs of slope instability on the basaltic units that underlie the turbine sites themselves. This is testament to the relative competency of the soils derived from these units by weathering.

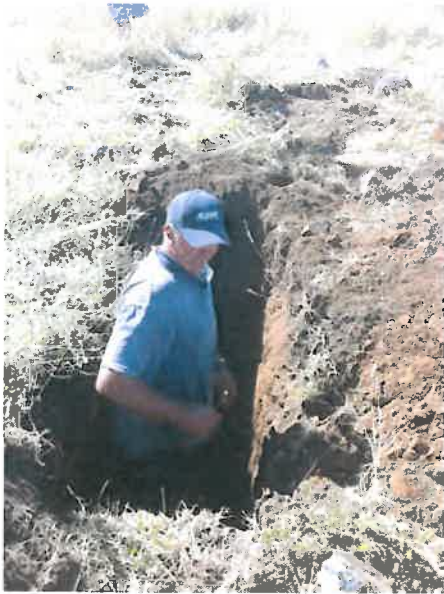
During construction of a wind strength testing tower in February 2013, a number of <2.0m deep pits were dug near to proposed turbine site 2 (Fig. 6). I have examined photographs of these pits, and observe that the material recovered within them appear similar to the soil I recovered during the hand auger investigation reported herein. Again, groundwater was not encountered in any of these pits.

Figure 6: Photograph of test pit dug for testing tower foundation
