**GreenTrees Ltd**Peter Waymouth - Consulting Arborist  
11 Bouverie St, Dunedin, NZ, 9010p 03 473 8065  
m 027 432 9646  
e pw@greentrees.co.nz

23.08.24

Phillipa & Darren Bain  
27 King St  
Mosgiel 9024

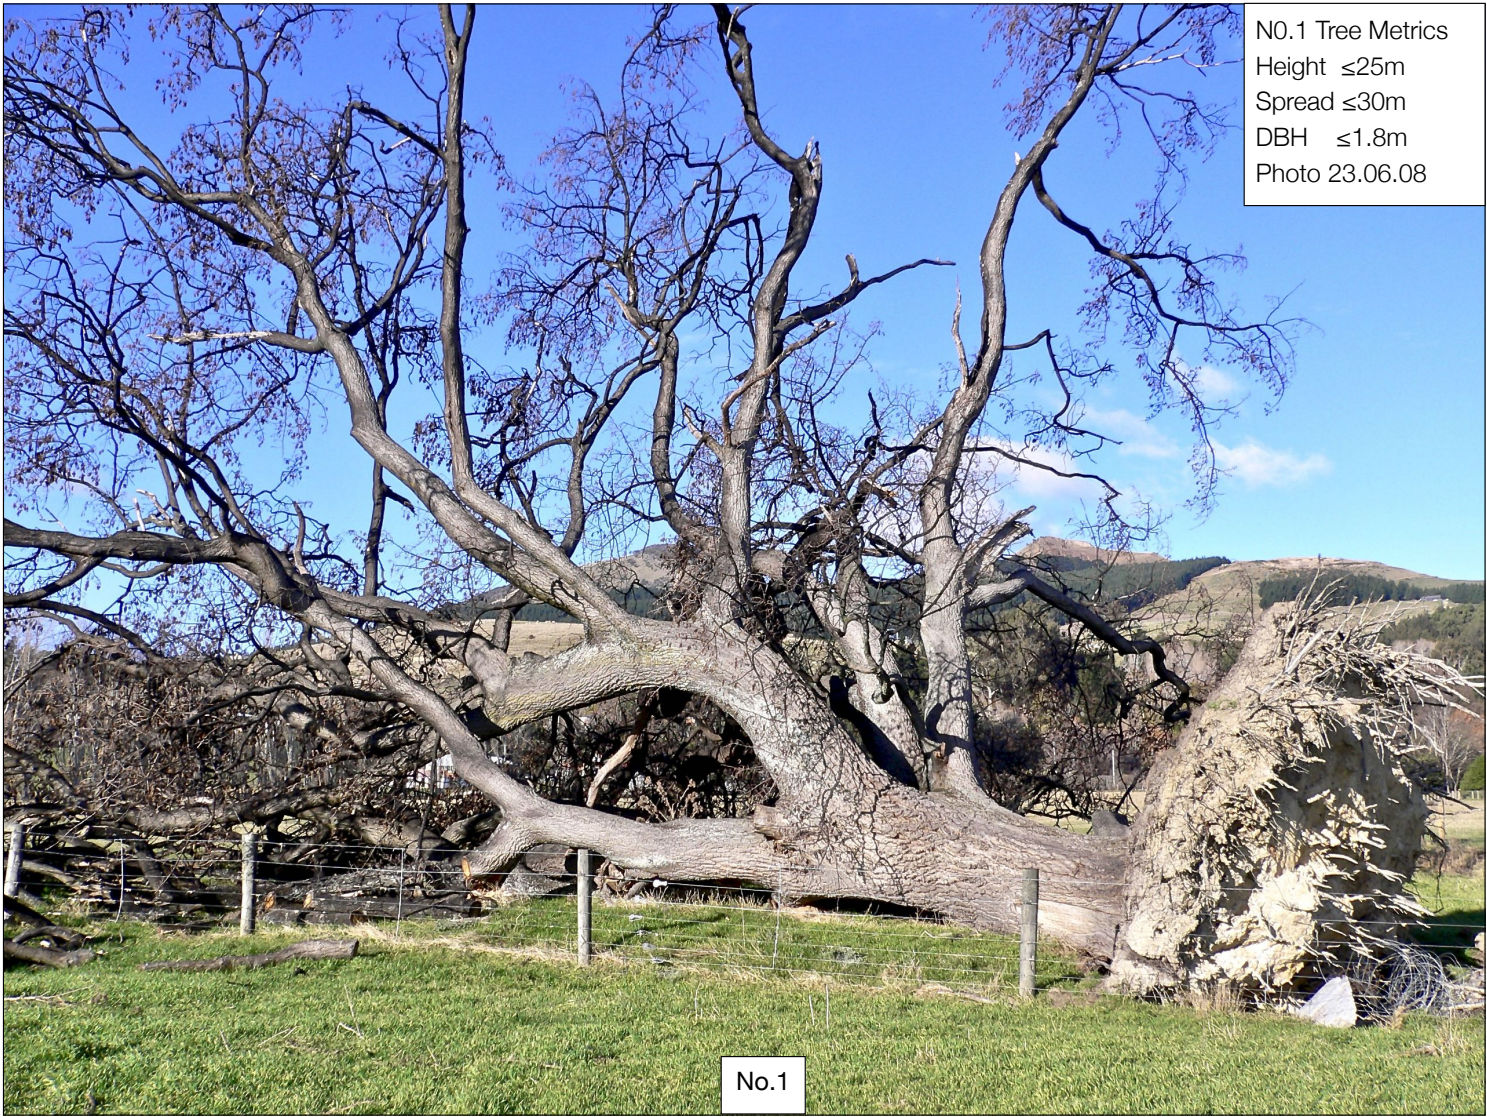
The tree was healthy, without any rot & had only recently been uprooted with about a 5 tonne root-plate attached. Some withered leaves were still attached to the branchlets but essentially it had blown over when out of leaf. It was astounding because it appeared impossible that this could happen to a 150 year tree, after standing through so many storms in its lifetime. As arborists we do talk of Oaks as 'bombproof' trees, meaning that they simply keep standing for 5 centuries or more. It certainly would not have seemed credible for a large old Oak tree to be simply uprooted; until I had seen it with my own eyes.

The only explanation of the old Oak tree uprooting could be that an intense period of rain together with sou'west gales had combined to loosen the grip of the root system in saturated soils.

2x Large 150 year old healthy English Oaks: No.1 uprooted in a storm at East Taieri - autumn 2008 & No.2 still standing on the East Taieri straight - 2024

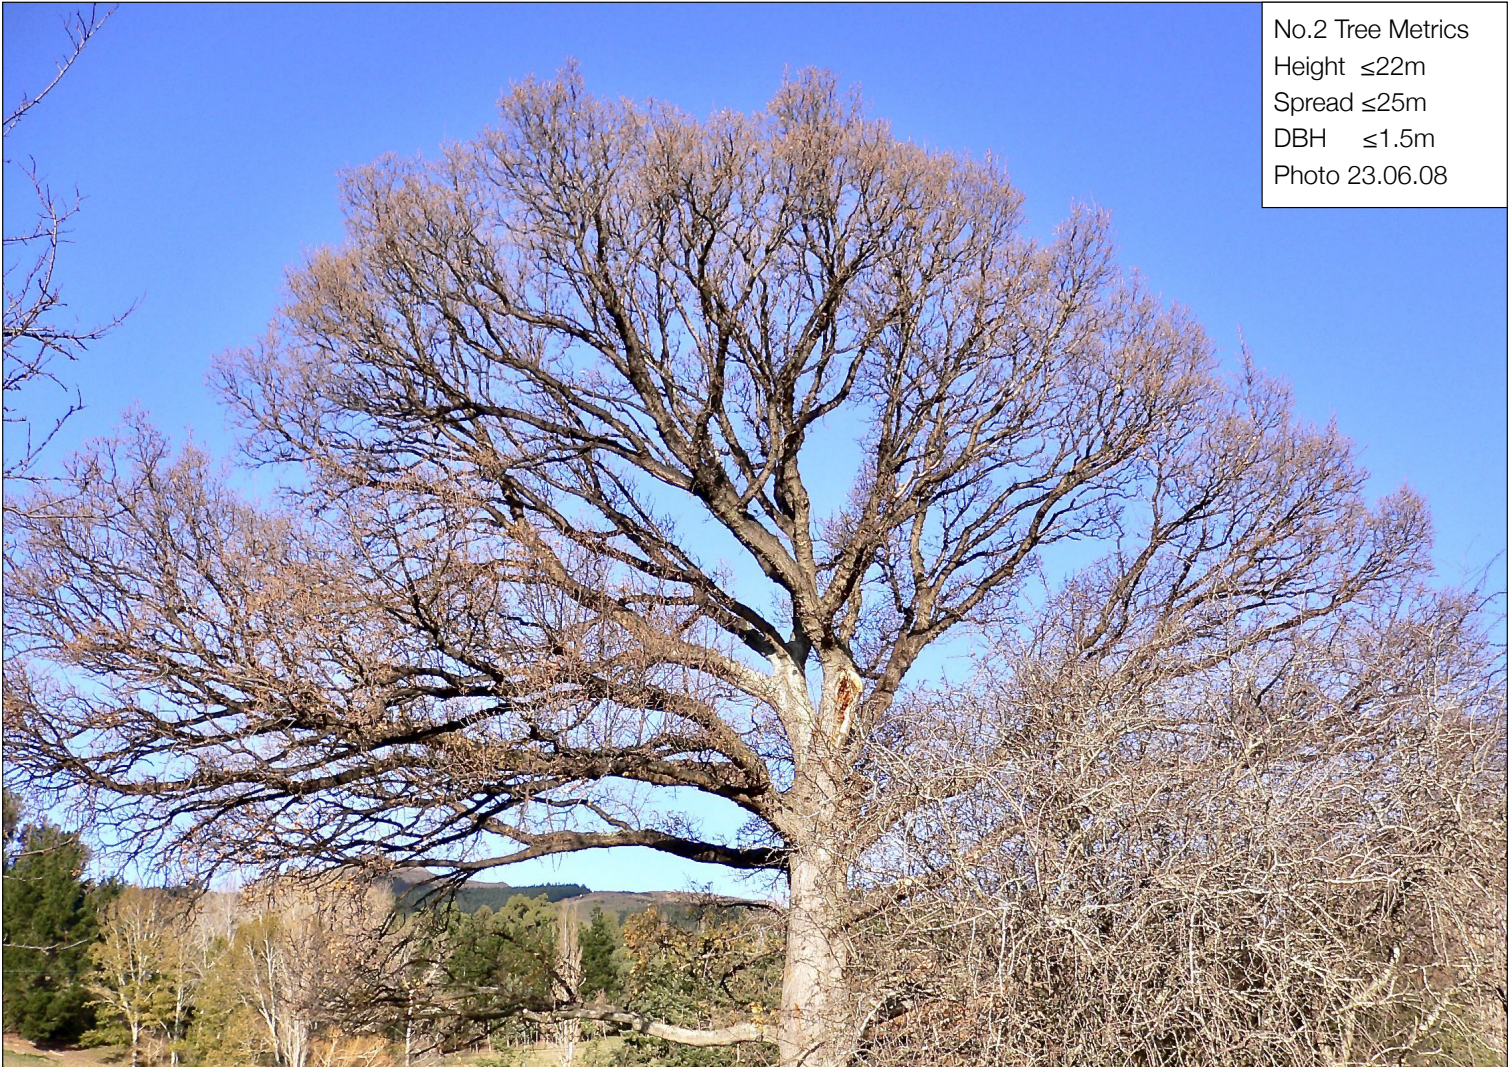
2x Large 150 year old healthy English Oaks: No.1 uprooted in a storm at East Taieri - autumn 2008 & No.2 still standing on the East Taieri straight - 2024

No.2 Tree Metrics  
Height ≤22m  
Spread ≤25m  
DBH ≤1.5m  
Photo 23.06.08

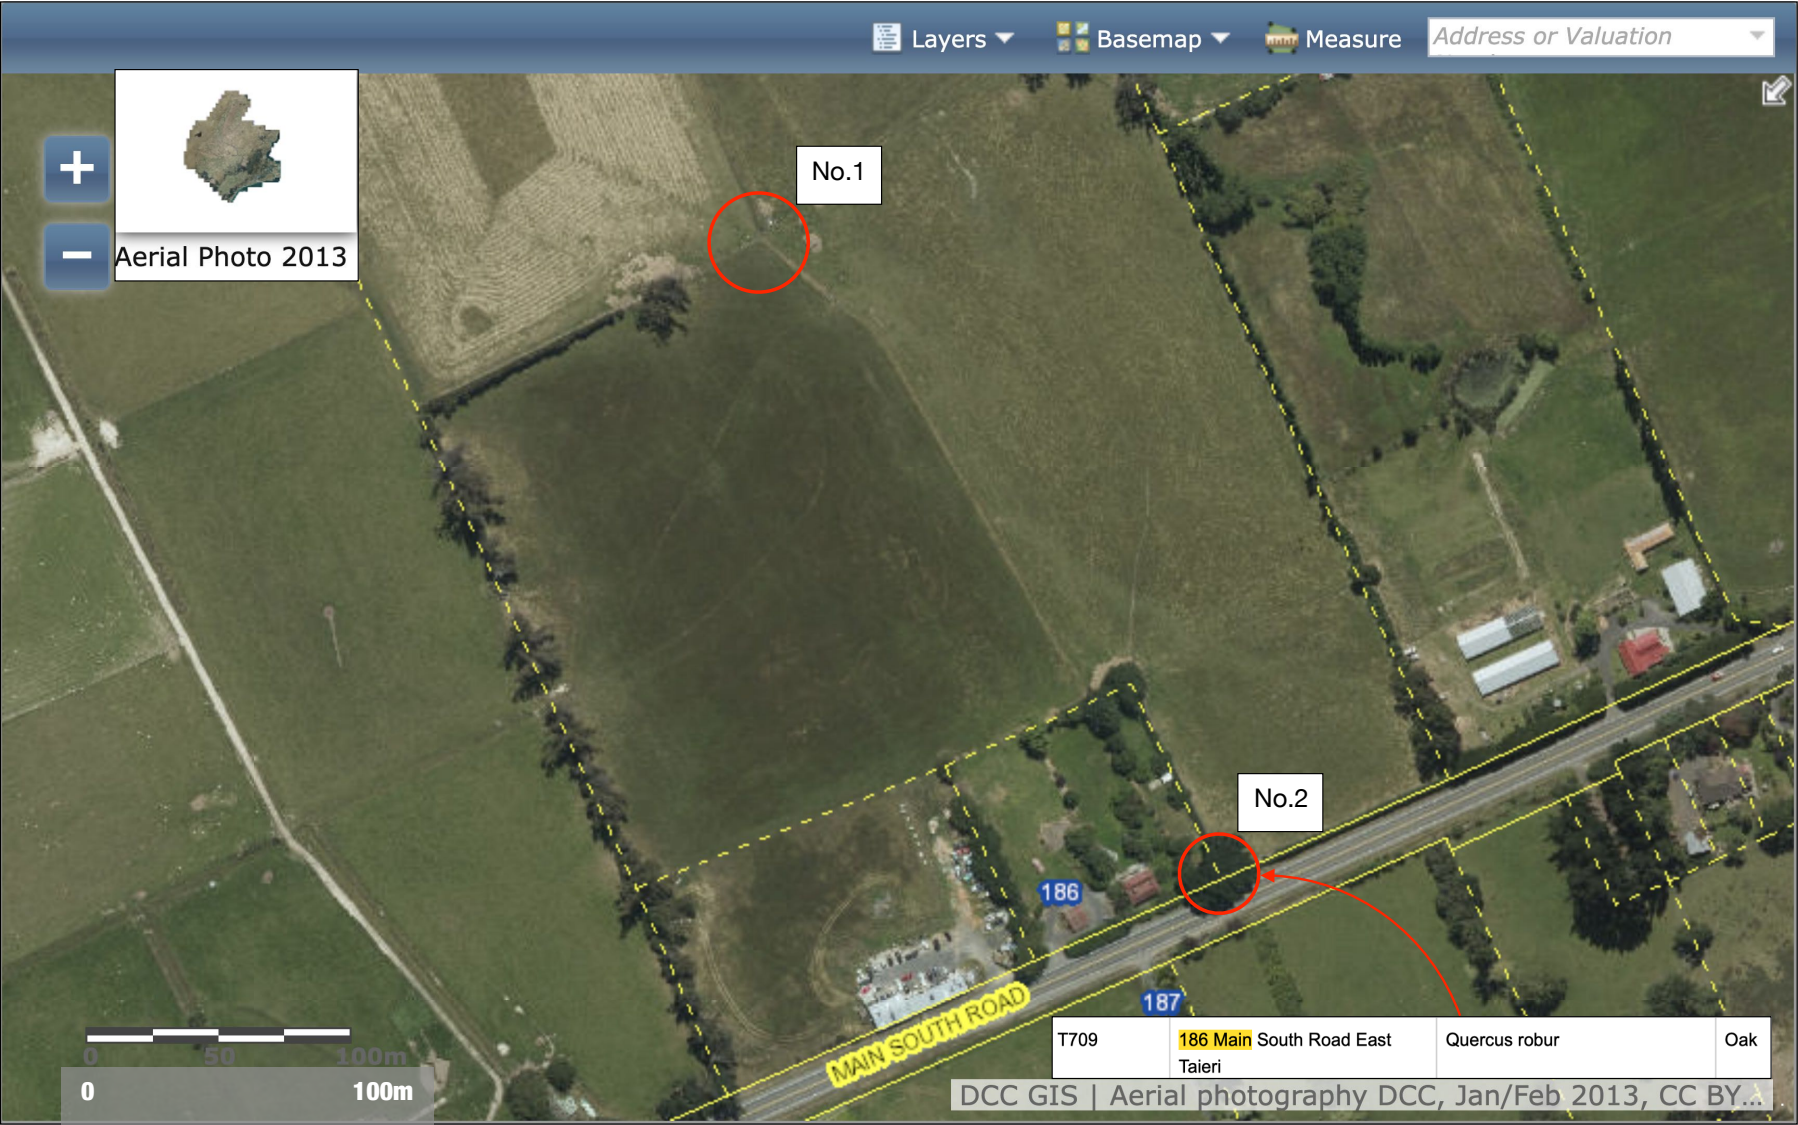
2x Large 150 year old healthy English Oaks: No.1 uprooted in a storm at East Taieri - autumn 2008 & No.2 still standing on the East Taieri straight - 2024

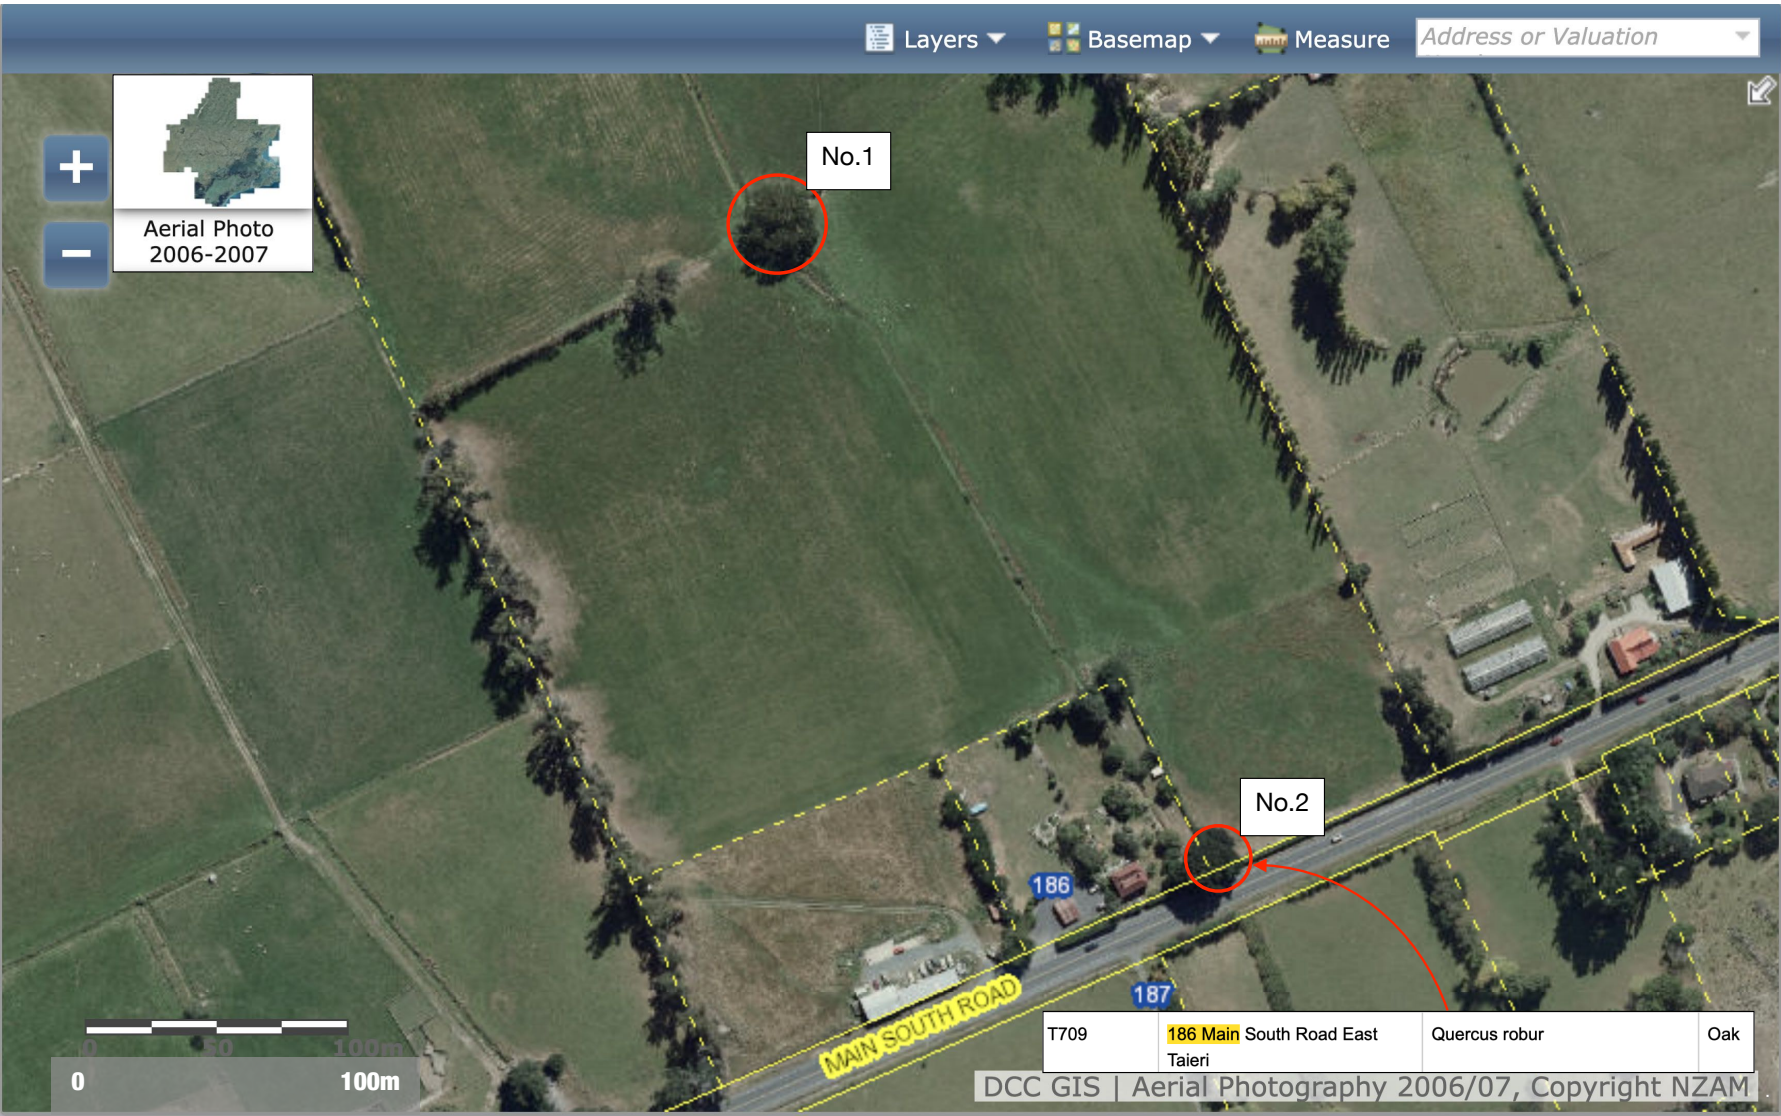
2x Large 150 year old healthy English Oaks: No.1 uprooted in a storm at East Taieri - autumn 2008 & No.2 still standing on the East Taieri straight - 2024

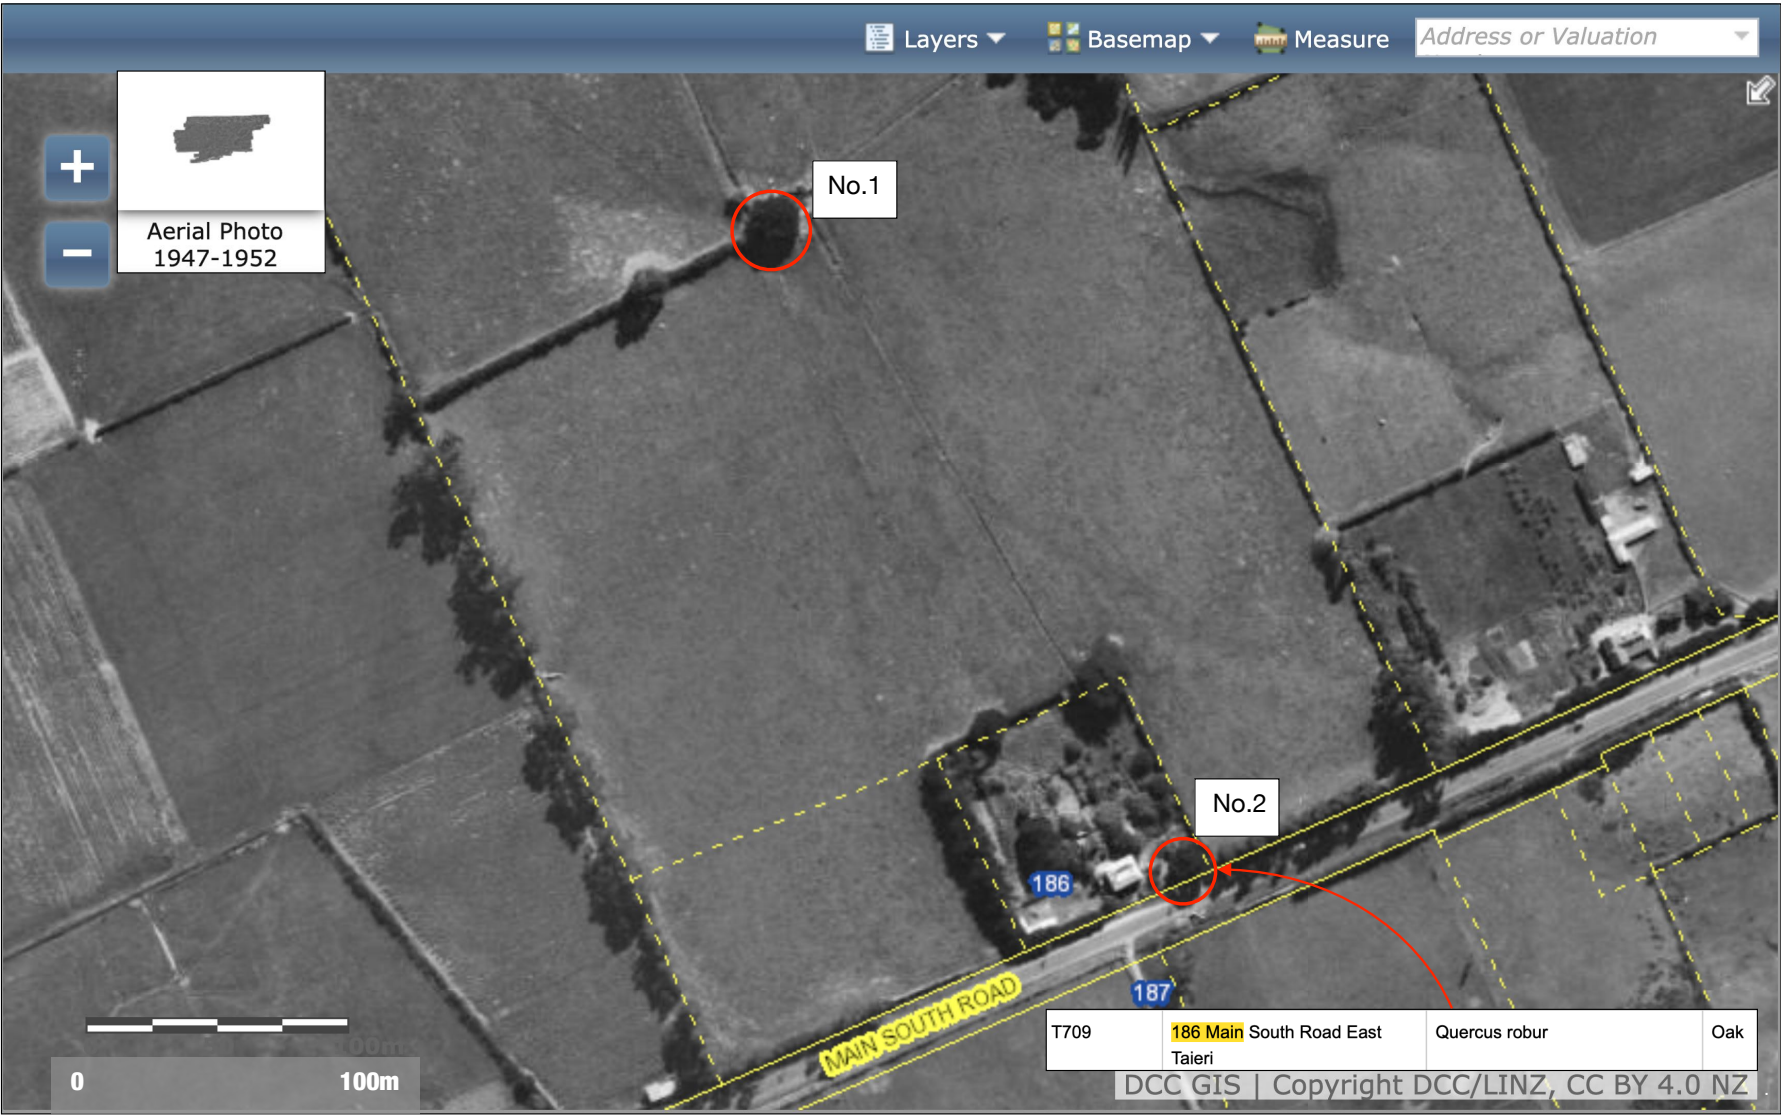
2x Large 150 year old healthy English Oaks: No.1 uprooted in a storm at East Taieri - autumn 2008 & No.2 still standing on the East Taieri straight - 2024

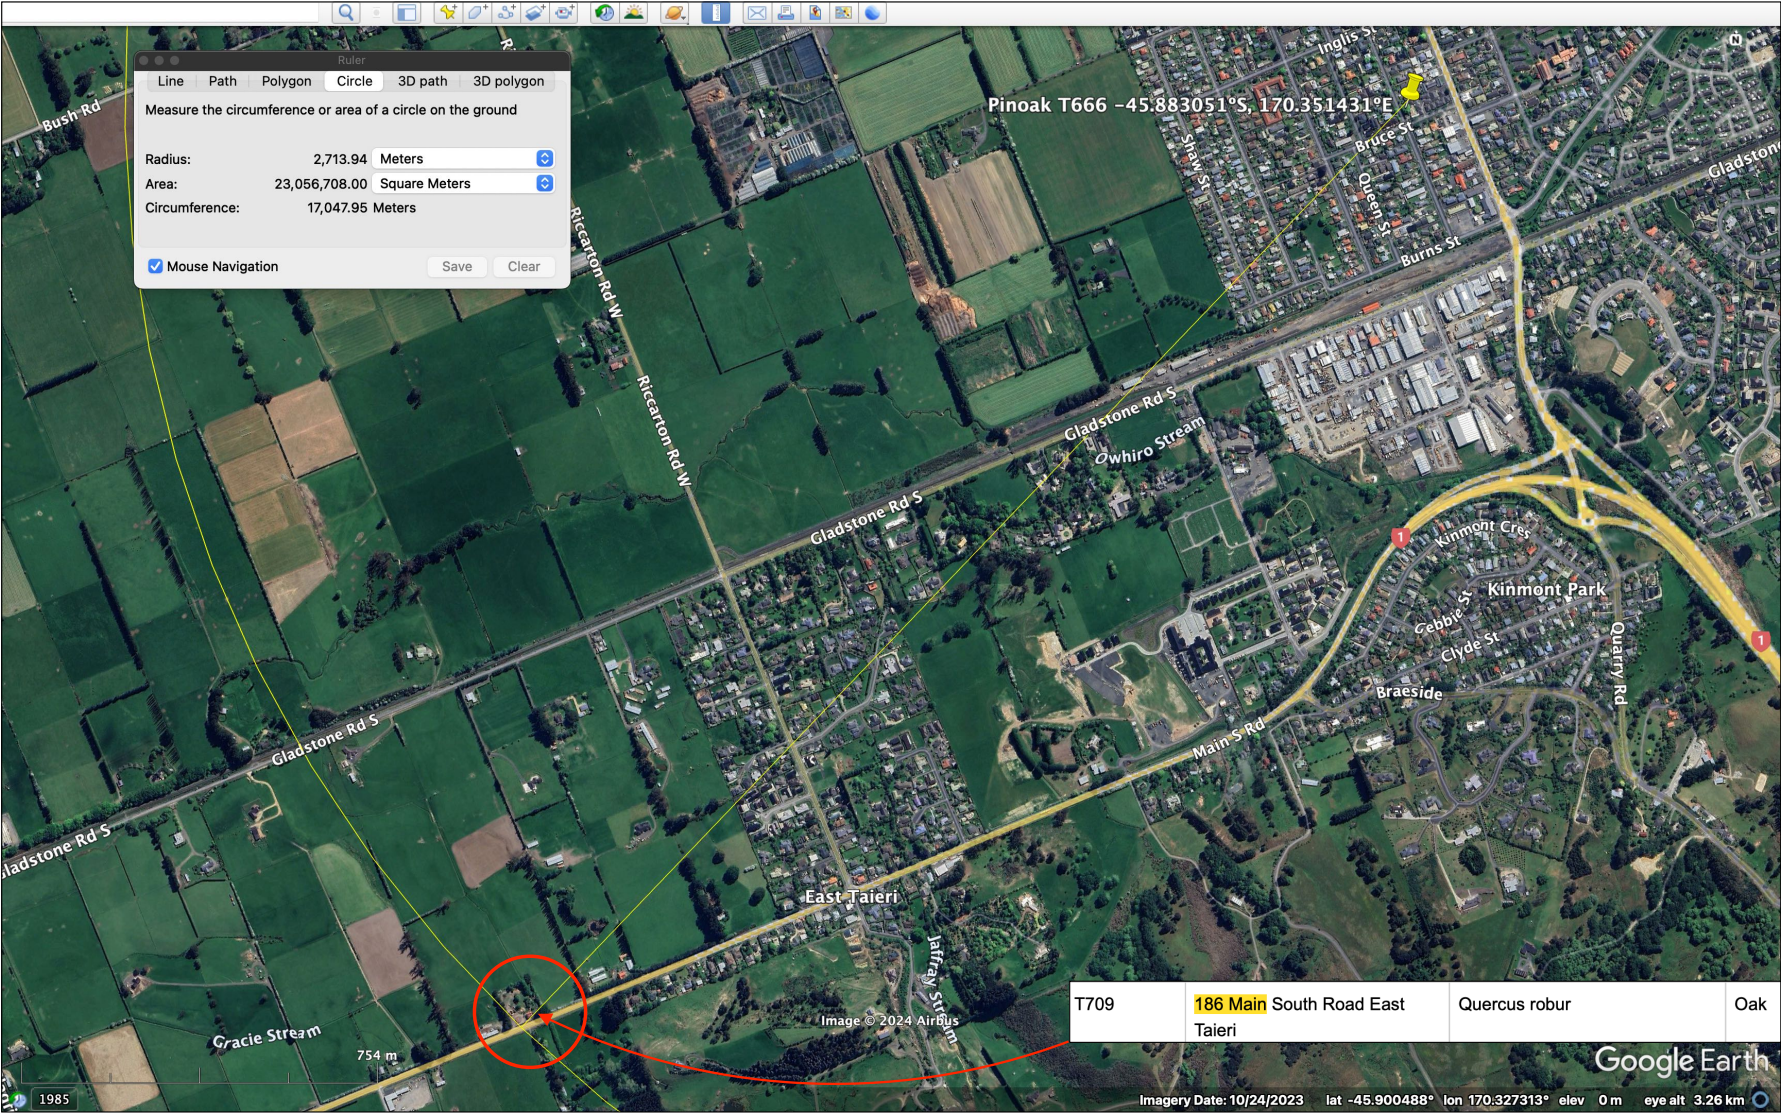
2x Large 150 year old healthy English Oaks: No.1 uprooted in a storm at East Taieri - autumn 2008 & No.2 still standing on the East Taieri straight - 2024
