# Macraes MP4 Consenting Project

## Project Element 4.3.2: Open Pit Stability Assessment for Frasers TSF

PSM71-285R Rev 1

01 February 2024

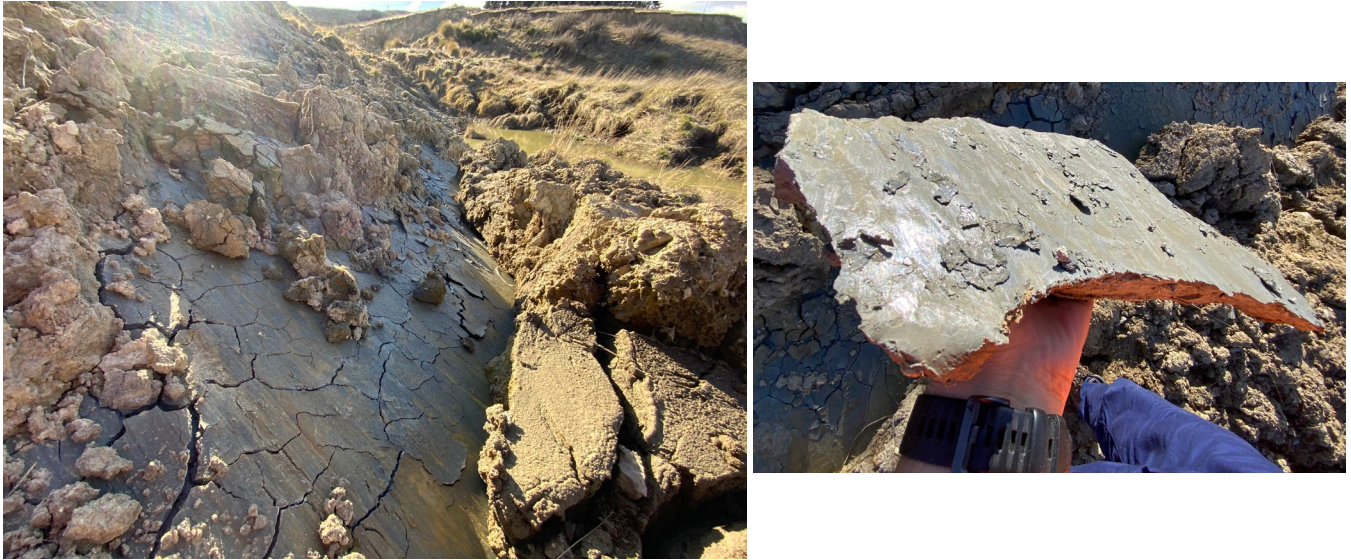
**Photo 1:** Example of the FF surface condition as exposed in the upper Frasers West headscarp. The sliding surface is described as slickensided and undulous, comprising high plasticity moist firm clay. Note: The exposed orientation does not reflect the regional geometry due to interactions with the Macraes Fault Zone.

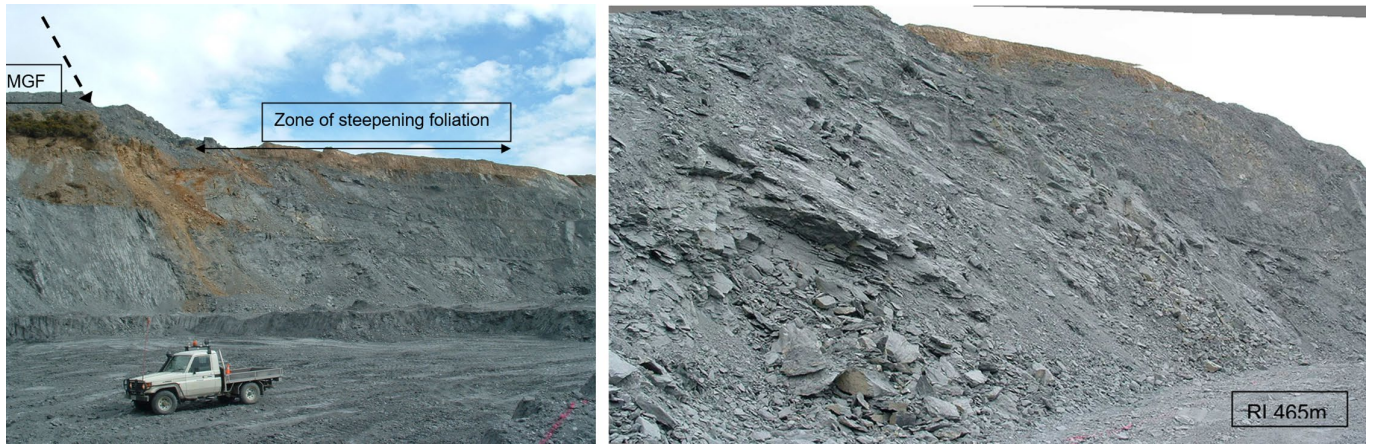
**Photo 2: MGF in west wall of Frasers South. Left: Hanging wall of MGF acting as a failure plane. Right: Close up of steepened foliation.**

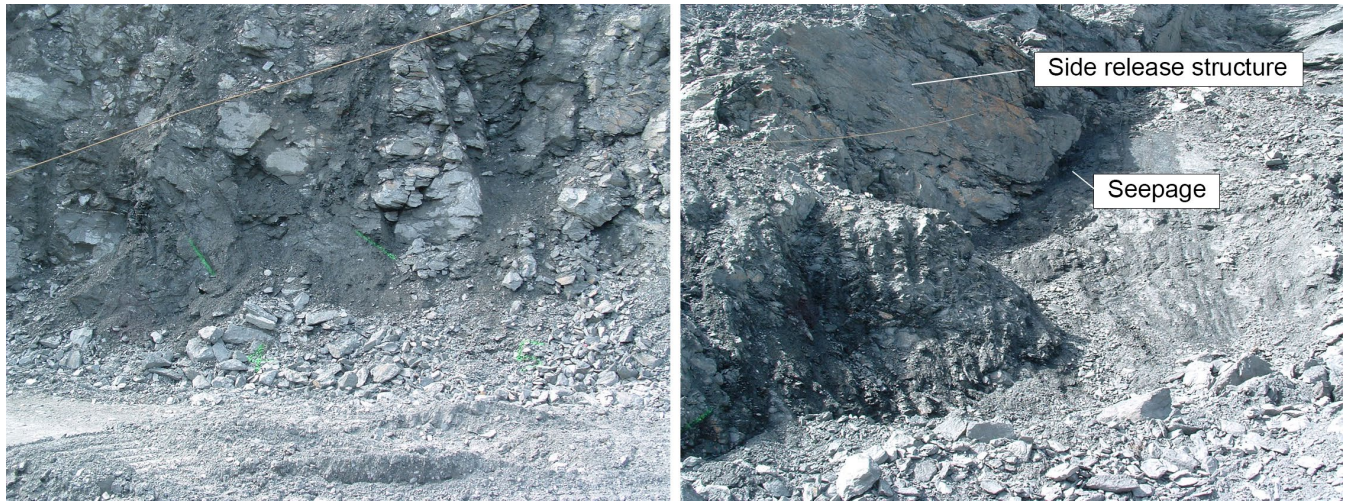
**Photo 4: Structural controls of east wall failure. Left: cross-cutting structures in rock mass near failure. Right: northern flank of failure showing side release structure and seepage.**

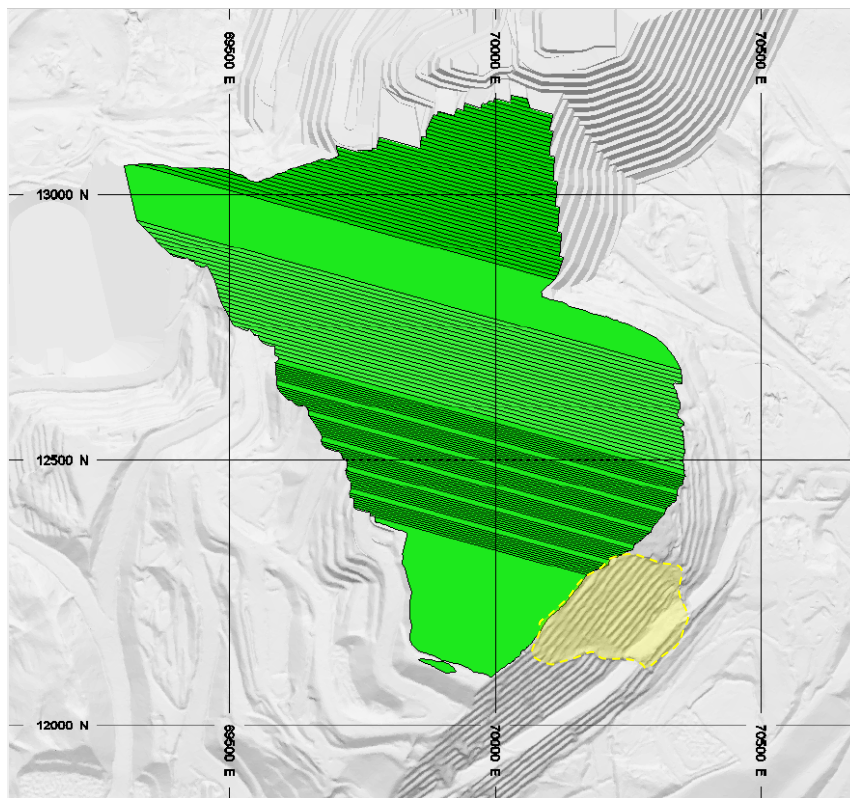
A package of stopes within Frasers Underground (FRUG) known as the “3P’s” are located beneath the east wall of FROP. During December 2022 a localised production blast within these stopes initiated slope movement along a package of geological structures, extending laterally from 2013 failure and truncated by the Hanging Wall Shear at its base. The extent of movement is presented in plan relative to the proposed FTSF embankment geometry, Inset 2. To limit further strain in the rock mass all further development within the 3P’s stopes was halted following the observed movement.

**Inset 2: East wall slope instability extents following 2022/2023 movement. Proposed FTSF embankment geometry overlain for context.**

Buttress support will be provided to this area by the upstream shoulder of the FTSF embankment and deposition of tailings. Construction staging of the FTSF should be assessed during detailed design to manage highwall stability and associated risk of further slope movement. This is an example of potential long-term degradation of the highwalls and helps to define a zone of influence for closure around the pit crest.

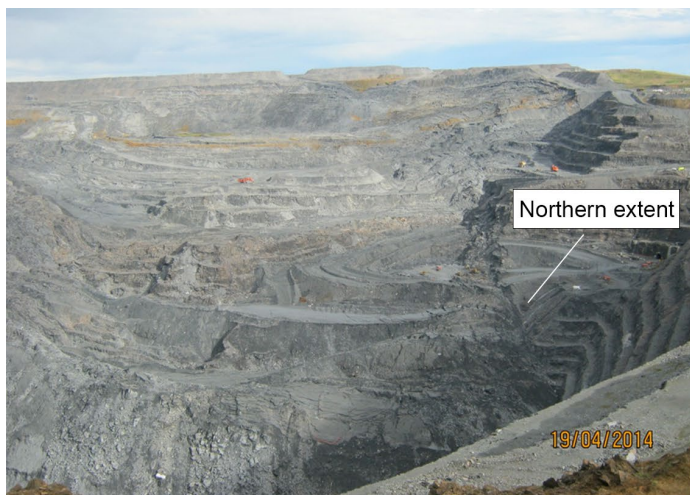
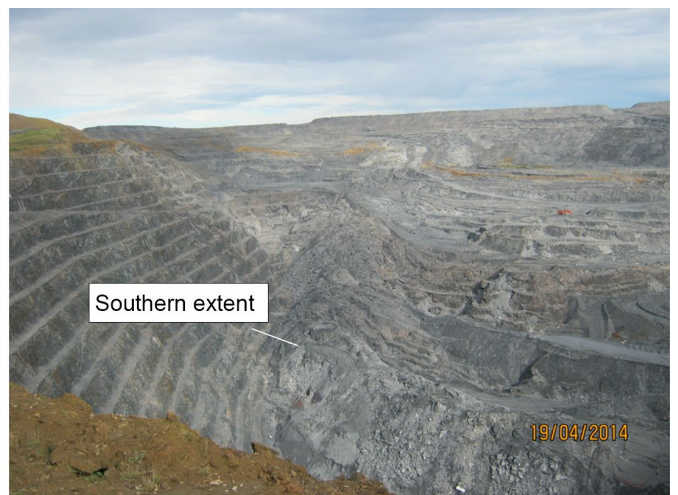
- The northern margin is well-defined at approximately 12500 mN. It is created by a series of discrete joints and cracks induced by previous movement including the 5 January 2013 failure, Photo 5
- The southern margin of the failure is indistinct, blending into the open pit excavation. It approximately coincides with 11800 mN, Photo 5
- The failure stopped against the east wall and pushed up tens of metres of toe heave
- The FF is the basal plane of the failure. The FF has been exposed in part of the failure's headscarp, Photo 6 and Photo 7
- Areas of the failure mass moved up to 200 m into the pit.

**Photo 5:** Northern and southern extent of failure.

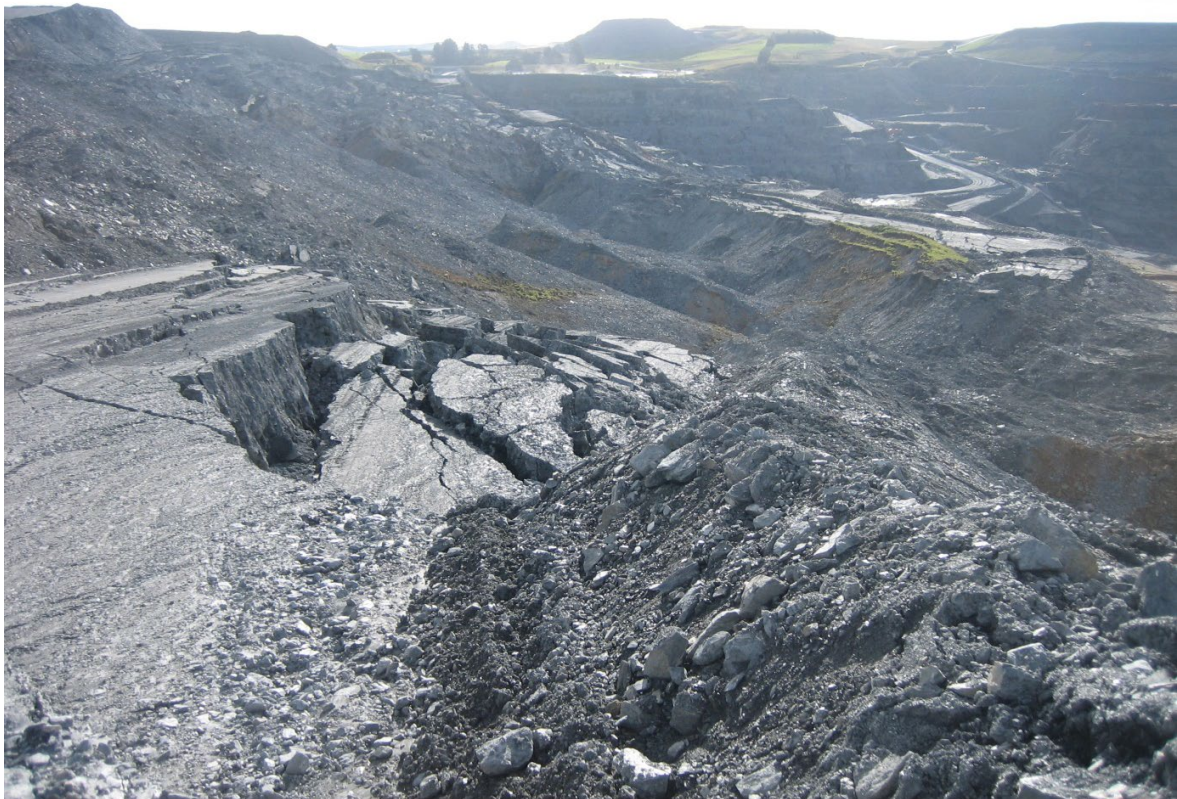
**Photo 7:** Headscarp of FF exposed at the top of failure. Photo taken along strike towards the north.

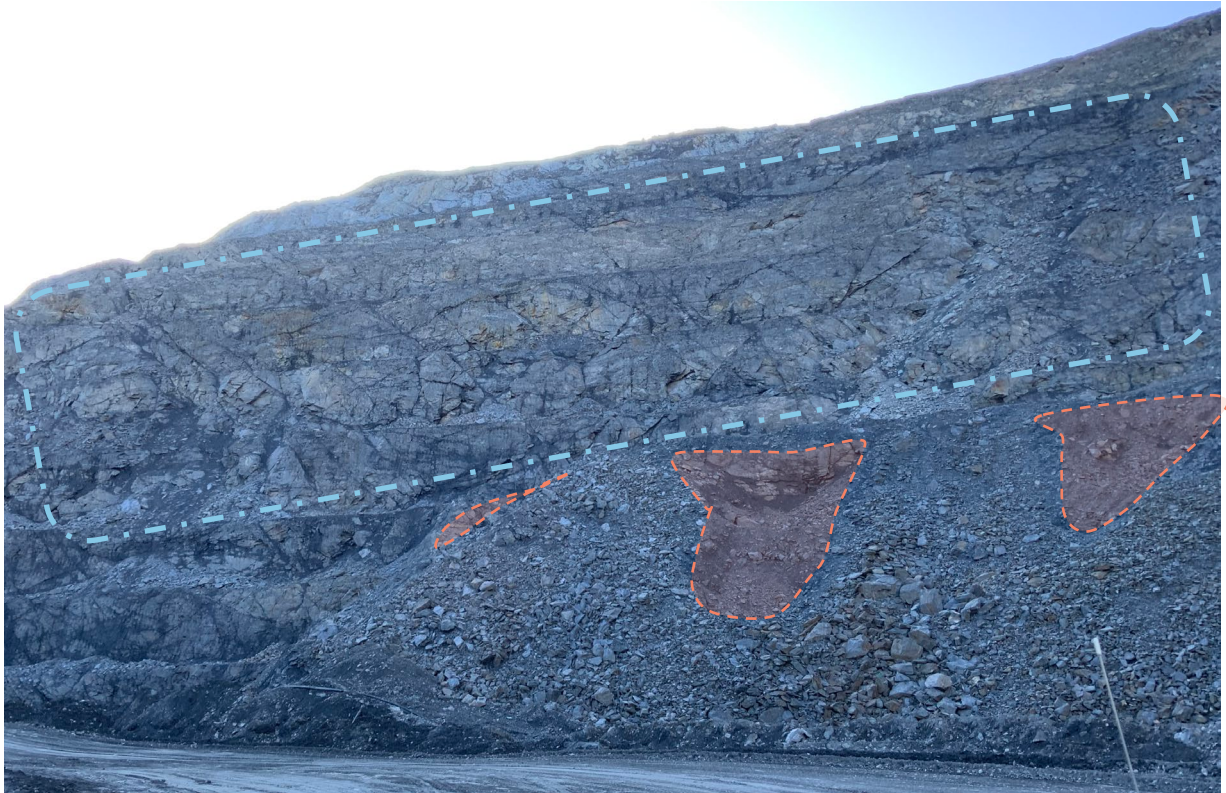
The FRUG mine includes a series of drives and stopes located beneath the Frasers/FRIM highwall. Development of underground workings causes a redistribution of stresses within the rock mass. Yielding can occur where the induced stress exceeds the rock mass strength. Within FROP this is expressed as large-scale fracturing with increased dilation along geological structures. Dilated geological structure is visible throughout the pit wall with localised zones of caving in the pit floor where existing “Panel 1” workings have been mined out, Photo 8.

The FRUG Panel 1 workings with the least rock cover are located beneath the proposed FTSF embankment. Additional surcharge load associated with construction of the FTSF embankment has the potential to cause further subsidence. This is expected to choke rapidly underground and ongoing subsidence is expected to be negligible. During embankment construction the highwall rock mass will be progressively supported with additional buttressing from the placed fill.

**Photo 8:** Fraser 6/FRIM north wall - Surface caving expression of near surface stopes highlighted in orange. Dilated structures associated with rock mass relation visible through the zone in blue.

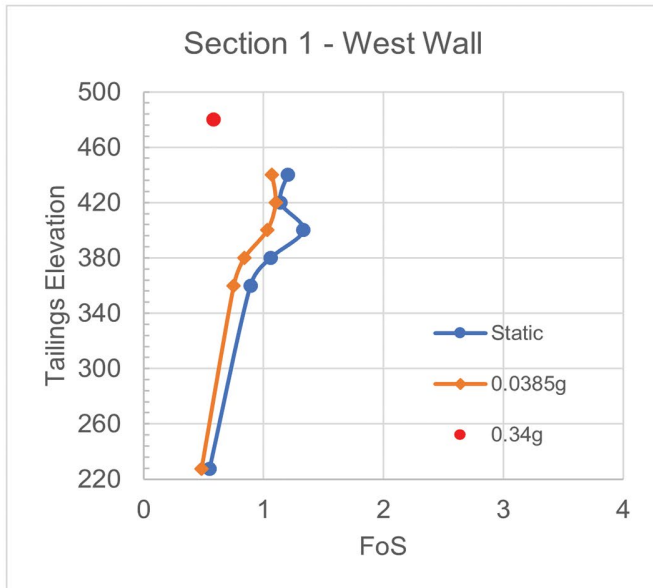
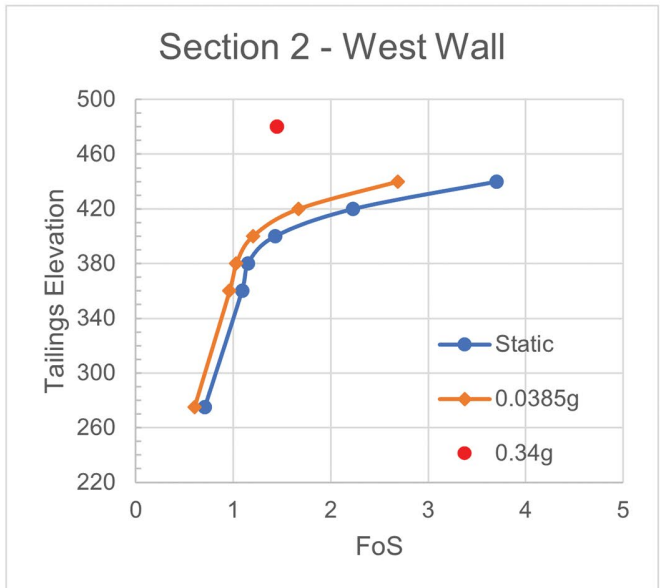
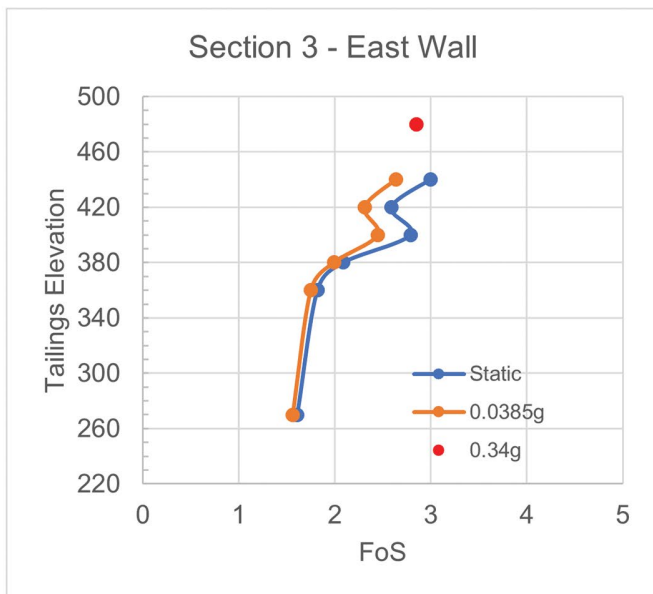
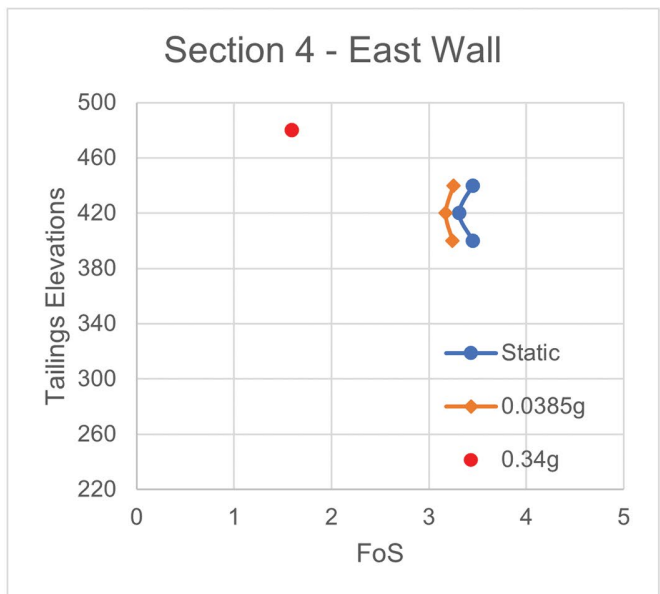
- The resultant FoS values account for both the elevated groundwater pressures and an increase in buttressing from tailings is depicted in Inset 9
- The analyses suggest the balance is generally in favour of increasing stability. The lowest FoS of the four sections (Table 4) occurs at the current condition prior to tailings deposition
- The modelled stability of the west wall at the current condition (FoS <1) is consistent with the long-term west wall creep experienced within Frasers.

**Inset 9: Stability results illustrating the modelled FoS response to changes in tailings level during backfill.**

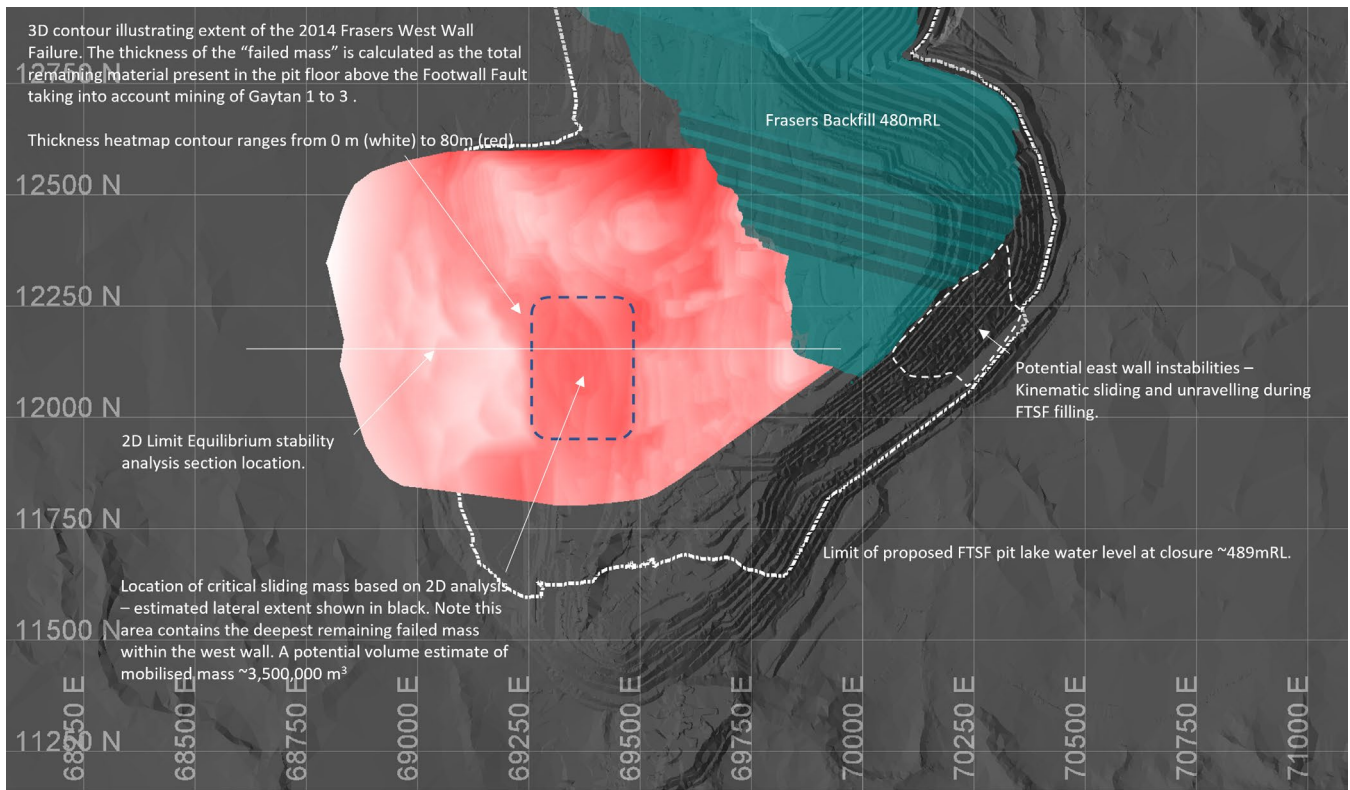
**Inset 11: Summary of potential failure mechanisms with increased susceptibility during FTFS filling.**
