Appendix to  
Greentrees Tree Report of 03.07.19  
concerning a Silver Fir (*Abies alba*) T444  
23.10.19

### Appendix to Greentrees original tree report 03.10.19

Further to recent phone conversation about your application LUC.2019.380, 5 Ferntree Drive, Dunedin for the removal of Silver Fir (*Abies alba*) T444, which belongs to the DCC Community & Parks department, I am able to expand a several points within my original tree report dated 03.07.19.

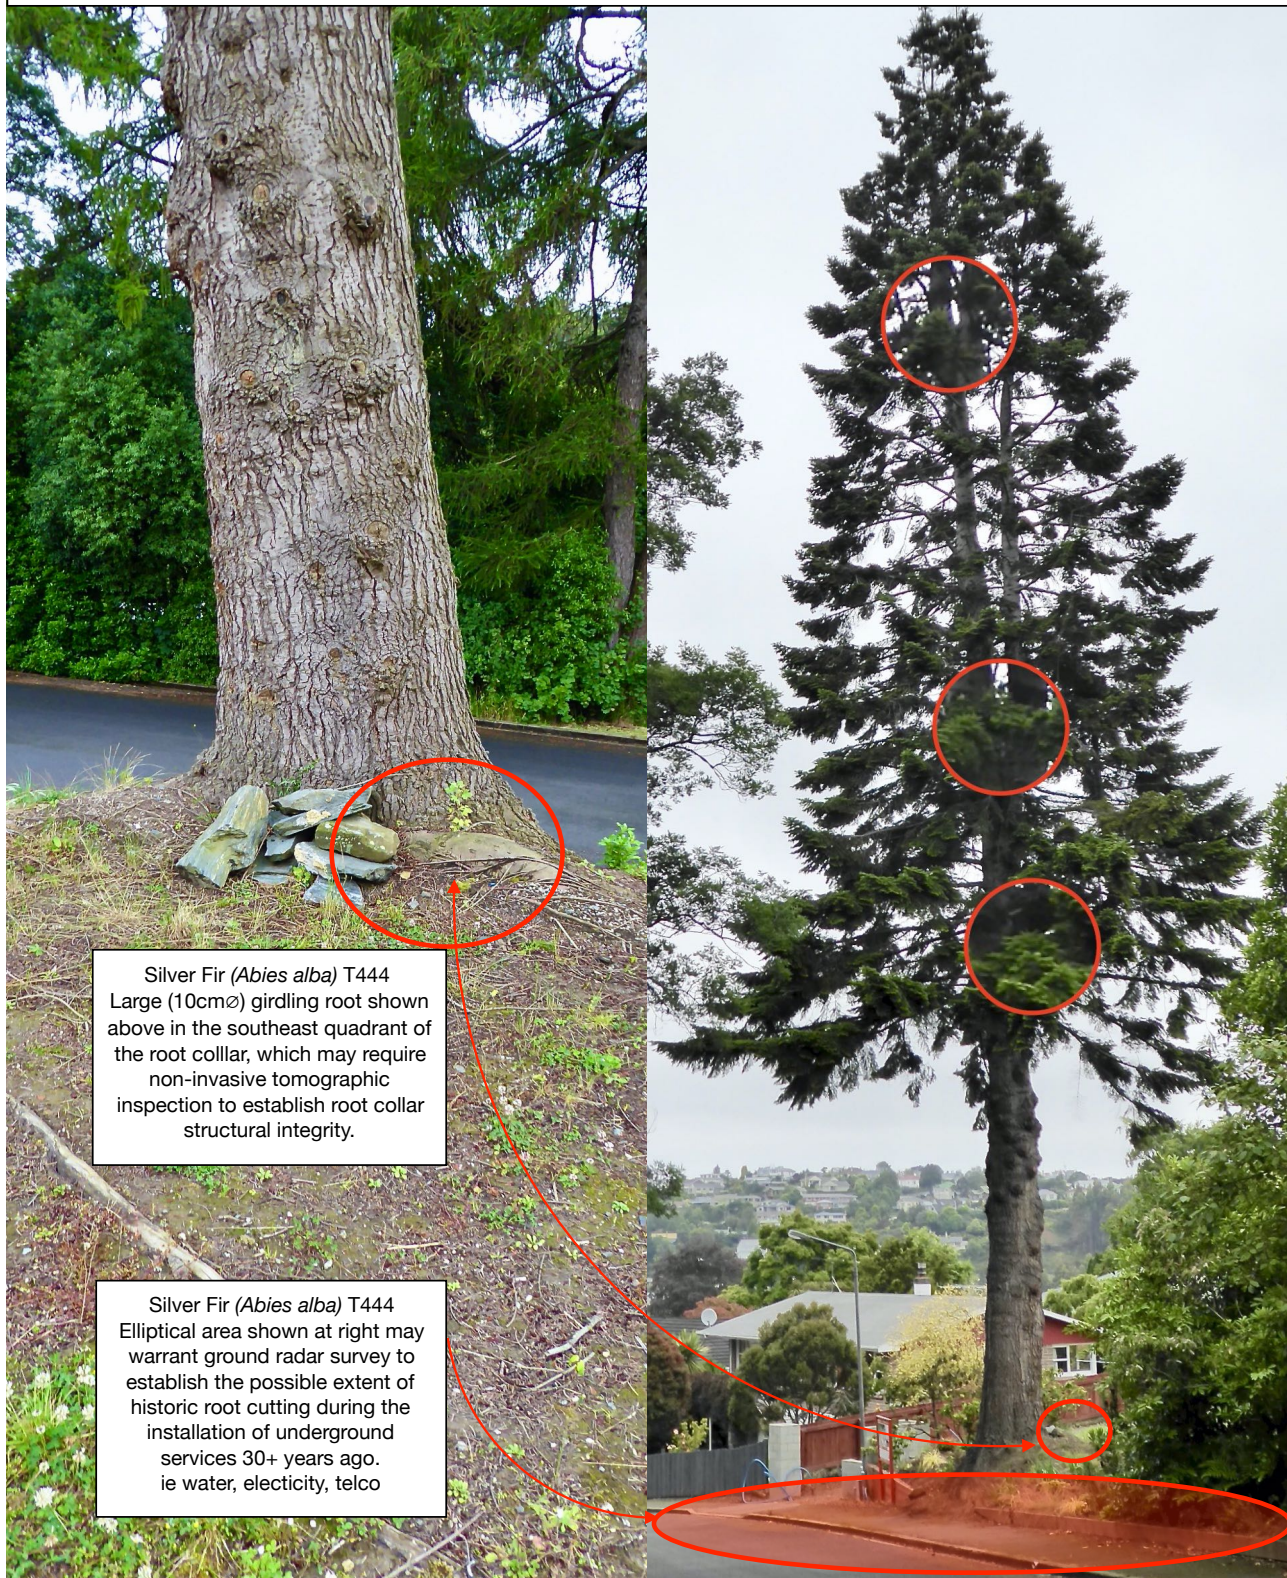
If insufficient large structural roots are not present then the possibility of root-plate instability leading to windthrow arises. Establishing the critical structural root spread would require an tree expert ground radar operator to survey & rule out the possible lack of sufficient structural compression roots, particularly on the northside as shown in the shaded elliptical area (pg 5).

Silver Fir (*Abies alba*) T444 with 3x structural canopy defects, a large girdling root & possible root cutting when digging trenches for underground services installation during the 1980's. In July 2019 water mains, sewer & storm water services were connected at 3 Ferntree Drive, under consent LUC.2019.61. Only fine adventitious roots were observed, which would be consistent with historic root cutting in the disturbed soil profile. The trench showed only asphalt, gravel ballast & hard clay beneath the footpath/road. Tomographic inspection of the root collar & a ground radar survey would be useful in establishing the integrity of the tree's longterm stability.

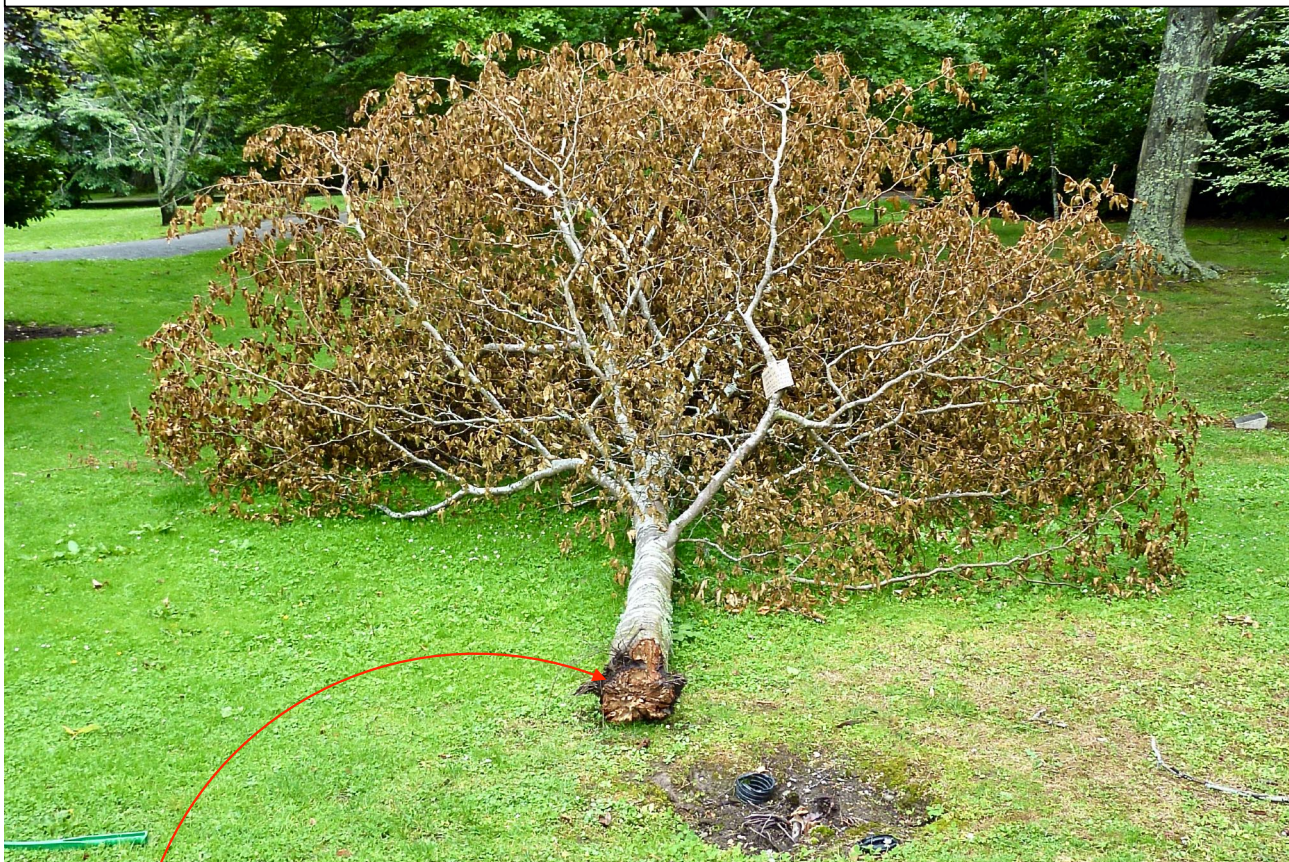
An example of windthrow in a sheltered situation at Chingford Park, Dunedin in 2011, where trunk weakness at the root collar has been caused by root girdling. Severe constriction of the phloem has lead to strangling of trunk growth expansion, allowing a strong south wind to snap the 20cmØ stem neatly at ground level, without any root heave or soil disturbance. Large girdling roots may also proportionally affect the stability of large mature trees, without the presence of fungal decay.

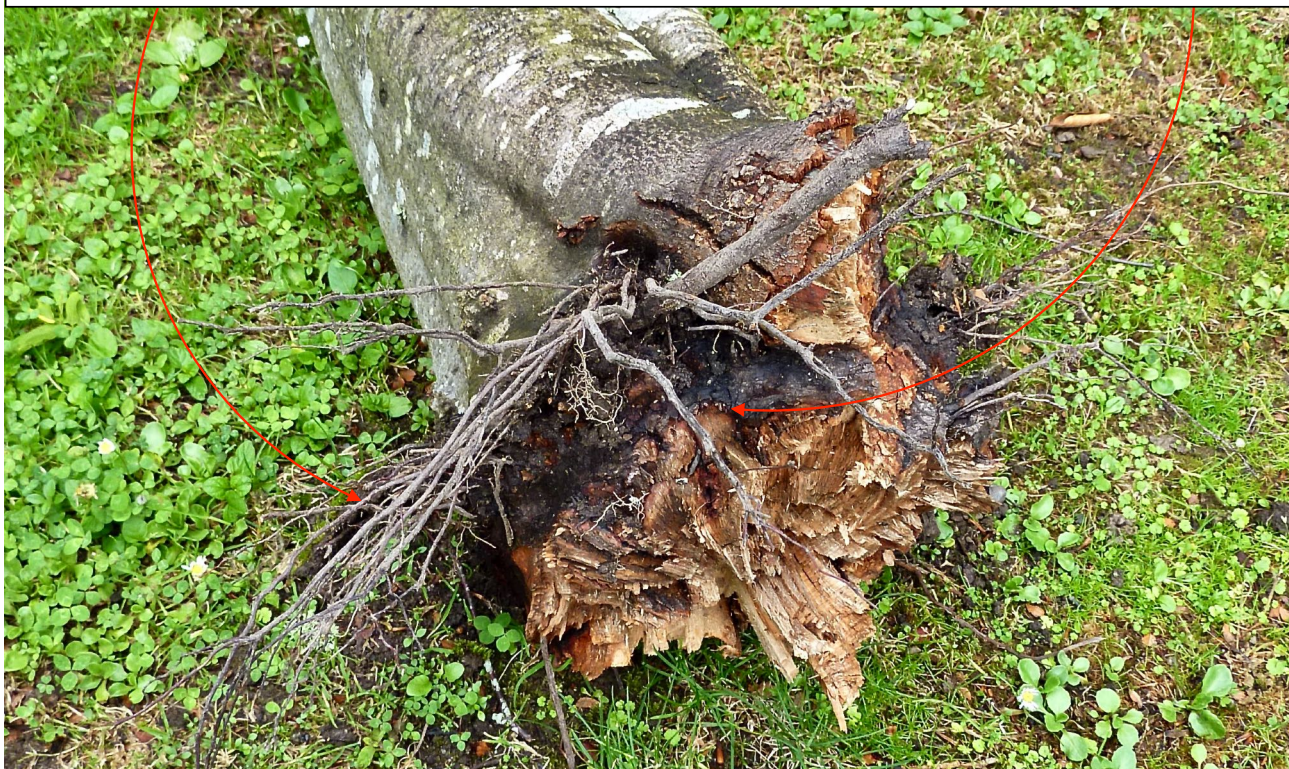
The dark brown girdling root channel is clearly visible in the photos above & below, along with a cluster of small adventitious roots indicating a similar stress reaction often observed in pruned tree roots.
