**RE: Works under the dripline of T026**

As per your November 10, email request regarding proposed and previously undertaken works at number 17C Melrose Street within the dripline of T026.

The works relate to Planning Application LUC-2020-546. The schedule tree T026 is described in the 2GP tree list (Appendix A1.3) as a Wellingtonia (*Sequoia sempervirens*) and shown as growing on number 47 Garfield Avenue.

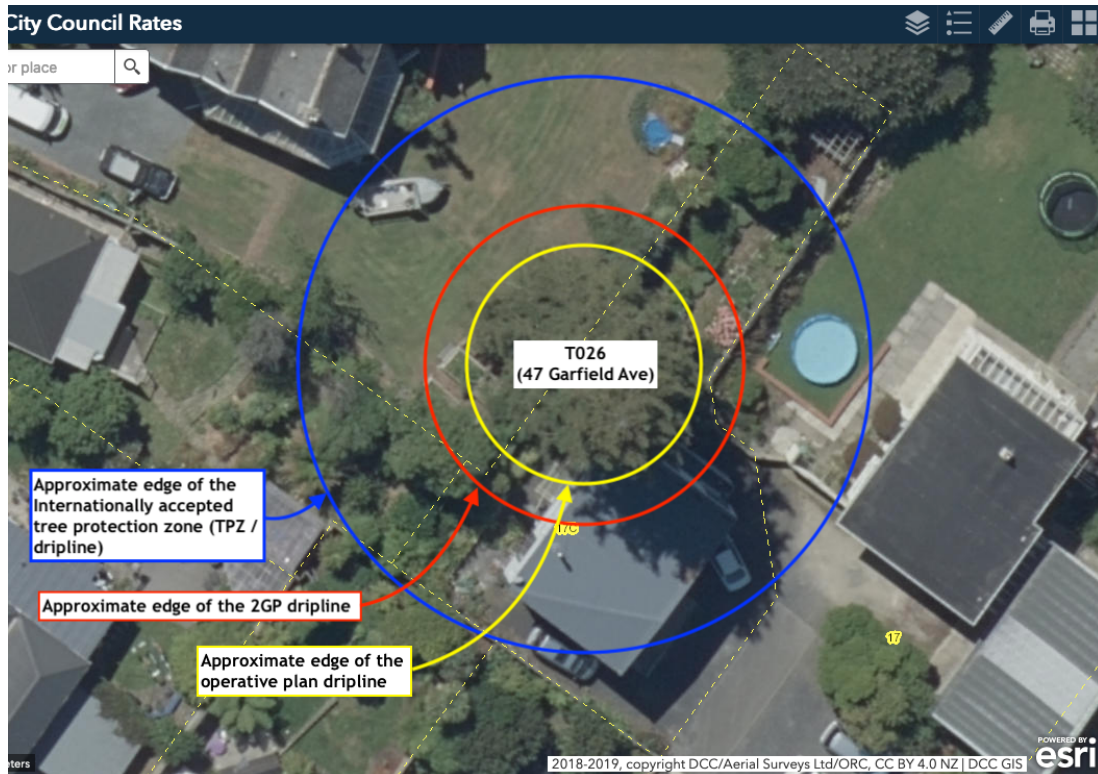
*'changes to ground level (removal of the upper layer of soil) and post-hole digging have taken place under the natural drip-line of the tree, which is the tree protection zone according to the operative District Plan (by default this also means the works have taken place inside the tree protection zone according to the proposed 2GP). The works have potentially removed over 40% of the trees rooting system.*

**Image one:** Image of T026 showing the approximate location the relative drip lines / tree protection zones

5. No further excavation or soil removal shall take place within the 2GP dripline of T026 (*see image one*)
6. All existing 'open' fence post holes shall be backfilled with top-soil - fence posts shall not be placed in these holes and no additional holes shall be dug within the 2GP dripline of T026

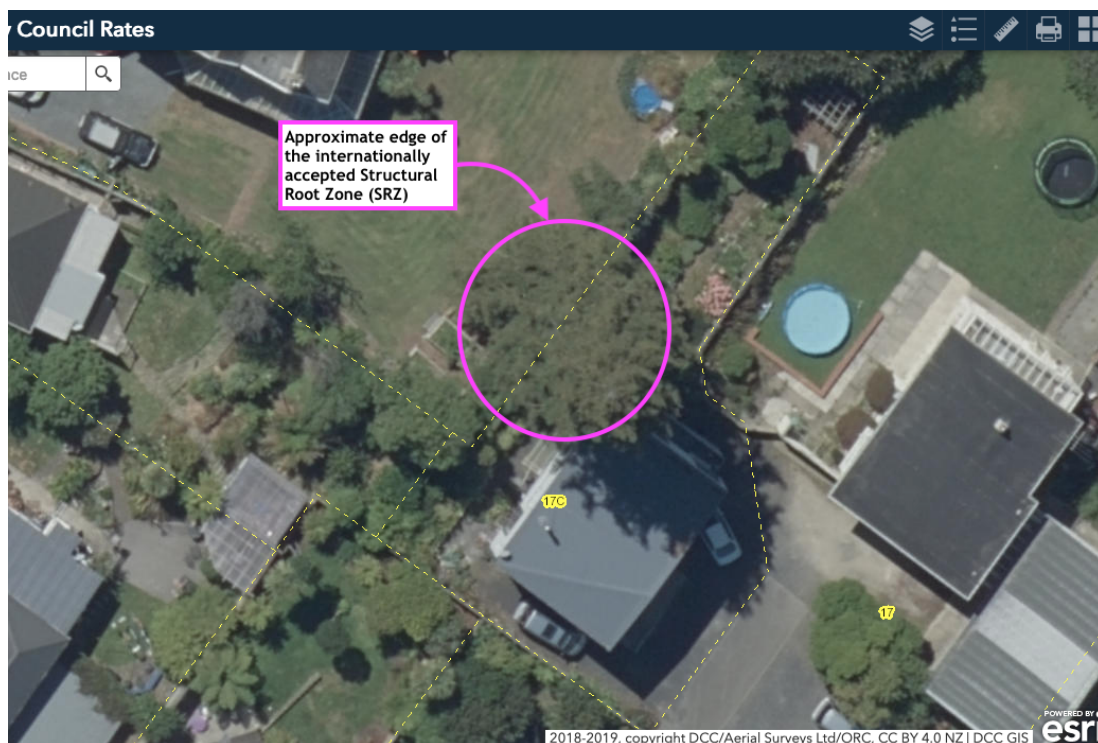
*Secondary, yet more importantly to the excavation works taking place under the tree protection zone, the works have taken place inside the structural root zone. As the name would suggest, the structural root zone is where structural roots are considered to exist, and damage to these roots could compromise the structural integrity of the tree (i.e. cause the tree to fall over).*

**Image two:** Image of T026 showing the approximate location the structural root zone; *damage to roots in this zone could compromise the structural integrity of the tree (i.e. cause the tree to fall over).*

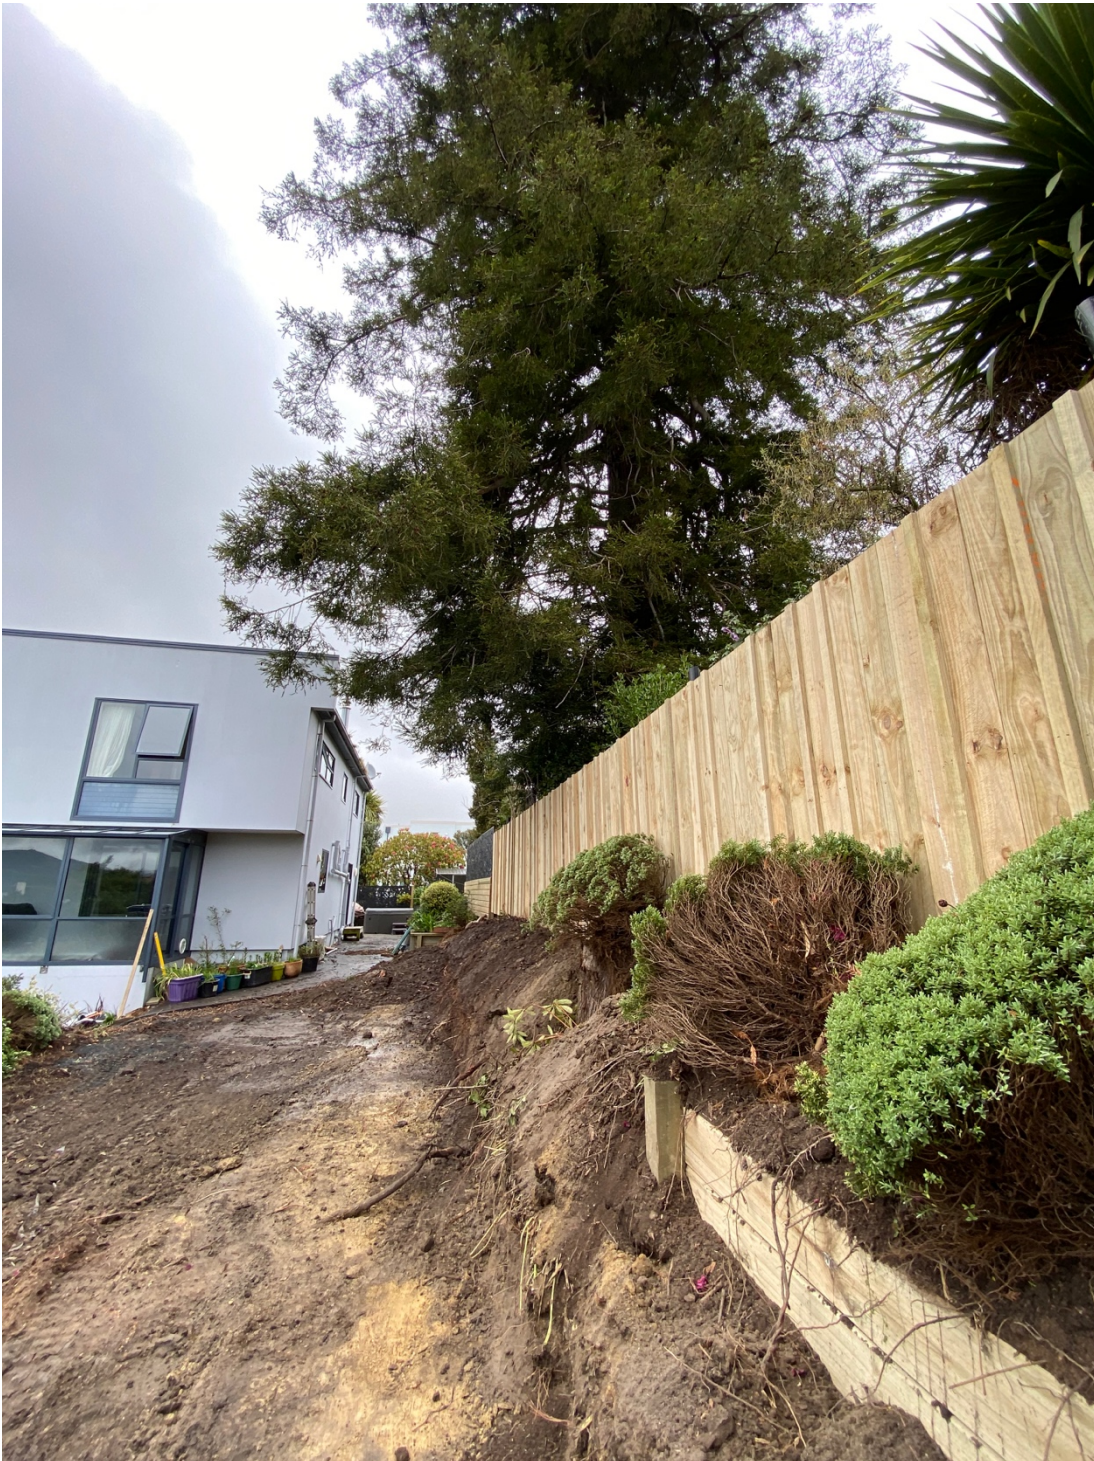
At the October 19 site visit works had already been undertaken, including post hole boring and the removal of at least 40cm soil on the 17C Melrose Street side of the dripline (image three). The soil removal works involved lowering the existing ground level along the boundary line between numbers 17C Melrose St and 47 Garfield Ave, with the excavation basically running parallel to and about 1m from the boundary fence (image four).

- 2.1 Based on the depth and proximity of the cut (soil excavation) to T026, I estimated that approximately 40% of all roots have been removed, including up to 30% of the structural roots.
  - 2.2 According to international standards, an incursion of more than 10% into the tree protection zone is considered a major incursion, and no works should take place inside the structural root zone
3. There were a number of fence post-holes dug and left open – these holes had no fence posts in them at the time

**Image three:** Image of T026 taken from inside 17C Melrose Street, showing the extent of the soil removal, proximity of the 'cut' to the boundary line, the clay-loam type soil and the complete absence of roots in the soil beyond the cut face.

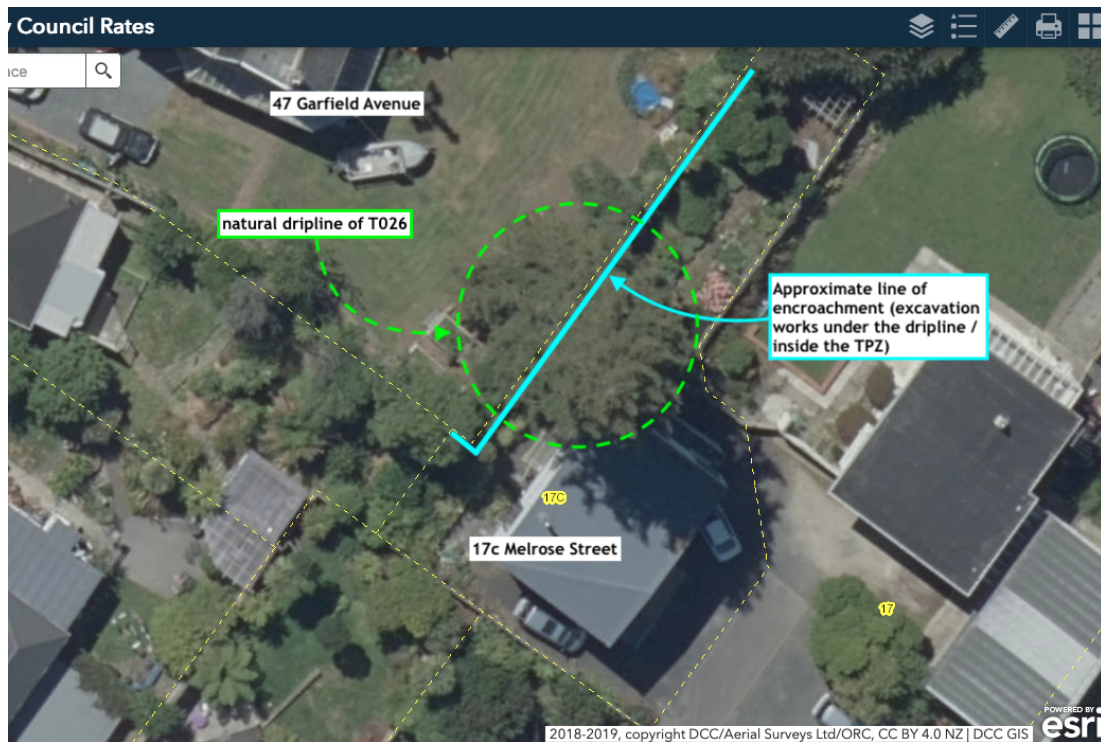
**Image four:** Image of T026 showing the approximate line and extent of the excavation/soil removal works

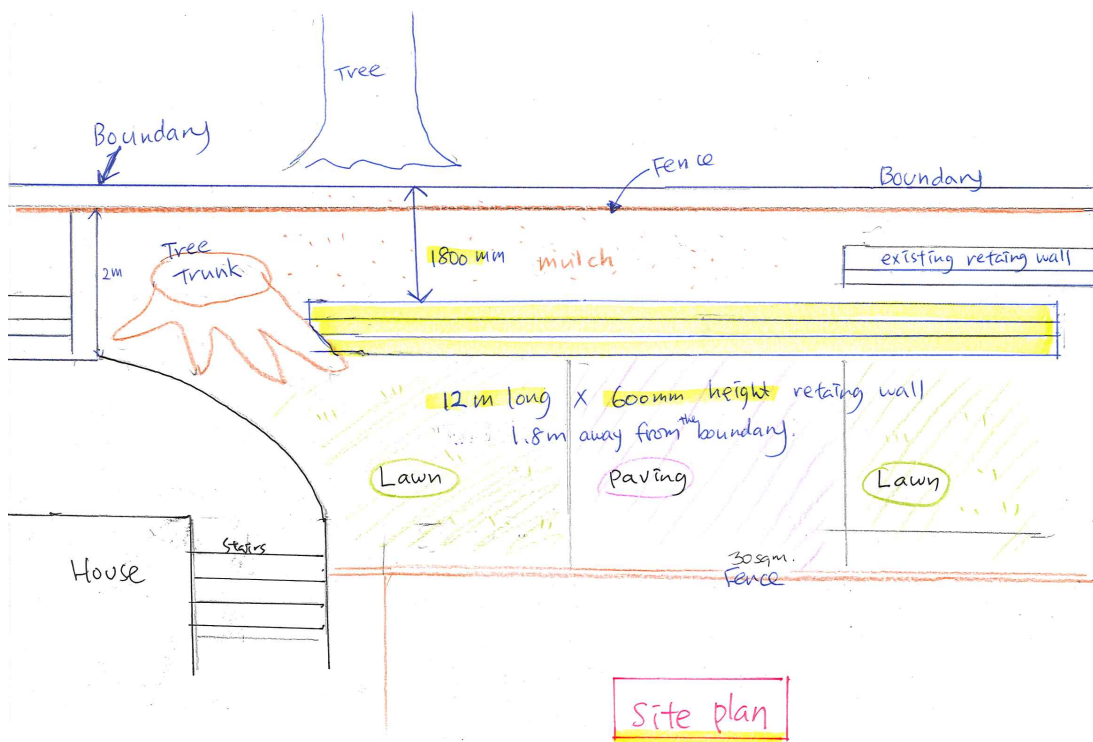
- *a retrospective resource consent application for Works within the dripline of significant tree T026*
4. Application LUC-2020-546 contains a hand-drawn Site Plan which may or may not be to scale (image five). It shows a 0.6 x 12m long proposed retaining wall running 1.8m from the boundary. It shows a stump that does not appear in the photos taken on October 19 and indicates that the fence is built inside the boundary by an unspecified distance.

**Image five:** Copy of the applicant's 02/11/20 Site Plan attached as page 9 of application LUC-2020-546

8. The retaining wall shall extend from the side of the raised garden bed (*as shown in image five and indicated in image six*) and run parallel to the fence extending to beyond the outside edge of the 2GP dripline of T026
