## Site Inspection Record

| <b>Project:</b> Slope re-battering earthworks | | <b>Project Number:</b> 240732 |
| <b>Date:</b> 27/01/2025 | <b>Time:</b> 12:30 pm | <b>Inspection #:</b> GI01 |

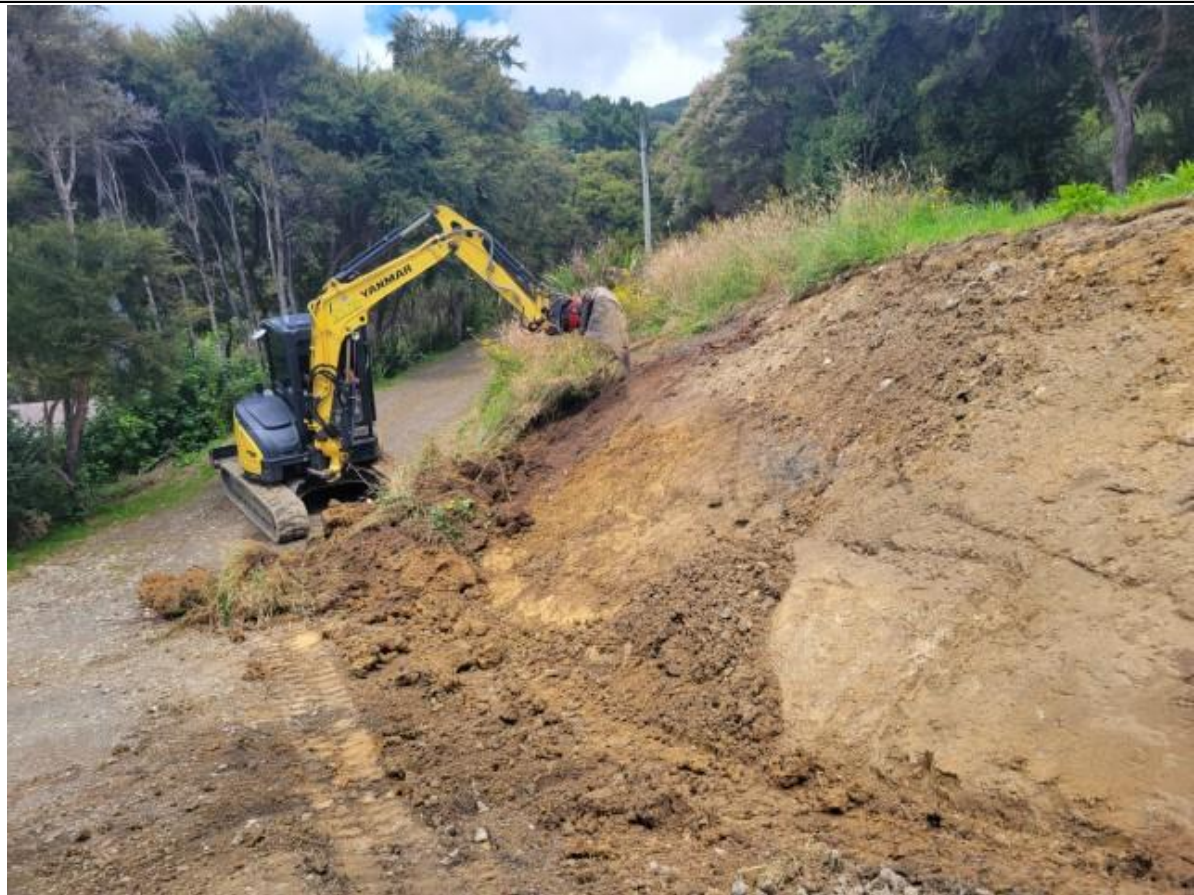
*Photograph 1: Earthworks on the main (highest) cut slope underway*

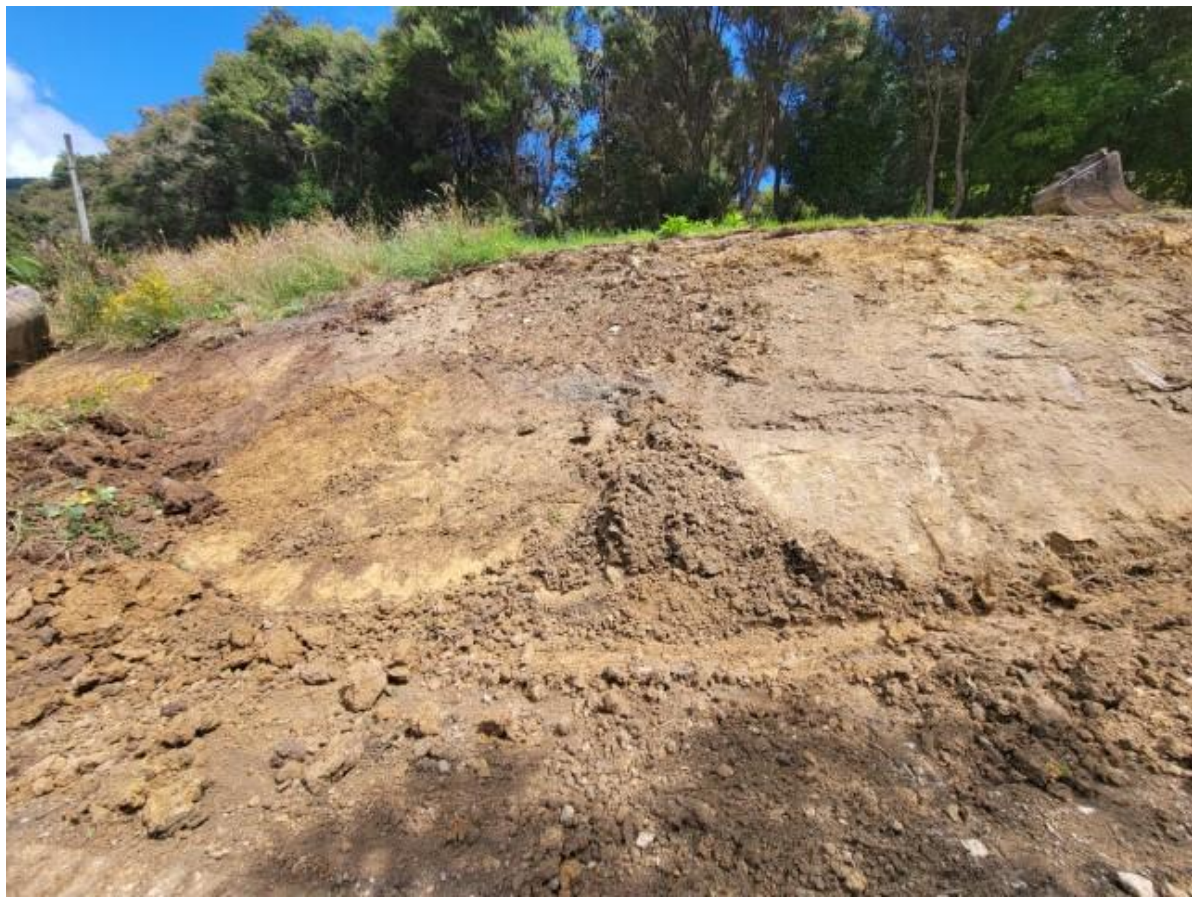
*Photograph 2: Main cut slope, with the fill contact clearly visible about 1/3 of the way up the slope*

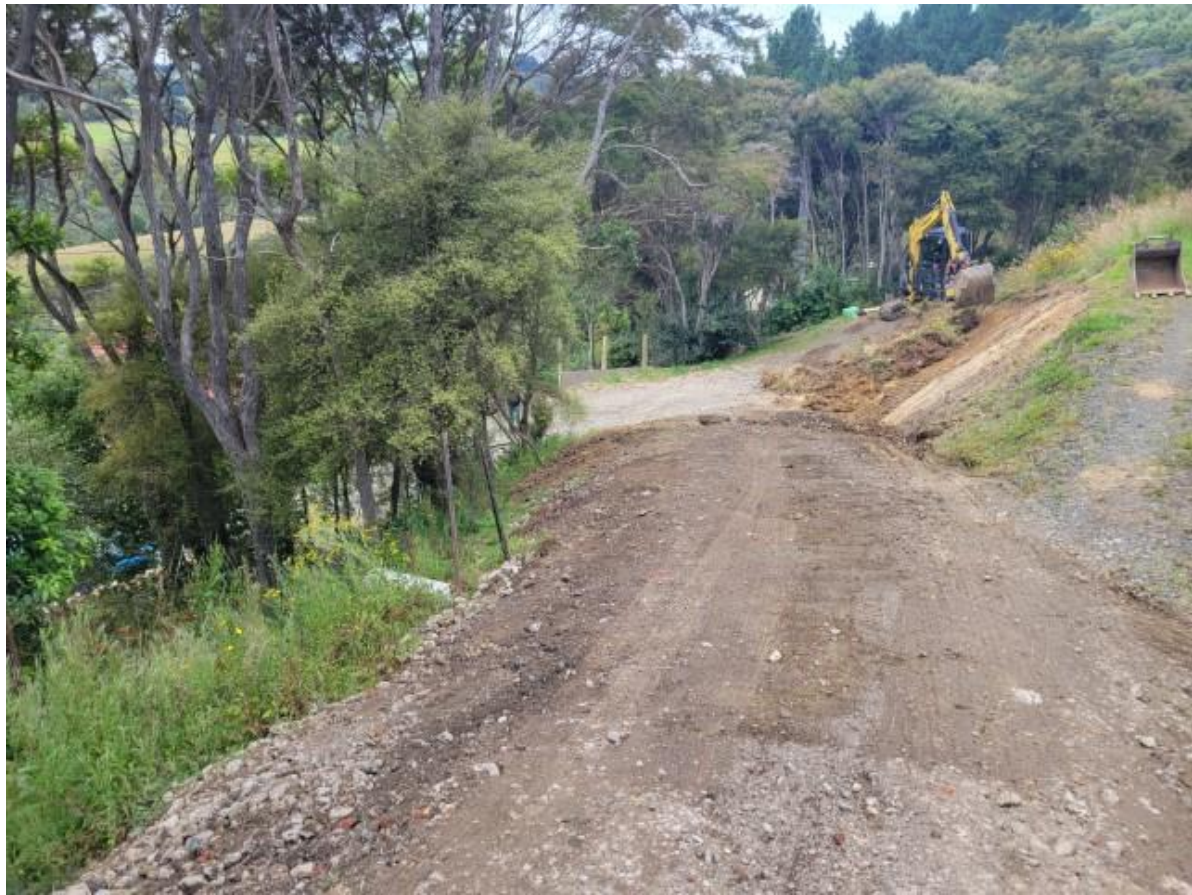
*Photograph 3: Landslide debris and some fill removed from outside road shoulder, with minimal (recent) fill remaining to be removed*

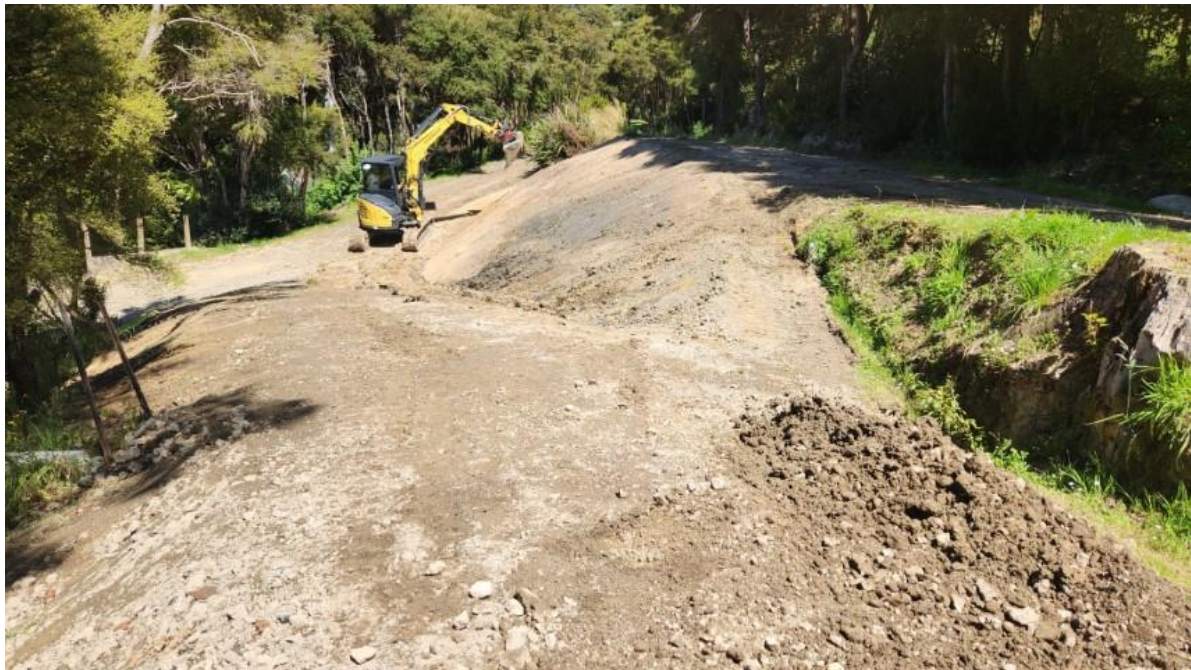
*Photograph 4: Main slope at the completion of re-grading (photo supplied by P Napier)*

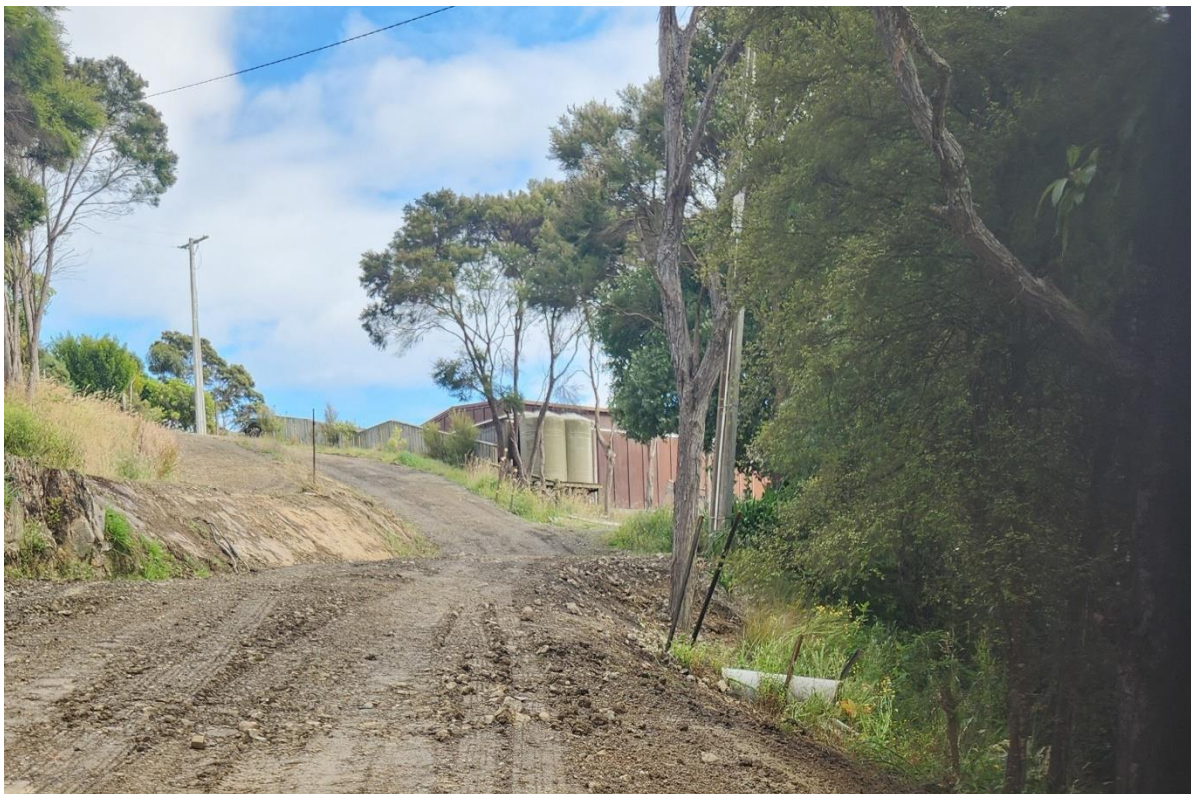
*Photograph 5: Re-grading on northern slope now complete (photo supplied by P Napier)*

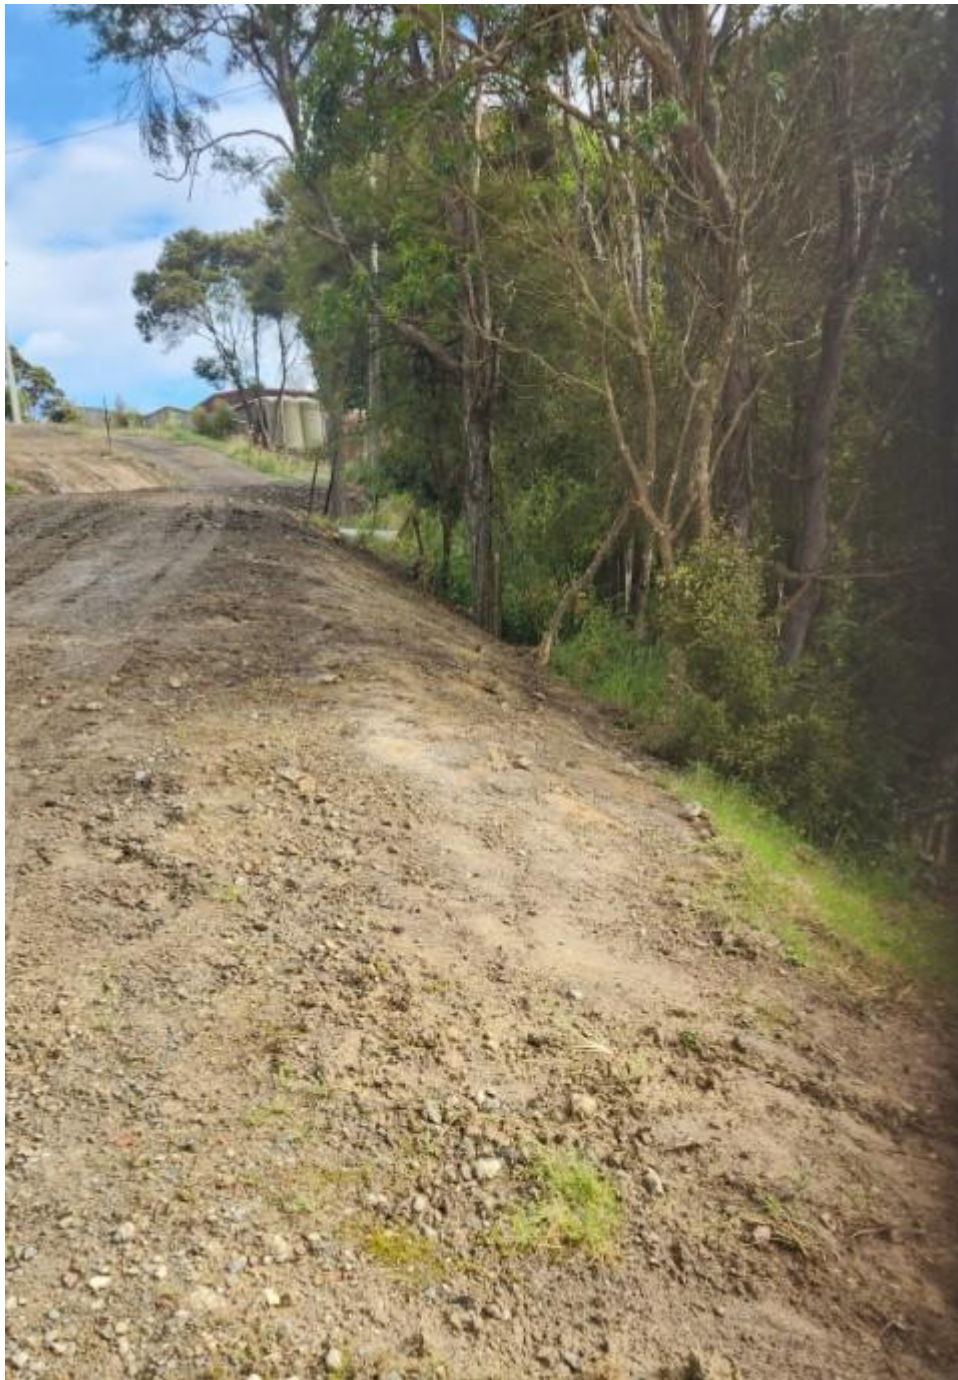
*Photograph 6: Road shoulder following removal of all (recent) fill (photo supplied by P Napier)*
