CONDITION REPORT

FORTUNE THEATRE, 231 STUART STREET, DUNEDIN

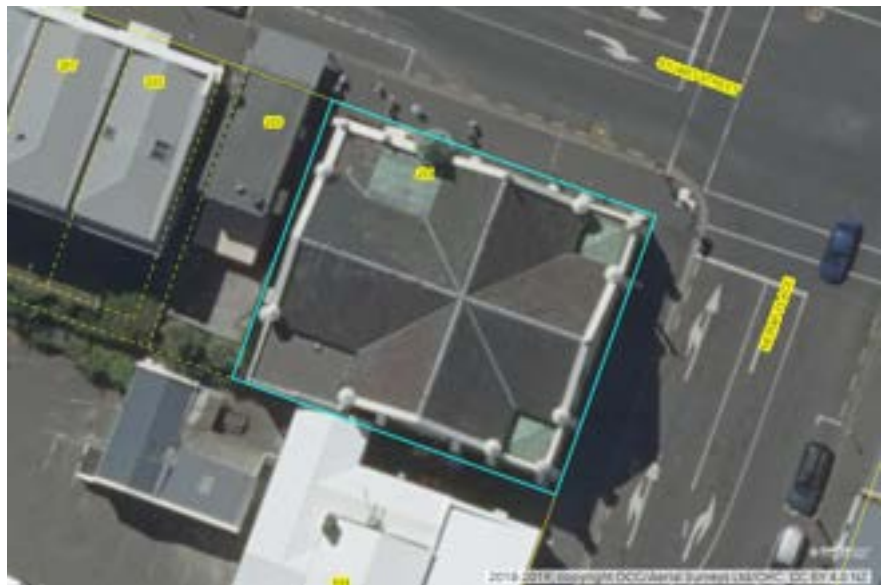
General Description:	<p>The building is located on the corner of Moray Place and Upper Stuart Street in the city of Dunedin.</p> <p>The subject building was the former Trinity Methodist Church designed as an example of Gothic Revival Architecture by R. A. Lawson and was opened in 1870.</p>
General Construction:	<p>The structure of the building is believed to comprise corbelled brick / stone and concrete slabs and foundations, local solid stone external wall construction, and steel, and timber joinery under a pitched slate and flat copper roofs.</p>

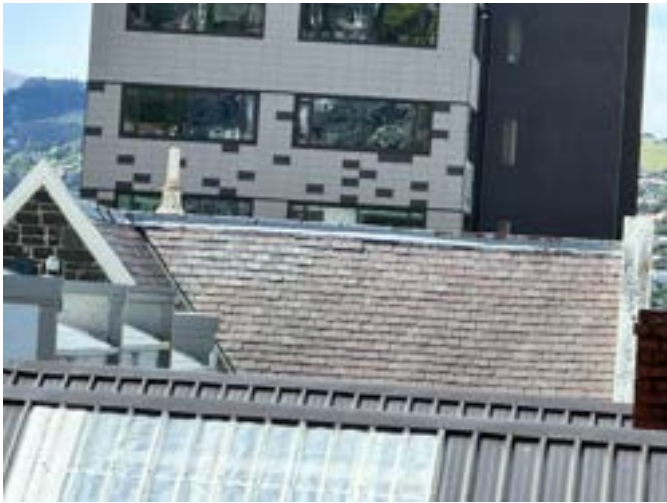
Photograph 1 – Showing the south western roofs and flat roof area above the extension.

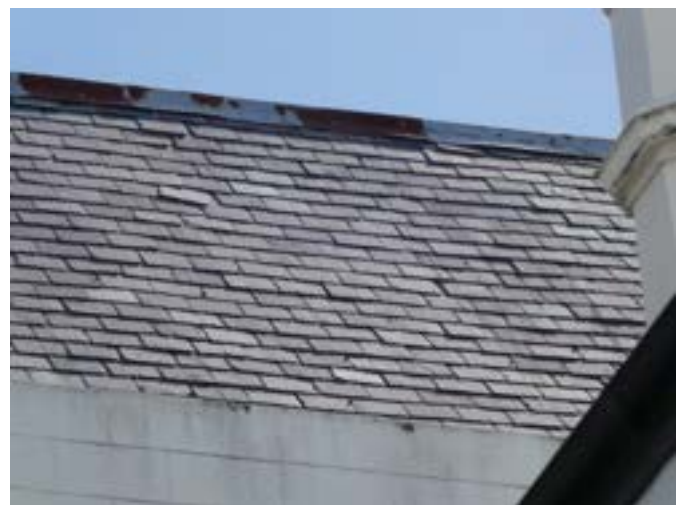
Photograph 4 – Showing the south western roof noting slipped slates and extensive rust to the ridge capping.

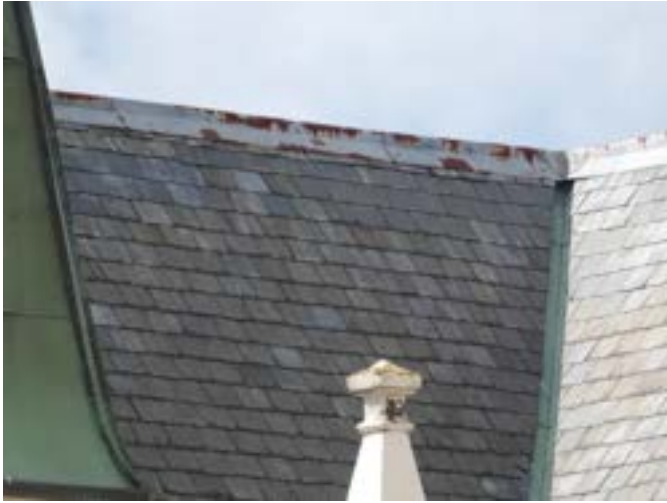
Photograph 5 – Showing the corroded ridge flashings to the north.

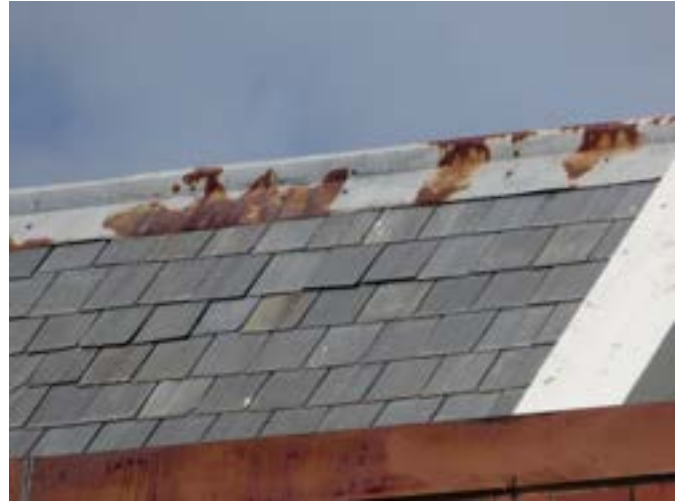
Photograph 6 – Showing the corroded ridge flashings to the north.

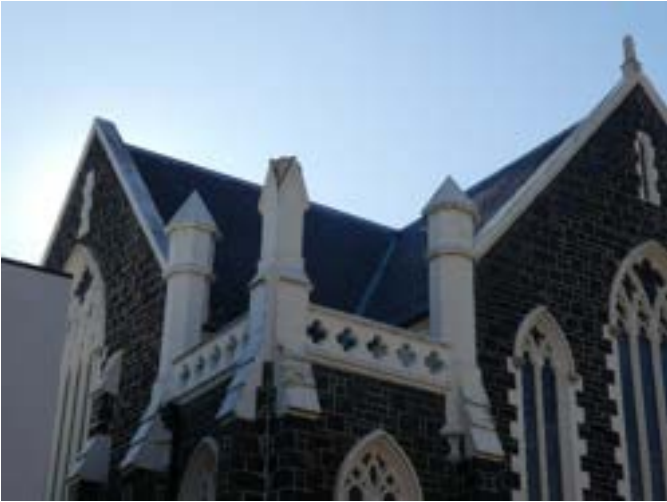
Photograph 7 - Showing the slate roof to the south eastern corner.

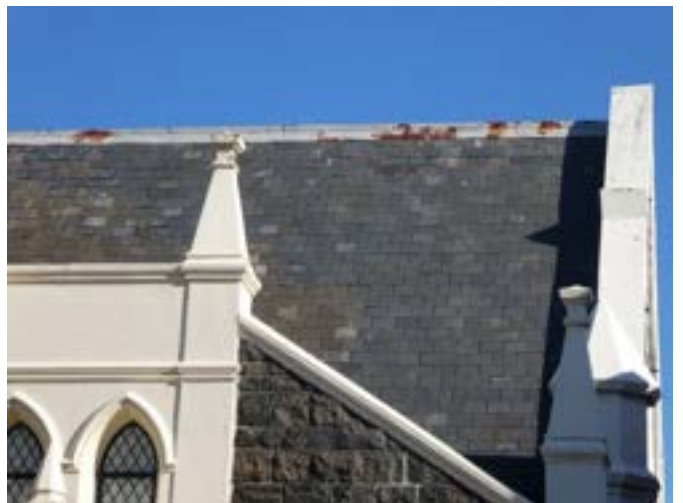
Photograph 10 – Showing the slate roof to the north western corner.

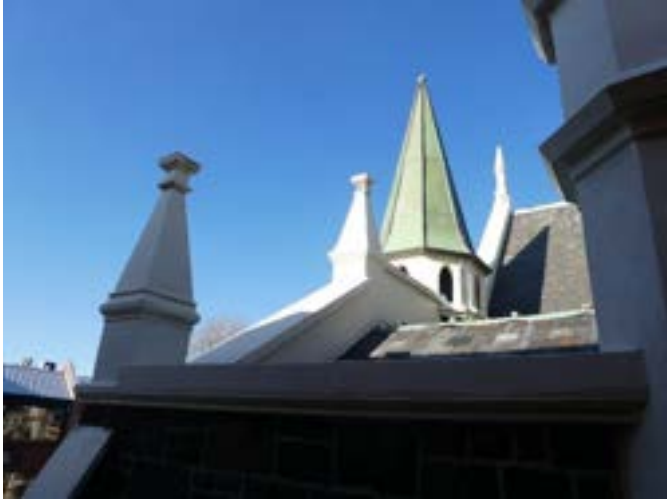
Photograph 11 – Showing the edge detail to the copper standing seam roof to the north western corner.

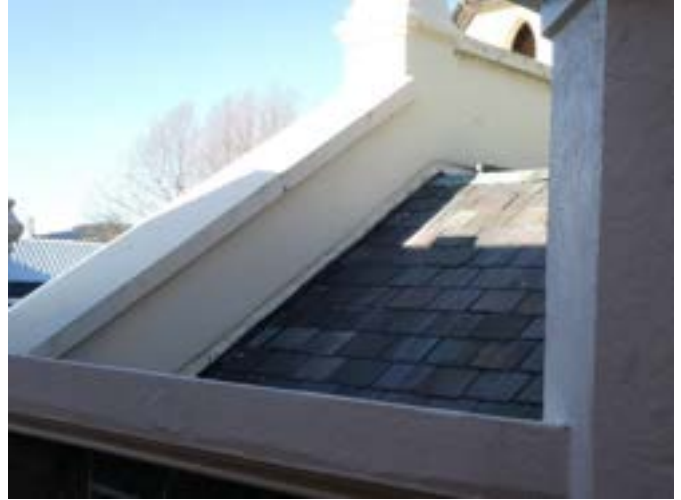
Photograph 12 – Showing the flashings detail to the rear of the parapet wall to the north western corner.

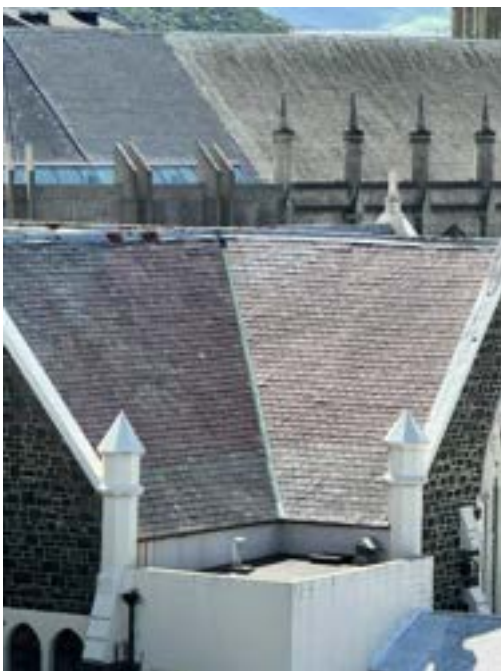
Photograph 13 – Showing the south western roofs and flat roof area above the extension.

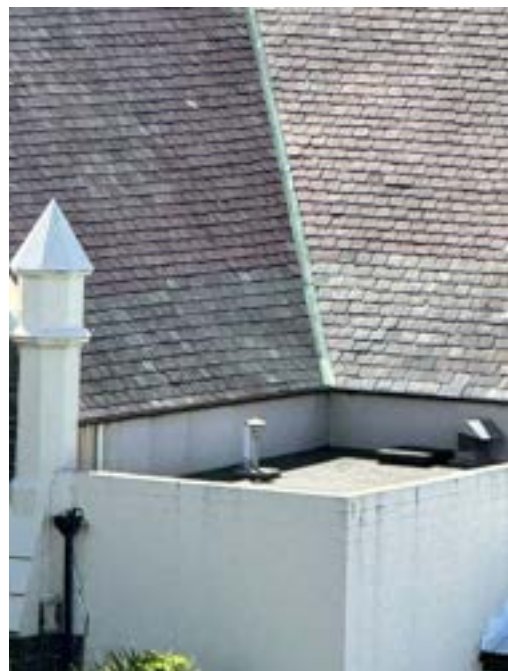
Photograph 14 – Showing the south western roofs and flat roof area above the extension.

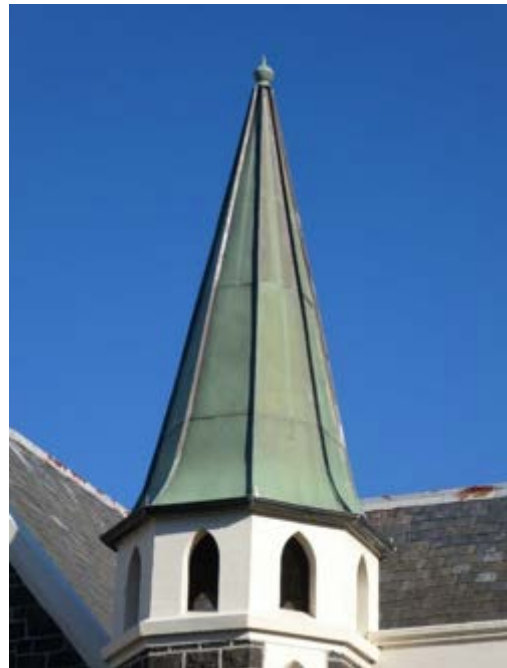
Photograph 15 – Showing the replacement copper roof to the bell tower.

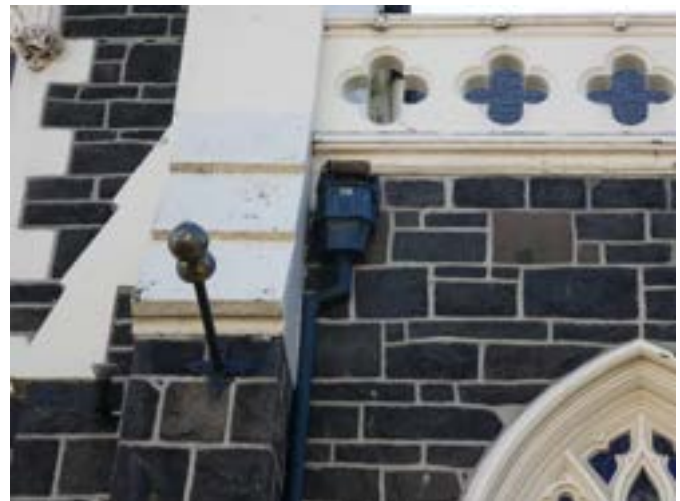
Photograph 16 – Showing the hopper and rainwater downpipe from the south eastern roof.

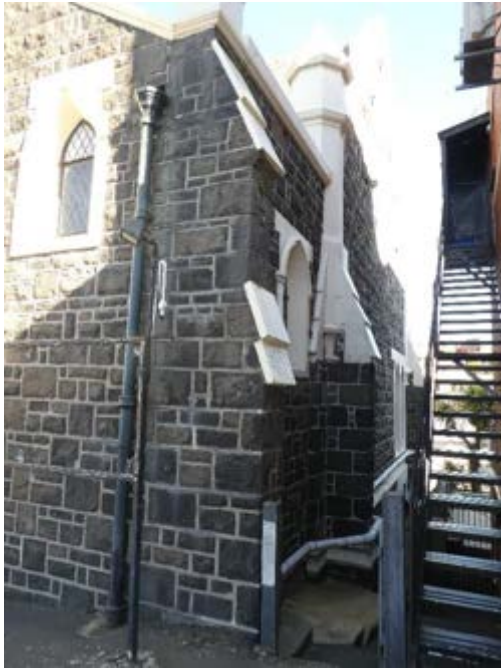
Photograph 17 - Showing the rainwater hopper and iron downpipe to the north western corner.

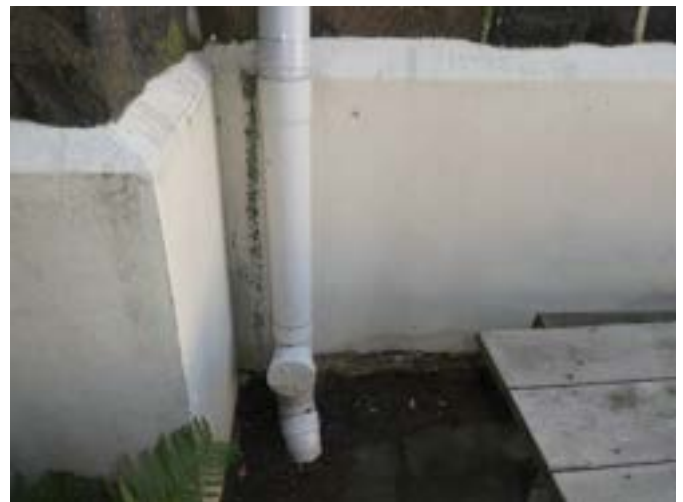
Photograph 19 – Showing the replacement uPVC rainwater downpipe and inspection point to the southern elevation.

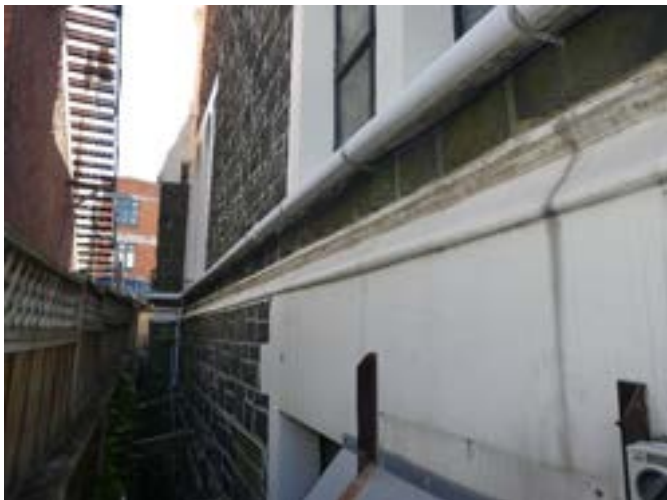
Photograph 20 – Showing the uPVC rainwater pipework to the western elevation.

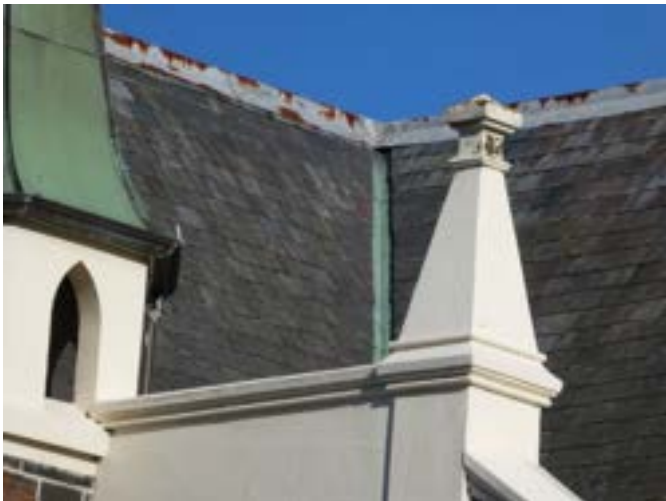
Photograph 26 - Showing typical pinnacle detail to the northern elevation.

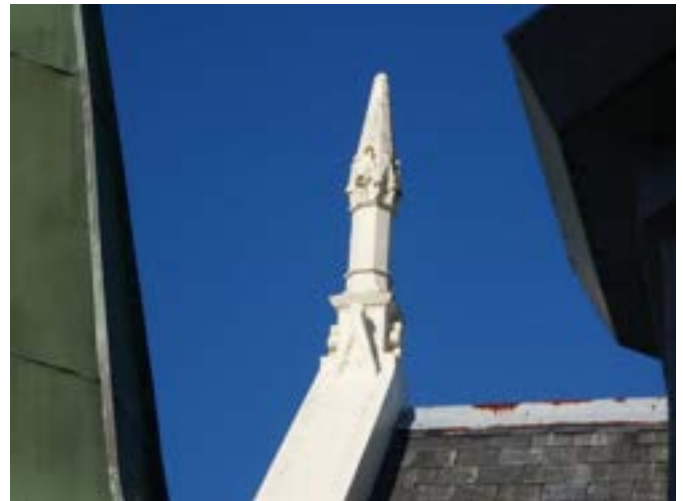
Photograph 27 – Showing the pinnacle to the northern gable.

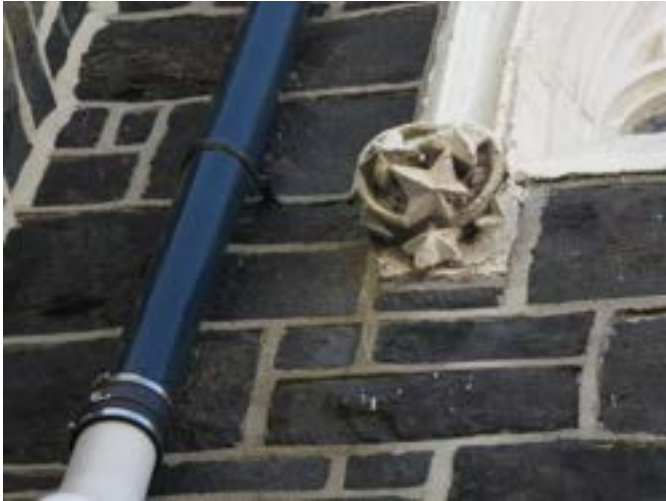
Photograph 28 - Showing typical boss detail to the windows.

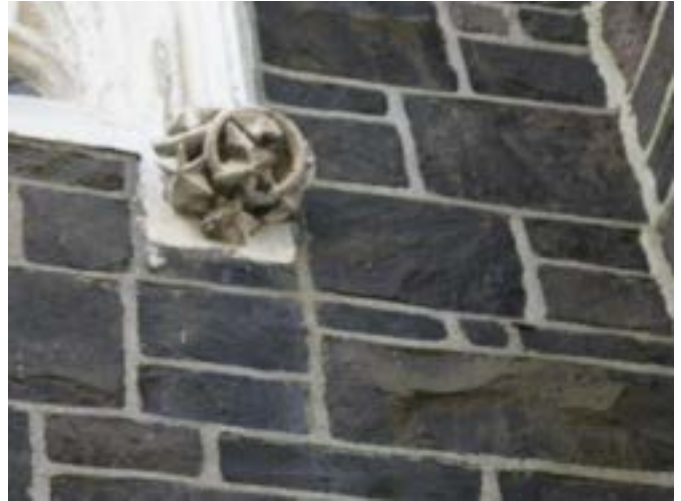
Photograph 29 – Showing typical boss detail to the windows.

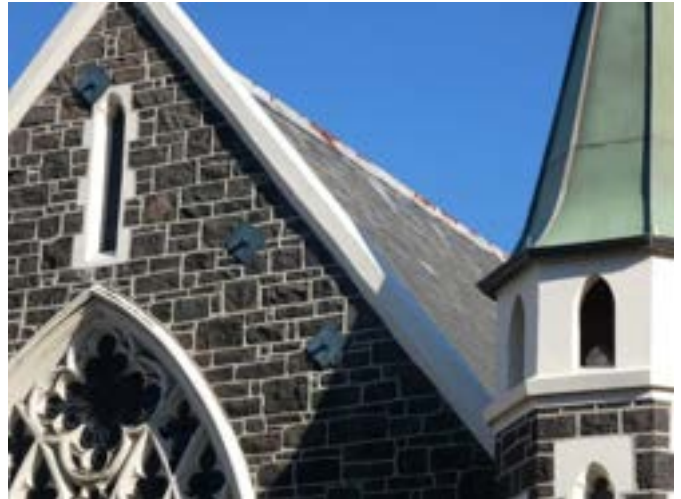
Photograph 30 – Showing the metal tie rods to the northern gable.

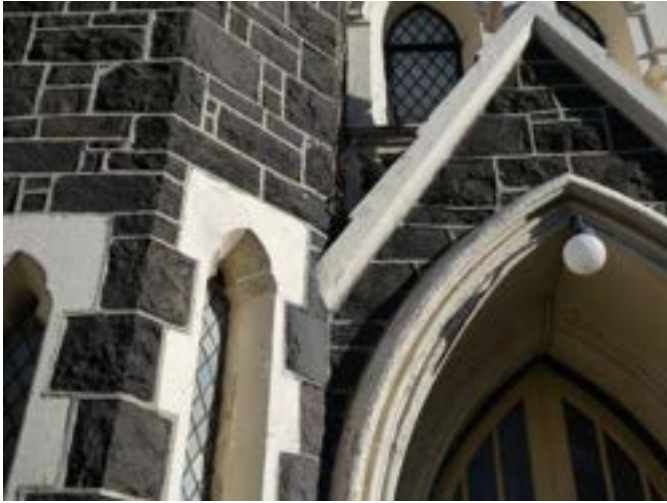
Photograph 31 – Showing the vegetation growth above the northern entrance.

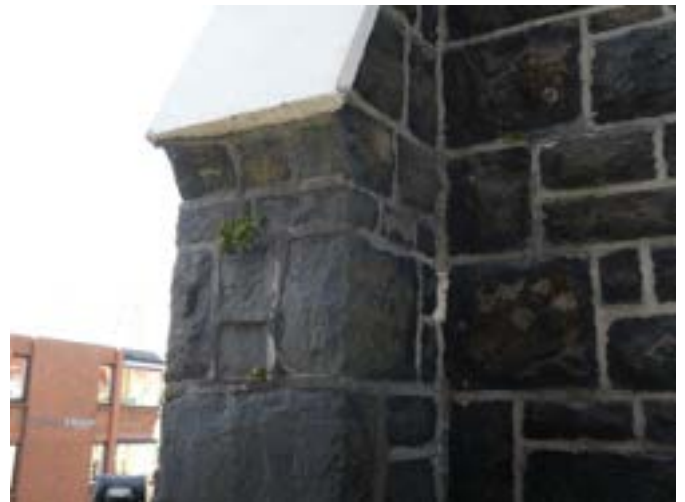
Photograph 36 – Showing the vegetation growth to the north western buttress.

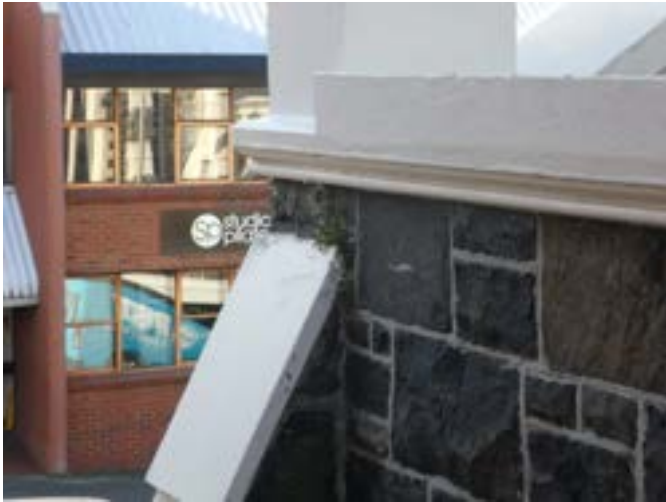
Photograph 37 - Showing the vegetation growth to the north western buttress.

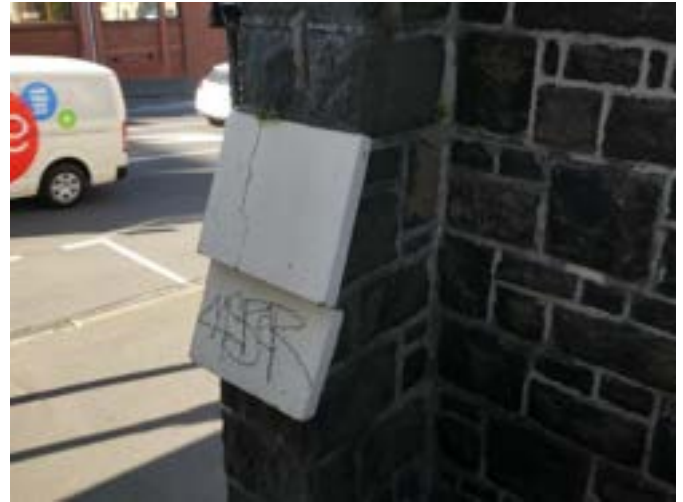
Photograph 38 – Showing the graffiti to the north western buttress.

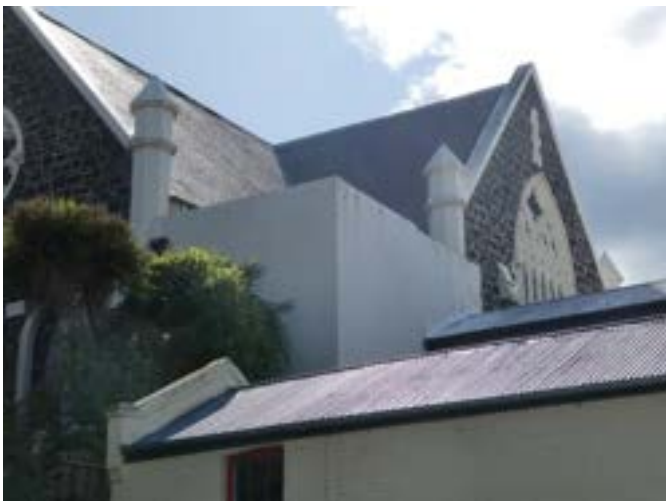
Photograph 39 – Showing the two-story extension to the south western corner.

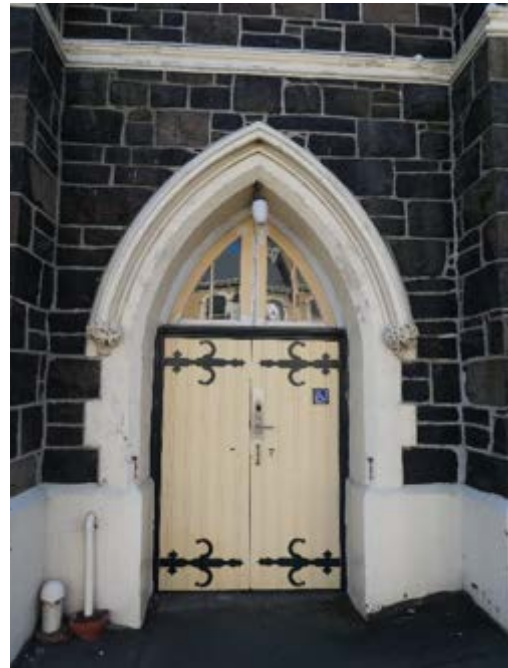
Photograph 43 – Showing the south western double entrance doors.

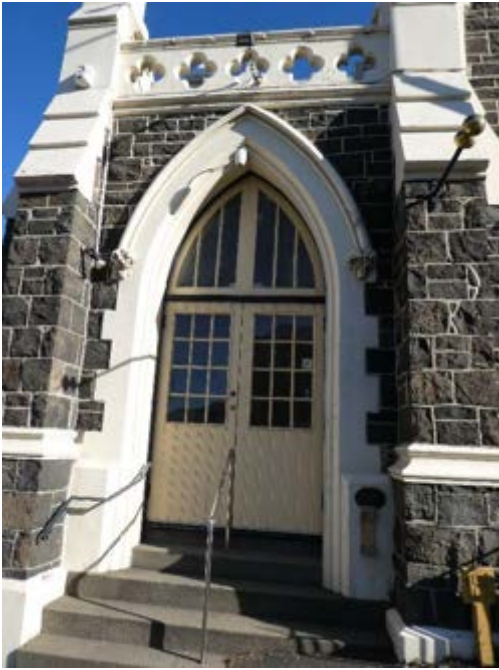
Photograph 44 - Showing the north eastern double entrance doors.

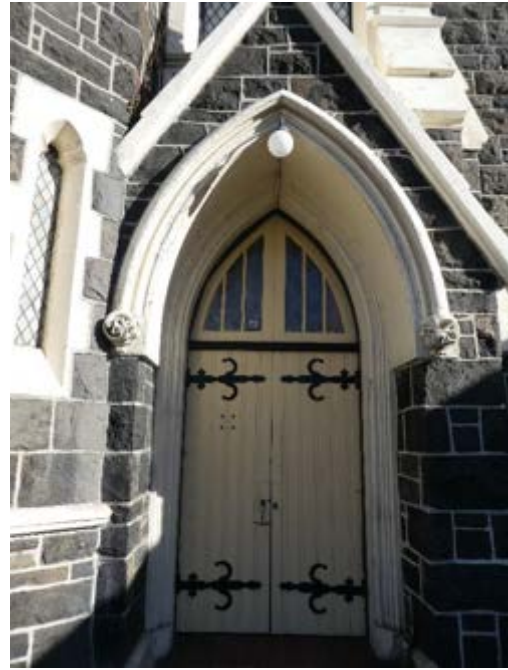
Photograph 45 – Showing the north western double entrance doors.

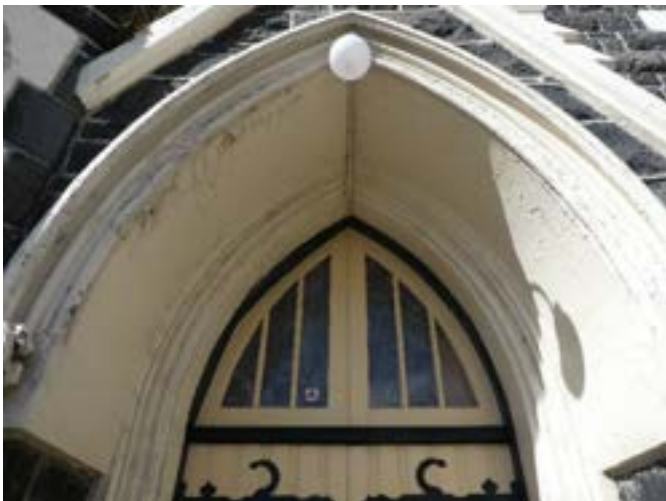
Photograph 46 - Showing the glazed top light above the northern entrance door.

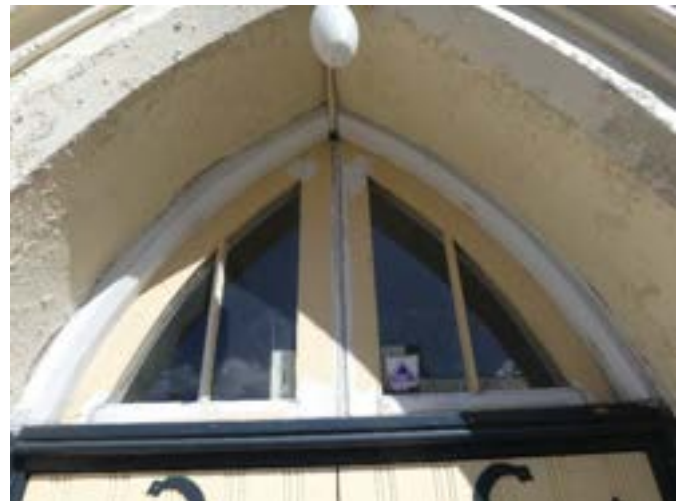
Photograph 47 – Showing the unfinished painting to the glazed top light above the southern entrance door.

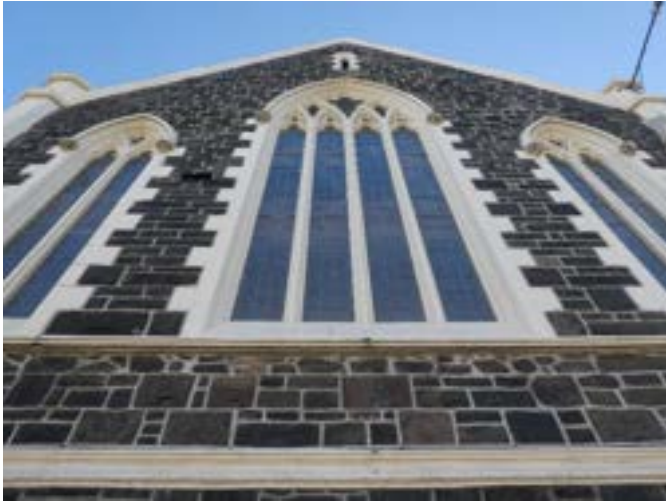
Photograph 48 - Showing the eastern tracery window.

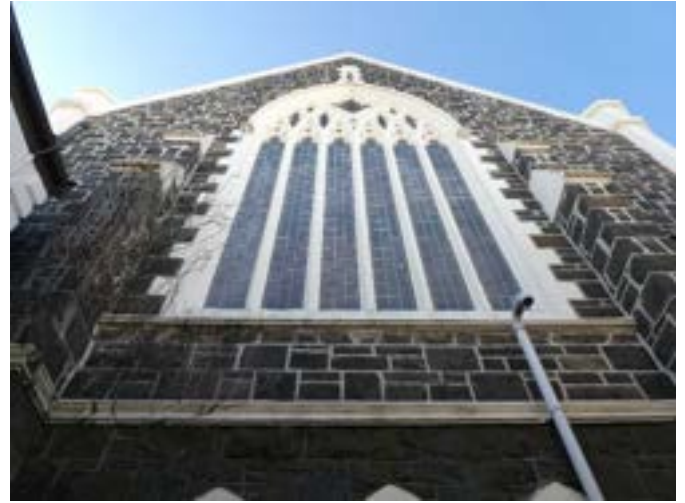
Photograph 49 – Showing the southern tracery window.

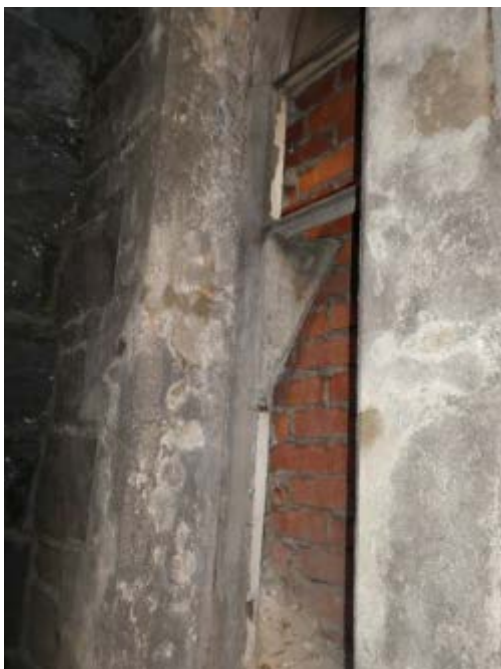
Photograph 50 - Showing the broken glazing to the steel framed windows which has been bricked up to the south western courtyard area.

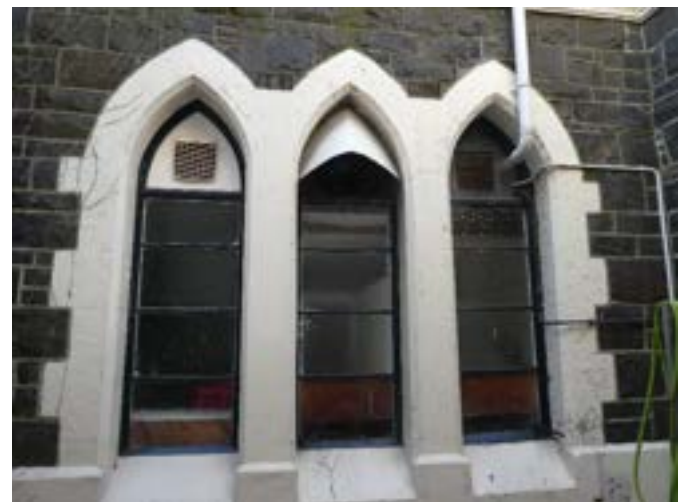
Photograph 51 – Showing the steel framed windows on the western elevation. Noting inappropriate positioning of services.

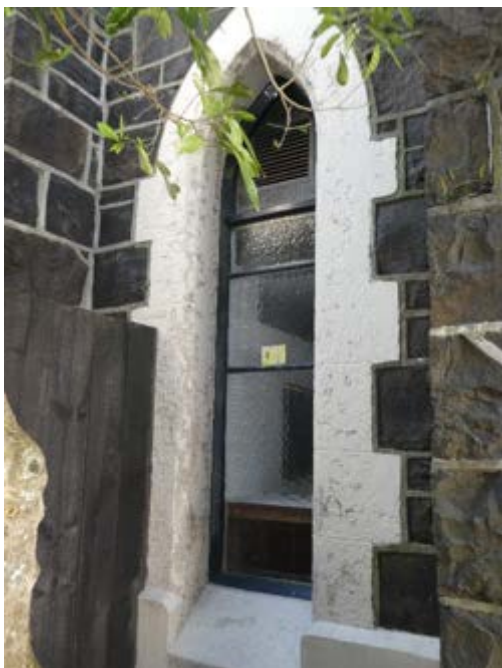
Photograph 52 - Showing the steel framed windows to the south western courtyard area. Noting paint failure and replacement putty.

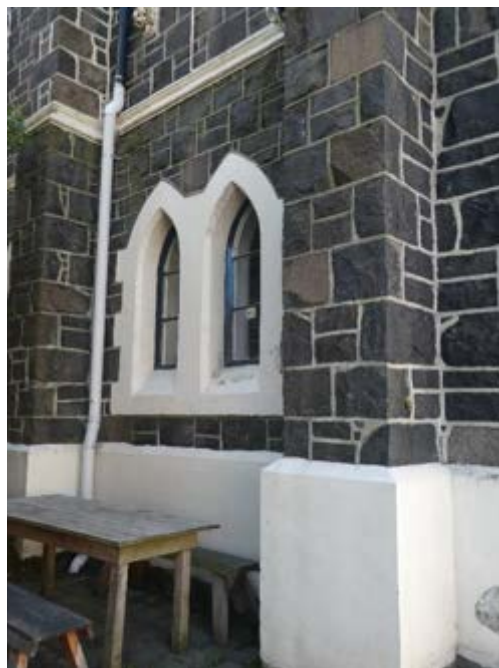
Photograph 53 – Showing the steel framed windows to the south western courtyard area. Noting paint failure, and replacement putty.

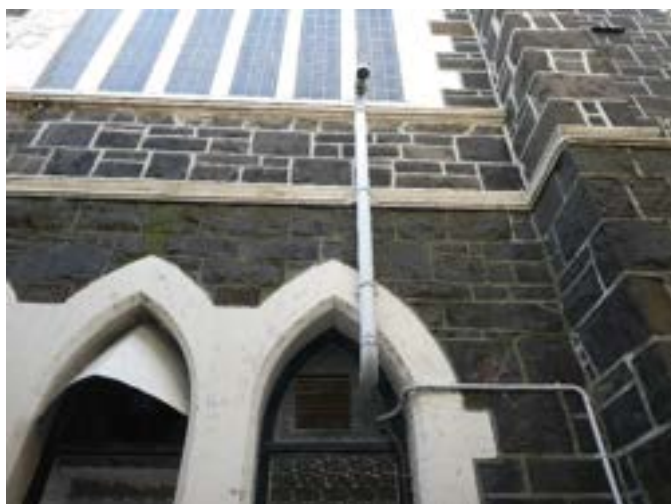
Photograph 54 - Showing the steel framed windows on the western elevation. Noting inappropriate positioning of services.

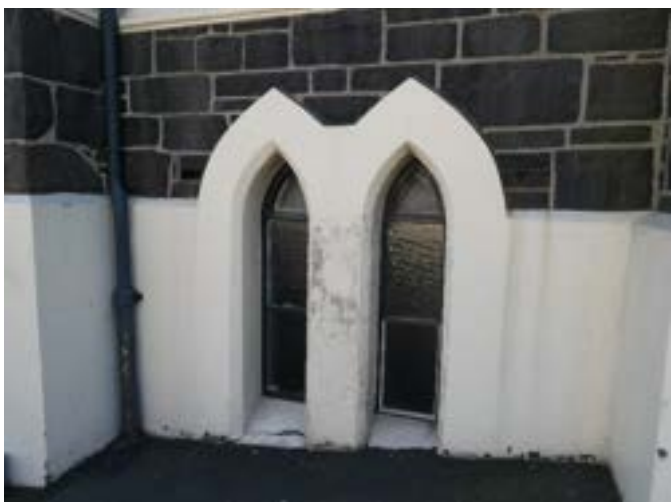
Photograph 56 - Showing the steel framed windows on the southern elevation. noting paint failure, cracking to the sill and unpainted replacement putty.

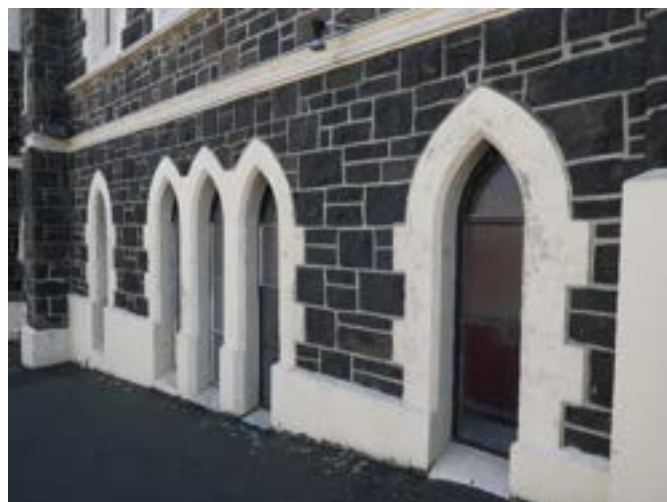
Photograph 57 – Showing the steel framed windows on the southern elevation.

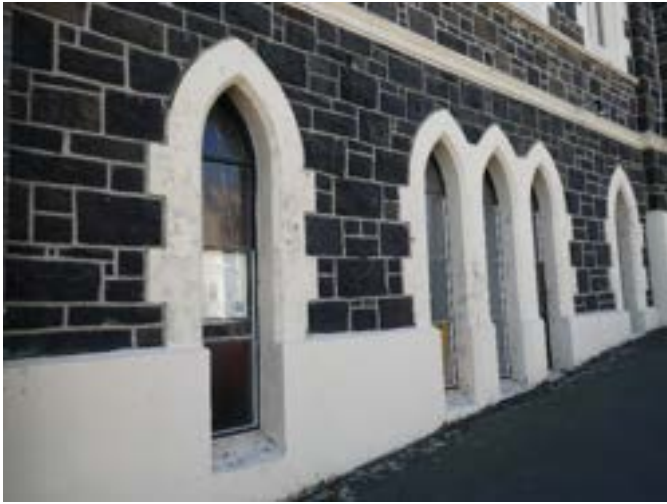
Photograph 58 - Showing the steel framed windows on the southern elevation.

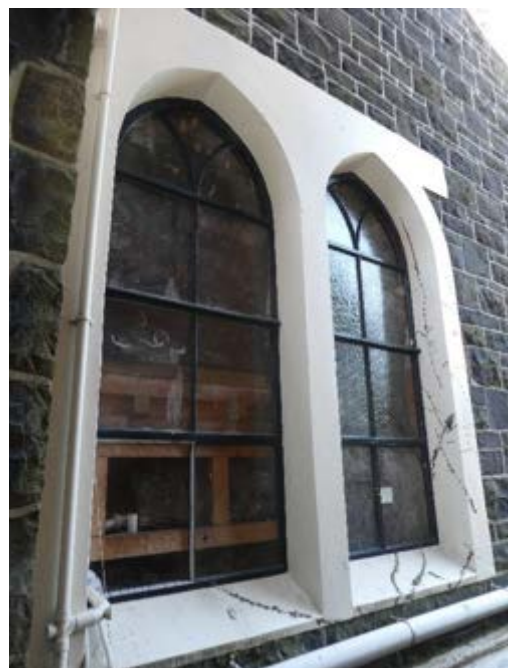
Photograph 63 – Showing the western elevation. Noting corrosion to the steel window frame

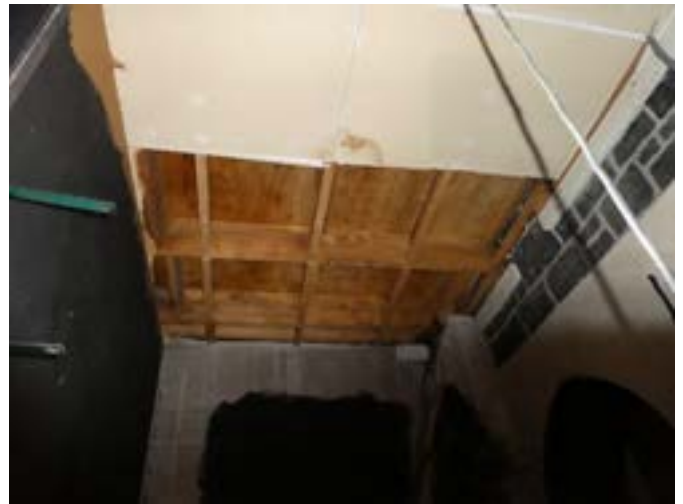
Photograph 64 – Showing the exposed and uninsulated flat roof to the south western extension.

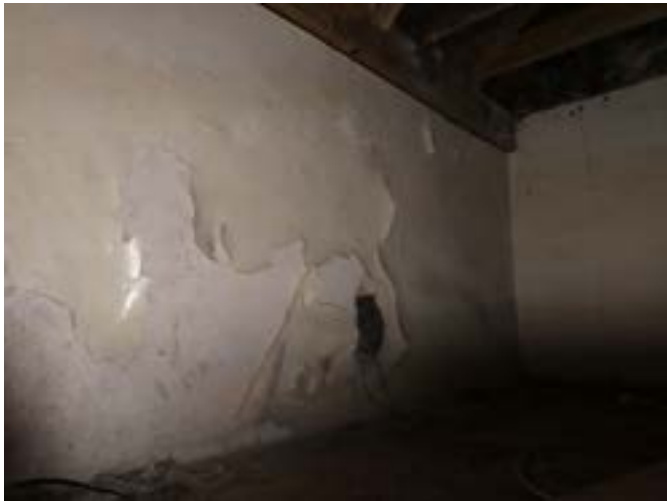
Photograph 65 - Showing the paint failure to the hidden walls within the roof space above the kitchen / bar.

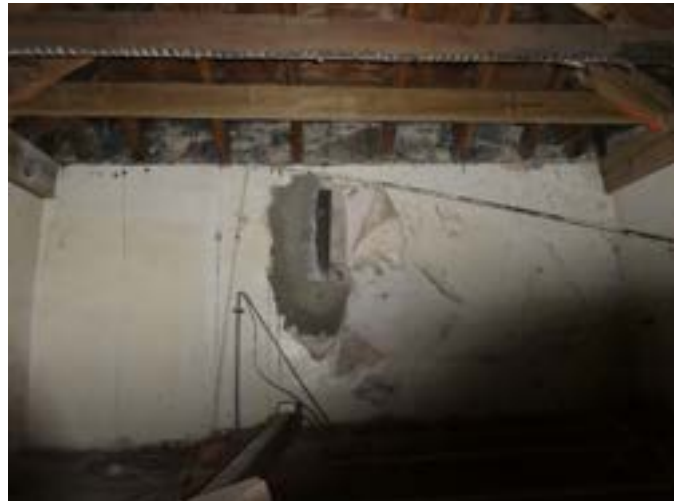
Photograph 66 – Showing the paint failure to the hidden walls within the roof space above the kitchen / bar.

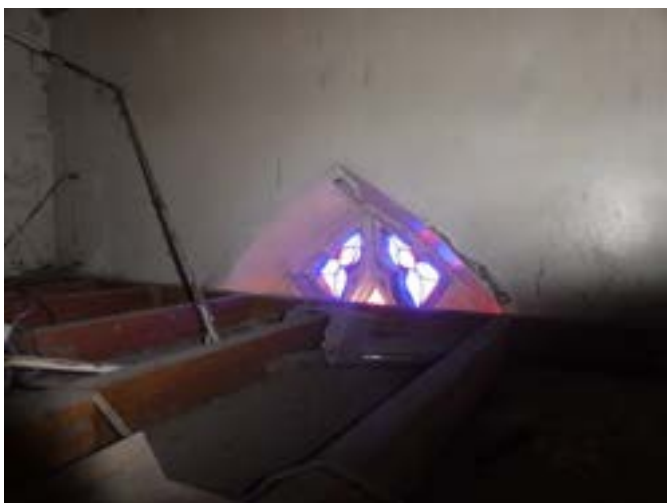
Photograph 67 - Showing the ceiling joists and the hidden top to the leaded lancet window within the roof space above the kitchen / bar.

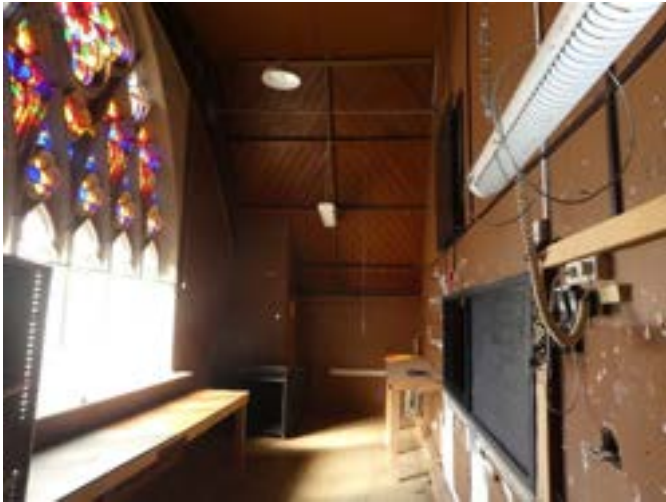
Photograph 69 - Showing the meeting / theatre technical room.

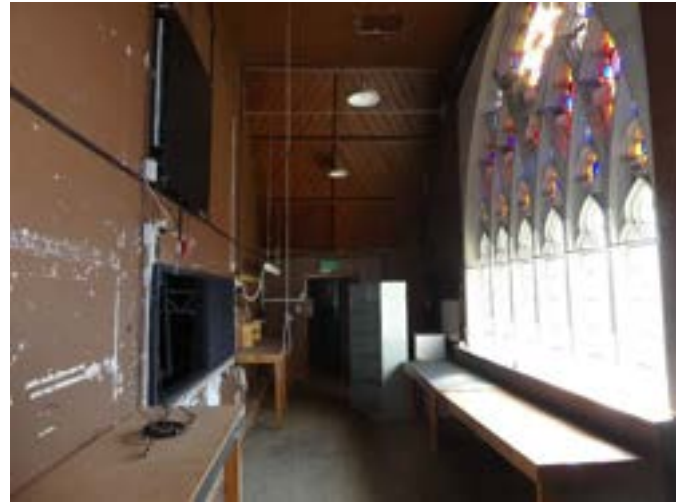
Photograph 70 – Showing the meeting / theatre technical room.

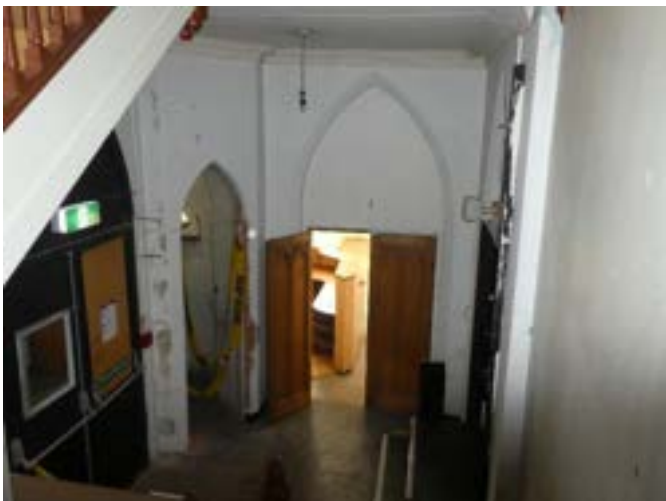
Photograph 71 - Showing the north western vestibule / stage left.

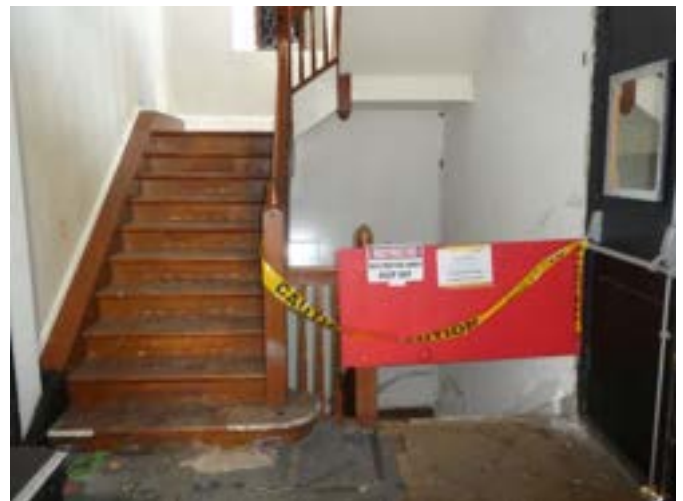
Photograph 72 – Showing the staircase from the north western vestibule / stage left.

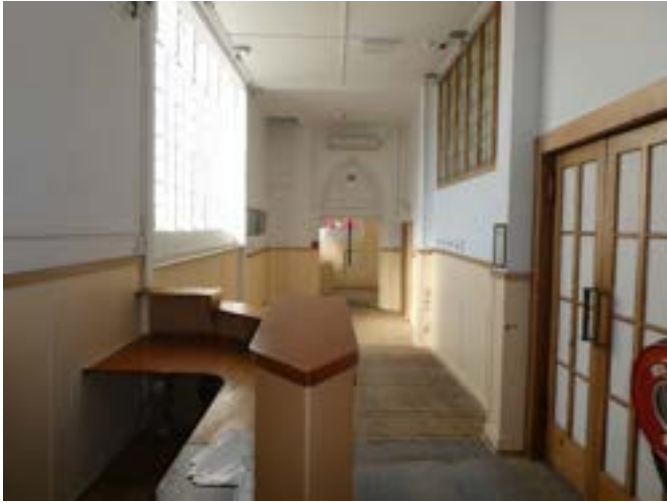
Photograph 73 - Showing the reception desk and main entrance foyer.

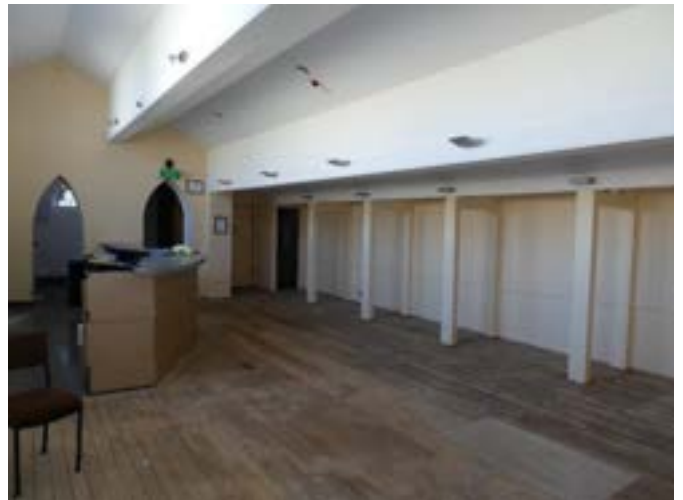
Photograph 78 – Showing the eastern bar area.

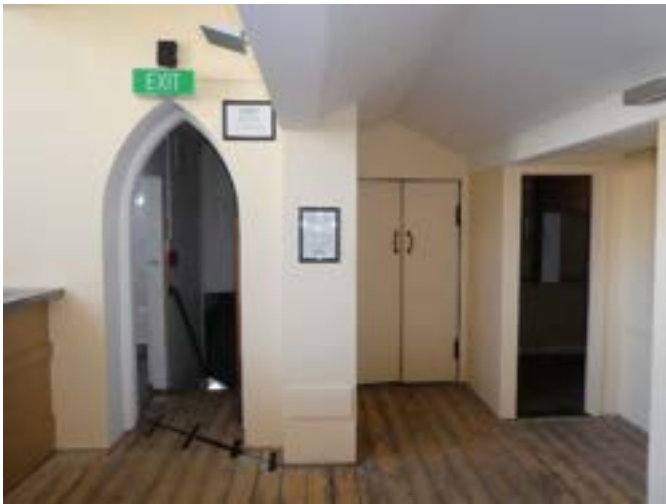
Photograph 79 - Showing the southern bar area and stairs to the lower entrance and rear entrance to the main theatre.

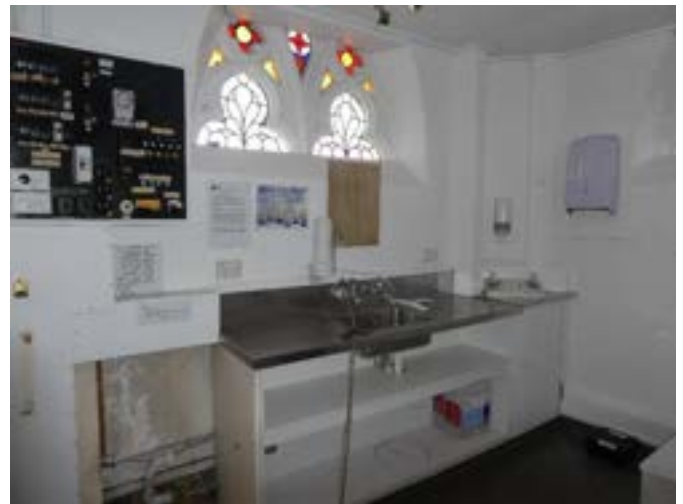
Photograph 81 – Showing the southern kitchen adjacent to the bar area. Noting electrical sub-distribution board to the southern wall.

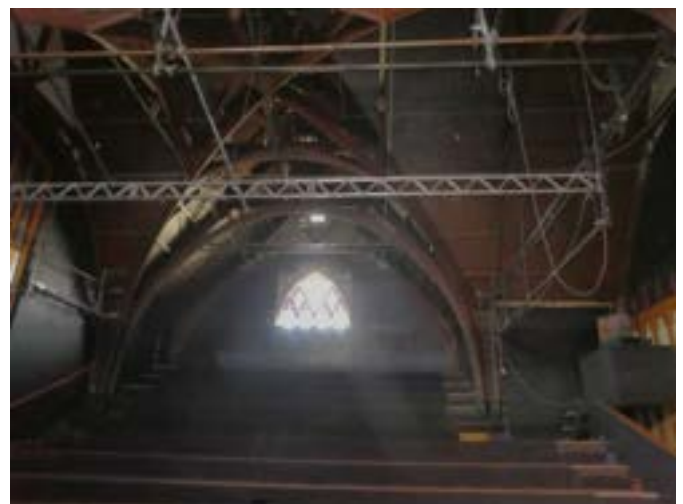
Photograph 83 – Showing the main theatre looking to the east.

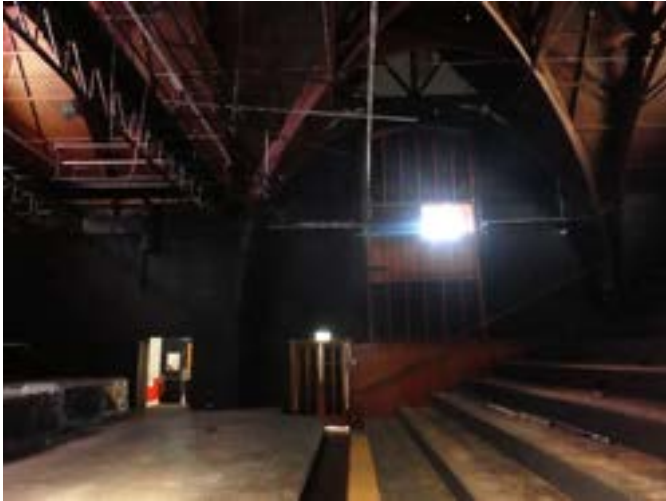
Photograph 84 - Showing the main theatre looking to the north.

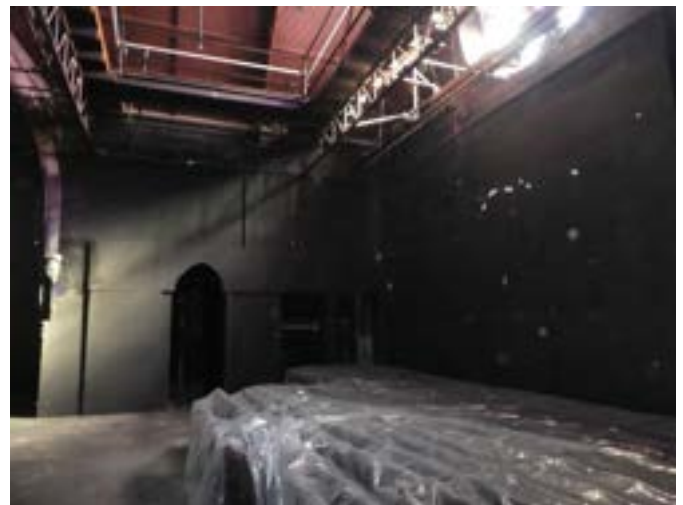
Photograph 87 – Showing the main theatre looking to the south.

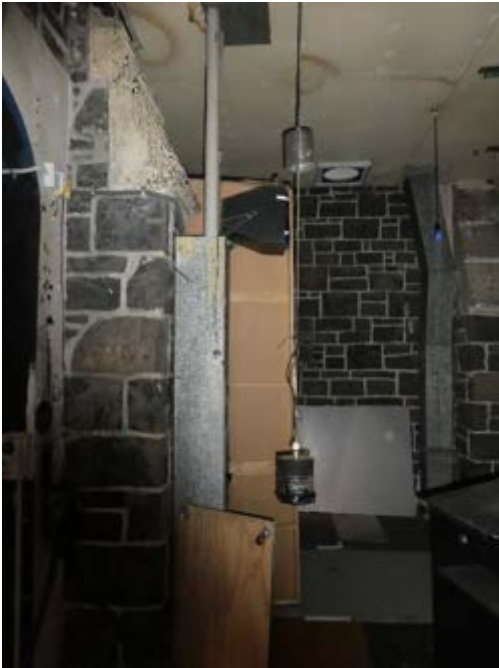
Photograph 88 - Showing the exterior walls to the now enclosed area to the south western corner. Noting moisture staining to the ceiling linings.

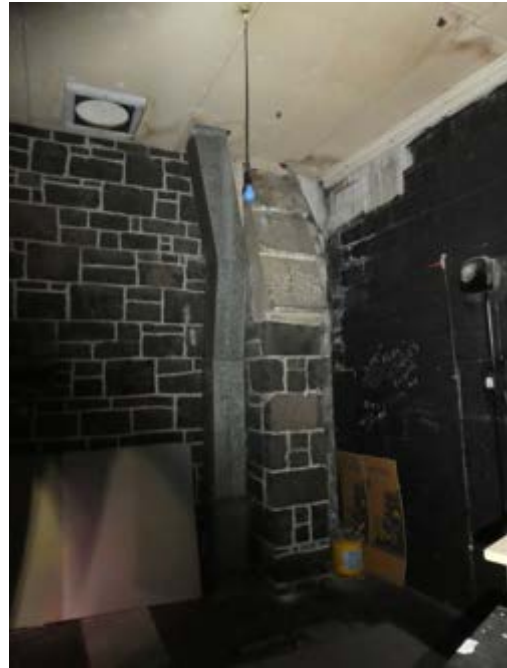
Photograph 89 – Showing the exterior walls to the now enclosed area to the south western corner. Noting moisture staining to the ceiling linings.

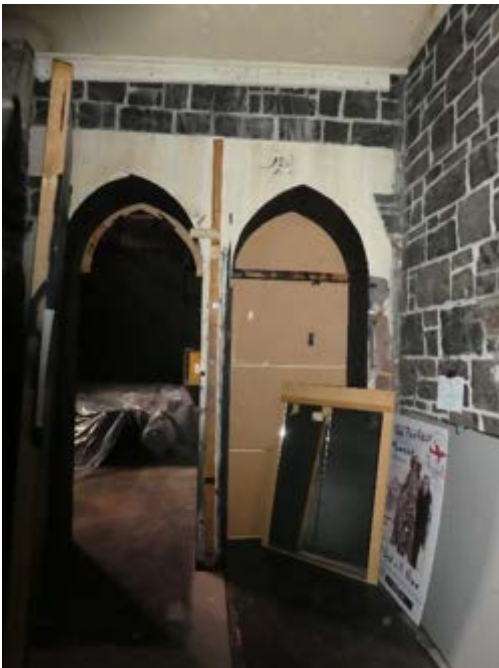
Photograph 90 - Showing the exterior walls to the now enclosed area to the south western corner. Noting the original steel sashes removed.

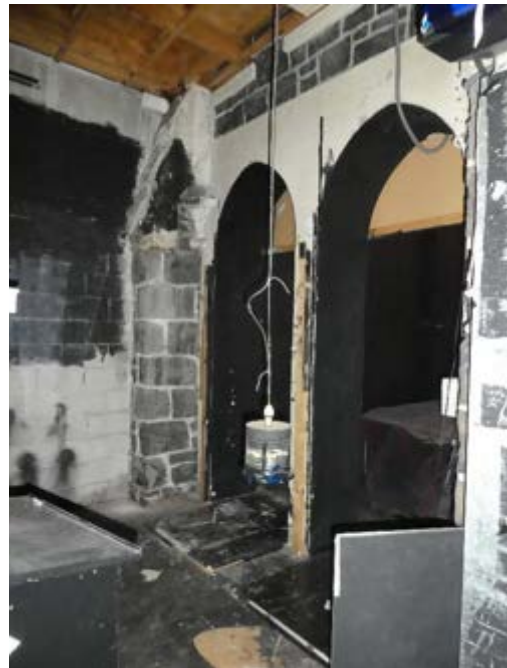
Photograph 91 – Showing the exterior walls to the now enclosed area to the south western corner. Noting the concrete block wall and timber flat roof structure above. Noting the original steel sashes removed.

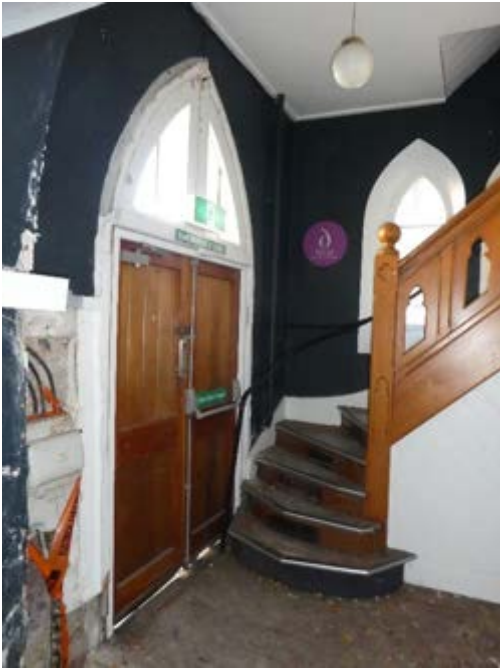
Photograph 92 - Showing the south eastern entrance and vestibule.

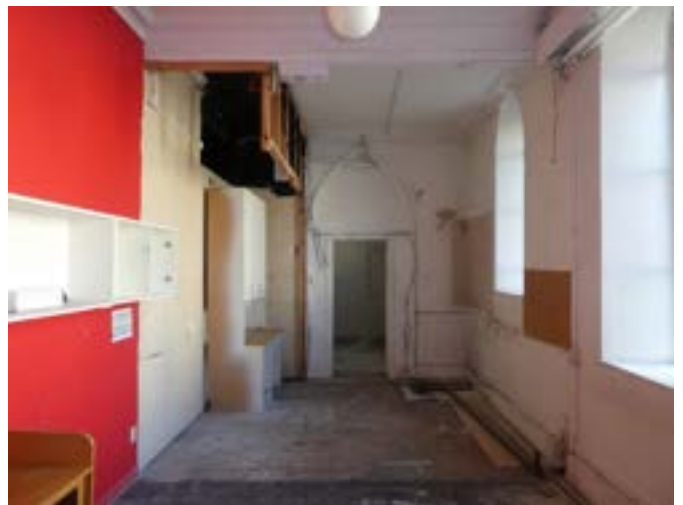
Photograph 97 – Showing the basement offices.
