CONDITION REPORT

FORTUNE THEATRE, 231 STUART STREET, DUNEDIN

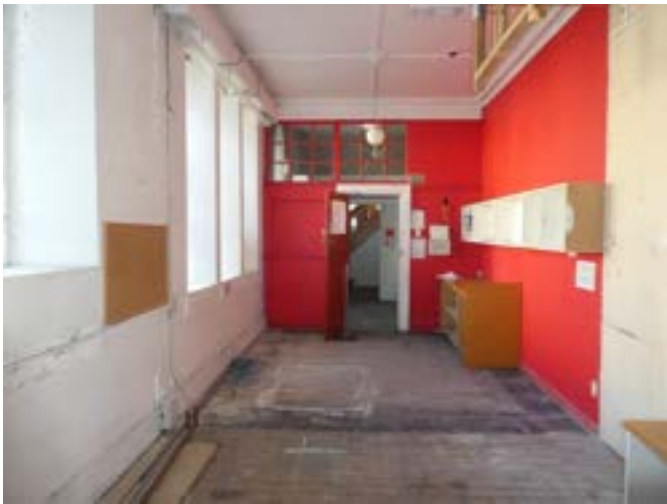
Photograph 98 - Showing the basement offices.

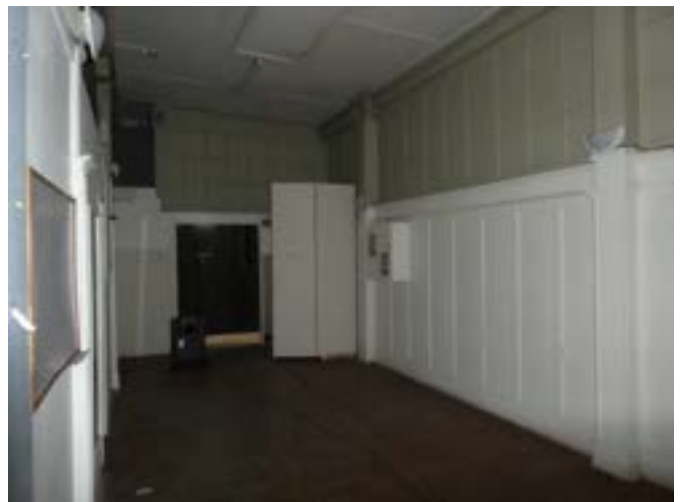
Photograph 103 – Showing the Green Room behind the basement studio theatre. The upper levels appear to be the original glazing which has been painted.

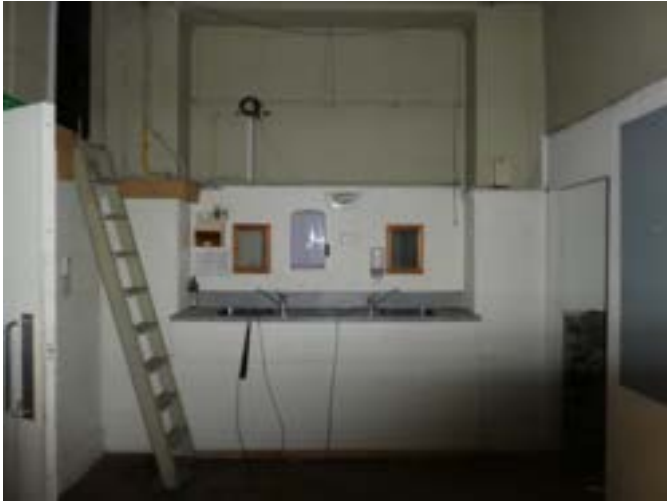
Photograph 104 - Showing the Green Room and kitchenette behind the studio theatre.

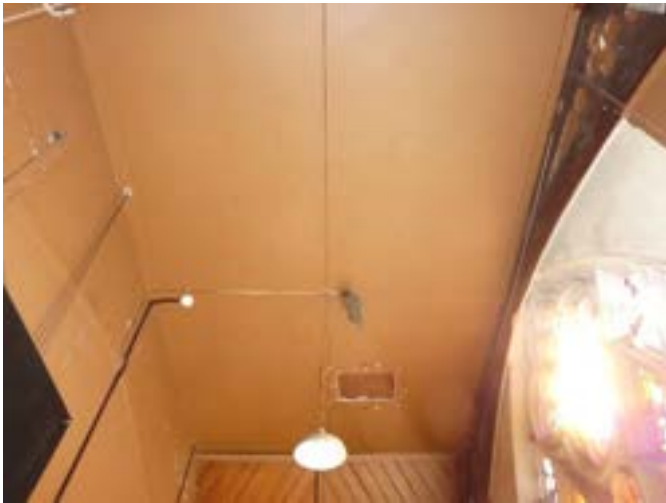
Photograph 114 - Showing the fibrous plaster ceiling to the meeting / theatre technical room. Noting poorly cut and secured roof access hatch.

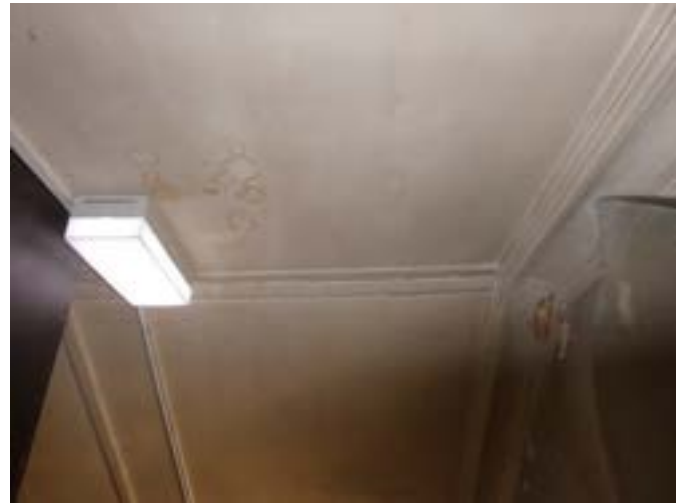
Photograph 115 – Showing typical moisture staining to the original fibrous plaster ceilings.

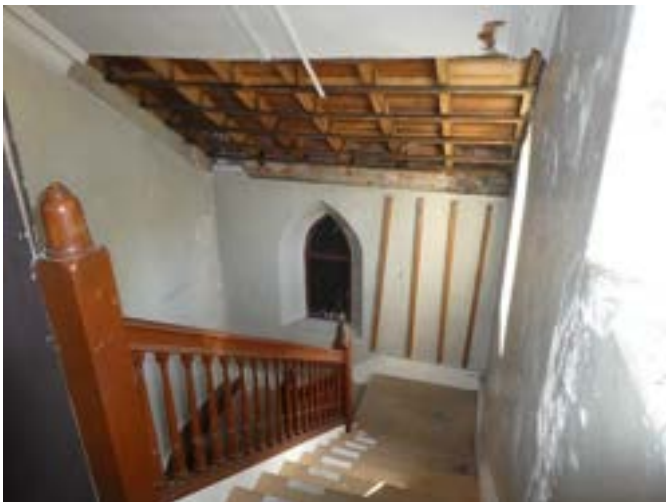
Photograph 116 - Showing the open underside of the roof structure to the north eastern stairwell.

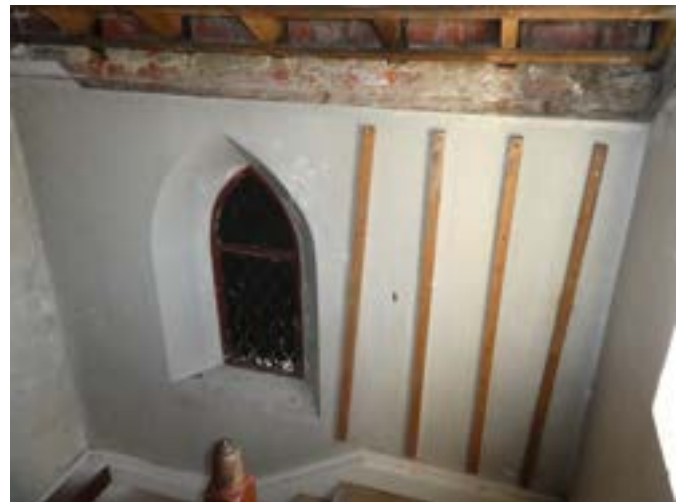
Photograph 117 – Showing typical moisture staining to the original fibrous plaster ceilings.

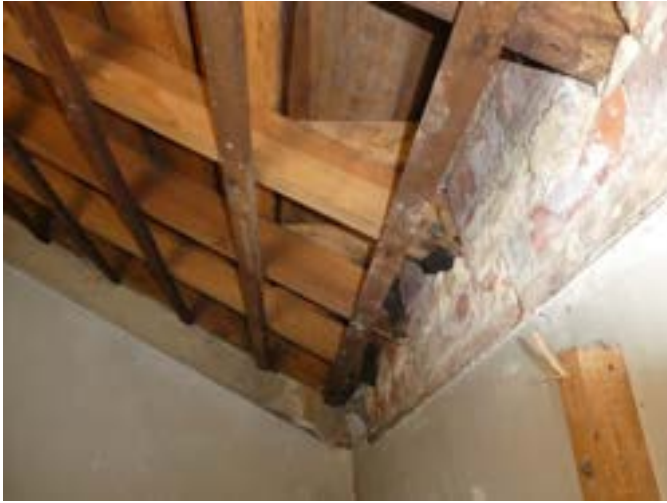
Photograph 118 - Showing the timber rafters built into the solid brick external walls to the western wall of the north western stairwell.

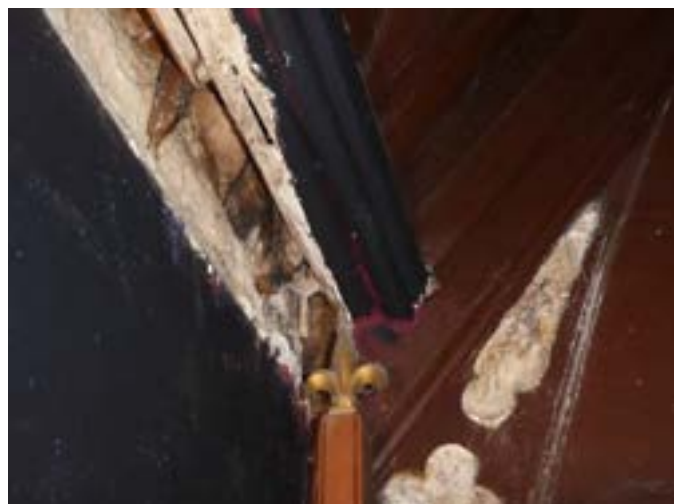
Photograph 123 – Showing typical moisture damage and decay to the rafters built into the solid external walls to the southern wall of the main theatre.

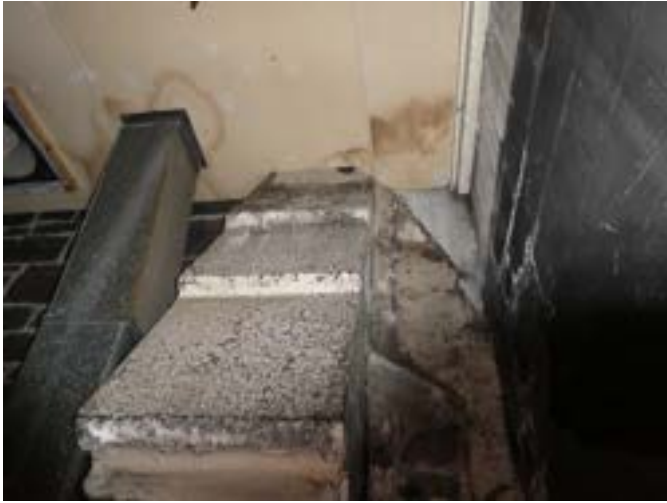
Photograph 124 - Showing the moisture stained ceilings to the now enclosed south western area adjacent to the main stage.

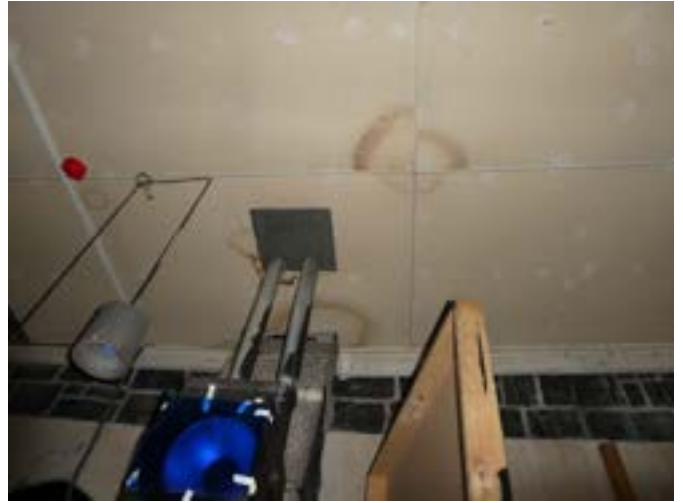
Photograph 125 – Showing the moisture stained ceilings to the now enclosed south western area adjacent to the main stage..

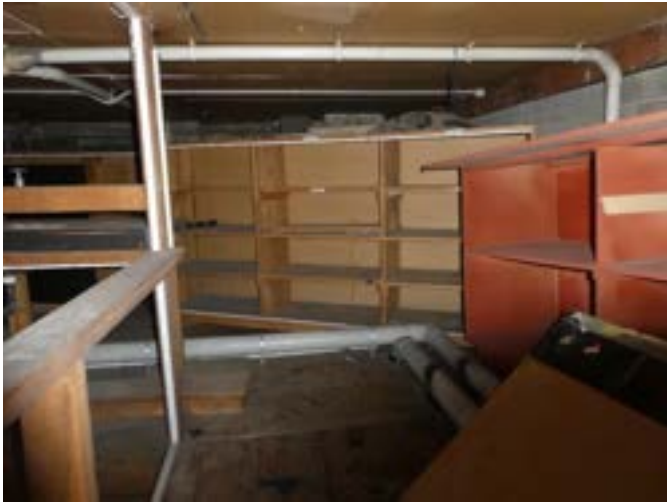
Photograph 126 - Showing the storage area above the south western toilets.

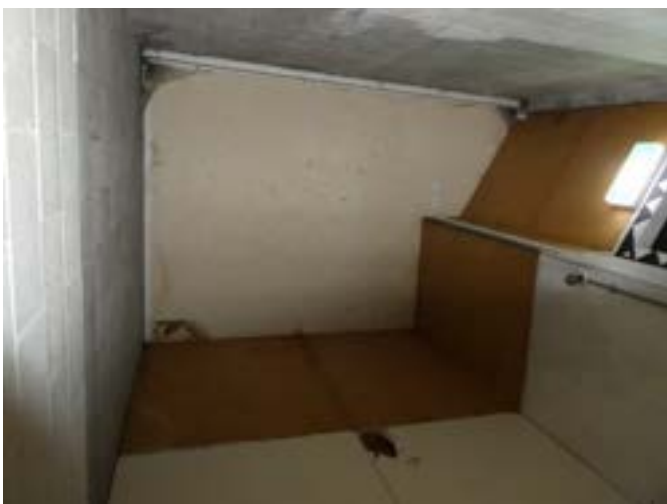
Photograph 128 - Showing the moisture stained ceilings to the south western stairwell.

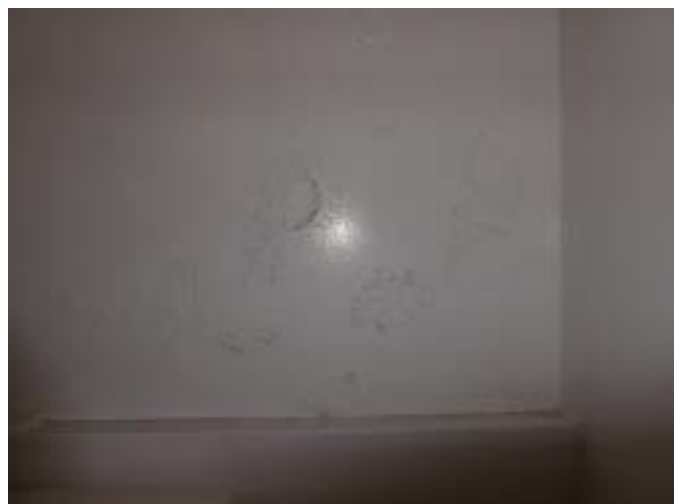
Photograph 129 – Showing the defective paint to the ceiling within the public male toilet.

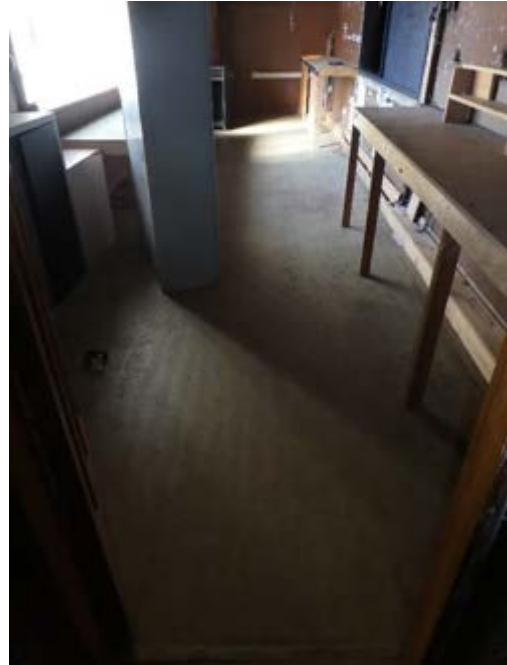
Photograph 130 – Showing the damaged vinyl flooring to the meeting / theatre technical room.

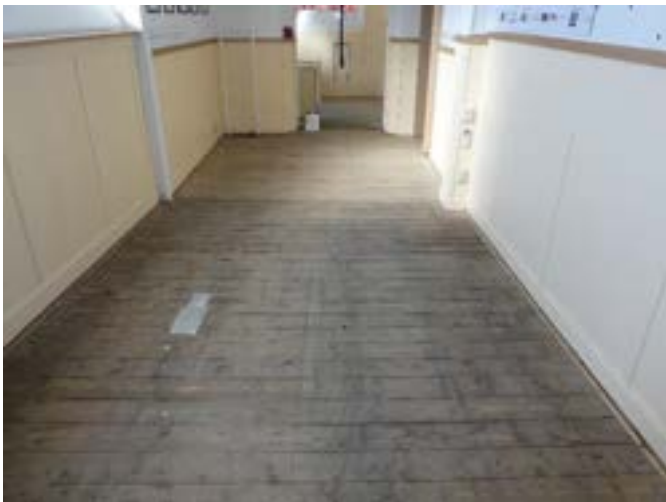
Photograph 131 - Showing the timber floor boards to the main entrance foyer.

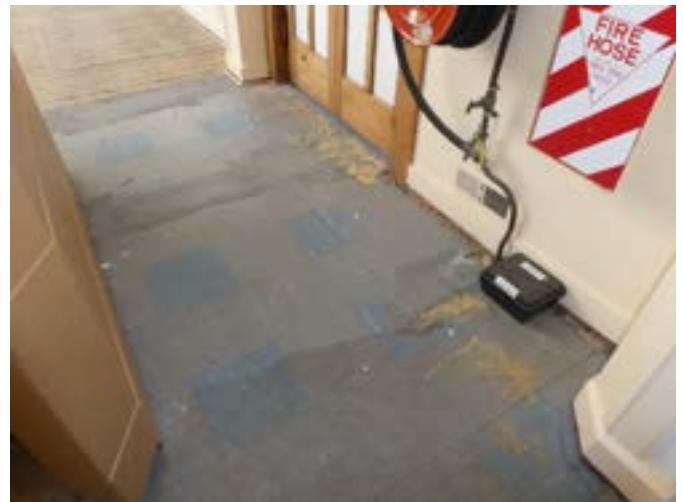
Photograph 132 – Showing the thermoplastic floor tiles to the main entrance foyer. **Note these tiles may contain asbestos.**

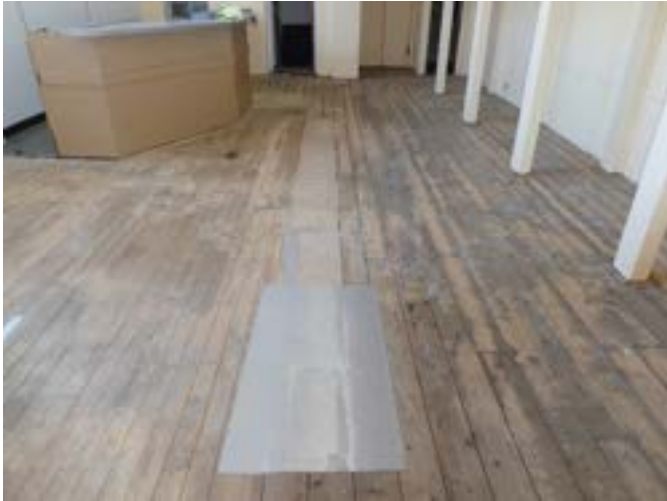
Photograph 133 - Showing the timber floor boards and target repairs within the bar area.

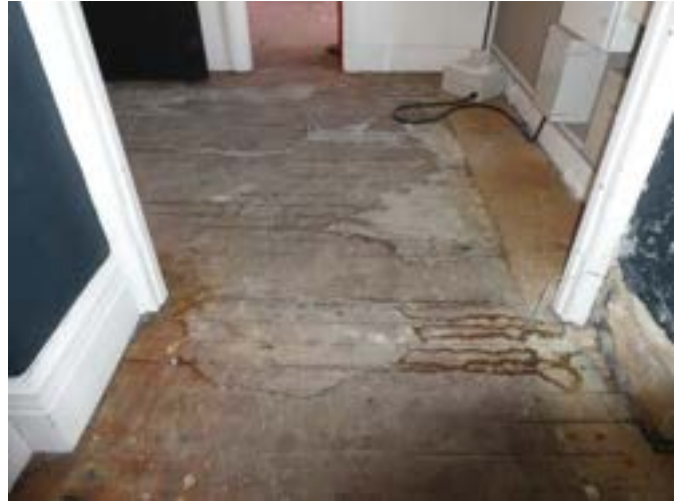
Photograph 134 – Showing the timber floor boards to the south eastern vestibule.

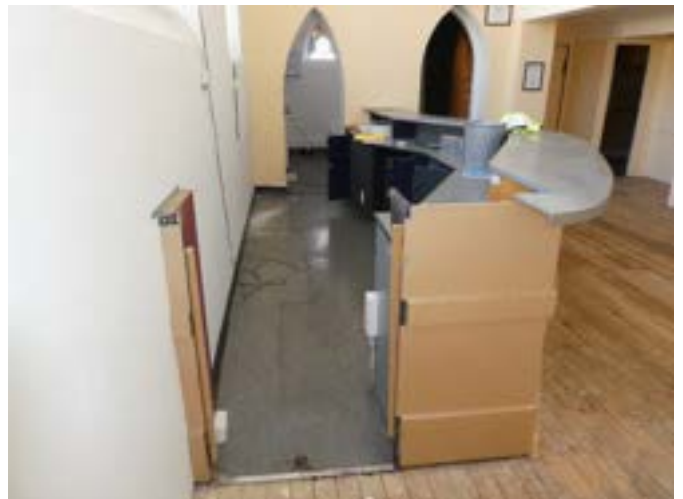
Photograph 138 – Showing vinyl flooring to the bar and kitchen area.

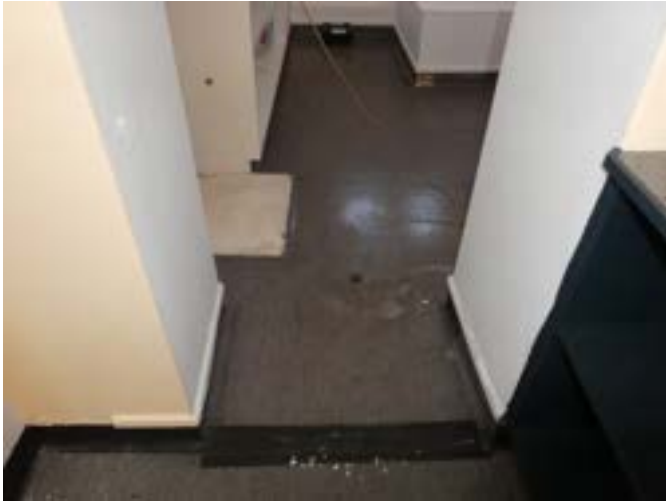
Photograph 139 - Showing vinyl flooring to the bar and kitchen area.

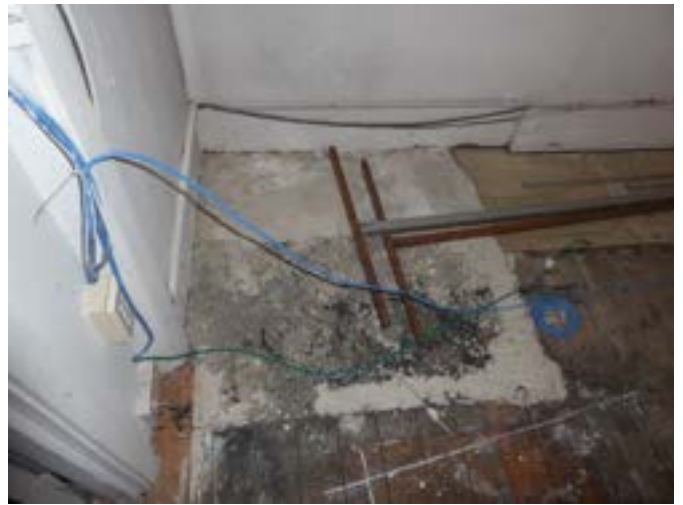
Photograph 142 – Showing the piecemeal repairs to the basement office floor noting concrete, timber and custom wood.

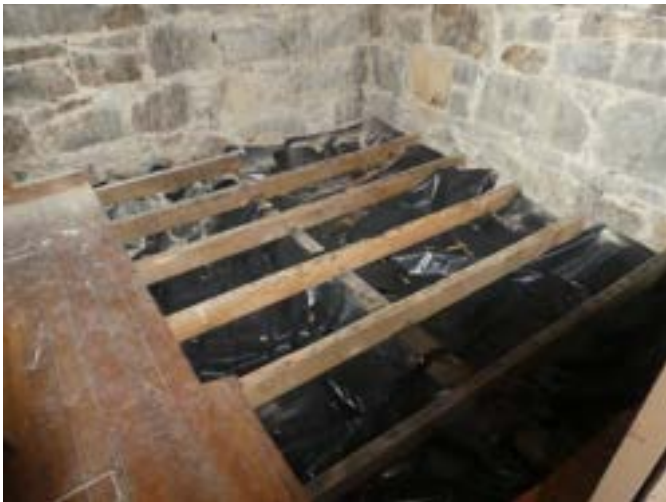
Photograph 143 - Showing the floorboards partially removed to the Dressing Room 2 behind the studio theatre within the basement.

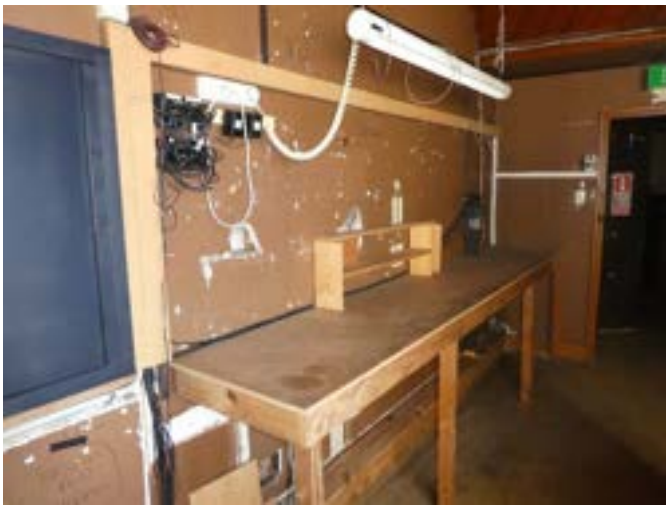
Photograph 145 - Showing the damaged fibrous plaster wall and benching to the meeting / theatre technical room.

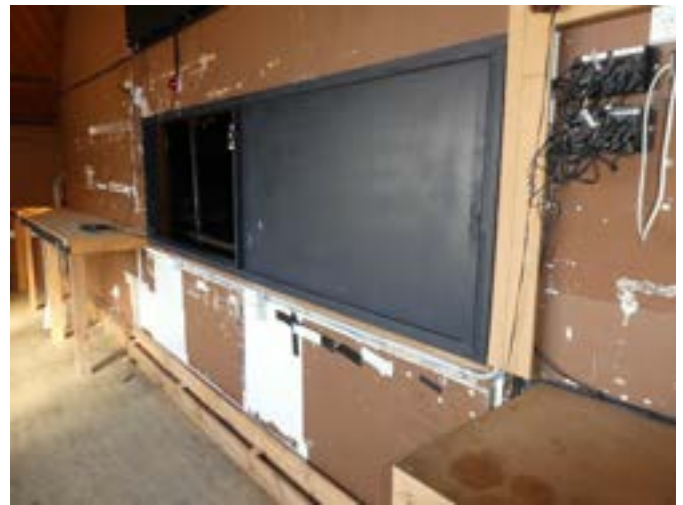
Photograph 146 – Showing the damaged fibrous plaster wall and benching to the meeting / theatre technical room.

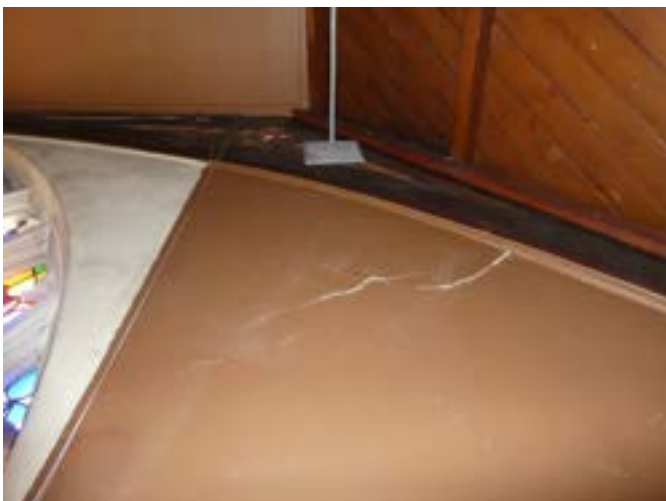
Photograph 147 - Showing typical hairline cracking to the plaster on the external walls.

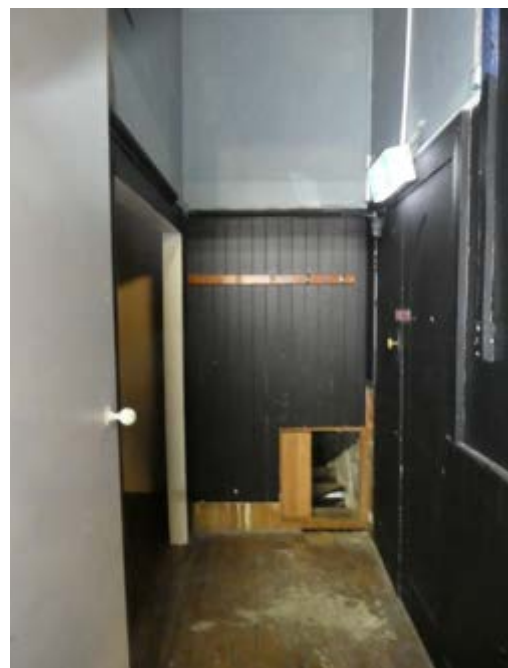
Photograph 148 – Showing original painted timber panelling to the basement area.

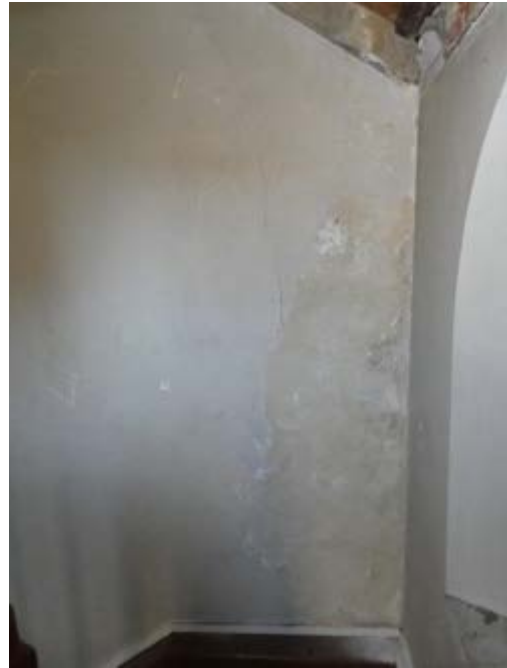
Photograph 149 – Showing the vertical cracking to the plaster wall within the north western staircase.

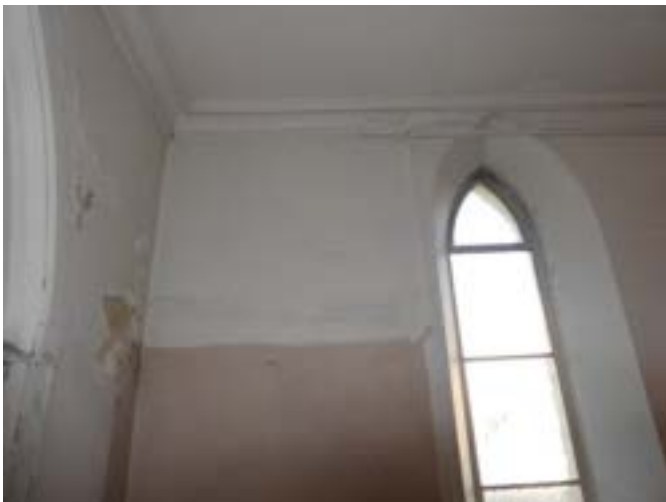
Photograph 150 - Showing the defective plaster to the basement walls within the marketing office.

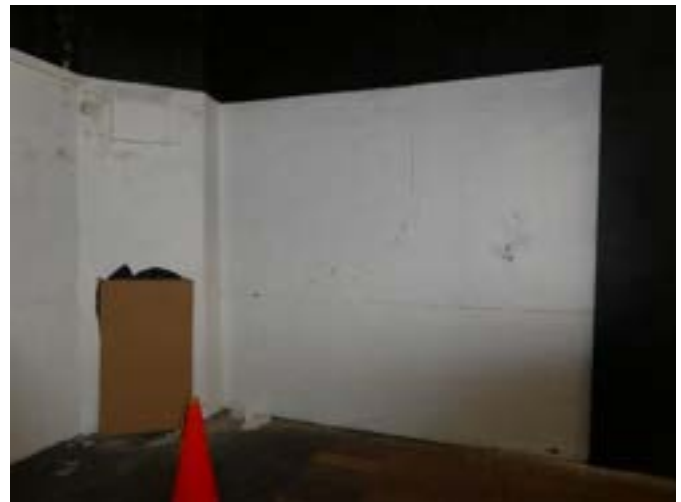
Photograph 151 - Showing the poor condition to the walls and opening within the studio theatre.

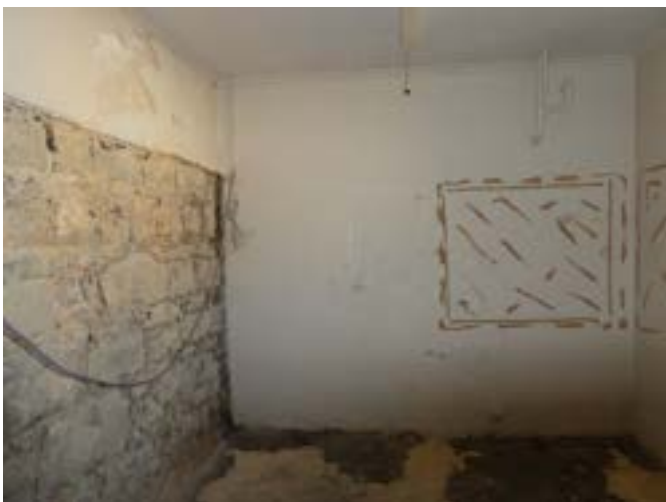
Photograph 152 - Showing the plaster removed from the basement administration office.

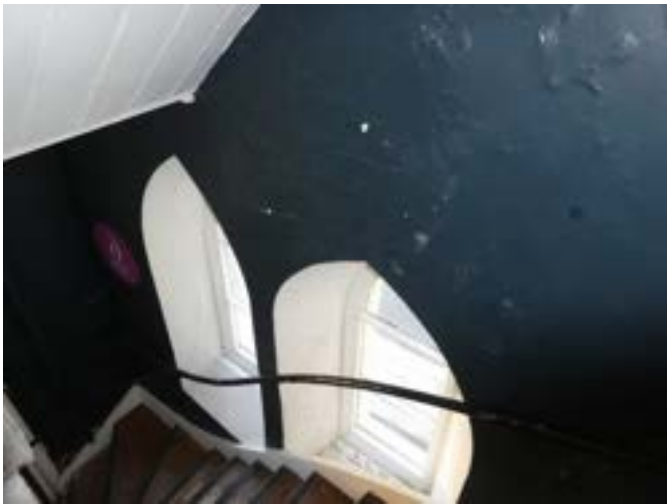
Photograph 154 - Showing the defective plasterwork above the timber lancet windows to the south eastern stair.

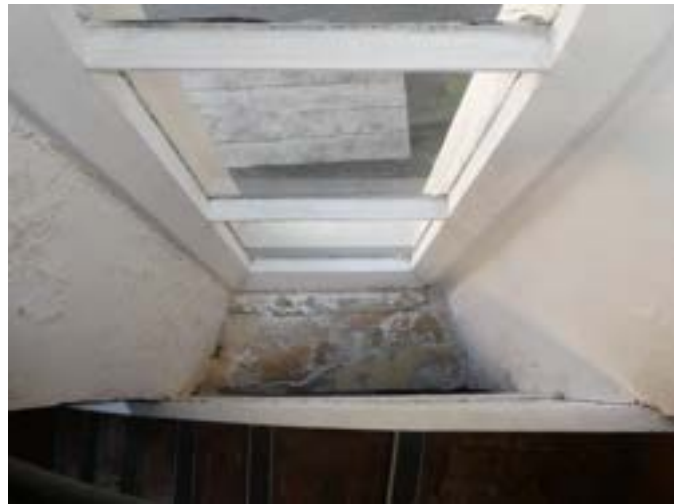
Photograph 155 – Showing the defective plasterwork to the sill of the timber lancet windows to the south eastern stair.

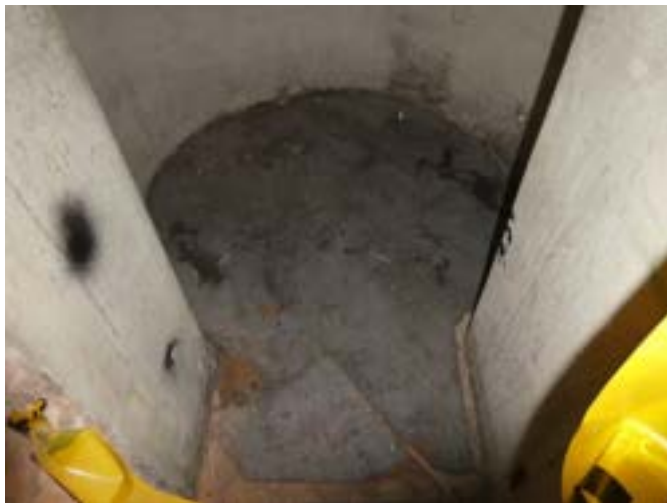
Photograph 156 - Showing the aged vinyl floor covering within the bell tower.

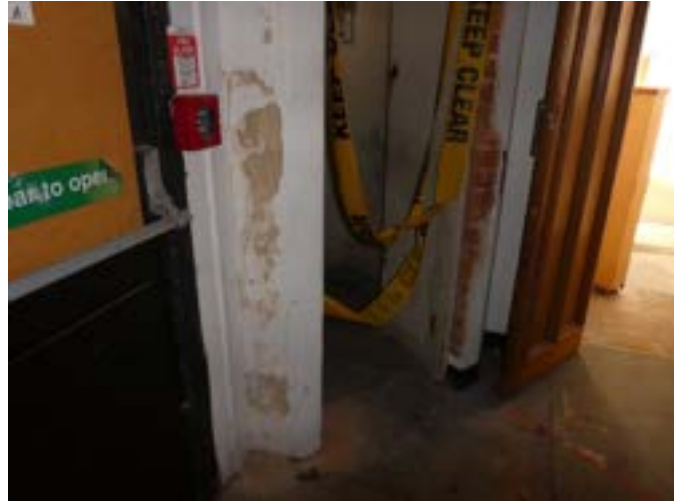
Photograph 159 – Showing the defective paint and plaster adjacent to the bell tower.

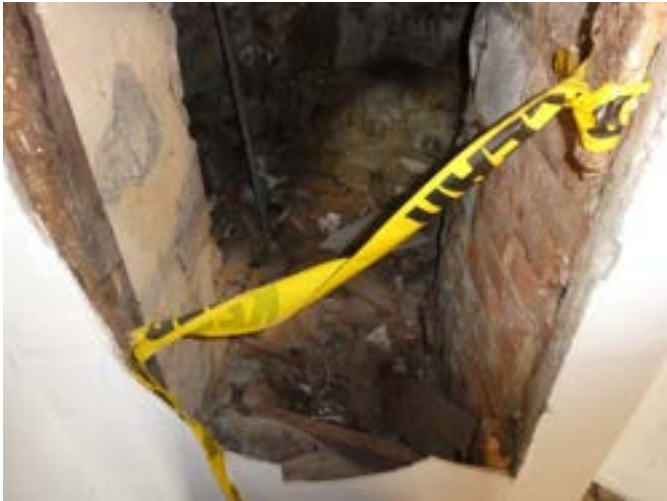
Photograph 160 - Showing the bell tower / turret from within the basement area.

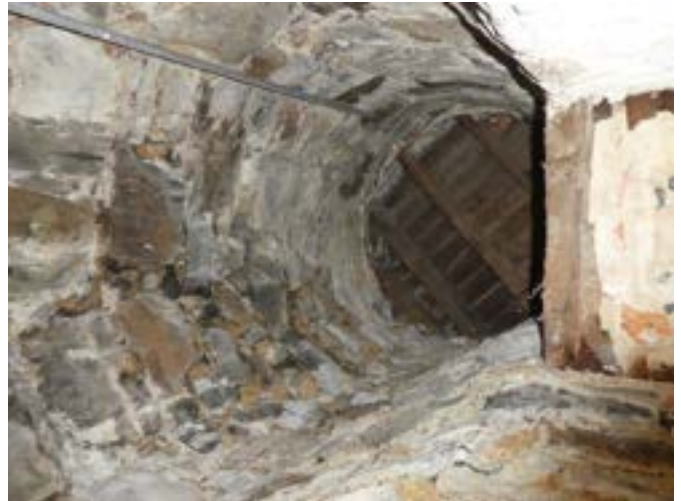
Photograph 161 – Showing the ceiling / timber floor installed within the bell tower looking up from the basement area.

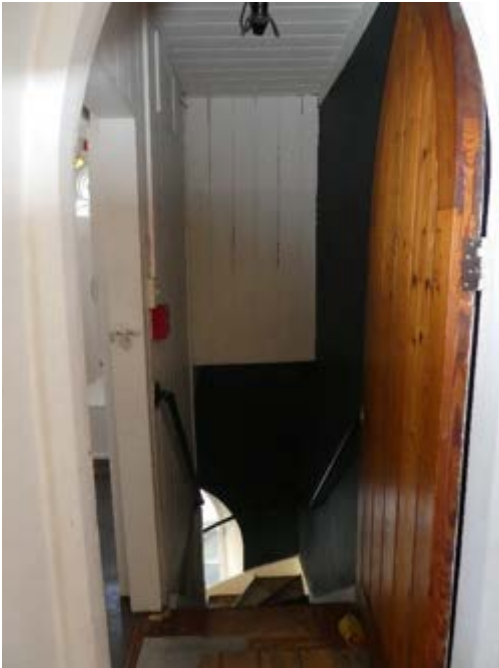
Photograph 162 - Showing the painted T&G panelling to the south western stairwell.

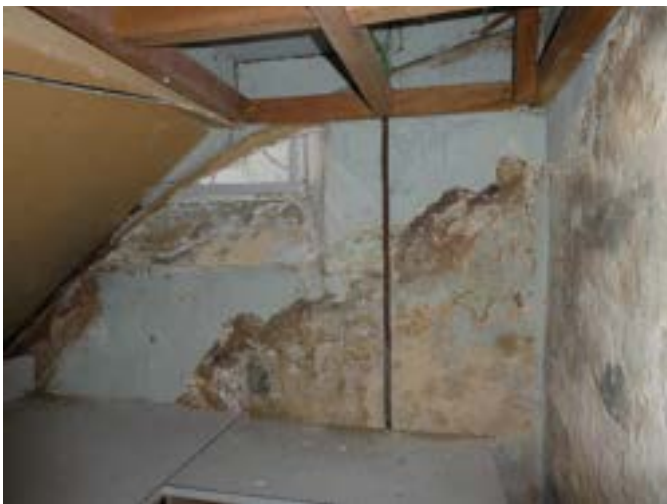
Photograph 164 - Showing the typical condition of the basement walls below the south eastern stairs.

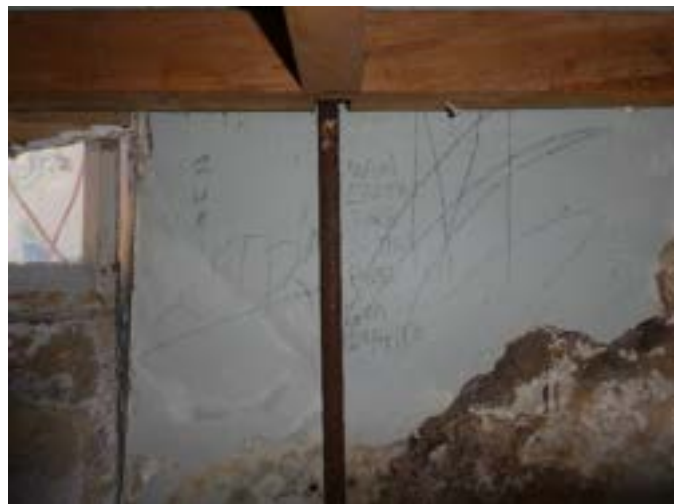
Photograph 165 – Showing the typical condition of the basement walls below the south eastern stairs.

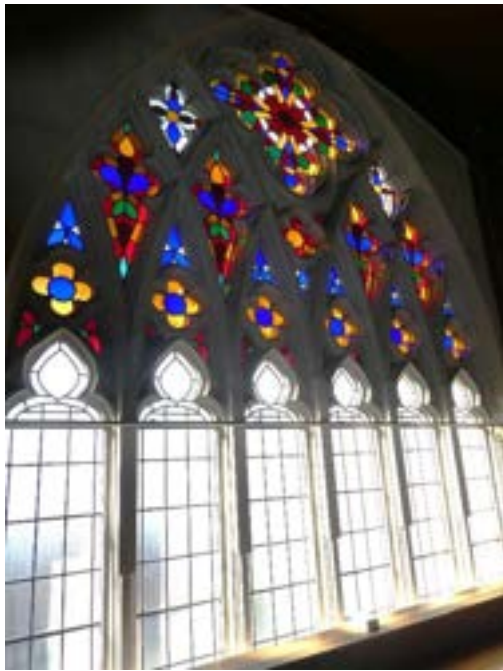
Photograph 166 - Showing the stained glass to the eastern tracery window within the meeting / theatre technical room.

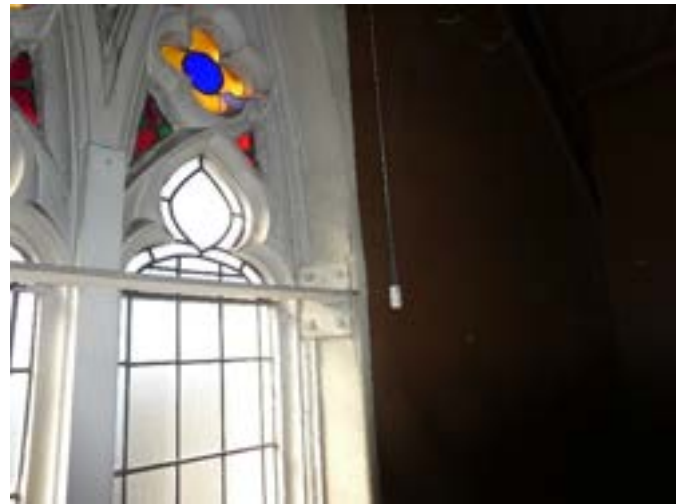
Photograph 167 – Showing the horizontal steel reinforcing / strengthening bar to the inside of the mullioned window. Noting cracking to the stone surround.

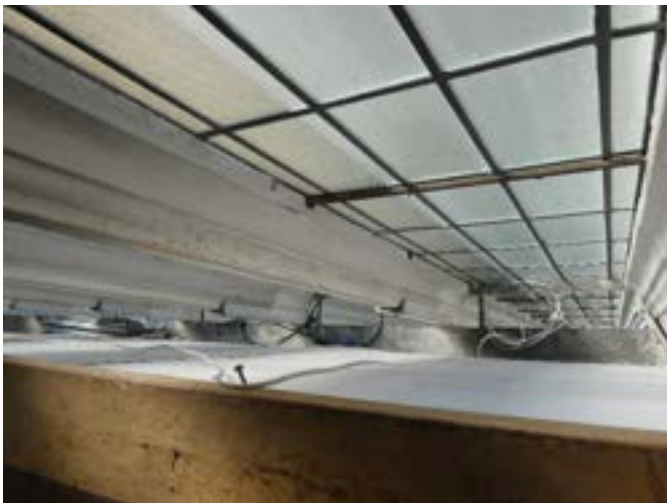
Photograph 168 - Showing the corroded horizontal steel reinforcing and strengthening bars to the inside of the mullioned window.

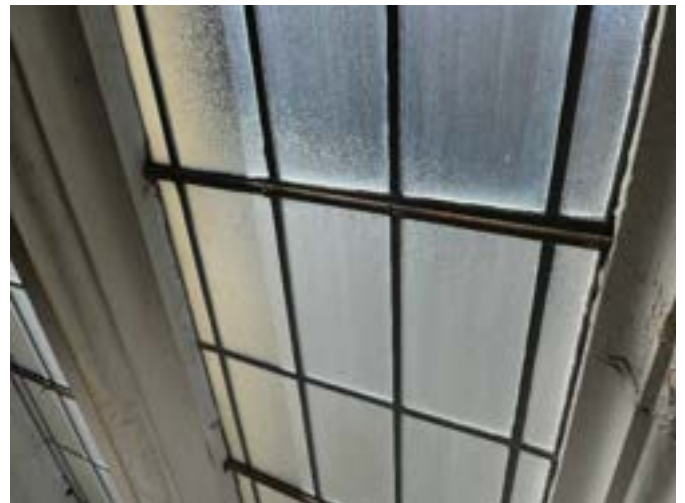
Photograph 169 – Showing the corroded reinforcing bars to the inside of the mullioned window. Noting paint failure to the stone mullions.

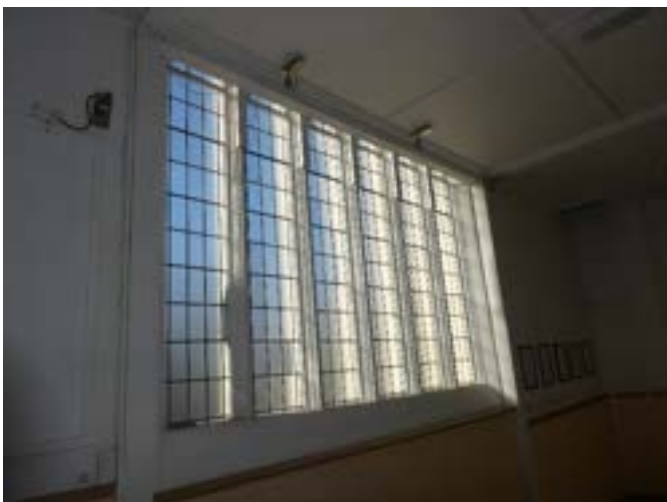
Photograph 170 - Showing the leaded windows and stone mullions at the base of the stained glass window to the east within the entrance foyer.

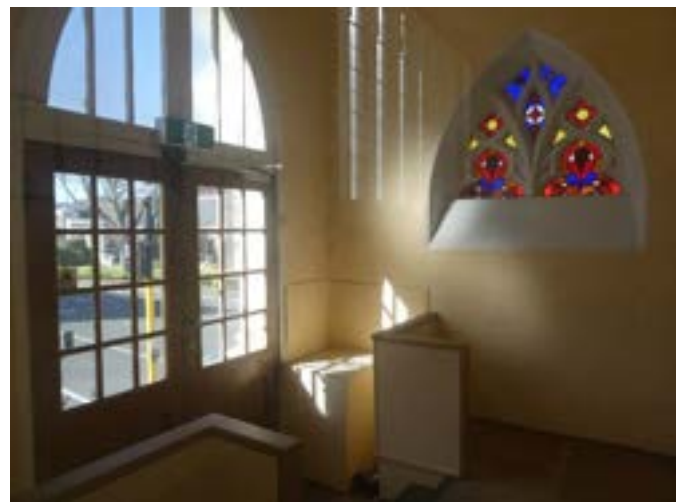
Photograph 171 – Showing the south eastern entrance and stained glass to the small lancet tracery window.

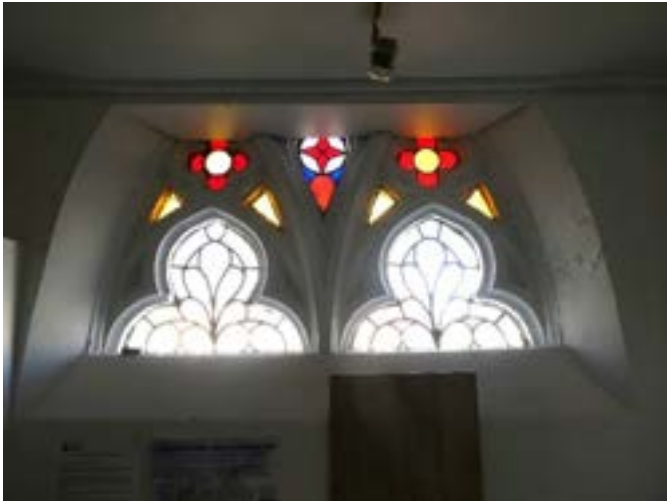
Photograph 172 - Showing the base of the leaded windows to the south western corner elevations from within the kitchen.

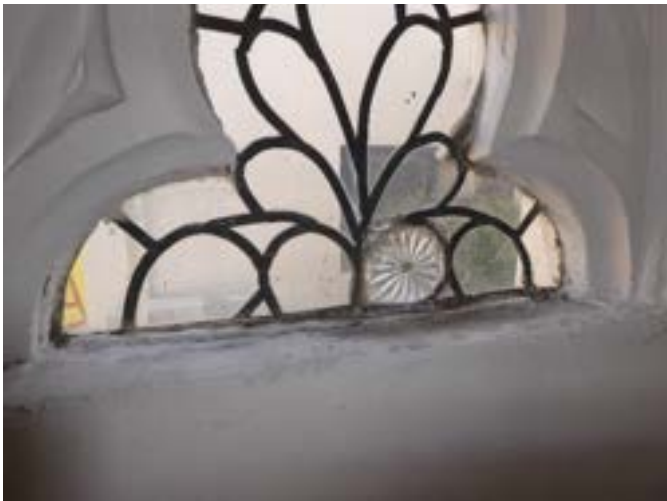
Photograph 174 - Showing inappropriate glazing repair and also noting cracking to glass panels.

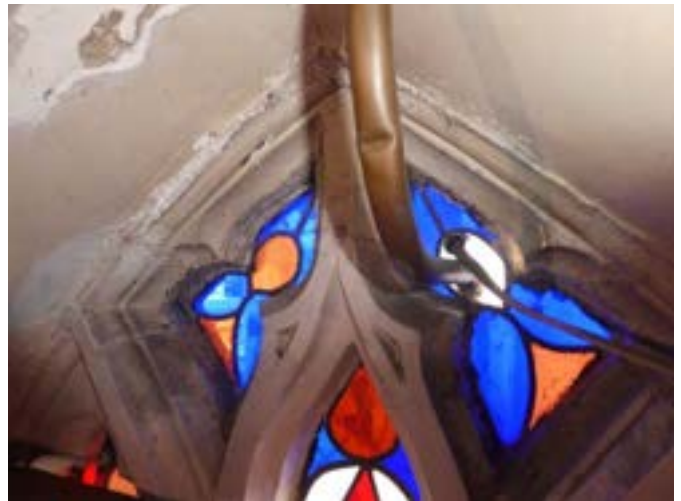
Photograph 175 – Showing inappropriate and unsealed copper pipe and electrical cable penetration through the glazing from the hot water cylinder.

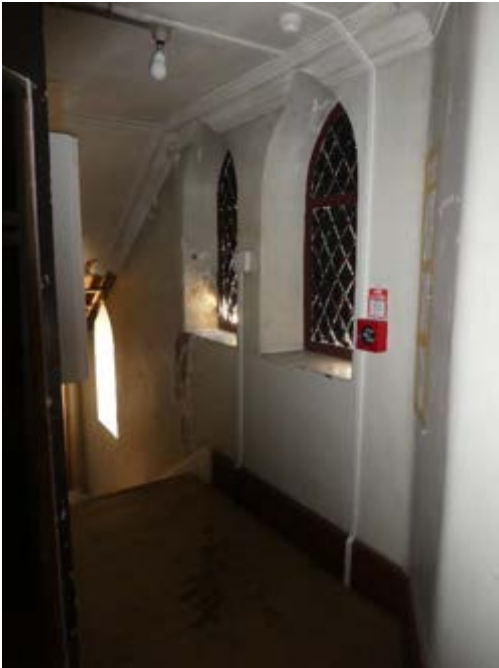
Photograph 176 - Showing the defective plasterwork to the steel leaded lancet windows at the stair landing on the eastern elevation.

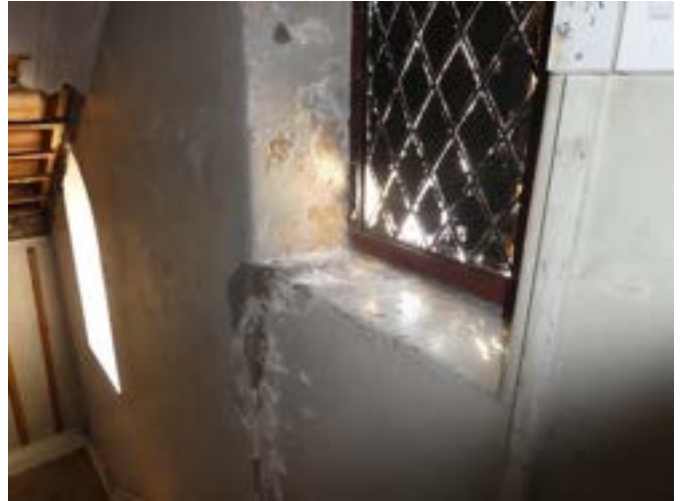
Photograph 177 – Showing the defective plaster and efflorescence to the jamb and sill of the steel leaded lancet windows at the stair landing on the eastern elevation.

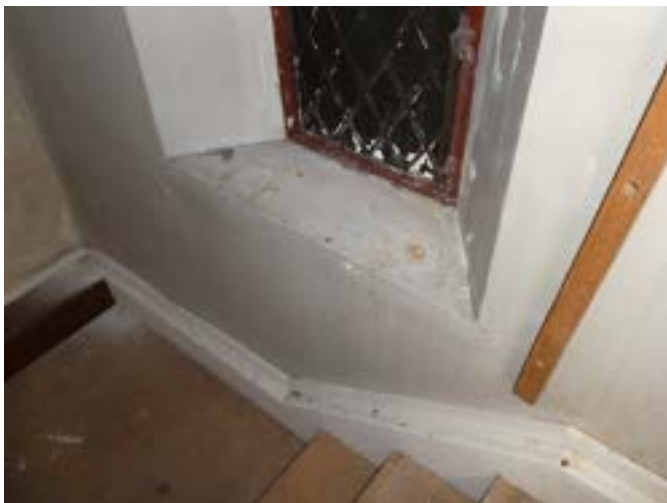
Photograph 178 - Showing the defective cracked plasterwork to the steel leaded lancet windows at the stair landing on the western elevation.

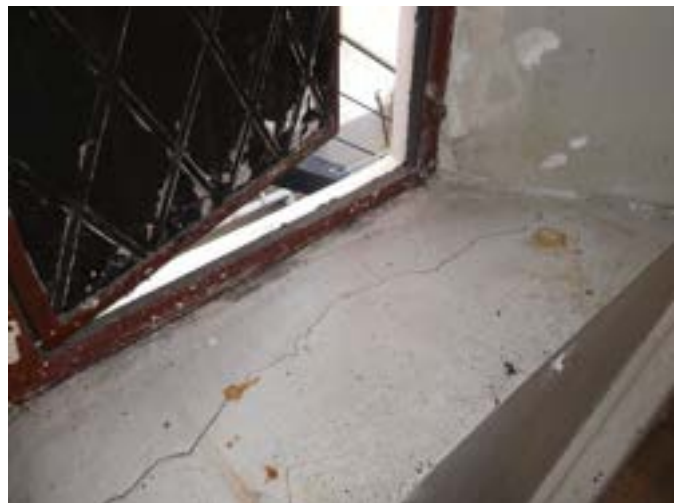
Photograph 179 – Showing the defective cracked plasterwork to the steel leaded lancet windows at the stair landing on the western elevation.

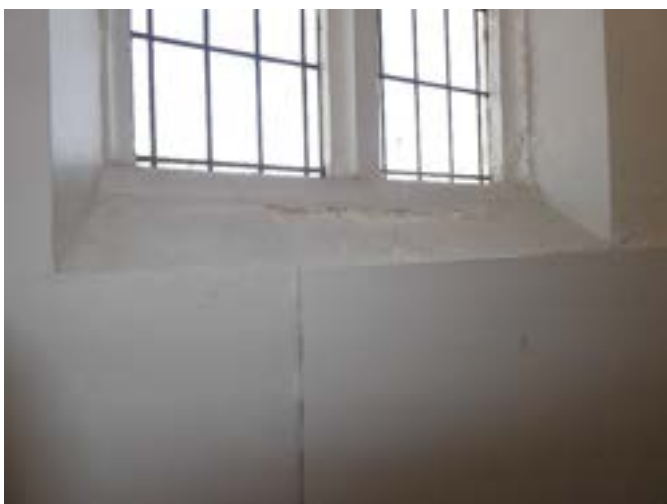
Photograph 180 – Showing the defective paint and plaster to the window sill on the southern wall.

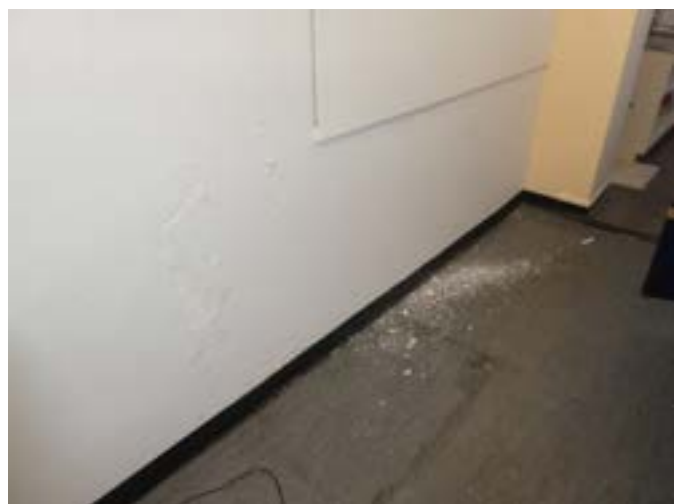
Photograph 181 – Showing typical plaster dust to the vinyl flooring in the bar area.

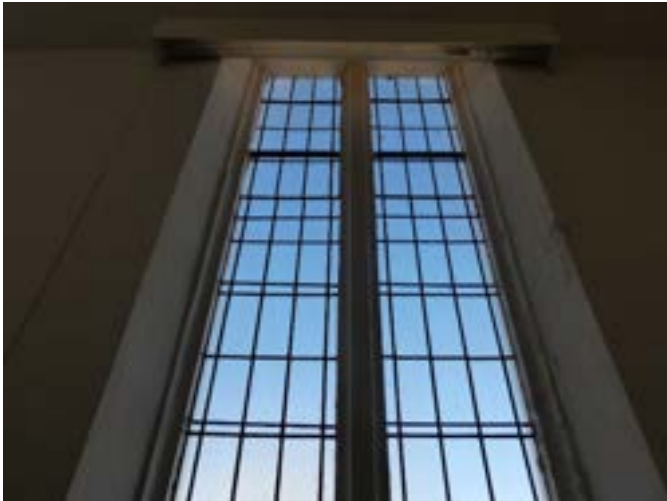
Photograph 182 - Showing the leaded windows and stone mullion of the stained glass window to the south within the bar area.

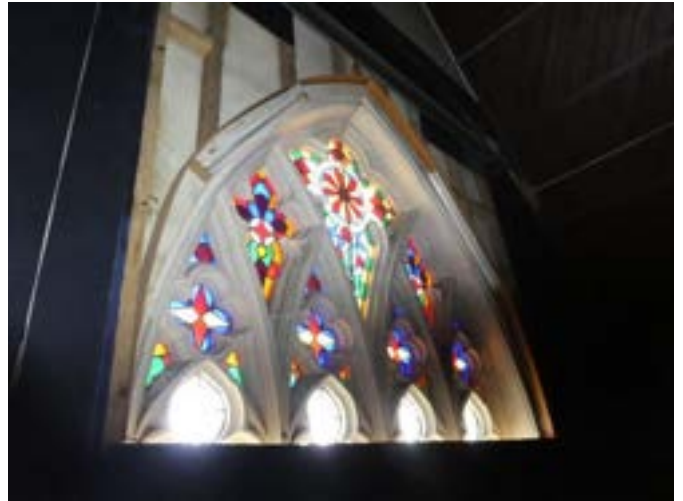
Photograph 183 – Showing the southern stained glass to the lancet tracery window on the southern elevation above the seating area of the theatre.

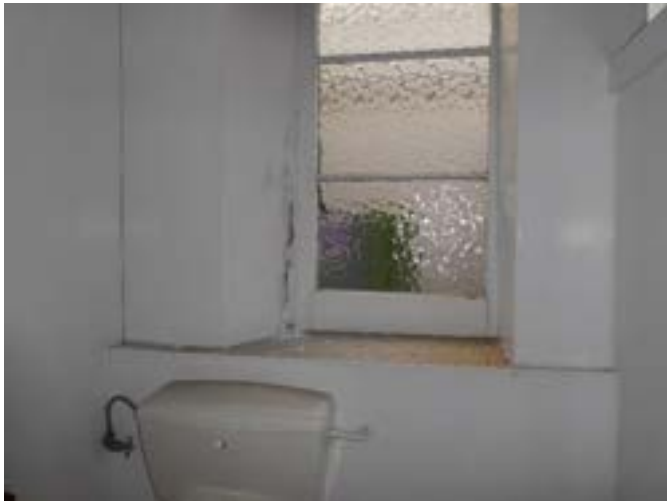
Photograph 184 – Showing the defective paint and plaster to the window in the south western toilets.

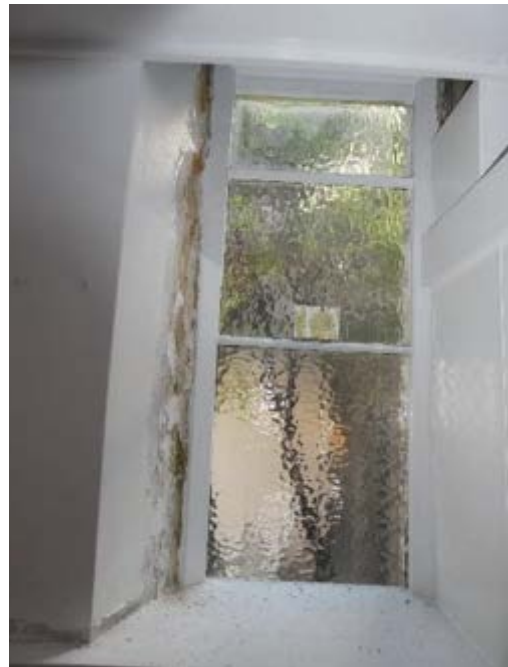
Photograph 185 – Showing the defective paint and plaster to the window in the south western toilets.

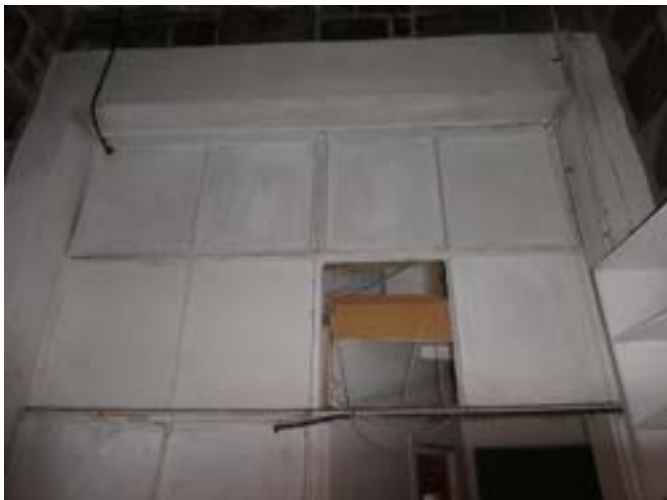
Photograph 186 - Showing the painted windows within the south western stairwell. Noting missing pane.

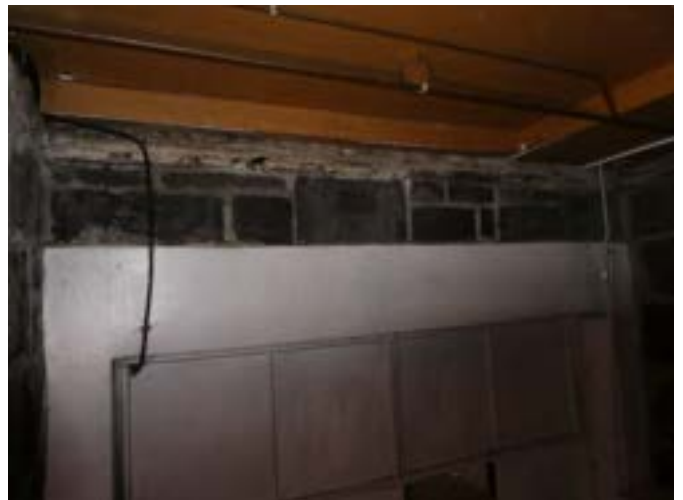
Photograph 187 – Showing the painted windows within the south western stairwell.

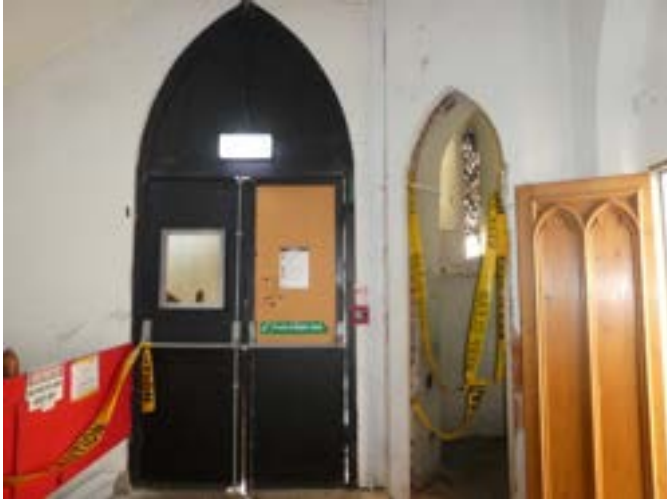
Photograph 188 - Showing the north western entrance door and the open internal panel door to the north western vestibule.

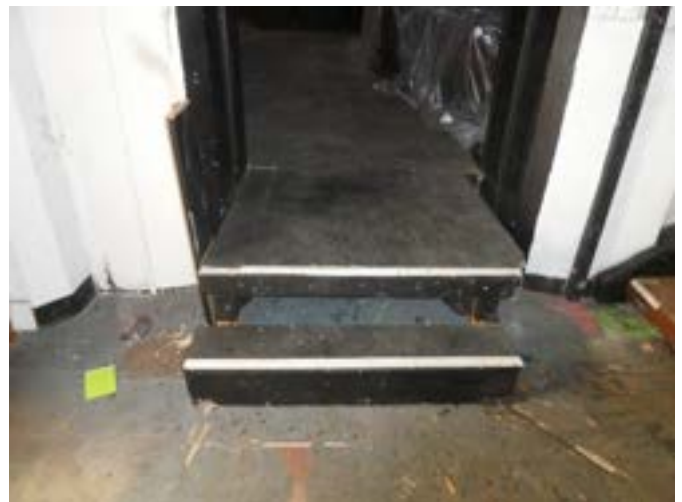
Photograph 191 – Showing the damaged steps leading to the main stage from stage left.
