CONDITION REPORT

FORTUNE THEATRE, 231 STUART STREET, DUNEDIN

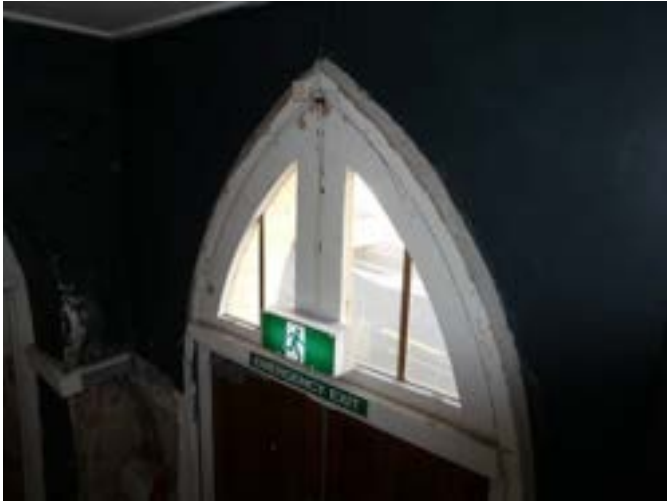
Photograph 192 - Showing the poor condition of the timber lancet top-light window to the south eastern entrance. Noting the maintained fire exit signage.

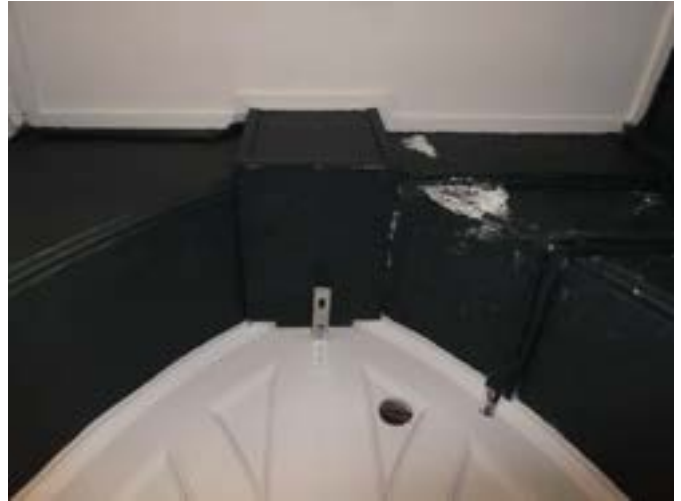
Photograph 193 – Showing the condition of the timber infill panel above the internal doorway to the basement foyer. Noting efflorescence to the solid walls

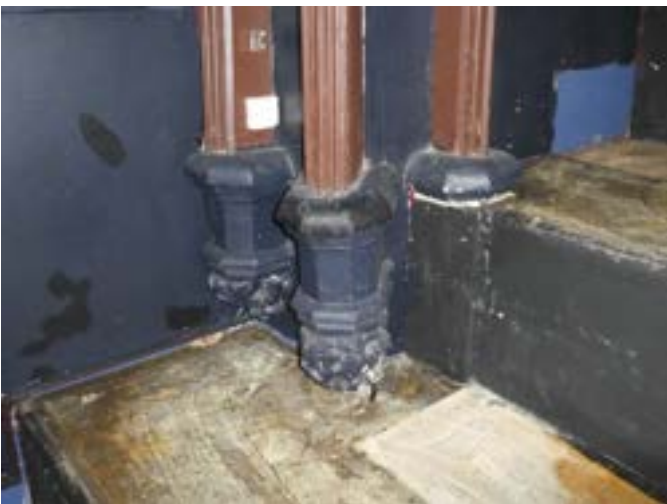
Photograph 194 - Showing the typical timber moulding at the base of the columns within the main theatre.

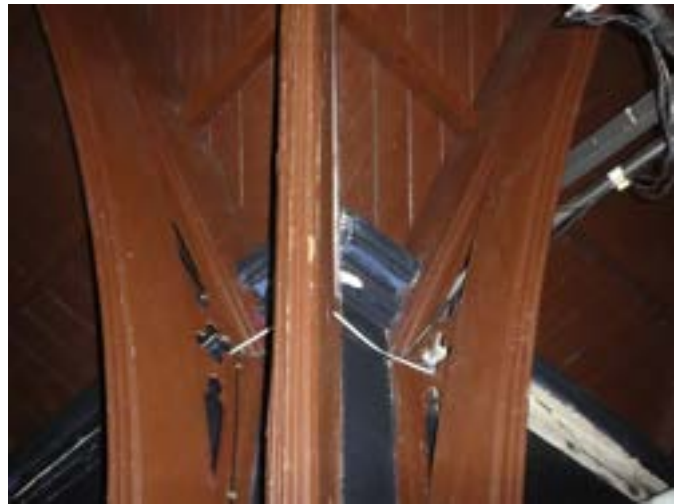
Photograph 196 – Showing the typical timber detailing at the base of the timber trusses at the columns within the main theatre.

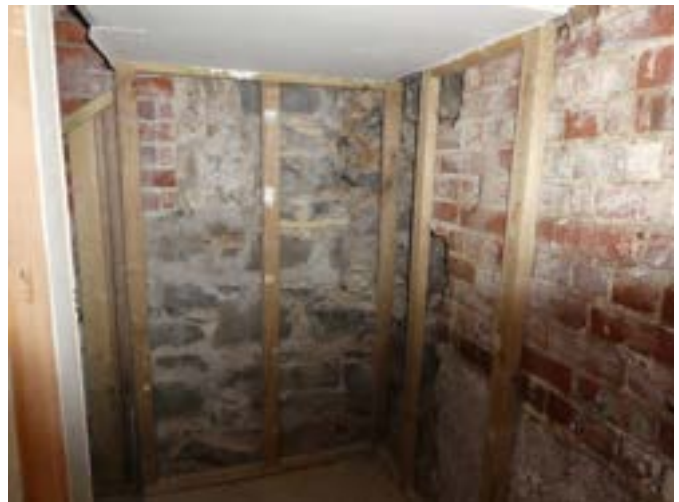
Photograph 200 – Showing the linings removed from the basement floor to the former project managers office at the north western stairwell.

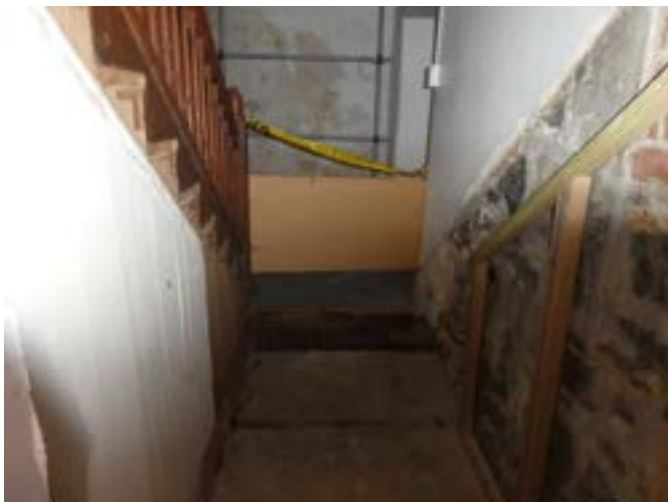
Photograph 201 - Showing the linings removed from the basement floor to the former project managers office / stairs at the north western stairwell.

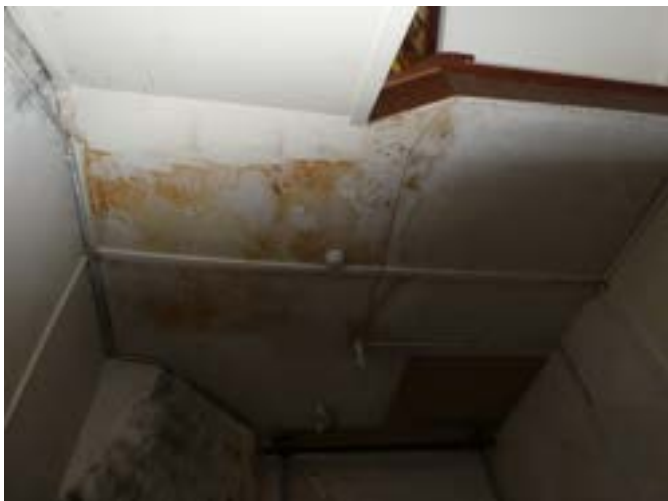
Photograph 203 - Showing the damage and staining to the ceiling linings within the north western stairwell.

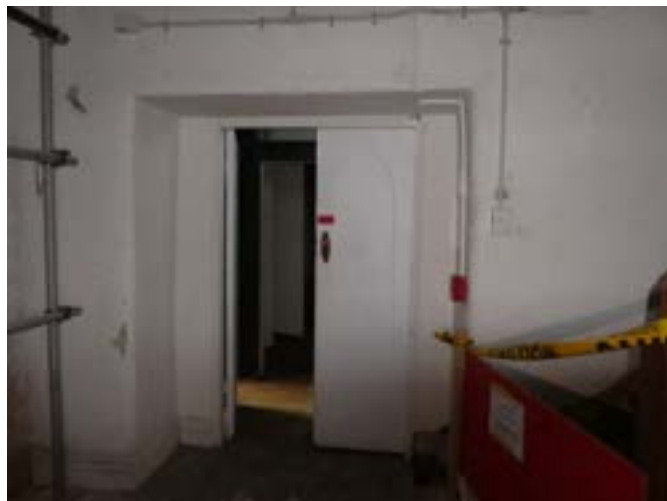
Photograph 204 – Showing the entrance doors leading to the Green Room from the north western stairwell.

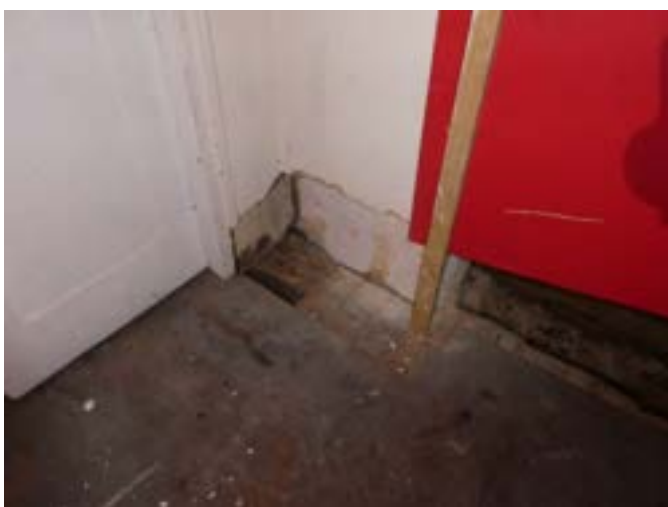
Photograph 205 - Showing defective flooring and low level plaster within the north western stairwell.

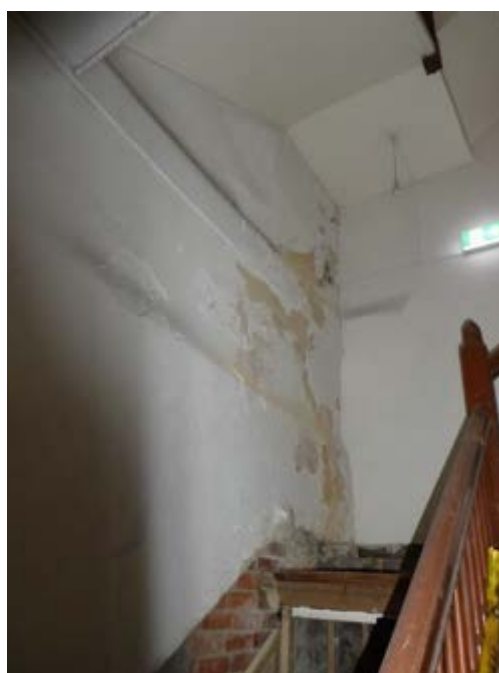
Photograph 206 – Showing the defective plaster within the north western stairwell.

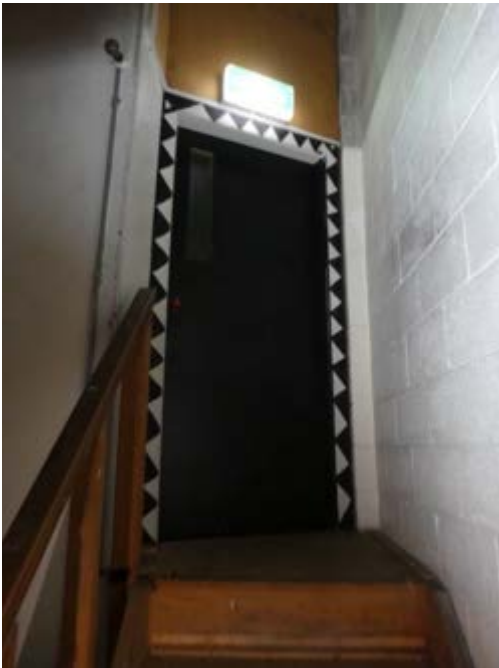
Photograph 207 - Showing the fire exit door and landing with maintained emergency lighting to the south western stairwell from stage right.

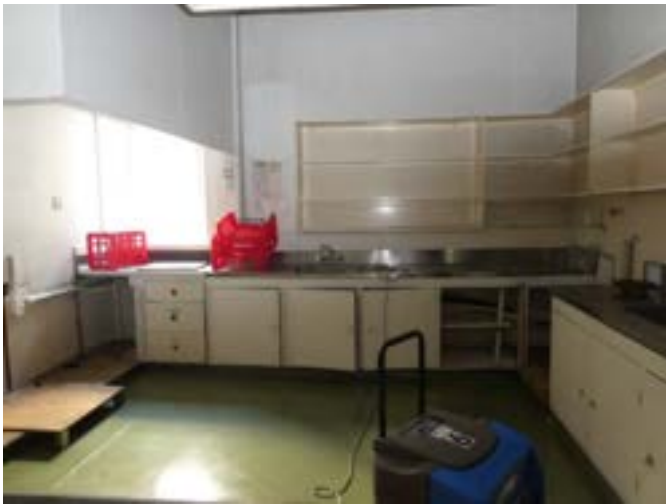
Photograph 215 - Showing the kitchen within the basement area.

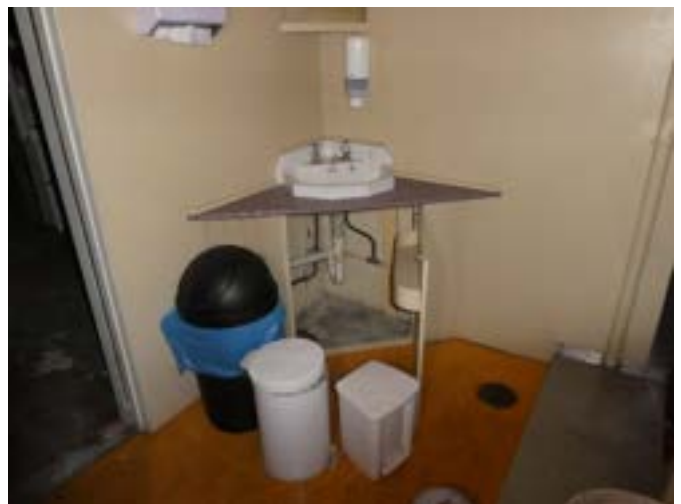
Photograph 219 – Showing the corner wash hand basin in the male toilet.

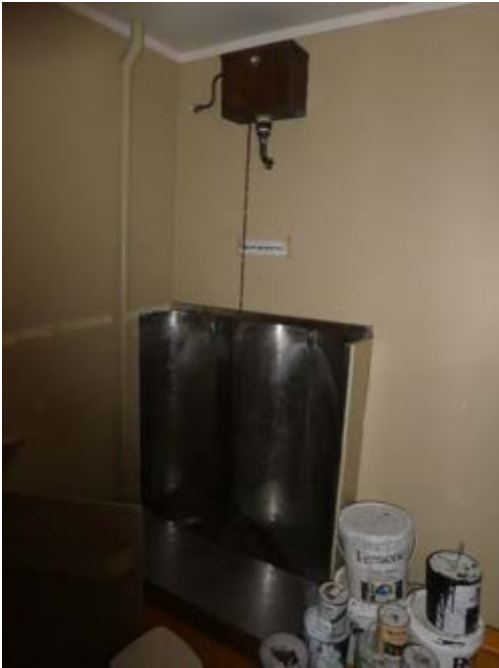
Photograph 220 – Showing the stainless steel urinal to the male toilet.

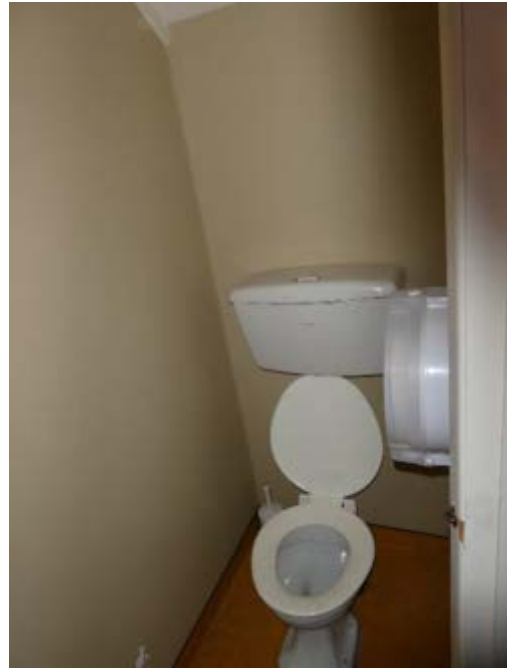
Photograph 221 – Showing the cubicle to the male toilet.

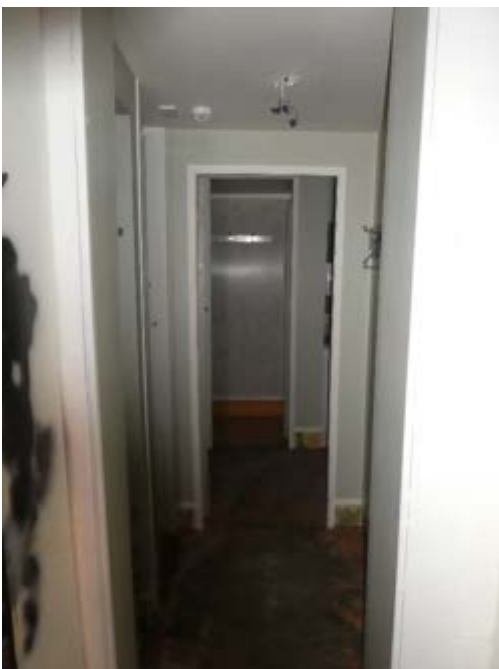
Photograph 222 – Showing the lobby to the shower and the female toilets.

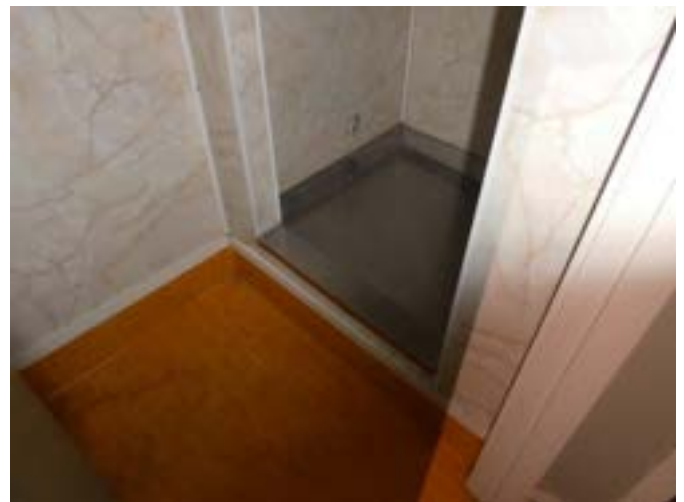
Photograph 223 – Showing the stainless steel shower tray and Seratone linings.

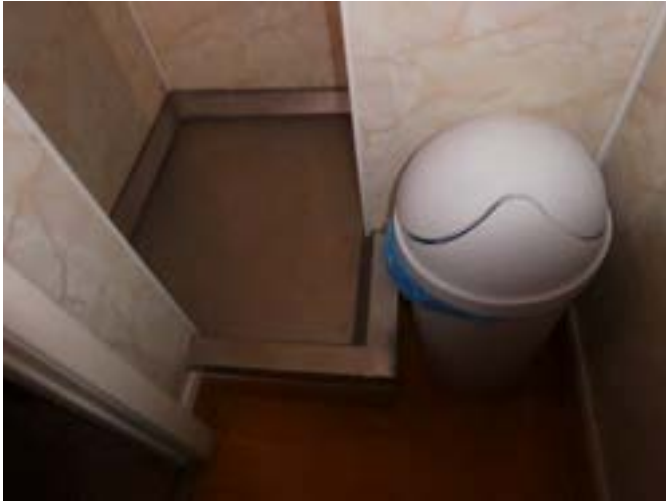
Photograph 224 – Showing the stainless steel shower tray and Seratone linings.

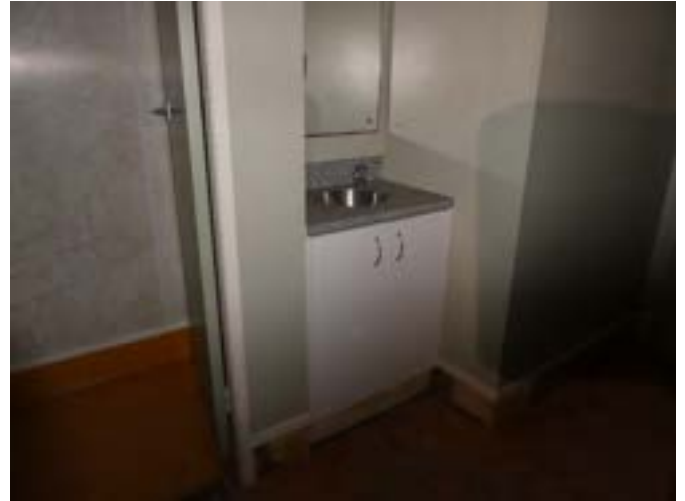
Photograph 225 – Showing the wash hand basin in the male toilet.

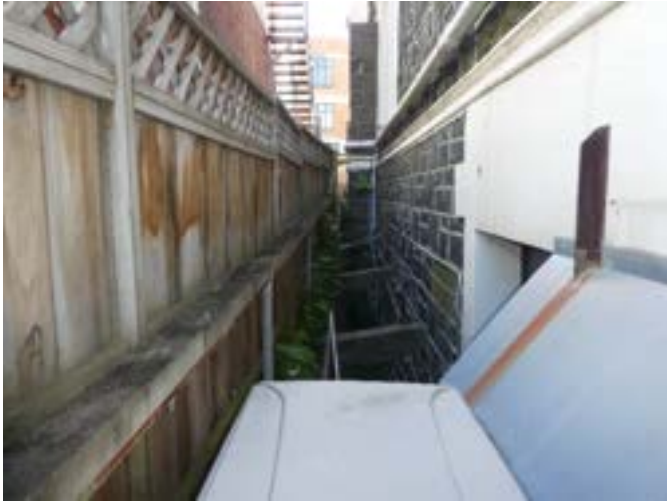
Photograph 233 - Showing the concrete braces buttressing the retaining wall to the western elevation.

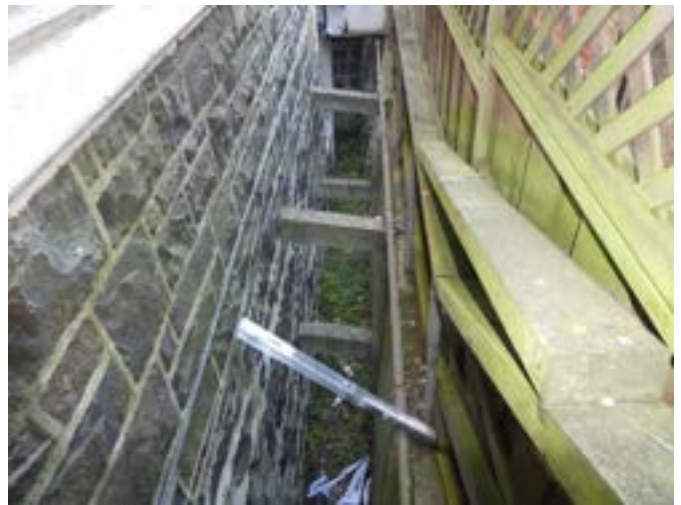
Photograph 236 – Showing the concrete braces buttressing the retaining wall to the western elevation.

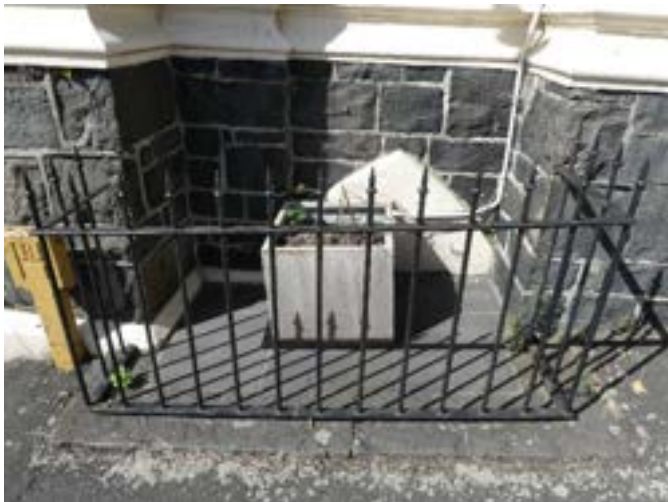
Photograph 237 - Showing the iron railings and blocked up basement windows to the north elevation.

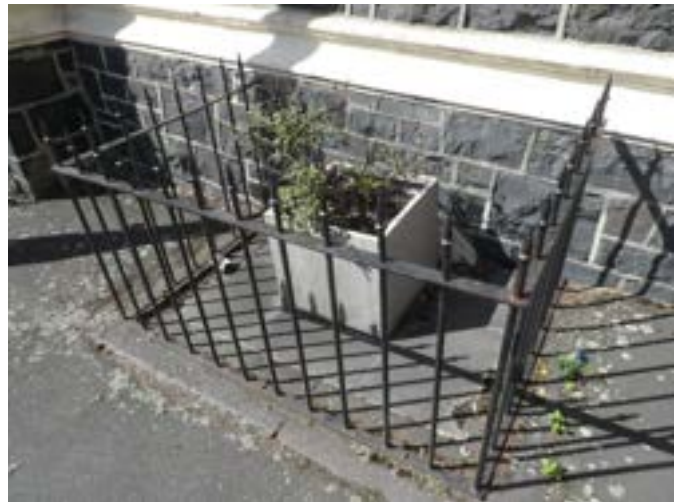
Photograph 238 – Showing the iron railings and blocked up basement windows to the north elevation.

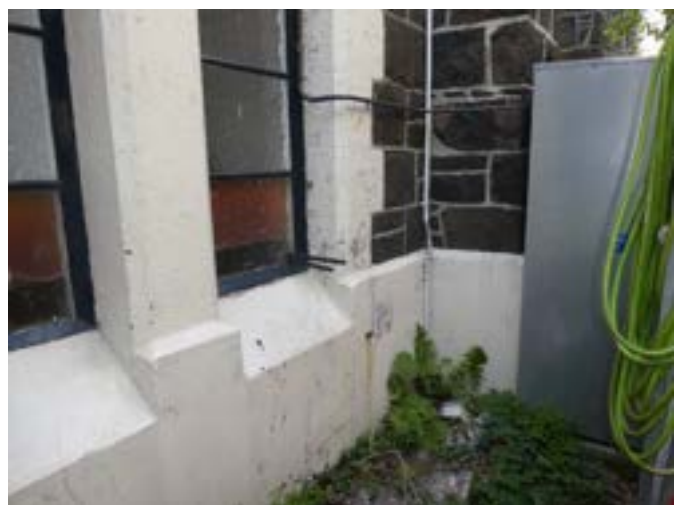
Photograph 239 – Showing the vegetation growth to the southern courtyard area.

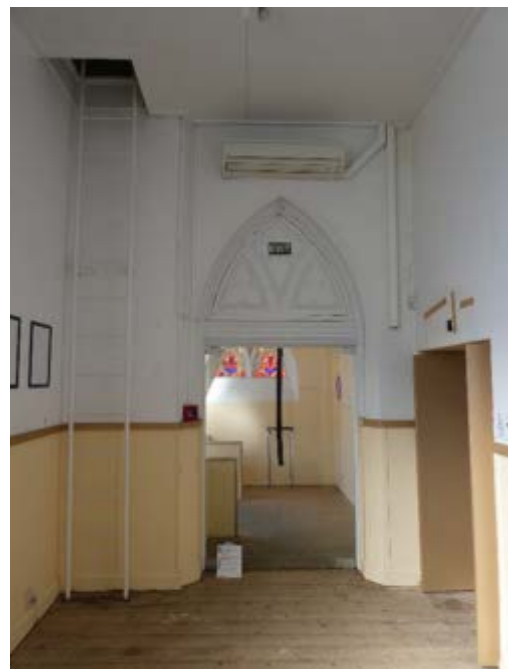
Photograph 242 – Showing the vertical fire escape ladder from the meeting / theatre control room to the entrance foyer.

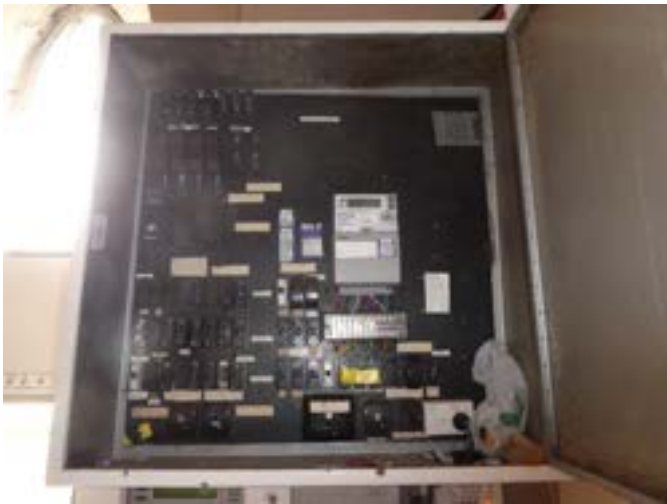
Photograph 243 – Showing the main switchboard to the south eastern basement foyer.

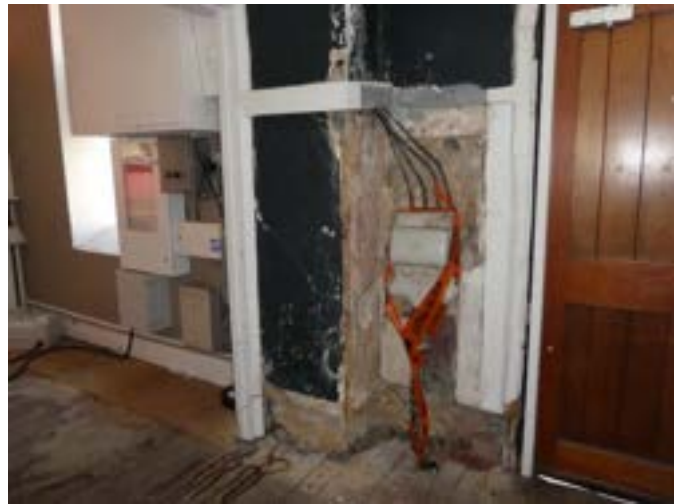
Photograph 244 – Showing the old electric meter.

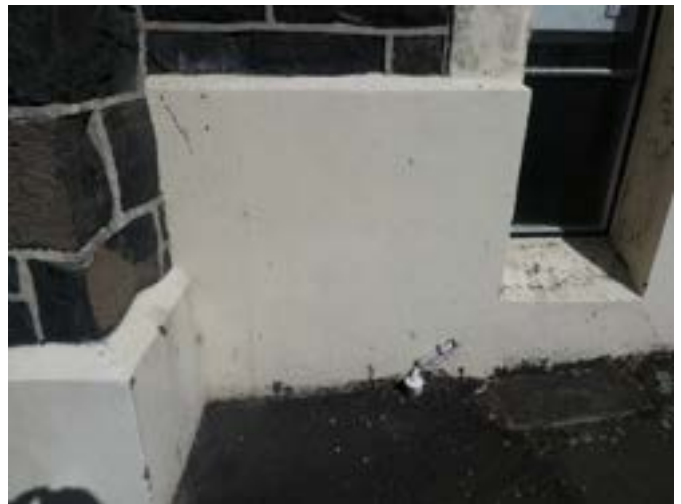
Photograph 245 – Showing the earth stake to the eastern elevation.

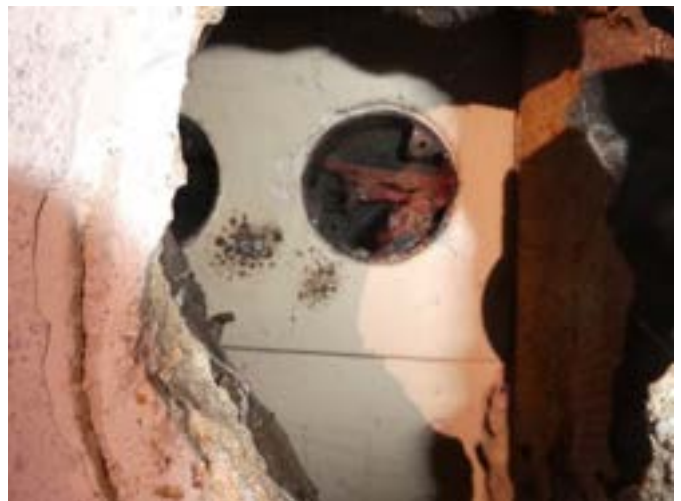
Photograph 247 – Showing old redundant VIR cables within the internal walls.

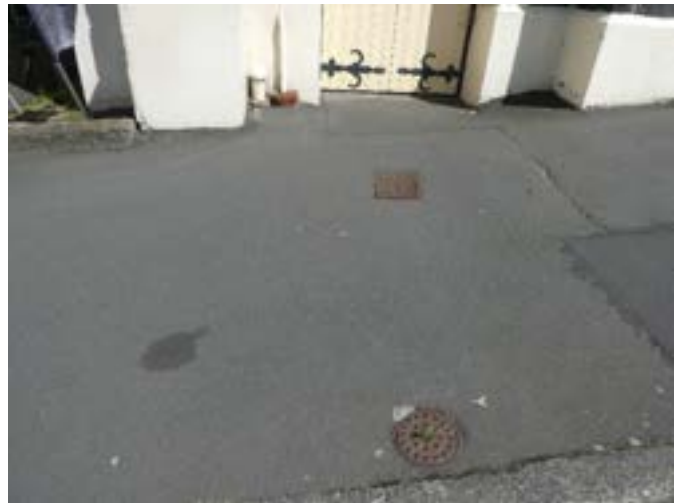
Photograph 248 – Showing the water shut off point to the south east.

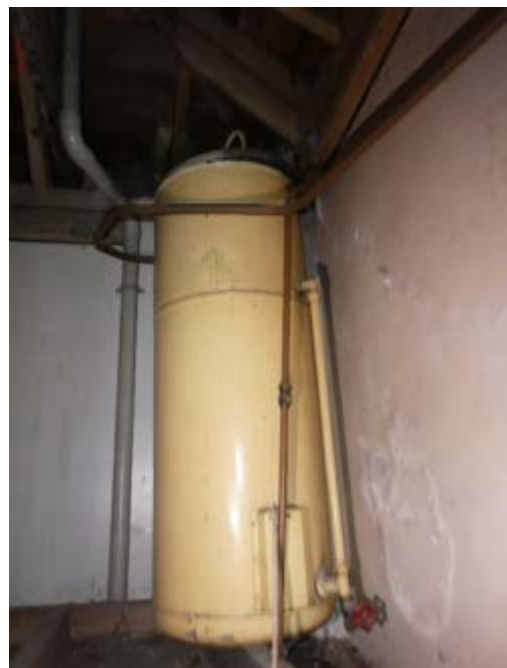
Photograph 249 – Showing the old low pressure hot water cylinder housed within the roof space above the bar / kitchen.

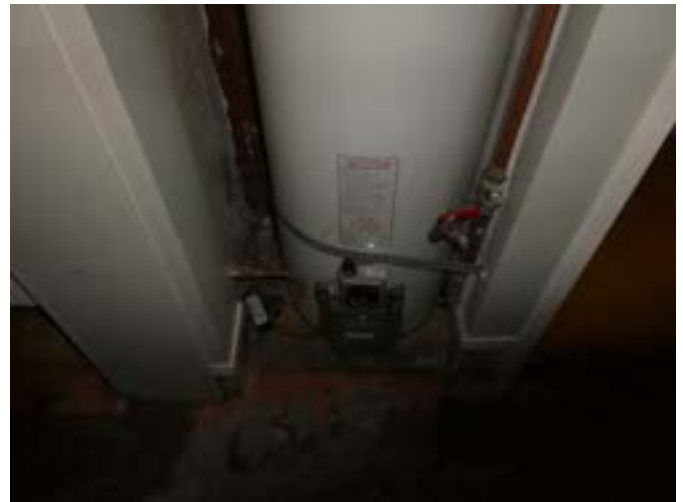
Photograph 251 – Showing the mains pressure gas hot water cylinder housed within the basement toilets.

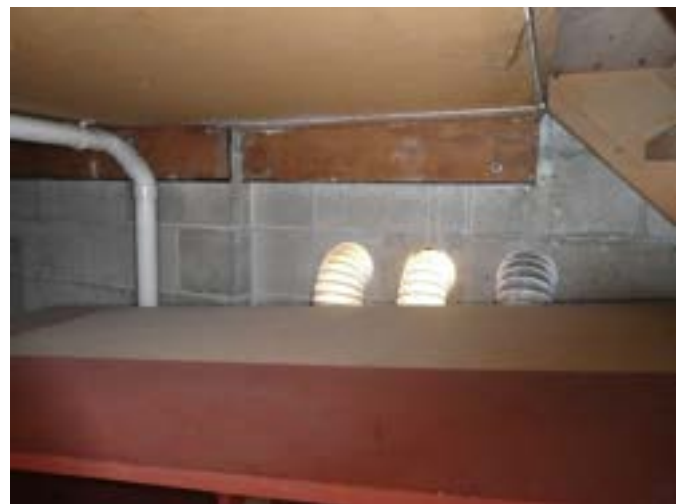
Photograph 252 – Showing the flexible ducting penetrations to the concrete masonry wall from the south western basement toilets.

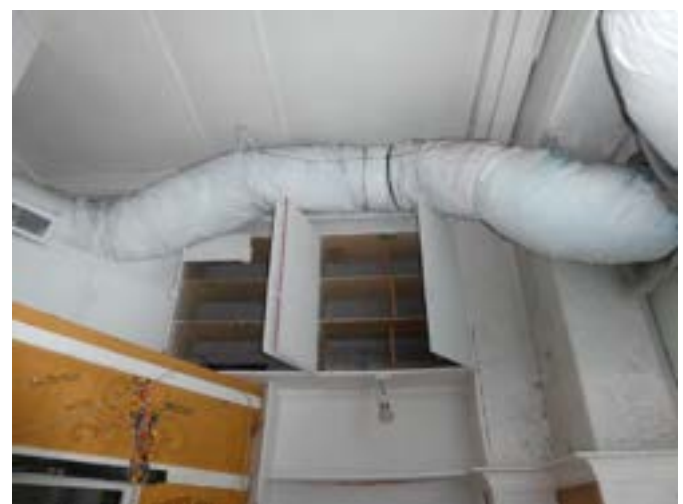
Photograph 254 – Showing insulated warm air heating duct to the western basement rooms.

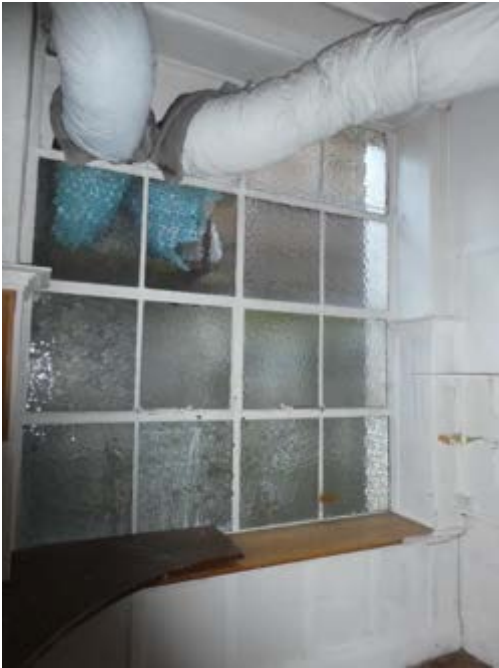
Photograph 255 – Showing poor installation of the insulated warm air ducting to the western basement rooms.

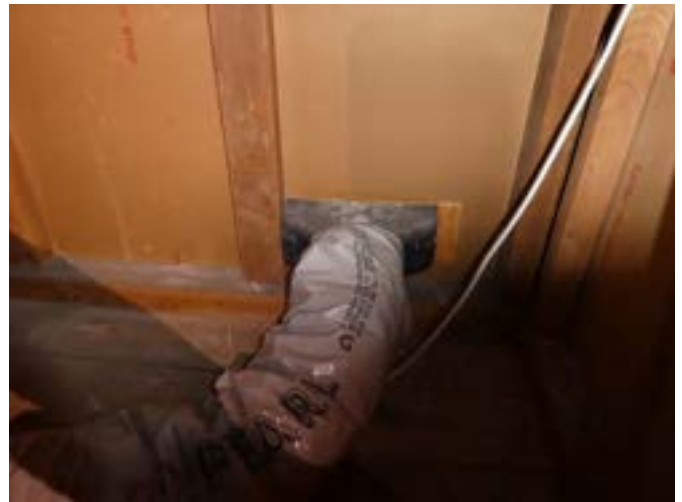
Photograph 258 – Showing the insulated warm air ducting below the seating with outlet to the bar area.

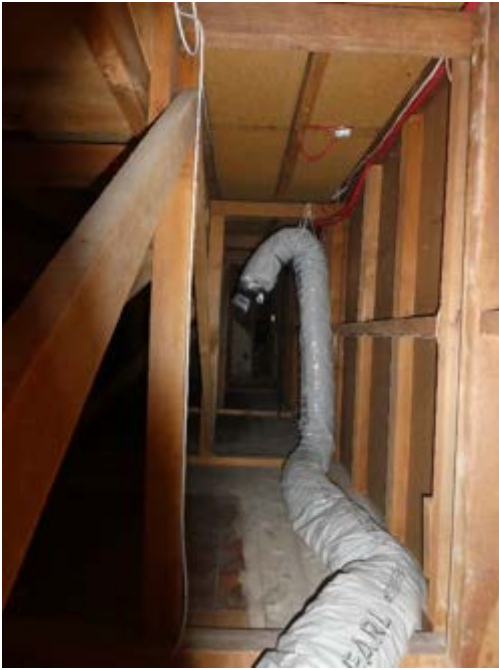
Photograph 259 – Showing the insulated warm air ducting below the seating in the main theatre.

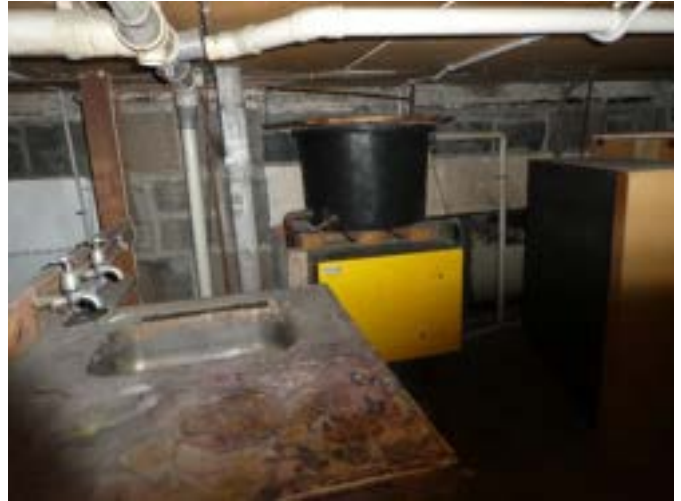
Photograph 263 – Showing the foul water pipework in the south western stairwell. Noting disconnected pipework which requires further investigation.
