**RE: LUC-2017-372 (request to remove listed tree T790)**

On Wednesday September 6, Alan Worthington (DCC, City Planning) contacted me and requested that I conducted a site visit of 8 Michie Street to assess a Silver beech (*Nothofagus menziesii*) listed as significant tree T790 of schedule 25c. I am a consulting arborist based in Dunedin [Appendix one].

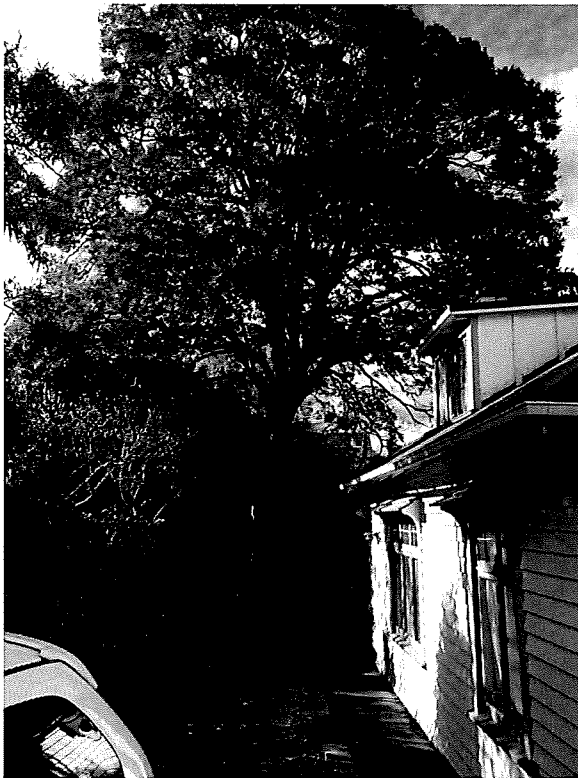
- 1.1 At the time of assessment, the tree was in good health; it was evenly foliated, exhibiting good vigour and vitality [image one].
- 1.2 The tree had a relatively evenly foliated canopy and small amounts of deadwood typical for the species.

**Image one:** Showing the foliage cover of Significant tree T790

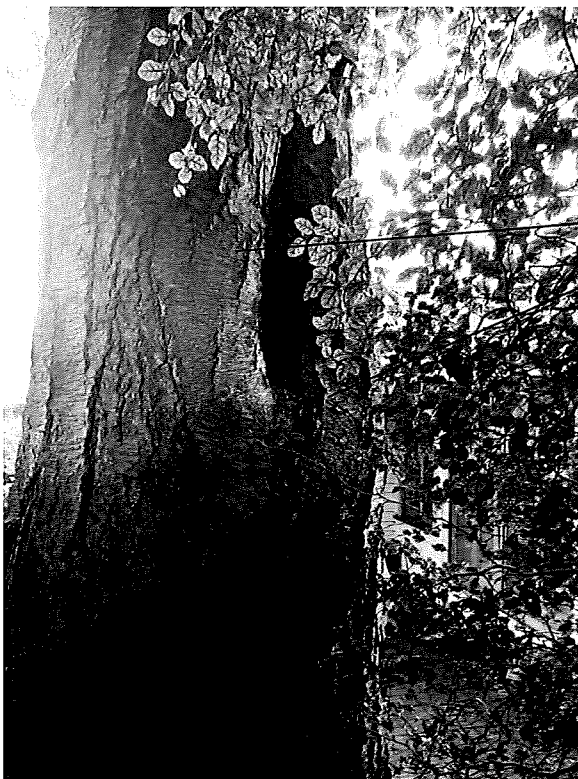
- 1.4 There is an open cavity on the eastern side of the trunk at approximately two meters. The cavity extends up the centre of the trunk for about one meter [image two]. The cavity is not recent and there was considerable response growth on either side of the opening.

Response growth on either side of the opening

**Image two:** Showing the open cavity on the eastern side of the trunk of Significant tree T790
