# Plan of 8 Michie Street Road Boundary and Silver Beech T790

### **Building Report**

Property damage relating to Significant Tree, DCC# T790 on Road Reserve adjoining at 8 Michie Street, Dunedin.

Review of application by Graeme Parmenter  
for the removal of a Tawhai tree T790  
by GreenTrees Ltd

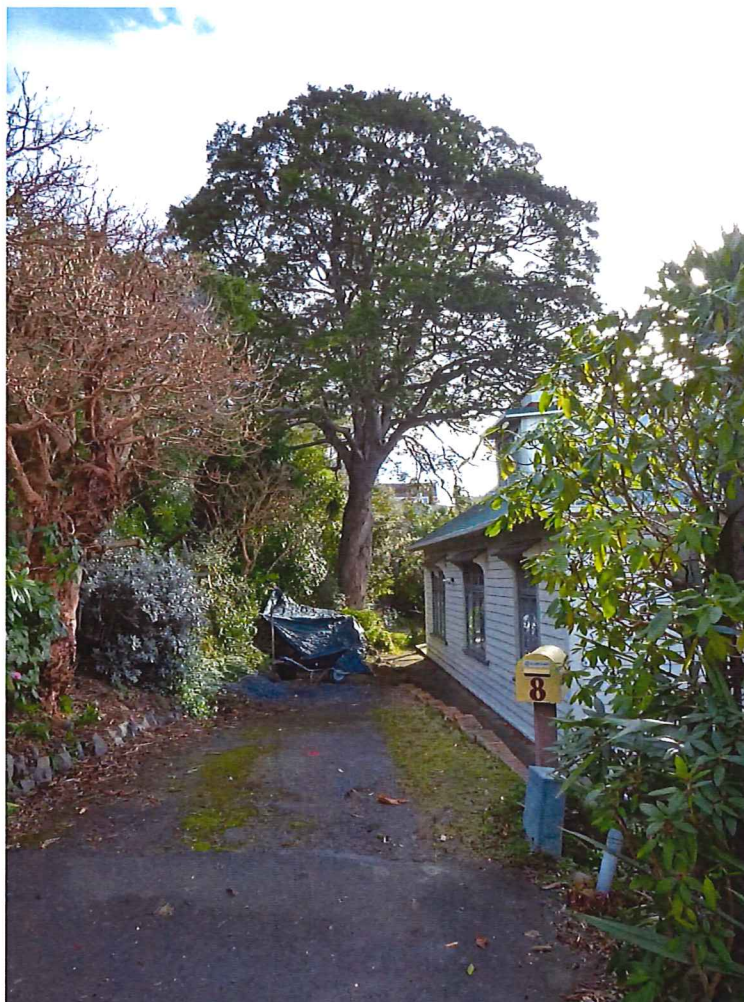
## STANDARD TREE EVALUATION FORM

| CONDITION EVALUATION | | | | | | |
|---|---|---|---|---|---|---|
| Double leader | | | | | | Subtotal Points 75 |

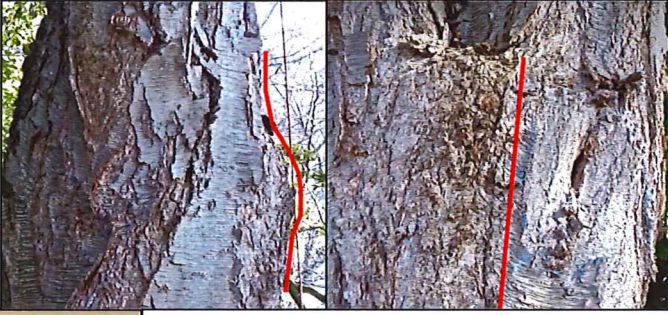
| Tree Characteristics | | Client: Graeme Parmenter | | E: graeme.parmenter@honeylane.nz | | | | | | |
|---|---|---|---|---|---|---|---|---|---|---|
| Flush Cuts | Raised | Response Growth: Bulge on eastside of mainstem indicative response growth due to fractional joint movement at the point where the mainstream bifurcates. | | | | | | | | |
| Main Concerns: There is a possibility of failure at the bulge seam where the codominant leaders bifurcates since all the forces of a storm of 120kph+ are transferred throughout the tree. The bulge represents a weaker fulcrum, which if exposed to extreme windloading may fail. | | Main Concerns: N/A | | | | | | | | |

The seam bulge on the eastside of the trunk indicates response growth to fractional internal movement within the bifurcation joint. This can be remedied through reduction of wind loading by end weight reduction of long branches. Supplemental cabling support would mitigate the risk of catastrophic collapse of half the canopy onto the house in an extreme storm event. (ie 100mm rain in 8 hours, plus winds exceeding 120 kph+ from the Sou'west, with a heavy water laden canopy).

Red lines show closed seam & response growth bulge
