Prepared for Lion NZ Ltd  
Prepared by Beca Limited

## Location and Extent

**Asbestos Demolition Survey of**

Lion NZ Limited requested Beca to inspect and prepare a structural condition report for the building at 180 Rattray St, Dunedin, with respect to the current condition of the structure and any specific hazards or structural weaknesses presented by the current condition of the structure. This report has been prepared in response to this request.

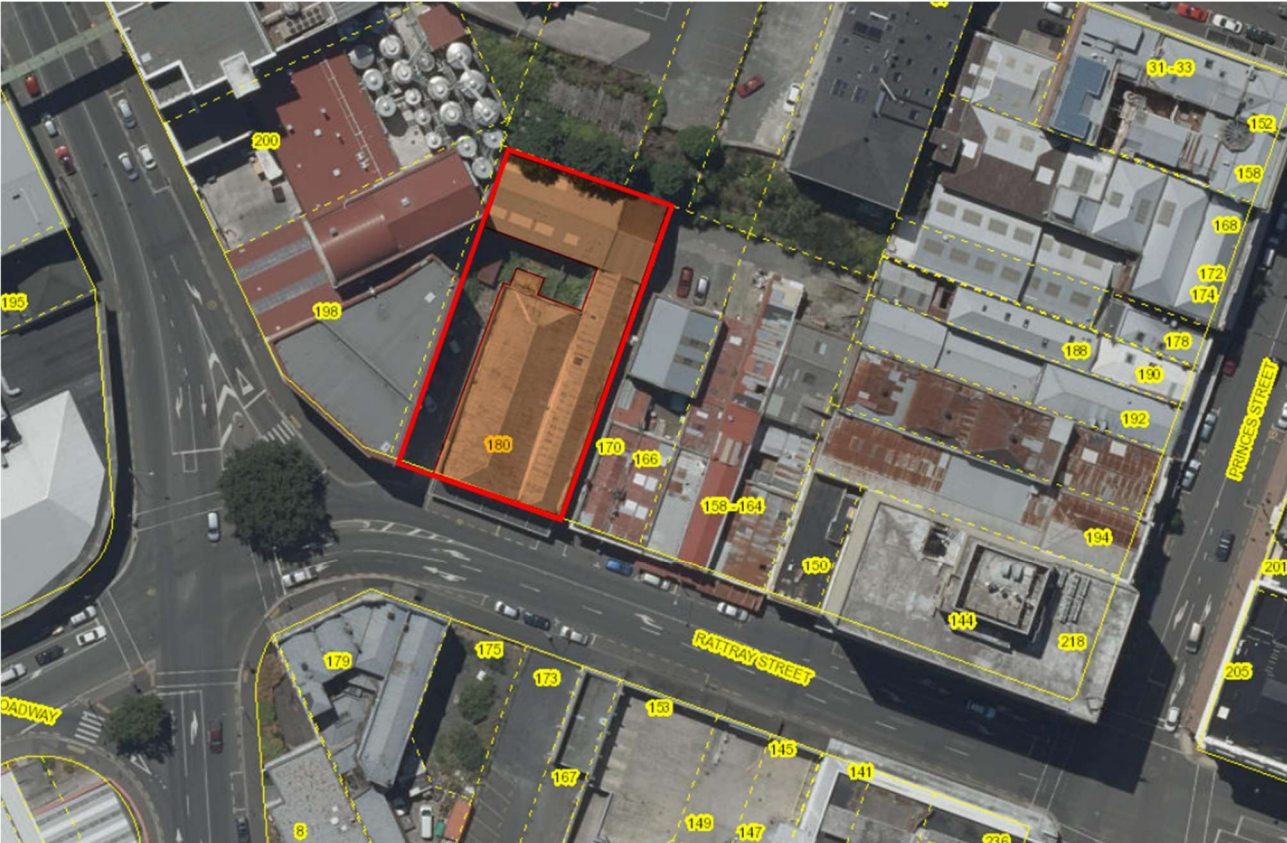
Image 1: 180 Rattray Street demolition extents

All buildings within the red highlighted boundary, known as 180 Rattray Street, Dunedin, shown in image 1, are proposed to be demolished down to ground floor slab level.

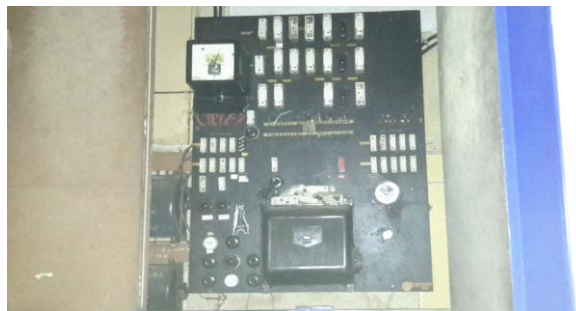
Room/Area: Floor 0, Room A (Ground Floor Internal Areas)

Description: Fuse backing board to electrics (Composite) - 18-047155-01

Recommendations: Remove by licensed contractor prior to demolition works

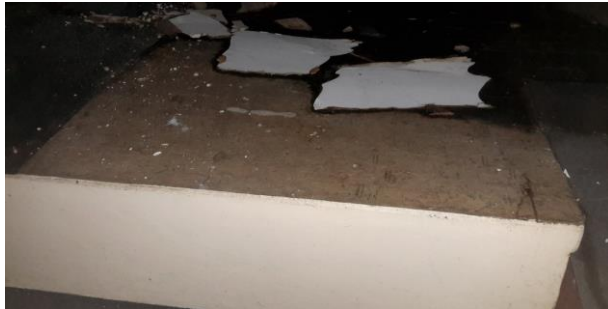
Room/Area: Floor 0, Room A (Ground Floor Internal Areas)

Description: Coveting to wooden floor (Vinyl) - 18-047155-02

Recommendations: No further action required

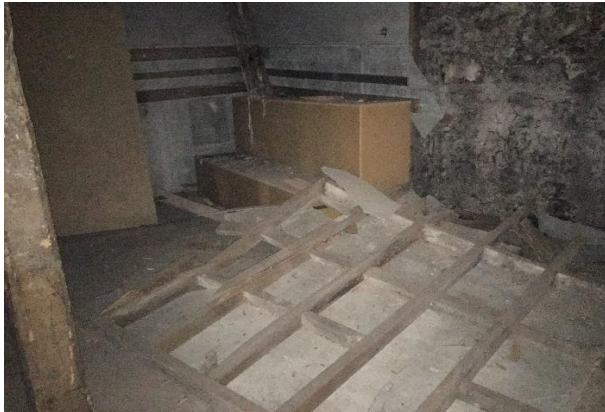
Room/Area: Floor 0, Room A (Ground Floor Internal Areas)

Description: Redundant wall panels (Fibre Cement) - 18-047155-04

Notes: Highly damaged panels to floor, small pieces to ground.

Recommendations: Remove by licensed contractor prior to demolition works

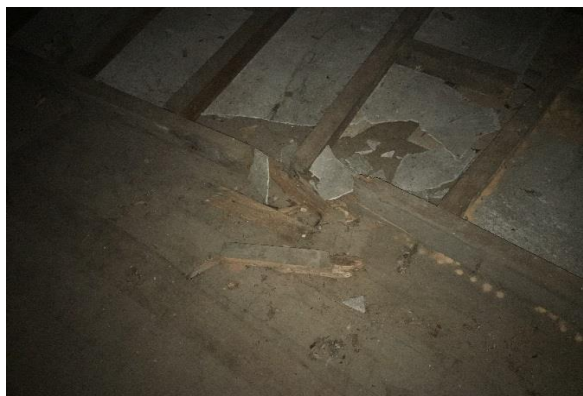
Room/Area: Floor 0, Room A (Ground Floor Internal Areas)

Description: Debris to floor (Fibre Cement) - As 18-047155-04

Notes: Highly damaged panels to floor, small pieces to ground.

Recommendations: Remove by licensed contractor prior to demolition works

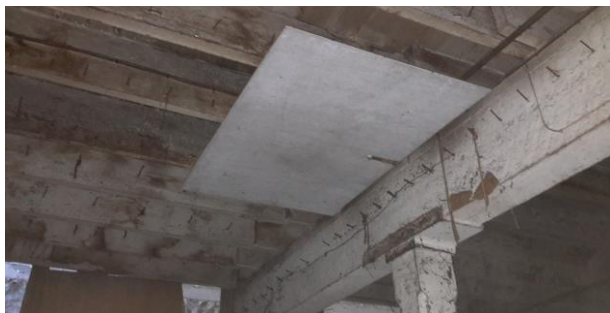
Room/Area: Floor 0, Room A (Ground Floor Internal Areas)

Description: Ceiling panel (Fibre cement) - As 18-047155-04

Recommendations: Remove by licensed contractor prior to demolition works

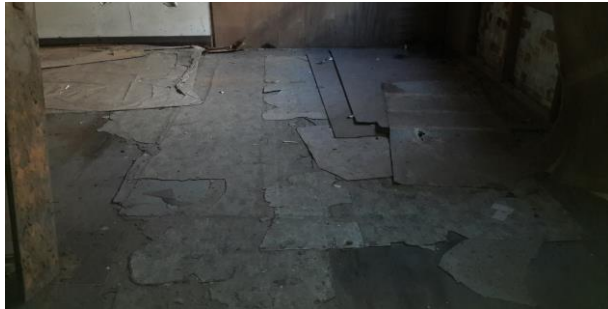
Room/Area: Floor 0, Room A (Ground Floor Internal Areas)

Description: Floor covering (Vinyl) - 18-047155-05

Recommendations: No further action required

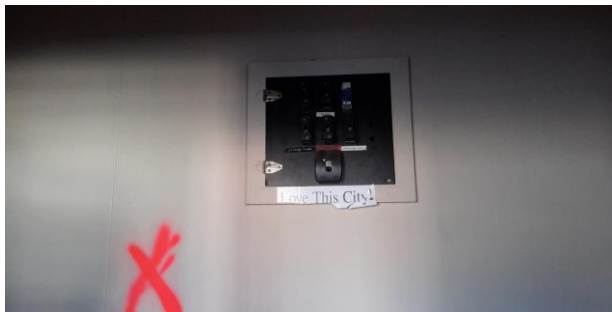
| | Room/Area: Floor 1, Room B (First Floor Internal Areas) |

| | Description: Fuse backing board to electrics in corridor (Composite) -As 18-047155-01 |

| | Recommendations: Remove by licensed contractor prior to demolition works |

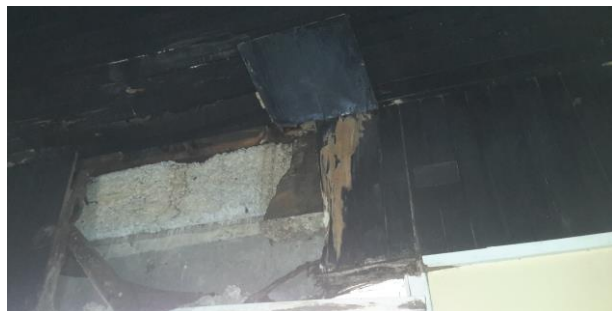
Room/Area: Floor 1, Room B (First Floor Internal Areas)

Description: Lining behind wooden wall cladding (Felt) - 18-047155-03

Recommendations: No further action required

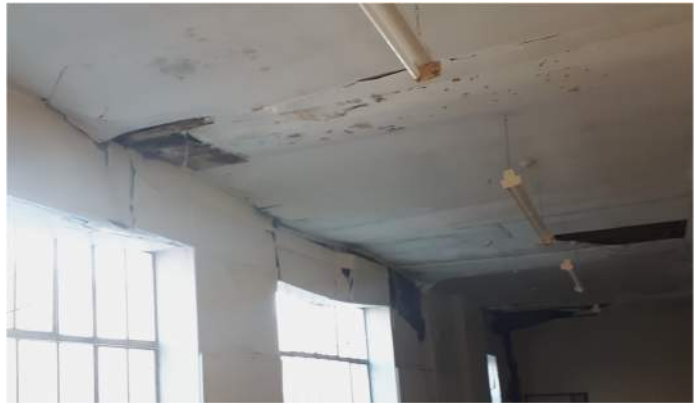
Extensive damage to area 2 where the ceiling is in very poor condition. Figure 6 shows ceilings sagging and falling away, mould growth, general deterioration.

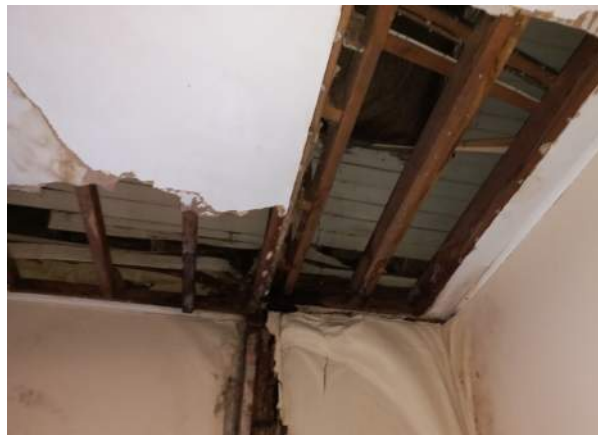
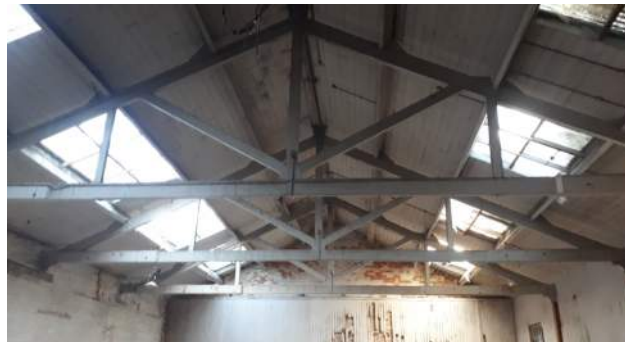
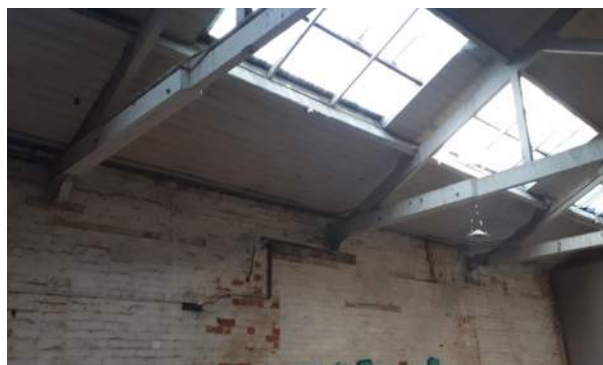
The roof framing in area 1 and 2 is in variable condition, depending on proximity to water ingress locations. In areas observed close to roof leaks, it looks to be in poor condition.

Roof trusses in the rear building are generally dry and in moderate condition. Some localised damage to timber truss elements and to bricks supporting the truss ends.

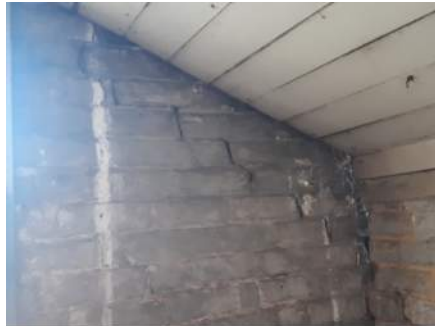
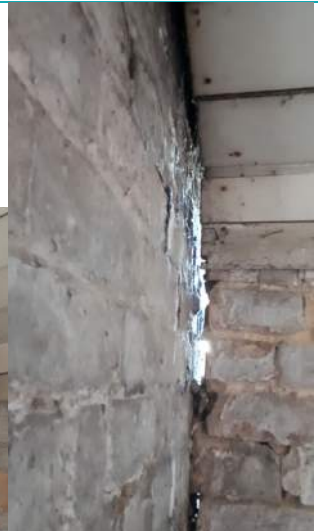
Observations on the outside of the gable end wall made in 2013 show several locations with loose and displaced bricks. Figure 15 and Figure 16 show horizontal and vertical displacement in the corners of the gable end wall. This is consistent with the cracking pattern observed internally in Figure 10 and Figure 11.

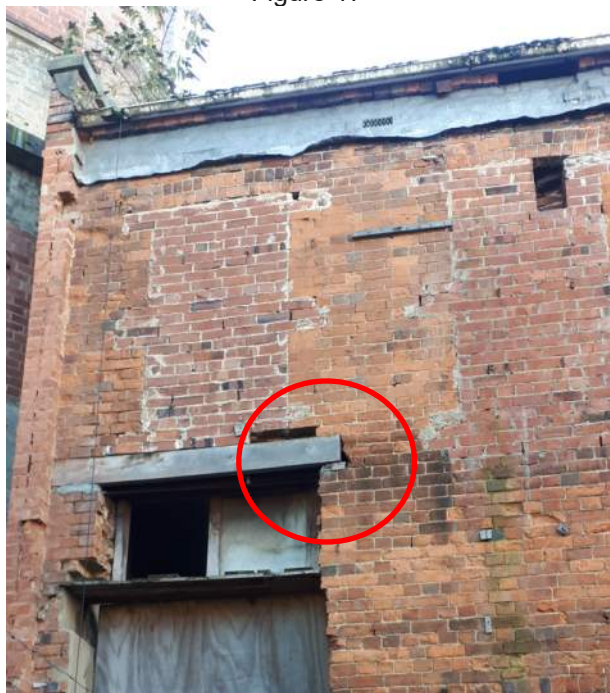
The timber lintel in area 3 shown in Figure 18 is seated on a short length of brick wall which is unrestrained and showing signs of crumbling. The timber lintel is supporting approximately 3m of brick wall above.

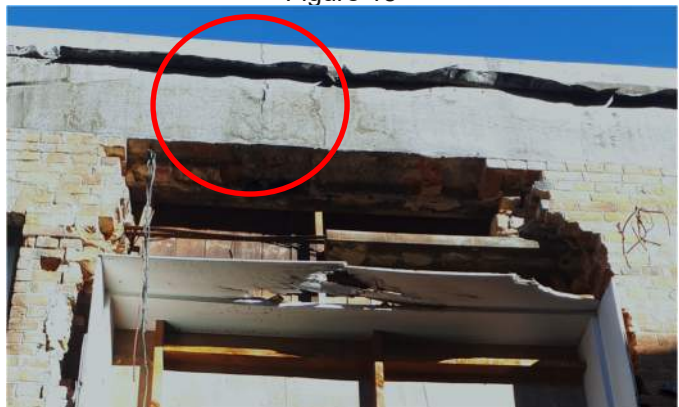
Figure 19

Lintel to high level window on rear elevation of area 1, shown in Figure 19. The brick lintel has fallen away, a crack has appeared through the full depth of the concrete parapet above.

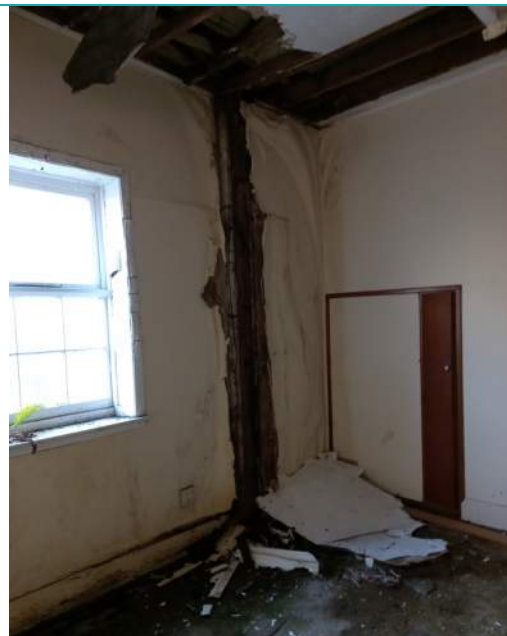
Figure 21

Internal wall linings in area 2 are in very poor condition. Wall linings have come away due to water damage or otherwise, exposing timber framing and external brick façades.

Internal wall linings in area 1 and 3 are in moderate to poor condition

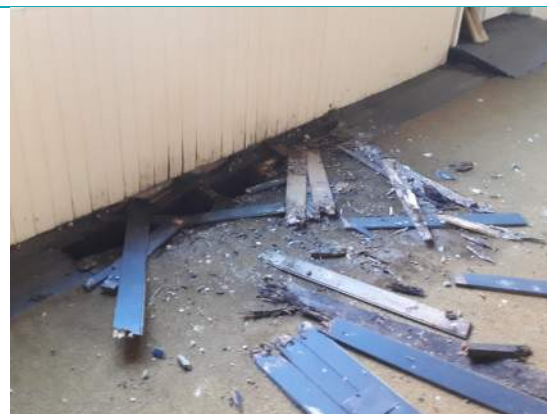
Figure 22

Very poor condition, several areas with water damage and holes through the floor. Floors generally unsafe to walk on across most of the ground floor, and locally at the upper level of area 1 and area 2.

At ground floor level, natural ground level is close to the underside of the timber joists. There does not appear to be a moisture barrier or airflow to allow for drying. Timber floors are sagging and highly degraded. It is unstable to walk on and breaks easily under pressure.

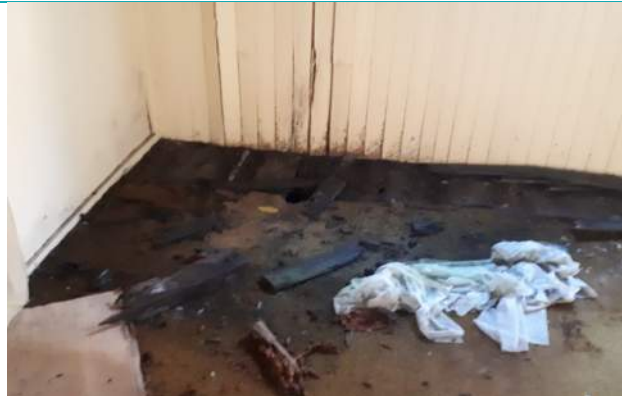
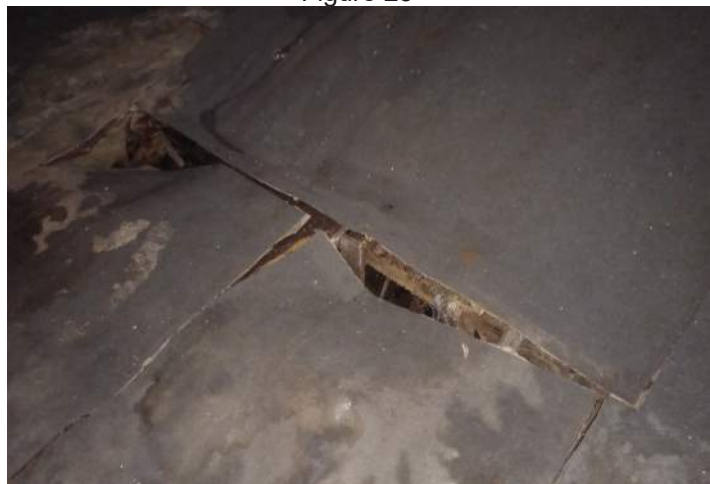
At first floor level, water ingress from holes in the roof appears to have caused local damage to several areas of flooring. With the presence of holes in the floor, sagging floors boards, mould, damaged floor linings.

The level 1 floors in area 3 appear to be less damaged compared to the front areas. We were unable to access ground floor in area 3.

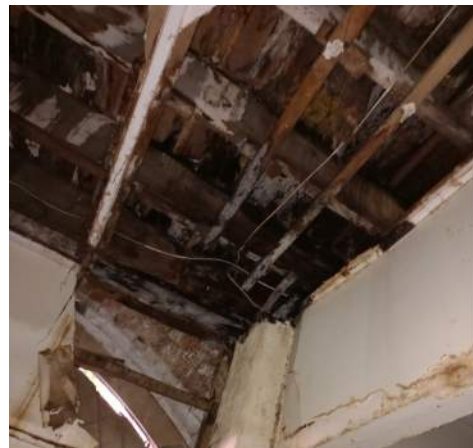
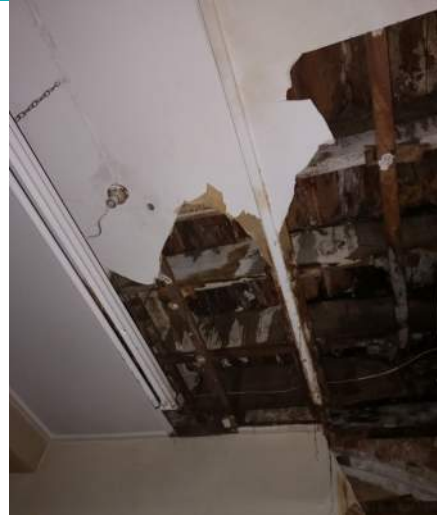
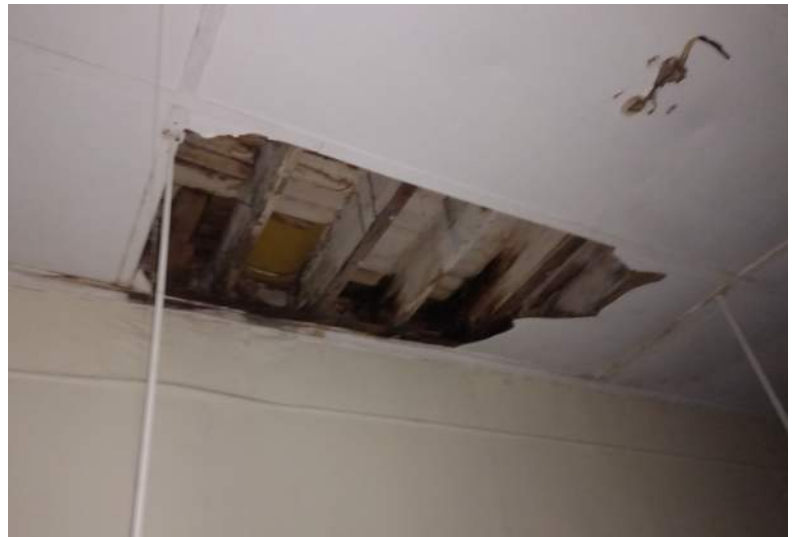
Level 1 floor framing is typically lined underneath with tongue and groove linings. Extensive water damage has exposed the timber framing in some locations of area 1 and 2, with visible degradation to the floor joists.

We were unable to view the connections to external walls but given the condition of the flooring and joists it is reasonable to assume the connections are in similarly poor condition in these locations.

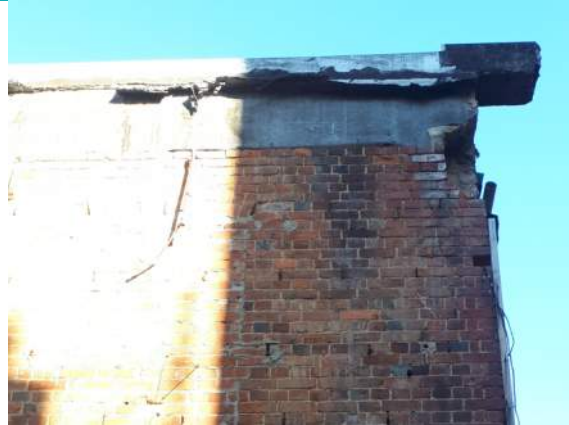
Figure 29

In some locations to the rear of area 1, the top of the brick wall is crumbling and falling away from underneath the concrete parapet, shown in Figure 29.

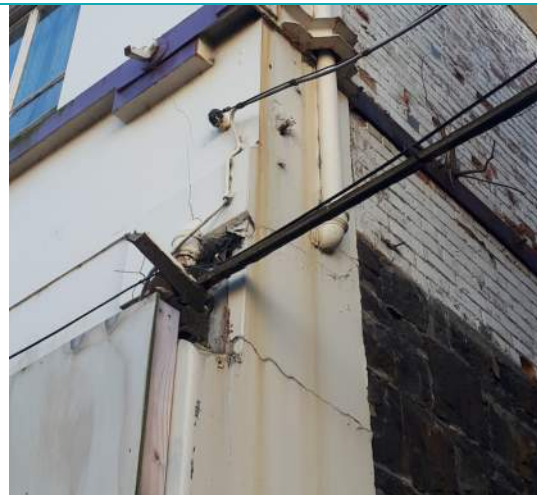
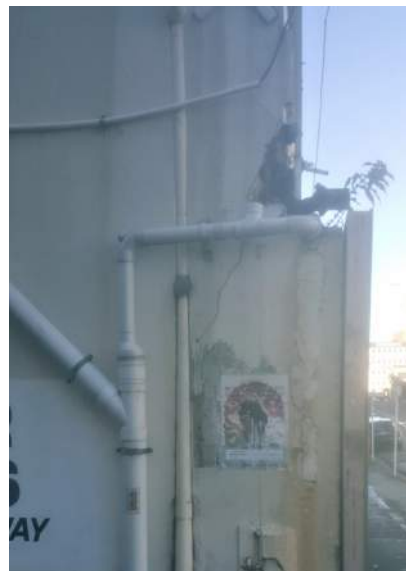
Minor cracks observed in façade render, typically extending out from wall penetrations.

Horizontal cracks in the render aligning with the interface between top of brick wall and the newer concrete parapet.

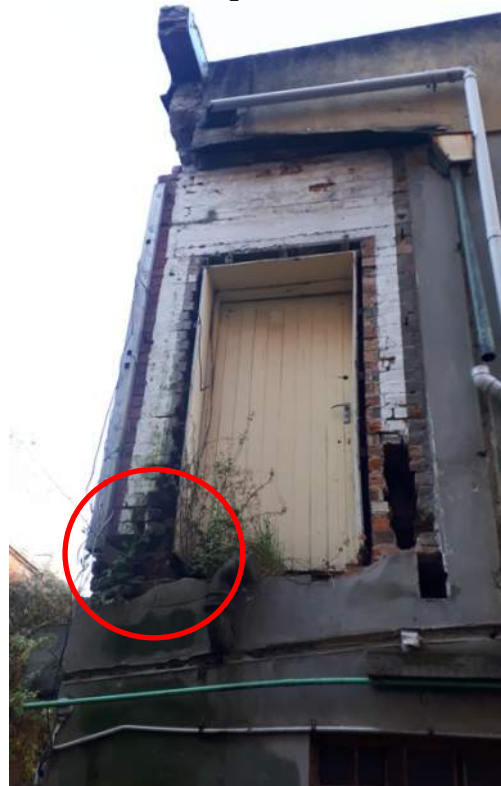
Figure 33 shows displaced bricks to the North-West corner of the area 1.

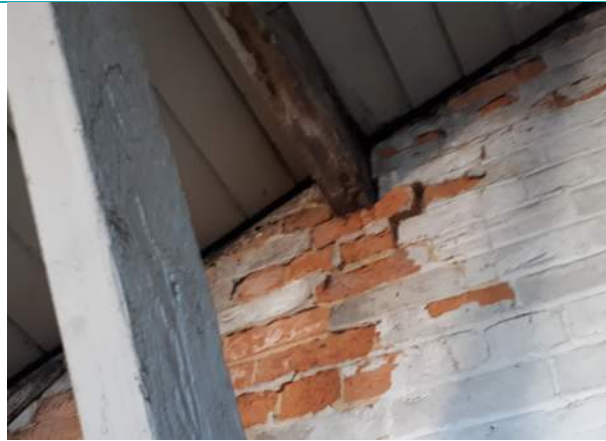
Figure 34

Individual bricks were observed to be crushed and crumbling at locations supporting the timber roof rafter, shown in Figure 34. These bricks are in poor condition and have lost their integrity.

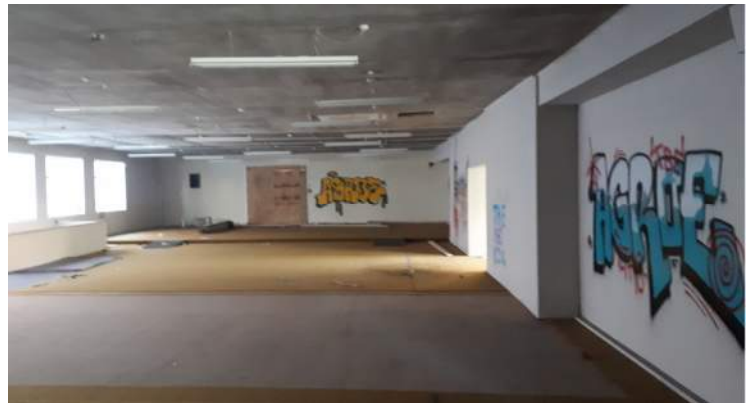
Figure 35 – Area 1 Level 1

- There is bird/animal intrusion into the building.
- Plants, mould and other organic matter growing inside the building, on the roof guttering, and the external façades.
- Exterior doors rotting and glass panels broken throughout building.
- Evidence of recent activity and vandalism
