# Dunedin City Council **DCC Landslide Monitoring Report**

## **Greenacres Street Earthflow**

23 February 2026

6-CD109.A9

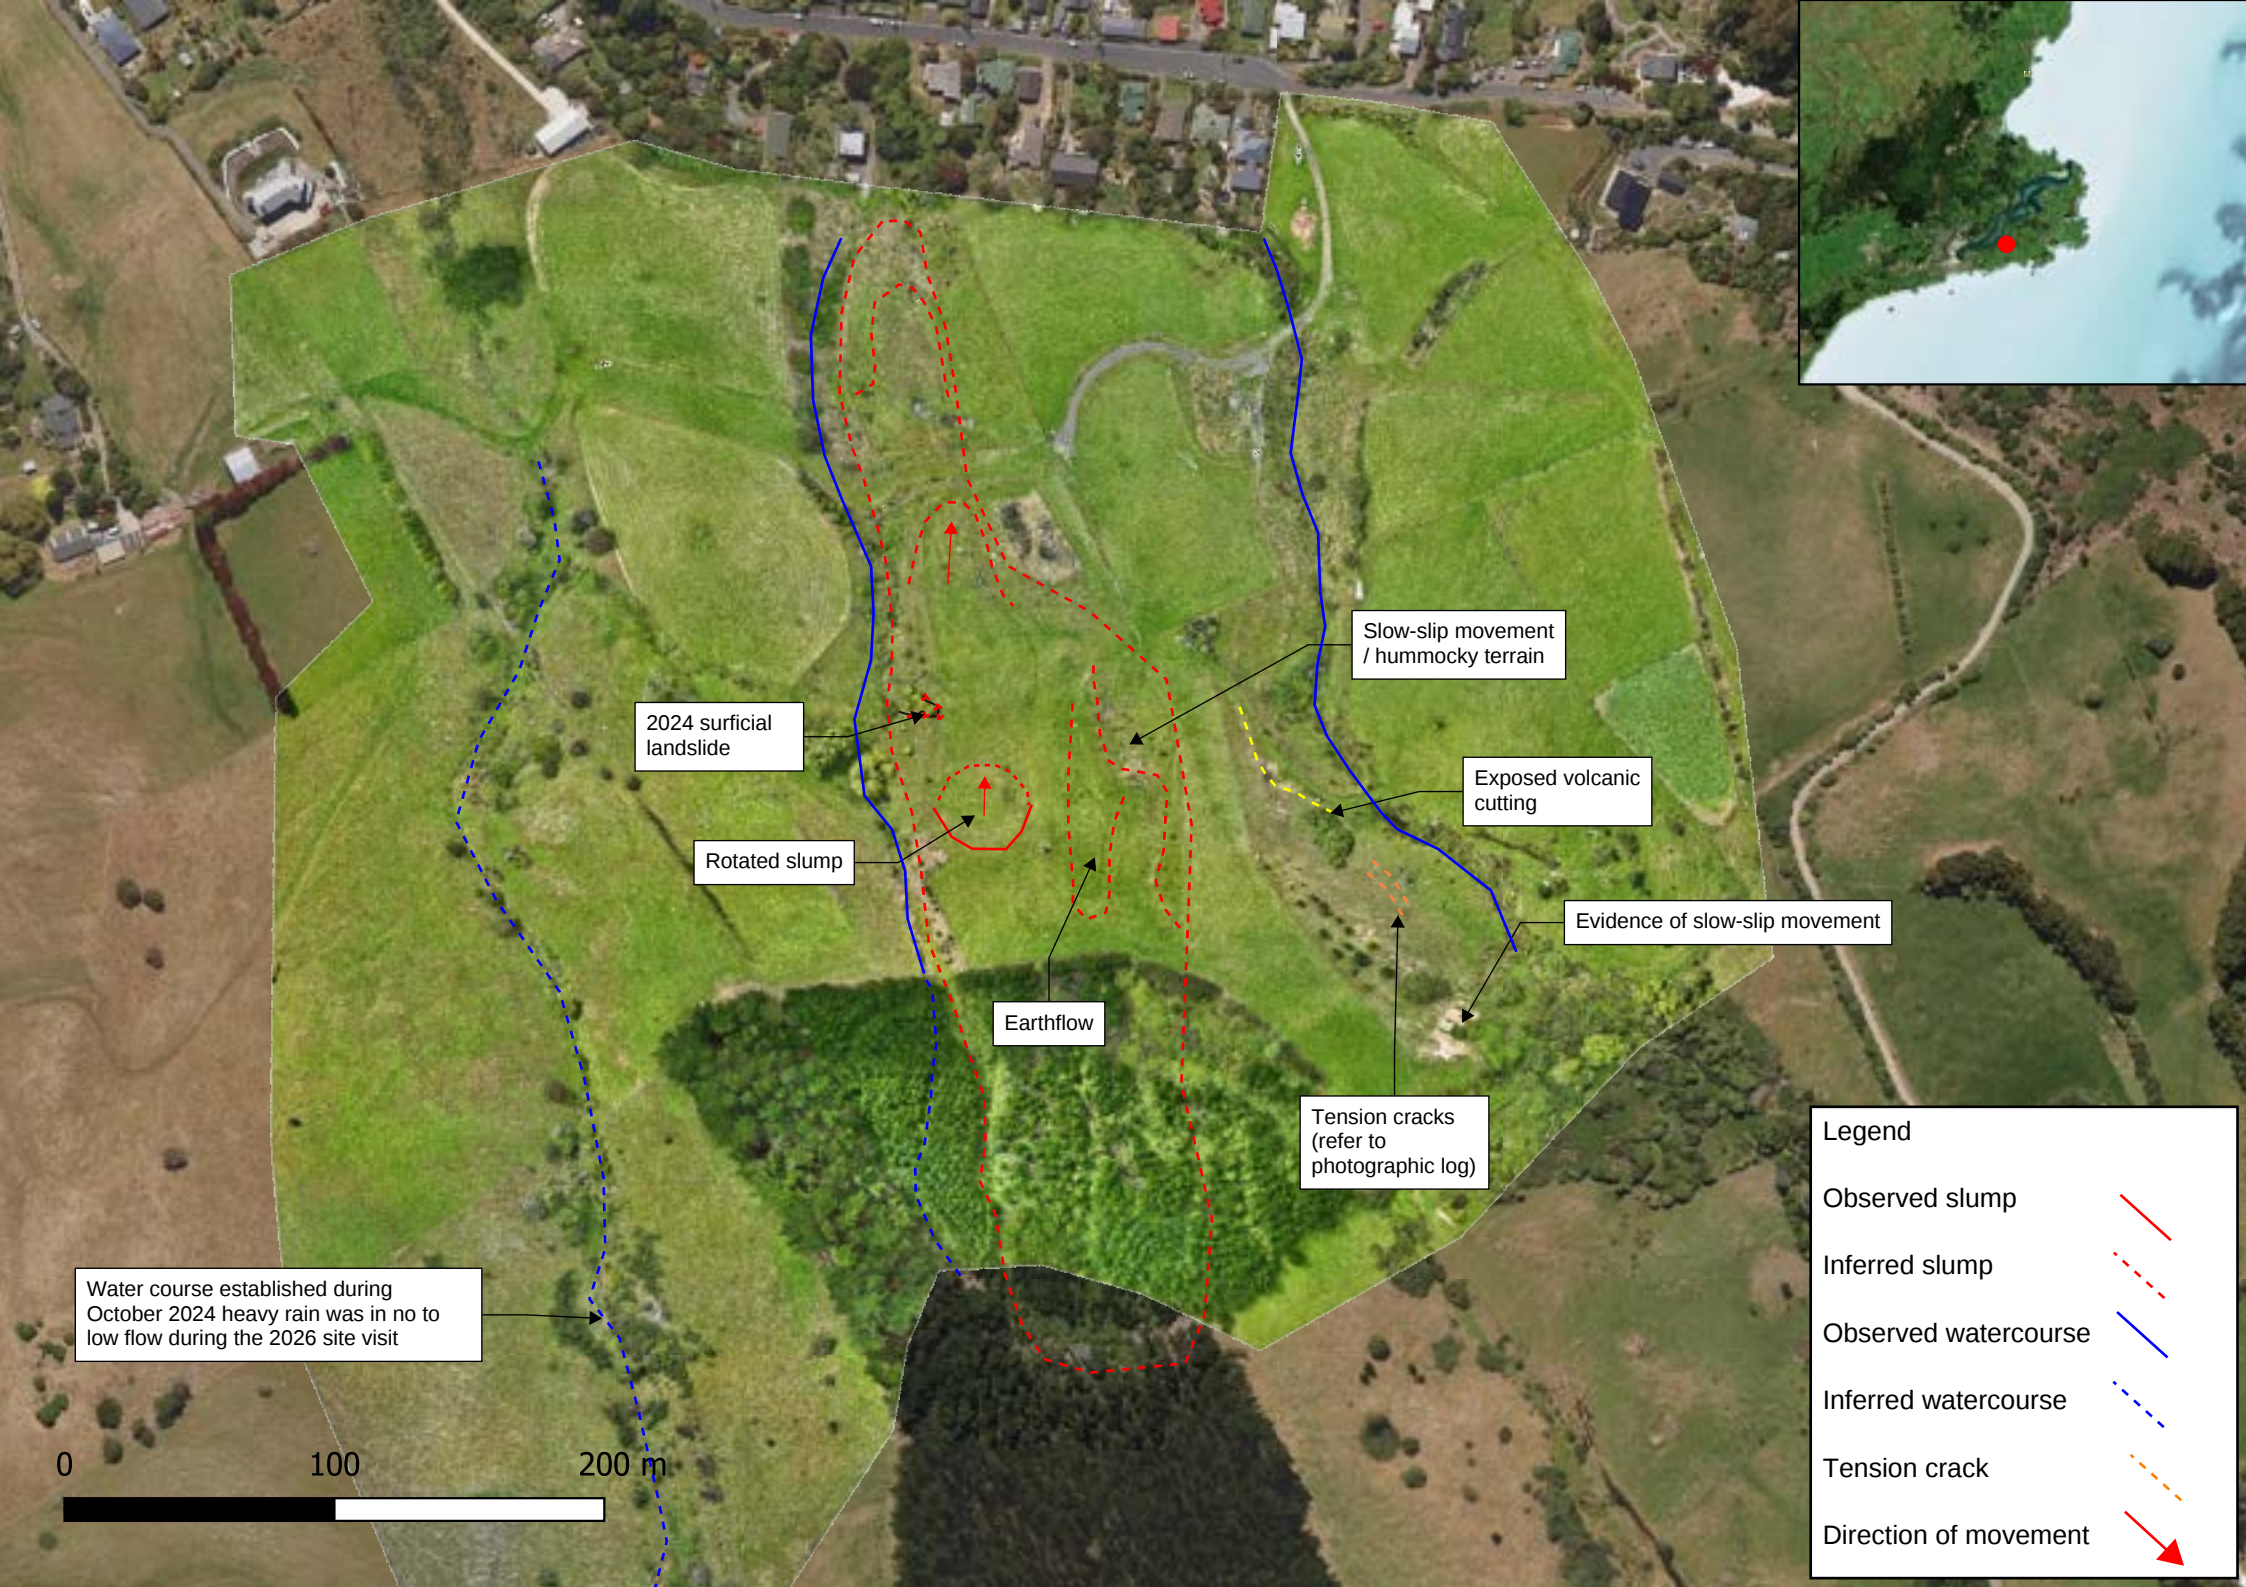
## PRELIMINARY OBSERVATIONS / UAV MAP

A preliminary engineering geological map of the identified geological site features is included in Appendix A, with a photographic log in Appendix B.

Landslide hazard mapping can aid the decision around avoidance, prevention or mitigation of the existing and future landslide hazards. Notable observations have been compiled into a preliminary map provided in Appendix A and used to inform the risk assessment for this report. An outline of the risk assessment methodology is discussed in Section 5.

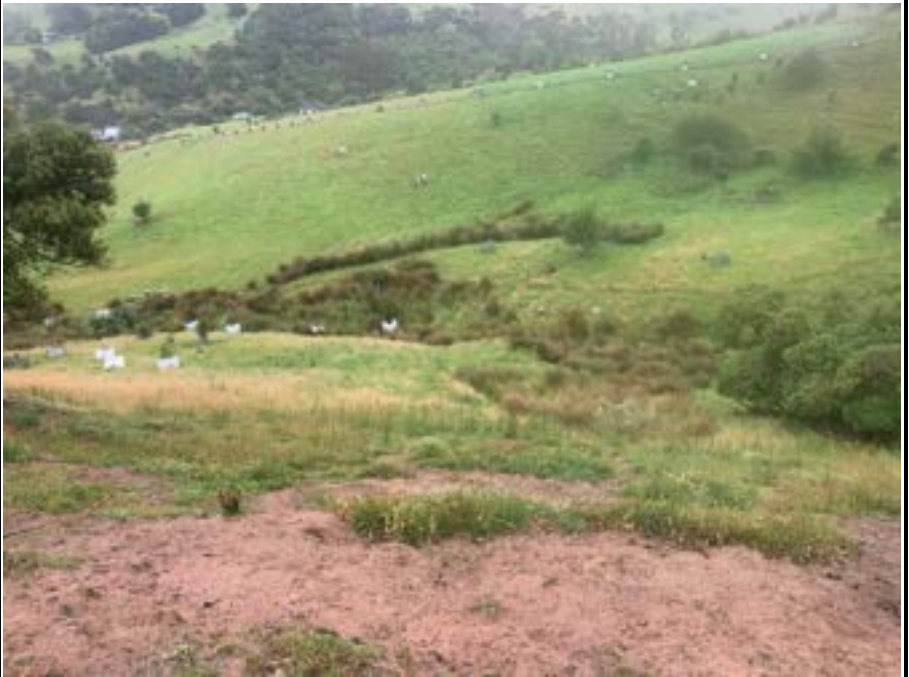
| Photograph No. | Date | |
|---|---|---|
| 1 | 22/01/2026 | |

| Photograph No. | Date | |
|---|---|---|
| <b>Description</b><br>View of the watercourse feature down the flanks of the earthflow (to the left of the image). Image taken facing north | | |

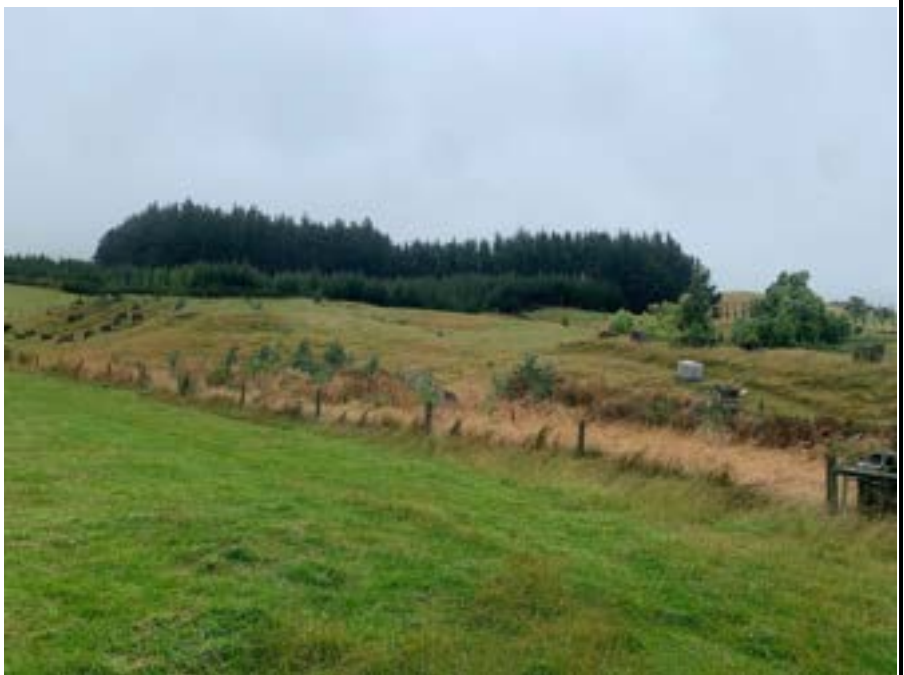
| Photograph No. | Date | |
|---|---|---|
| 2 | 22/01/2026 | |

| Photograph No. | Date | |
|---|---|---|
| <b>Description</b><br>Looking up towards the headscarp, within the pine plantation. Image taken facing south | | |

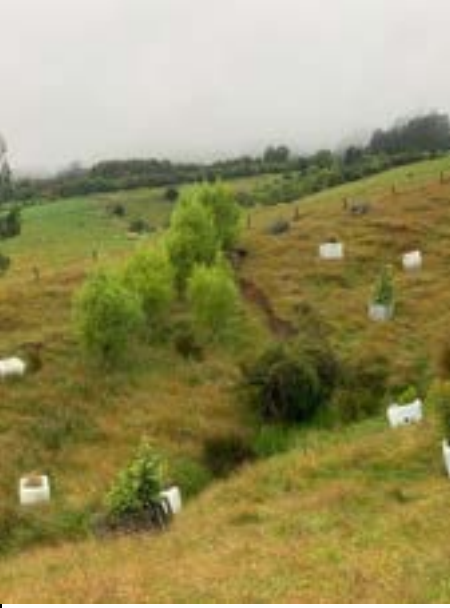
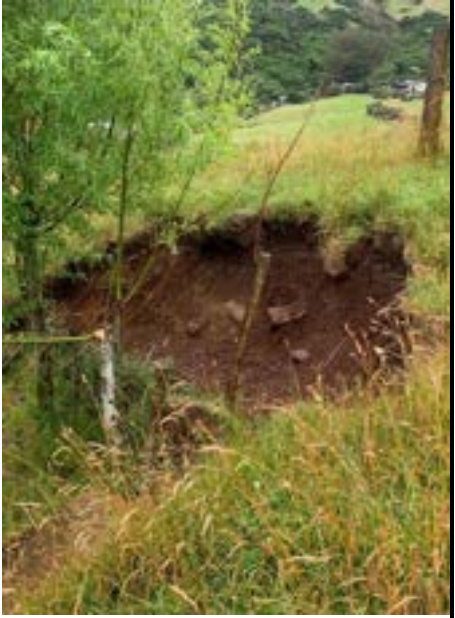
A small landslide headscarp identified in the 2024 site inspection showed no evidence of further movement (refer to photograph 3, Appendix B). Tension cracks were identified along the eastern edge of the landslide in the area mapped as likely and appeared to be of similar age to the 2024 headscarp (refer to photograph 8, Appendix B).

| Photograph No. | Date | | |
|---|---|---|---|
| <b>Description</b><br>Small landslide as a result of the October 2024 heavy rainfall event and evidence of slope stabilization (tree planting) in the valley. Image taken facing southeast. No evidence of significant recent movement visible in the headscarp. | | | |

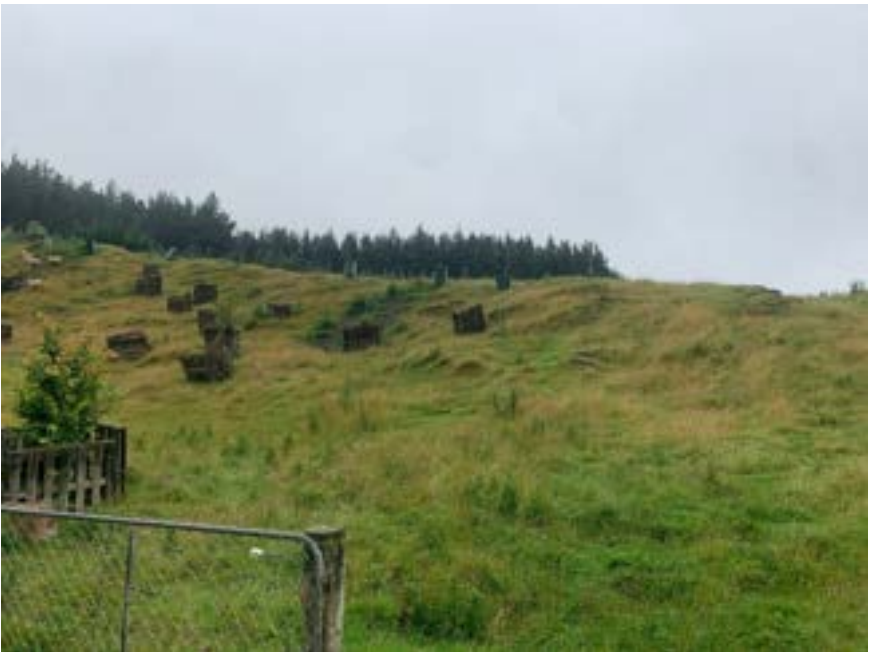
| Photograph No. | Date | | |
|---|---|---|--|
| 4 | 22/01/2026 | | |

| Photograph No. | Date | | |
|---|---|---|--|
| <b>Description</b><br>View of blocks of earthflow. Image taken facing main body of earthflow and west | | | |

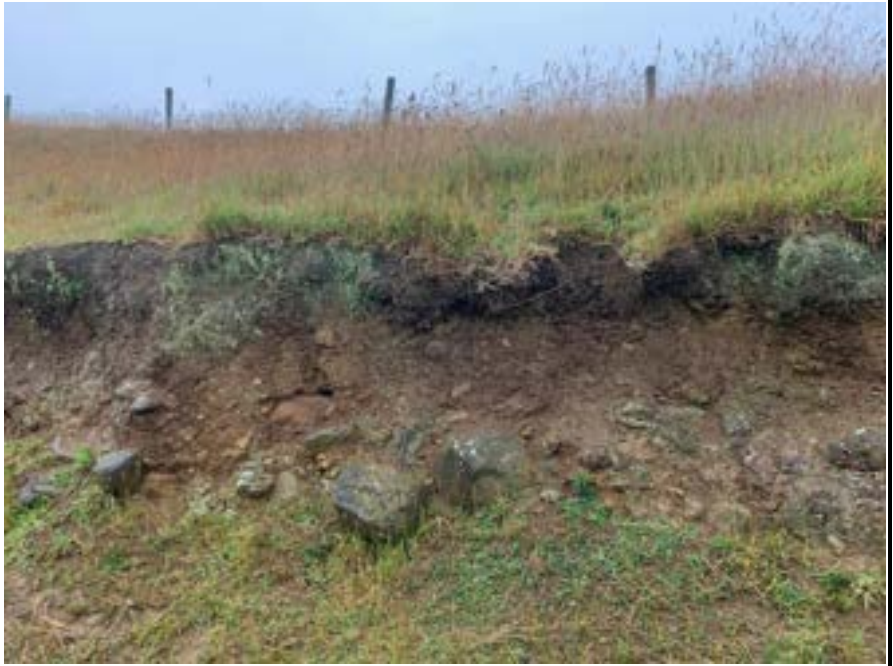
| <b>Photograph No.</b> | <b>Date</b> | |
|---|---|---|
| 5 | 22/01/2026 | |

| <b>Photograph No.</b> | <b>Date</b> | |
|---|---|---|
| <b>Description</b><br>Cut and fill exposure of volcanics overlain by a thin layer of loess, within the “Likely” certainty area of the mass movement. Image taken facing north | | |

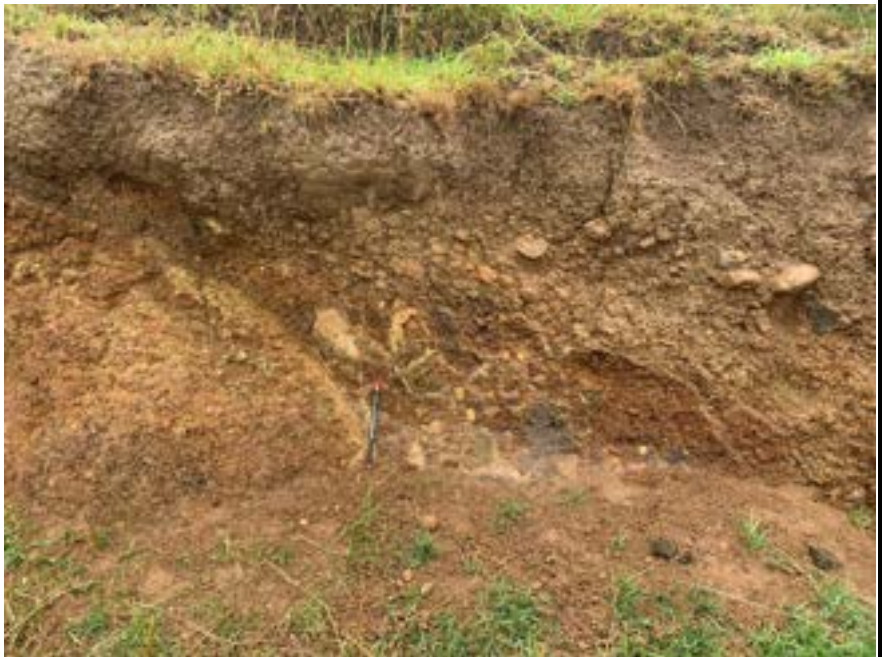
| <b>Photograph No.</b> | <b>Date</b> | |
|---|---|---|
| 6 | 22/01/2026 | |

| <b>Photograph No.</b> | <b>Date</b> | |
|---|---|---|
| <b>Description</b><br>Close up view of the cut and fill platform. Completely weathered pyroclastics overlain by topsoil | | |

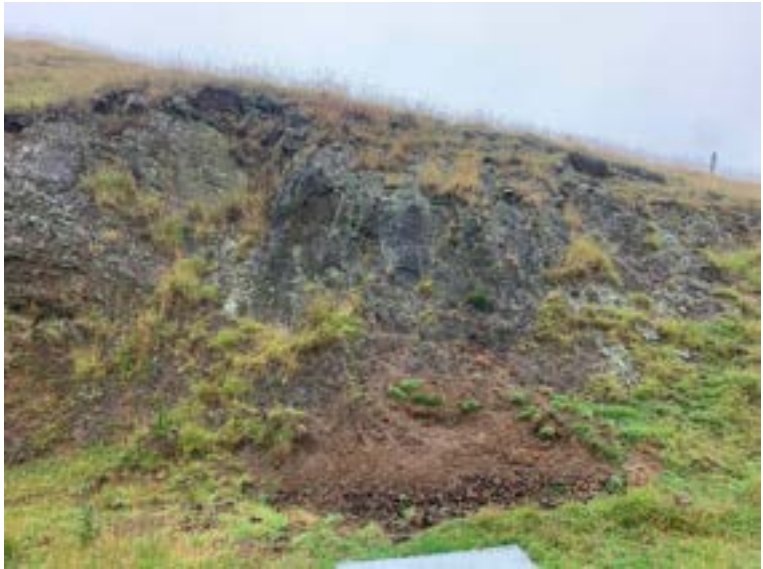
| Photograph No. | Date | | |
|---|---|---|--|
| 7 | 22/01/2026 | | |

| Photograph No. | Date | | |
|---|---|---|--|
| <b>Description</b><br>Outside of landslide boundary, cutting for farm track exposing shallow volcanics with thin overlying topsoil. Image taken facing south | | | |

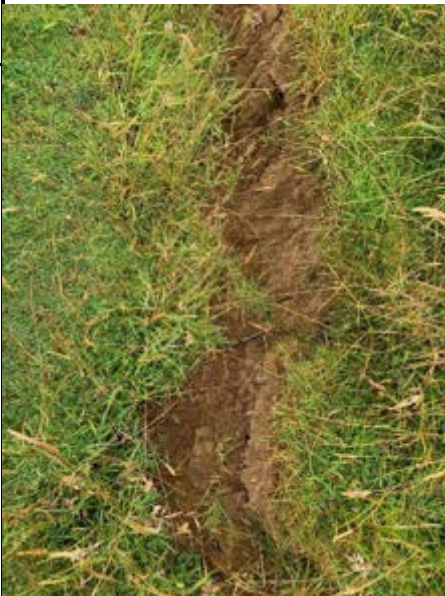
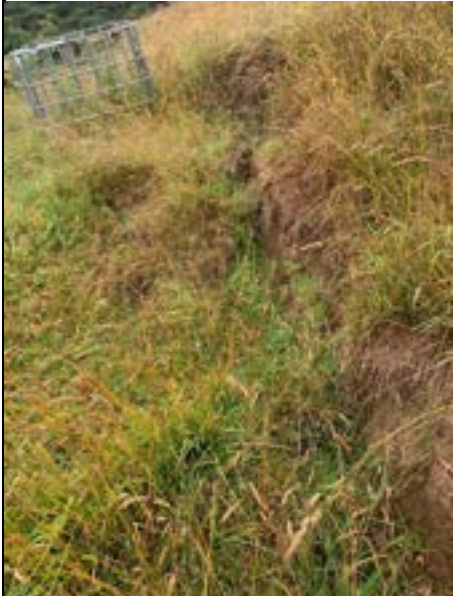
| Photograph No. | Date | | |
|---|---|---|---|
| 8 | 22/01/2026 | | |

| Photograph No. | Date | | |
|---|---|---|---|
| <b>Description</b><br>Tension cracks near the eastern edge of the landslide | | | |

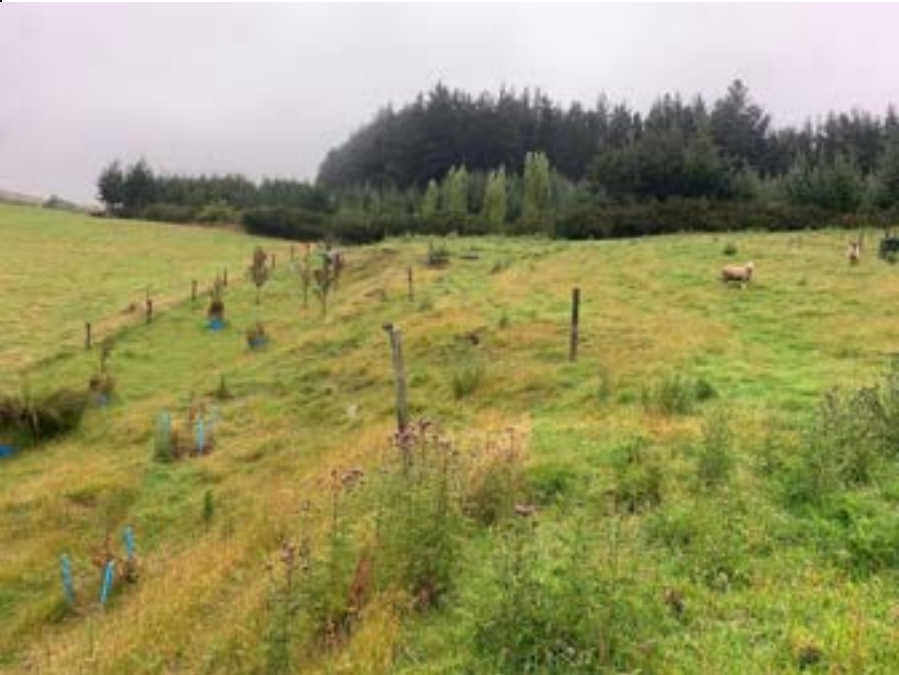
| Photograph No. | Date | |
|---|---|---|
| 9 | 22/01/2026 | |

| Photograph No. | Date | |
|---|---|---|
| <b>Description</b><br>Hummocky terrain – saturated underfoot, looking up at pine plantation | | |

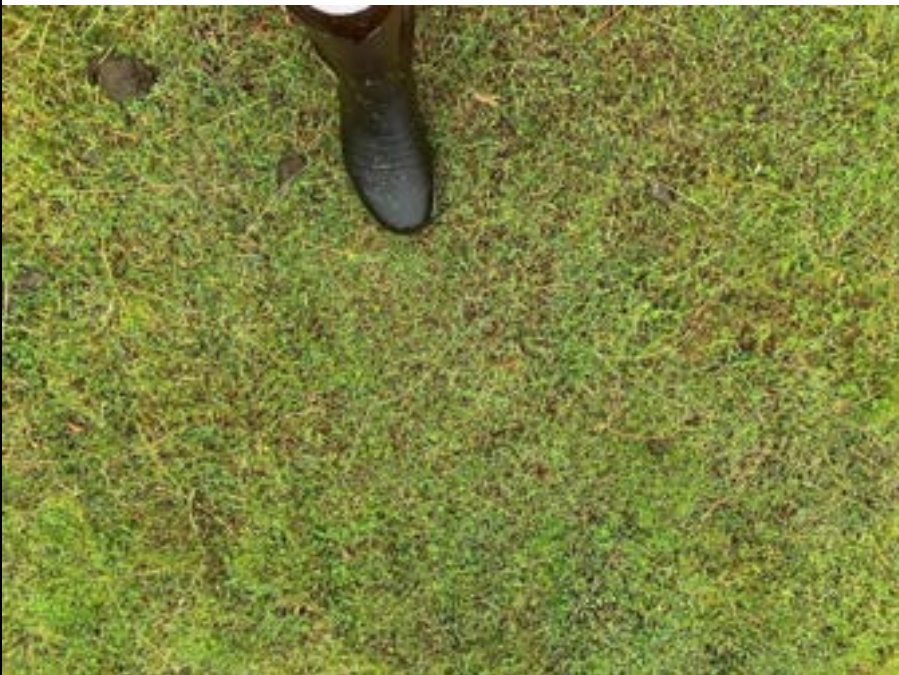
| Photograph No. | Date | |
|---|---|---|
| 10 | 22/01/2026 | |

Areas where drainage measures have been implemented were still saturated underfoot, and there had been areas of block sliding. Water also caused ballooning of the ground surface. Areas of ponding and water flow paths were observed whilst onsite, and the majority of the grass underfoot was wet to saturated (refer to photograph 10, Appendix B).

| Photograph No. | Date | |
|---|---|---|
| <b>Description</b><br>When applying pressure to the ground surface at this location, water extruded from the ground | | |

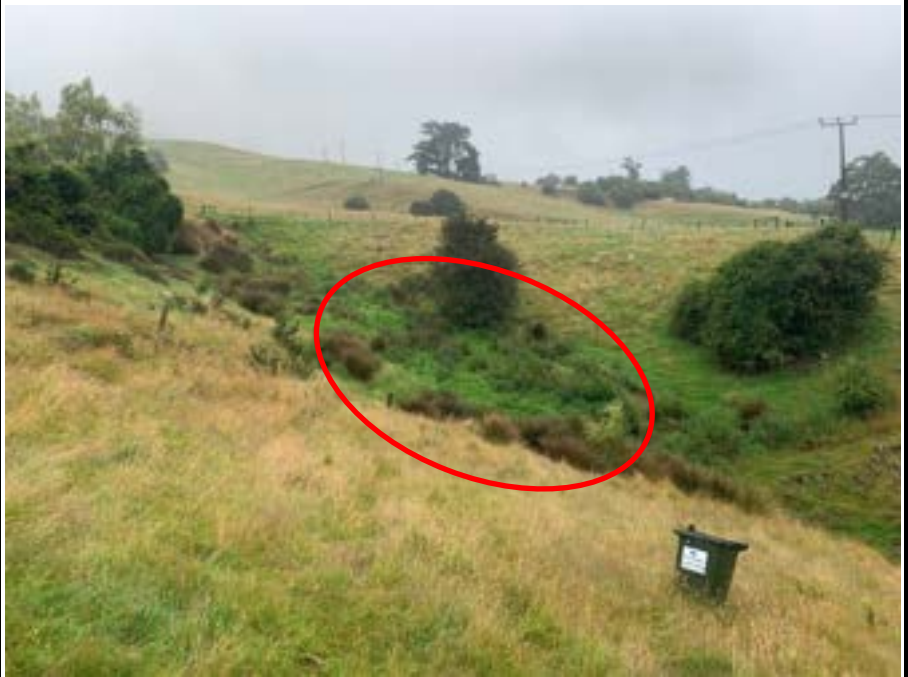
| Photograph No. | Date | |
|---|---|---|
| 11 | 22/01/2026 | |

| Photograph No. | Date | |
|---|---|---|
| <b>Description</b><br>Image of debris flow that activated during October 2024 floods circled in red. | | |

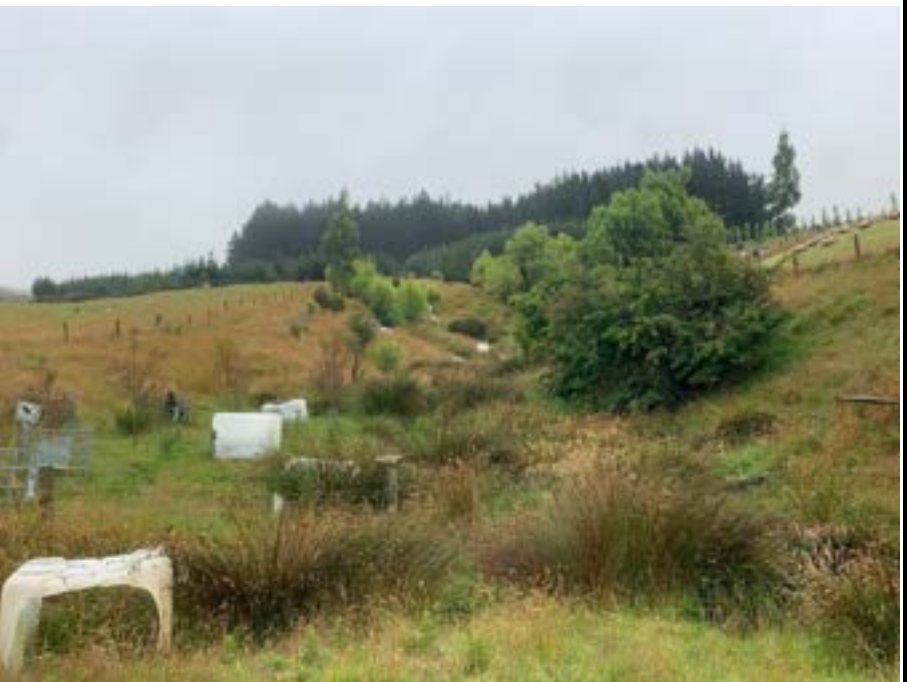
| Photograph No. | Date | |
|---|---|---|
| 12 | 22/01/2026 | |

| Photograph No. | Date | |
|---|---|---|
| <b>Description</b><br>Image of stabilization (tree planting). | | |
