Supplemental subsurface geological information presented in support of Resource Consent Application of Mainland Property (2004) Ltd, 82 Riccarton Road East

Dr JK Lindqvist Geological Consultant 7 August 2016

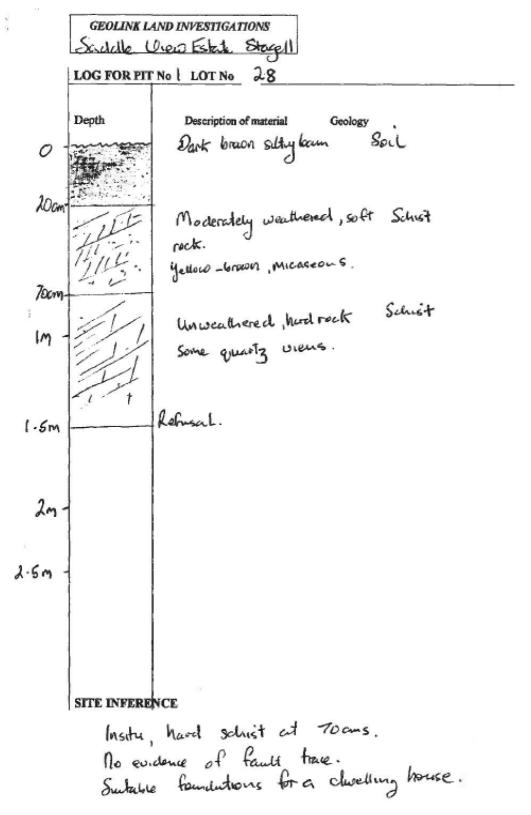
5. Previous subsurface investigation pits centred on the two previously proposed building platforms in the upper ridge area (Robins 2003; Pit-1, & Pit-2) show a very thin veneer of soil and loess overlying schist rock. Robins' (2003) subsurface observations confirm the interpretation of the geology of the eastern part of the high ridge area from surface exposures, as presented earlier by Lindqvist (2015, 2016a). In light of the inherently strong, enduring rock types underlying this area, Otago Regional Council's (p.4) assertion that, 'Relying on a 10 year old assessment of land instability in relation to Lots 1 and 2, is not appropriate, particularly as the scale and characteristics of that risk may have changed in that time' is considered to lack substance.

Subsurface log of Pit-1, from the western upper ridge area, extracted from Robins (2003). See previous page for location.

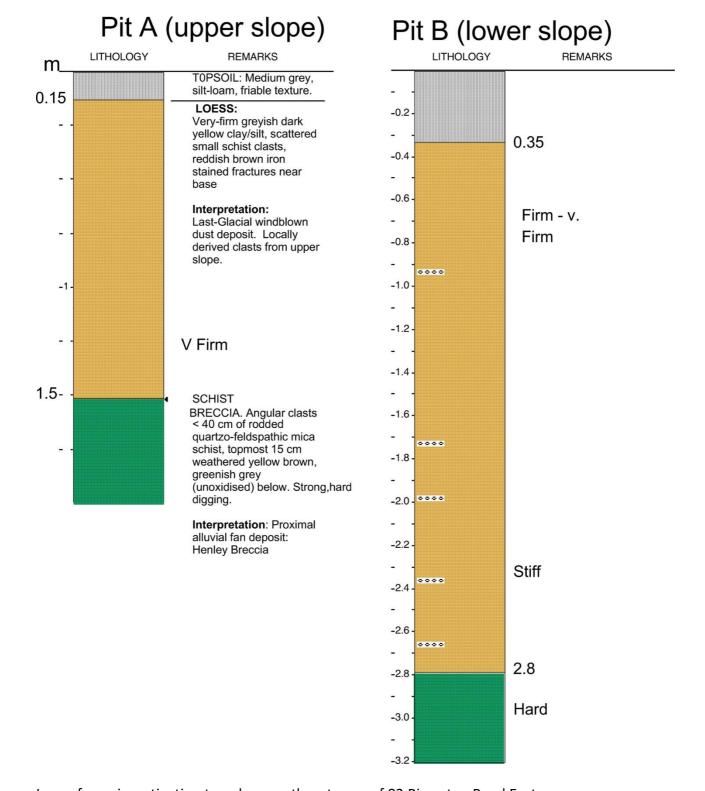
- 2. Together with surface information, four new test pits dug on 29 July 2016 by mechanical digger in the area where house construction is proposed within New Lot 2 show the thickness of loess subsoil as steadily increasing downslope from the ridge area where less than 0.5 m is preserved, to 2.8m beneath up to 40 cm of silt loam topsoil; all underlain at depth by relatively fresh schist boulder and cobble conglomerate (Henley Breccia). In all four pits the yellow-brown to grey loess deposit, except for sparse locally-derived volcanic and schist rock granules and pebbles, is quite homogenous and is firm to stiff. It lacks indications of previous or ongoing slope instability such as wet soft shear zones, or any traces of older soil horizons buried by over-riding slump runout masses.

Logs of new investigation trenches, northeast zone of 82 Riccarton Road East

- 3. In light of the thickness of insitu loess beneath the lower part of the proposed building platform defined on New Lot-2, the requirement for removal of subsoil materials above schist bedrock prior to building pad construction is considered unnecessary. It is recommended that any foundation construction constraints that have been applied to the strip of house lots bordering State Highway 1 immediately north of and adjacent to New Lot-2, are also applied to New Lot-2.

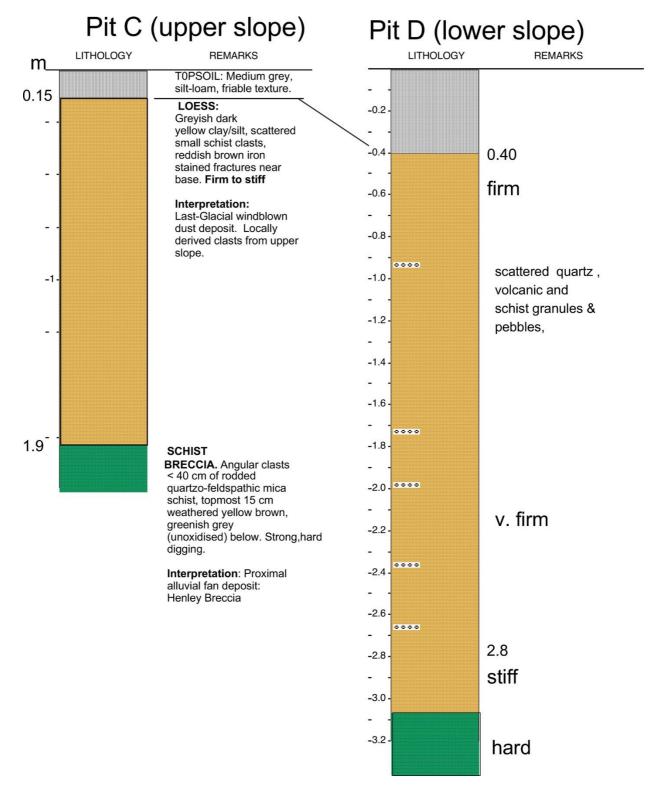
Logs of new investigation trenches, northeast zone of 82 Riccarton Road East
