# Dunedin City Council

## **DCC Landslide Monitoring Report**

### **Puketeraki Landslide**

23 February 2026

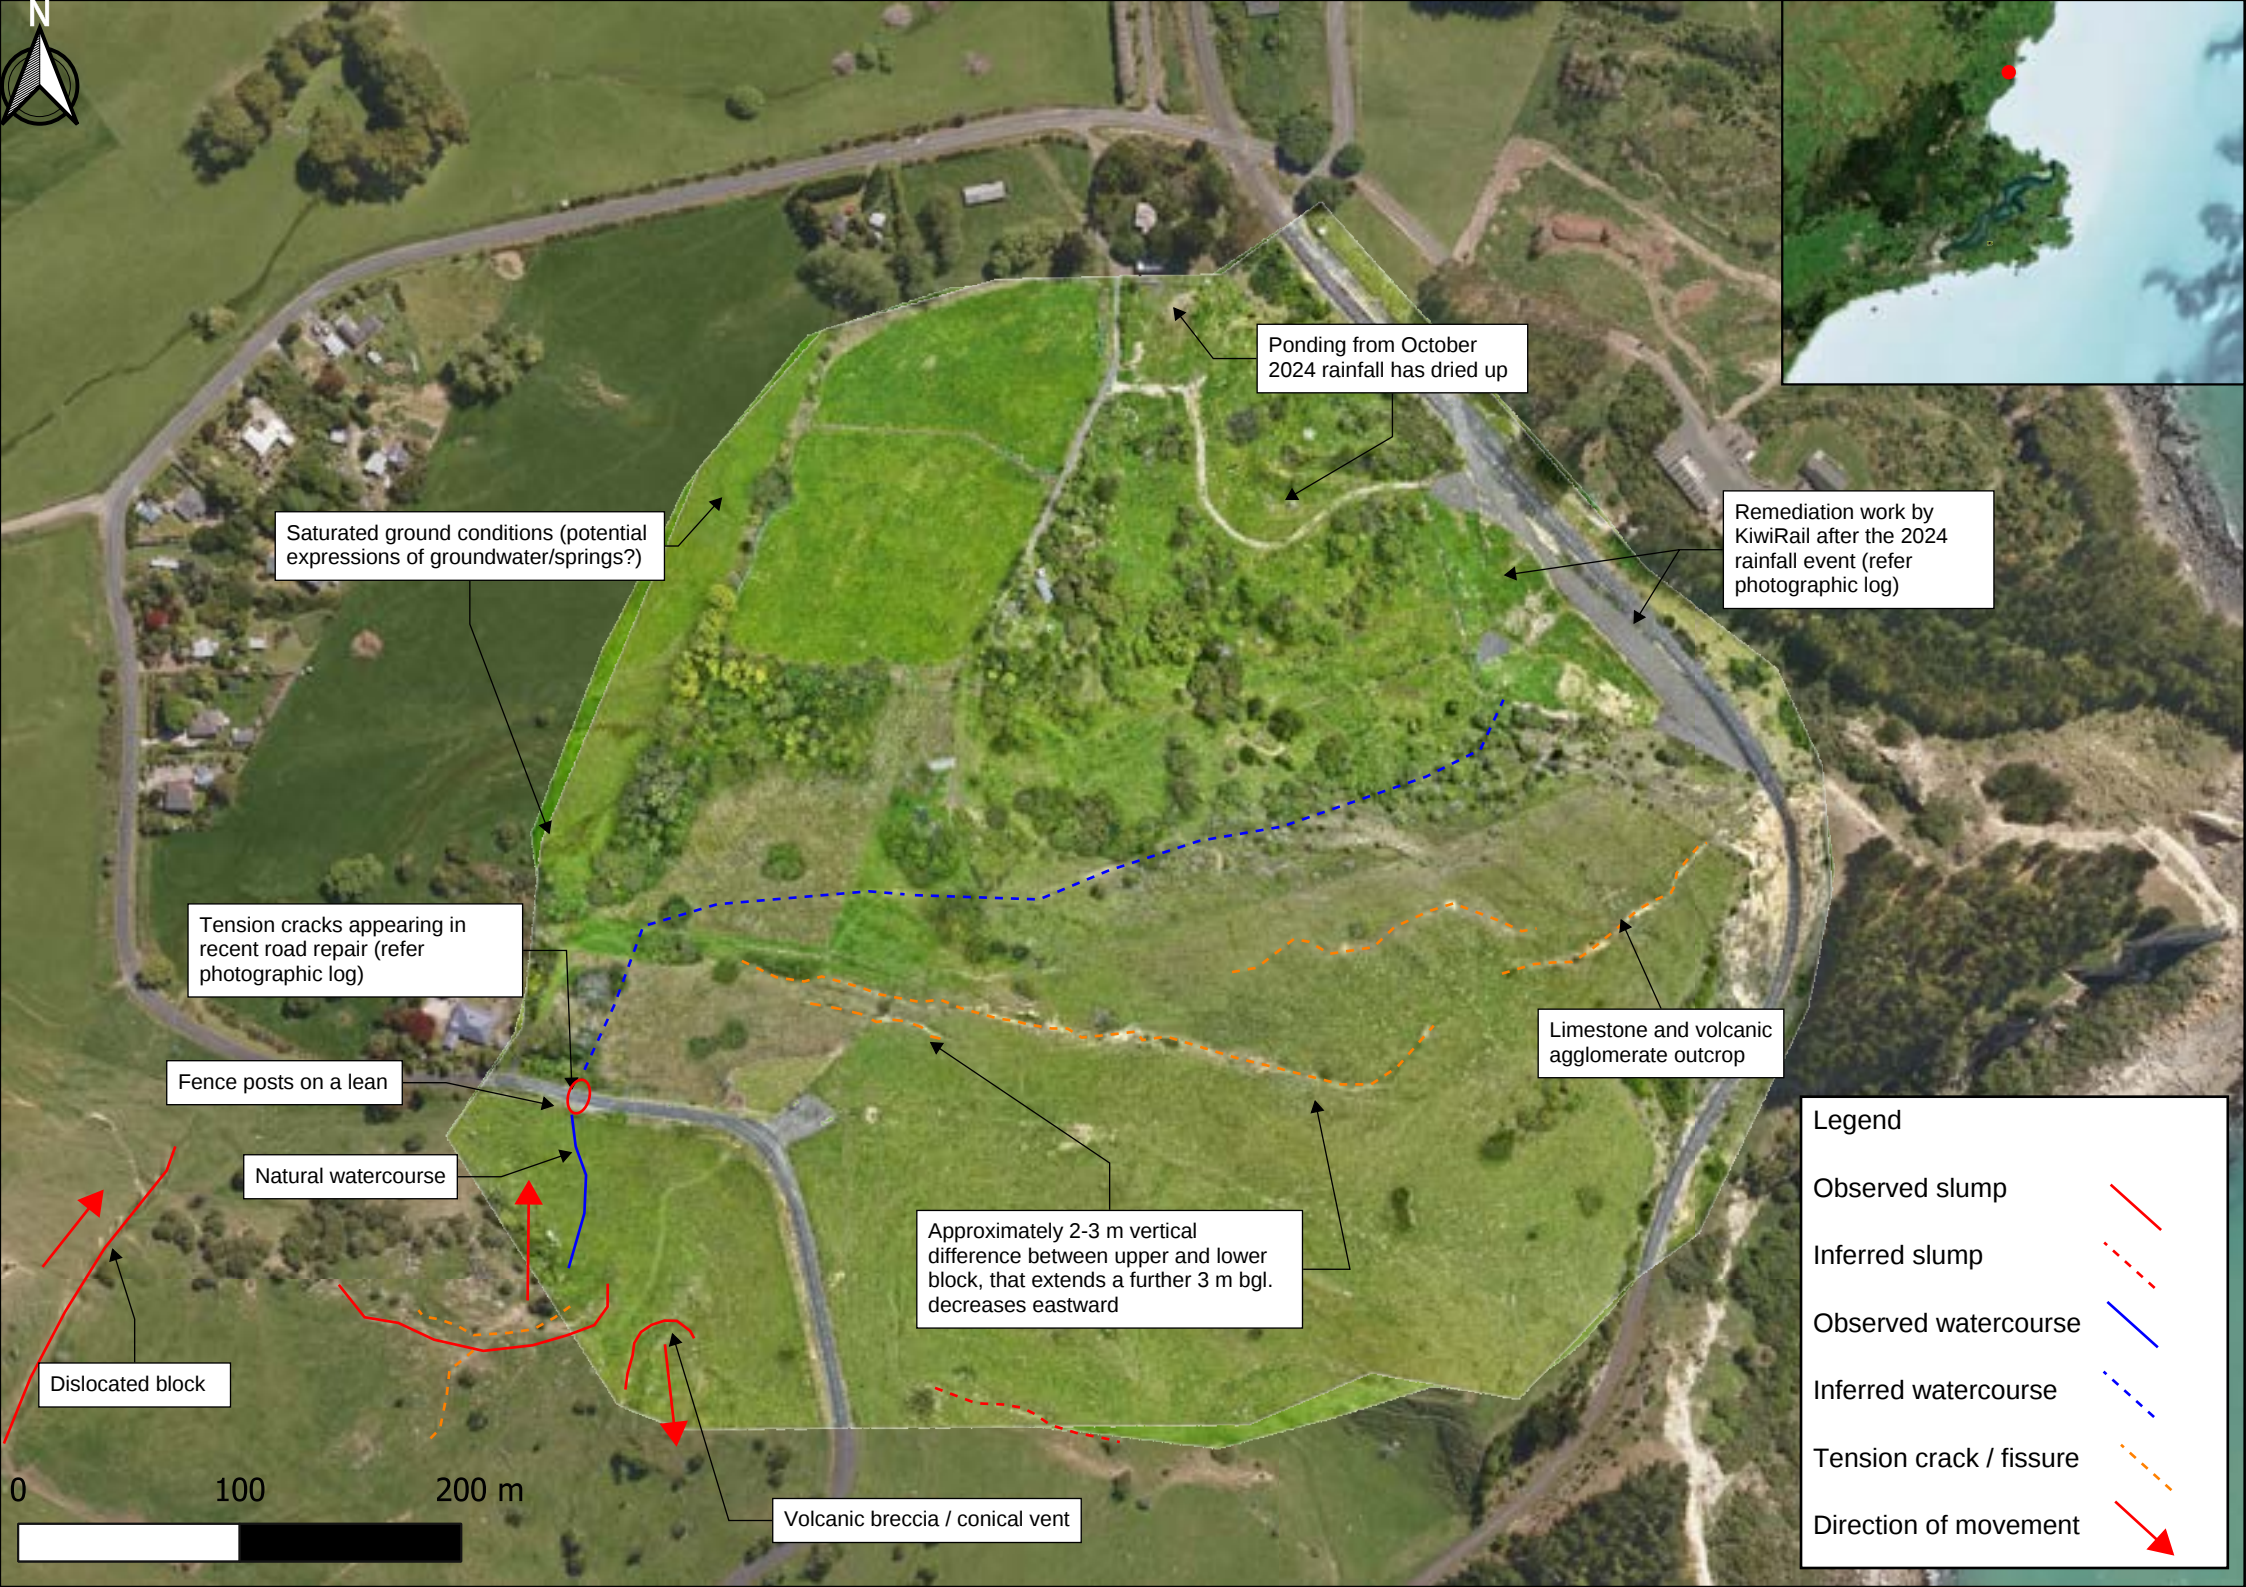
## PRELIMINARY OBSERVATIONS / UAV MAP

Saturated ground conditions (potential expressions of groundwater/springs?)

Ponding from October 2024 rainfall has dried up

Remediation work by KiwiRail after the 2024 rainfall event (refer photographic log)

Tension cracks appearing in recent road repair (refer photographic log)

Fence posts on a lean

Dislocated block

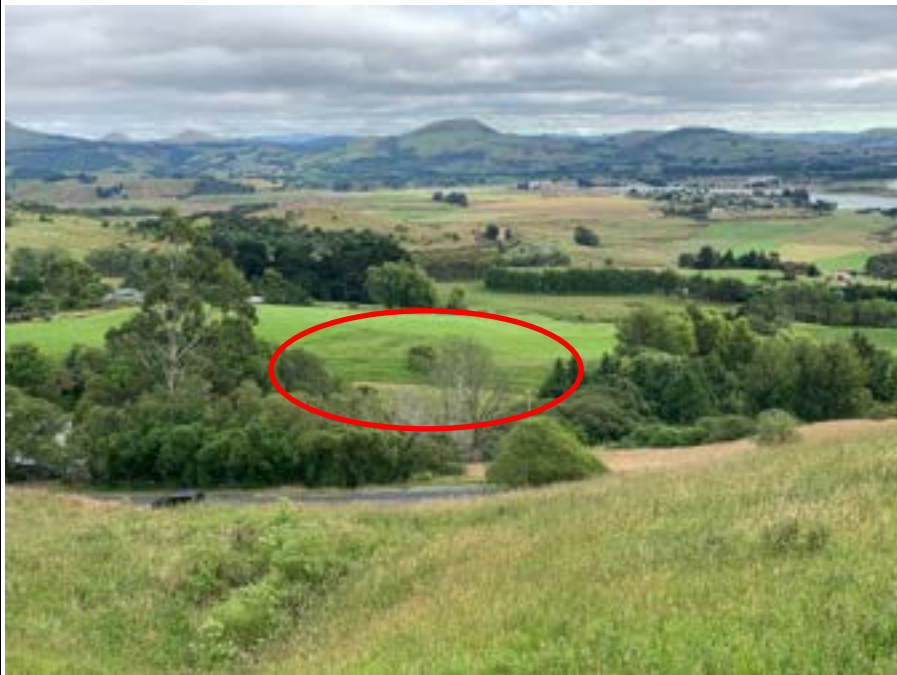
| Photograph No. | Date | |
|---|---|---|
| 2 | 27/01/2026 | |

| Photograph No. | Date | |
|---|---|---|
| <b>Description</b><br>Small slump forming in farmland opposite Coast Road. Image taken facing north | | |

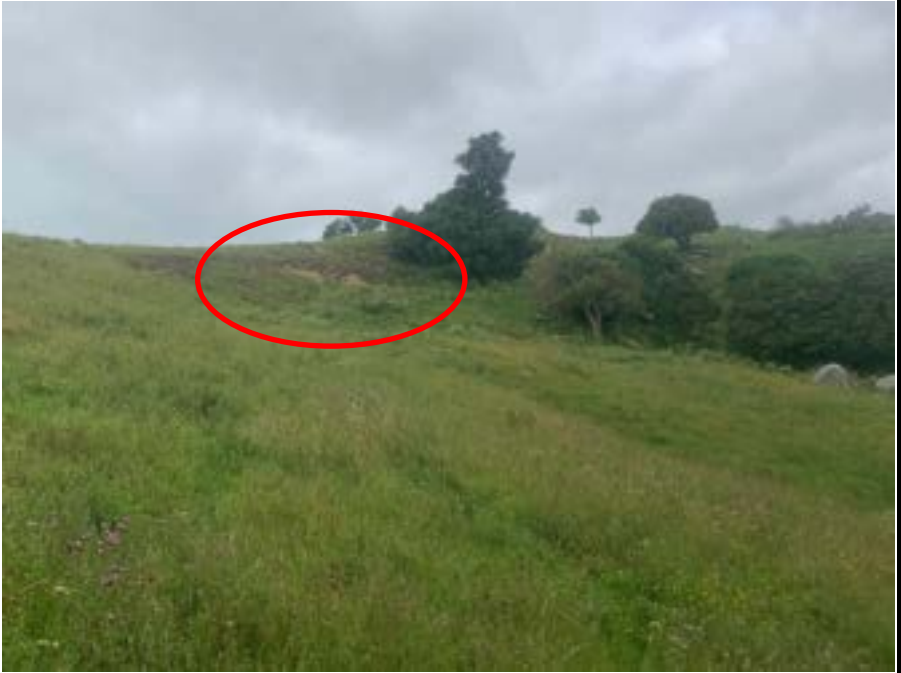
| Photograph No. | Date | |
|---|---|---|
| 3 | 27/01/2026 | |

| Photograph No. | Date | |
|---|---|---|
| <b>Description</b><br>View of recent scarps from the 2024 rainfall event (red circle). Image taken facing southwest | | |

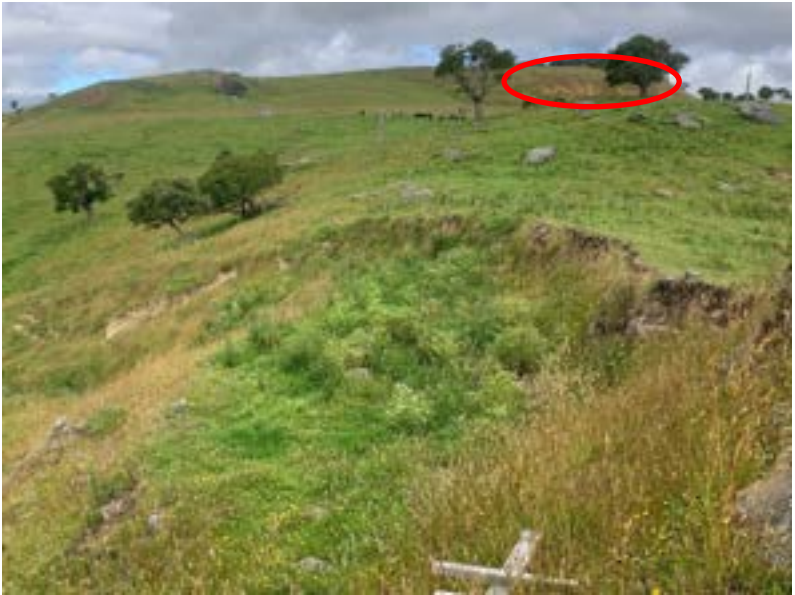
| Photograph No. | Date | |
|---|---|---|
| 4 | 27/01/2026 | |

| Photograph No. | Date | |
|---|---|---|
| <b>Description</b><br>Puketeraki Landslide main scarp identified in red circle. Rotational slide in foreground (ORC Landslide ID: 101416). Image taken facing south | | |

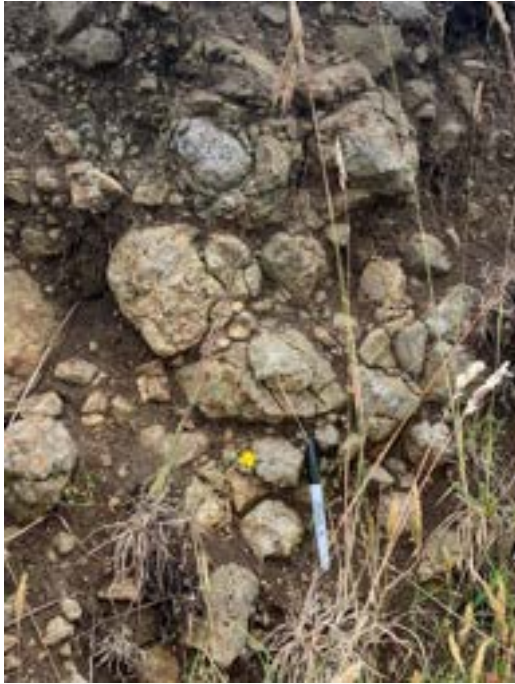
| Photograph No. | Date | |
|---|---|---|
| 5 | 27/01/2026 | |

| Photograph No. | Date | |
|---|---|---|
| <b>Description</b><br>Image of headscarp observed in Photograph 4 above, in volcanic agglomerate. | | |

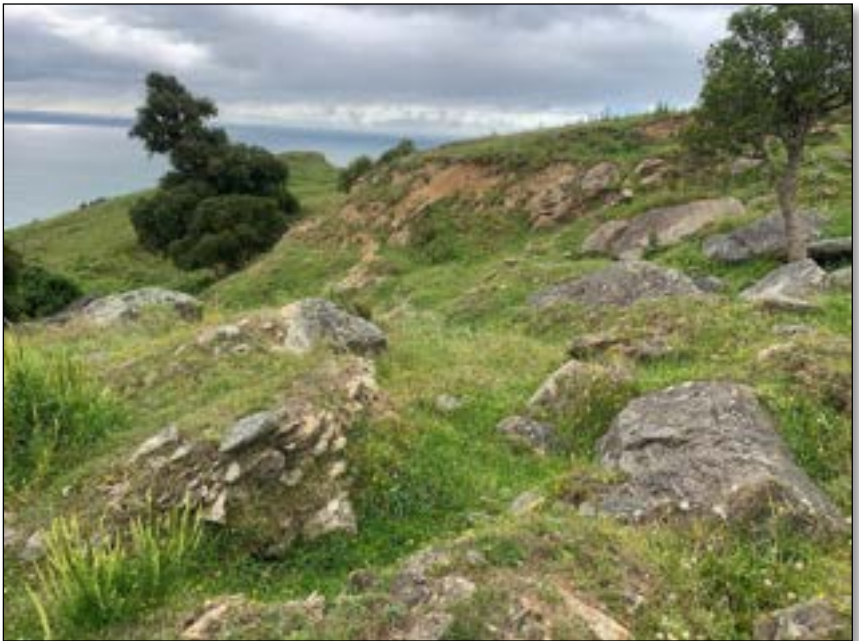
| Photograph No. | Date | |
|---|---|---|
| 6 | 27/01/2026 | |

| Photograph No. | Date | |
|---|---|---|
| <b>Description</b><br>T Slump above Coast Road. Image taken facing northeast | | |

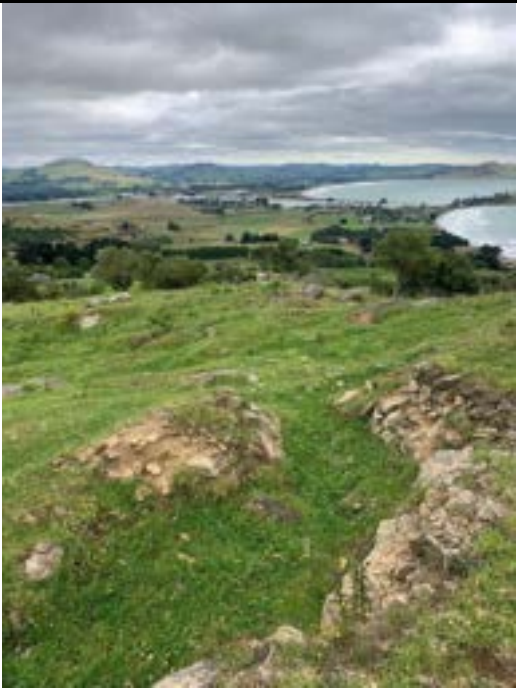
| Photograph No. | Date | | |
|---|---|---|--|
| 7 | 27/01/2026 | | |

| Photograph No. | Date | | |
|---|---|---|--|
| <b>Description</b><br>Slump above Coast Road. Image taken facing north | | | |

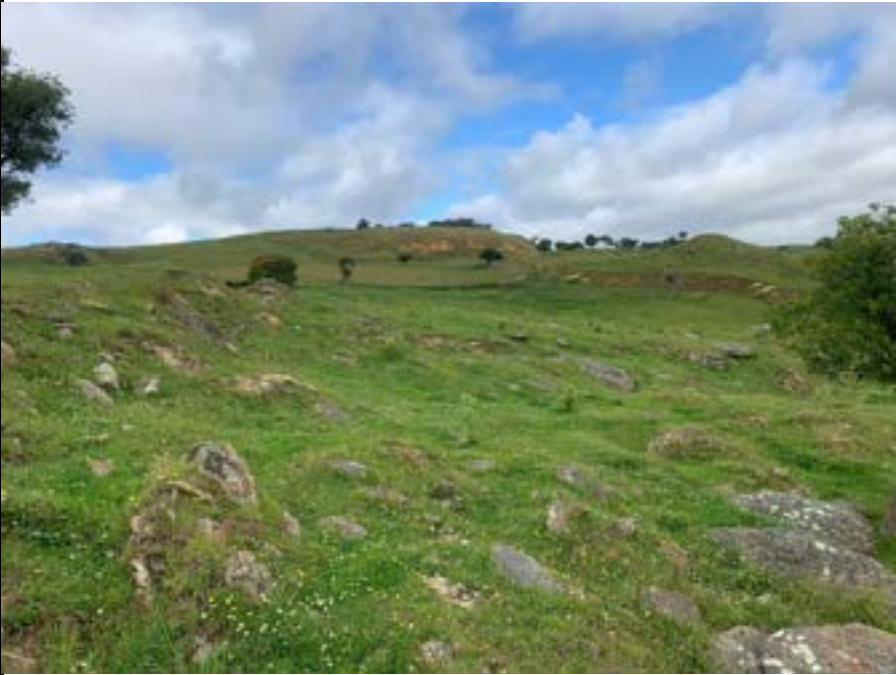
| Photograph No. | Date | | |
|---|---|---|--|
| 8 | 27/01/2026 | | |

| Photograph No. | Date | | |
|---|---|---|--|
| <b>Description</b><br>View of main scarp (background) off Puketeraki. Image taken facing southwest | | | |

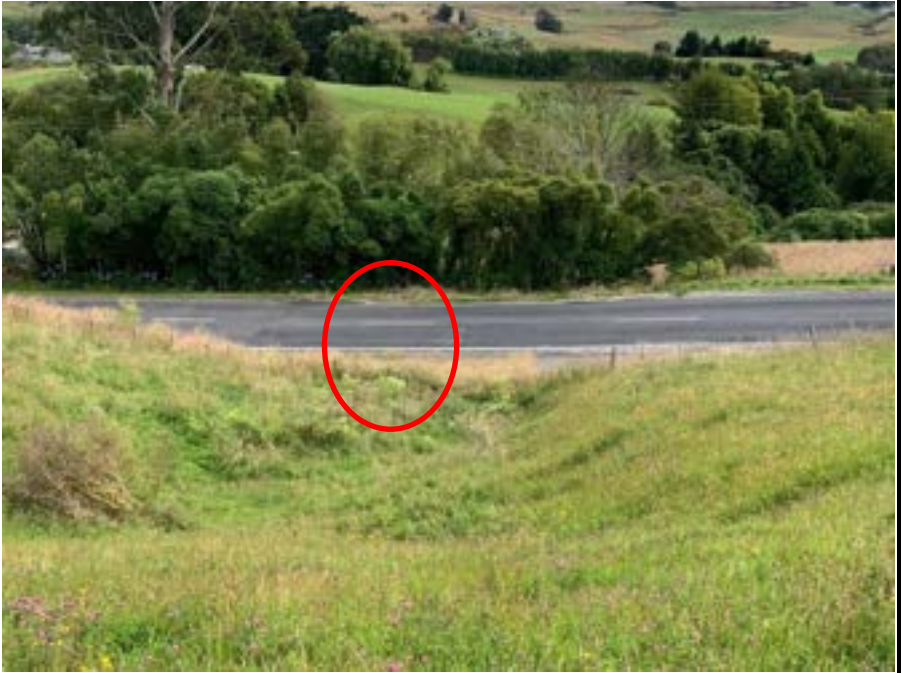
| Photograph No. | Date | |
|---|---|---|
| 9 | 27/01/2026 | |

| Photograph No. | Date | |
|---|---|---|
| <b>Description</b><br>View of repaired section of Coast Road after damage caused by the October 2024 rainfall event | | |

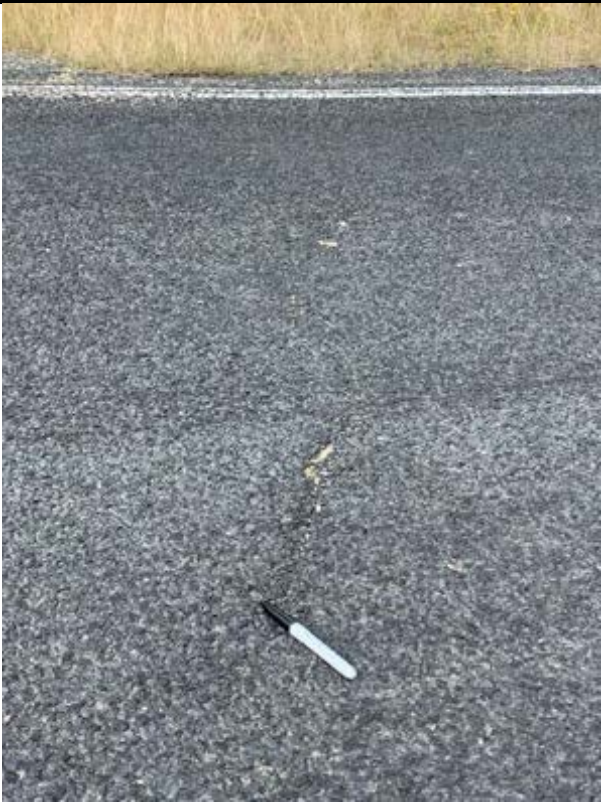
| Photograph No. | Date | |
|---|---|---|
| 10 | 27/01/2026 | |

The tension cracks and damage previously identified along Coast Road during the last site visit have been repaired. However, new tension cracks have developed within the recently repaired section of road (refer to Photograph 10, Appendix B).

| Photograph No. | Date | |
|---|---|---|
| <b>Description</b><br>Close up of tension cracks forming in the repaired section of Coast Road from Photograph 9 above. | | |

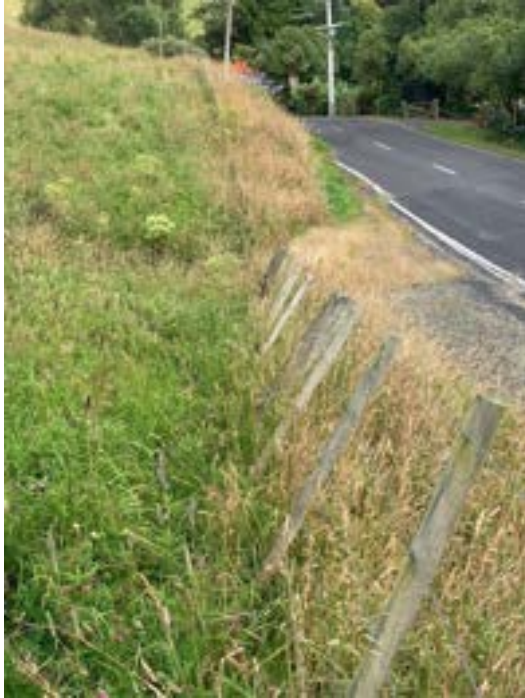
| Photograph No. | Date | |
|---|---|---|
| 11 | 27/01/2026 | |

| Photograph No. | Date | |
|---|---|---|
| <b>Description</b><br>Fence posts above the road repair on a lean. | | |

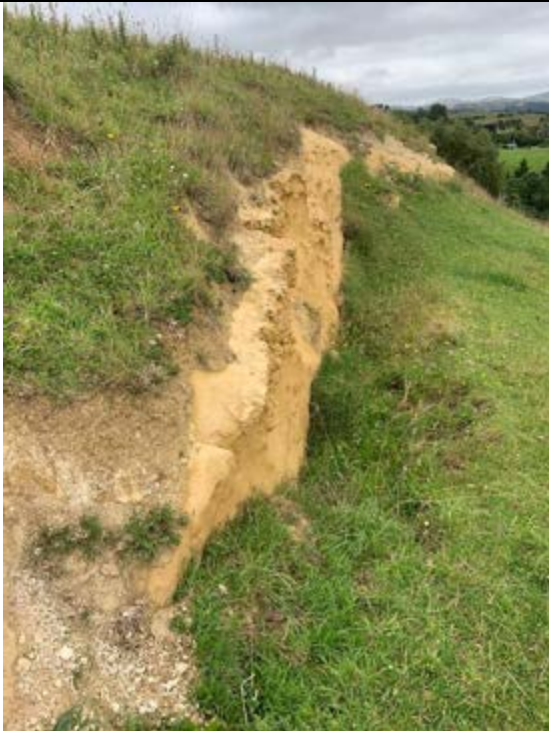
| Photograph No. | Date | |
|---|---|---|
| 12 | 27/01/2026 | |

| Photograph No. | Date | |
|---|---|---|
| <b>Description</b><br>View of dislodged block. Image taken facing west | | |

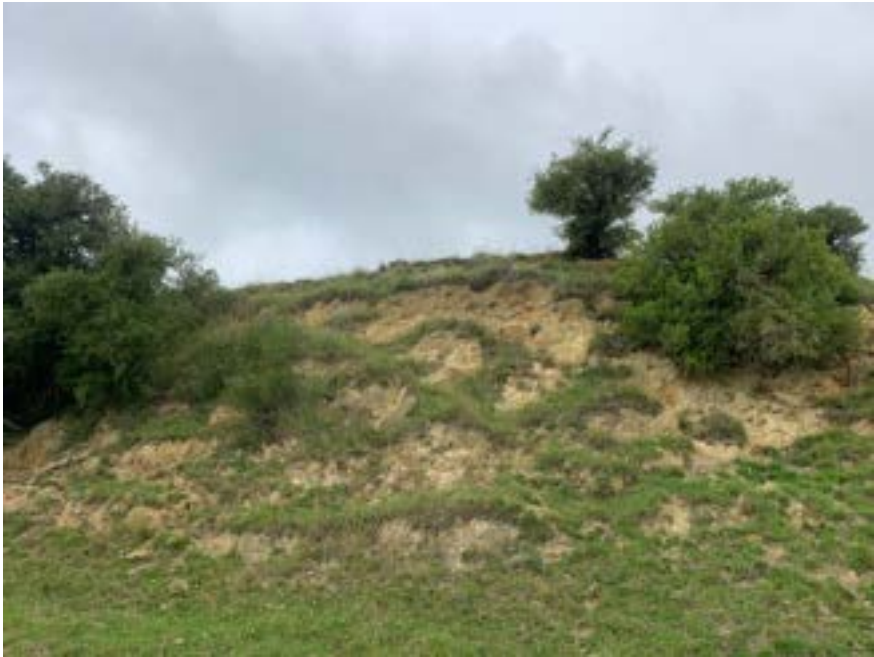
| Photograph No. | Date | |
|---|---|---|
| 14 | 27/01/2026 | |

| Photograph No. | Date | |
|---|---|---|
| <b>Description</b><br>Block slumping and exposure of slope (lower end of field area). | | |

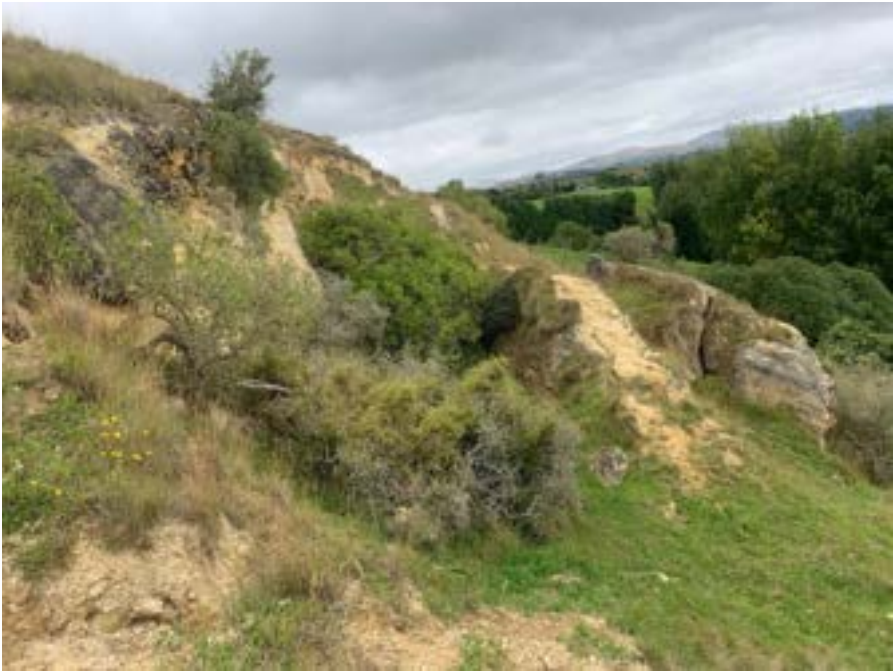
| Photograph No. | Date | |
|---|---|---|
| 15 | 27/01/2026 | |

A difference in topography was noted in the middle of the site, where large vertical deformation had occurred. A height difference of approximately 2-3 m between blocks was noted along the trace of the inferred fault shown in Figure 2 (refer to photograph 15, Appendix B).

| Photograph No. | Date | |
|---|---|---|
| <b>Description</b><br>Block slumping and exposure of slope along the trace of the inferred fault. | | |

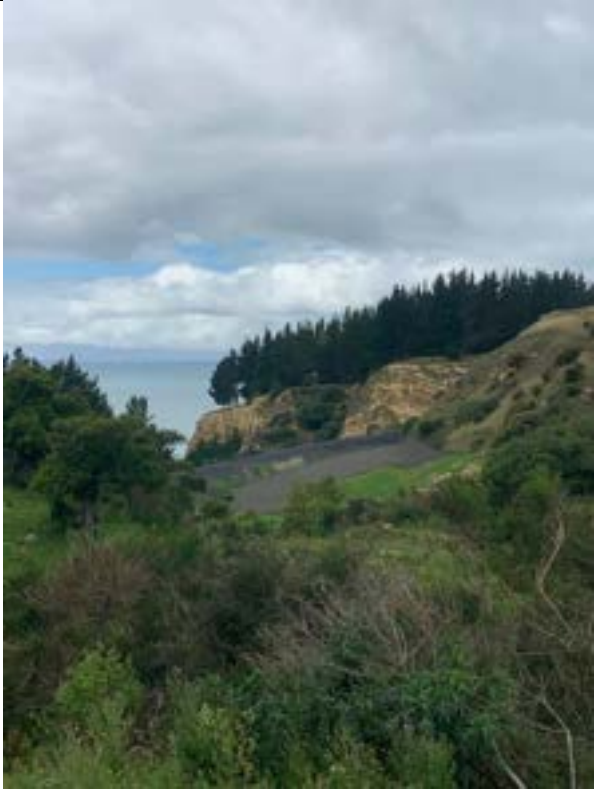
| Photograph No. | Date | |
|---|---|---|
| 16 | 27/01/2026 | |

Land affected by the 2024 rainfall event along the KiwiRail Main South Line has been remediated and contoured in an attempt to control water runoff in future high rainfall events (refer to photographs 16 and 17, Appendix B)

| Photograph No. | Date | |
|---|---|---|
| <b>Description</b><br>Remedial works taken place after the October 2024 rainfall event along the KiwiRail Main South Line | | |

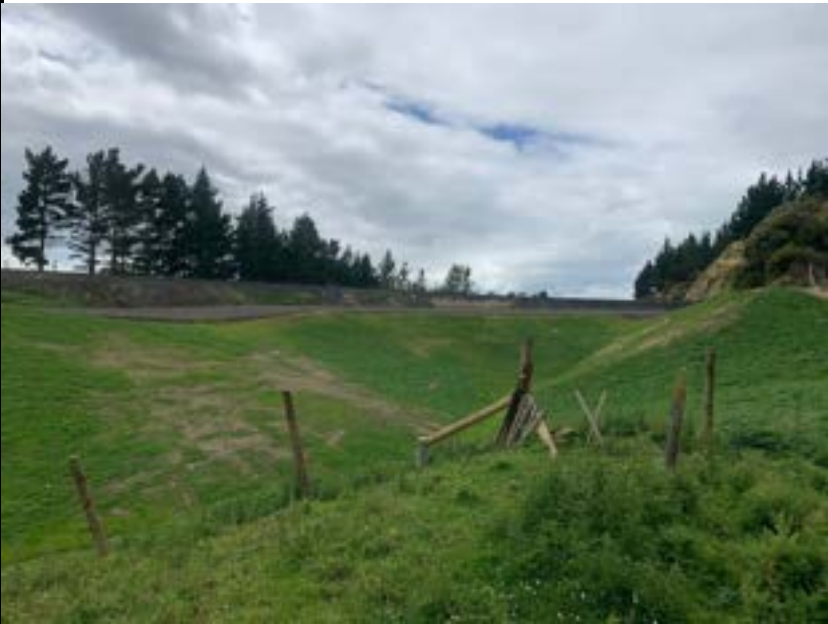
| Photograph No. | Date | |
|---|---|---|
| 17 | 27/01/2026 | |

| Photograph No. | Date | |
|---|---|---|
| <b>Description</b><br>Closer view of the remedial works along the KiwiRail Main South Line | | |
