**APPENDIX 3:  
COUNCIL OFFICER EVIDENCE**

RE: STEM Condition Assessment for the copper beech T1176

**TO:** Robert Buxton, Planner  
**FROM:** Luke McKinlay, Landscape Architect  
**DATE:** 01-February-2020  
**SUBJECT:** Land Use Consent – Scheduled Tree  
LUC-2020-524 – 61 Wallace Street  
Landscape Architect Comments

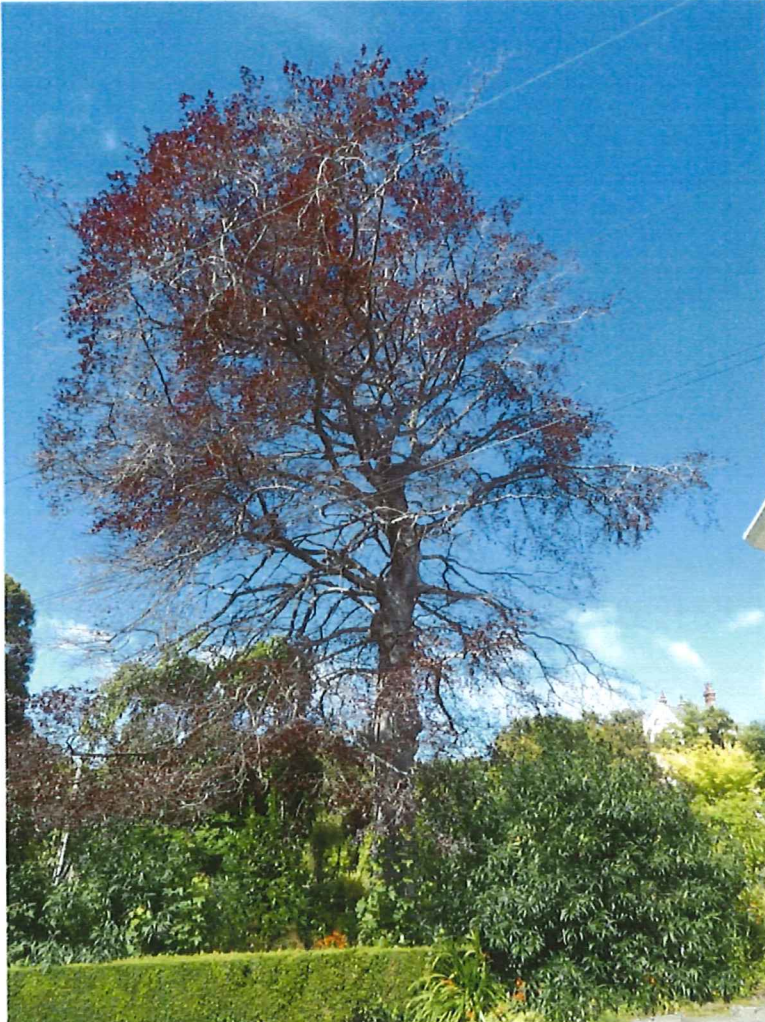
Figure 1. View towards T1176 from the driveway of the adjacent site

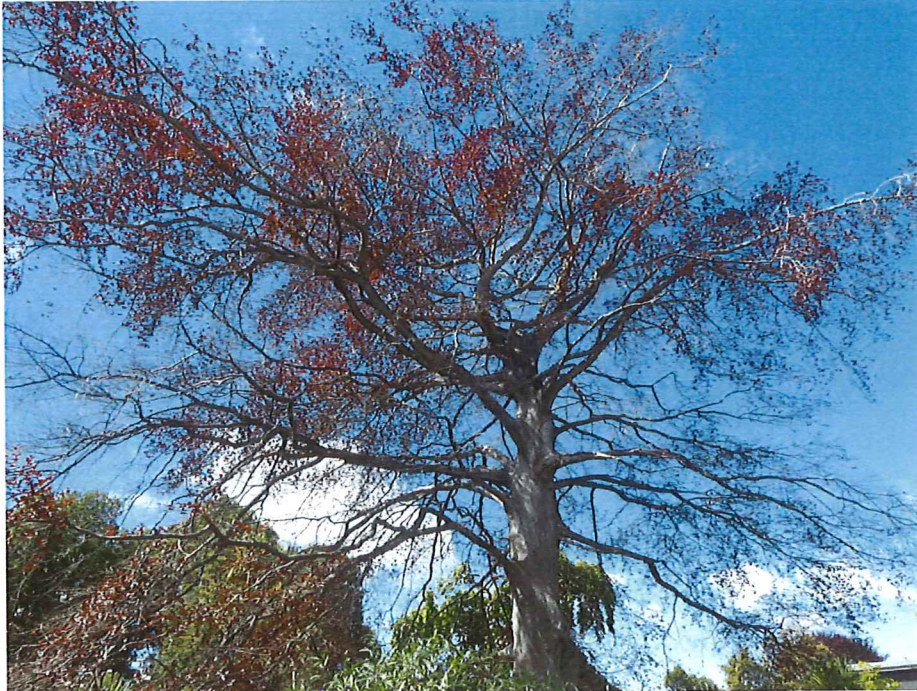
*The tree is in decline and has been in decline for a number of years. There is reduced growth at the extremities and no substantial internal canopy. There was evidence that some response and wound closure growth was occurring which indicates some vigour remains, giving **Some** for Vigour & Vitality: **9 points**.*

Figure 2. View of T1176 canopy

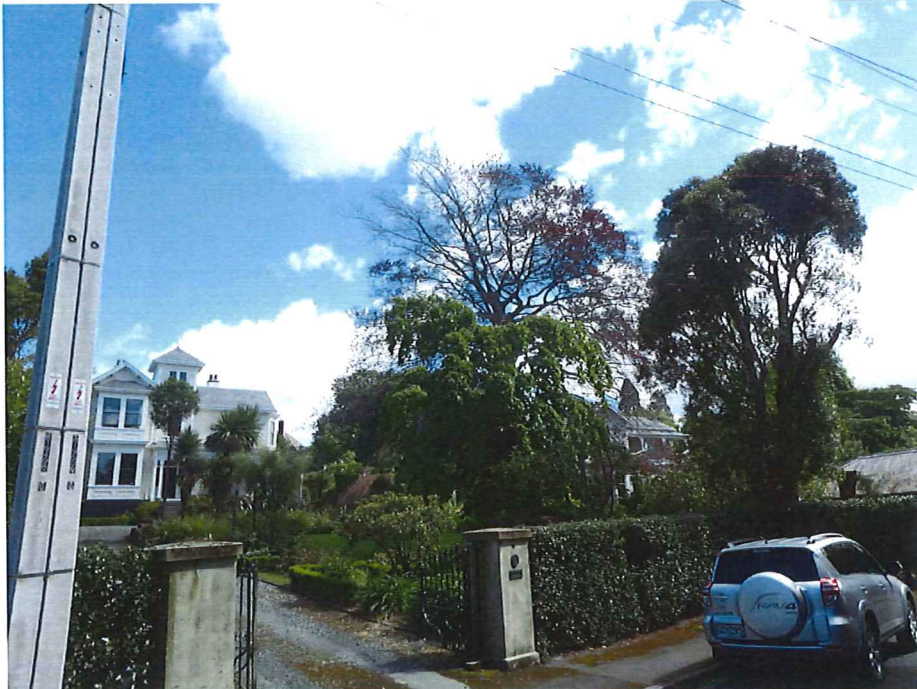
This tree's obvious signs of decline negatively affect its amenity value. The healthy cooper beech at 55 Wallace street (also a scheduled tree), only 100m from the subject tree, provides a good example of a healthy specimen of this species. The contrast between this healthy example and T1176, brings into focus the declining condition of T1176 and associated diminished amenity values.

Figure 3. View towards T1176 from street front of the subject site

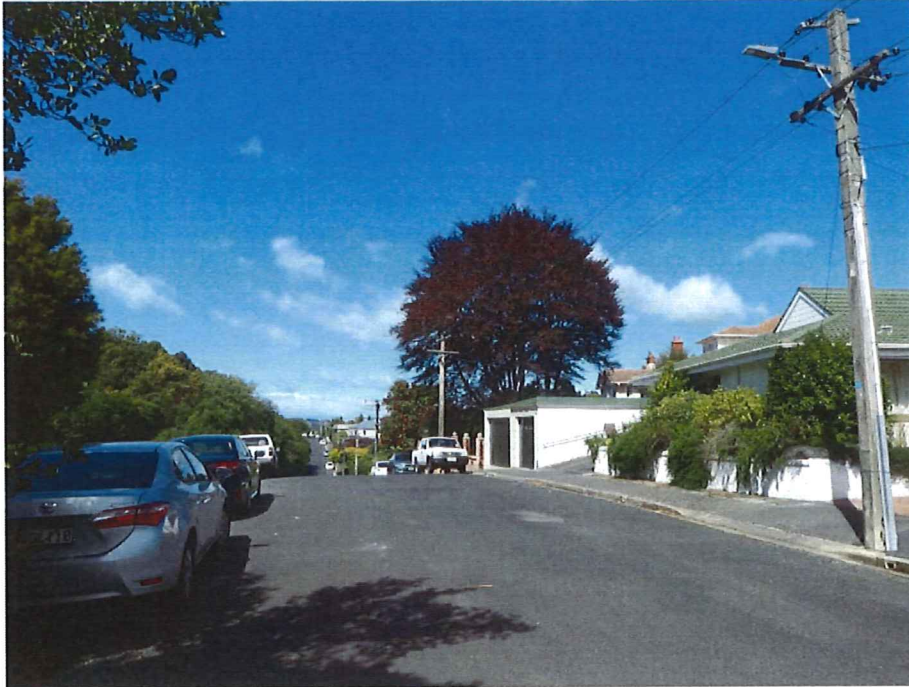
Figure 4: View of T1175, a healthy specimen of this species, from near the subject site
