## NORTHERN GULLY SILT POND EMBANKMENT FINAL CONSTRUCTION REPORT

**MACRAES MINING COMPANY LTD**

**NORTHERN GULLY SILT POND EMBANKMENT**

Woodward-Clyde (NZ) Ltd  
PO Box 8246  
CHRISTCHURCH

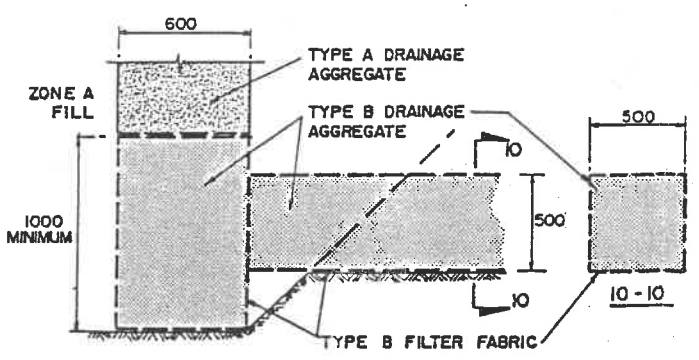
**CHIMNEY DRAIN BASE COLLECTOR**  
1:20

The chimney drain base collector was formed after approximately one metre of Zone A fill had been placed. A trench was excavated through the fill along the line of the drain (refer drawing NGRD 3A). Filter fabric was placed so as to cover the

exposed foundation and to line the sides of the trench. Type B drainage aggregate was placed to a depth in excess of one metre and compacted. The filter fabric was then lapped over the top of the aggregate. Chimney drain sand was then placed and compacted to fill the trench to fill surface level.

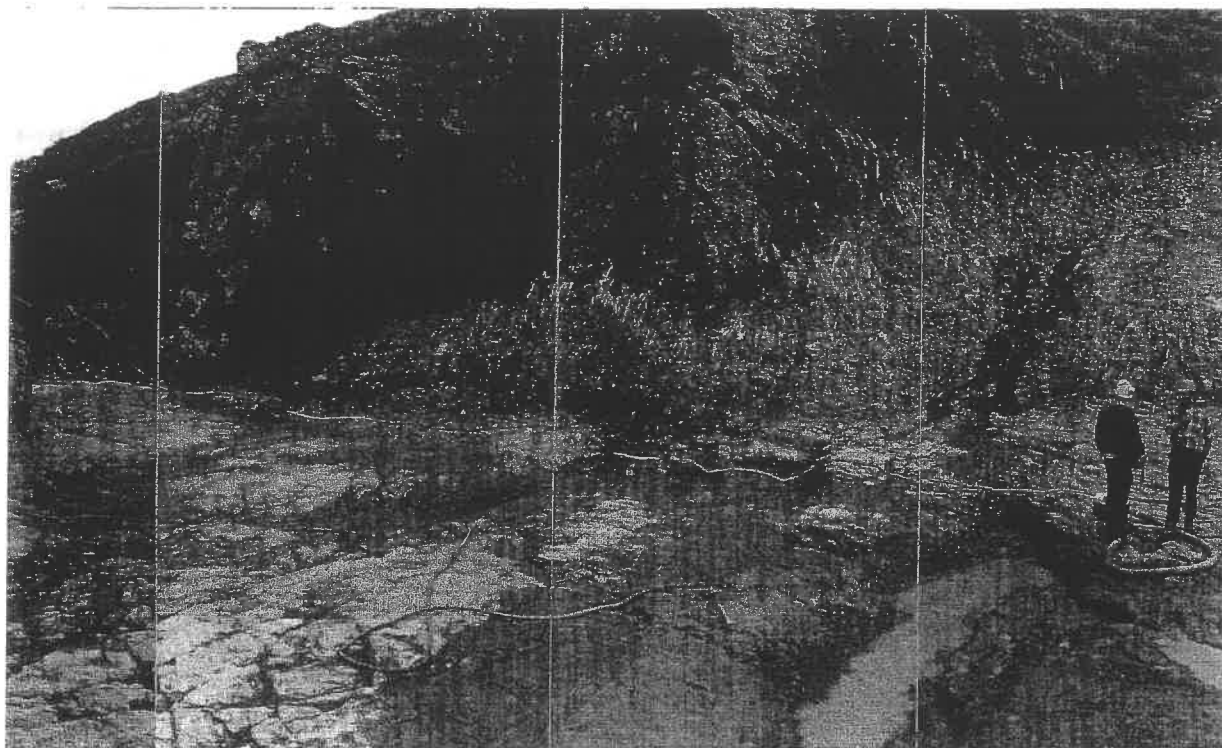
Plate 1

Embankment Footprint Looking North-west

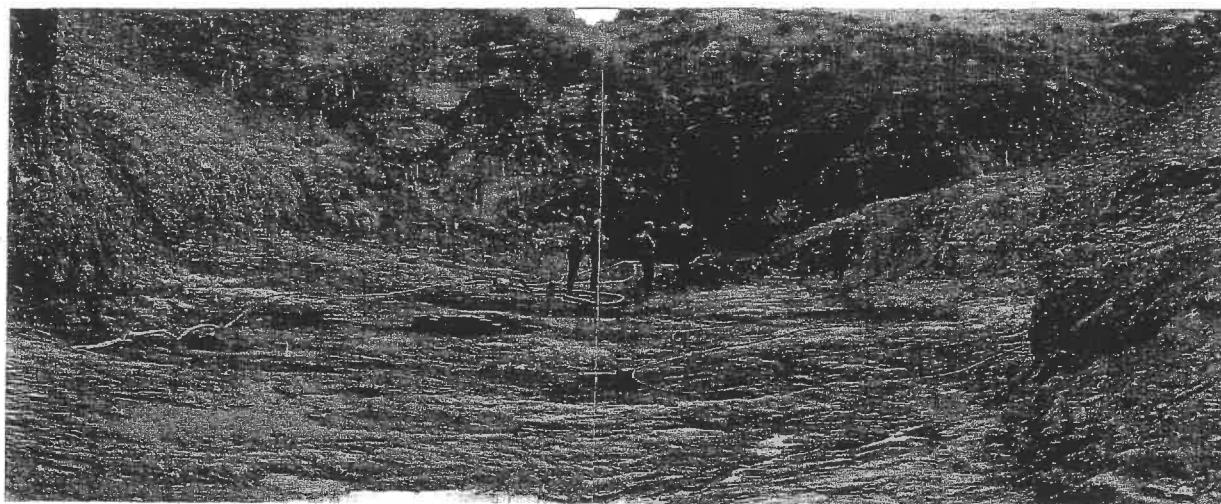
Plate 2

Embankment Footprint Looking South-east

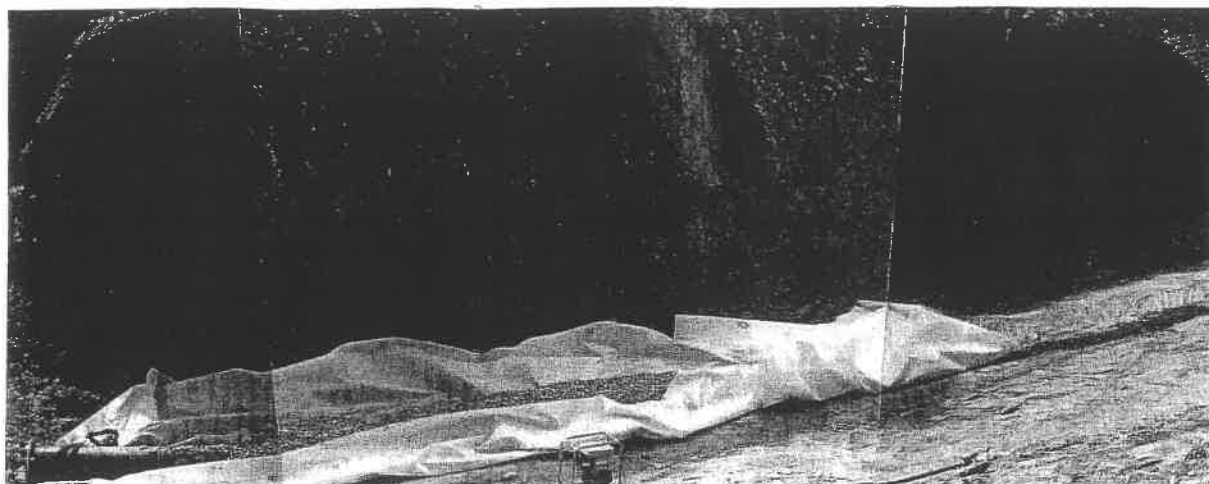
Plate 5

Outlet Pipe in South Arm

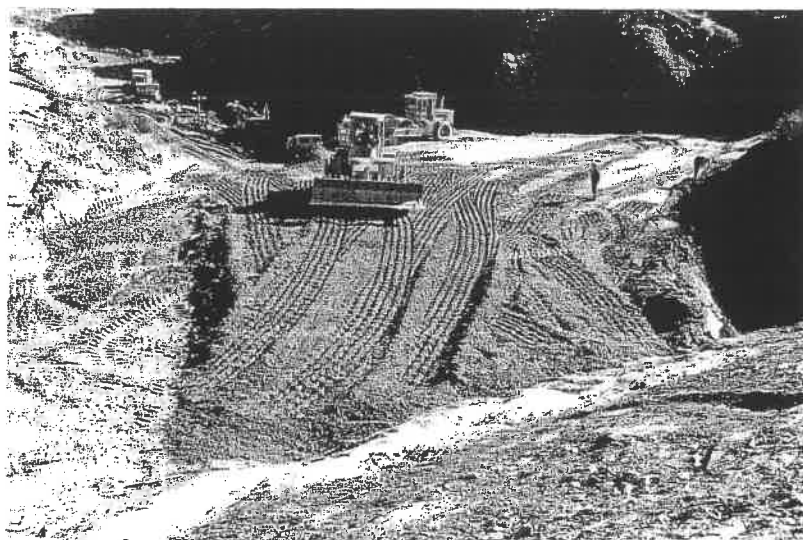
Plate 6

Embankment Construction  
(From Right Abutment)

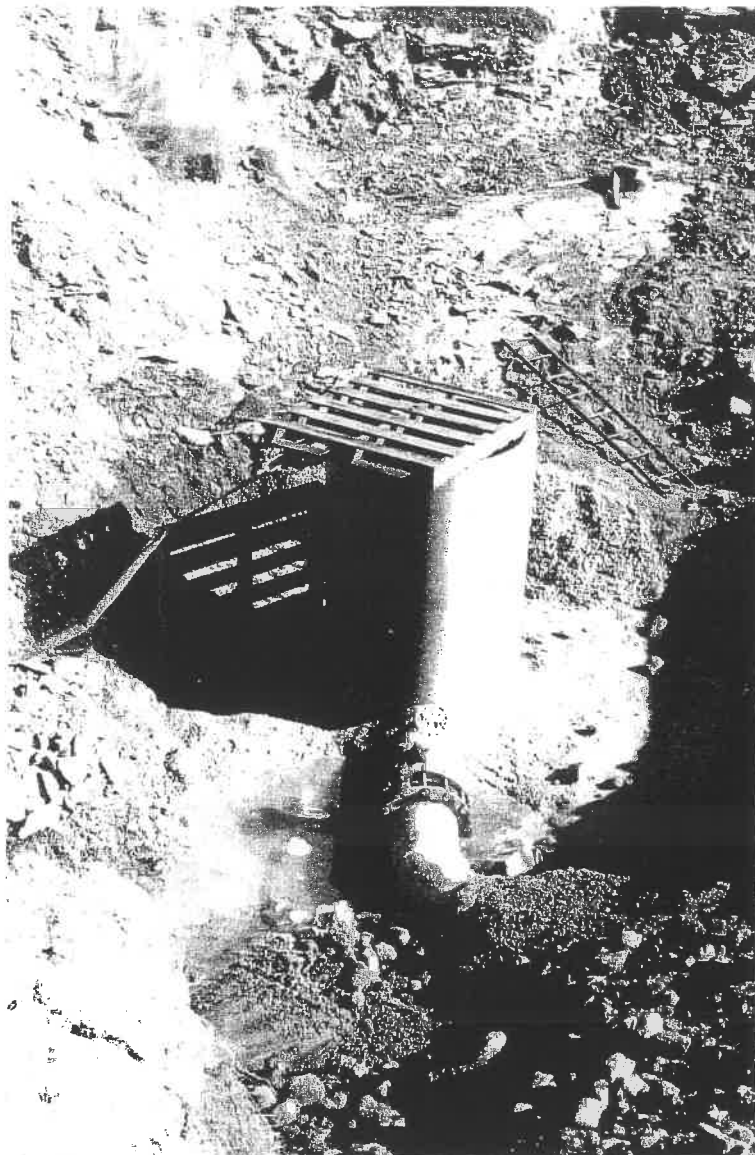
Plate 7

An outlet structure, comprising a precast manhole as an entry to the outlet pipe and a remotely controlled butterfly valve, were constructed at the upstream toe of the embankment (refer Plate 7). The manhole section used was set in concrete placed on a clean rock foundation. The operating shaft for the valve was mounted on steel stakes driven into the upstream shoulder of the embankment. The valve can be operated by turning a wheel fixed to the top end of the shaft. A butterfly valve was also fitted to the downstream end of the outlet pipe. This valve, which is normally set open, can be operated using a lever attached to the top of the spindle.

Outlet Structure in South Arm  
(Butterfly valve set with spindle aligned up the shoulder of the Embankment )

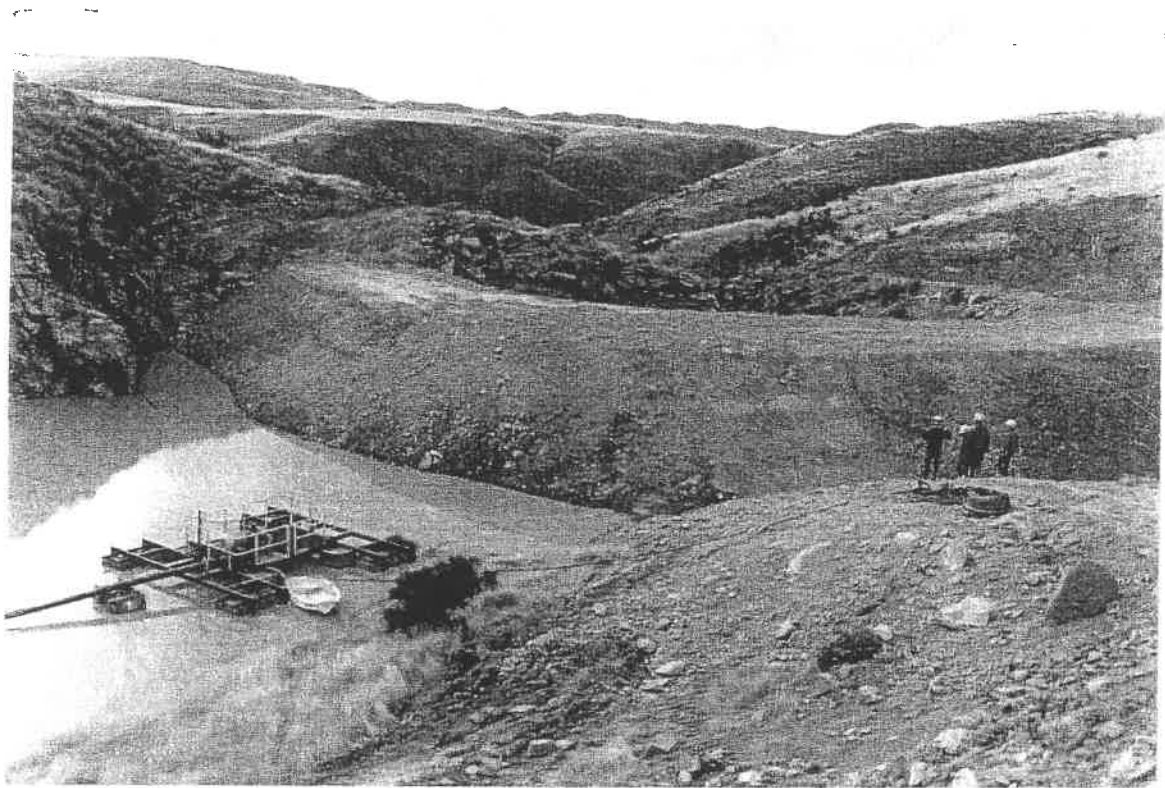
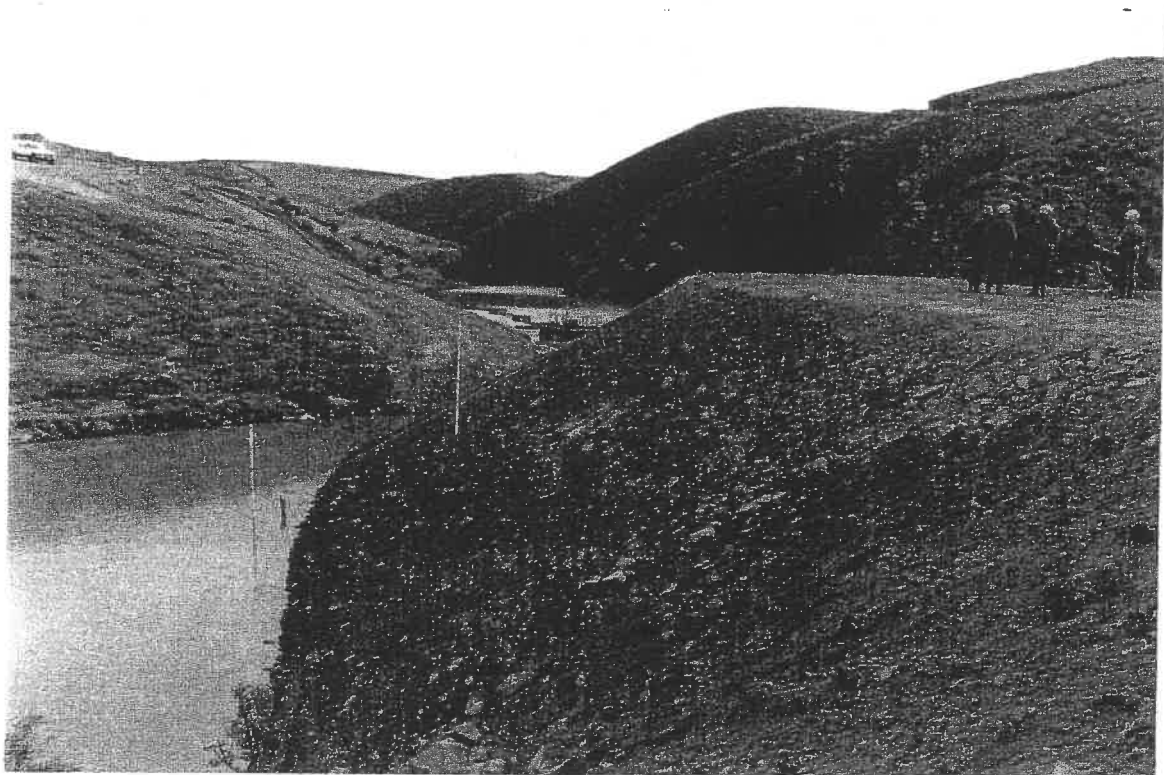
Plate 8  
Completed Embankment:

Looking North

Looking West

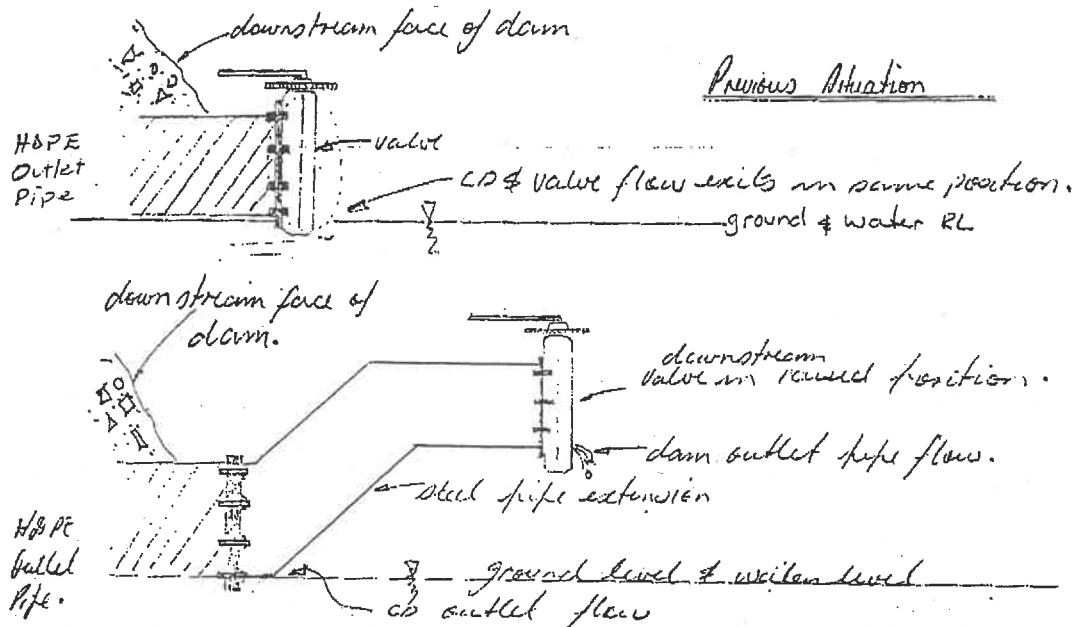
**Situation Once Refurbishment Complete**

- The downstream valve for the outlet pipe was raised on Friday so that accurate CD and valve leakage readings could be taken. Brian Vickery made the fitting (refer below). A V-notch is also proposed to measure CD flow.
