**Project:** Lookout Point Fire Brigade  
Detailed Seismic Assessment

**Reference:** 233791

**Prepared for:** New Zealand Fire Service

**15 March 2013**

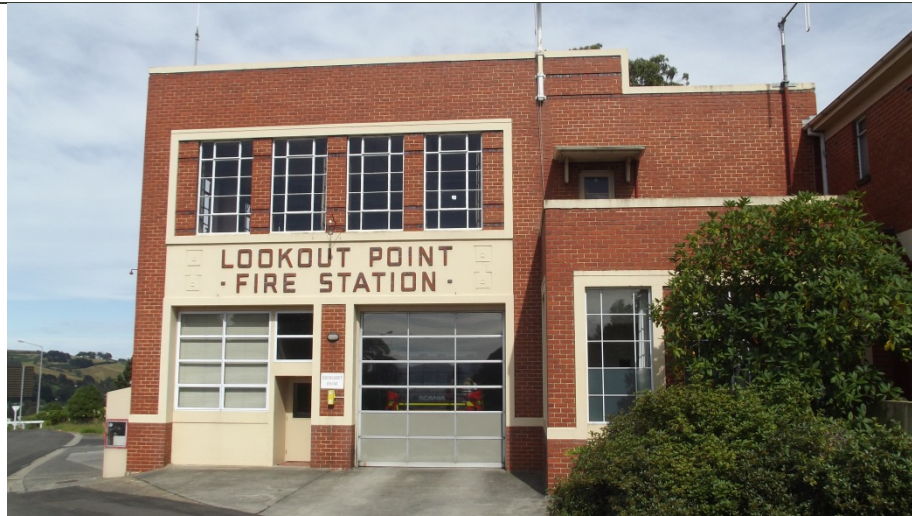
East Elevation of South Wing.

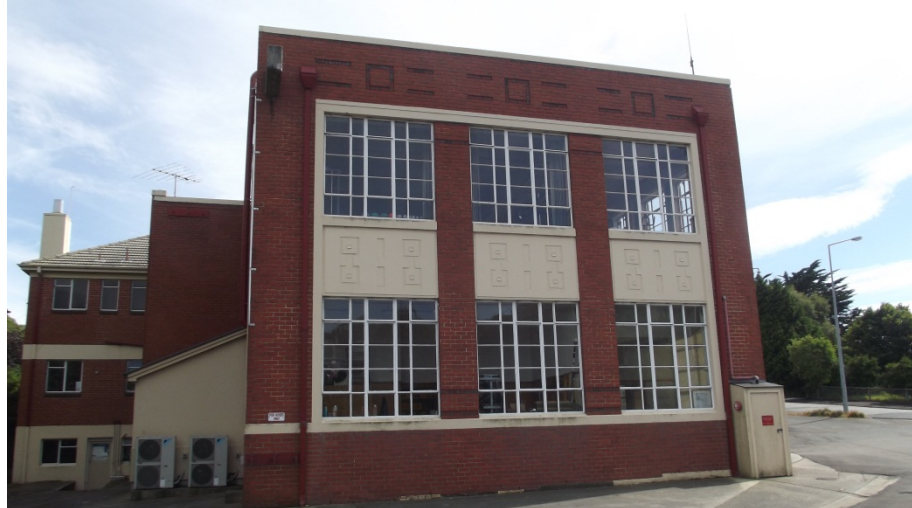
South Elevation of South Wing. West Wing visible on the left.

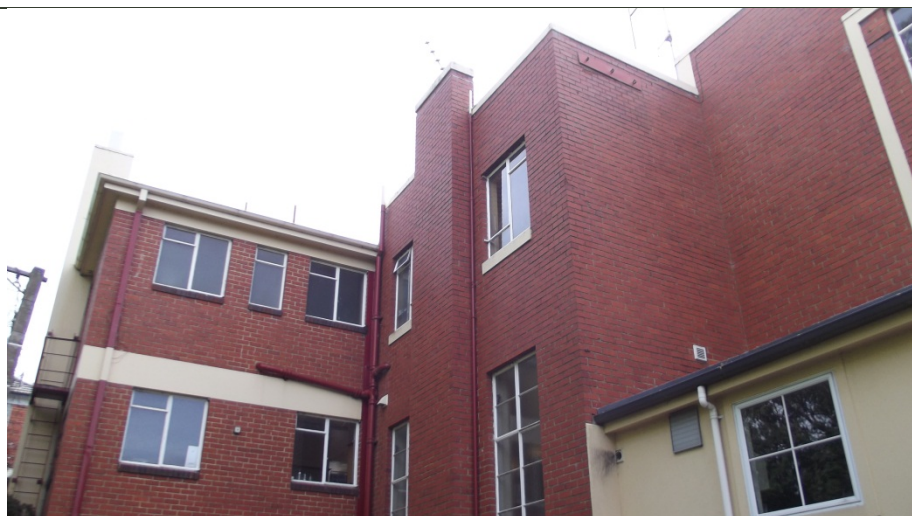
West Elevation of South Wing and West Wing.

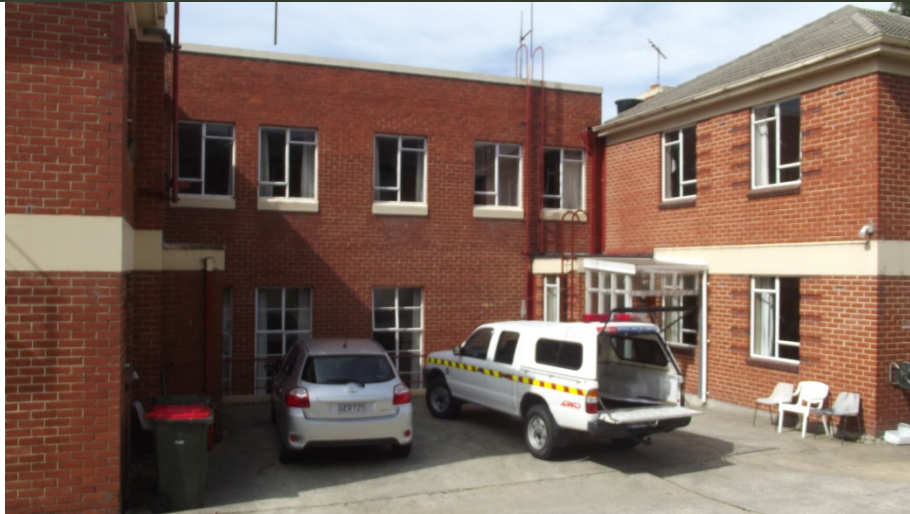
North Elevation of South Wing. East Wing and West Wing are visible on the left and right hand sides respectively.

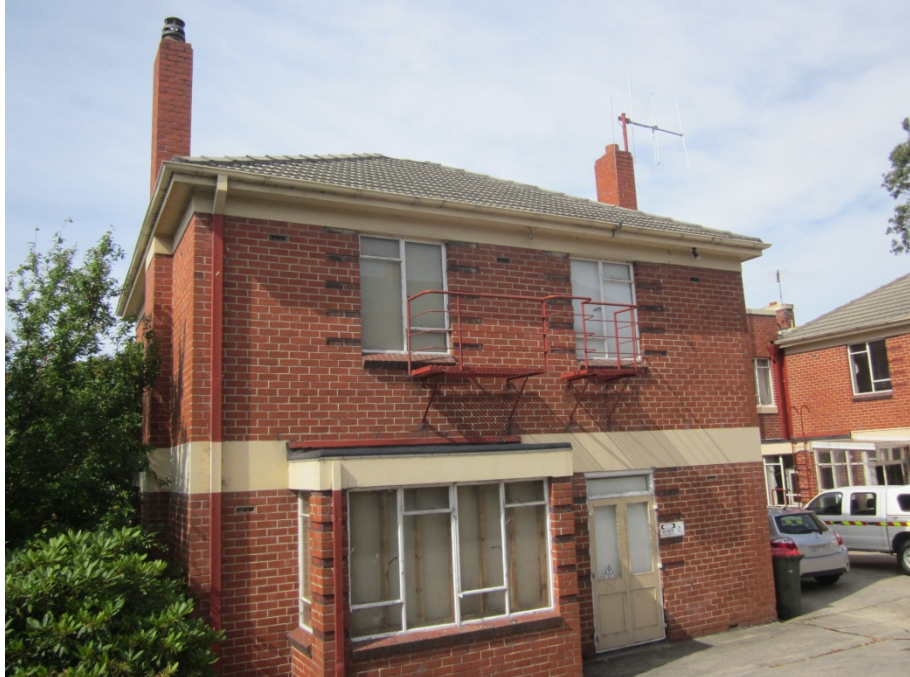
| Element | % NBS Capacity | Commentary |
|---|---|---|
| Brick walls in plane | 27% | |
| Brick walls out of plane | 35% | |

North Elevation of East Wing

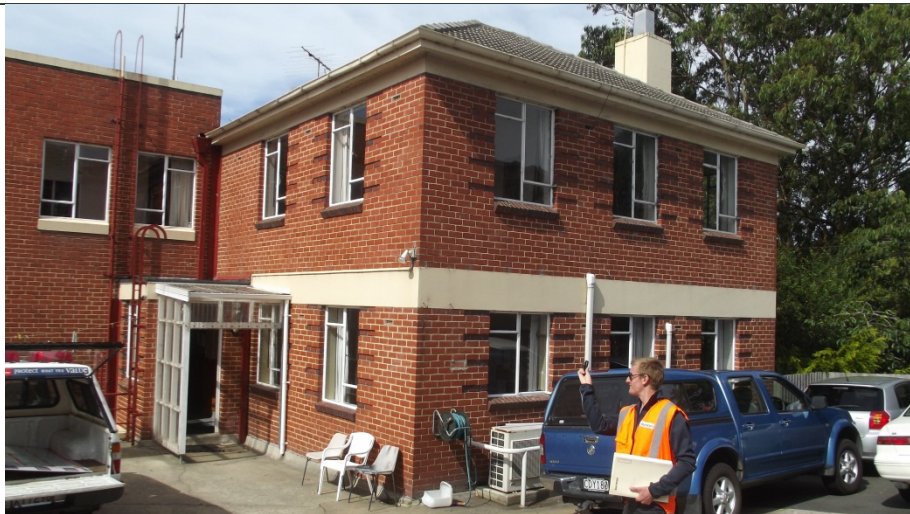
| Element | % NBS Capacity | Commentary |
|---|---|---|
| Brick walls in plane | 22% | |
| Brick walls out of plane | 35% | |

North Elevation of West Wing

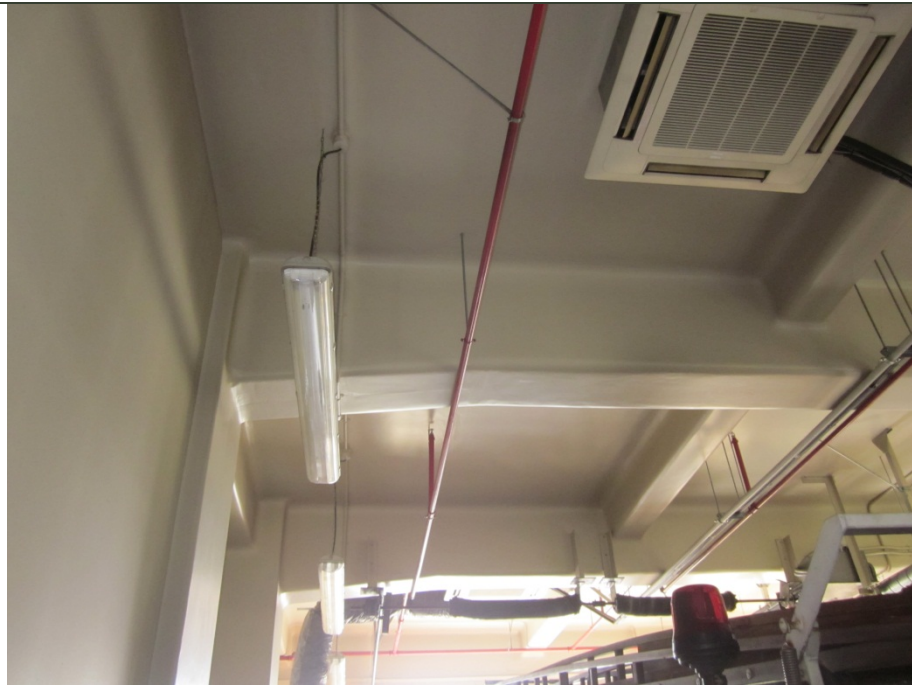
The available existing drawings have no details for the South Wing reinforced concrete beams at first floor and roof levels. Our analysis has assumed that all the beams have a minimum tension steel content ratio of 0.5% to the beam cross sectional area, at the column faces. It is also assumed that the detailing of these beams provides a full development length of the tension steel at the column face locations. If the tension steel content is less than assumed then this could potentially reduce the %NBS score for the moment resisting frames. We recommend that further intrusive investigations be undertaken to confirm these assumptions.

Ground floor of South Wing - Appliance Bay. Looking up at the first floor beams and slab soffit.

- Steel reinforcement content of the first floor and roof beams in the South Wing. We would recommend using ferro-scanning combined with some localised concrete break outs.
- Determine the extent of remedial works that had been installed for the cut stair stringer in the South Wing. We would recommend removing wall linings to expose the back face of the stair stringer.
- Brick wall tie installation to the brick skin walls. We would recommend localised breakout of the brick walls to confirm type and spacings.

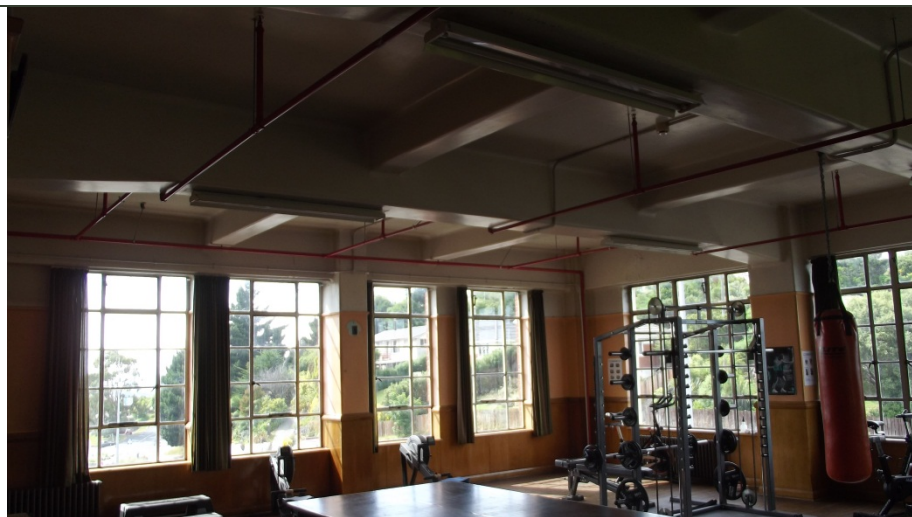
First floor of South Wing - Gym (above the Appliance Bay).

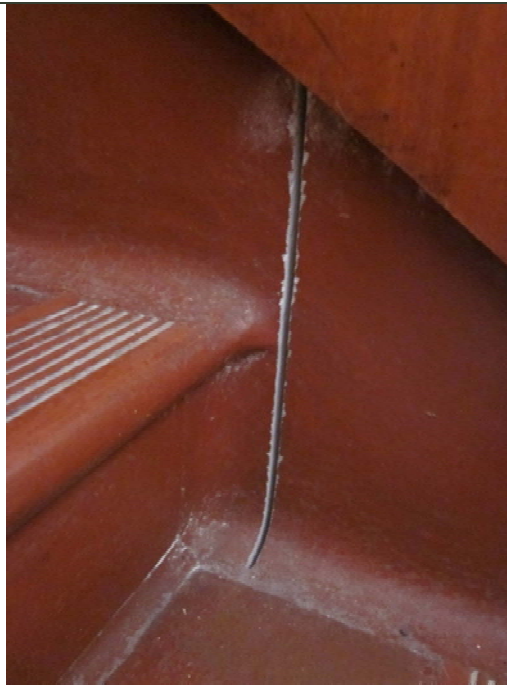
The South Wing has a reinforced concrete winder staircase at the northern end. The available drawings have limited information with regards to the structural detail of these stairs. The staircase has not been assessed as a lateral resisting element of the building due to the stairs being of a winder type. However, as the stairs are tied into the structure, in a seismic event they will likely attract some load. In this event it is possible that some tearing failure or connection failure could occur. The stairs appear to bear on reinforced concrete walls which should provide support against collapse. It was noted on site that one of the concrete stair stringers has previously been saw cut right through at approximately 1400mm from the top stair landing. We recommend that further intrusive investigations are undertaken to confirm if any remedial strengthening works had been installed to secure the saw cut stair stringer.

Saw cut through reinforced concrete stair stringer in the South Wing leading up to the first floor.

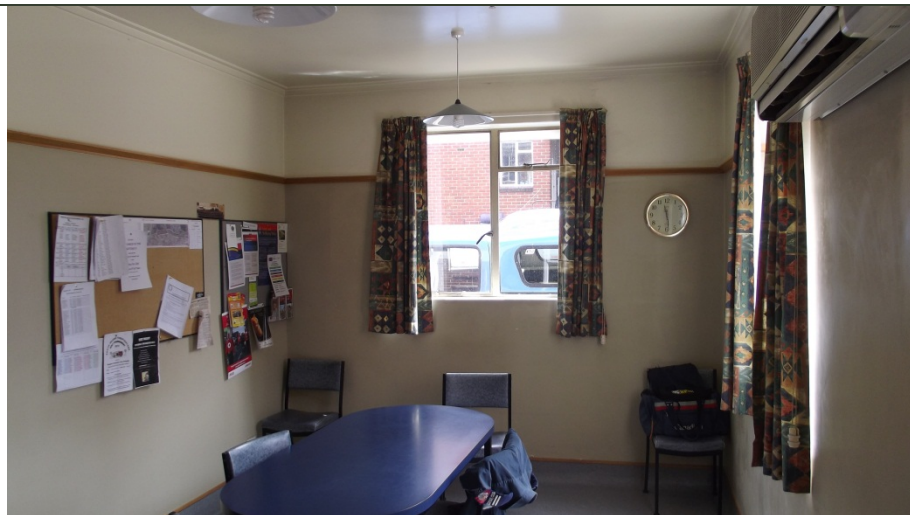
Dining area in ground floor of West Wing.
