**In the Matter of** Hearing 4 of the Proposed Variation 2 (Additional  
Housing Capacity) of the Second Generation Dunedin  
District Plan – Appeals Version (**2GP**)

**Brief of Evidence of Mark Tapio Walrond  
on behalf of:**

GeoSolve Ref: 220581  
12 August 2022

### Geotechnical Assessment 353 Main South Road, Sunnyvale, Dunedin

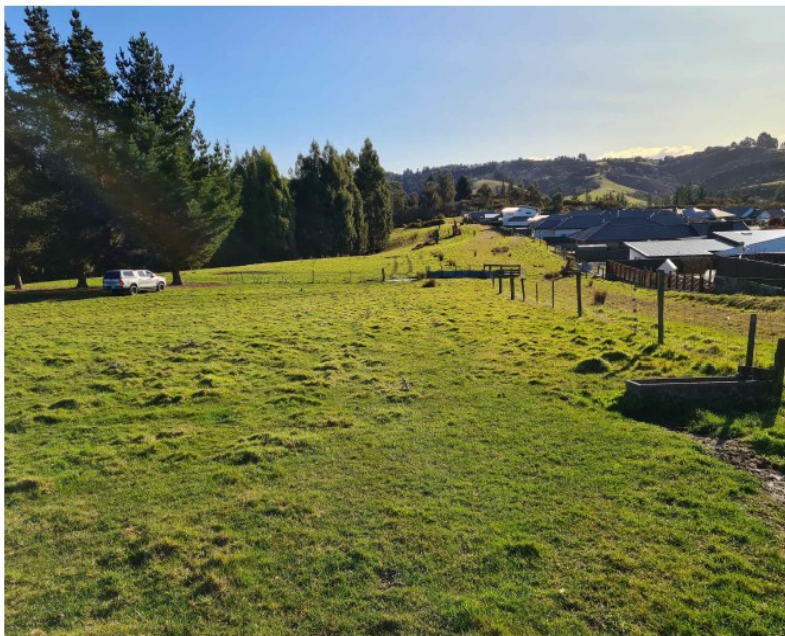
*Photo 1 – Typical view of the northern extents of the site adjacent to recent residential development*

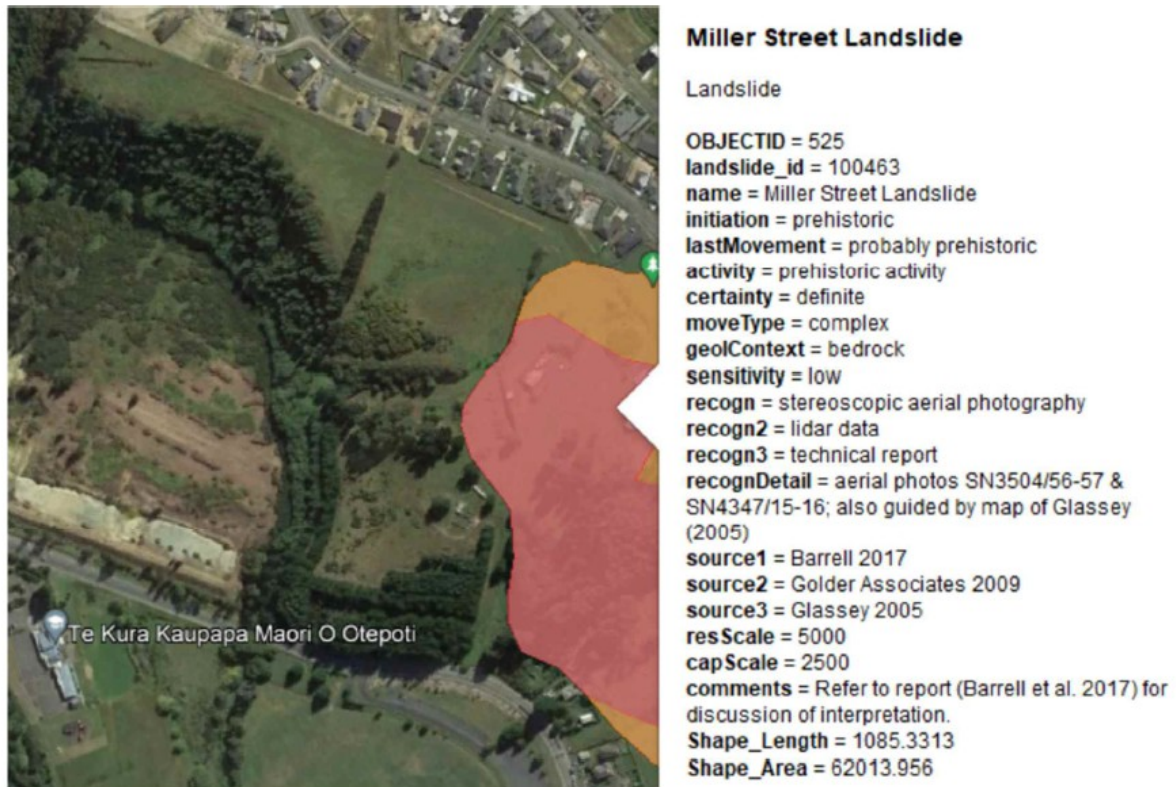
Figure 4 – Location of the Miller St landslide over the extreme east of the subject site.

The Miller St landslide is considered an ancient area of instability. There is no available evidence that the landslide is moving at present although areas within such landslides can become reactivated, especially during storms or severe earthquake shaking and on steeper areas. In addition, elevated groundwater can be problematic, but drainage solutions can generally be applied in these cases.

Only the GF05a site (and a very small part of the GF05 site) lies within the extents of the Miller St Landslide. We note that recent residential development has taken place within the extents of the landslide but this may have been consented via Section 72-73 of the Building Act.

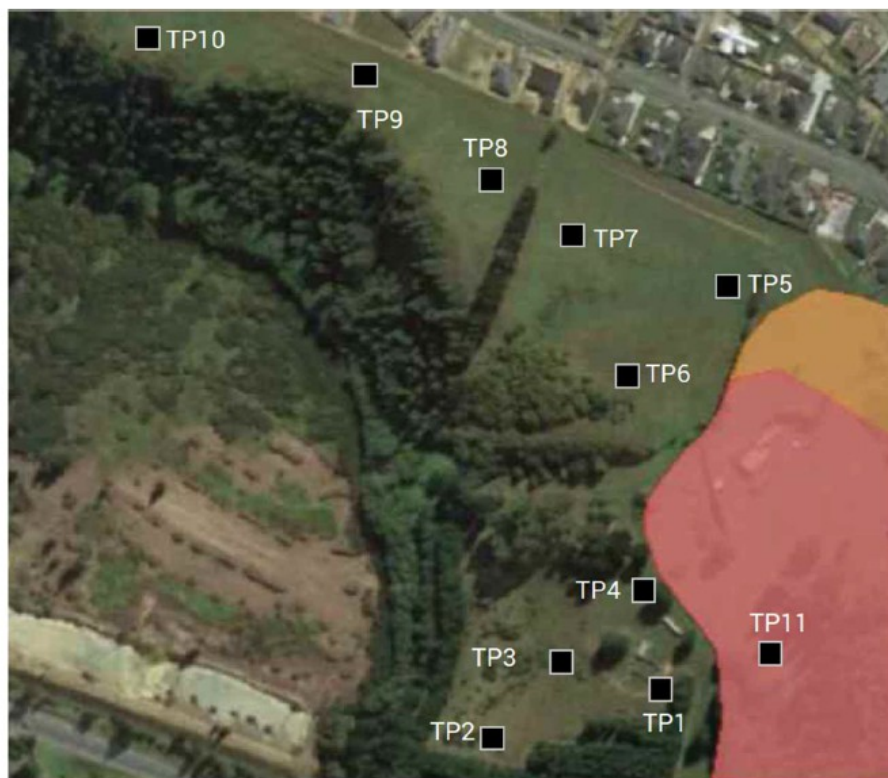
*Figure 5 – Location of the test pits with respect to the Miller St landslide.*

Our recent test pitting comprised 11 test pits taken to a depth of 3.2 m to assess the near surface soils and groundwater conditions. In summary the soils are mostly colluvium or ancient landslide debris overlying Abbotsford Formation bedrock which was visually observed in 2 test pits at depths of between 0.5 m (TP2) and 2.7 m (TP6).

No groundwater was observed for most of the site, apart from the test pit in the GF05a area (TP11).

Only localised uncontrolled fill was observed (up to 1 m in TP3 and 9 – likely associated with forestry and brick works). Some obvious stockpiles of fill are also located near the north-east corner of the site.

The weathered mudstone below the debris was considerably more difficult to excavate and comprises weathered weak sedimentary rock (glaucinitic mudstone). Further investigations are recommended at the subdivision consenting stage to confirm local depth and persistence of bedrock.

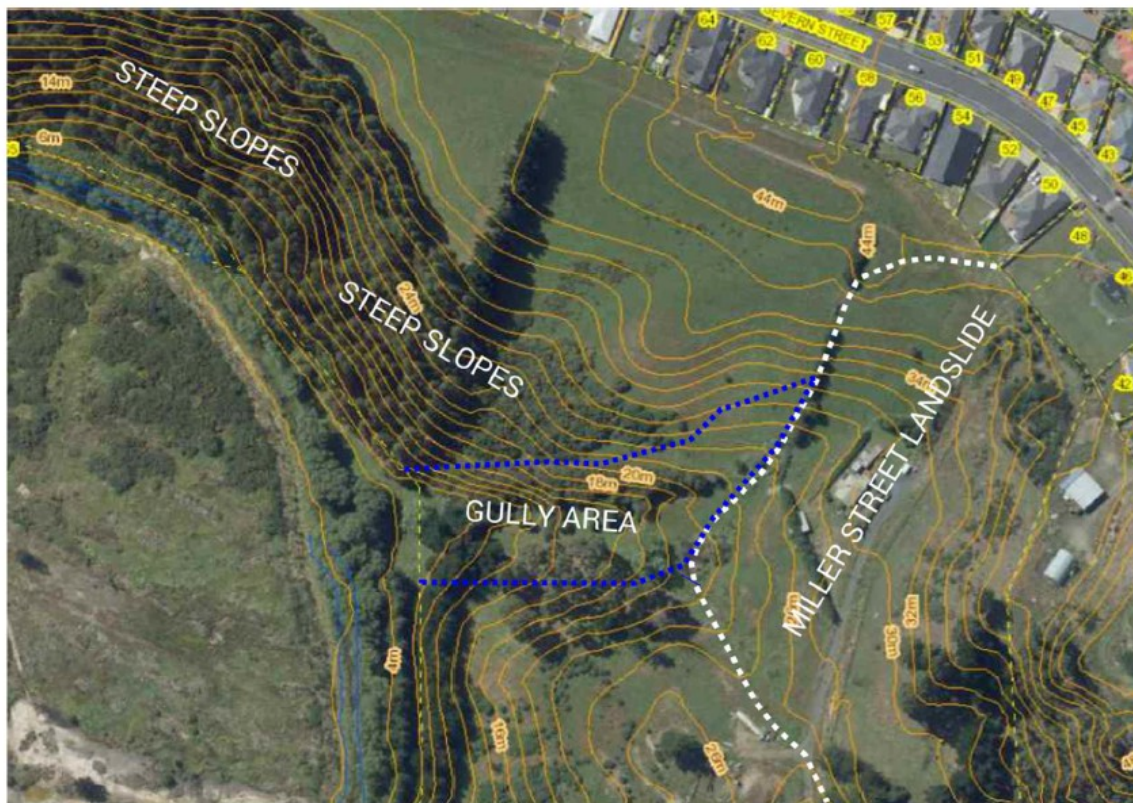
Figure 6 – General areas where residential development may be constrained.

However, there are some steeper areas (mostly tree-covered) and areas of softer soils within the main gully on site where some under-runners exist which could cause localised instability if insufficient engineering measures are applied. The presence of localised ancient landslide debris can indicate that reactivation of any softened debris is possible in major storm events or if the soils are able to become saturated. However, in this case the landslide debris was confirmed to be stiff, clearly ancient in origin and contained no groundwater (apart from TP11 which is within the Miller St landslide extents).

Consequently, risk of slope stability for most of the property (GF05 area) can be managed by ensuring that sufficiently detailed geotechnical investigation is in place to support subdivision intentions and design is applied at the design stage for individual dwellings, depending on their eventual locations and construction styles. In addition, any proposed earthworks should be subject to specific geotechnical assessments to ensure that these do not promote global slope instability and this work should include determination of bedrock persistence, bedrock dip angles and any potential zones of shearing. These items can be addressed during preparation of future geotechnical report to accompany the subdivision consent application and individual building consent applications.

Particular emphasis on geotechnical advice should be applied to any proposal for residential development on land steeper than 15 degrees or within the gully area/Miller St landslide shown approximately on Figure 6. These areas may be better suited to reserves, however with sufficient engineering and acceptance of risk, some areas such as these could be considered for development.
