**GEOLINK LAND INVESTIGATIONS Ltd**

**PRELIMINARY GEOTECHNICAL ASSESSMENT FOR PROPOSED SUBDIVISION, TE NGARU,  
ARAMOANA ROAD- A GTR 4**

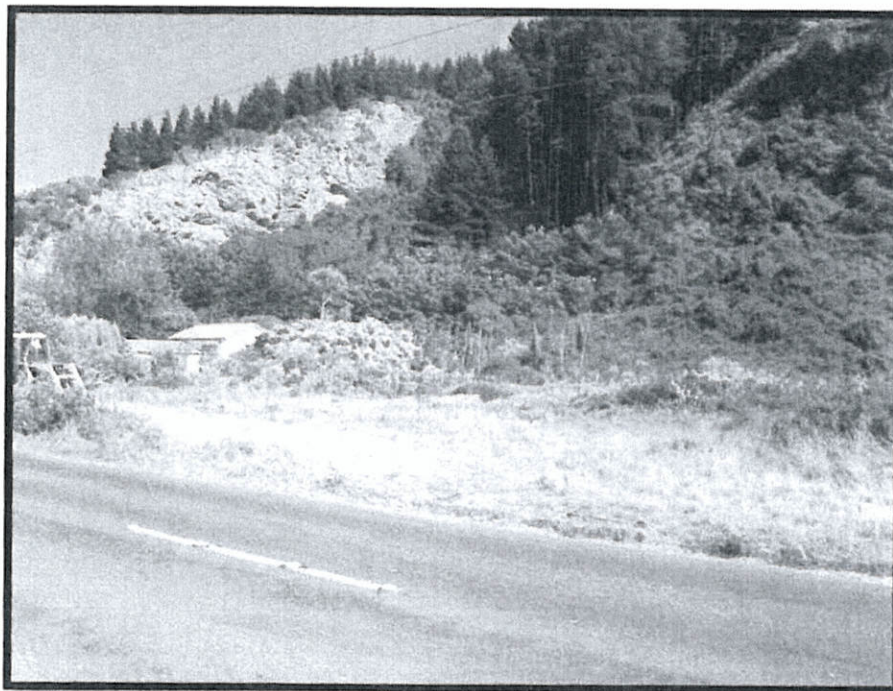
**Photo 1- View of western end of property showing sand plane, dunes and steep land.**

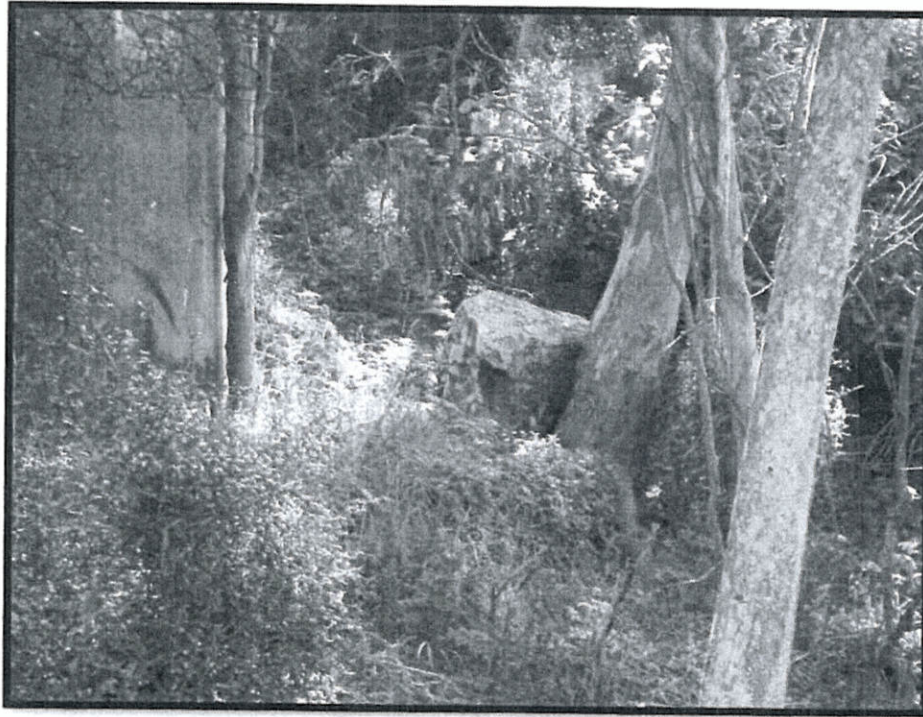
No obvious evidence of landslides was seen probably due to the extensive bush cover of the steep land. A number of old debris slides were identified on the upper slopes feeding into the two hanging valleys. There was evidence of rock fall with a number of basalt boulders at the base of the cliff and also some larger blocks. There appear to be a number of debris fans below the hanging valleys which have now been covered by the sand dunes. These would indicate inundation from above. These issues are discussed in more detail for the possible building platforms.

Photo 2- Large boulder which has rolled down cliff. Note bends in trees indicating ground slumping.

**Hazards-** The proposed site is a large volcanic block that has slumped from the cliff. There is evidence of land instability and also evidence of recent rock fall from the upper slopes. (See photo 2 )

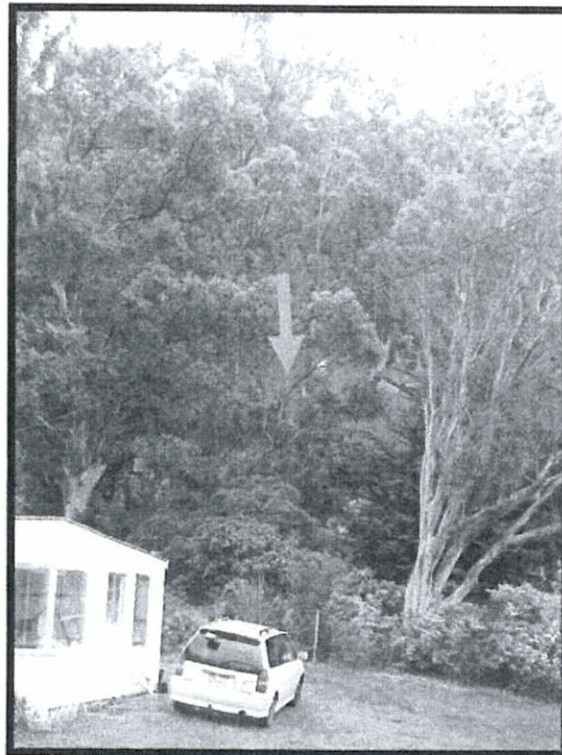
**Site stability-** The possible building platform is located on a large volcanic block above no. 767. The block has slumped from the cliff above. The bowing of trees ( see photo 2) and the tilting of the water tank indicates quite severe ground movement to the west of the site.

**Photo 3. Site of possible building platform on volcanic block**

**Recommendations-** The site is not considered suitable for locating a dwelling due to physical limitations and the risk of inundation and/or instability.

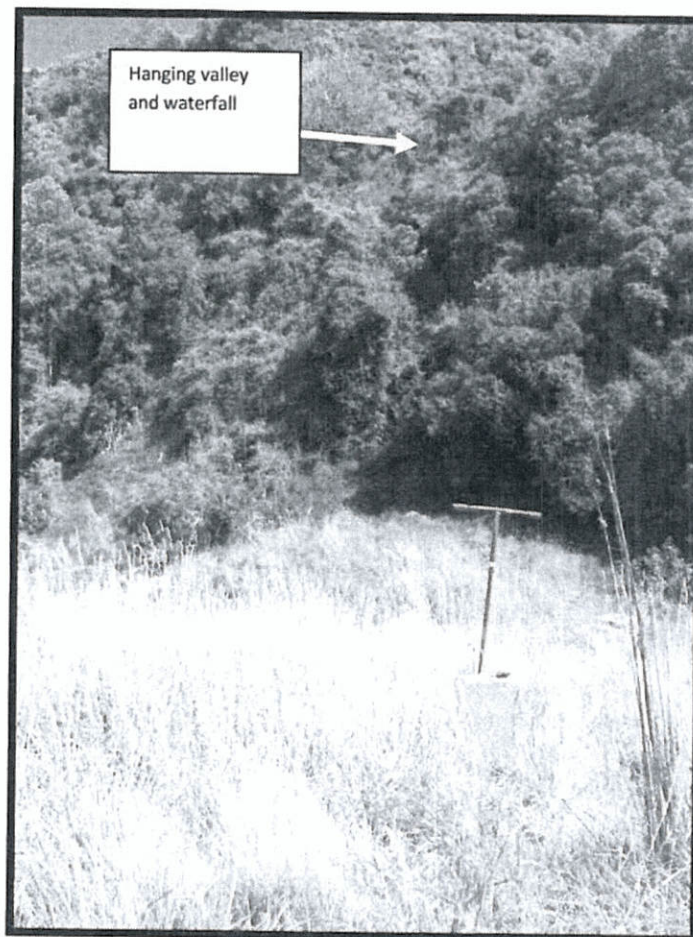
**Site stability-** The site is located on a small dune. There is no evidence of land instability on the site.

**Hazards-** The site is almost directly under a hanging valley which acts as a waterfall during winter months. ( Local pers com.) The dune itself is very likely located on a debris fan resulting from inundation from the upper valley. A number of landslide features were identified feeding into the upper valley. The sand plain is subject to flooding and a high water table.

Photo 4- Possible building platform for lot 5

**Recommendations-** Further investigation of the site is required to assess if it is a debris fan (subsurface investigation) and monitoring of the site during winter conditions. The sand plain is subject to flooding and a high water table.

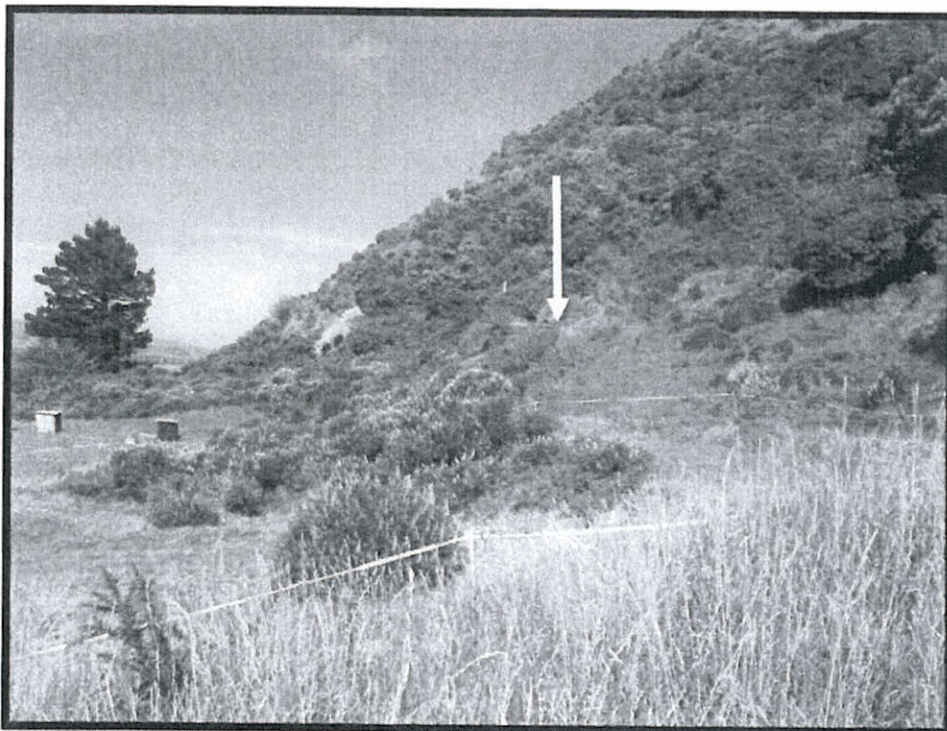
Again no evidence of land instability.

Similar to site 1 and may be underlain by a debris fan. A drainage channel exists at the base of steep slope to divert water. There is some evidence of rock debris in the channel.

**Photo 5- Possible building site.**

Same as site 1 requires more investigation and monitoring.

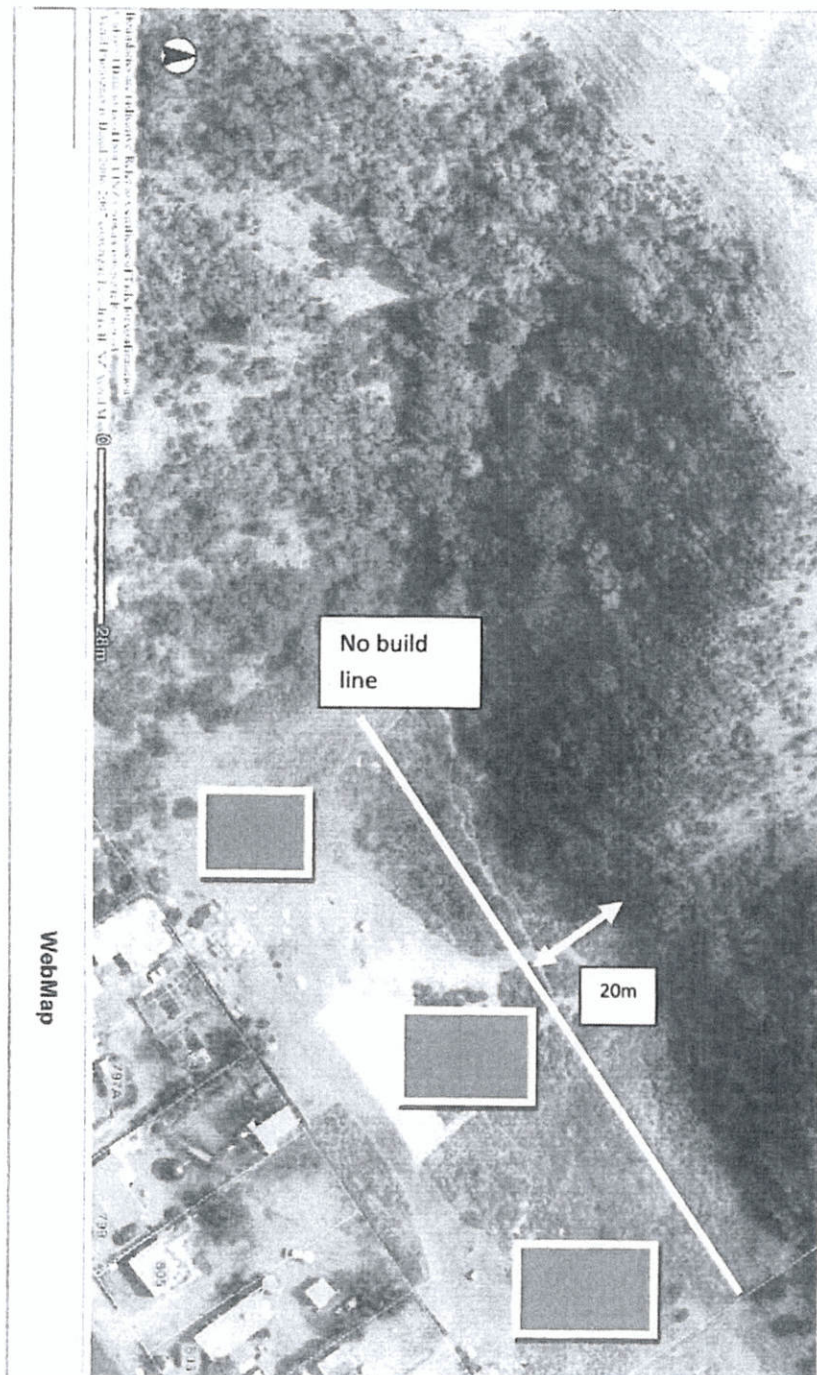
## Appendix II- Additional building sites for Lot5.

Possible sites are shown in appendix II. These are situated further away from the base of the cliff ( at least 20m) and not located on probable debris fans. Further investigation is required for foundation conditions and groundwater issues.
