## **REPORT ON FLOODABILITY ISSUES 16 HARE ROAD BRIGHTON**

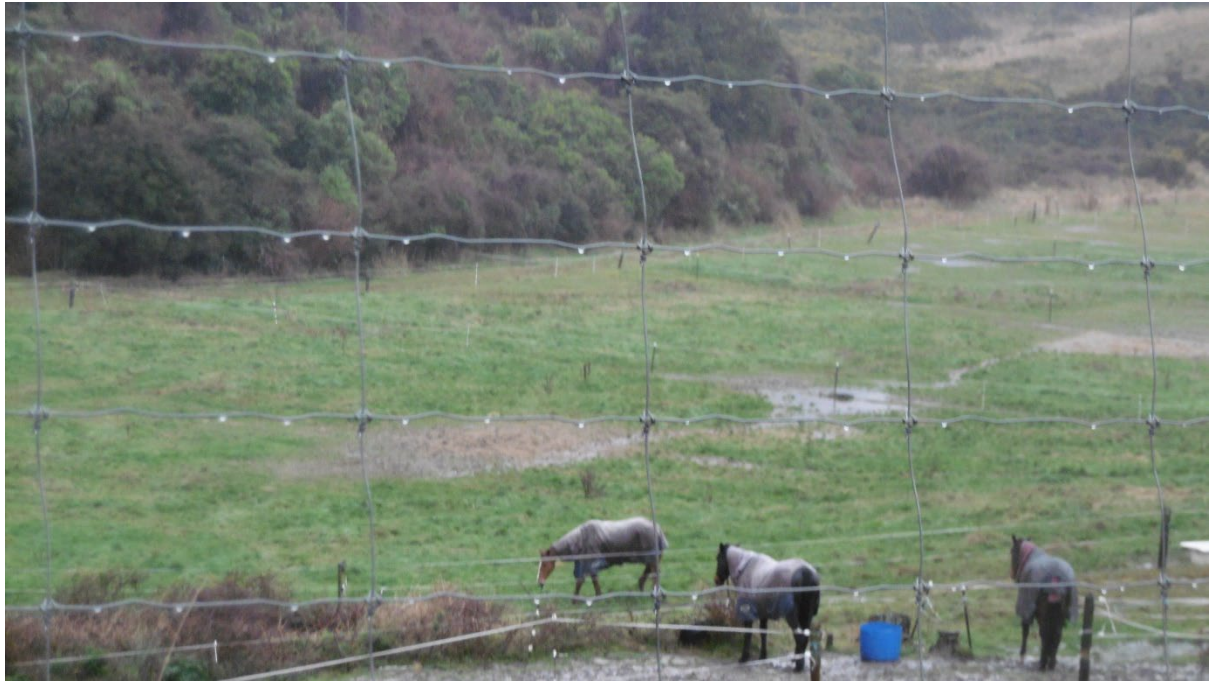
- There was only minor ponding in the lowest parts of the property (refer photo below)

- 
- This was assessed as being internal rainwater that had fallen directly into the basin that forms the property.
- There was no evidence of overtopping from Taylor's Creek into the property.
- The flow in the stream would have been past its peak at the time of inspection but was still well in excess of the ford culvert's capacity. The ford was submerged by approximately 75mm of floodwater (refer photo below).

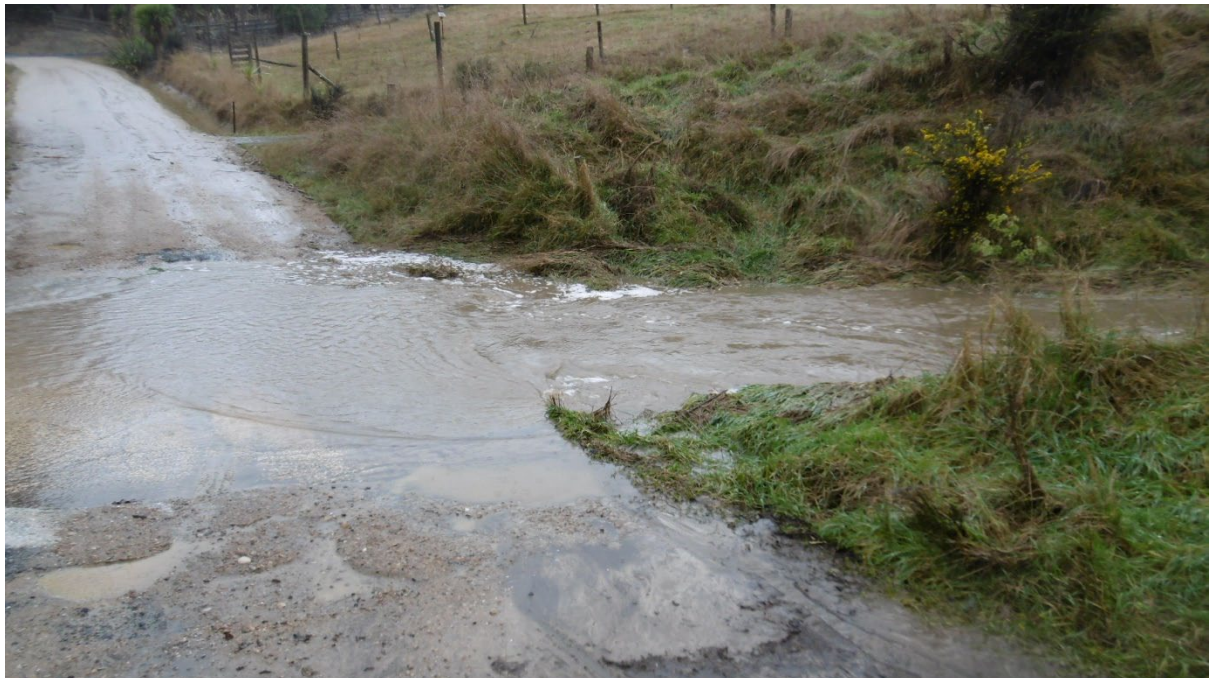
There appears to be a mismatch between Mr Ind's recall that access to some sections of Kayforce Road had been cut on *at least 2 occasions*, but the creek had overflowed into the property in question *on multiple occasions*. Observations (and photos) leave little doubt that overtopping of the ford that serves the newer Kayforce Road properties would be by far the more frequent occurrence.

Mr Ind's reference to access to properties adjacent to the property in question (16 Hare Road) being cut might cause the reader to assume that the disruption to access is in some way associated with concurrent flooding on Mr Campbell's land. The reality is quite different. The culvert under the road ford is of such limited capacity that overflowing of the ford will occur relatively frequently. (It was probably designed that way as a balance between cost and inconvenience). Consequently, road access will be cut from time to time, but not as a result of the creek's lack of capacity. The culvert's lack of capacity impacts on road access to some Kayforce Road properties from time to time, but is irrelevant to any

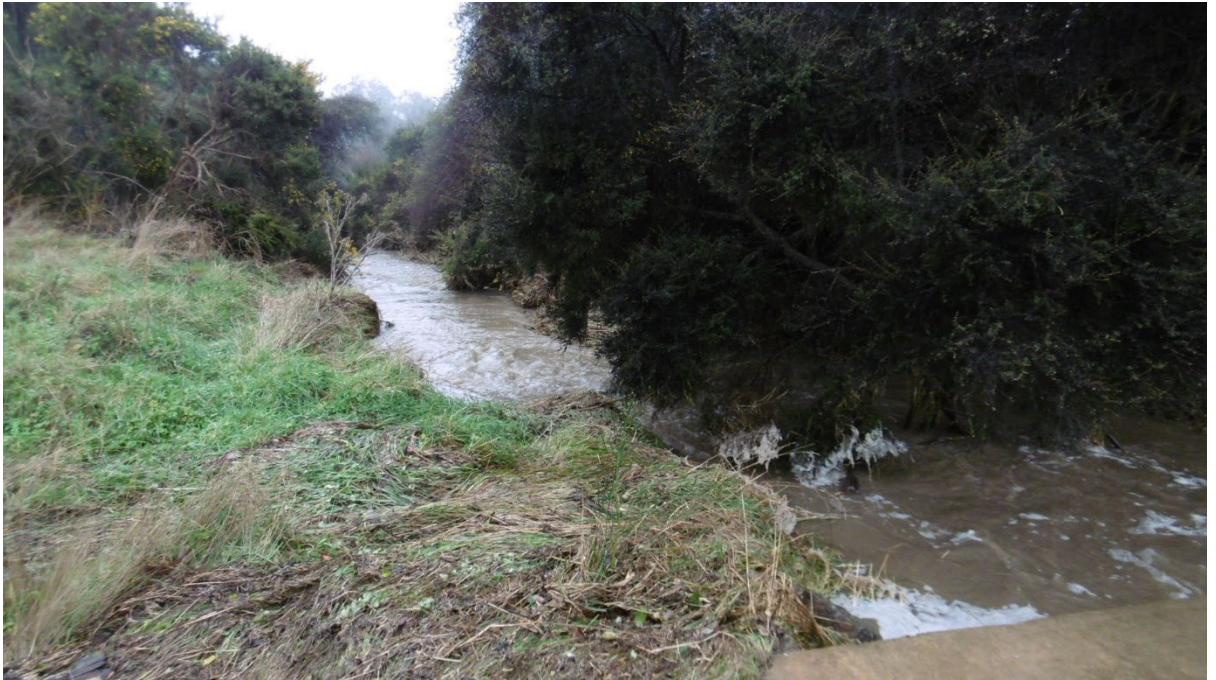
- From the vantage points available in the conditions, Taylor's Creek was flowing well within its banks (refer photo below).

Observations of 13 July (see above) made towards the tail end of a prolonged period of heavy and persistent rain (incidentally, sufficient to cause a fatality in the nearby Silverstream catchment) raise some doubt re the claim of inundation from the stream on *multiple occasions*. There was certainly no threat of overflow from the creek on this occasion.

- The stream certainly requires an extensive clean-out of excess vegetation. This would likely apply to the entire length of the channel adjacent to the property in question, based on observations made at random points of inspection. Mr Ind's recommendation of an "upgrade" of the stream is supported in this regard.
