RS14- Jennifer Robinson - FS116

## Photographs – 9 Freeman Close, Abbotsford, Dunedin

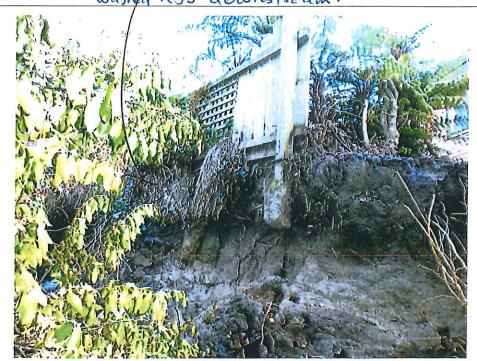
Photograph 3: View of scour from flood flow in the creek

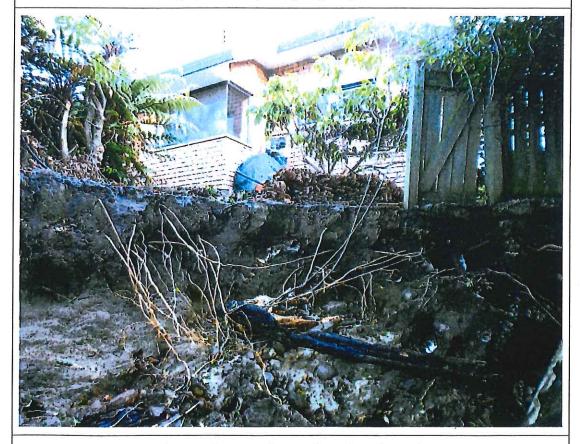
Photograph 4: View of scoured area from the creek

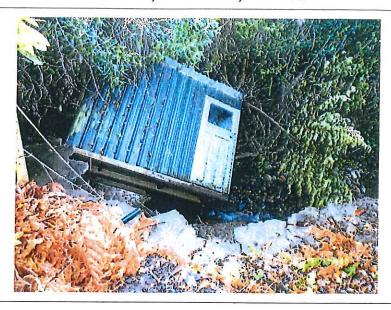
Photograph 1: View of the scour damage from the top of the slope showing shed in creek

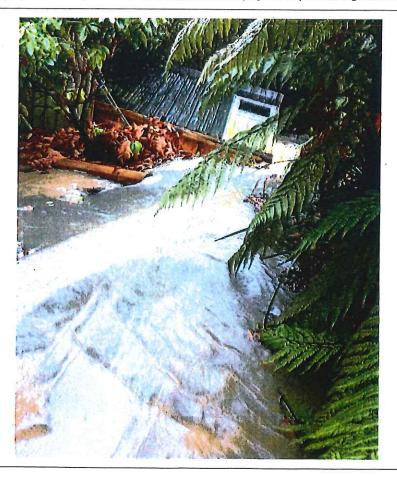
Photograph 2: Similar angle taken during flood event
