ASBESTOS DEMOLITION SURVEY

65 Crawford Street, Dunedin

Contact Details	91 Annan Street, Invercargill, 9810 birney@asmnz.co.nz 03 928 5371 027 740 1246
Project Number	39948
Site Audit Date	8 February 2018
Asbestos Survey Report Issue Date	20 February 2018
Document Administration	
Version Number <i>(refer to Version Records section for history)</i>	1
Version Date	20 February 2018

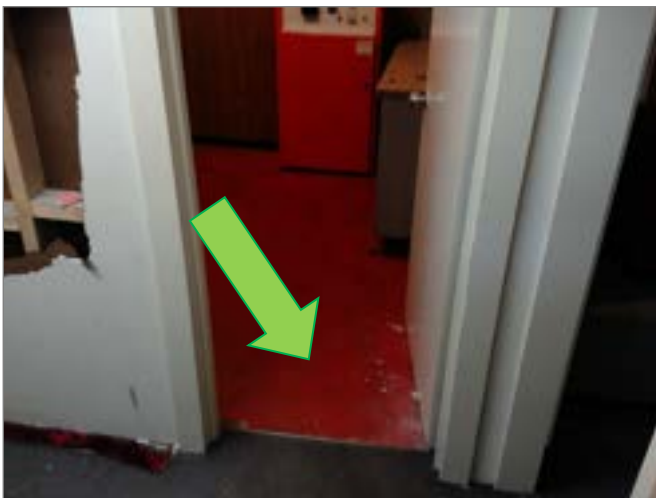
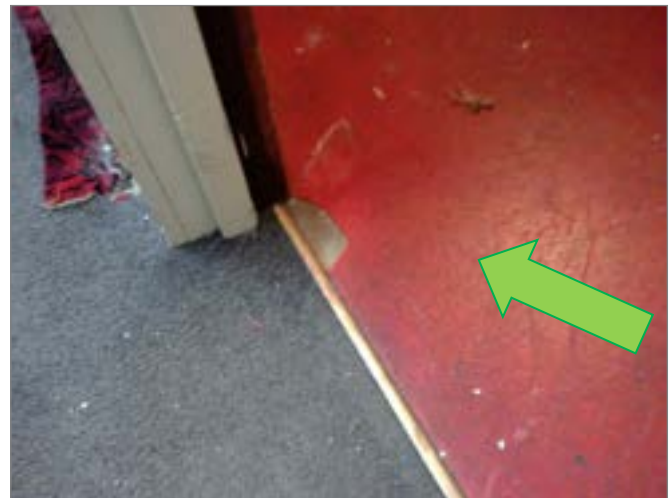
Item Number	001
Sample Date	8 February 2018
Location	Switchboard Room
Material Type	Vinyl
Area (m ²)	9m
Sampling Method	Bulk
Sample Number <i>(Laboratory Reference)</i>	159136
Result	No Asbestos Detected

Comments	A composite sample of this red vinyl was taken from areas on the ground floor– No Asbestos was detected.
Recommendations	No Action Required

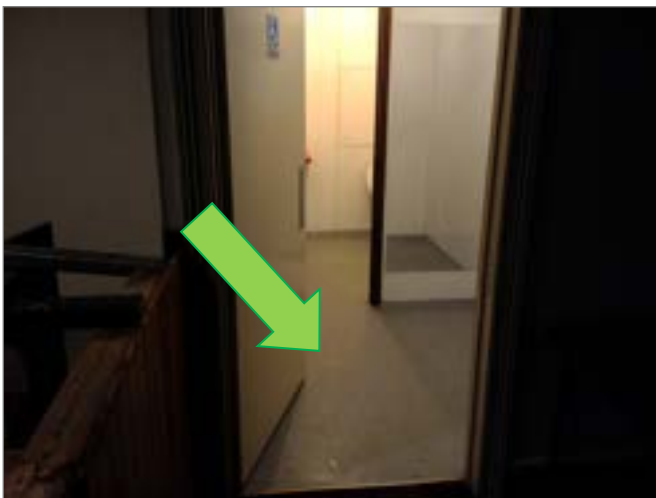
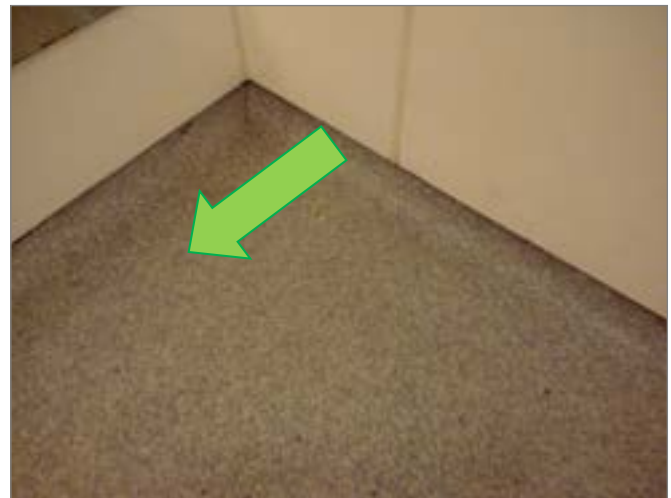
Comments	This vinyl is also present in the ground floor bar, a composite sample of this vinyl was tested.
Recommendations	No Action Required

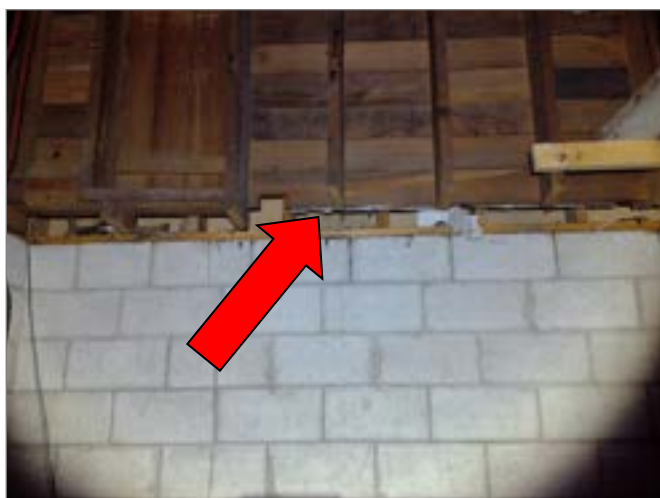
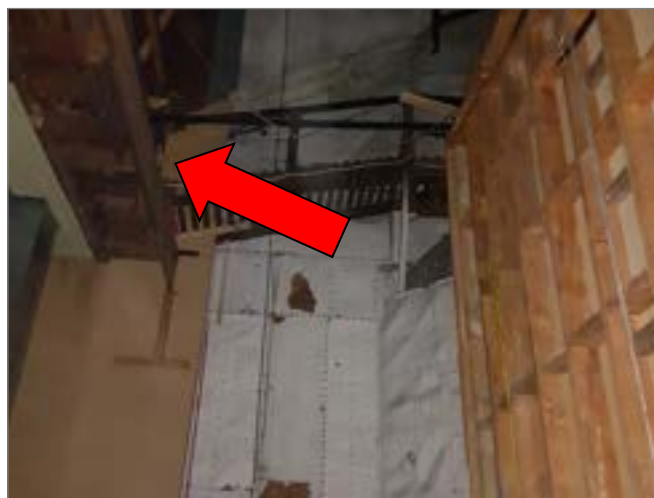
Material Assessment		
Asbestos Type	Chrysotile (White)	0
Location	Interior	2
Accessibility	Medium	2
Friability	Non-Friable	1
Condition	High Damage	3
Surface Treatment	Unsealed	2
Product Risk Score <i>(Total of Material Assessment Scores)</i>		10
High Risk (10-15)

Comments	<p>Cement board sample taken from roof space above ground floor kitchen/ bar. (Left Photo) Right photo is the other side of wall (back of stage)</p> <p>* The entire wall behind stage is a mixture of low density cement board and a softer asbestos board.</p>
Recommendations	<p>This cement board is a High risk and action should be taken to remove this material. The back of stage area should be restricted until this hazard has been removed.</p> <p>Removal of this material must be undertaken by an A Class removalist with an ARCP in place.</p>

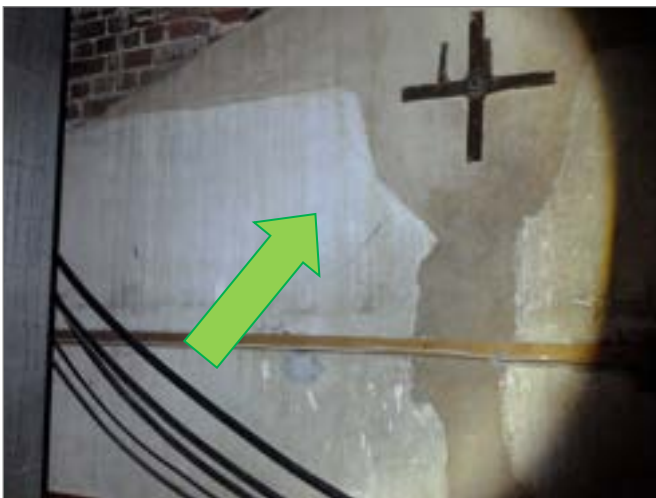
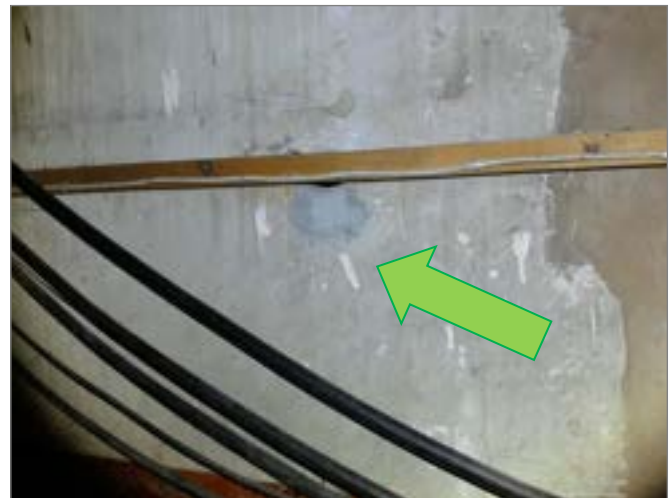
Comments	Plaster skim coat over brick wall.
Recommendations	No Action Required

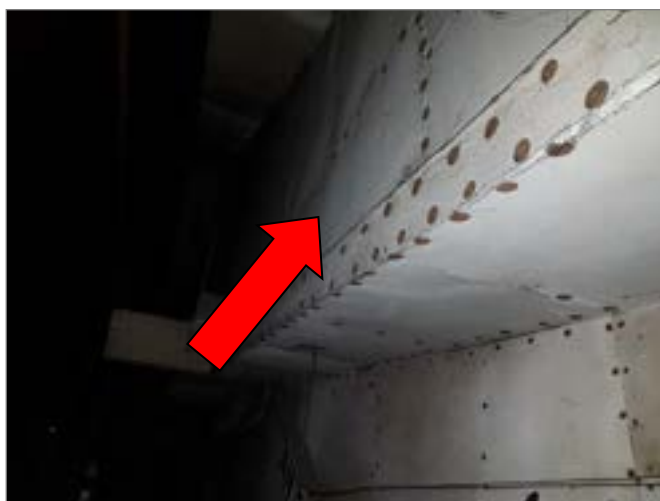
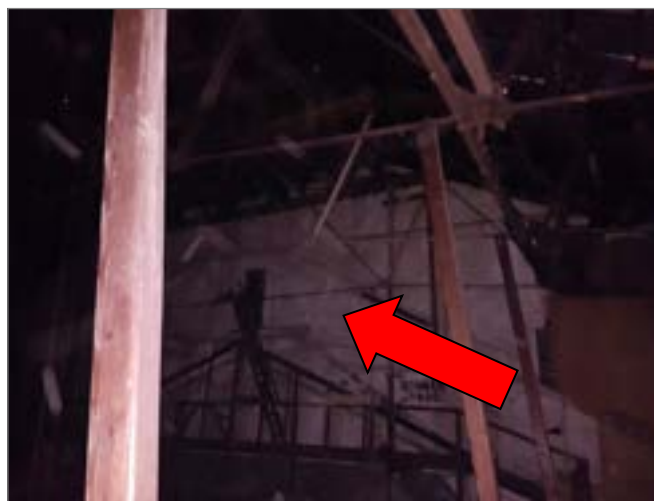
Material Assessment		
Asbestos Type	Chrysotile (White)	0
Location	Interior	2
Accessibility	Medium	2
Friability	Friable	3
Condition	High Damage	3
Surface Treatment	Unpainted/ Unsealed	2
Product Risk Score <i>(Total of Material Assessment Scores)</i>		12
High Risk (10-15)

Comments	*The entire wall behind the stage is a mixture of low density cement board and softer mill-board material.
Recommendations	This cladding is a high risk and action should be taken to remove this material. The back of stage areas should be restricted until this hazard is removed. Removal of this material should be undertaken by an A Class removalist with an ARCP in place.

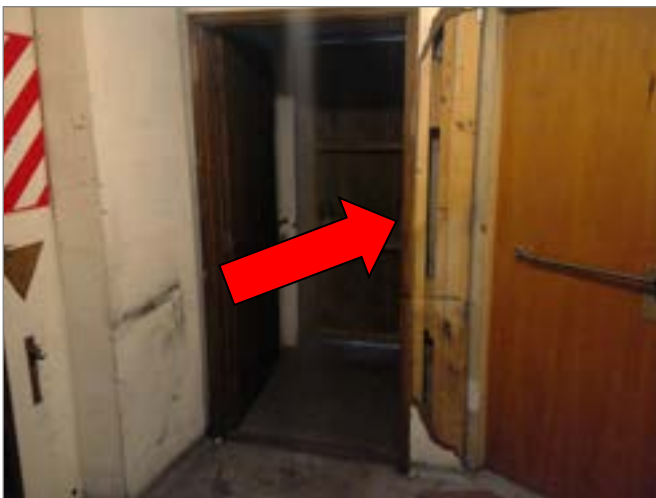
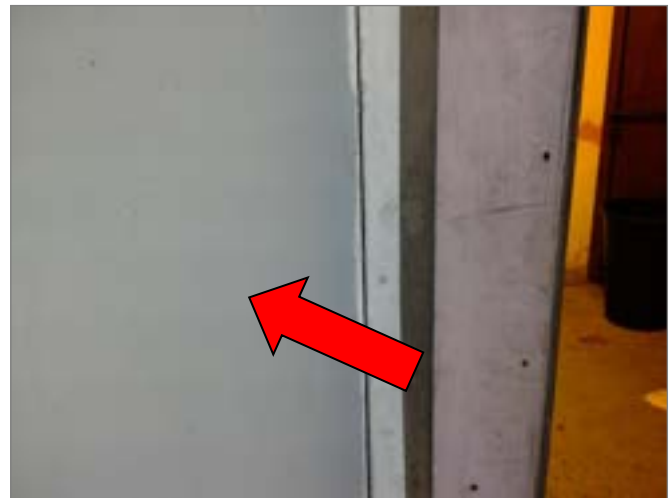
Material Assessment		
Asbestos Type	Chrysotile (White), Amosite (Brown)	2
Location	Interior	2
Accessibility	Medium	2
Friability	Non-Friable	1
Condition	Medium Damage	2
Surface Treatment	Painted / Sealed	0
Product Risk Score <i>(Total of Material Assessment Scores)</i>		9
Medium Risk (6-9)

Comments	
Recommendations	<p>This cement board is a medium risk material and should be removed prior to any work which may interfere with it.</p> <p>This removal should be undertaken by an A or B class removalist with an ARCP in place.</p>

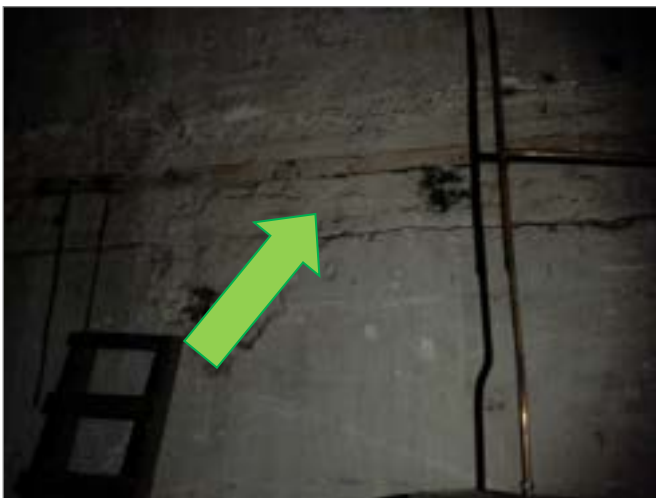
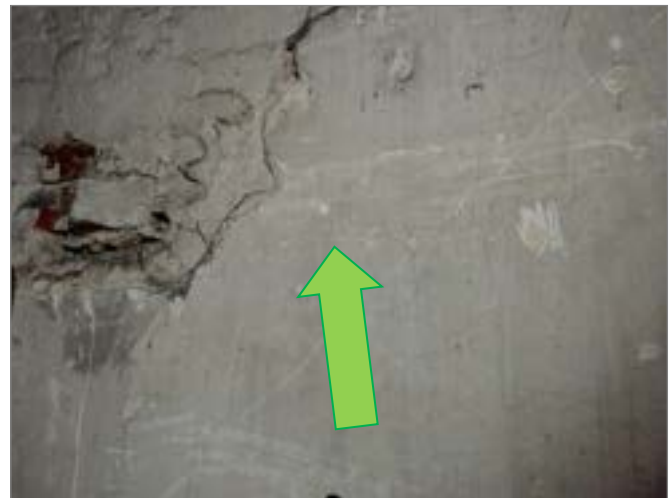
Comments	Plaster skim coat over brick.
Recommendations	No Action Required

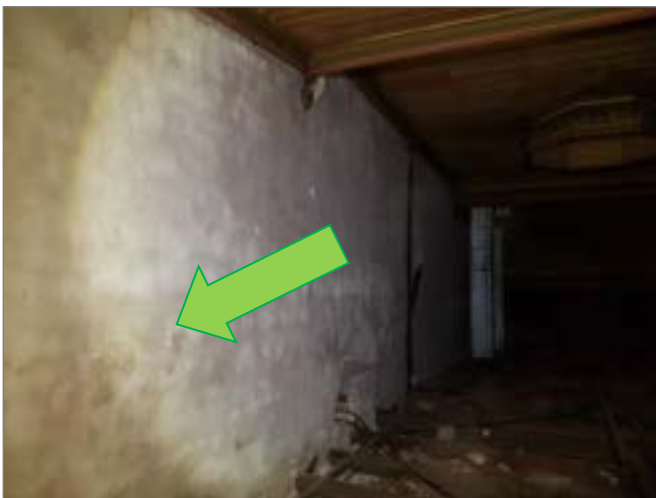
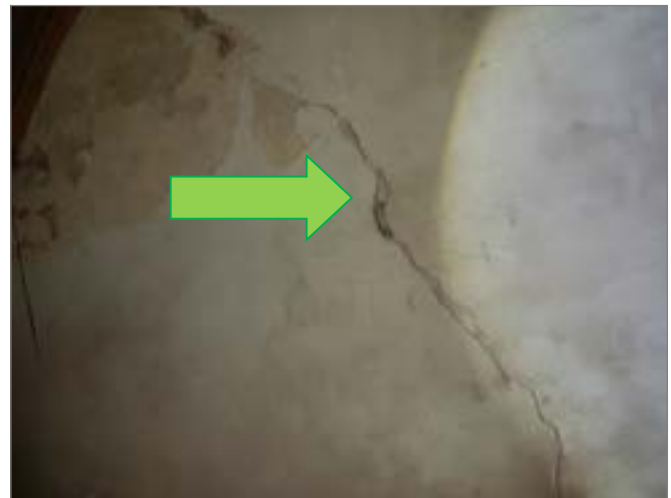
Comments	Plaster skim coat over bricks.
Recommendations	No Action Required

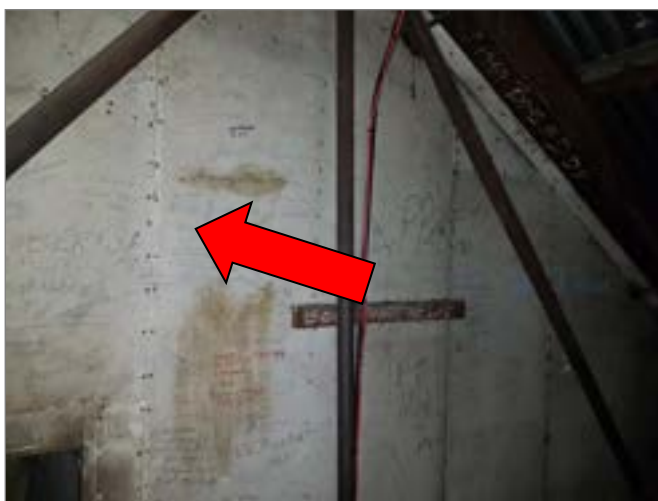
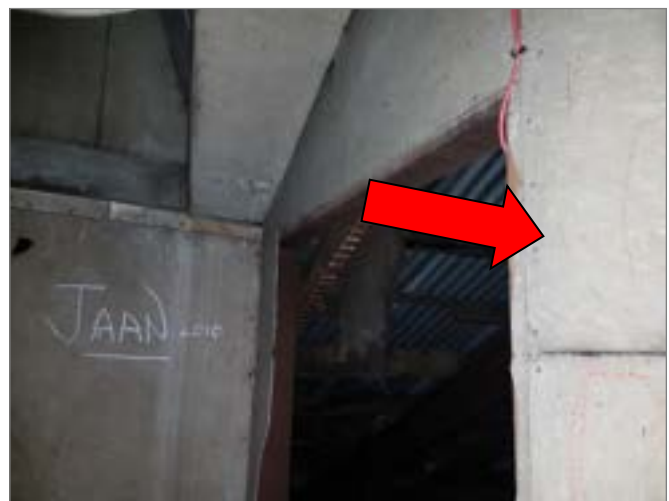
Material Assessment		
Asbestos Type	Chrysotile (White)	0
Location	Interior	2
Accessibility	Medium	2
Friability	Friable	3
Condition	High Damage	3
Surface Treatment	Unpainted, Unsealed	2
Product Risk Score <i>(Total of Material Assessment Scores)</i>		12
High Risk (10-15)

Comments	<p>Entire wall behind stage is a mixture of cement board and millboard materials. Exact quantities of each are unknown. Very top section appears to be mainly cement board.</p> <p>Highly damaged cement board was observed at the bottom of ladder up to this ceiling space.</p>
Recommendations	<p>This material is considered a high risk and action should be taken to remove this cladding. The behind stage/ roof space areas should be restricted until this material is removed.</p> <p>Removal should be undertaken by an A Class removalist with an ARCP in place.</p>

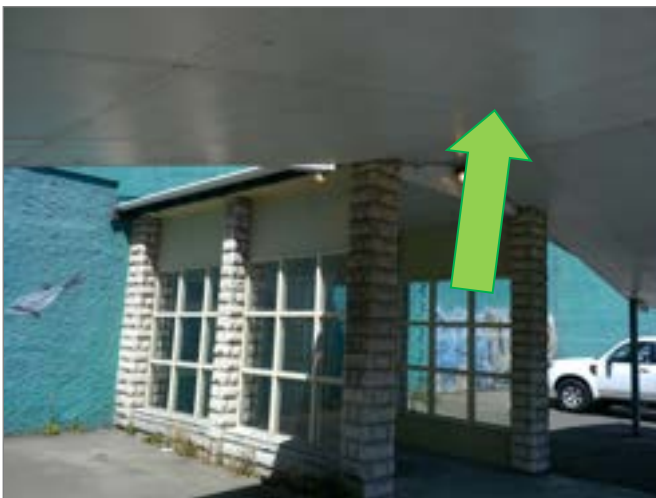
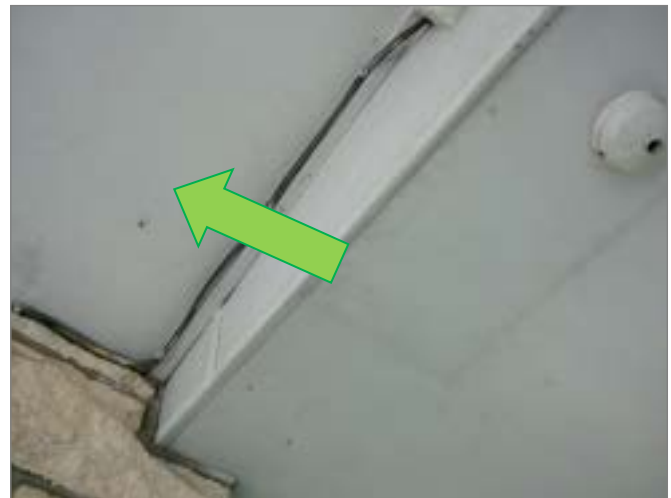
Comments	Underside of entrance way.
Recommendations	No Action required

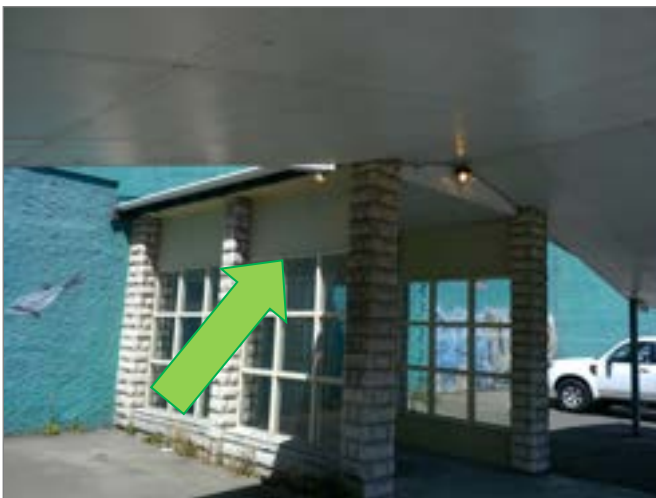
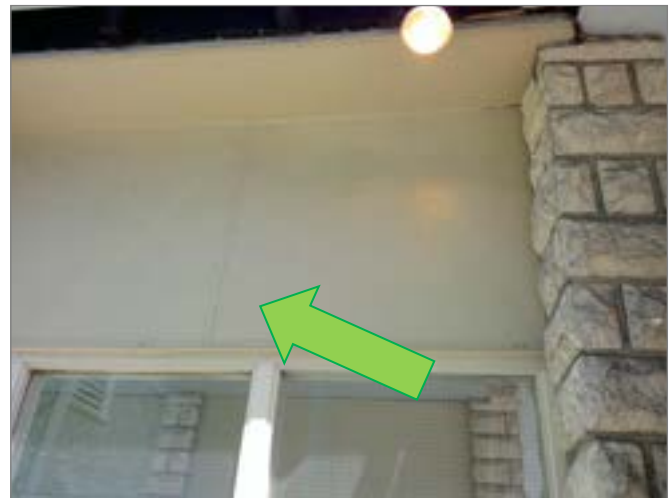
Comments	Cement cladding above windows.
Recommendations	No Action Required

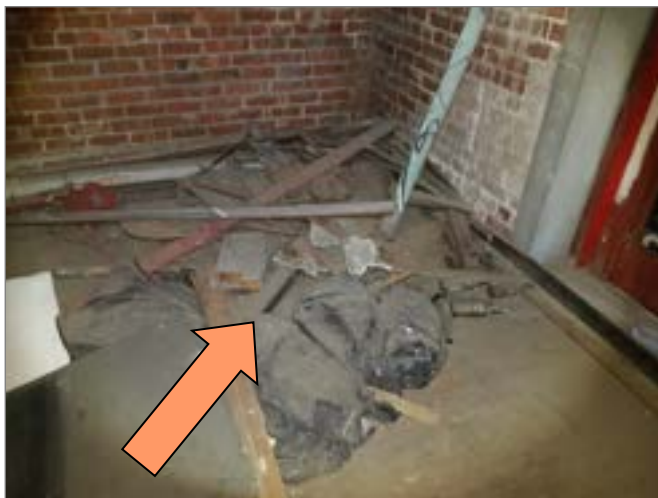
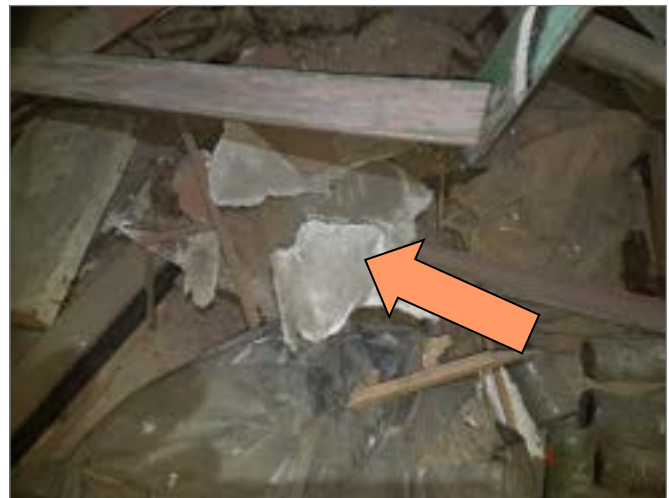
Broken asbestos board debris were also observed in the Northwest corner of the upper mezzanine, as well as the access way to the upper roof space, these areas are likely to be a hotspot for ACD contamination also.

Comments	A pile of debris found in the north-west corner of the backstage mezzanine. Asbestos claddings were observed amongst the debris, the surrounding area is highly likely to be contaminated.
Recommendations	This should be removed and disposed of as contaminated waste

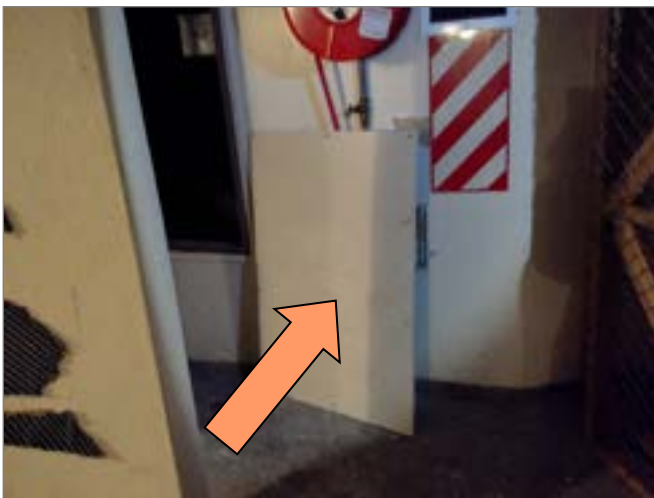
Comments	<p>This cement board panel is highly likely to contain asbestos.</p> <p>No sample taken as testing costs would outweigh cost of removal.</p>
Recommendations	<p>This panel should be treated as an asbestos material. It should be removed and disposed of as asbestos waste.</p>

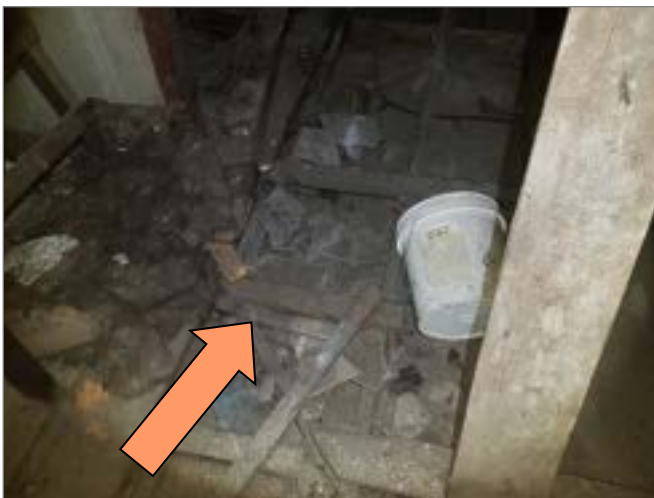
Comments	This broken asbestos board is found above the stage at the base of the ladder to the upper ceiling space.
Recommendations	This material should be removed and the surrounding area cleaned up.
