# CONDITION REPORT

SAMMY'S ENTERTAINMENT VENUE,  
65 CRAWFORD STREET, DUNEDIN.

- Report commissioned by:** Feldspar – David Booth
- Report and site inspection undertaken by:** Grant Parker MSc Arch MNZIBS  
Registered Building Surveyor

- Date of Inspection:** Monday 26<sup>th</sup> September 2016 @ 9:00 am & 3:00 pm
- Other persons present:** The Current Owner, Agent, Fire Engineer and Valuer

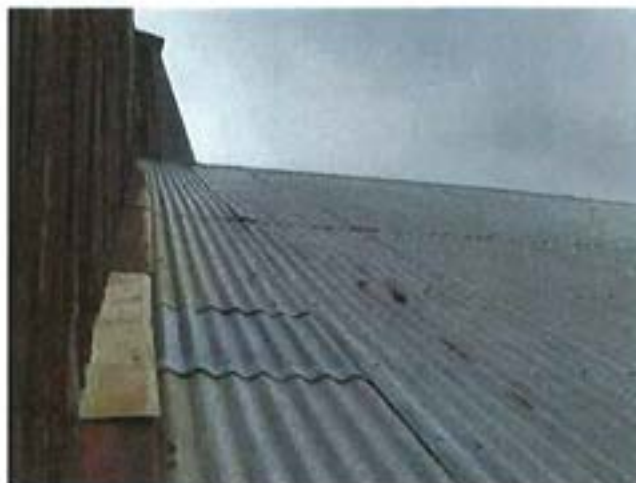
Photograph 1

- 4.5 The gutter is lined with metal, which is buckled with areas of corrosion and ponding water which, suggest that it is not laid to adequate falls. There is a build-up of debris at the parapet which will require periodic clearing. The redundant downpipe within the gutter should be removed.

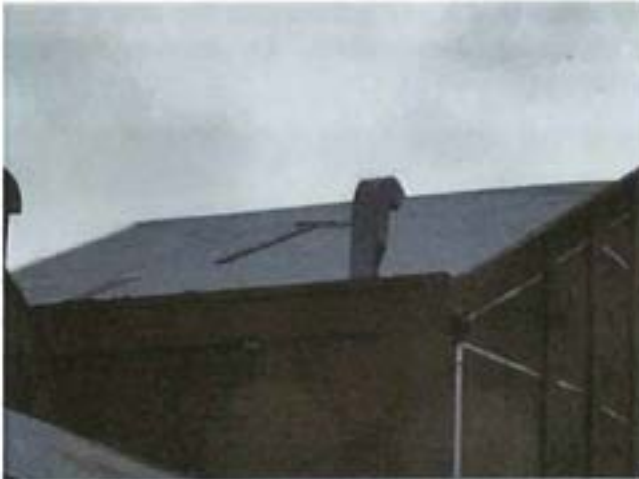
Photograph 4

- 4.7 The eastern roof has been covered with short-run corrugated sheet metal roofing, with associated ridge and apron flashings and appeared in reasonable to average condition when viewed from ground levels. The roof covering appears to be of older origin and secured with lead head nails. There are some lifted end laps between sheets and heads to the fixings, with some corrosion, which require monitoring to ensure that they remain weathertight.

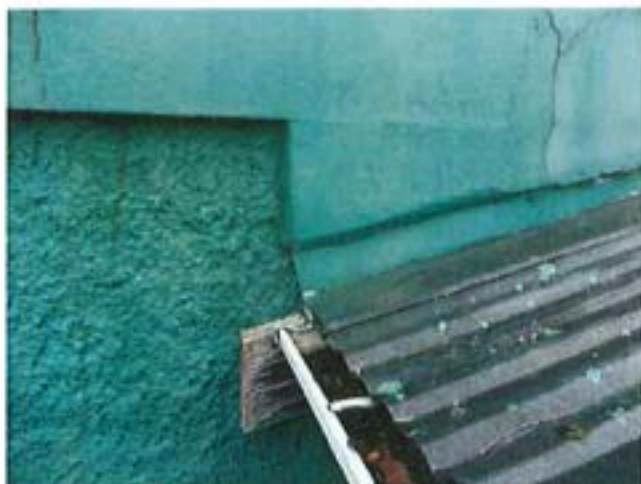
Photograph 8

- 4.8 The roof above the western entrance has been covered with painted, long-run corrugated sheet metal, with associated ridge and barge flashings and appeared in reasonable to average condition. There are paint spatters to the roof covering and the actual paint coting is deteriorating and would benefit from re-decoration.

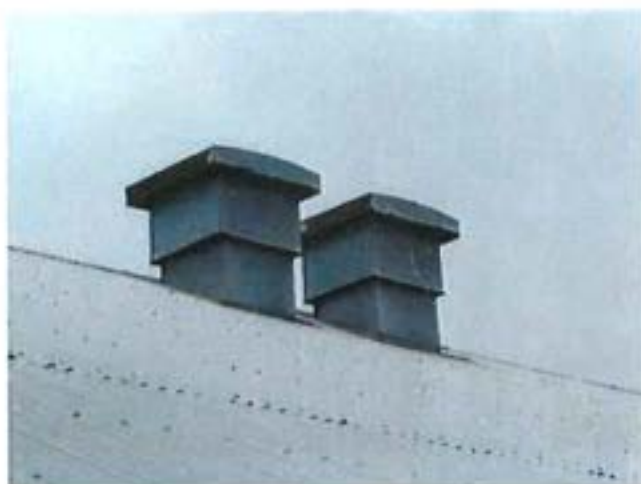
Photograph 12

- 4.9 The roof penetrations that were able to be viewed appeared to be remain adequately flashed, although the flues and metal flashings are corroding, in particular to the top edges behind the penetrations. All roof penetrations are considered to be weak points and will require ongoing monitoring.

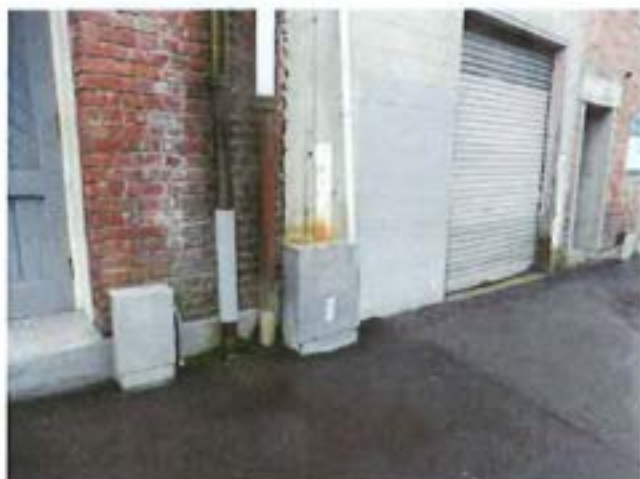
Photograph 14

- 4.10 Rainwater downpipes to the east are uPVC and are not adequately secured as the older metal brackets are re-used in places and these require replacement. The original metal pipe remains to the southern side at low level and would benefit from replacement. These downpipes discharge direct to the below ground drainage.

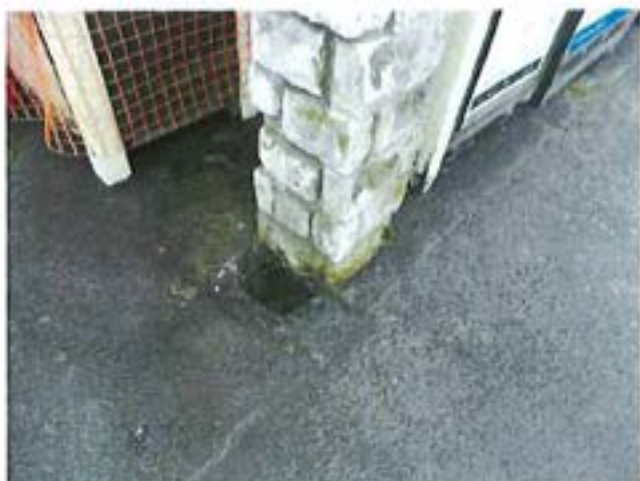
Photograph 18

- 4.13 The spouting is generally installed to minimum falls to the western entrance roof and these areas will require monitoring and cleaning on a regular basis. The rainwater downpipes to the entrance discharge clear of the property over gullies. The gullies should be properly cleared of all debris to ensure that water can flow away freely. The downpipes to the western columns are hidden behind the veneer and this is considered a high risk detail. The downpipes should be re-installed externally and connect to the below ground drainage.

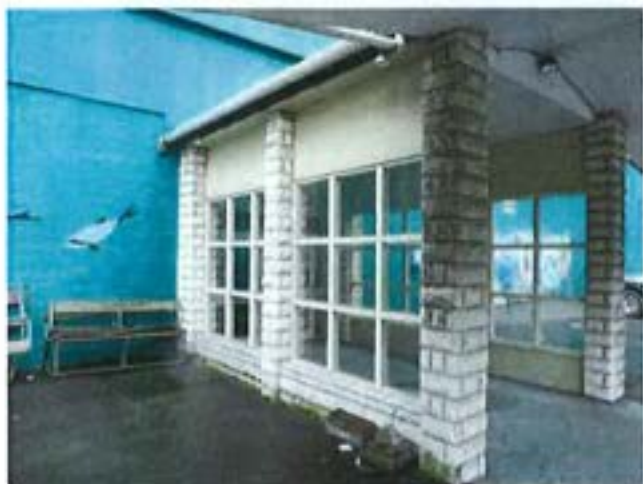
Photograph 29

- 5.5 The signage to the entrance is in poor condition, likely as a result of aging and deferred maintenance, with a number of lightbulbs missing. The painted timber fascia boards appeared in poor condition and decorative order. The fascias behind the spouting have not been re-decorated and there is paint failure to these hidden areas. Consideration should be given to removing the spouting when re-decorating the fascias. There may be some areas of decayed timber that require replacement.
- 5.6 The entrance corridor at the main door has infill timber windows with Georgian wired glazing and fibre cement cladding above, which is in reasonable to average condition and decorative order; the timber requires re-decoration.

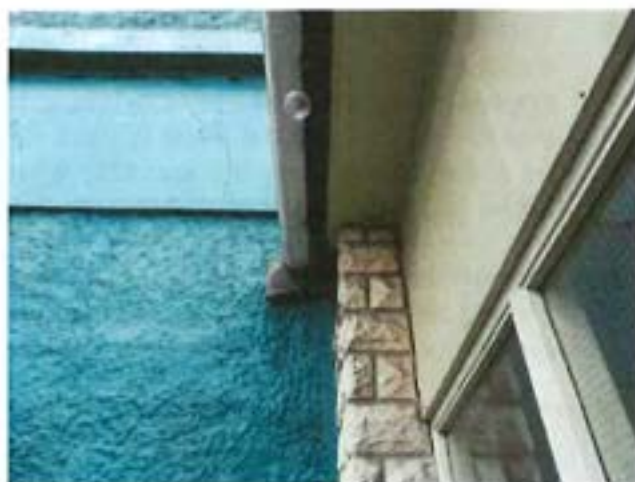
Photograph 33

- 5.8 There is open cracking between the concrete masonry, the fibre cement sheets at high level and the original solid plastered walls on the western elevation, which should be suitably sealed.

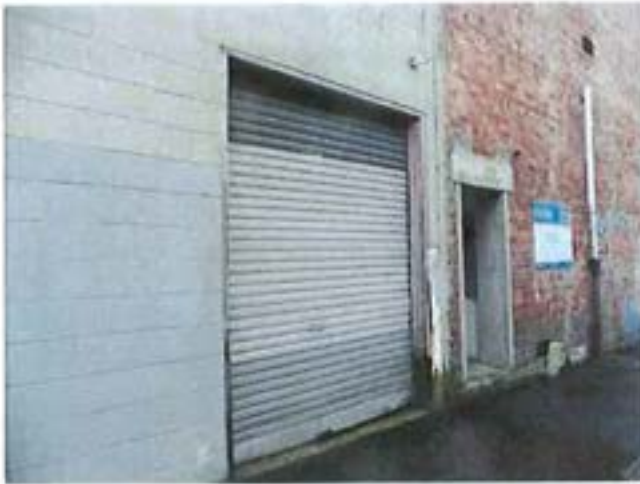
Photograph 58

5.33 The timber framing for the roller shutter door is in poor condition as a result of moisture and is mould stained and decayed.

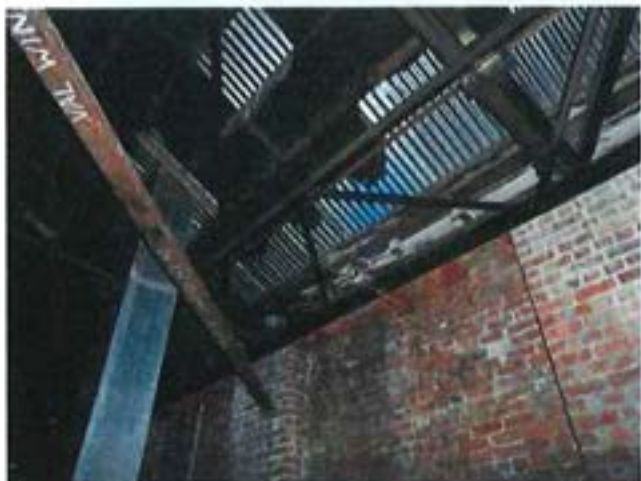
Photograph 80

7.4 The roof structure appears reasonable however, there is some moisture staining to the roofing timbers and to the hidden parapet gutters, which will require further investigation and monitoring. Additional steel bracing has been installed as part of the strengthening process and specialist comment may be required in this regard. Additional timber framing has been installed where ventilation ducting penetrates through the roof covering.

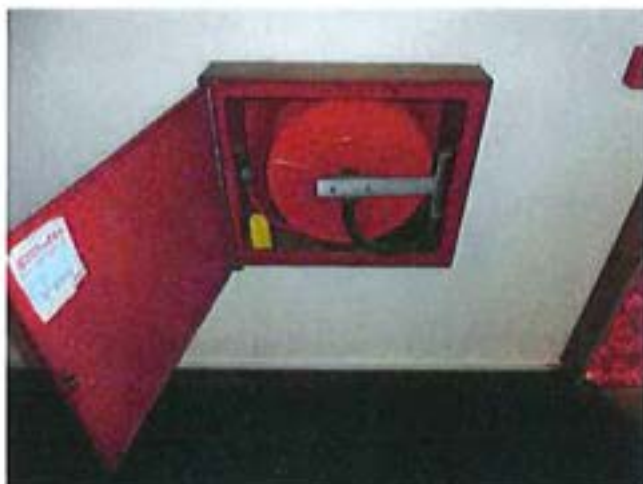
Photograph 168

- 10.4 The fire hose reel to the upper balcony is currently leaking and requires immediate attention.

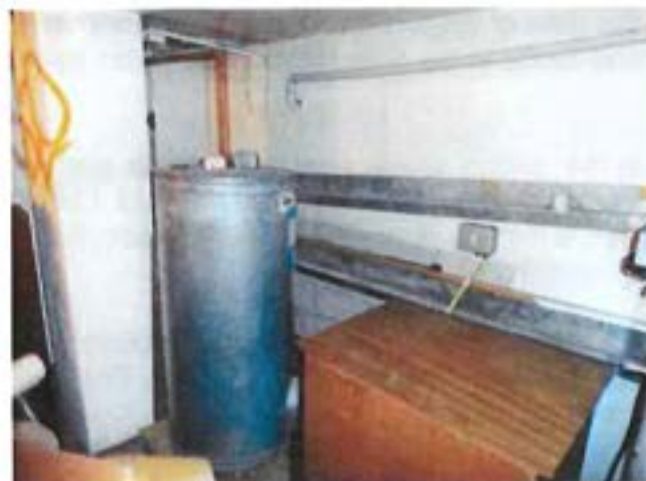
Photograph 174

- 10.7 There is another hot water cylinder located to the basement area to the southern side. This is a low pressure cylinder manufactured by 'Valley Industries' of Dunedin and has a capacity of 180 litres and a manufacture date of May 1991. This cylinder has not been seismically restrained. The cylinder sits onto a plywood platform and it appears that there may be some leakage. This requires further investigation and monitoring.
