Project Number: 6-CD109.55

Landslide Monitoring Report - Cargill Street, Dunedin Central

13 August 2021 CONFIDENTIAL

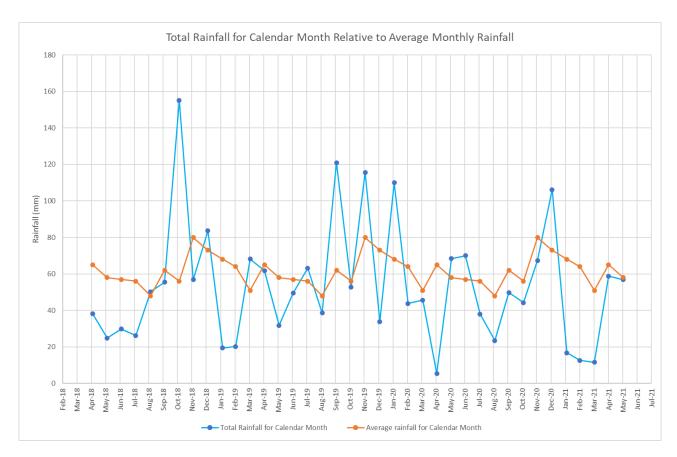
Figure 1 Measured monthly rainfall compared with average monthly rainfall (CliFlo.niwa.co.nz).

A summary of the rainfall data since the previous survey is presented in Figure 1 below. Data was retrieved from the NIWA (National Institute of Water and Atmospheric Research) National Climate Database website (CliFlo.niwa.co.nz) using the Musselburgh Station (Agent ID #15752). Mean monthly rainfall is calculated for the "Dunedin" area between 1981 and 2010 (source: https://niwa.co.nz/education-and-training/schools/resources/climate/meanrain).

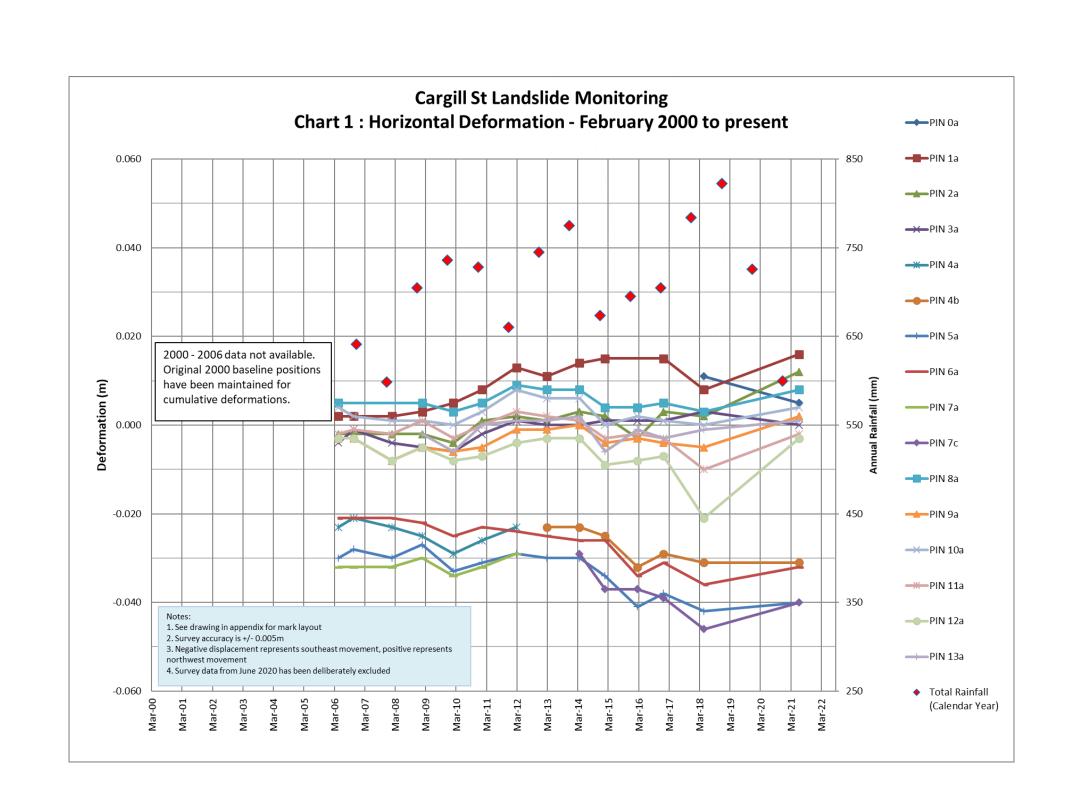
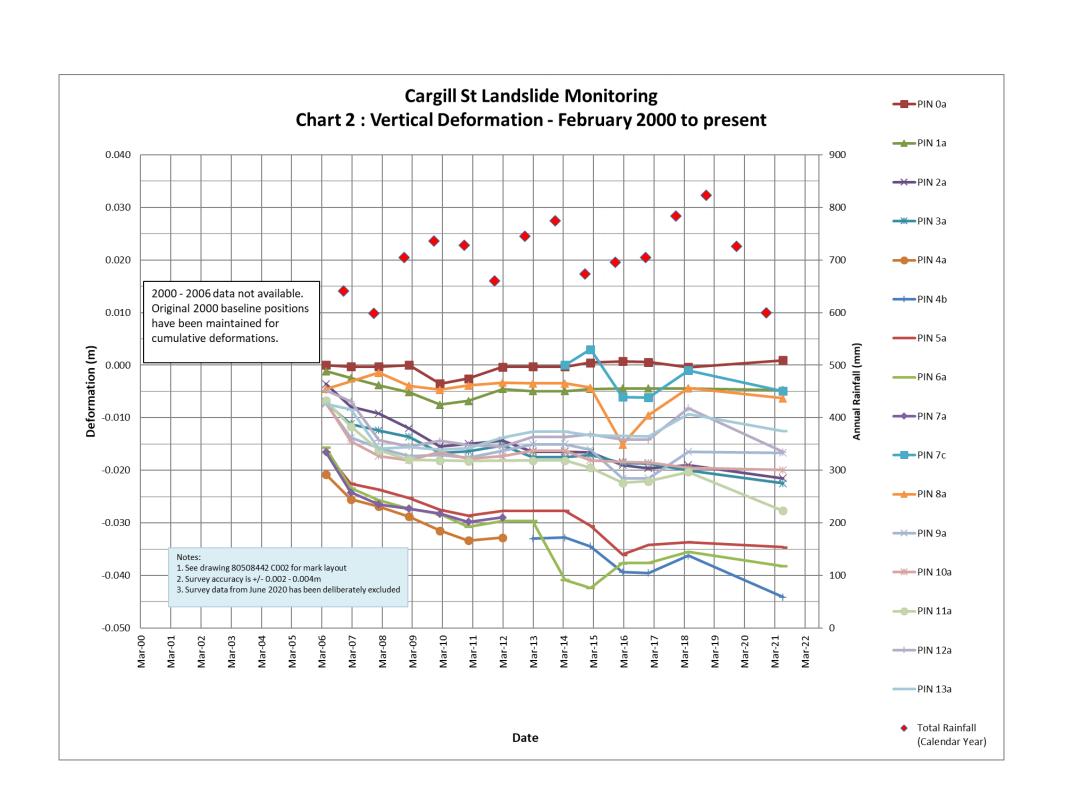
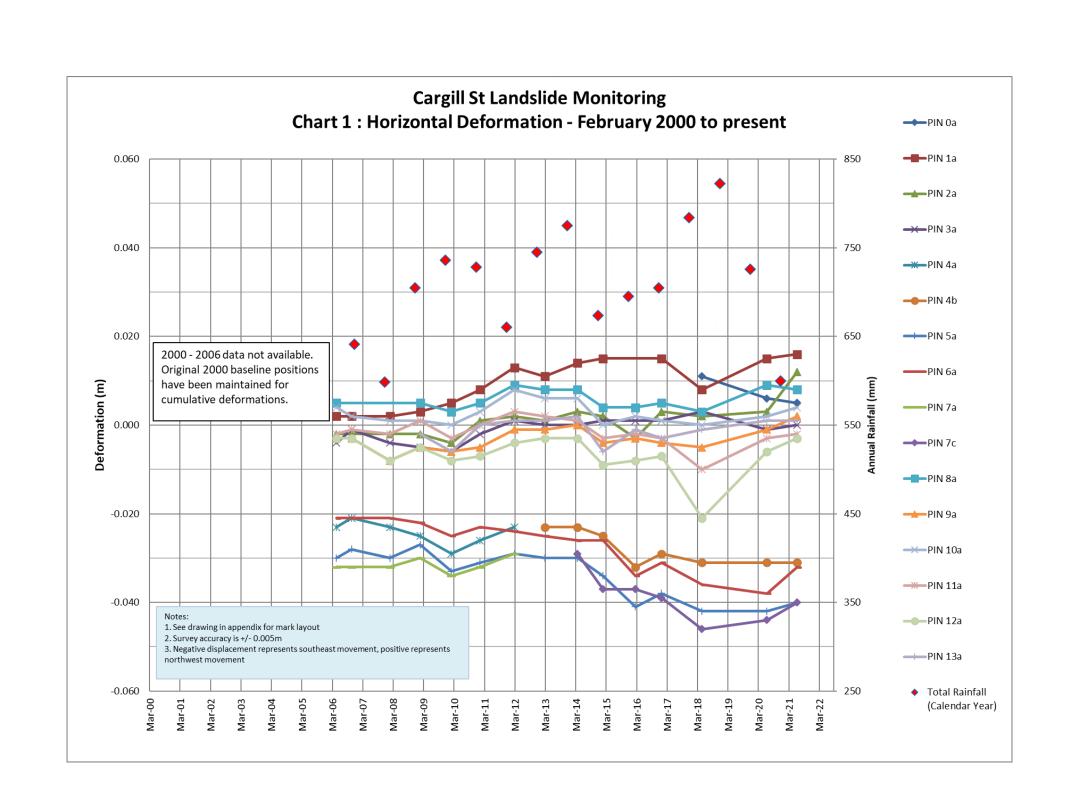
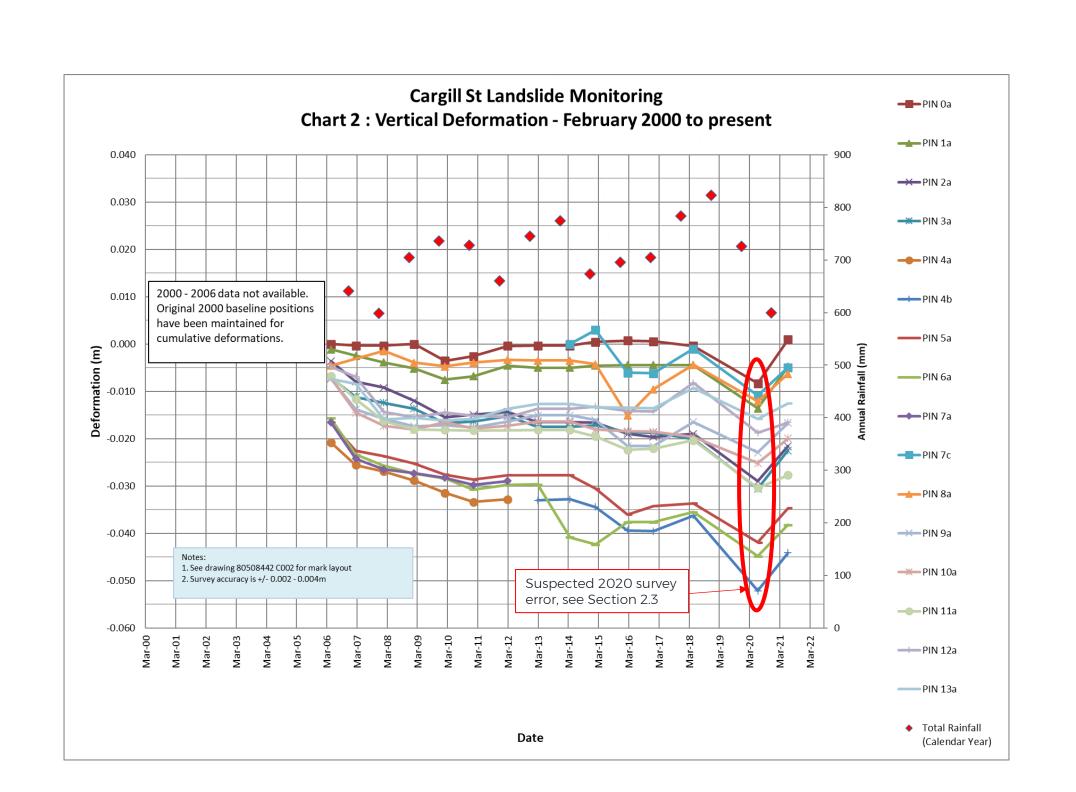
Appendix B Selected Monitoring Charts

Due to an inferred systematic survey error discussed in Section 2.3, Table 2 below compares the most recent survey with that from May 2018, rather than the previous survey undertaken in June 2020. While this inferred error relates only to vertical deformations, both horizontal and vertical deformations have been compared with that from 2018 to maintain consistency. Two versions of graphed data have been presented in Appendix B, the first excluding June 2020 survey data, and the second including it.

Within this report, characteristic landslide deformation has been defined as downslope movement in conjunction with vertical settlement. Either of these movements in isolation is likely related to a different mechanism such as consolidation, root jacking, retaining wall deflections etc. Only 4 marks (4b, 5a, 6a, and 7c) in this survey have exhibited movements consistent with landslide deformation.

Survey results indicate no negative horizontal deformation (downslope direction) exceeding the accuracy of the survey since 2018. Positive horizontal movements (in the upslope direction) of up to 18 mm have been recorded when compared with 2018, however these are considered unrelated to landslide deformation. The cause of these movements is currently unknown.

Of all marks considered related to landslide movement, an average settlement of 4 mm has been recorded when compared against 2018 data. The long-term average rate of settlement of these same marks since 2000 is equal to 1.4 mm/year, or 4.2 mm over 3 years since 2018.

The recorded displacements are generally aligned with the long-term average, suggesting that the acceleration of vertical movement highlighted in the 2020 report is most likely related to the survey error discussed in Section 2.3.

We recommend the continuation of survey monitoring at an annual interval with the next survey scheduled for June 2022. We also recommend consideration be given to installing additional baseline markers in consultation with WSP to improve reliability of the monitoring network in future.
