Project Number: 6-CD109.55

Landslide Monitoring Report – Dickson Street

6 April 2023 CONFIDENTIAL

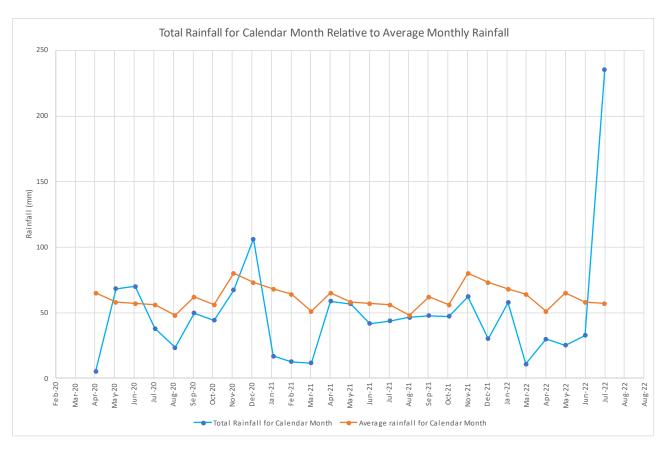
Figure 1: Measured monthly rainfall compared with average monthly rainfall (CliFlo.niwa.co.nz).

A significant rainfall during July 2022 is evident in Figure 5, whereby 235 mm was recorded in the calendar month, including 97.6 mm on 12-13 July and 94.6 mm on 26-28 July 2022.

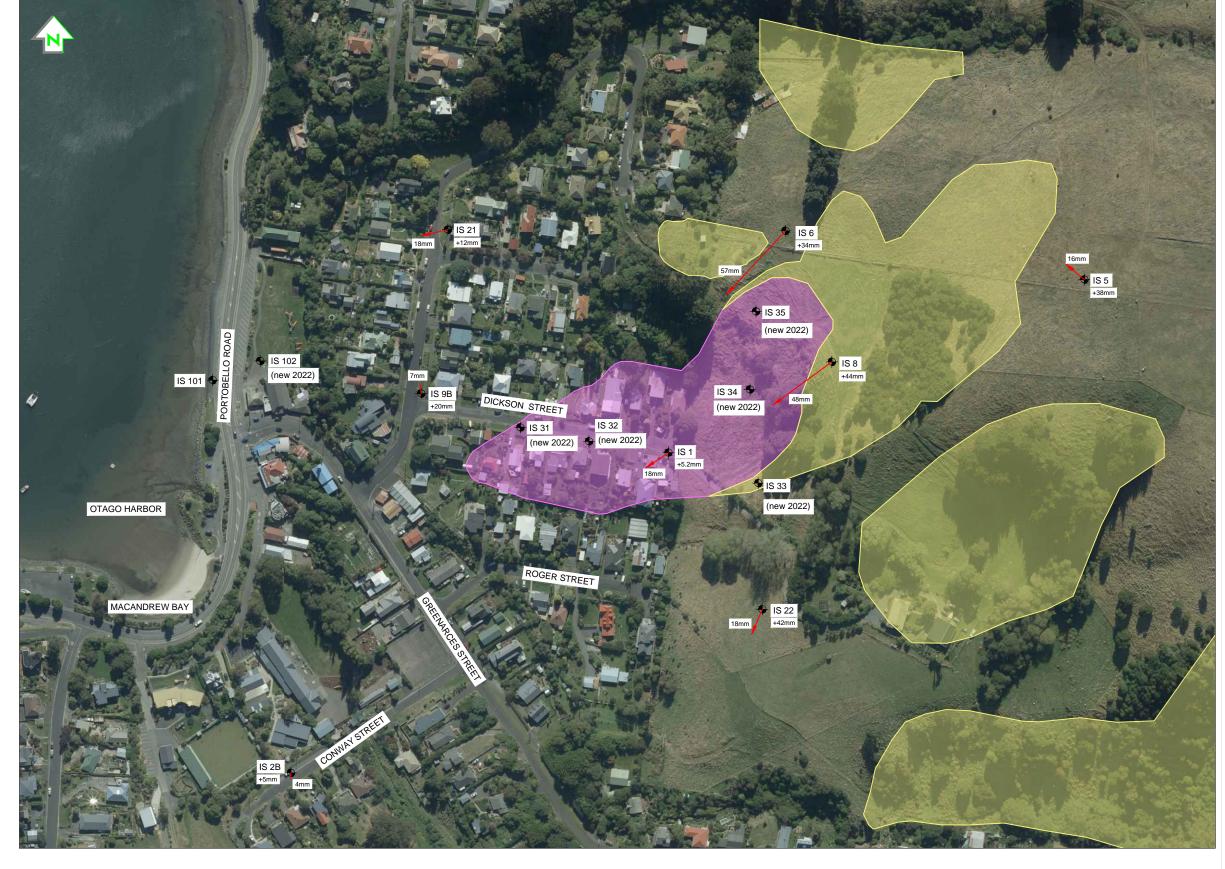
Appendix A Mark Displacement Diagram

The maximum displacements recorded since the base survey was completed are as follows:

- 57 mm horizontal,
- 52 mm vertical.
