Landslide Monitoring 2014/15

Dunedin City Council – Civil Defence Landslide Monitoring 2014/15 Brighton Road (Survey #17)

Dunedin City Council – Civil Defence Landslide Monitoring 2014/15 Cargill Street (Survey #10)

DCC CD Landslide Monitoring 2014/15
Cockerell Street Slide, Brockville

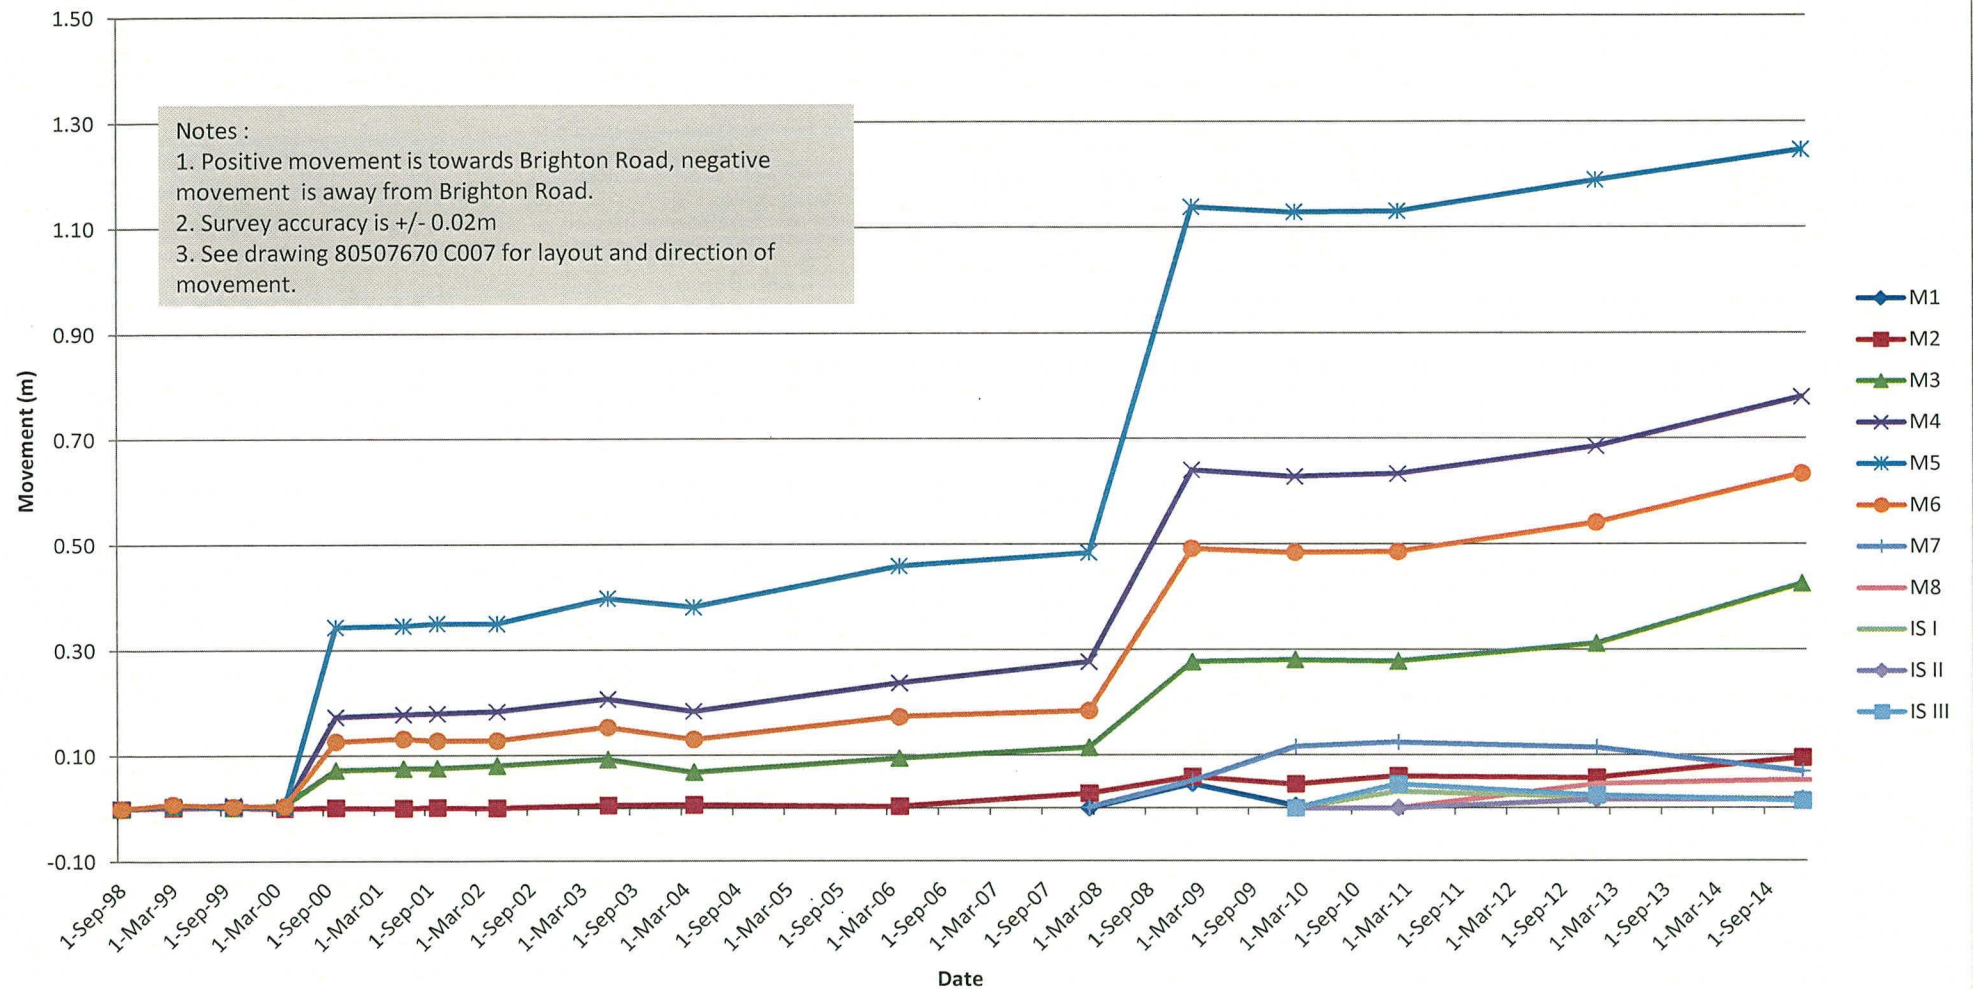
Chart 1: Cumulative Horizontal Movement

The maximum total horizontal movement is 1.25m and this has occurred over a 17 year period. Significant movement of 0.34m has occurred between October 1999 and April 2000 and 0.66m between February 2008 and February 2009. There has been minimal movement outside of these two periods.

Chart 1 shows the cumulative horizontal movement. Over the past two years there has been between 46-116mm horizontal movement at marks M3 to M7. This movement has been in a southerly direction and there has also been between 17-29mm vertical movement at these marks as shown in Chart 2.

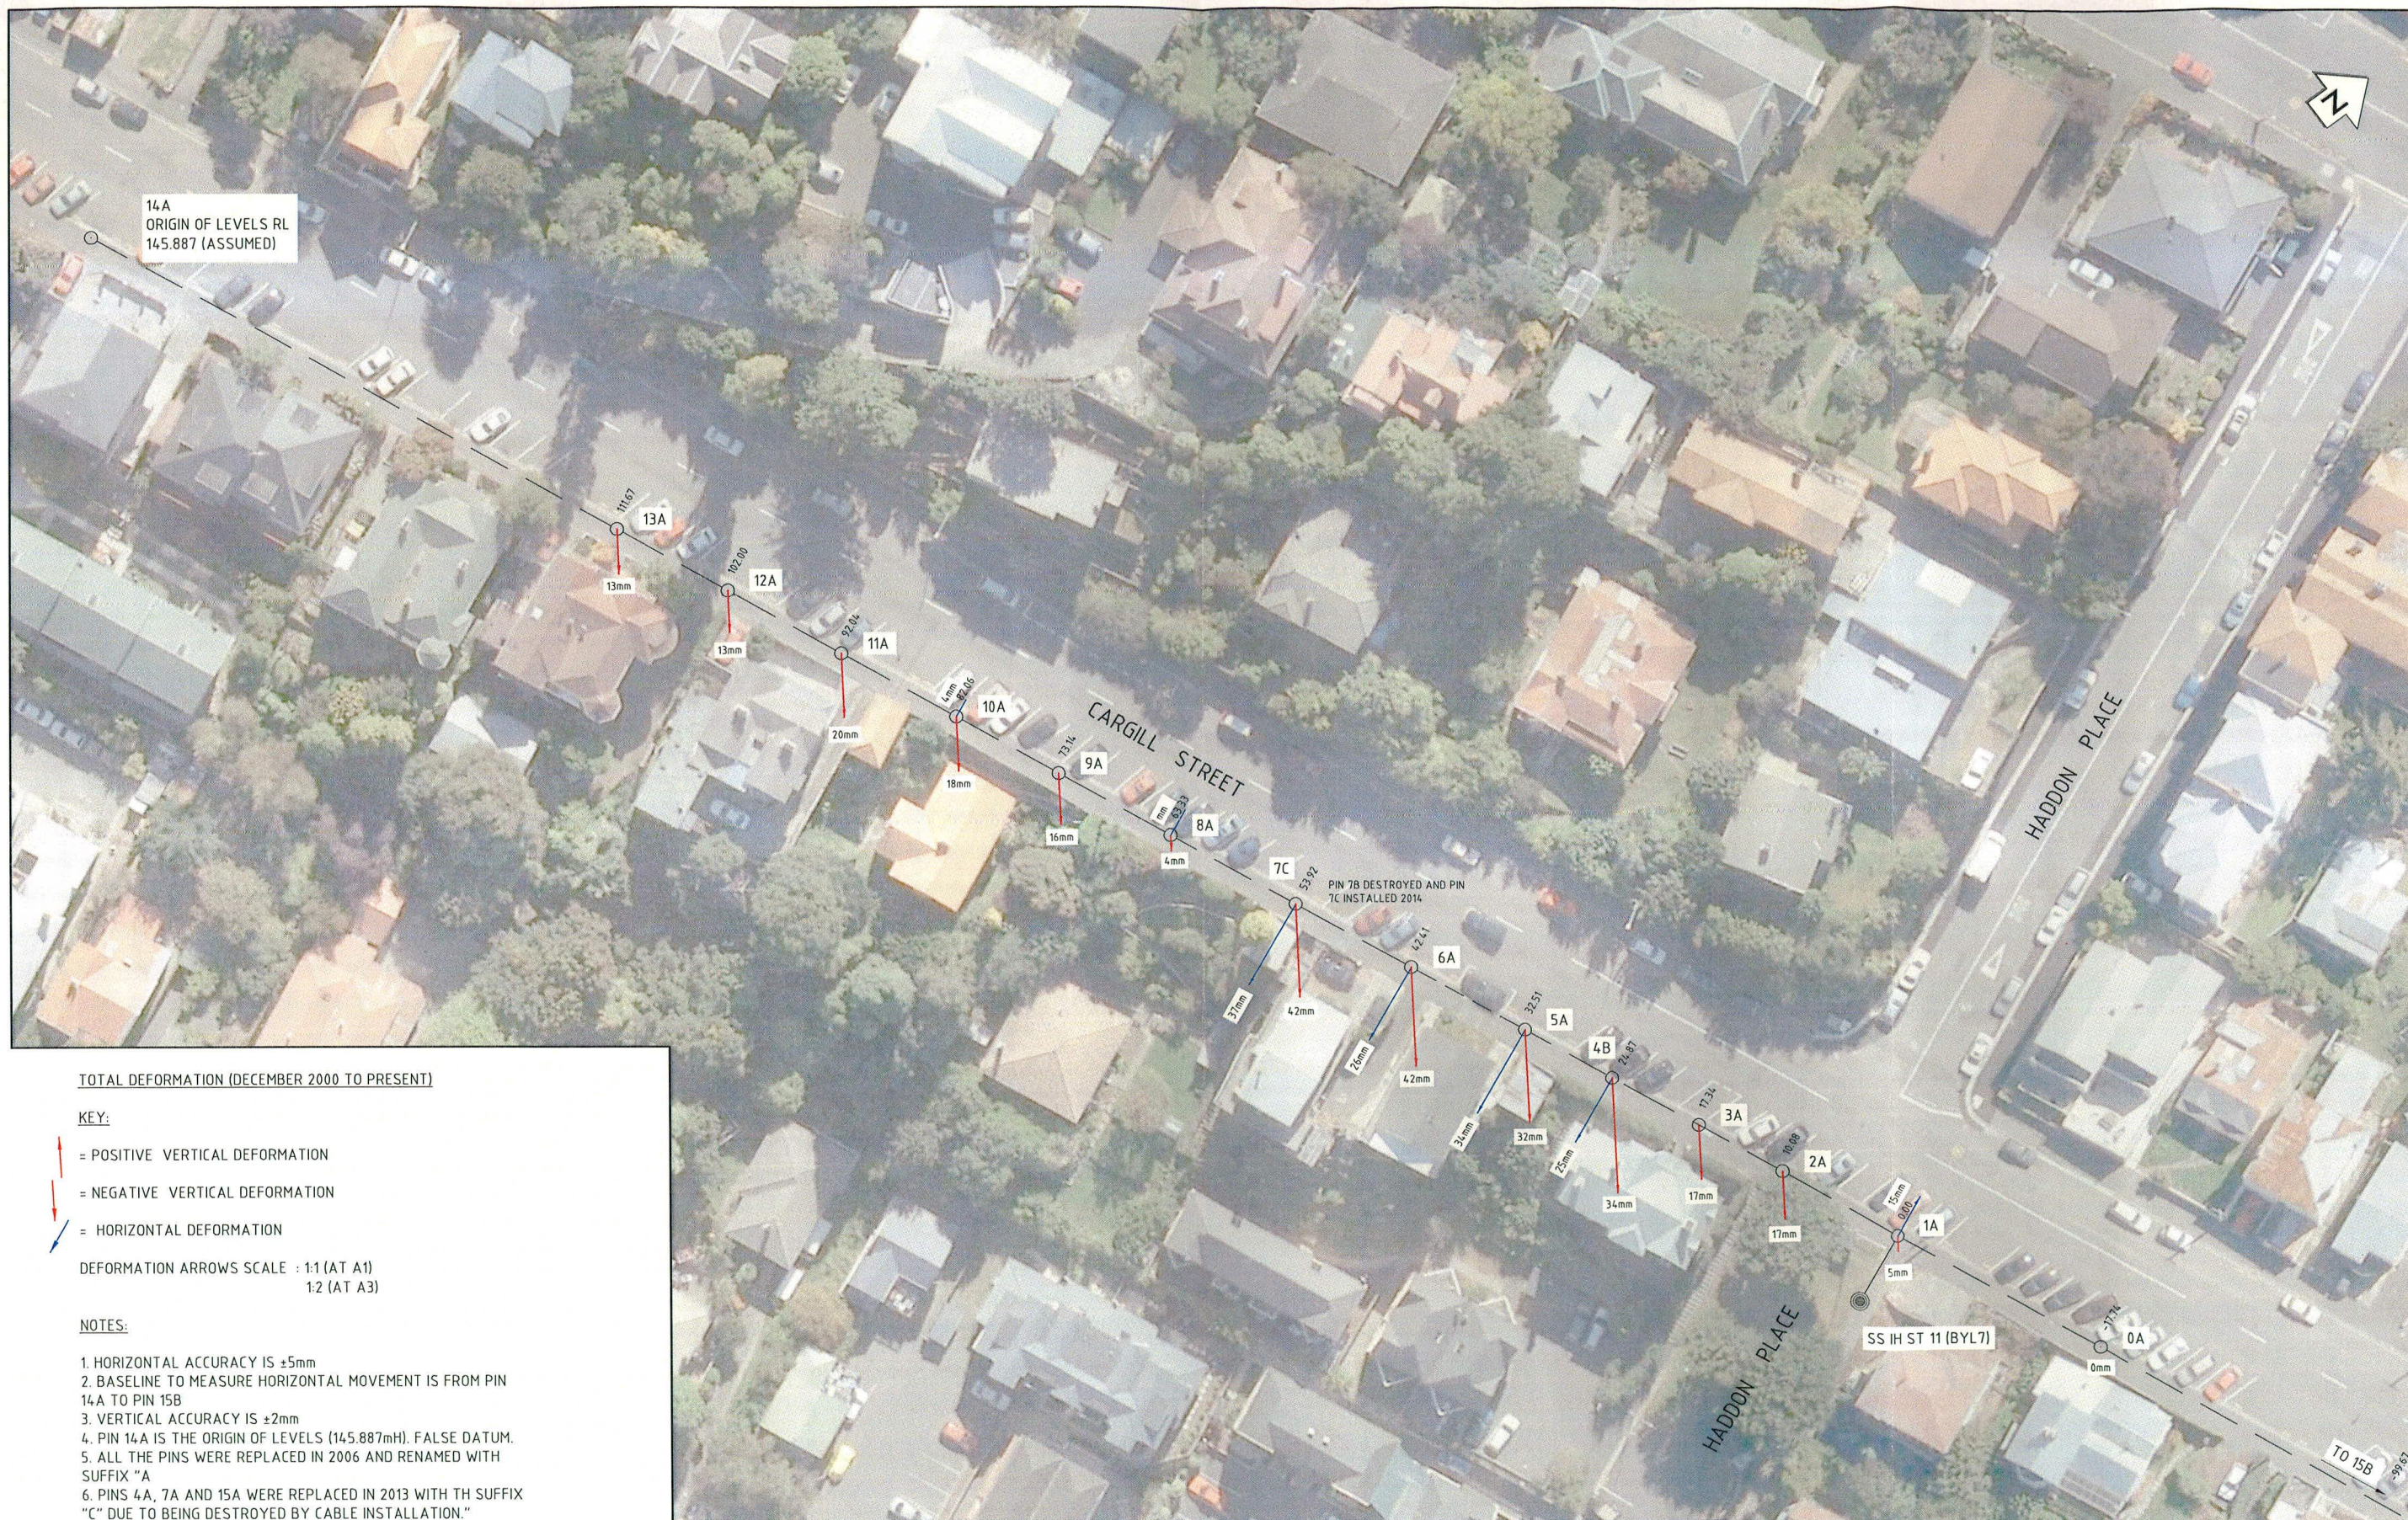
CARGILL STREET
MONITORING PLAN 2015

TOTAL DEFORMATION (DECEMBER 2000 TO PRESENT)

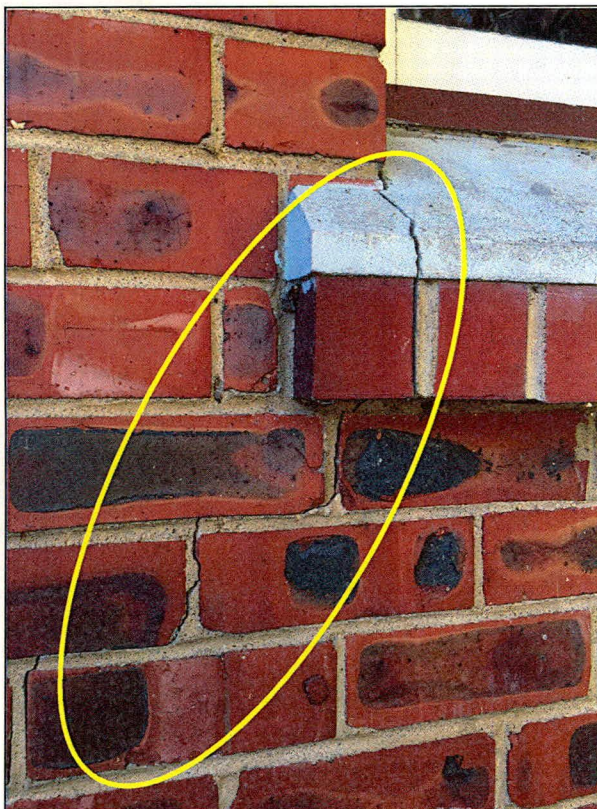
West Fall – Left Window – corner crack – left sill

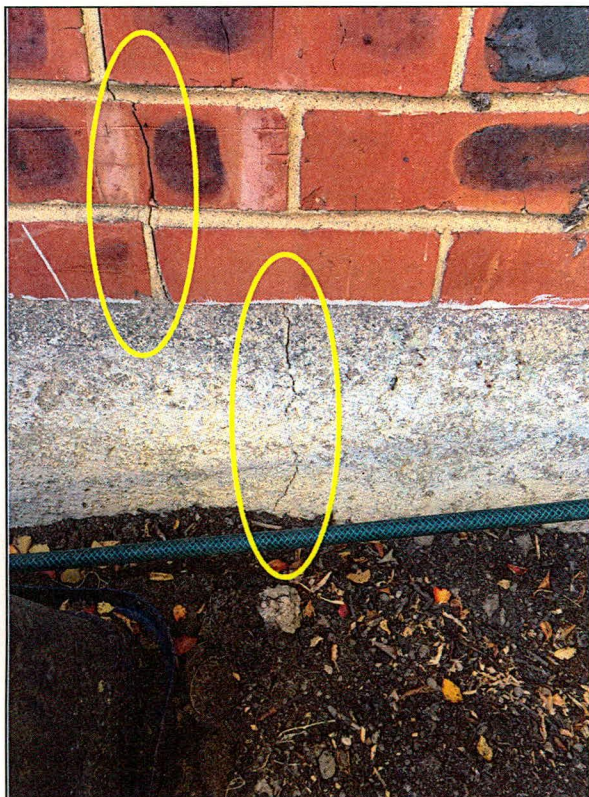
West Fall – Left Window - foundation

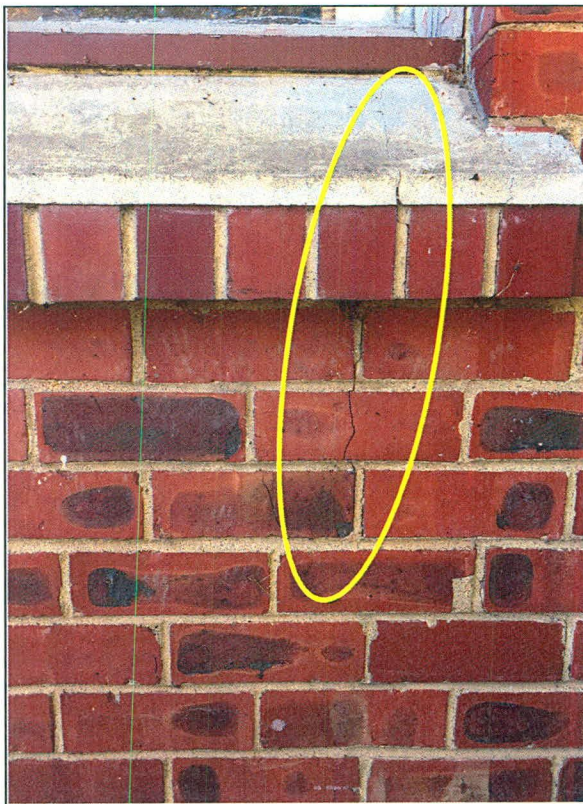
West Fall – Left Window – corner crack – right sill

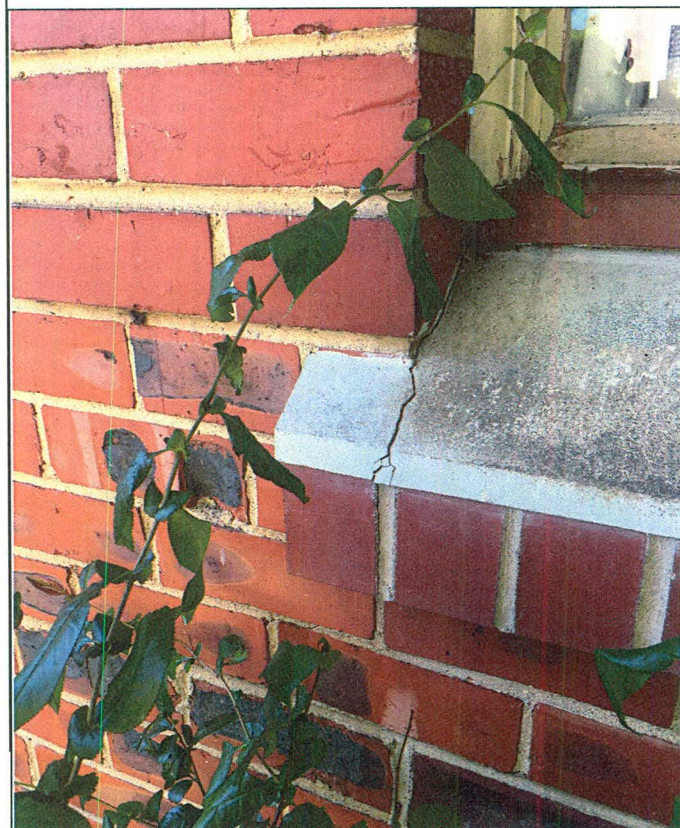
West Fall – middle Window – corner crack – left sill

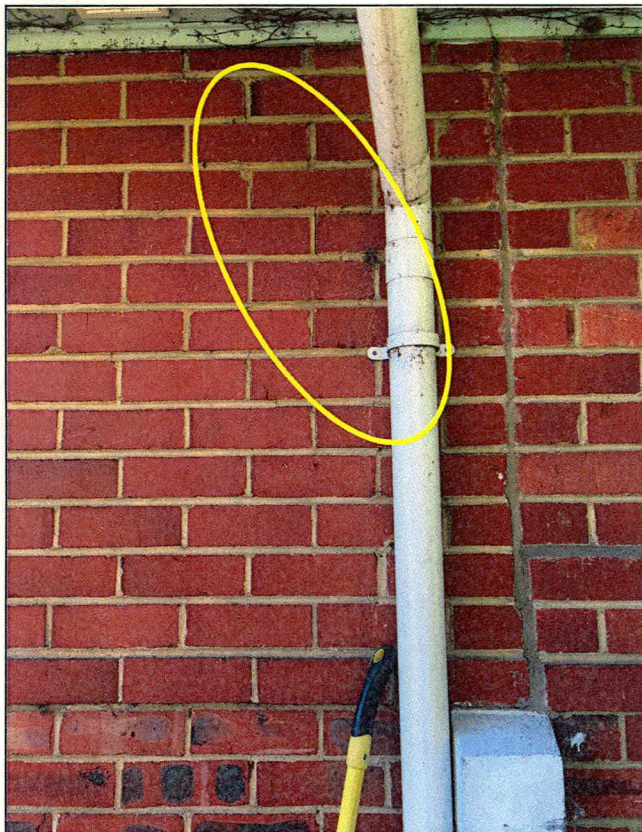
West Fall – masonry movement joint

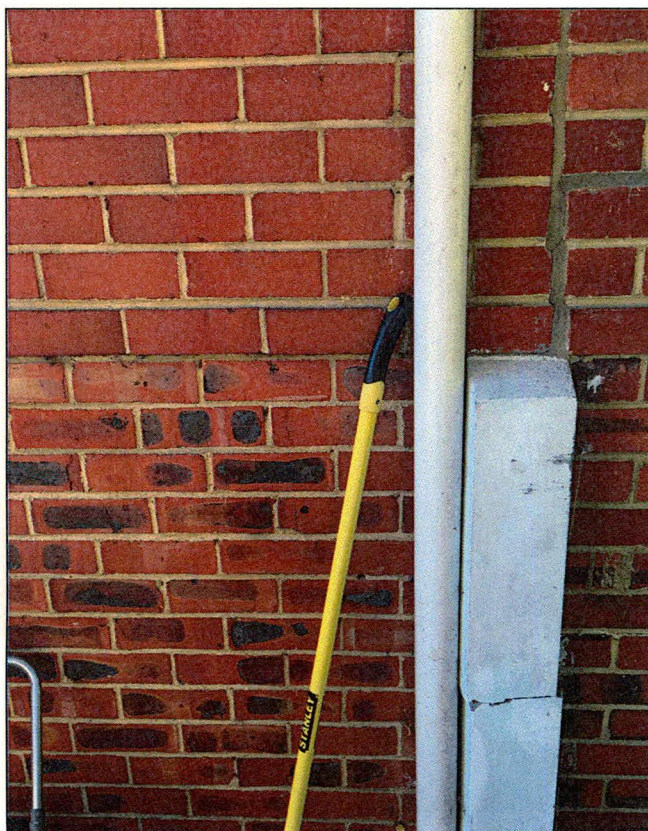
West Fall – masonry movement joint

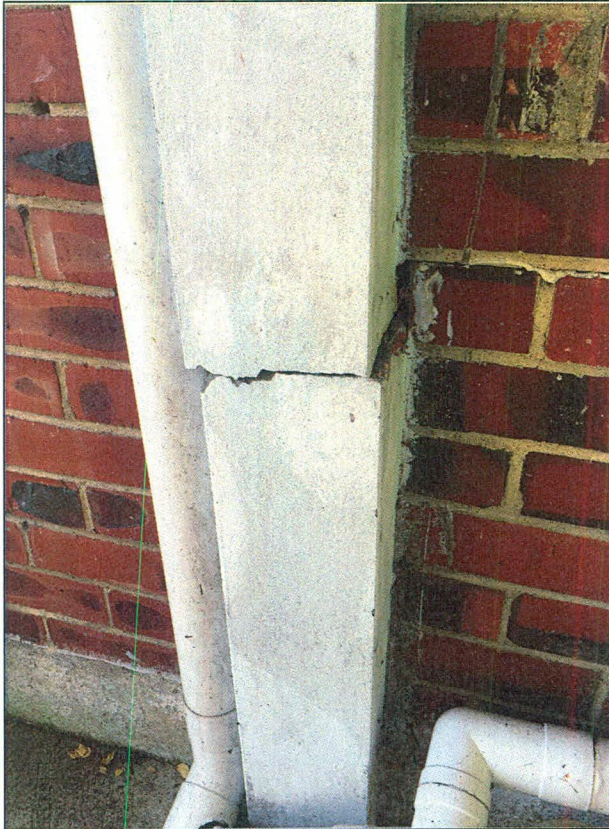
West Fall – masonry movement joint- service box

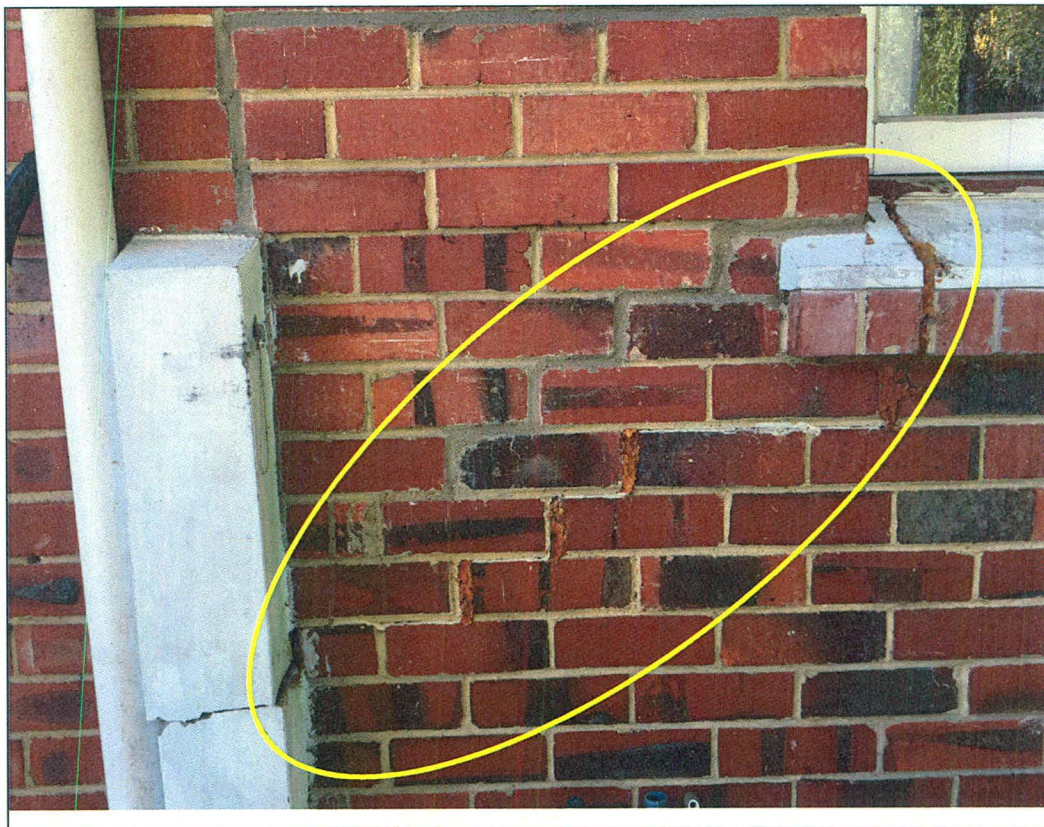
West Fall – Right Window – corner crack – left sill separation

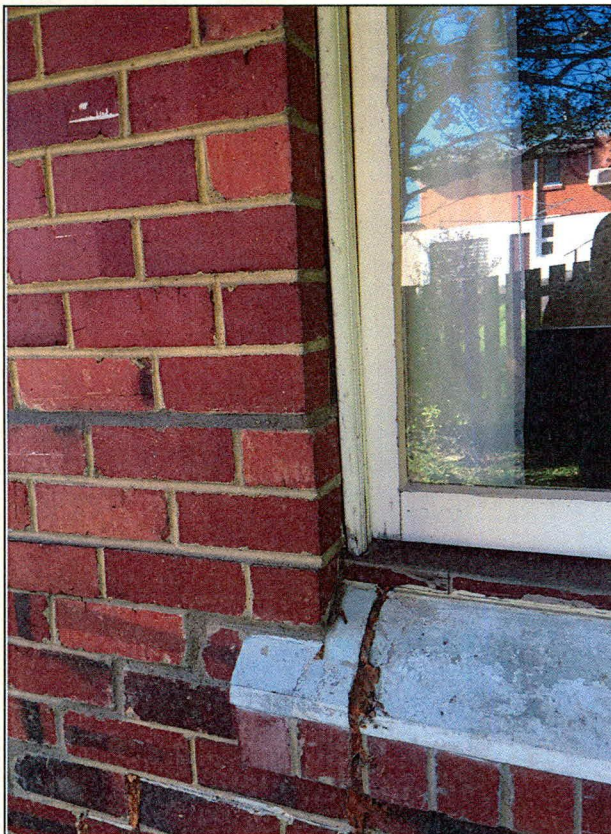
West Fall – Right Window – corner crack – left sill separation

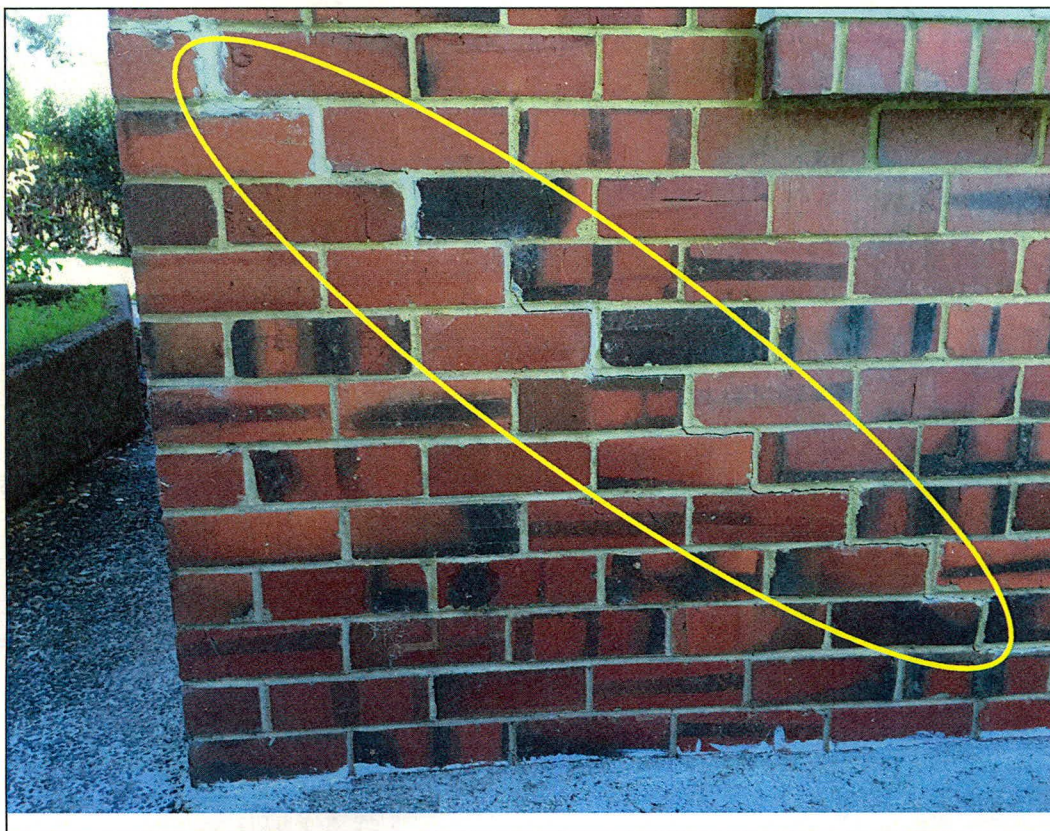
SW Corner – filled crack mortar

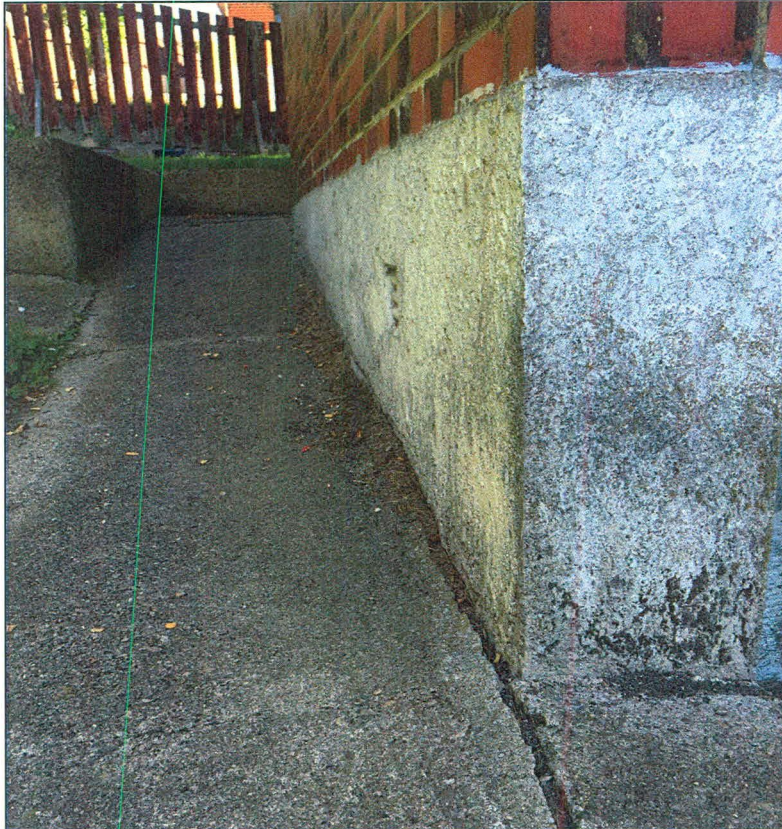
SE Corner – path separation

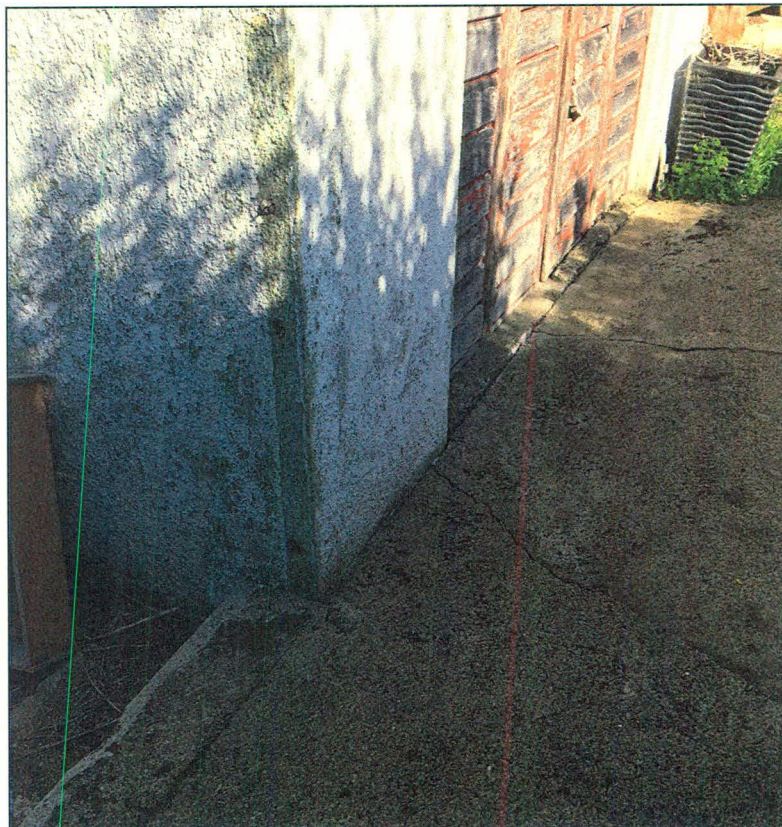
NE Corner – path separation

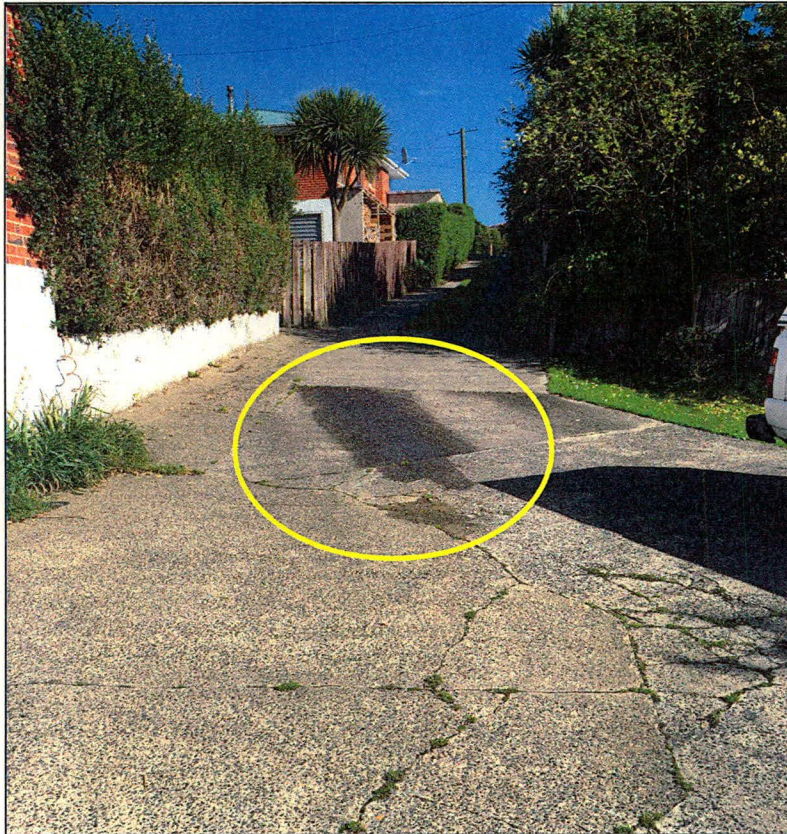
We are concerned that the current drainage, which was designed to positively drain out through the body of the slip (down the driveway) and discharge beyond the slip, appears to be discharging / bubbling up to ground surface at the bottom of the driveway. This may be indicative of a further blockage / breakage within the drain or outlet, and should be investigated, and cleared / repaired if necessary.

Driveway showing discharge of drains to surface

We suggest that a CCTV survey of the drainage is undertaken in order to confirm efficacy.

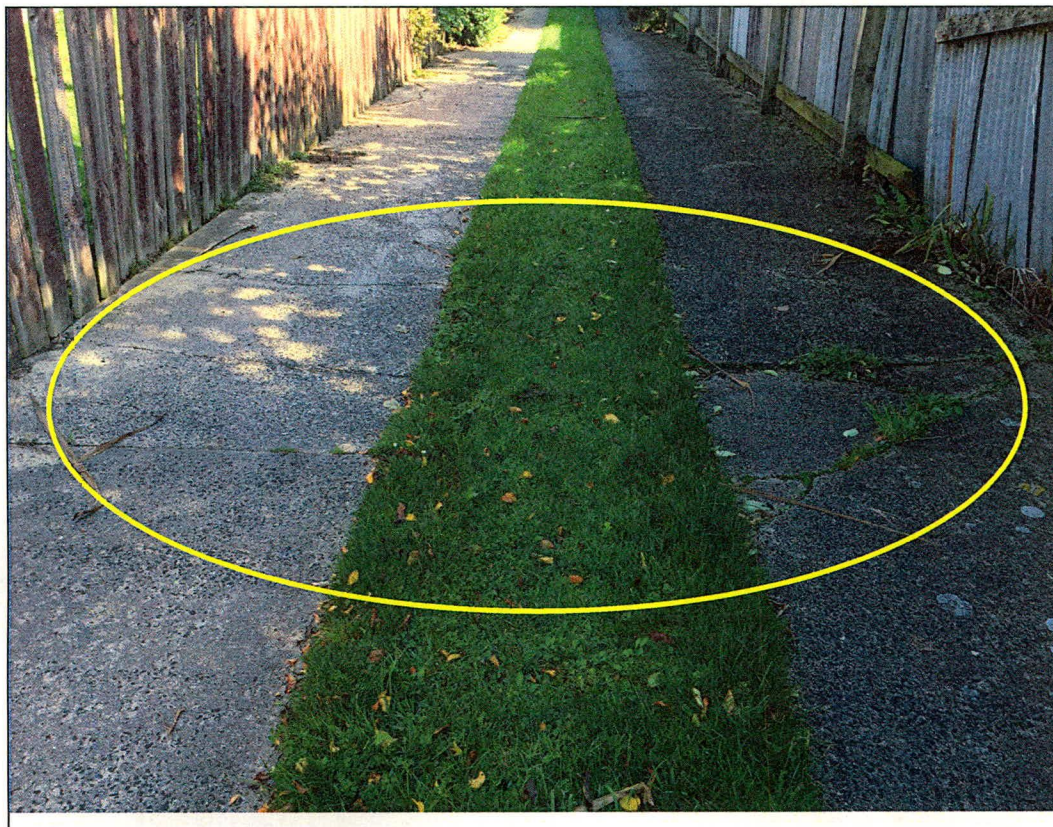
Driveway showing angled paving breakage (former scarp)

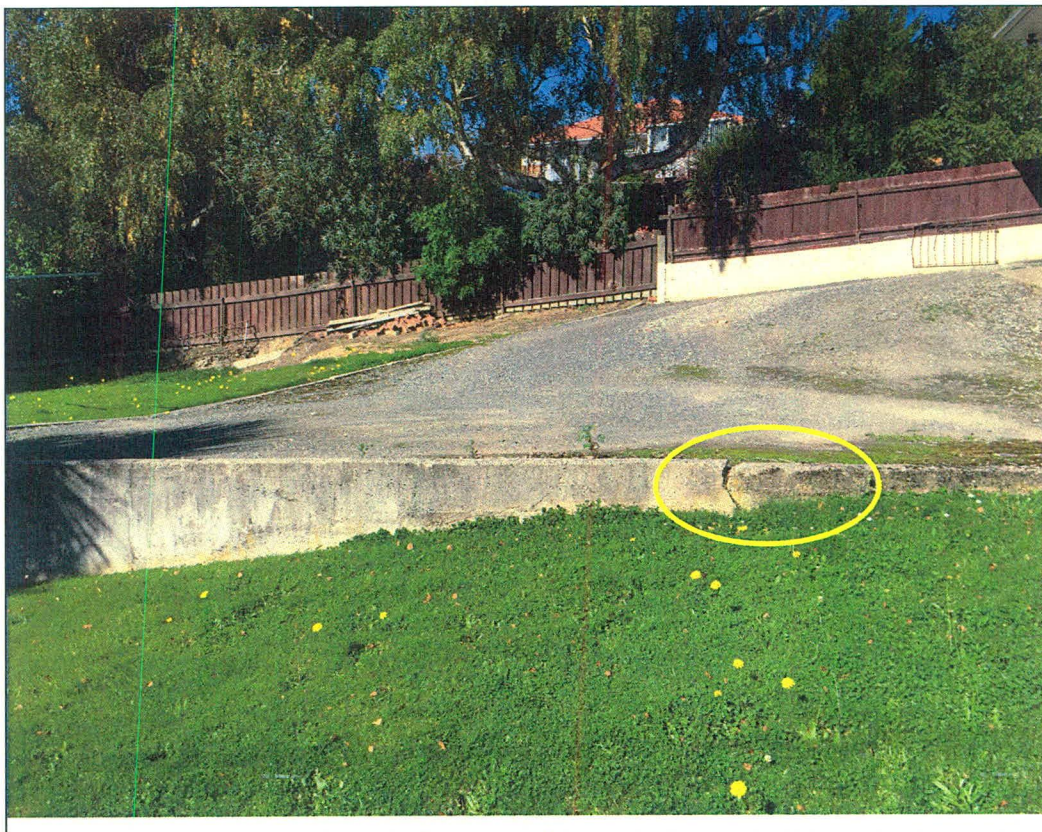
Rear platform to 239 Brockville – separating concrete wall.

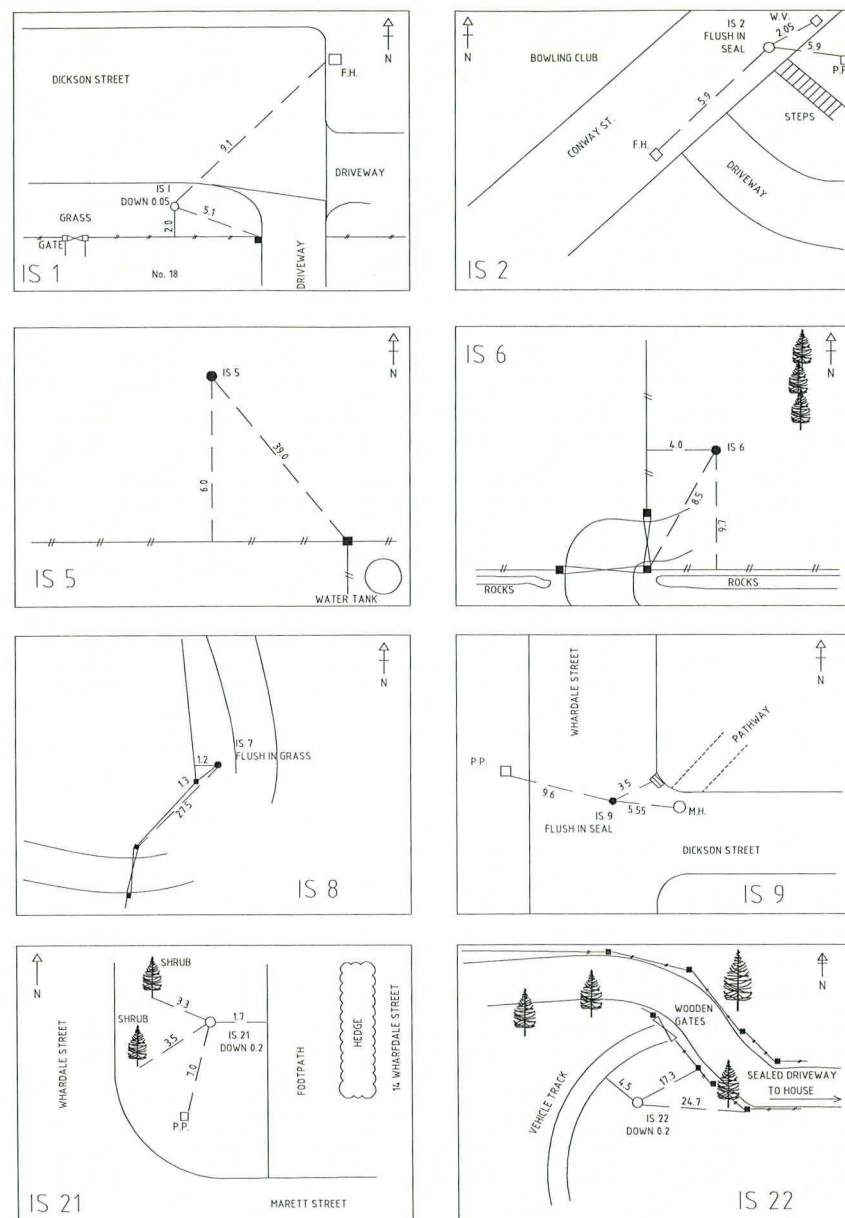
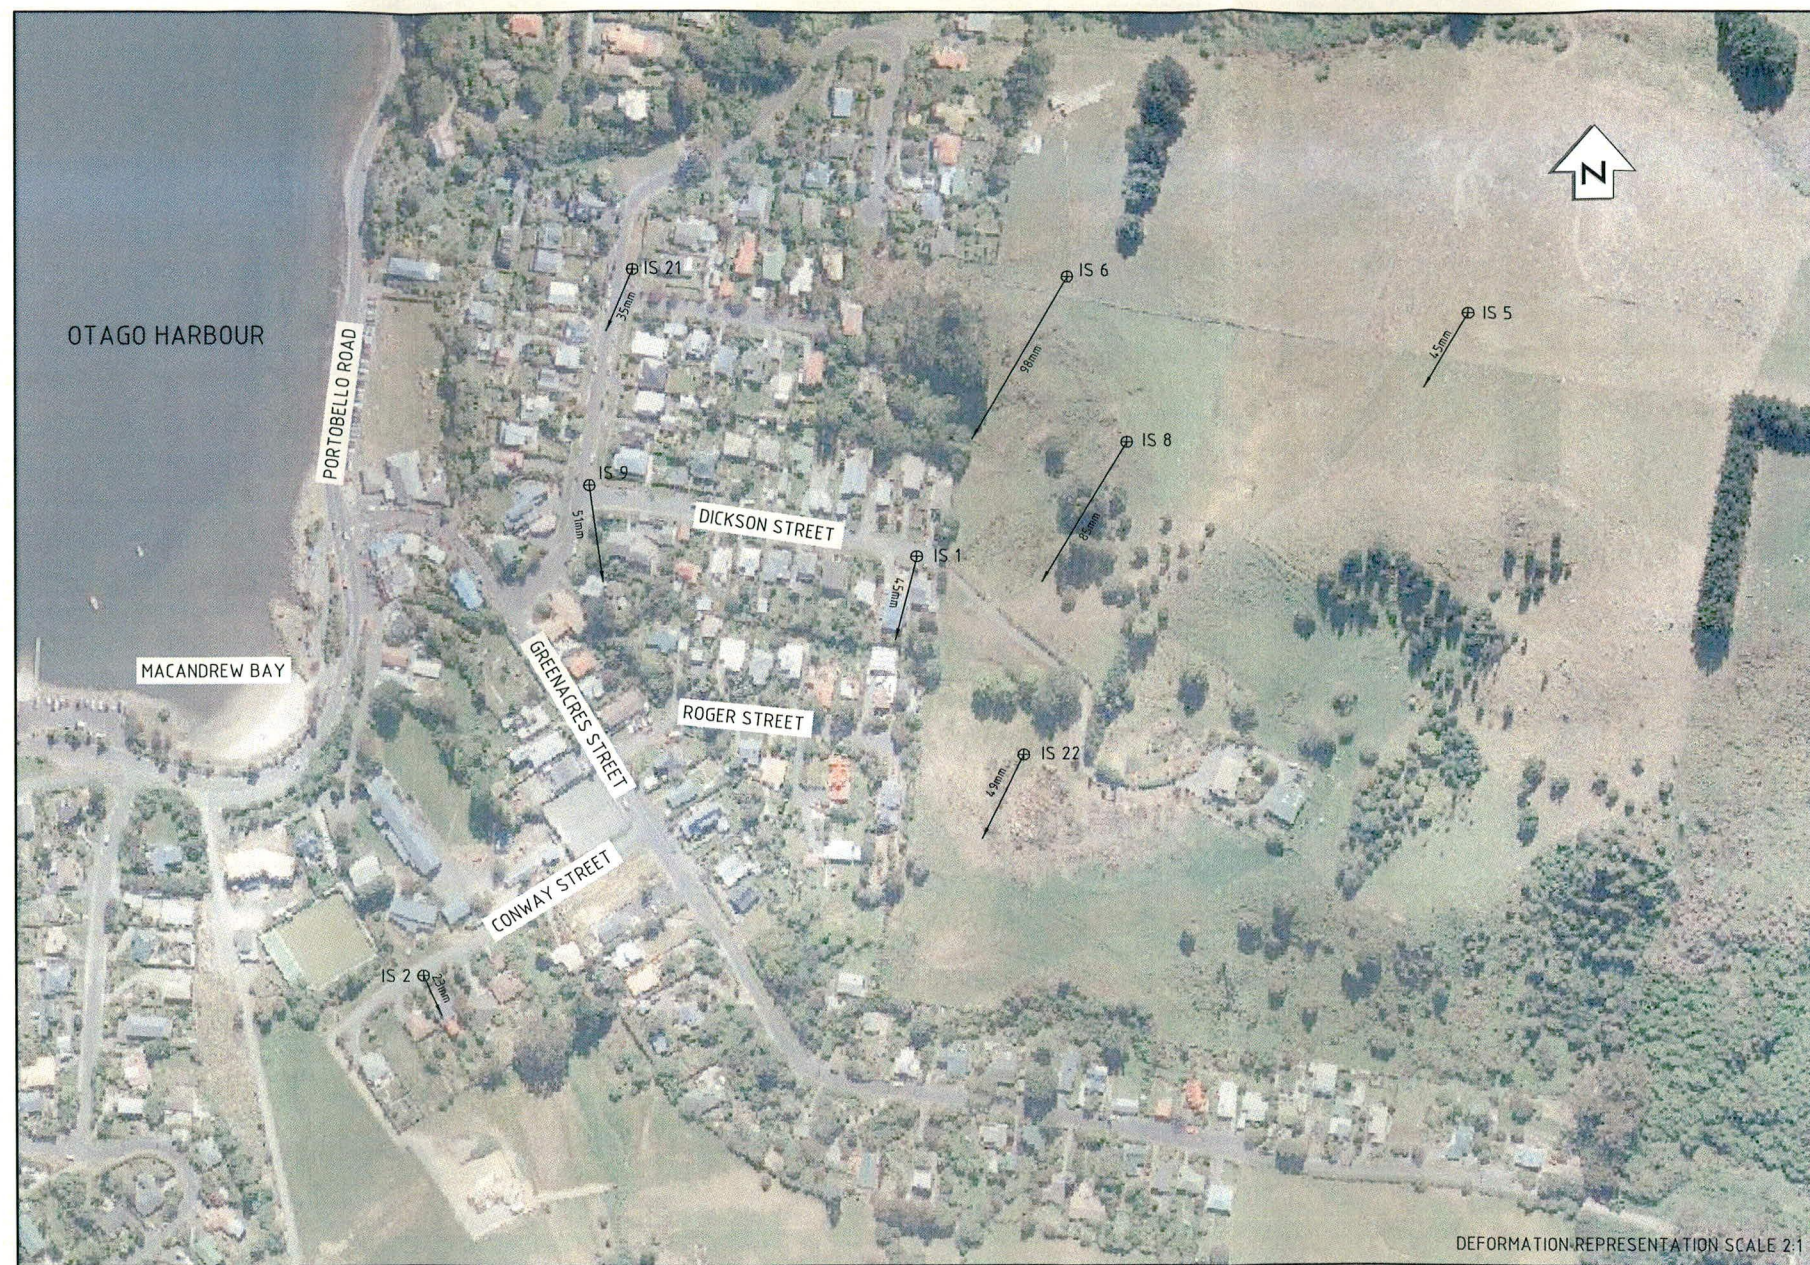
DICKSON STREET LANDSLIP
DEFORMATION PLAN 2015

The greatest movement was observed at IS6 (68mm) and IS8 (78mm) which are situated at the top of hummocky ground.

The Dickson Street site has cumulative movement of between 23-51mm. This has occurred at all marks except IS1, IS6 IS8 and IS9, which are slightly higher at 45-98mm. This movement is generally in a southerly direction. This movement is counter intuitive to the anticipated down-slope direction of movement, being towards the Greenacre Street valley. We will continue to monitor it in future surveys.

A resurvey of the site is currently scheduled for early 2017. A resurvey sooner would be able to confirm if it is moving.

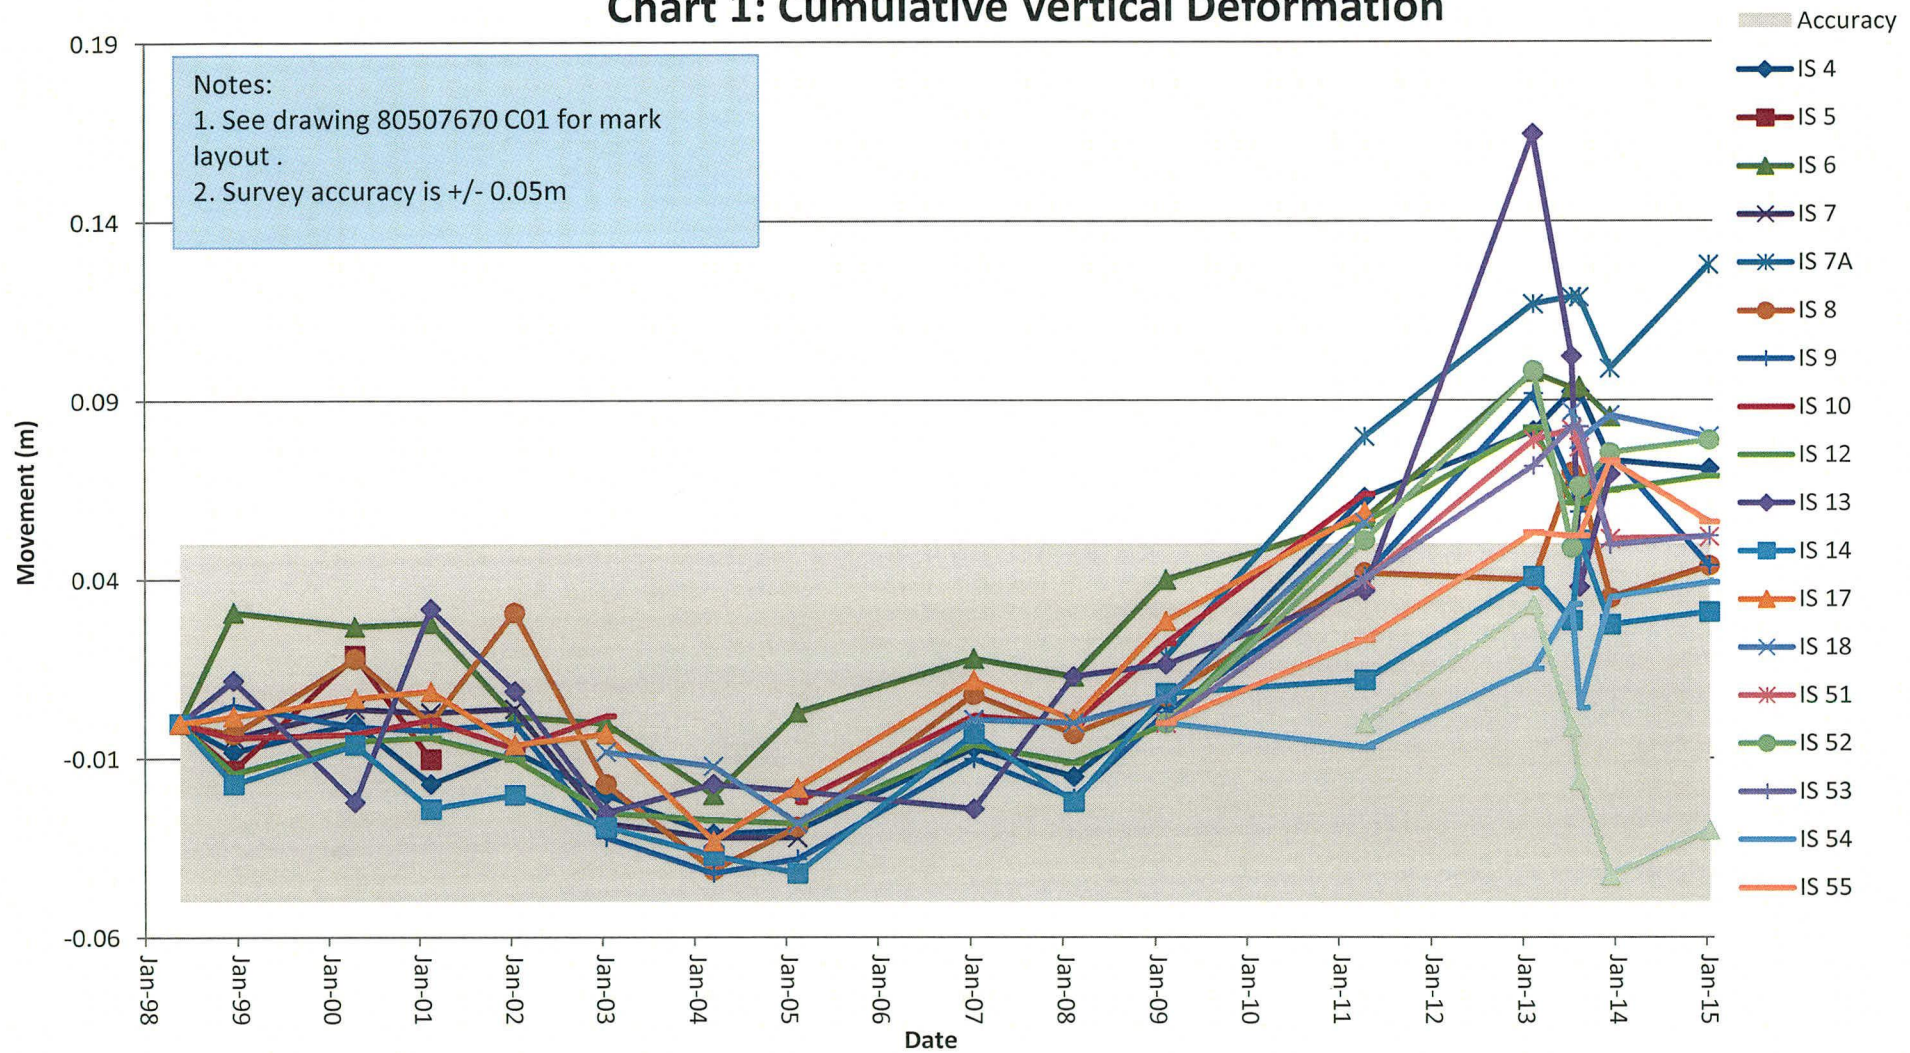
Chart 1: Cumulative Vertical Deformation

The observed displacements are in the range of 3-33mm for all marks since the previous survey. Most displacement vectors are at or close to the practical limit of accuracy for RTK GPS and our analysis indicates that these are unlikely to represent significant displacement.
