Landslide Monitoring 2014/15

Dunedin City Council – Civil Defence Landslide Monitoring 2014/15 Brighton Road (Survey #17)

Dunedin City Council – Civil Defence Landslide Monitoring 2014/15 Cargill Street (Survey #10)

DCC CD Landslide Monitoring 2014/15
Cockerell Street Slide, Brockville

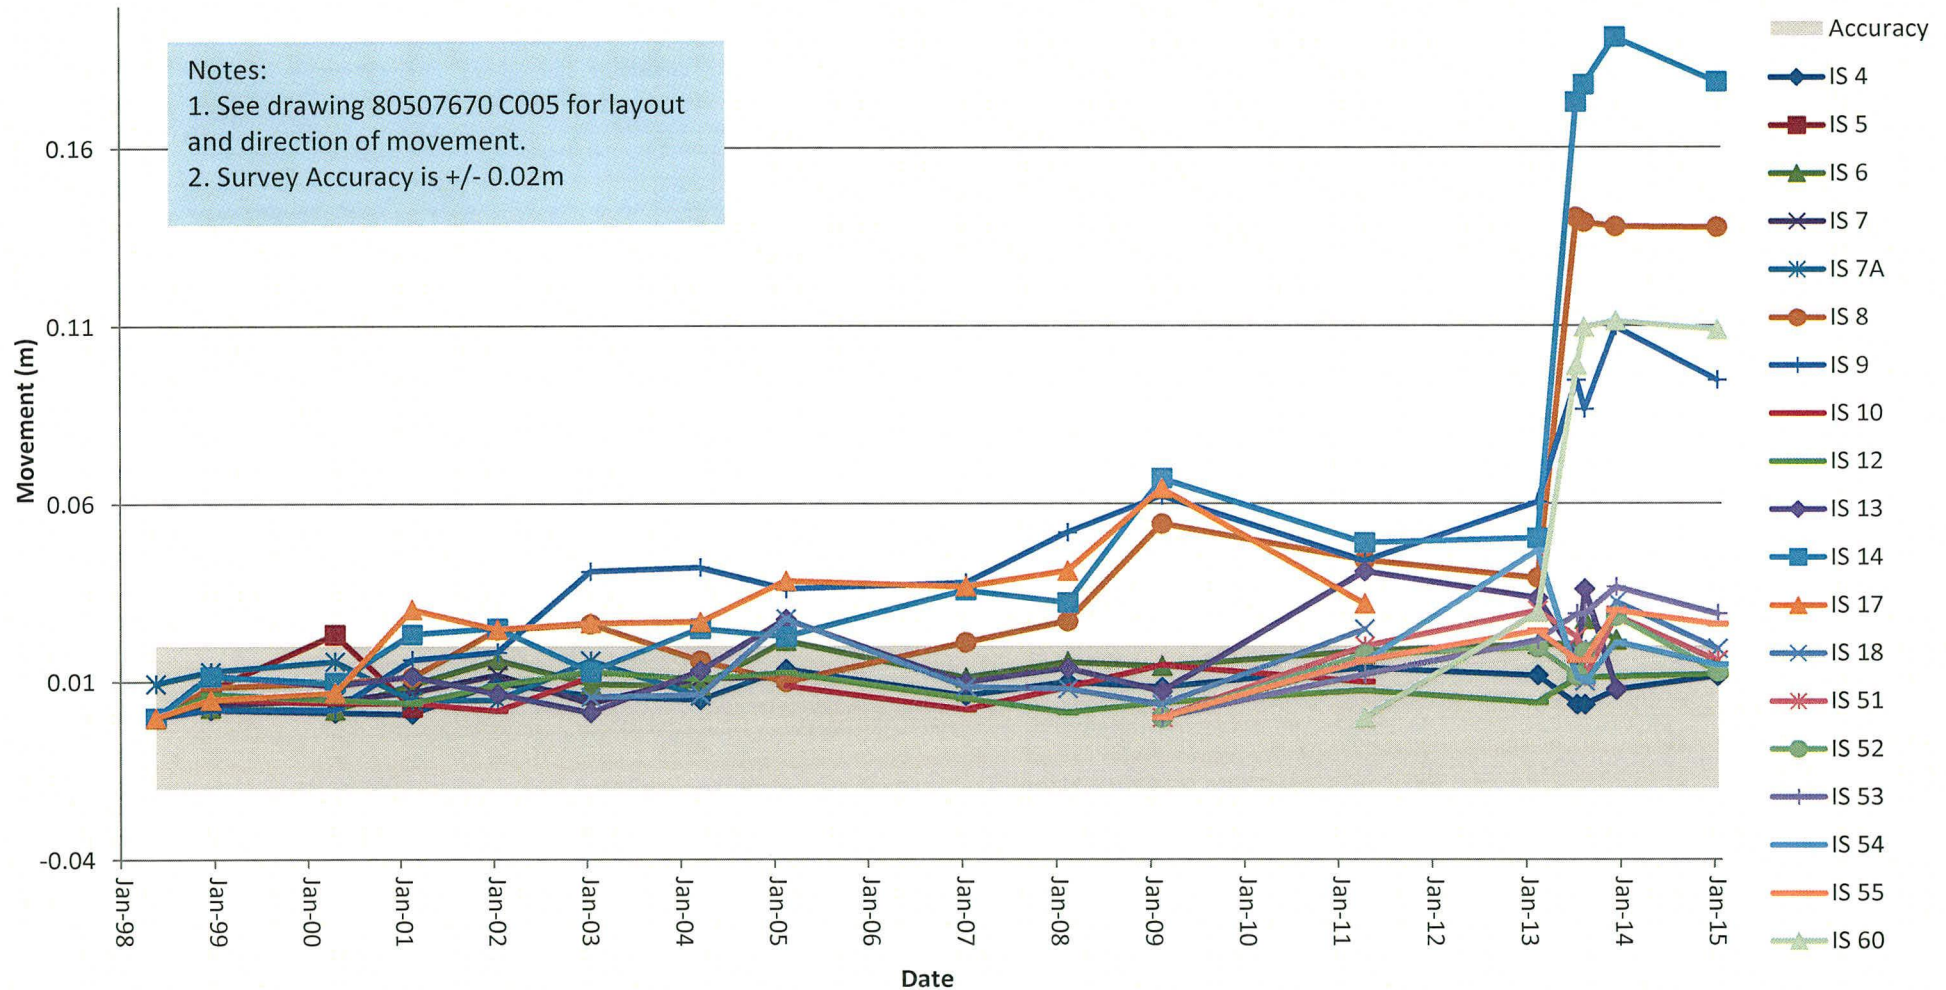
Chart 1: Cumulative Horizontal Deformation

For the Howard Street site cumulative movement of between 39-60mm in a north to north-westerly (downhill) direction has been observed at IS's 8, 9 and 14. These marks located in the paddocks above Howard Street have historically been the most active portion of the landslip area. The general trend in this area is a downhill displacement at a rate of 3-4mm per year.
