Dunedin City Council

LTES LONG-TERM LANDSLIDE MONITORING GREENACRES STREET EARTHFLOW

13 FEBRUARY 2025

LTES LONG-TERM LANDSLIDE MONITORING
GREENACRES STREET LANDSLIDE

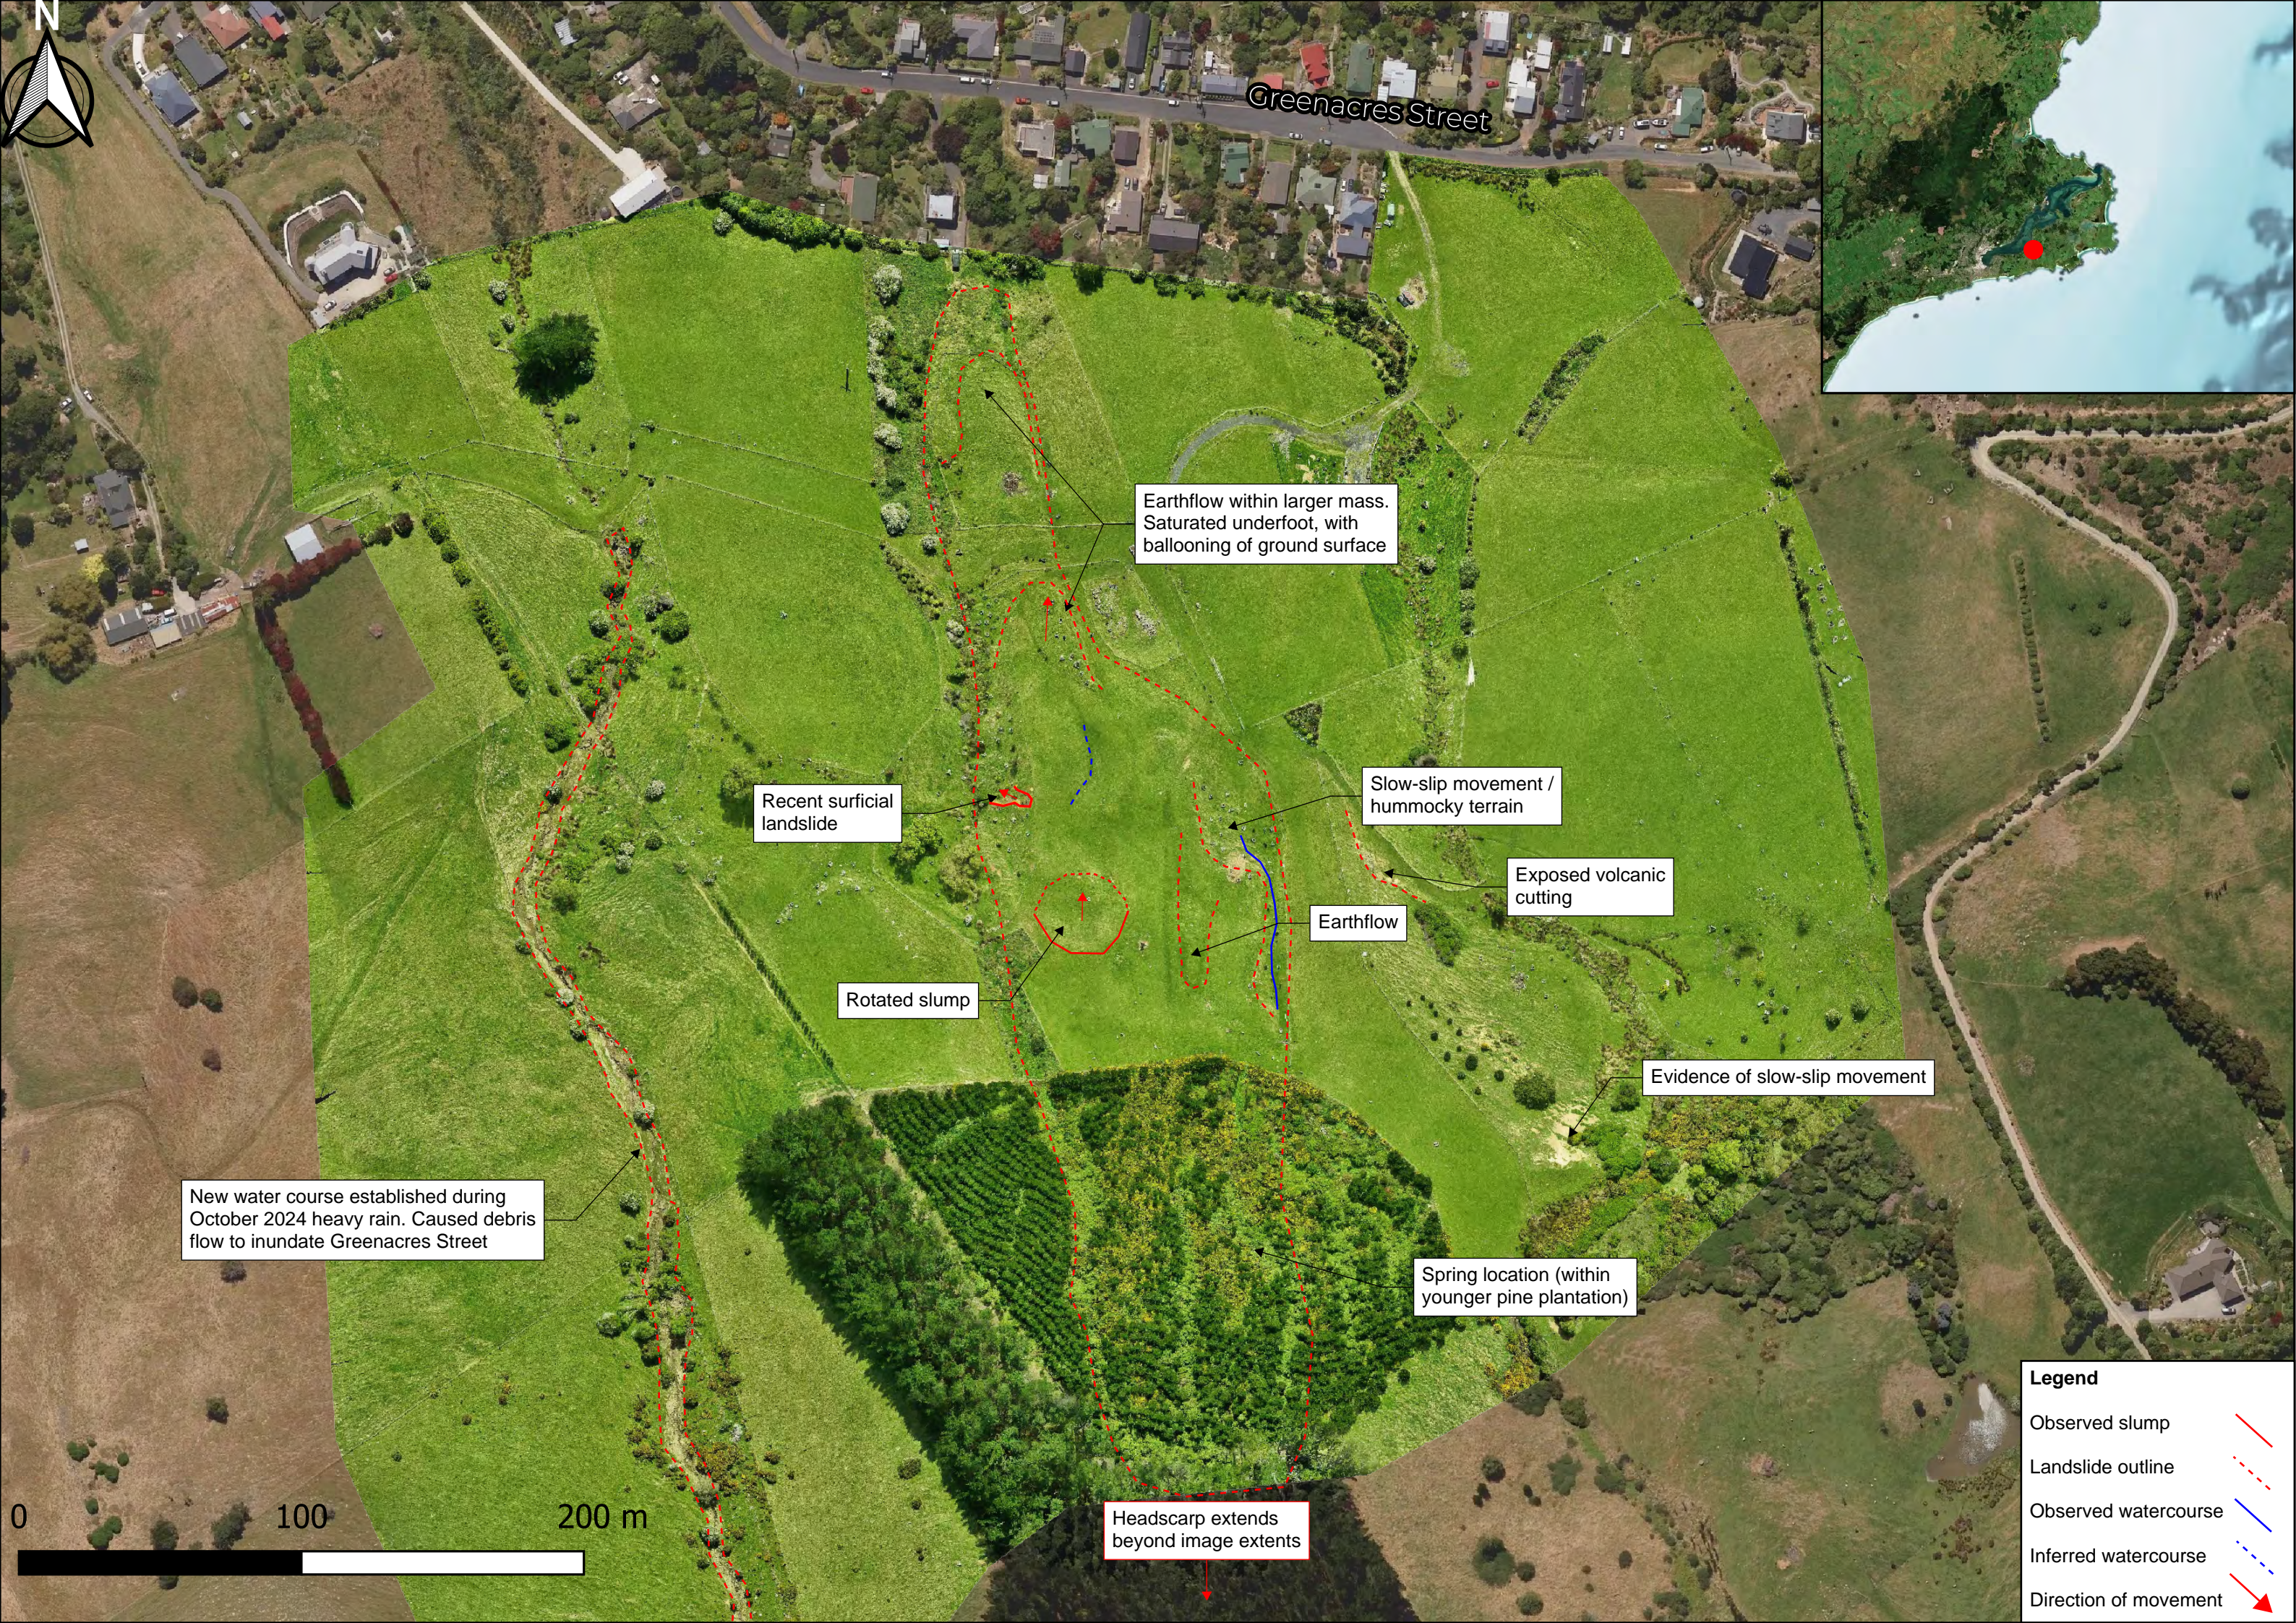
Preliminary Observations / UAV Map

Earthflow within larger mass.
Saturated underfoot, with
ballooning of ground surface

Recent surficial
landslide

Slow-slip movement /
hummocky terrain

Exposed volcanic
cutting

Rotated slump

Evidence of slow-slip movement

New water course established during
October 2024 heavy rain. Caused debris
flow to inundate Greenacres Street

Spring location (within
younger pine plantation)

- Continue with scheduled monitoring every 12 months, unless there is a significant rainfall or seismic event
- A site-specific report every two years with the debris flow to the west of the current earthflow boundaries to be added to future inspections
- Investigate options to control the direction and flow of surface water at Highcliff Road away from the area of the Greenacres Street Landslide

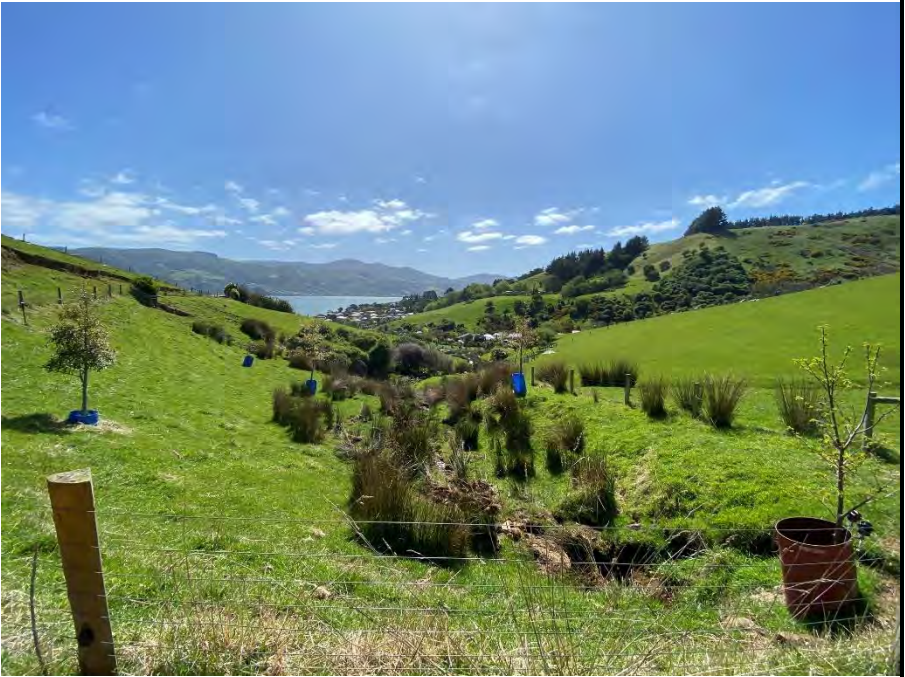
1	16/10/2024	
Description View of the watercourse feature down the flanks of the earthflow (to the left of the image). Image taken facing north

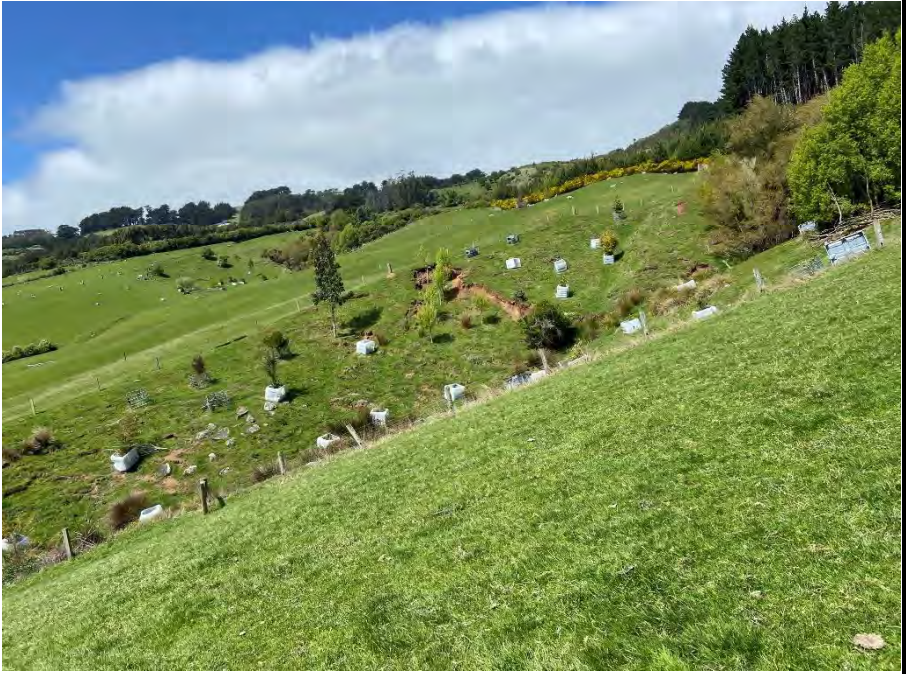
3	16/10/2024	
Description Small landslide as a result of the October 2024 heavy rainfall event and evidence of slope stabilization (tree planting) in the valley. Image taken facing southeast

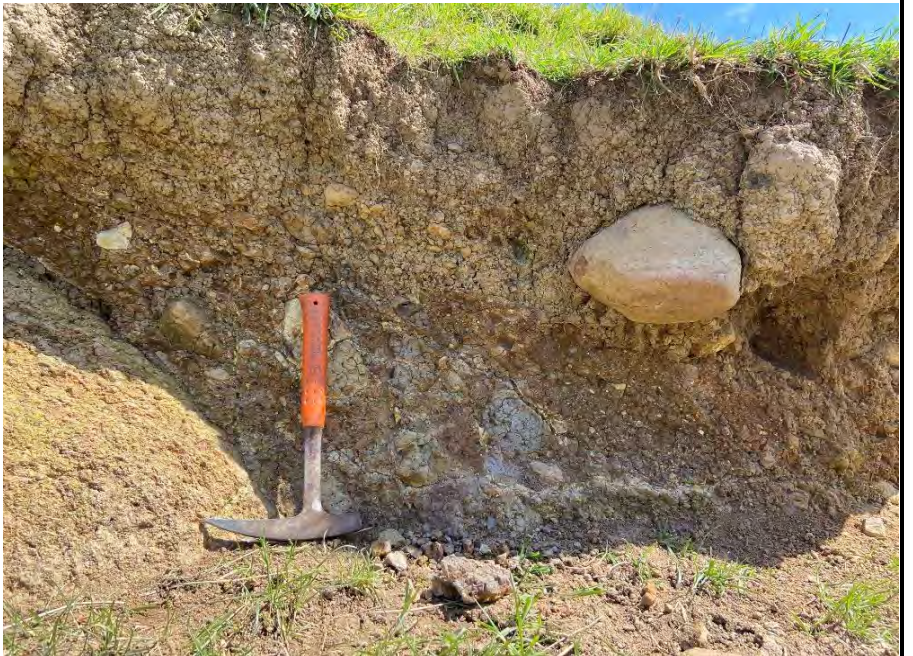
6	16/10/2024	
Description Close up view of the cut and fill platform. Completely weathered pyroclastics overlain by topsoil

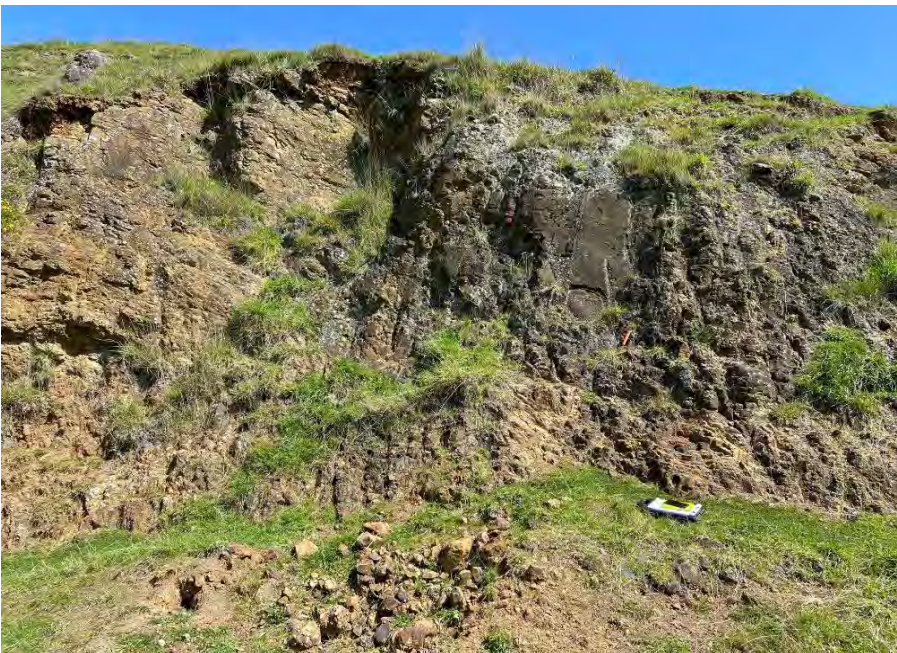
7	16/10/2024	
Description Outside of landslide boundary, cutting for farm track exposing shallow volcanics with thin overlying topsoil. Image taken facing south

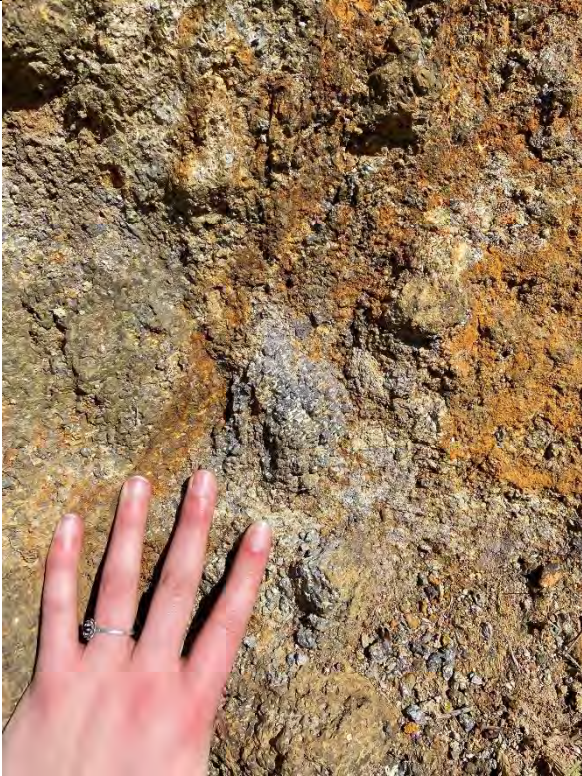
8	16/10/2024	
Description Close up of volcanics

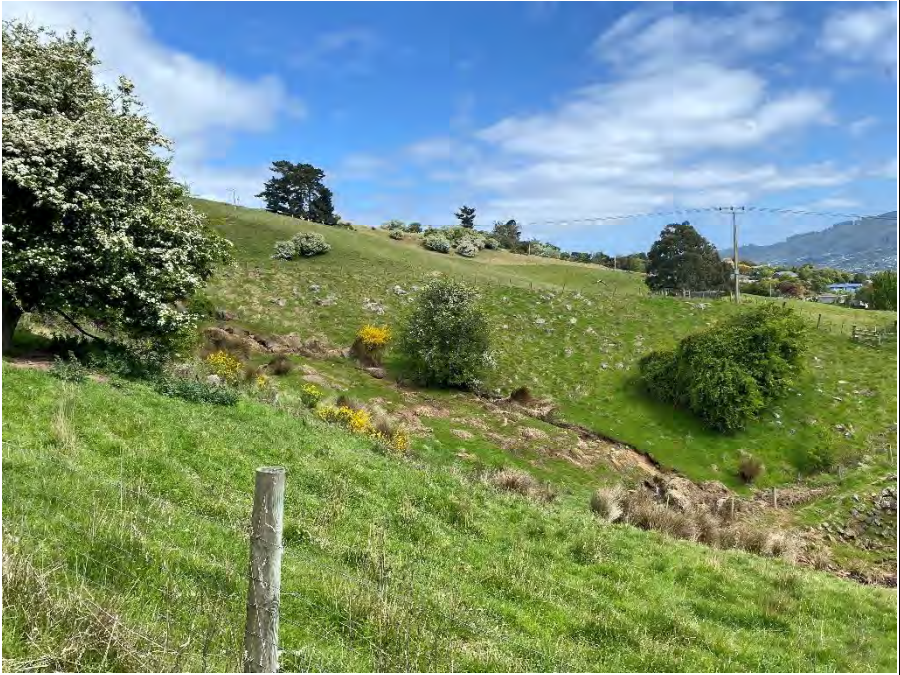
During the October 2024 heavy rainfall event, surface water from the surrounding slopes and runoff from Highcliff Road, activated a debris flow that could be seen in the area to the west of the identified Greenacres Earthflow. This debris flow led to the inundation of Greenacres Street during the October 2024 rainfall event.

11	16/10/2024	
Description Image of debris flow that recently activated during October floods
