Dunedin City Council

LTES LONG-TERM LANDSLIDE MONITORING PUKETERAKI LANDSLIDE

13 FEBRUARY 2025

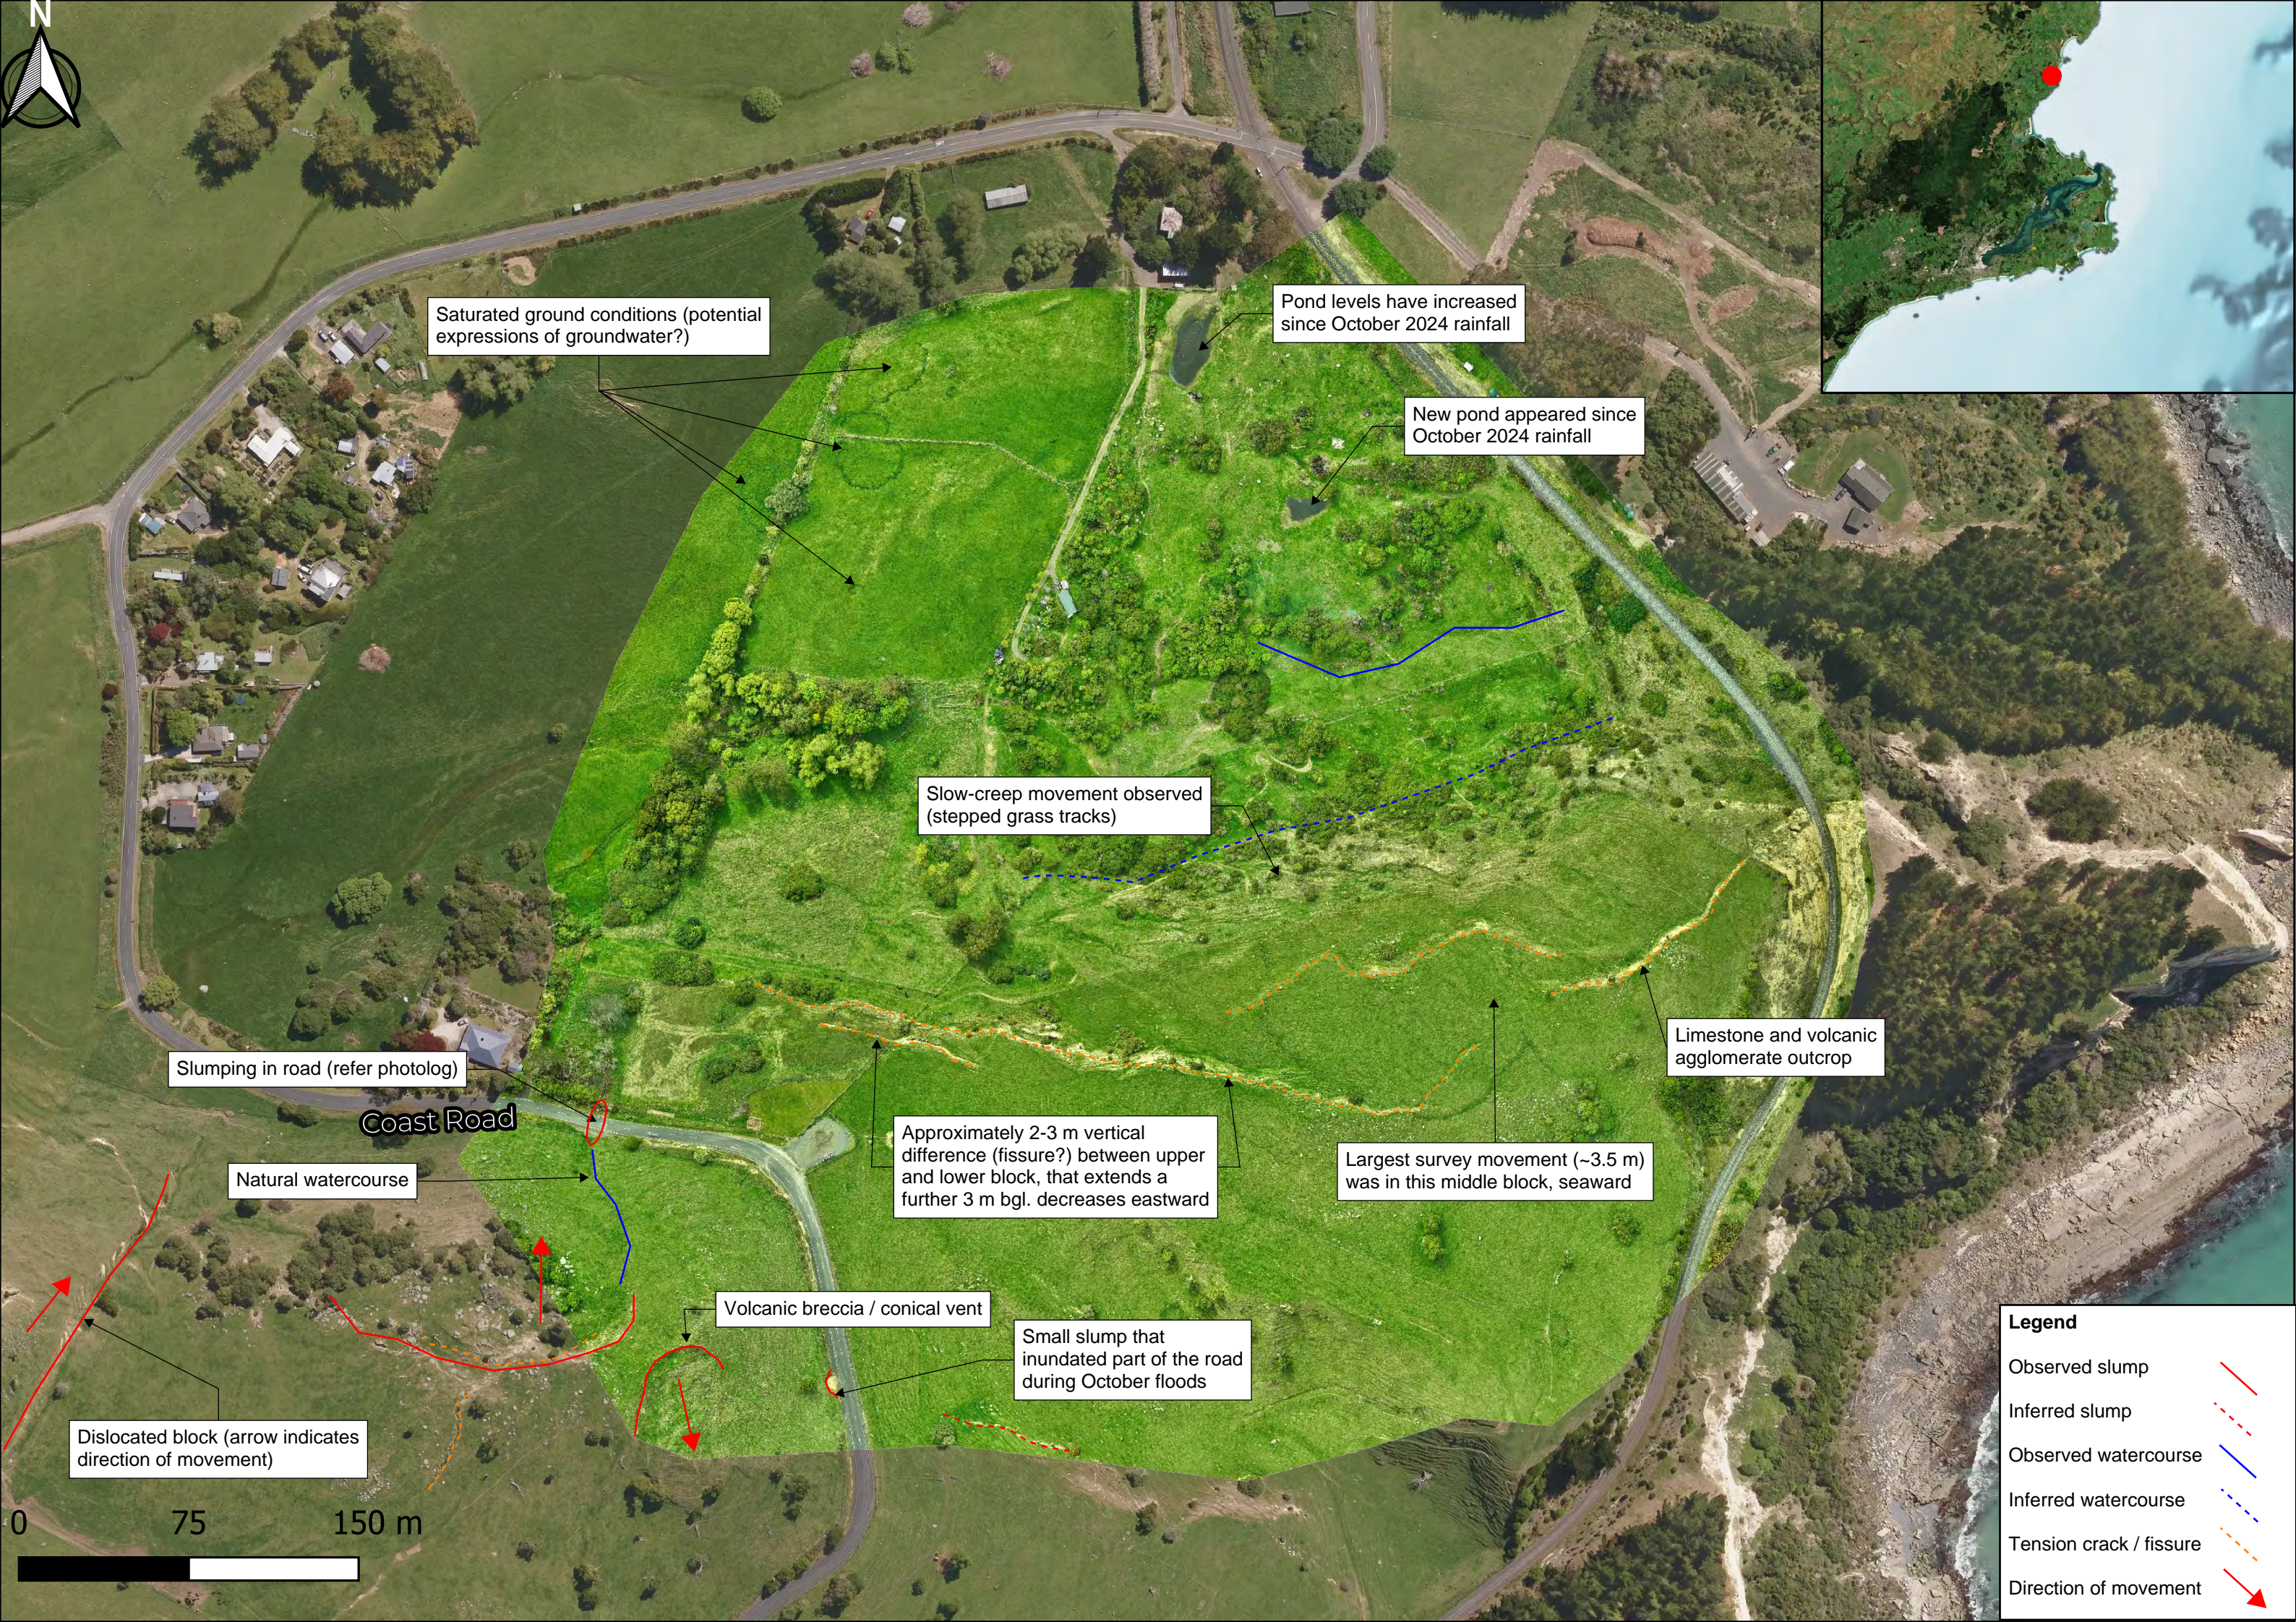
Preliminary Observations / UAV Map

The saturated ground conditions observed on site included an area of ponding of groundwater and surface water since the Otago heavy rainfall event. Anecdotal evidence from the landowners indicates that one of the two ponds on the site has appeared in 2024, and there is potential evidence for a few more underground expressions of groundwater to the west of the current ponds (Refer Appendix A)

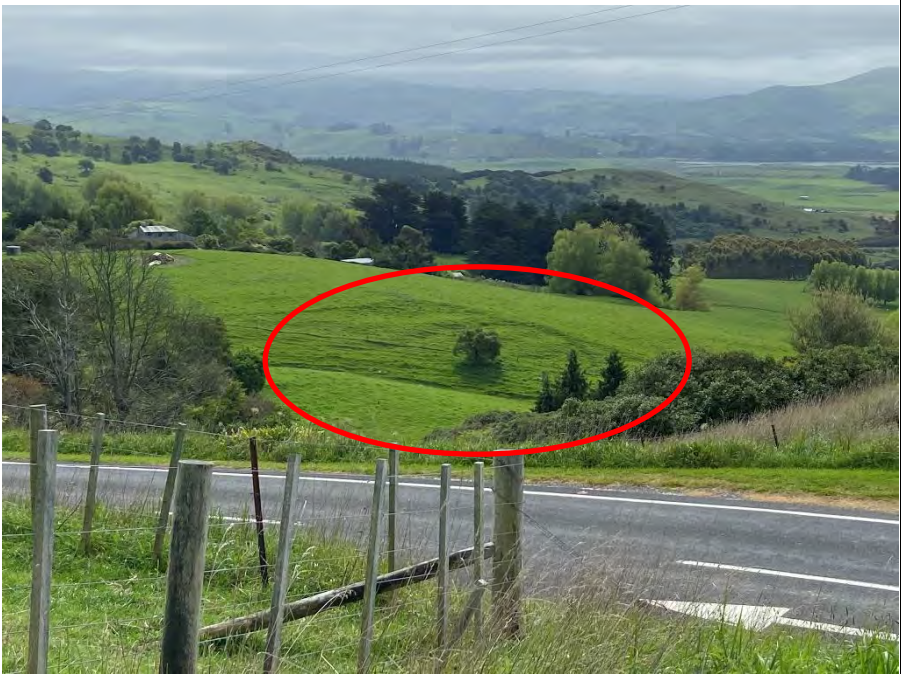
2	22/10/2024	
Description Small slump forming in farmland opposite Coast Road. Image taken facing north

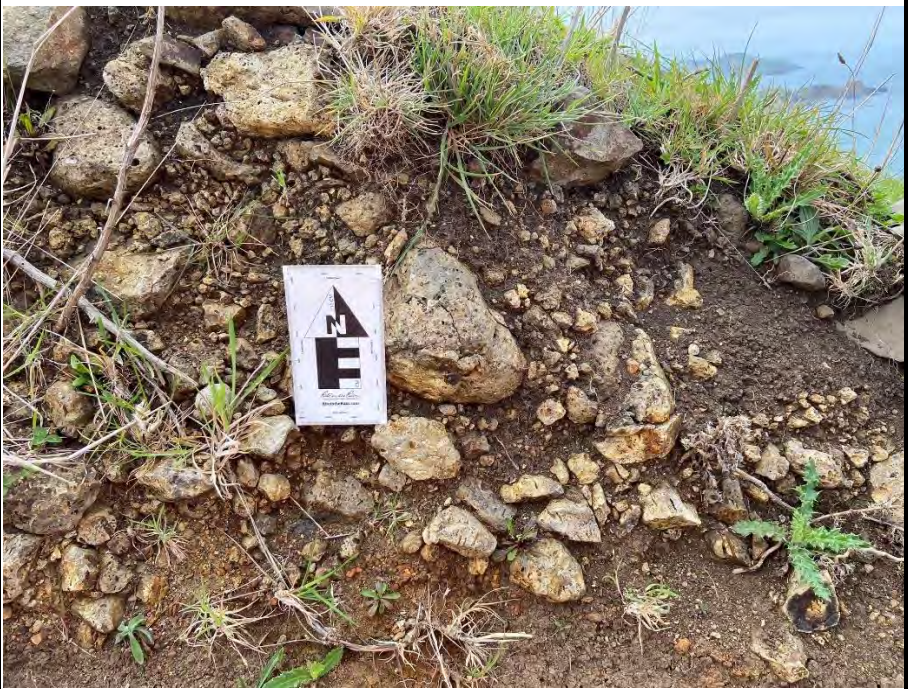
5	22/10/2024	
Description Image of headscarp observed in Photo 4 above, in volcanic agglomerate.

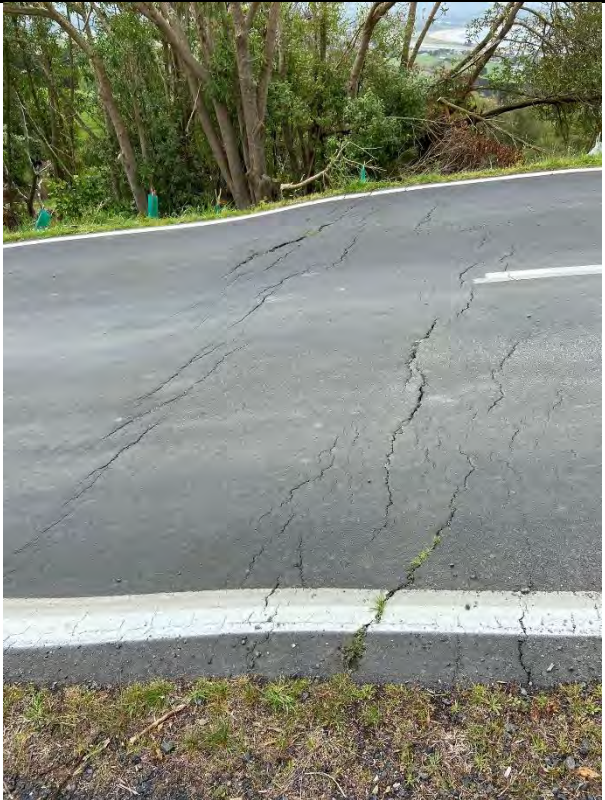
Tension cracks were noted across the site, and specifically across Coast Road, where there was obvious displacement and slumping of the road (Refer photograph 10 Appendix B). It is obvious that the road has required multiple surface patches in the past and there was an approximate 200 mm difference in the elevation of the road at the time of the inspection.

Photo No.	Date	Description	Image
10	22/10/2024		
Close up of tension cracks formed in Coast Road.

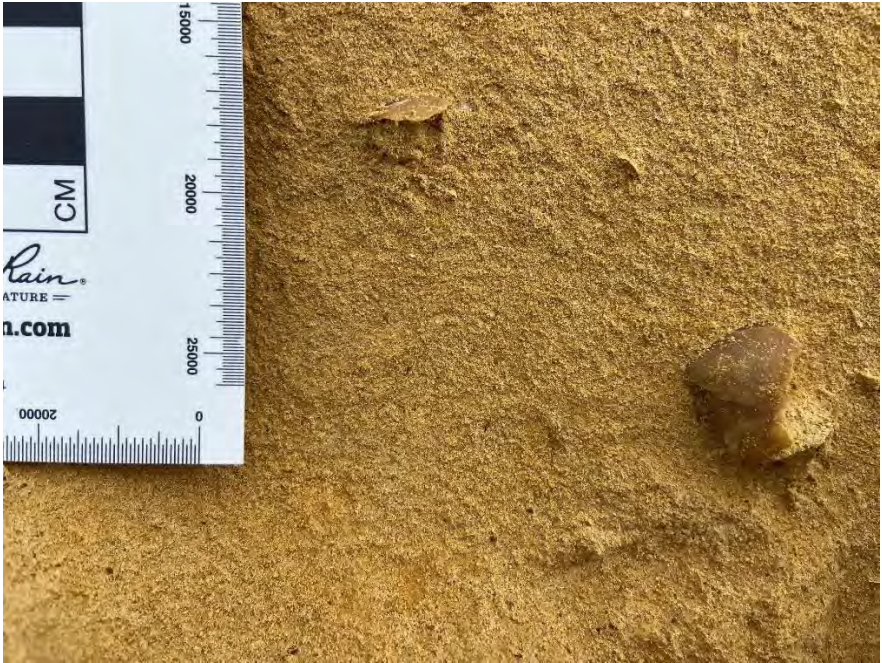
12	22/10/2024	
Description Close up of fossiliferous limestone observed in image 11.

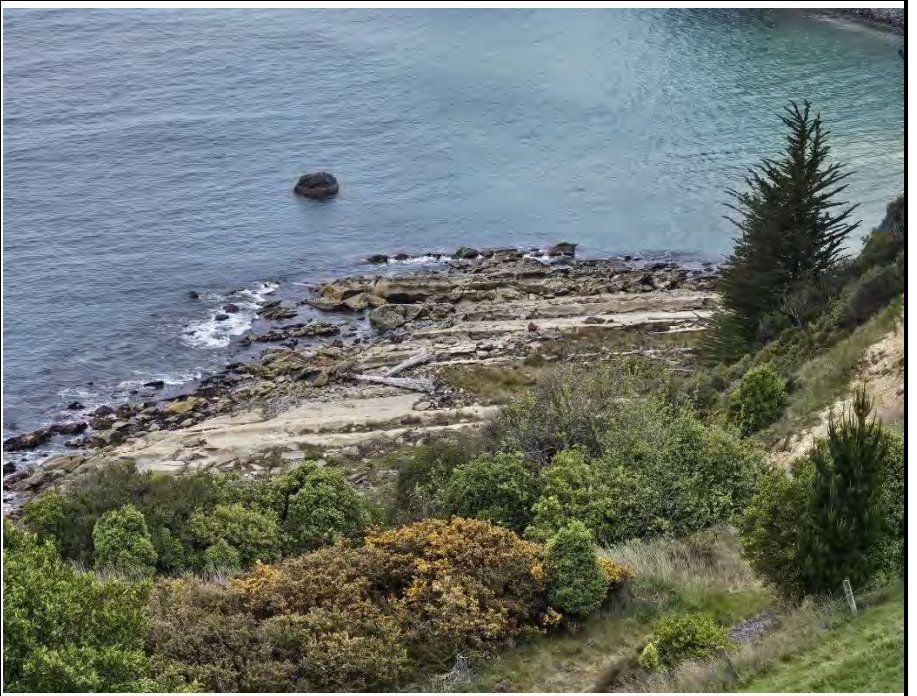
15	22/10/2024	
Description Planar beds dipping seaward. Located on the other side of the KiwiRail Main South Line
