From: [Kristy Rusher](#)
To: [lgoima](#)
Subject: FW: LGOIMA response re seismic assessments
Date: Thursday, 26 October 2017 04:05:24 p.m.
Attachments:

Street Number & Name:	1 Balmacewen Road, Maori Hill	Job No.:	12174
AKA:		By:	Ralf Schrub
Name of building:	Coronation Hall	Date:	21/11/2014
City:	Dunedin 9010	Revision No.:

Report

Prepared by Beca Limited

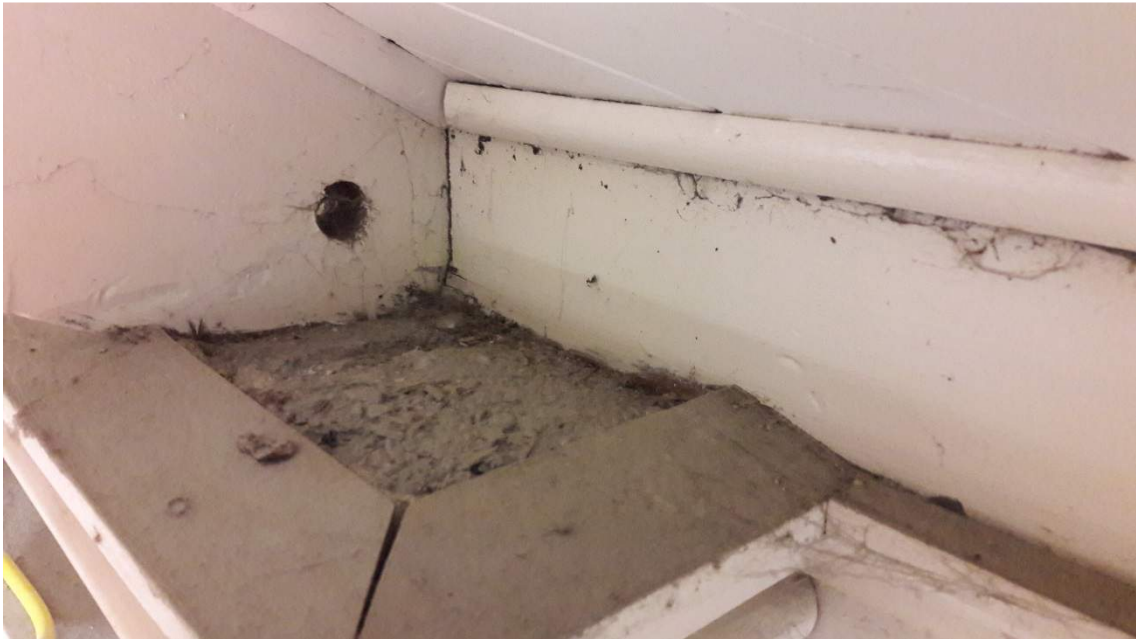
Figure 6 – 200mm x 60mm rafter cast into concrete cap atop pilasters in hall proper.

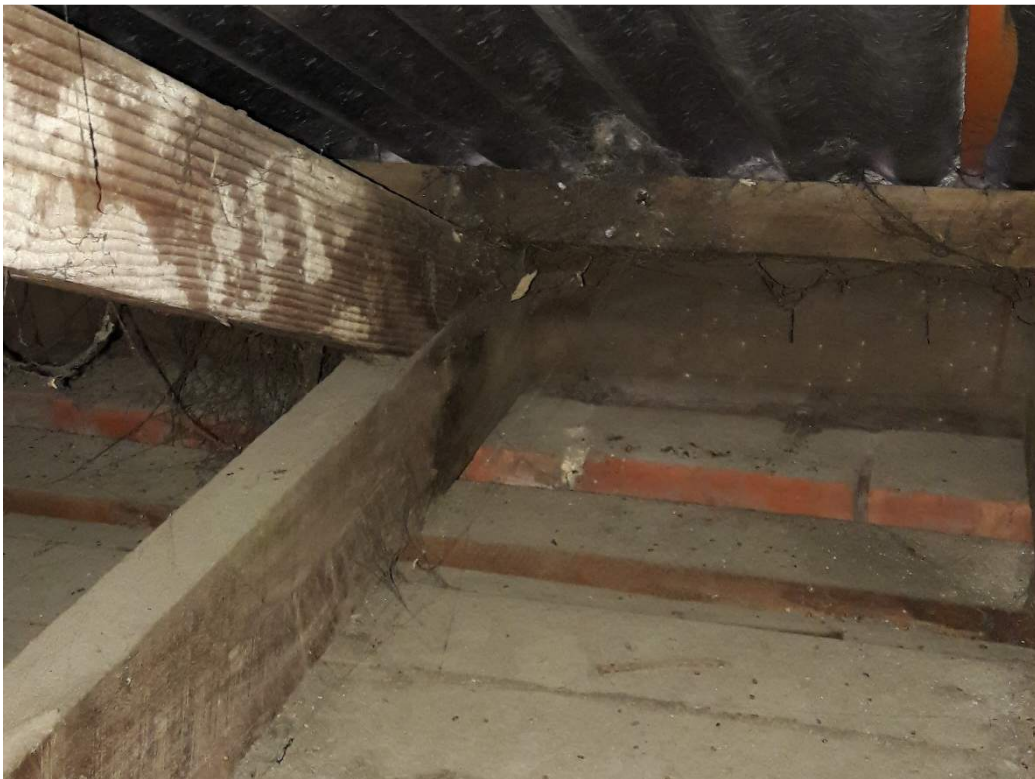
- The cavity brick side walls in the southern rooms are tall and narrow and are therefore vulnerable to out-of-plane failure and collapse.
- The connections from the roof to the North and South end walls (both at eaves and roof levels) are not adequate to resist the loading demand.

Figure 7 – 100mm x 45mm roof rafter sitting on wall in south end of building. Note no fixing between rafter and wall.

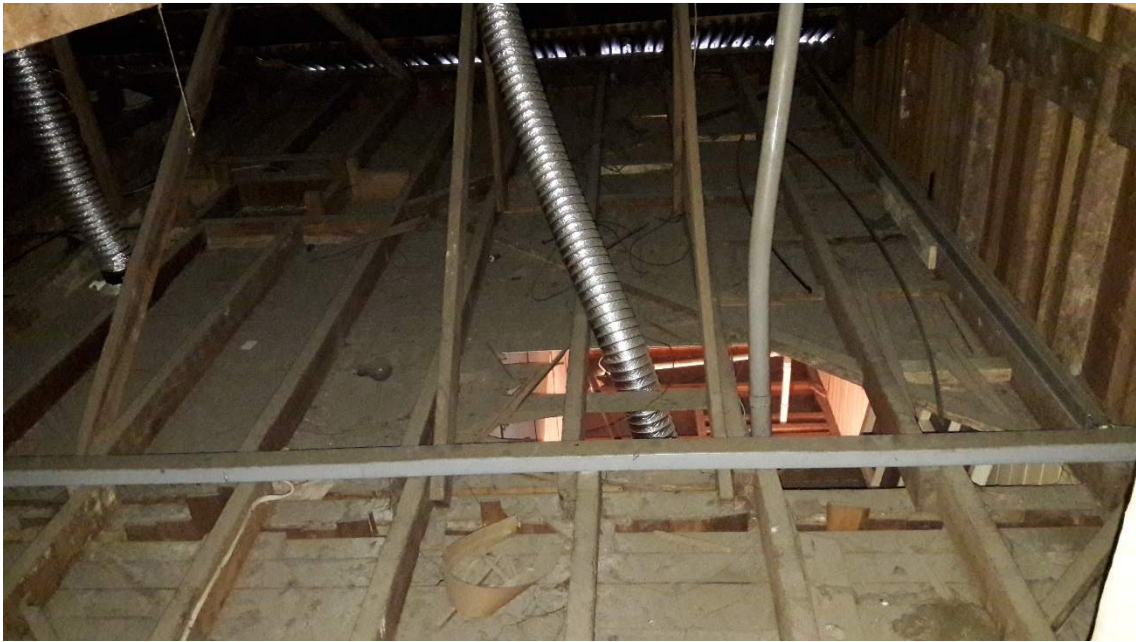
Figure 8 – 130mm x 50mm ceiling joists supporting tongue and groove ceiling lining. Penetration for services down to lower ceiling in ladies' toilets.

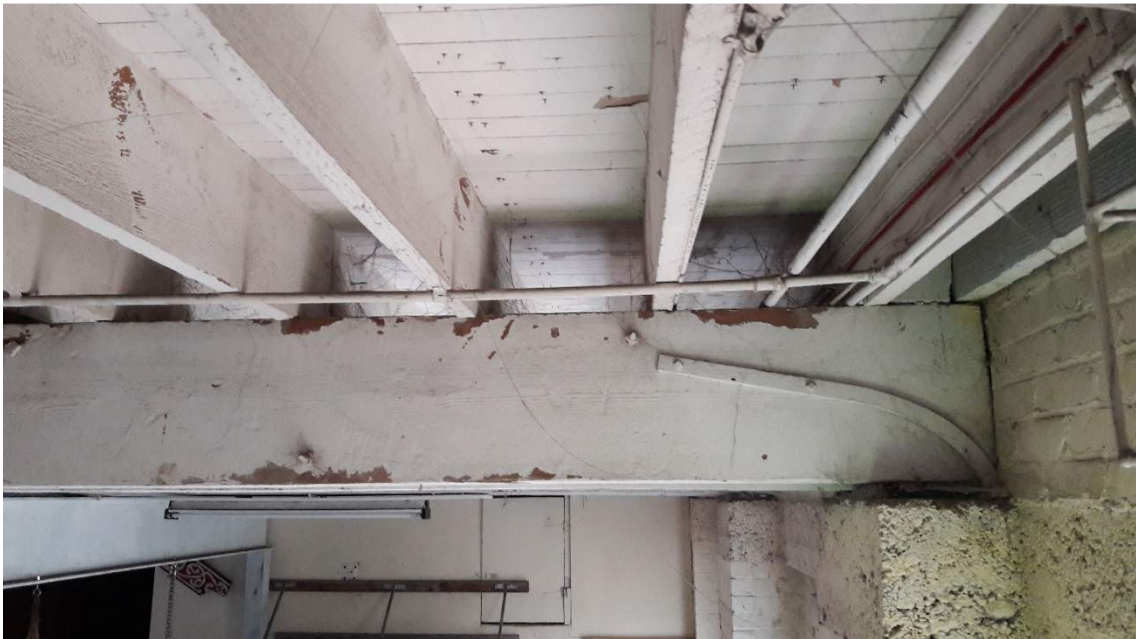
The detailed assessment has identified that the Maori Hill Hall has a capacity of less than 20%NBS(IL2), as a result of the lack of connection in the floor diaphragm to the southern foundation wall.

Figure 9 – Tongue and groove floor on 300mm x 45mm timber joists on timber flitch beam. No visible connection from flitch beam to concrete cap on pilaster.

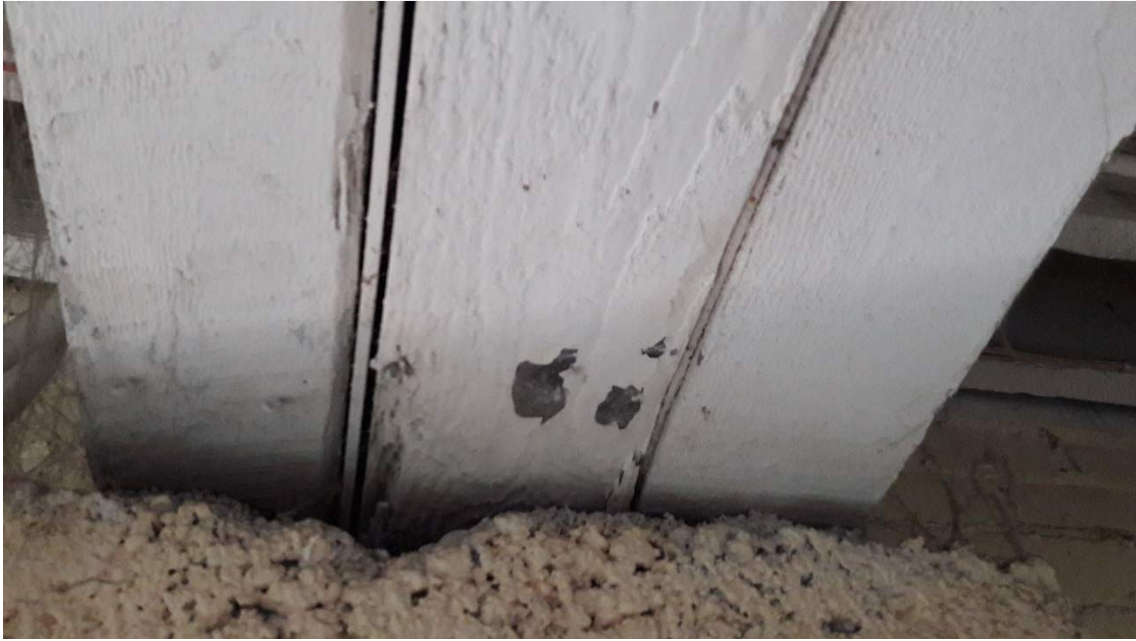
Figure 10 – Timber flitch beam in basement, consisting of 3x 400mm x 150mm timbers and 2x 6mm steel plates.

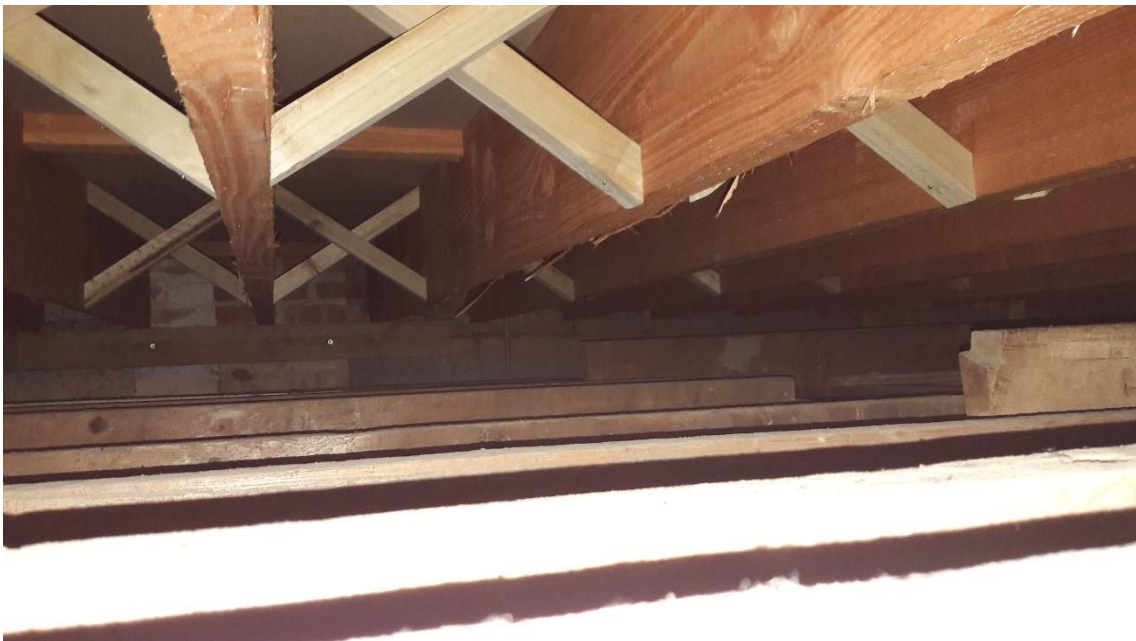
Figure 11 – North end wall elevation under the stage.

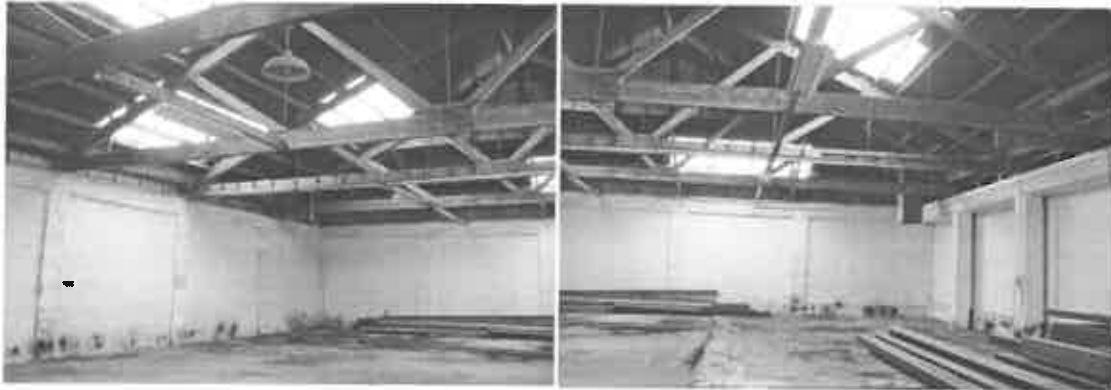
roof trusses on concrete frames and URM walls

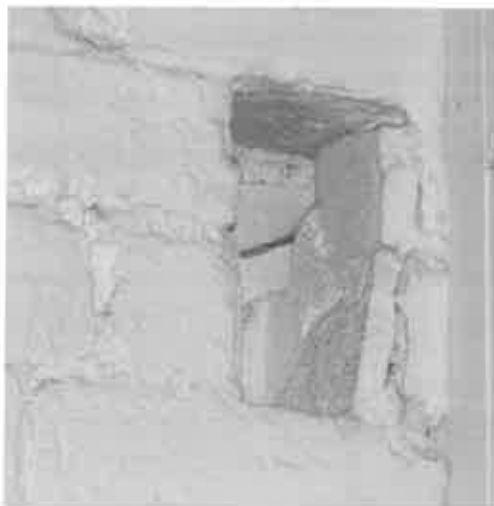
URM at least 2 layers of brick mortared together

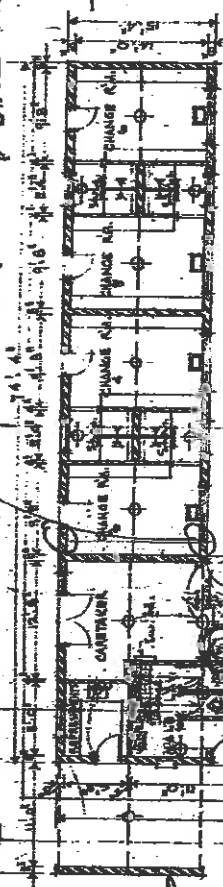
WATER TANK ON ROOF

100 mm PARTITION WALL SUSCEPTIBLE TO FACE ROADS
