Local Government Official Information and Meetings Act 1987 (LGOIMA) Request

Asbestos Survey Report

100 BLUE SKIN RD, PORT CHALMERS

29/04/2016

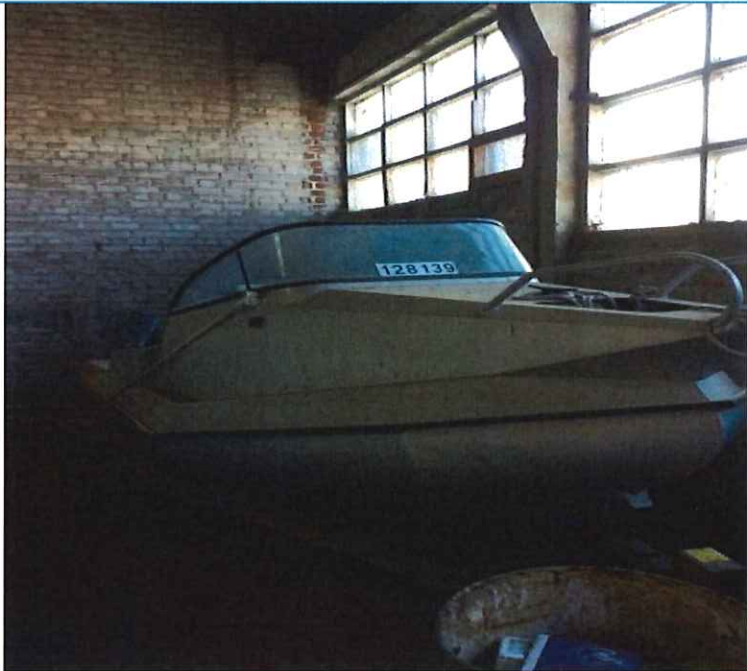
Client	DUNEDIN CITY COUNCIL				
Survey Address	100 BLUE SKIN RD, PORT CHALMERS				
Building	SIMS BUILDING				
Location	INSIDE SOUTH END OF BUILDING				
Survey Ref	SAMPLE 1-SWAB ON BOW				
Sample Ref	82278				
Photo Details

Rick Matrix					
Asbestos Type	CHRYSTILE	1	Product/Use	RESIDUAL DUST	3
Condition	HIGH DAMAGE	3	Treatment	RESIDUAL DUST CONTAMINATION FROM ROOFING	3
Identified Risk	HIGH RISK	3	Action	ACTION A	A
Extent	RESIDUAL DUST CONTAMINATION COVERS THE SURFACES OF THIS BOAT				
Accessibility	LADDER REQUIRED				
Remarks	DUE TO HEAVY RESIDUAL CONTAMINATION THROUGHOUT THE BUILDING ALL DIRTY/DUSTY SURFACES SHOULD BE TREATED AS ASBESTOS CONTAMINATED UNTIL PROVEN OTHERWISE.

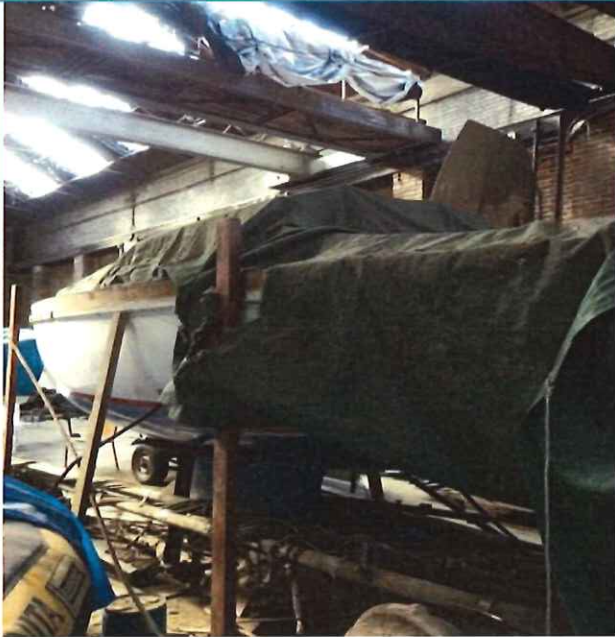
Client	DUNEDIN CITY COUNCIL				
Survey Address	100 BLUE SKIN RD, PORT CHALMERS				
Building	SIMS BUILDING				
Location	INSIDE CENTRE OF BUILDING				
Survey Ref	SAMPLE 2 – TARP SWAB				
Sample Ref	82279				
Photo Details

Rick Matrix					
Asbestos Type	CHRYSTILE	1	Product/Use	RESIDUAL DUST	3
Condition	HIGH DAMAGE	3	Treatment	RESIDUAL DUST CONTAMINATION FROM ROOFING	3
Identified Risk	HIGH RISK	3	Action	ACTION A	A
Extent	RESIDUAL DUST CONTAMINATION COVERS THE SURFACES OF THIS BOAT				
Accessibility	LADDER REQUIRED				
Remarks	DUE TO HEAVY RESIDUAL CONTAMINATION THROUGHOUT THE BUILDING ALL DIRTY/DUSTY SURFACES SHOULD BE TREATED AS ASBESTOS CONTAMINATED UNTIL PROVEN OTHERWISE.

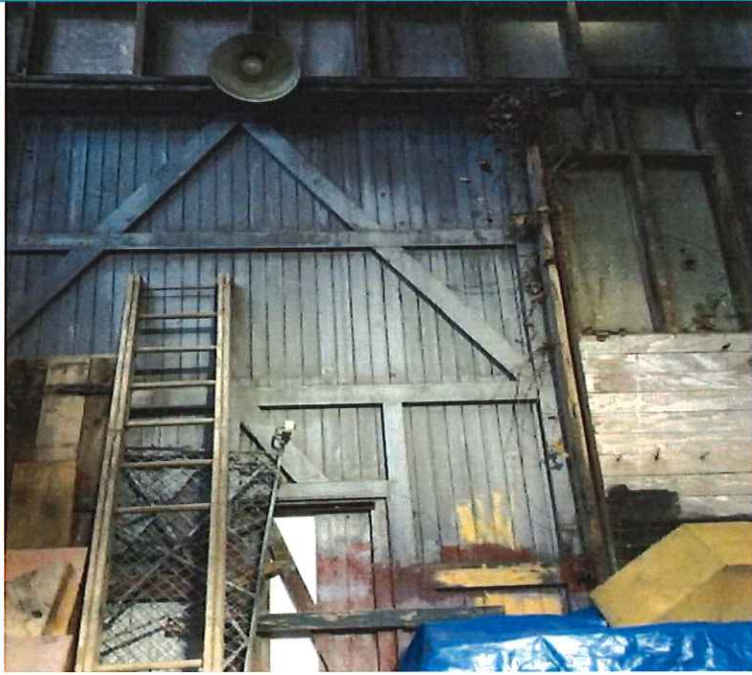
Client	DUNEDIN CITY COUNCIL				
Survey Address	100 BLUE SKIN RD, PORT CHALMERS				
Building	SIMS BUILDING				
Location	SOUTH WALL TIMBER DOOR SWAB				
Survey Ref	SAMPLE 7 - TIMBER DOOR SWAB				
Sample Ref	82284				
Photo Details

Rick Matrix					
Asbestos Type	CHRYSTILE/AMOSITE	2	Product/Use	RESIDUAL DUST	3
Condition	HIGH DAMAGE	3	Treatment	RESIDUAL DUST CONTAMINATION FROM ROOFING	3
Identified Risk	HIGH RISK	3	Action	ACTION A	A
Extent	RESIDUAL DUST CONTAMINATION COVERS EDGES ON TIMBER DOOR STRUCTURE.				
Accessibility	SCAFFOLDING REQUIRED				
Remarks	DUE TO HEAVY RESIDUAL CONTAMINATION THROUGHOUT THE BUILDING ALL DIRTY/DUSTY SURFACES SHOULD BE TREATED AS ASBESTOS CONTAMINATED UNTIL PROVEN OTHERWISE.

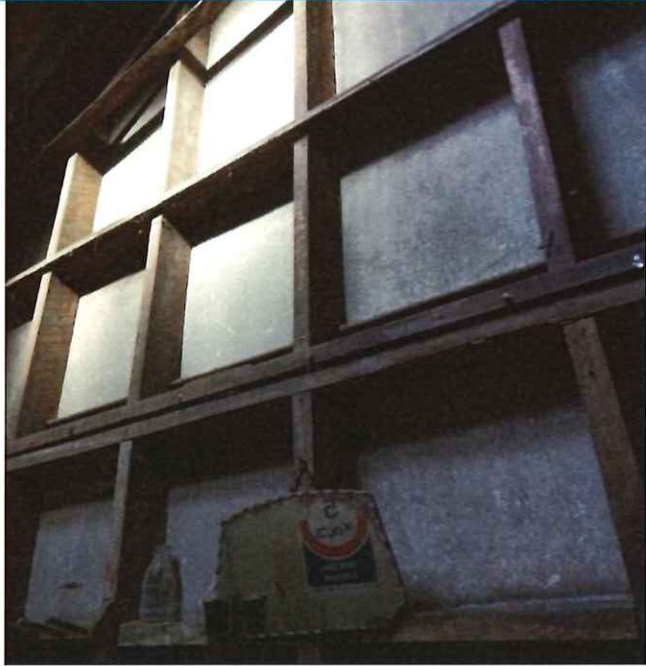
Client	DUNEDIN CITY COUNCIL				
Survey Address	100 BLUE SKIN RD, PORT CHALMERS				
Building	SIMS BUILDING				
Location	SOUTH WALL INTERNAL TIMBER FRAMING (END GABLE)				
Survey Ref	SAMPLE 8 - SWAB TIMBER FRAMING				
Sample Ref	82285				
Photo Details

Rick Matrix					
Asbestos Type	CHRYSTILE	1	Product/Use	RESIDUAL DUST	3
Condition	HIGH DAMAGE	3	Treatment	RESIDUAL DUST CONTAMINATION FROM ROOFING	3
Identified Risk	HIGH RISK	3	Action	ACTION A	A
Extent	RESIDUAL DUST CONTAMINATION COVERS TIMBER FRAMING INTERNALLY AT THE END GABLE				
Accessibility	SCAFFOLDING REQUIRED				
Remarks	DUE TO HEAVY RESIDUAL CONTAMINATION THROUGHOUT THE BUILDING ALL DIRTY/DUSTY SURFACES SHOULD BE TREATED AS ASBESTOS CONTAMINATED UNTIL PROVEN OTHERWISE.

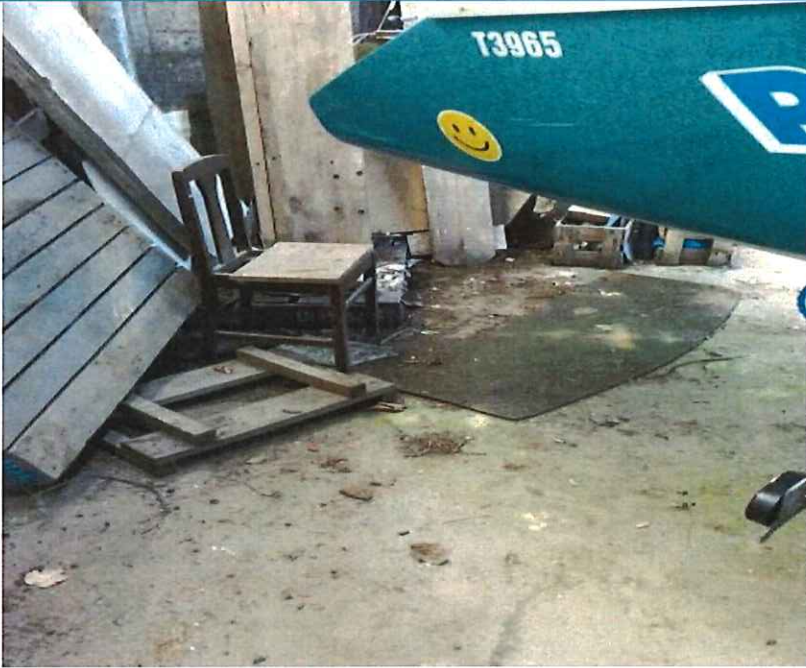
Client	DUNEDIN CITY COUNCIL				
Survey Address	100 BLUE SKIN RD, PORT CHALMERS				
Building	SIMS BUILDING				
Location	FLOOR WEST WALL FLOOR SWAB				
Survey Ref	SAMPLE 9 - FLOOR SWAB				
Sample Ref	82286				
Photo Details

Rick Matrix					
Asbestos Type	CHRYSTILE/AMOSITE	2	Product/Use	RESIDUAL DUST	3
Condition	HIGH DAMAGE	3	Treatment	RESIDUAL DUST CONTAMINATION FROM ROOFING	3
Identified Risk	HIGH RISK	3	Action	ACTION A	A
Extent	RESIDUAL DUST CONTAMINATION COVERS THE FLOORING AND OBJECTS IN THE CORNER.				
Accessibility	EASILY ACCESSIBLE				
Remarks	DUE TO HEAVY RESIDUAL CONTAMINATION THROUGHOUT THE BUILDING ALL DIRTY/DUSTY SURFACES SHOULD BE TREATED AS ASBESTOS CONTAMINATED UNTIL PROVEN OTHERWISE.

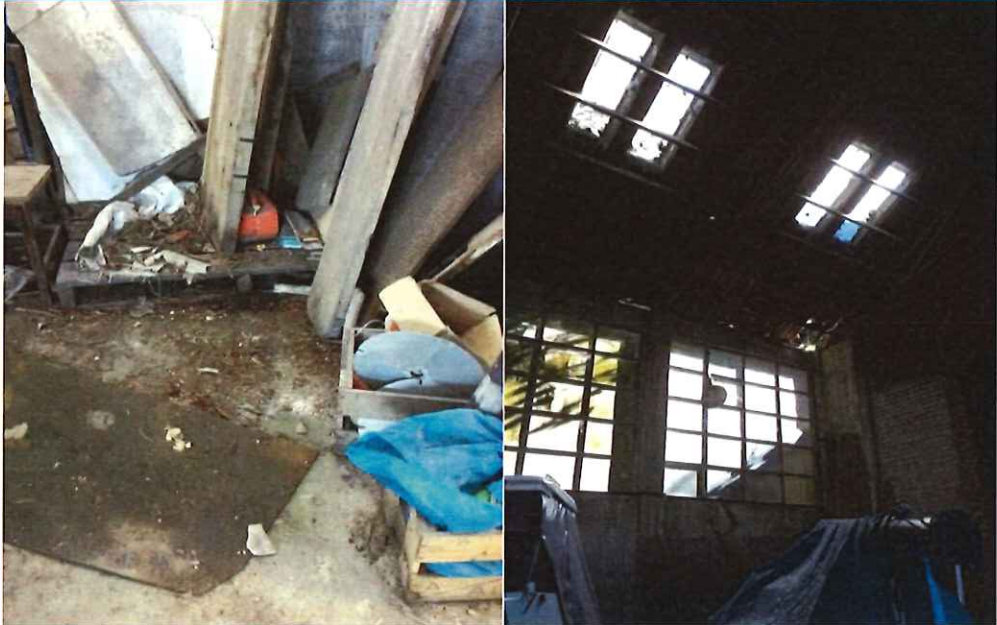
Client	DUNEDIN CITY COUNCIL				
Survey Address	100 BLUE SKIN RD, PORT CHALMERS				
Building	SIMS BUILDING				
Location	ROOFING MATERIALS&WALL CLADDING (BROKEN INSIDE BUILDING)				
Survey Ref	SAMPLE 10 – BROKEN ROOFING AND WALLS INSIDE BUILDING				
Sample Ref	82287				
Photo Details

Rick Matrix					
Asbestos Type	CHRYSTILE/AMOSITE	2	Product/Use	ROOFING/WALL CLADDING	1
Condition	HIGH DAMAGE	3	Treatment	BROKEN ROOFING/WALL	3
Identified Risk	HIGH RISK	3	Action	ACTION A	A
Extent	BROKEN PIECES IN VARIOUS INTERNAL LOCATIONS THROUGHOUT THE BUILDING				
Accessibility	EASILY ACCESSIBLE				
Remarks	EXTENSIVE BROKEN ASBESTOS PIECES INSIDE THE BUILDING IN VARIOUS LOCATIONS ON THE FLOOR AREA, WITH CLEARLY VISIBLE SIGNS OF ROOFING DAMAGE.

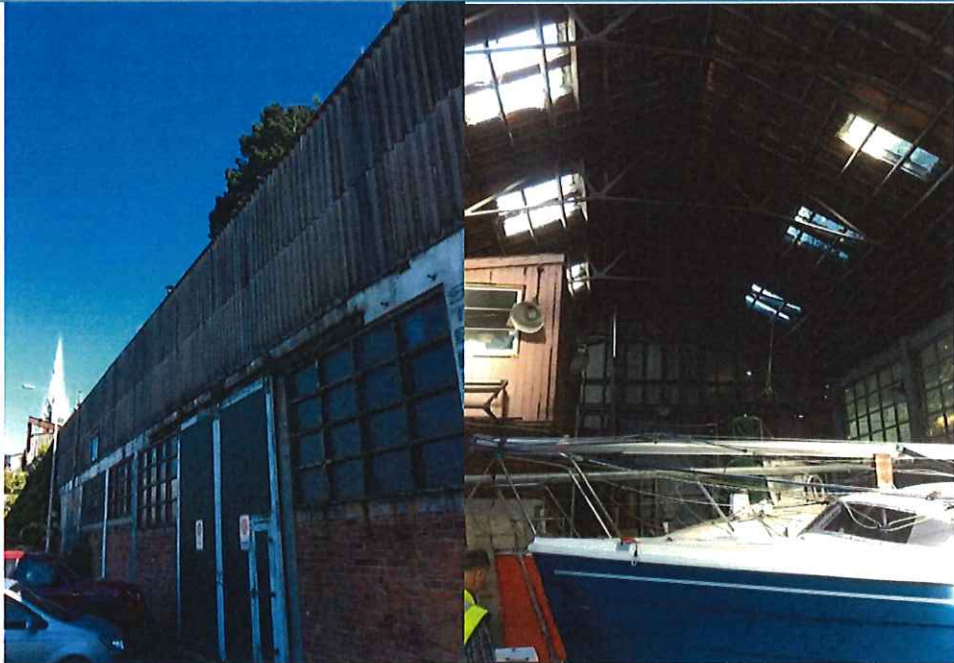
Client	DUNEDIN CITY COUNCIL				
Survey Address	100 BLUE SKIN RD, PORT CHALMERS				
Building	SIMS BUILDING				
Location	ROOFING MATERIALS & WALL CLADDING				
Survey Ref	SAMPLE 10 - OBTAINED FROM BROKEN ROOFING INSIDE THE BUILDING				
Sample Ref	82287				
Photo Details

Rick Matrix					
Asbestos Type	CHRYSTILE/AMOSITE	2	Product/Use	ROOFING/WALL CLADDING	1
Condition	HIGH DAMAGE	3	Treatment	BROKEN ROOFING/WALL	3
Identified Risk	HIGH RISK	3	Action	ACTION A	A
Extent	860m2 of roofing, 160m2 of walls, 65m2 gables.				
Accessibility	SCAFFOLDING REQUIRED				
Remarks	ROOFING/WALL CLADDING IS IN POOR CONDITION WITH SIGNS OF CRACKS AND HOLES THAT ARE LETTING WATER IN.

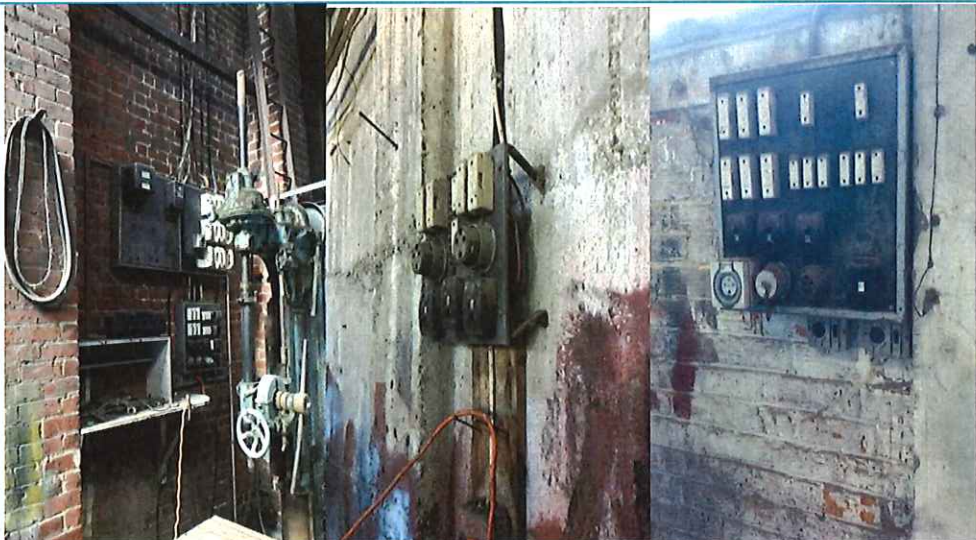
Client	DUNEDIN CITY COUNCIL				
Survey Address	100 BLUE SKIN RD, PORT CHALMERS				
Building	SIMS BUILDING				
Location	INTERNAL BUILDING				
Survey Ref	PRESUMED ASBESTOS SWITCHBOARD BACKING PLATES				
Sample Ref	PRESUMED ASBESTOS				
Photo Details

Rick Matrix					
Asbestos Type	PRESUMED ASBESTOS	4	Product/Use	SWITCHBOARD BACKING PLATES	1
Condition	GOOD CONDITION	0	Treatment	SEALED	0
Identified Risk	LOW RISK	1	Action	ACTION C	C
Extent	X5 SWITCHBOARD BACKING PLATES				
Accessibility	ISOLATION OF POWER REQUIRED				
Remarks	SWITCHBOARD PLATES ARE IN GOOD CONDITION AND ONLY REQUIRE ATTENTION DURING MAINTENANCE, WITH ASBESTOS LABLES REQUIRED.

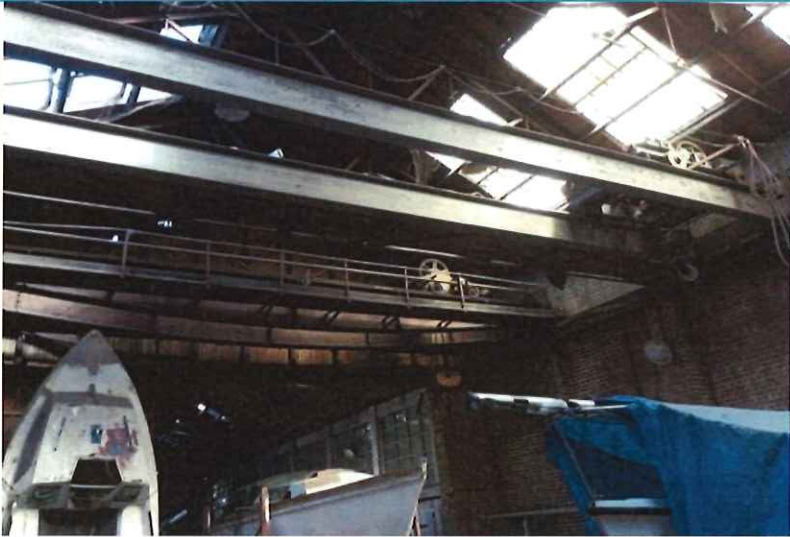
Client	DUNEDIN CITY COUNCIL				
Survey Address	100 BLUE SKIN RD, PORT CHALMERS				
Building	SIMS BUILDING				
Location	INTERNAL BUILDING				
Survey Ref	PRESUMED ASBESTOS DUST ON GANTRY CRANES AND UPPER LEVEL SURFACES .				
Sample Ref	PRESUMED ASBESTOS				
Photo Details

Rick Matrix					
Asbestos Type	PRESUMED	4	Product/Use	RESIDUAL DUST	3
Condition	HIGH DAMAGE	3	Treatment	RESIDUAL DUST CONTAMINATION FROM ROOFING	3
Identified Risk	HIGH RISK	3	Action	ACTION A	A
Extent	RESIDUAL DUST CONTAMINATION COVERS THE FLOORING AND OBJECTS SO WE IMAGINE UPPER LEVELS WILL BE CONTAMINATED ALSO				
Accessibility	SCAFFOLDING REQUIRED				
Remarks	DUE TO HEAVY RESIDUAL CONTAMINATION THROUGHOUT THE BUILDING ALL DIRTY/DUSTY SURFACES SHOULD BE TREATED AS ASBESTOS CONTAMINATED UNTIL PROVEN OTHERWISE.

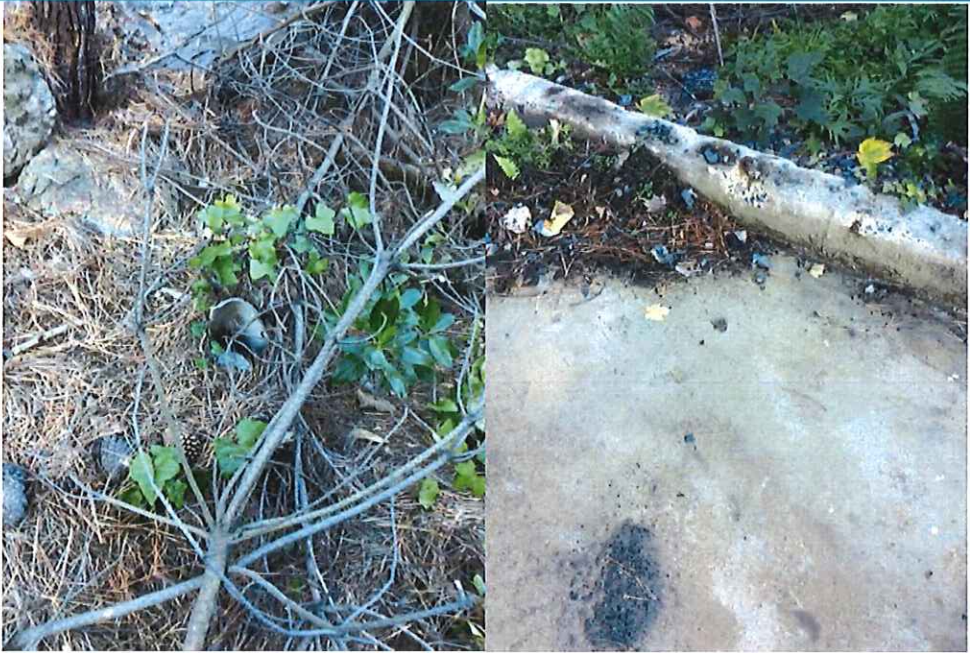
Client	DUNEDIN CITY COUNCIL				
Survey Address	100 BLUE SKIN RD, PORT CHALMERS				
Building	SIMS BUILDING				
Location	ROOFING MATERIALS&WALL CLADDING (BROKEN OUTSIDE THE BUILDING)				
Survey Ref	PRESUMED ASBESTOS				
Sample Ref	PRESUMED ASBESTOS				
Photo Details

Rick Matrix					
Asbestos Type	PRESUMED ASBESTOS	4	Product/Use	ROOFING/WALL CLADDING	1
Condition	HIGH DAMAGE	3	Treatment	BROKEN ROOFING/WALL	3
Identified Risk	HIGH RISK	3	Action	ACTION A	A
Extent	BROKEN PIECES IN VARIOUS EXTERNAL LOCATIONS AROUND THE BACK OF THE BUILDING.				
Accessibility	BURIED				
Remarks	BROKEN PIECES OF ROOFING AND WALL CLADDING ARE VISIBLE AROUND THE BACK OF THE BUILDING AND REQUIRE ATTENTION TO MAKE SAFE.

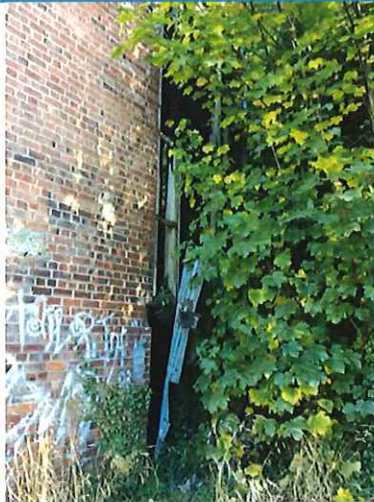
Area	Reason	Photo
NORTH BACK SIDE OF BUILDING (EXTERIOR)	NO SAFE ACCESS

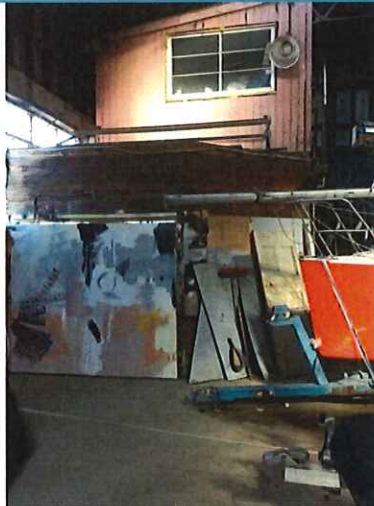
SOUTH END STORE UNDER OFFICE	NO ACCESS
