## **OFFICAL INFORMATION REQUEST – TAR WELL, DUNEDIN GASWORKS**

- GHD’s Dunedin Gasworks Tar Well: Proposal – Annual Monitoring 2022 (12 January 2022)
- GHD’s Dunedin Gasworks Annual Monitoring and Risk Assessment (17 April 2024)
- DCC’s Tar Pit Inspection report – 20 May 2024
- Tonkin and Taylor report – Interim Site Management Plan (May 2024)

## Annual Monitoring and Risk Assessment

17 April 2024

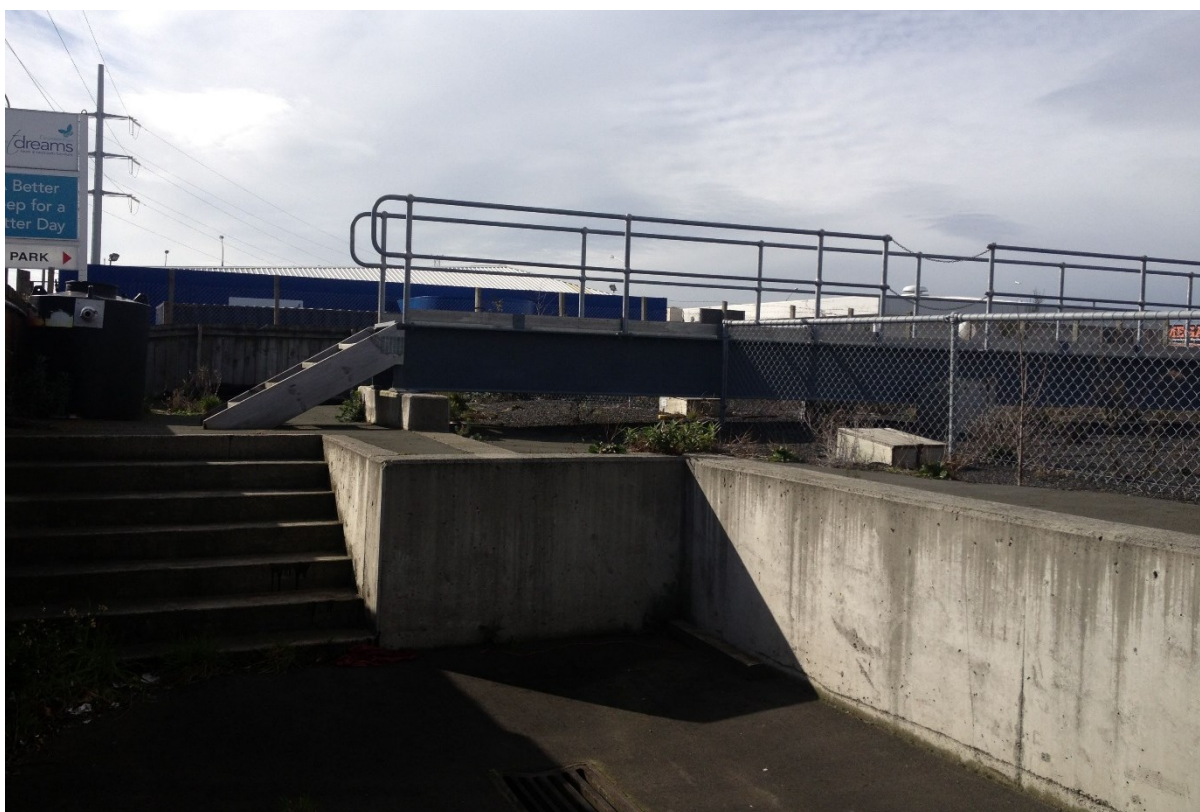
Photograph 3.1: Tar well raised above street level.

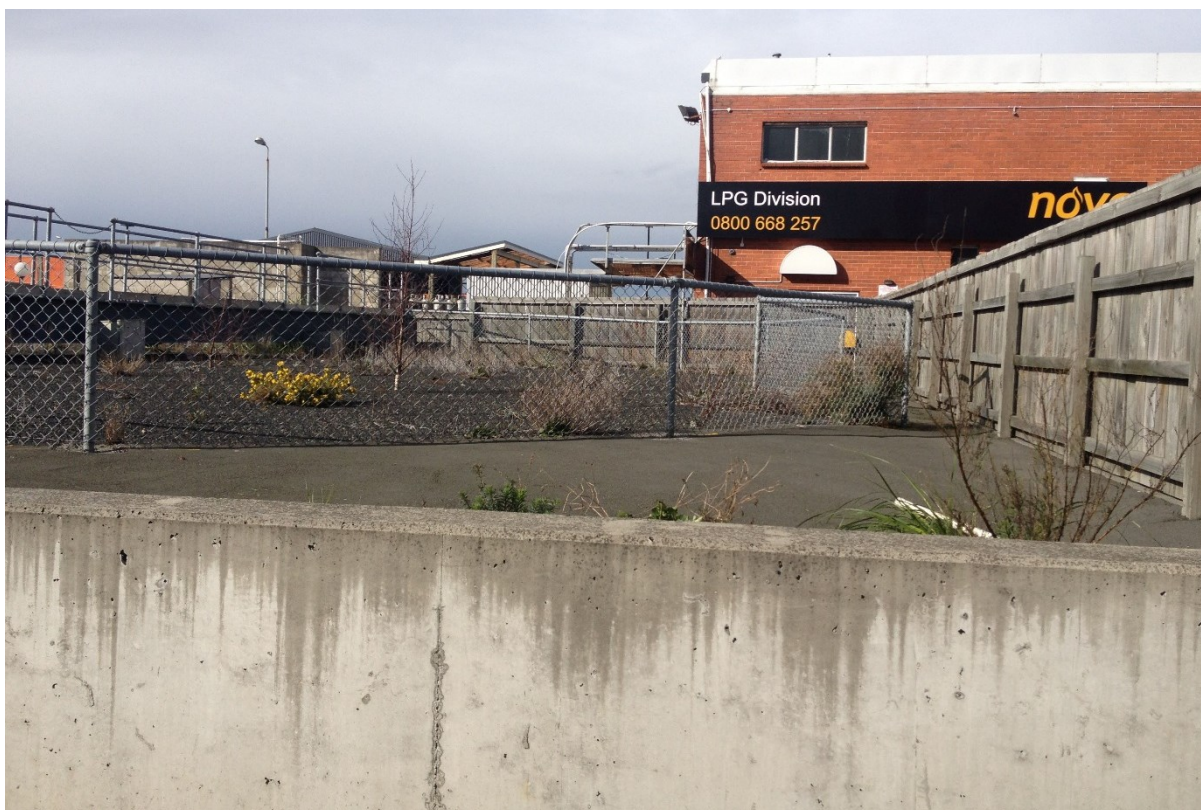
*Photograph 3.2: Tar well lid and fenced enclosure.*

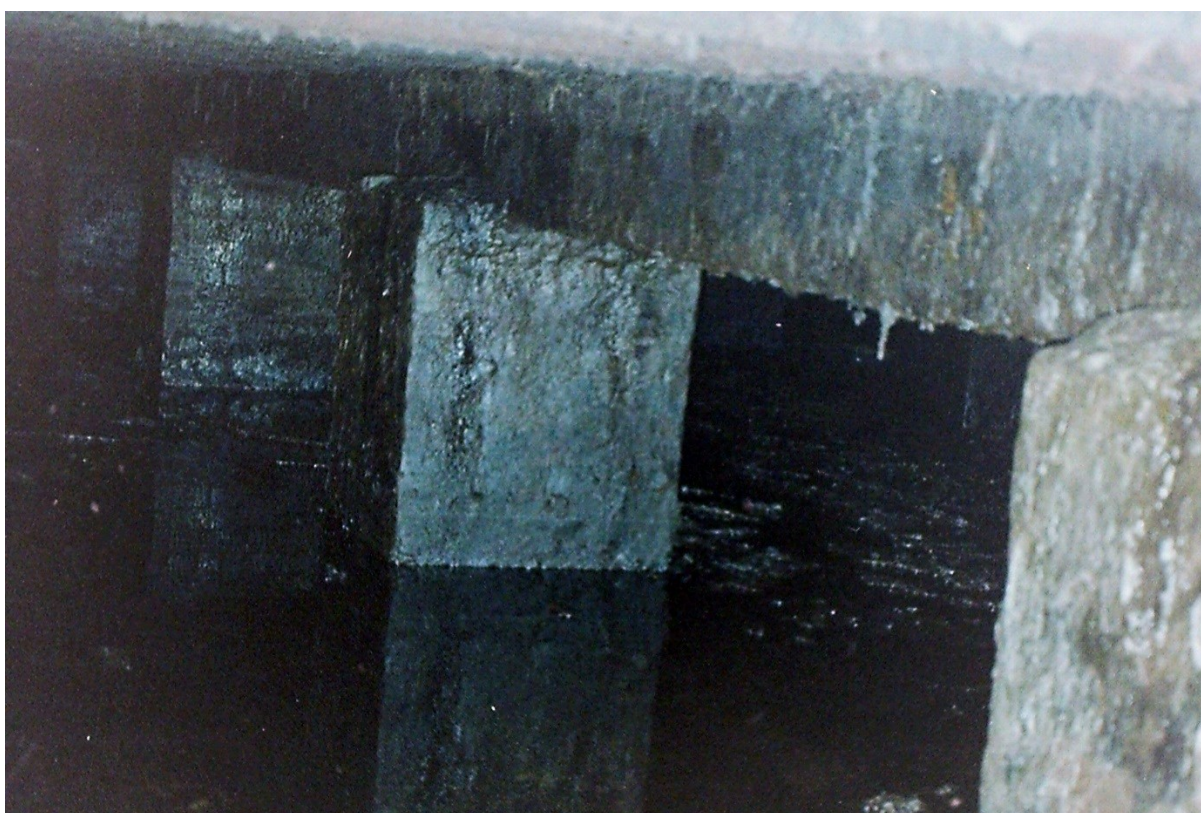
*Photograph 3.3: Inside the tar well showing the timber roof structure and liquid phase around 0.5 m from the site surface.*

Annual water testing by DCC confirms the presence of the above contaminants in the liquid phase. Observations by DCC maintenance staff along with water level monitoring data indicates the water level in the tar well is above ground level. This indicates the tar well structure itself is not leaking and suggests the source of accumulating water in the tank is surface runoff entering via the tar well lid or thinner brick-only walls of the tar well that are surrounded by fill but extend above the surrounding ground surface. The water level monitoring data also suggest around 60% of the equivalent rainfall falling directly on the tar well footprint recorded at the closest weather station is entering the tank. This appears consistent with entry of rainfall through the timber plank roof structure cover or edges rather than deeper inflows.

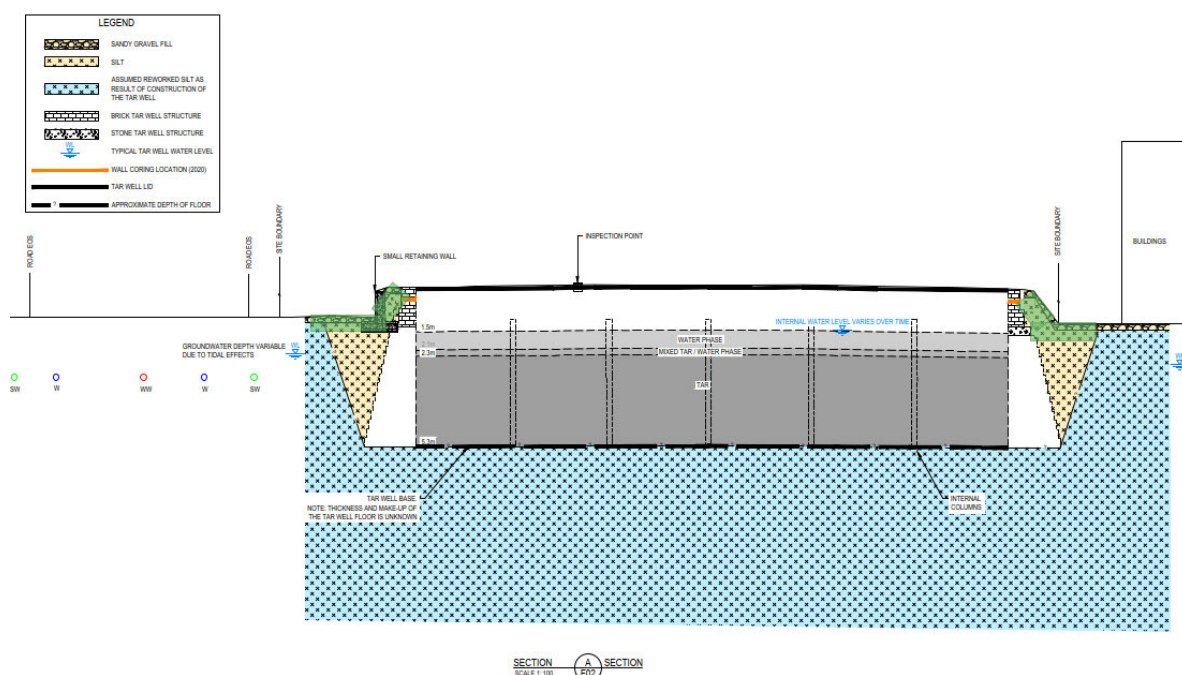
Figure 3.2: Schematic illustration showing the potential areas of contamination within the property (Source: T+T 2023).

Based on the available soil, groundwater and tar tank contents information, a model of potential contamination was developed. The cross section in Figure 3.2 illustrates the profile soil contamination and likely subsurface profile beneath the site.

The lithologies coloured green on the cross section are those where gasworks related contaminants are more likely to be present. The groundwater level is also shown.
