## Waikouaiti Metals Sampling Plan

## Pipe Condition and

This report has been prepared by WSP New Zealand Ltd (WSP) for Dunedin City Council (Dunedin CC), to document our findings and recommendations based on the two Cast Iron (CI) pipe samples received for condition and lead joint integrity assessment.

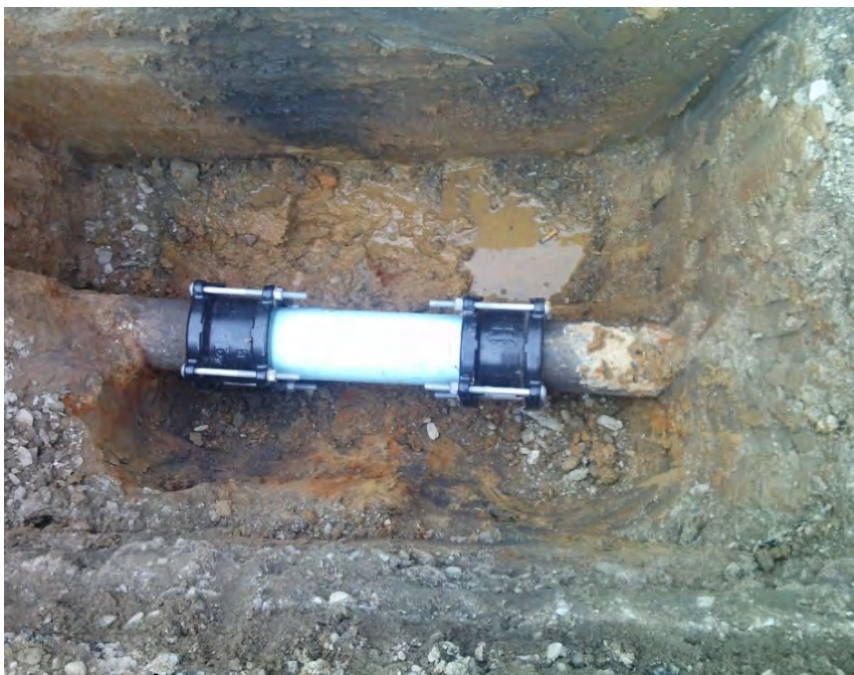
Only one pipeline failure has been reported by Dunedin CC on the 4" cast iron water main, this was recorded as 'Leak Gushing' in February 2015 and approximately 1 m of pipe was replaced, see Figure 3-1.

Figure 3-1 Repair to the 'Leak' that occurred in February 2015, photo courtesy Dunedin CC

The location of this failure was reported as approximately 85 m south of where pipe sample 21.006 CI was recovered.

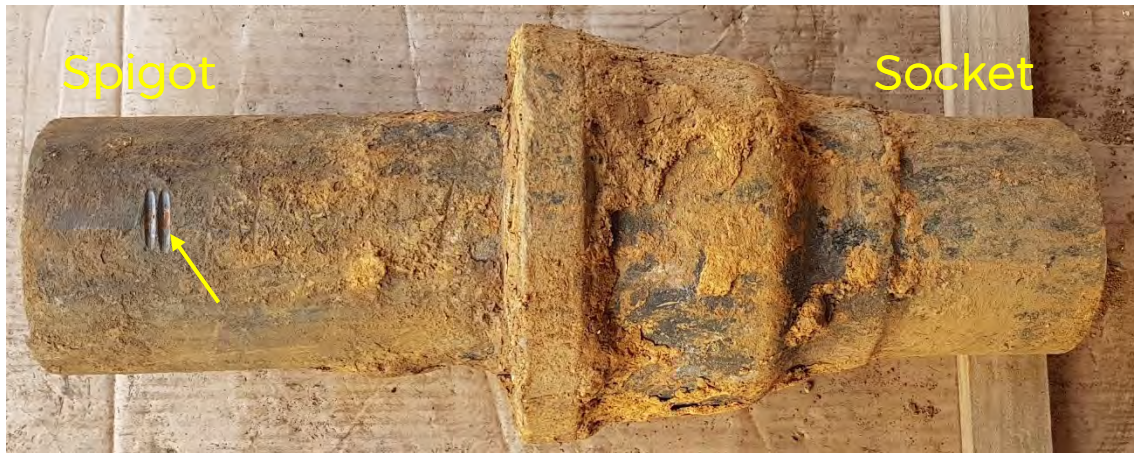
Photo A1

- Pipe Sample 21.006 CI as received on 10 February 2021.
- Top of pipe 'as laid' indicated by two grooves cut into the spigot end (yellow arrow).
- Surface corrosion and rusty clay is visible.

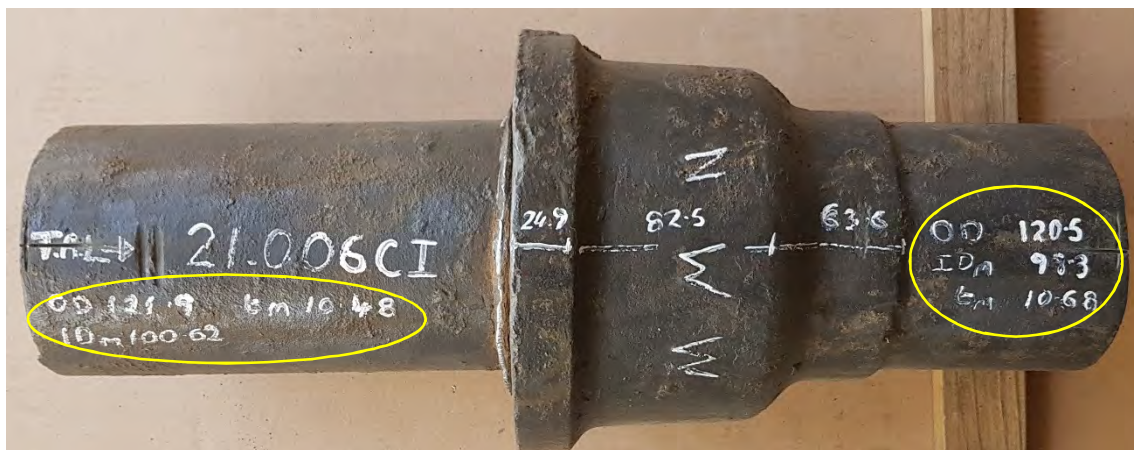
Photo A2

| Pipe Exterior | Pipe Interior |
|---|---|
| <ul style="list-style-type: none"> <li>• A factory applied bitumen dipped coating still covered ~95 % of the surface area, see Appendix A, photo A2.</li> <li>• We estimate that FWG of the cast iron could occur with the next two to five years, refer to Section 6.2.</li> <li>• The coating was no longer providing corrosion protection to approximately 90 % of the exterior surface and corrosion pits were up to ~3.7 mm deep, see Appendix A, photo A11.</li> <li>• No FWG had occurred.</li> <li>• Manufacturers marks were present on the socket 'S O' and '? W W' see Appendix A, photos A3 and A4.</li> </ul> | <ul style="list-style-type: none"> <li>• A factory applied bitumen dipped lining still covered ~90 % of the surface area, see Appendix A, photo A10.</li> <li>• Tuberculation was present and the reduction in bore was up to 25%, see Appendix A, photos A5 and A6.</li> <li>• The lining was no longer providing corrosion protection to approximately 60 % of the interior surface and corrosion pits were up to ~5.7 mm deep, see Appendix A, photo A12.</li> </ul> |

- After cleaning with a power wire brush in preparation for examination and measurements.
- The OD, mean ID and wall thickness's are annotated at each end of the pipe sample (yellow ellipses).
- The external bitumen coating covered ~95% of the pipe sample.
- Some manufacturers markers were visible on the pipe socket and are marked with a white pen for clarity, refer to photo A3 and A4 for details.

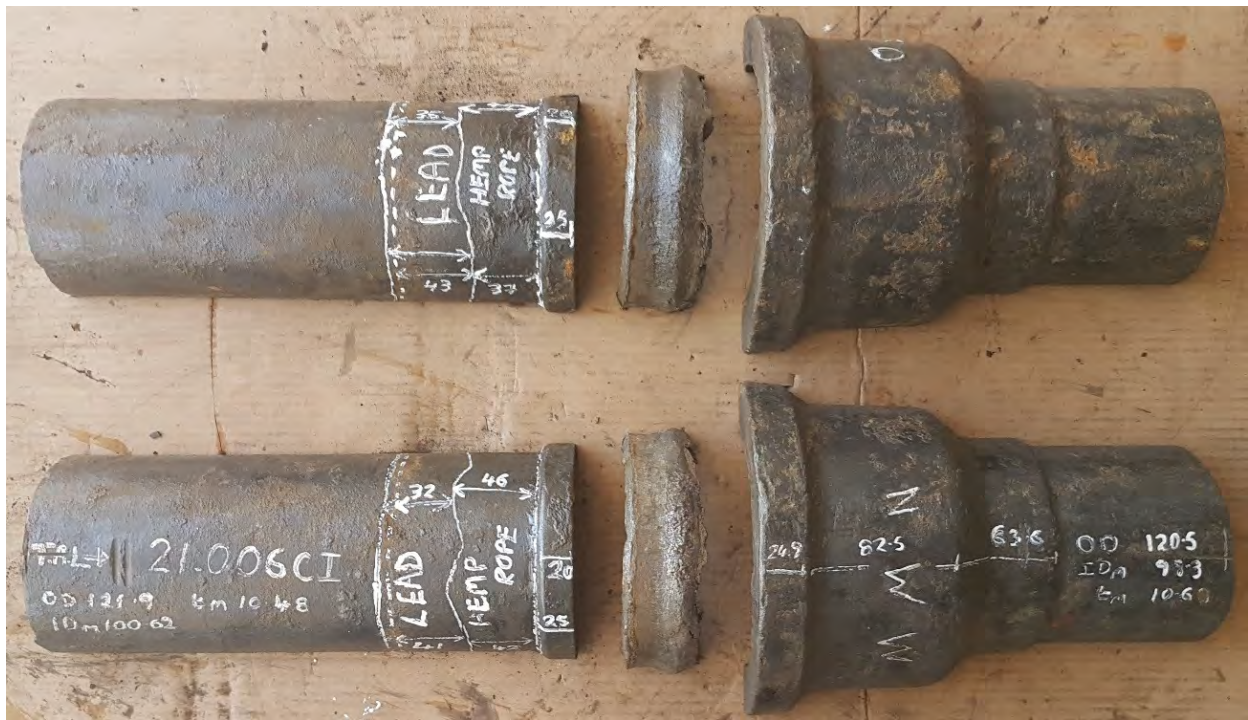
**Photo A8**

- Exterior view – pipe sample cut in half longitudinally (along the spring line of the pipe as-laid).
- The bitumen dipped composite coating is still visible and covered ~95 % of the pipe sample.
- Pre-sandblasting, some corrosion pits were visible.
- The approximate depths of lead and bitumen impregnated hemp rope and the collar at the end of the spigot are marked with a white paint pen for clarity.
- Manufacturers marking on the socket 'N W W' are highlighted in white pen for clarity.

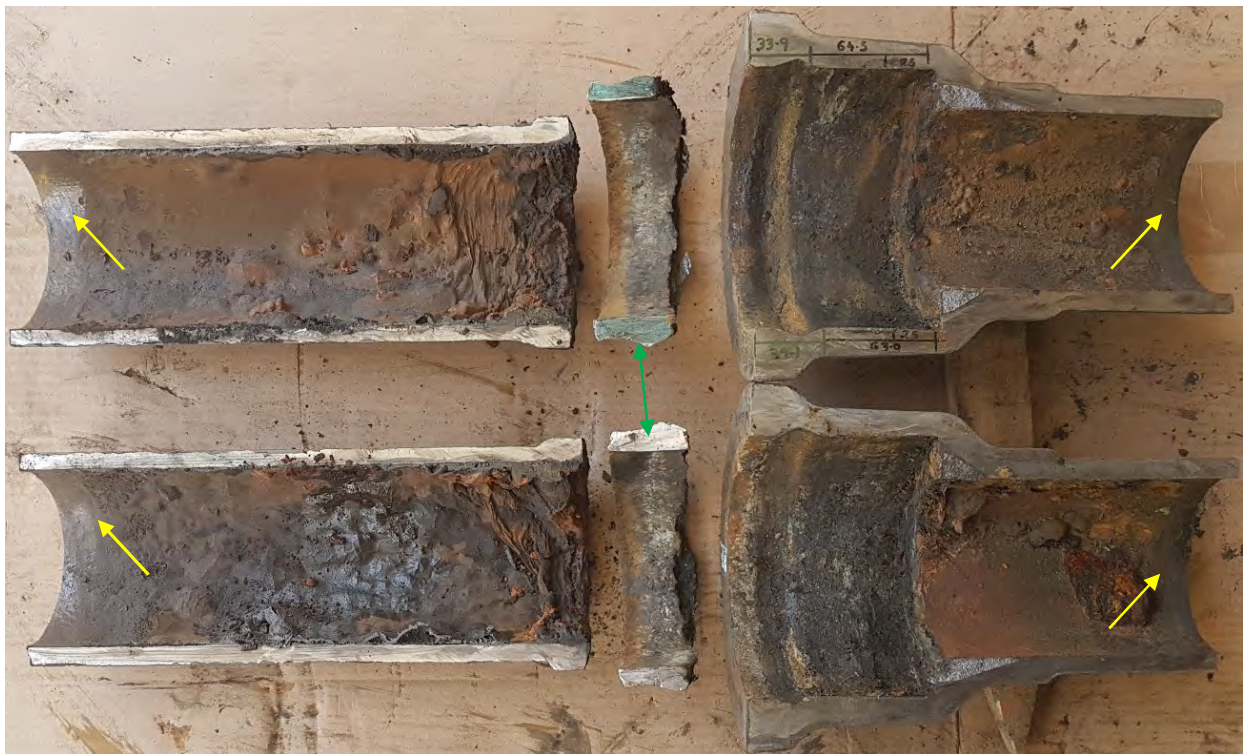
**Photo A9**

- Interior view of the pipe sample prior to the tuberculation being removed.
- A short section of tuberculation had been removed at each end to allow measurement of the wall thickness (yellow arrows).
- The lead between the spigot and socket is shown (green arrow).

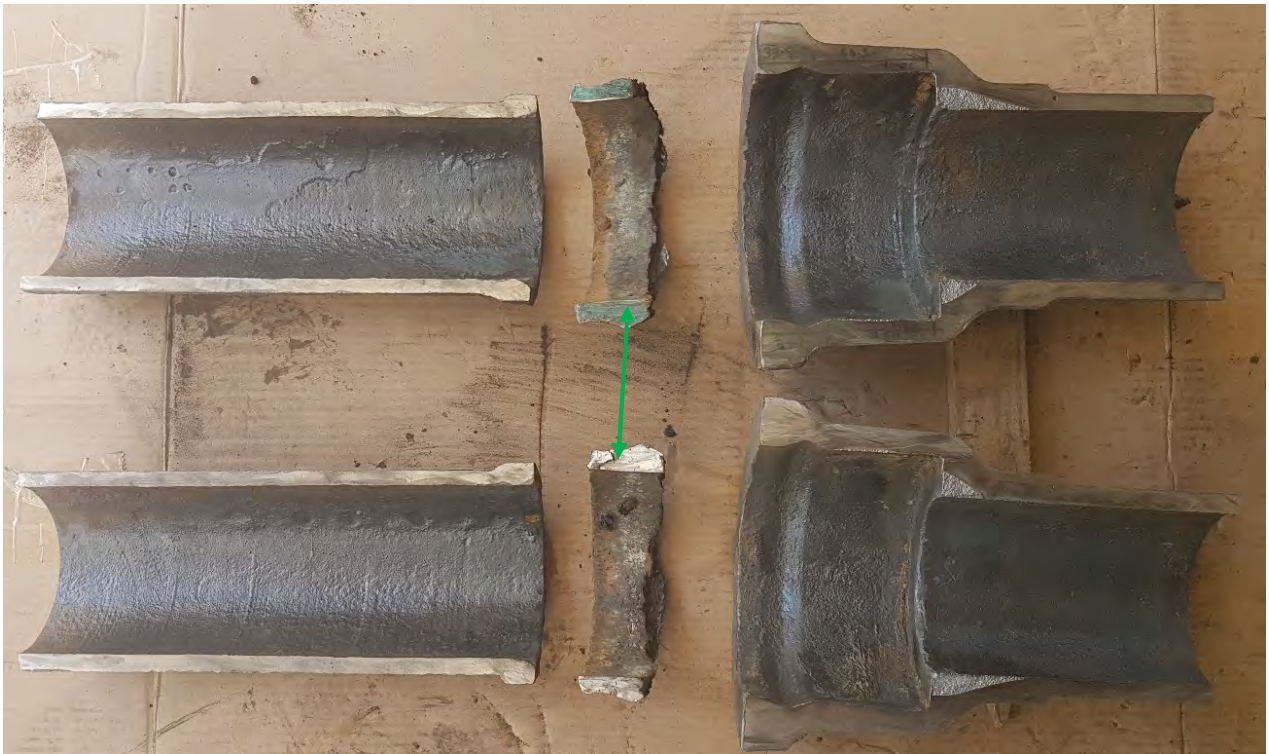
**Photo A10**

- Interior view of the pipe sample after the tuberculation was removed with a power wire brush.
- The bitumen dipped composite is still visible and covered ~90% of the pipe sample however, some graphitisation of the iron is visible.
- The lead between the spigot and socket is shown (green arrow).

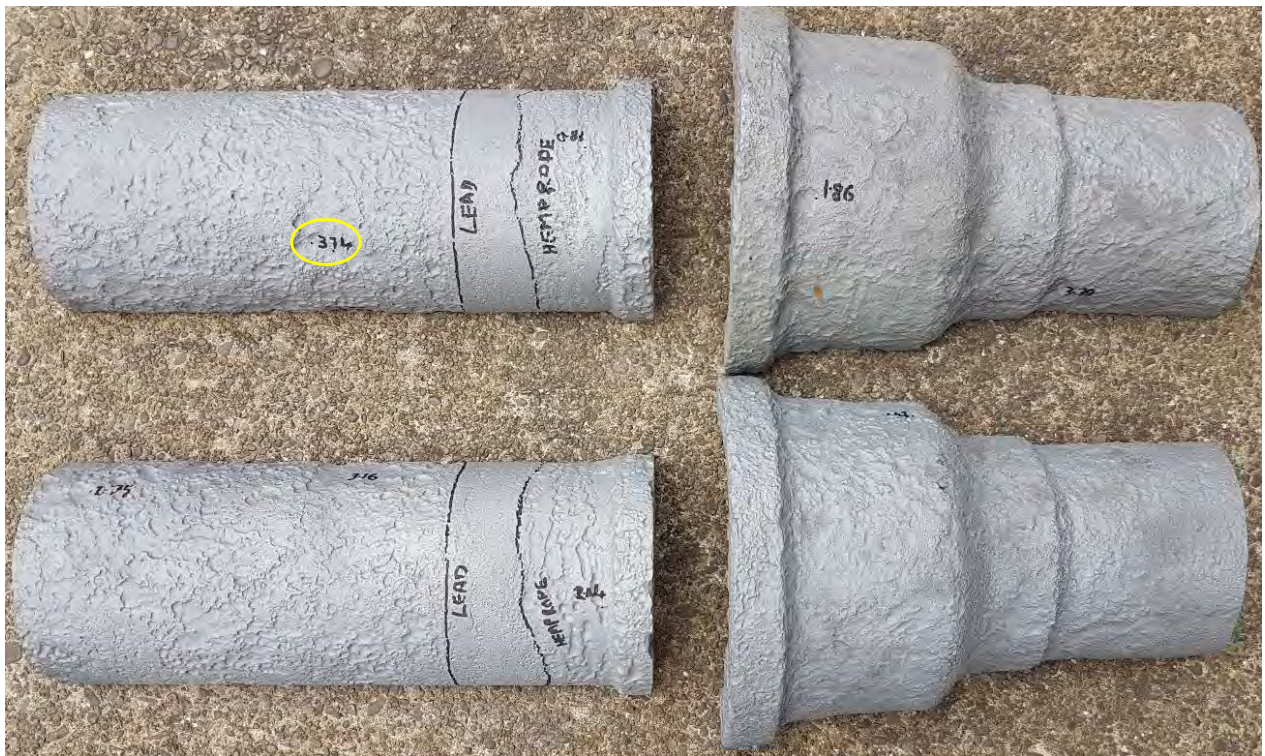
**Photo A11**

- Pipe exterior, after sandblasting to white metal.
- Corrosion pits up to 3.74 mm deep are visible (yellow ellipse).
- Approximately 90 % of the surface area is pitted.
- The approx. extent of the lead and bitumen impregnated hemp rope is marked and annotated on the spigot end.

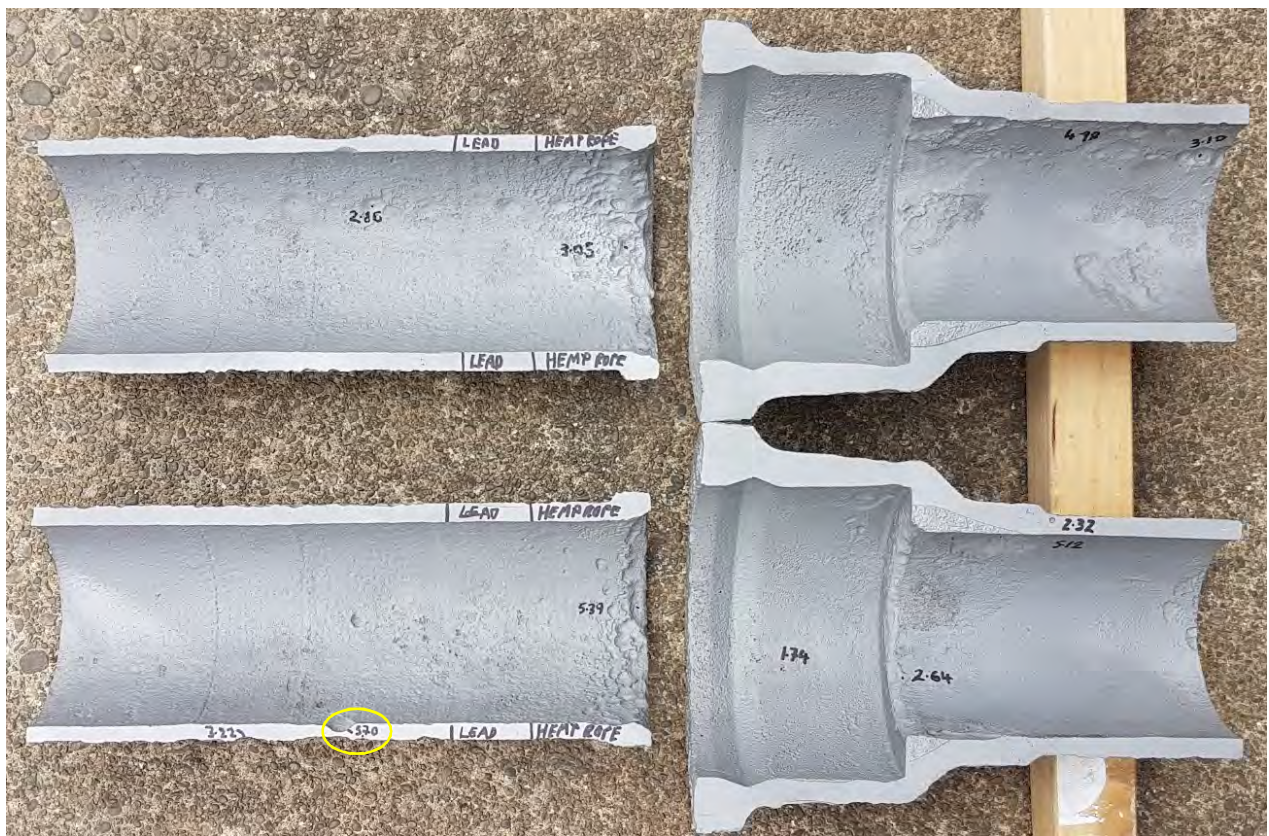
Photo A12

- There was minimal corrosion pitting under the lead and where the bitumen impregnated hemp rope was tightly packed.
- The bitumen composite lining was still providing limited corrosion protection to the interior surface of the cast iron. Some corrosion pits with graphitised iron were present, refer to Appendix A, photo A12 and Appendix B, photo B12.

- Pipe interior, after sandblasting to white metal.
- Corrosion pits up to 5.7 mm deep are visible (yellow ellipse).
- Approximately 60 % of the surface area is pitted.

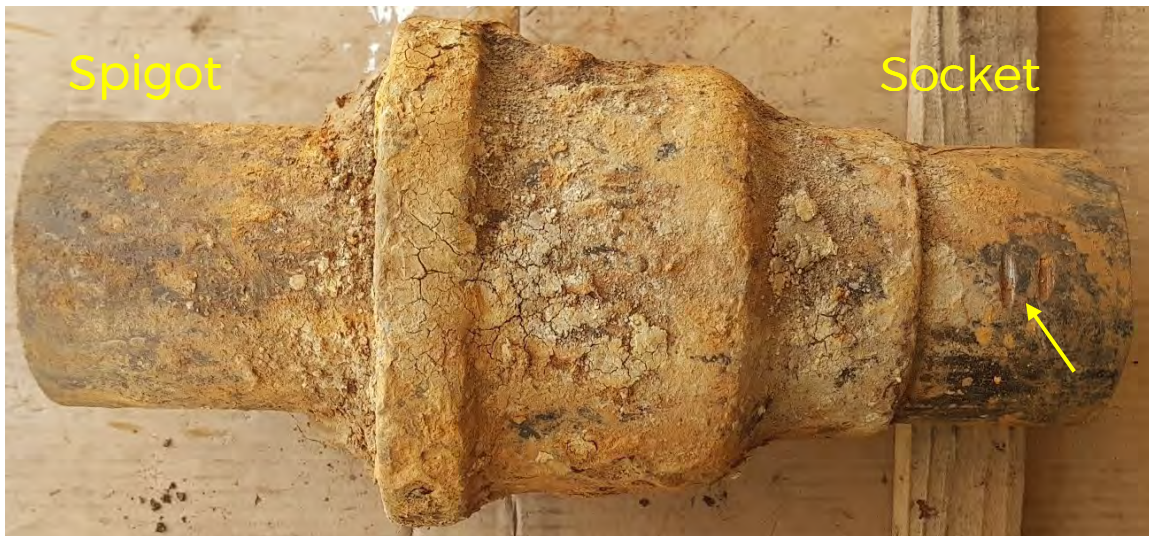
Photo B1

- Pipe Sample 21.007 CI as received on 10 February 2021.
- Top of pipe 'as laid' indicated by two grooves cut into the socket end (yellow arrow).
- Surface corrosion and rusty clay is visible.

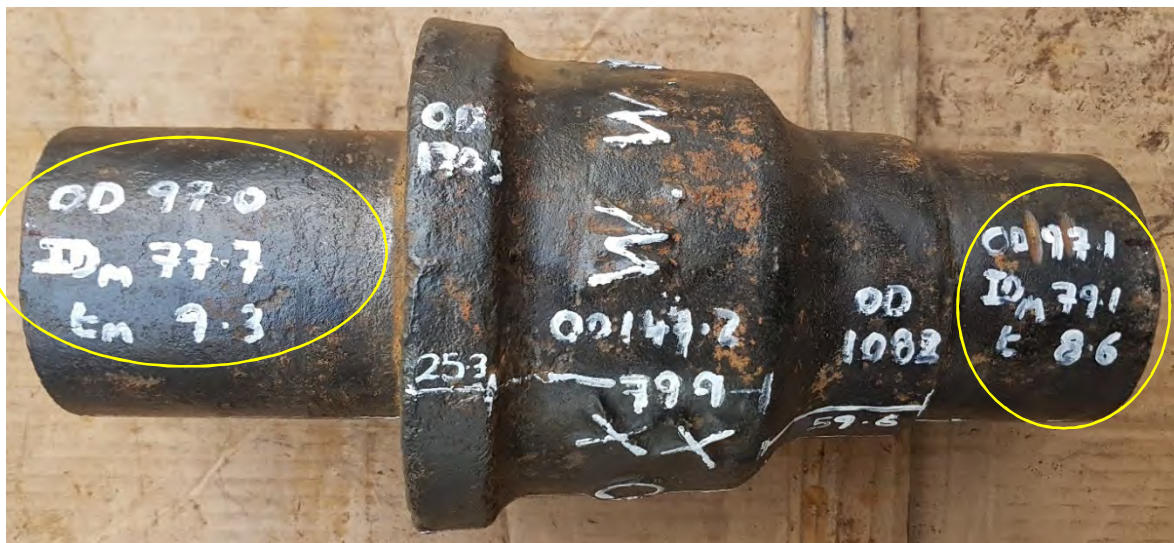
Photo B2

| Pipe Exterior | Pipe Interior |
|---|---|
| <ul style="list-style-type: none"> <li>A factory applied bitumen dipped coating still covered ~95 % of the surface area, see Appendix B, photo B2.</li> <li>Sand blasting revealed FWG of the cast iron that likely occurred in the late-1990's or early-2000's, see Appendix B, photos B11 and B12.</li> <li>The coating was no longer providing corrosion protection to approximately 60 % of the exterior surface and corrosion pits were up to ~3.1 mm deep, see Appendix B, photo B11.</li> <li>Manufacturers marks were present on the socket 'O XX' and 'W W W', see Appendix B, photos B3 and B4.</li> </ul> | <ul style="list-style-type: none"> <li>A factory applied bitumen dipped lining still covered ~95 % of the surface area, see Appendix B photo B10.</li> <li>Tuberculation was present and the reduction in bore was up to 40% in places, see Appendix B, photos B5 and B6.</li> <li>The lining was no longer providing corrosion protection to approximately 80 % of the interior surface and corrosion pits were up to ~6.2 mm deep, see Appendix B, photo B12.</li> </ul> |

- After cleaning with a power wire brush in preparation for examination and measurements.
- The OD, mean ID and wall thickness's are annotated at each end of the pipe sample (yellow ellipses).
- The external bitumen coating covered ~95% of the pipe sample.
- Some manufacturers markers were visible on the pipe socket and are marked with a white pen for clarity, refer to photo B3 and B4 for details.

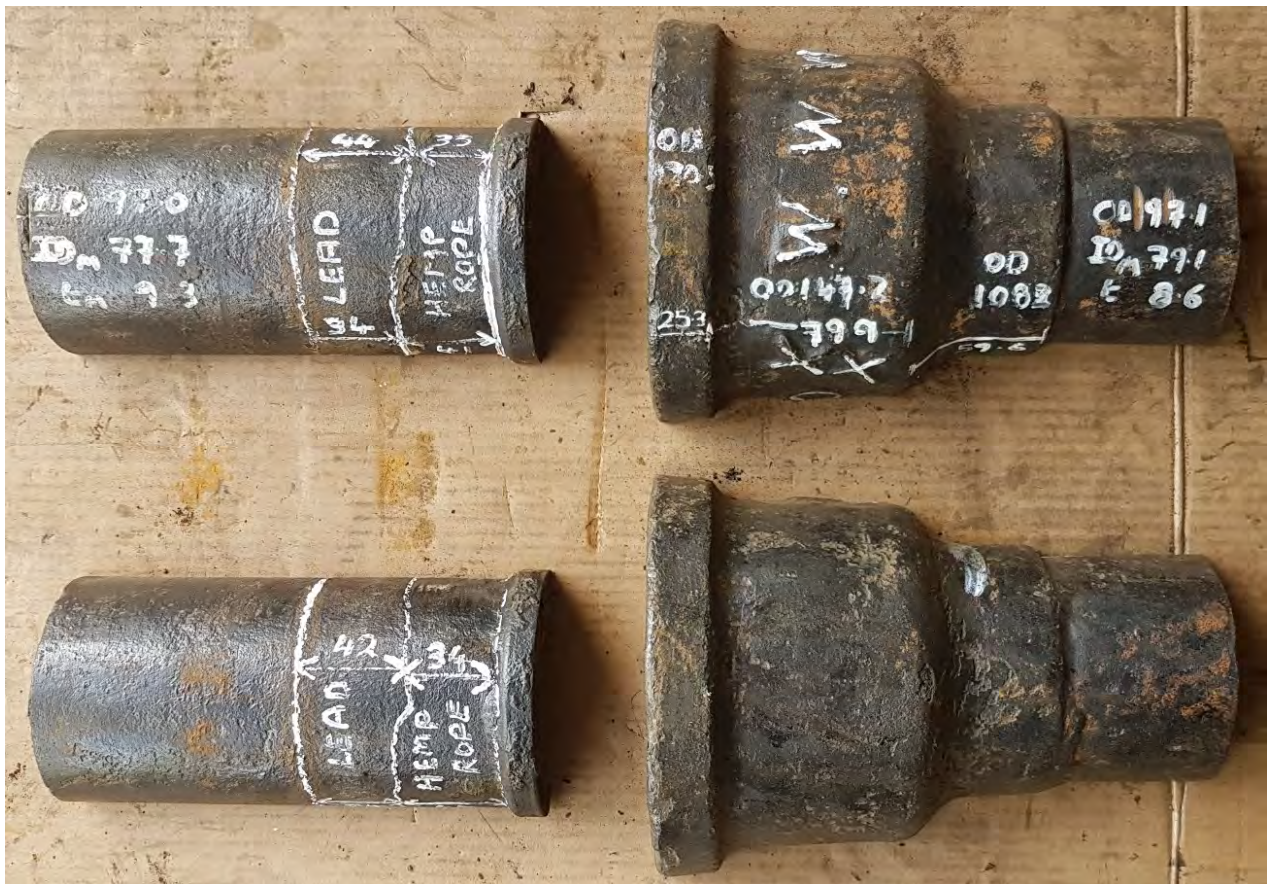
**Photo B8**

- Exterior view – pipe sample cut in half longitudinally (along the spring line of the pipe as-laid).
- The bitumen dipped composite coating is still visible and covered ~95 % of the pipe sample.
- Pre-sandblasting, some corrosion pits were visible.
- The approximate depths of lead and bitumen impregnated hemp rope and the collar at the end of the spigot are marked with a white paint pen for clarity. Manufacturers marking on the socket 'XX' and 'W W W' are highlighted in white pen for clarity.

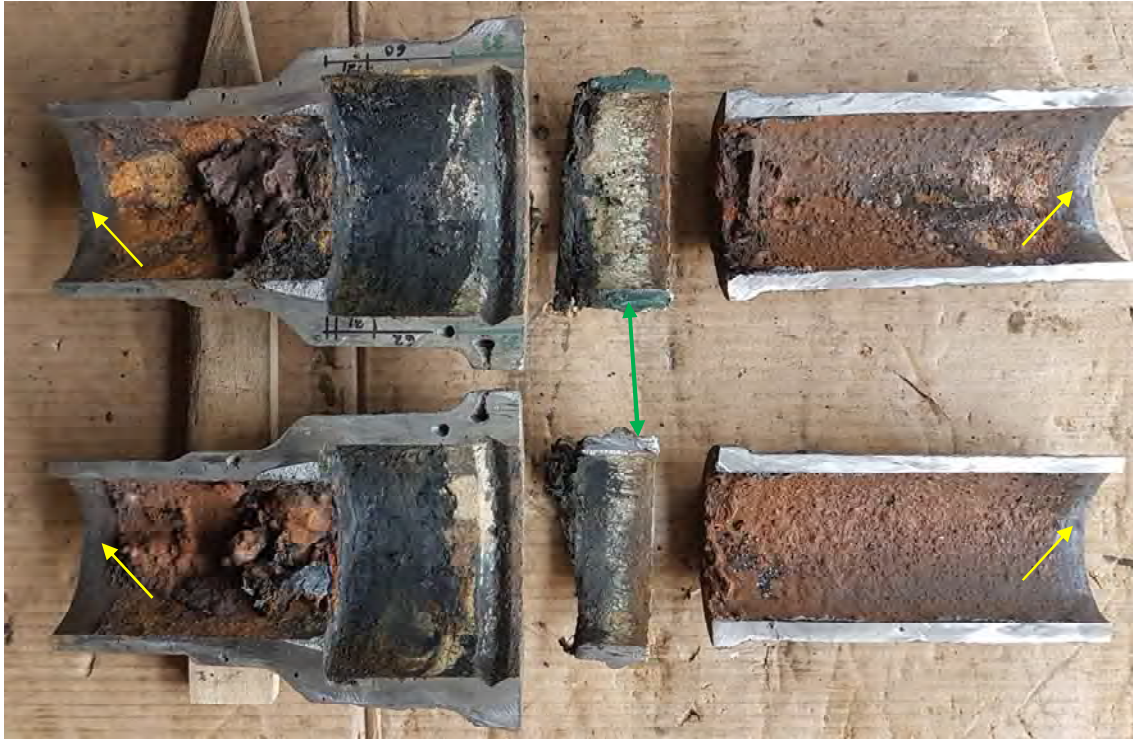
**Photo B9**

- Interior view of the pipe sample prior to the tuberculation being removed.
- A short section of tuberculation had been removed at each end to allow measurement of the wall thickness (yellow arrows).
- The lead between the spigot and socket is shown (green arrow).

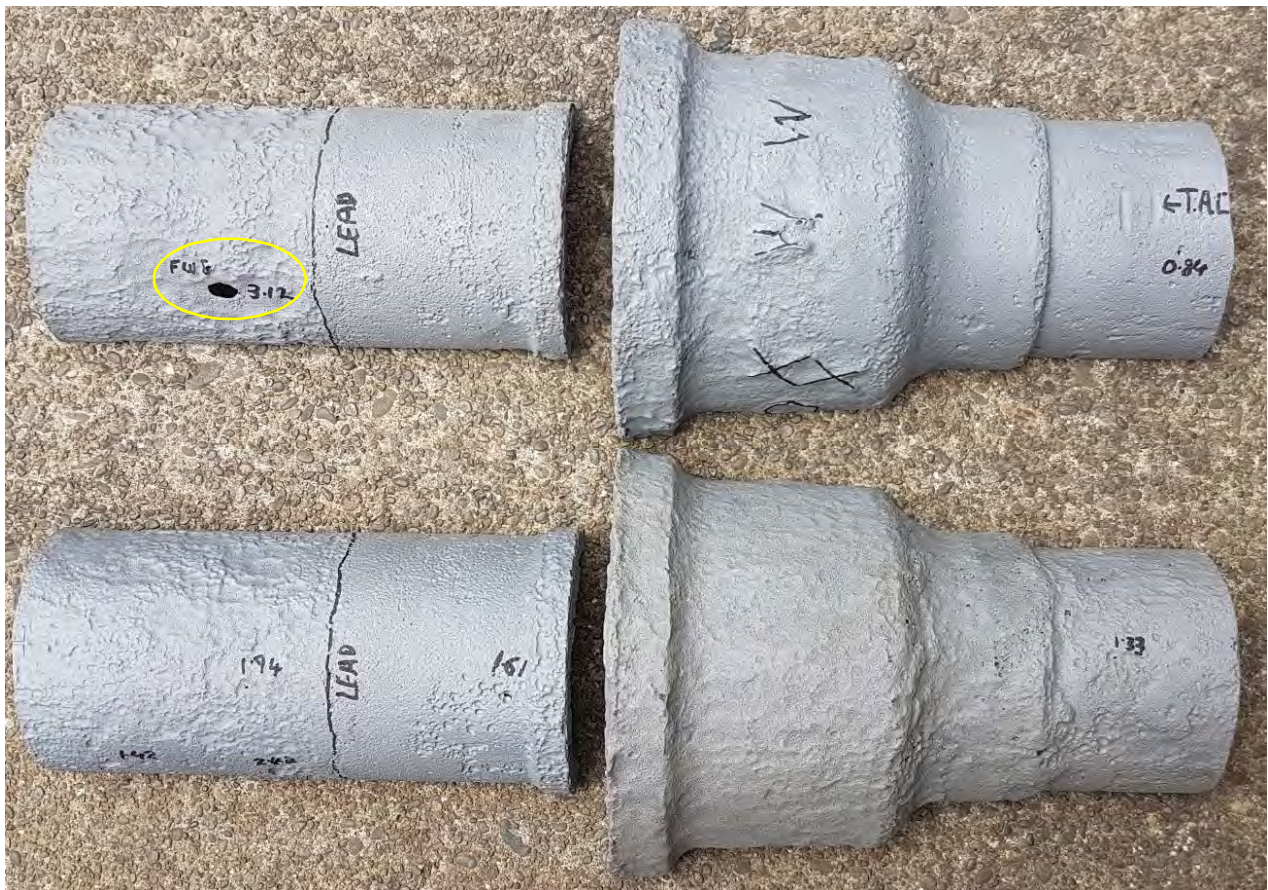
**Photo B11**

- Pipe exterior, after sandblasting to white metal.
- Corrosion pits up to 3.12 mm deep are visible and FWG has occurred, from combined external and internal corrosion (yellow ellipse).
- Approximately 60 % of the surface area is pitted.
- The approx. extent of the lead is marked and annotated on the spigot end.

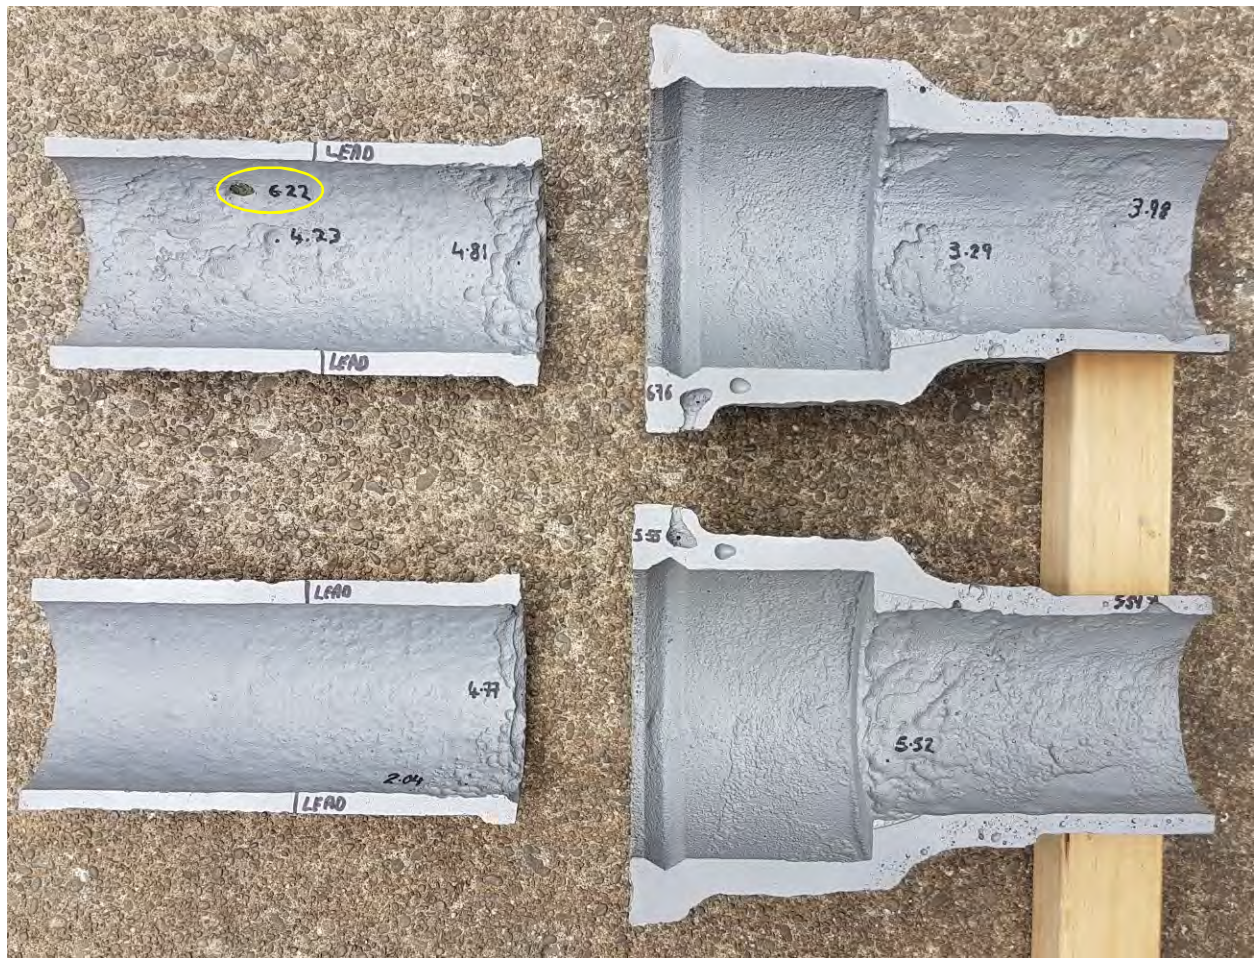
**Photo B12**

- Pipe interior, after sandblasting to white metal.
- Corrosion pits up to 6.22 mm deep are visible and FWG has occurred, from combined external and internal corrosion (yellow ellipse).
- Approximately 80 % of the surface area is pitted.
