Waikouaiti Metals – Investigation Report

A number of elevated lead results were found in the Waikouaiti, Karitane, and Hawksbury Village water supply scheme between 31 July 2020 and 20 January 2021. On 2 February 2021, the Dunedin City Council issued a Do Not Drink Notice (DNDN) for this scheme. Since then, an investigation team has been working to understand the causes of the results and determine the risks to public health as far as practicable. A key aspect of this is to understand the cause of the exceptional values observed on 8 December 2020 (at Waikouaiti Golf Club and Karitane Bowling Club) and 20 January 2021 (in the raw water reservoir).

This report details the investigation team's findings about the source of the elevated lead results. The investigation included a review of potential lead sources and a high-level overview of potential sources/causes of high readings is included in the table below.

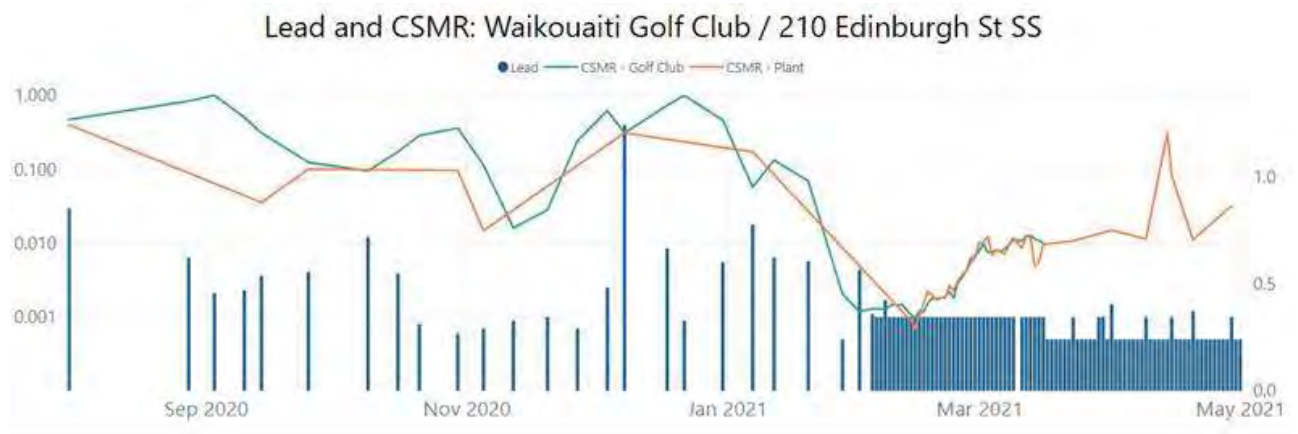
although flushing and the change in sample tap could also be factors. Results before 4 February 2021 were taken from customer taps, while the later results were taken from dedicated stainless steel sampling stations. The trends of lead and CSMR before 4 February 2021 show a weak correlation but this may not be causal. A small rain event on 4 December 2020 could potentially have dropped the alkalinity slightly.

Figure 18: Lead and CSMR @ Waikouaiti Golf Club / 210 Edinburgh St SS

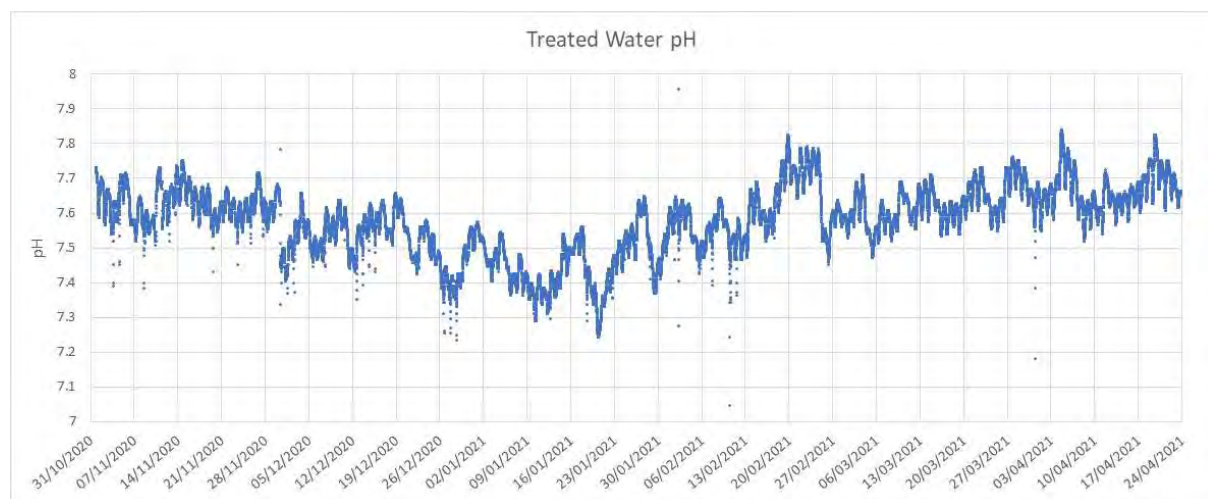
A review of treated water pH SCADA trends (see Figure 19) showed that the pH was generally between 7.2 and 7.85). In general, higher pH water is less corrosive to plumbing and there is little evidence that changes in pH caused a release of lead in the distribution network prior to 8 December 2020.

Figure 19: Waikouaiti WTP - Treated Water pH

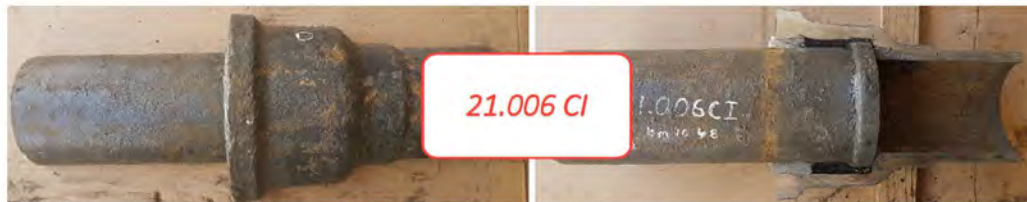
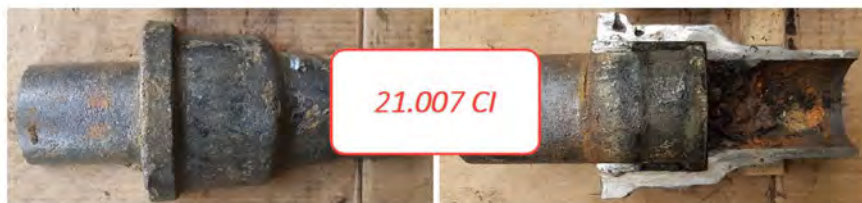
4" (DN 100), Cast Iron Pipe with Run-Lead Joint – 111 Edinburgh Street

3" (DN 75), Cast Iron Pipe with Run-Lead Joint – Perth Street

Figure 21: Sections of cast iron pipe sent to WSP for condition and lead joint integrity assessment from Waikouaiti Upper Levels zone.

- The pipes were estimated to be installed in 1913 and assessed to be at the end of life stage and due for replacement.
- In the two pipe sections analysed, there were no signs that the lead was directly exposed to the water supply and the hemp rope that seals the connection (isolating the water supply from the lead) was packed tightly into the socket (see Figure 22).
- Lead joints are unlikely to have contributed to the exceptionally high results observed on 8 December 2020.
- It is possible (though unlikely) that other lead joints on the cast iron water mains in Waikouaiti may be exposed to water due to the hemp rope not being sufficiently packed prior to the pouring of the molten lead or subsequent damage or degradation.

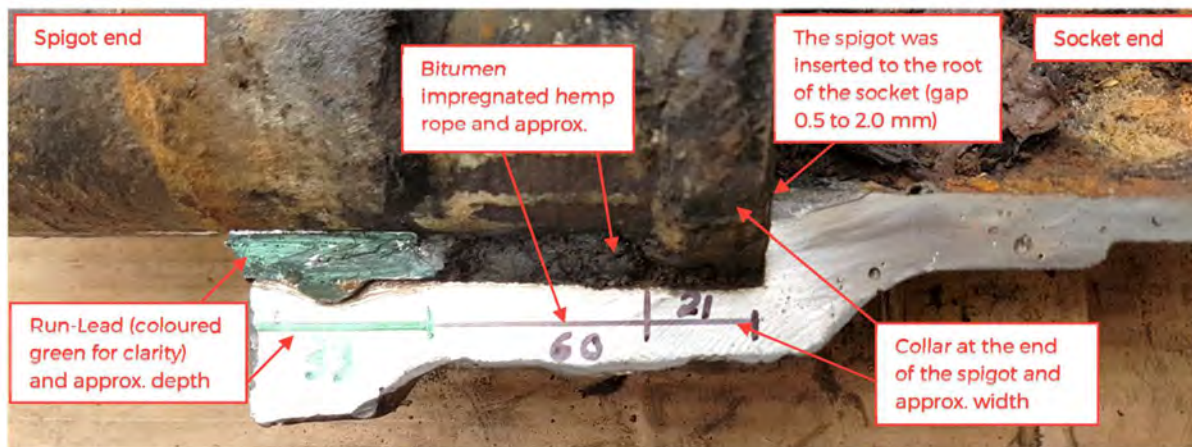
Figure 22: Cross-section of lead joint shows the tightly packed bitumen impregnated hemp rope blocking the direct contact of water with the lead joint.

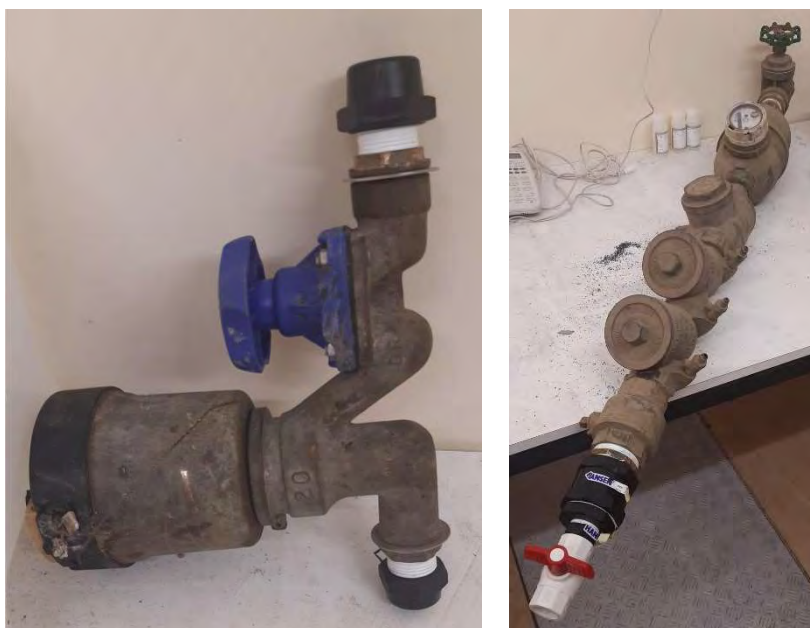
Prolonged stagnation of water could be a contributing factor of the readings on 8 December 2020 if the samples collected an element of water which had been stagnating in lead-bearing plumbing materials. The brass manifolds from both the Waikouaiti Golf Club and the Karitane Bowling Club were removed and replaced (see Figure 25 below). Stagnation tests were done by allowing water to sit in capped manifolds for 24 hours to assess the manifolds as a potential source for elevated lead readings. Water was then carefully sampled directly from the manifolds into 500 mL plastic containers. These samples were then sub-sampled and sent to Eurofins for analysis (lead – acid soluble, amongst other metals). The remaining sample was analysed by handheld lead analysers and recorded.

Figure 25: The meter and toby from Karitane Bowling Club (left) and the meter and double check valve with associated fittings and fixtures from Waikouaiti Golf Club (right)

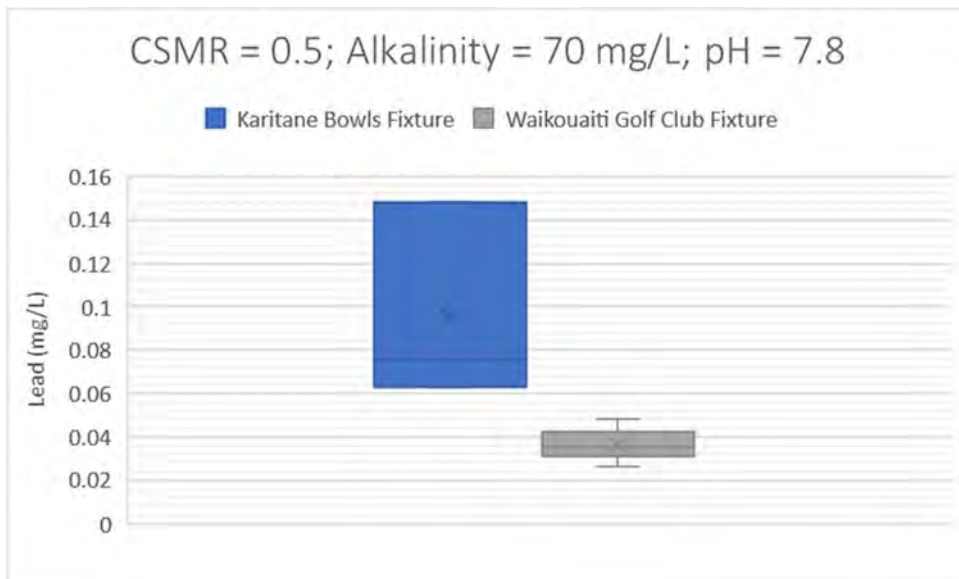
from Mt. Grand WTP which is typically more corrosive (CSMR = 9.5; alkalinity = 10 mg/L; pH = approx. 6.5).

Figure 26: Stagnation Test Results from Fixtures with Treated Water from Edinburgh St SS

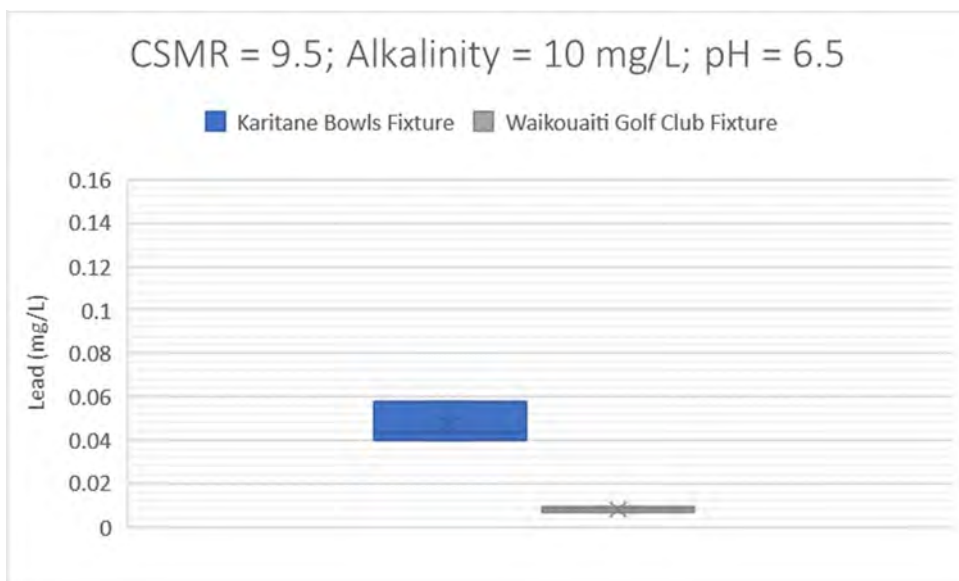
Figure 27: Stagnation Test Results from Fixtures with Filtered Water from Mt. Grand WTP

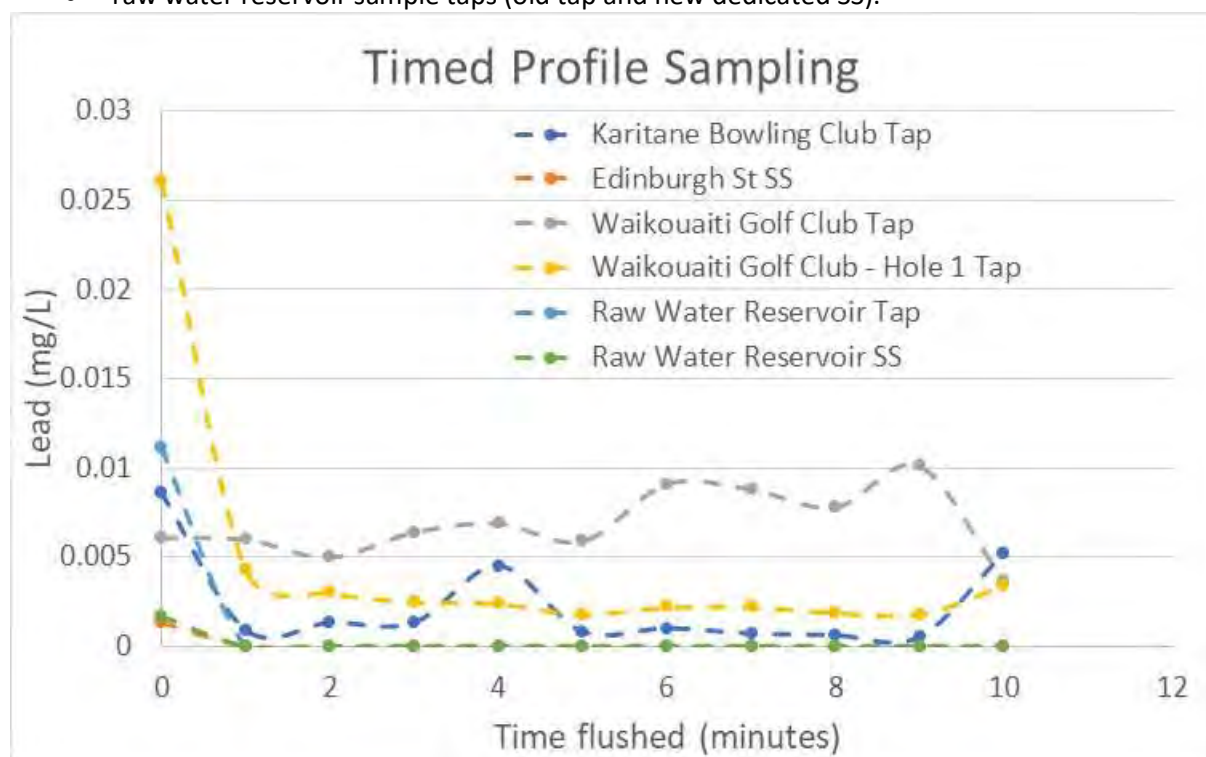
- customer taps at the Waikouaiti Golf Club (4 March 2021) and the Karitane Bowling Club (3 March 2021)
- dedicated sample stations close to the customer taps (210 Edinburgh St, 5 March 2021)
- raw water reservoir sample taps (old tap and new dedicated SS).

Figure 28: Timed Profile Samples. Dashed lines are shown as a guide only, not interpolation.

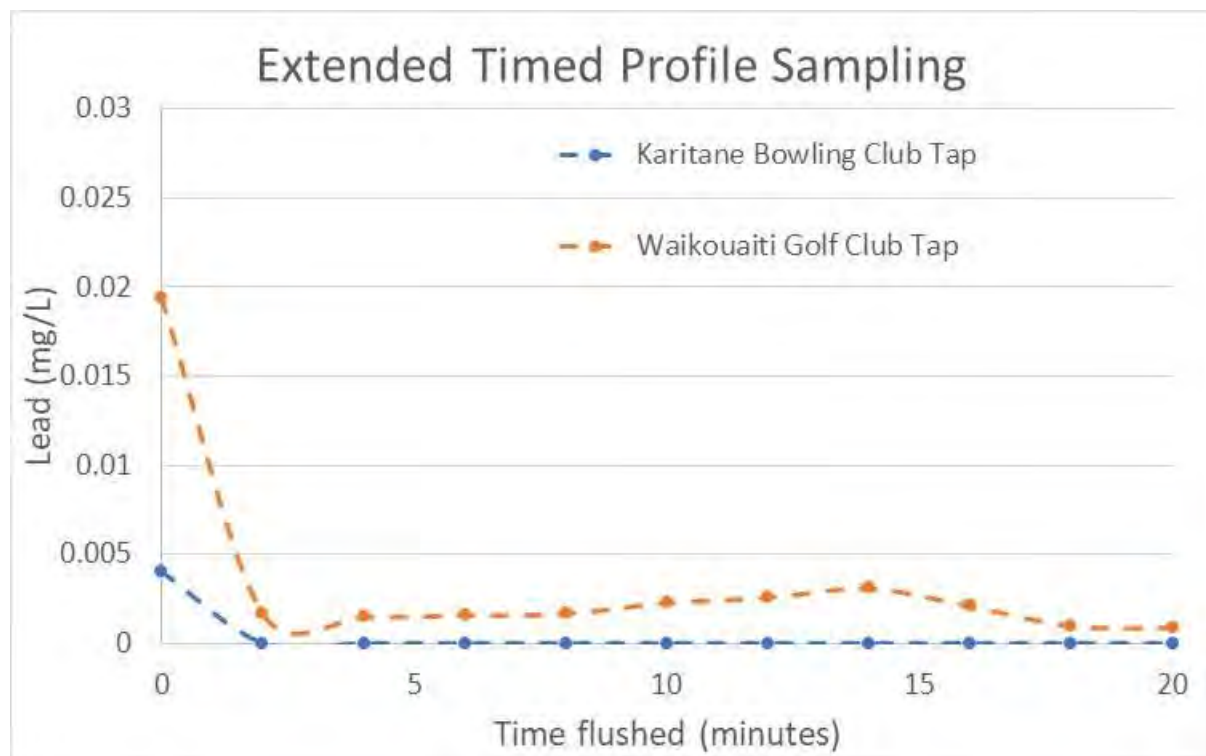
These tests also indicate that 10 minutes of flushing was insufficient to provide a sample of water which was representative of water in the distribution network at either location. An extended timed profile sample was undertaken to identify if representative samples might be obtained after 20 minutes of tap flushing. Samples were taken every two minutes and the results are shown in Figure 28.

Figure 29: Extended Timed Profile Samples. Lines are shown as a guide only, not interpolation.

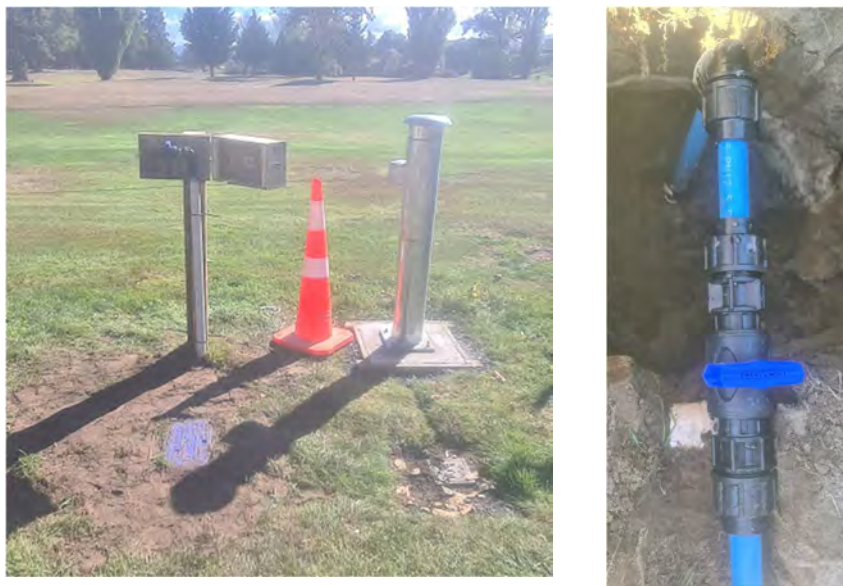
It is noted that the SS is secured in a locked galvanised casing and is not accessible for public use. It is also noted that SS are fabricated from metallic components to allow sterilisation using a blow torch.

Figure 30: (a) Plastic Sample Station (left) and Steel (right) @ 210 Edinburgh St (also installed at Bendigo Rd.) (b) Plastic tap connection to main

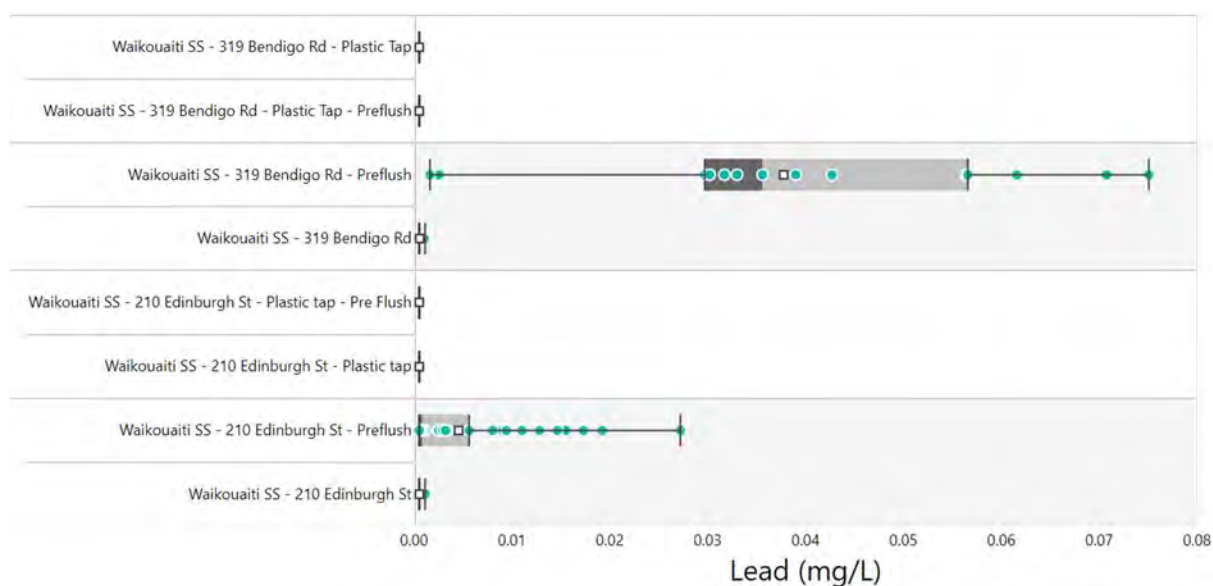
Figure 31 shows pre-flush and post-flush lead results from four sampling stations; a plastic SS and a stainless steel SS at 319 Bendigo Road, and a plastic SS and a stainless steel SS at 210 Edinburgh Street.

Figure 31: Pre-flush and post-flush results from sites with both stainless-steel SS and plastic SS

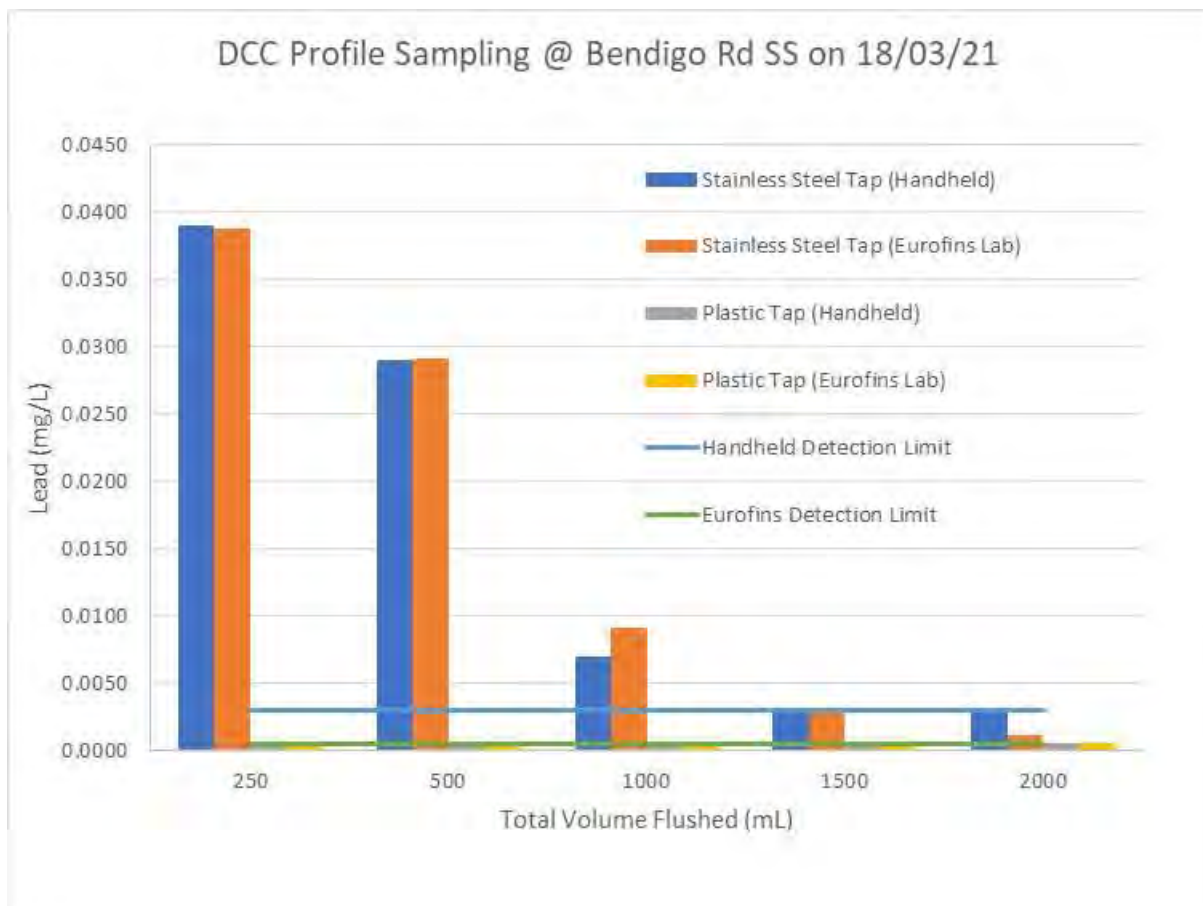
Figure 32 shows Eurofins and handheld test results from profile sampling of the stainless steel tap and the plastic tap at 319 Bendigo Road.

Figure 32: Profile sampling of Bendigo Road SS comparing Eurofins and handheld results

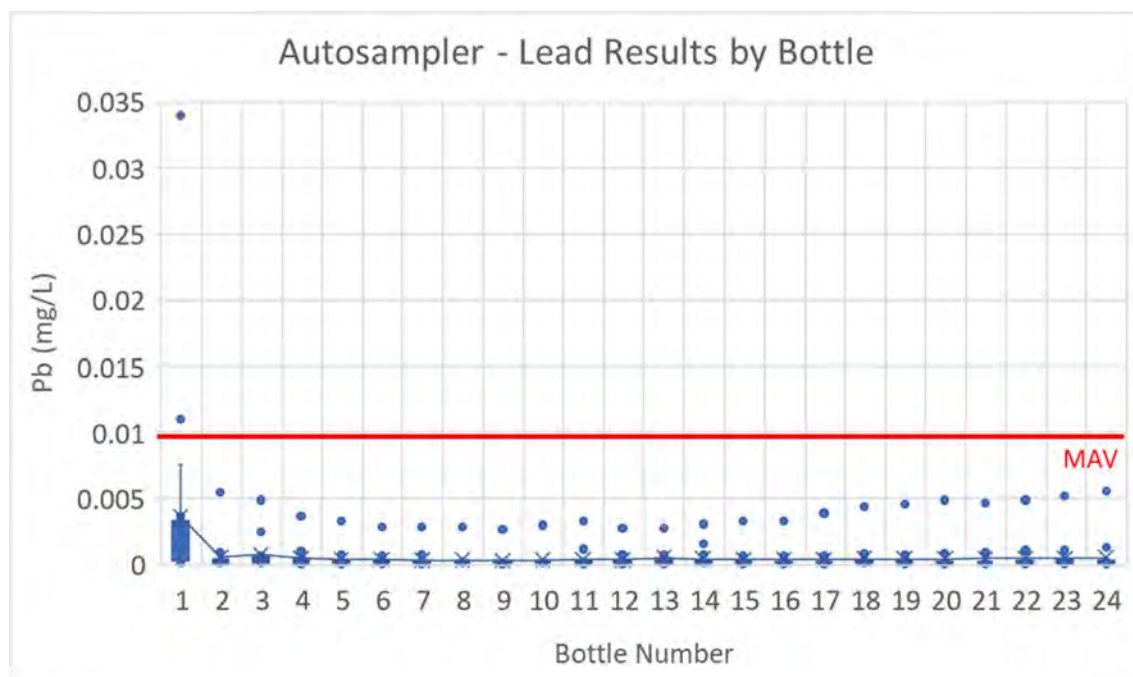
Figure 36 shows the systematically higher average (marked by the X and the line connecting the plots) concentration of lead in the first bottle.

Figure 36: Autosampler -Lead Results by Bottle

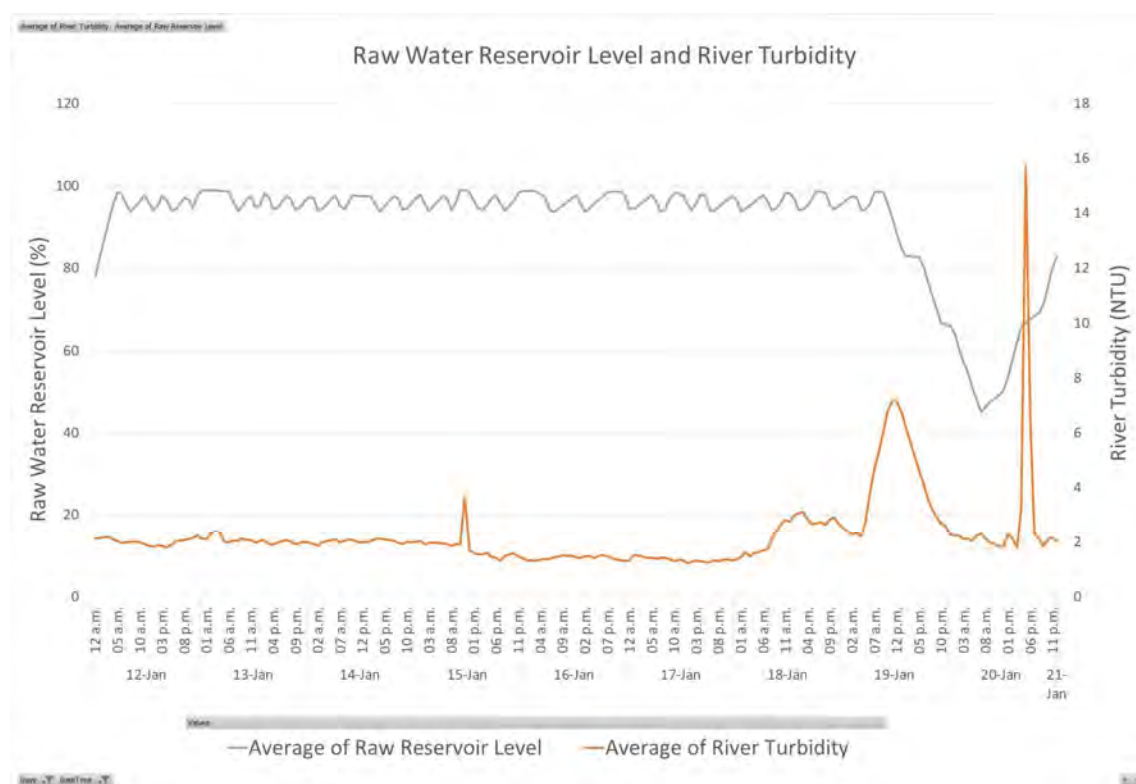
Water treatment plant SCADA trends were reviewed to identify any potential operational upset in the raw water reservoir on or around 20 January 2021. Figure 42 shows the level in the raw water reservoir and the river turbidity.

Figure 42: Raw Water Reservoir Level and River Turbidity
