# Lead Source Investigation Update

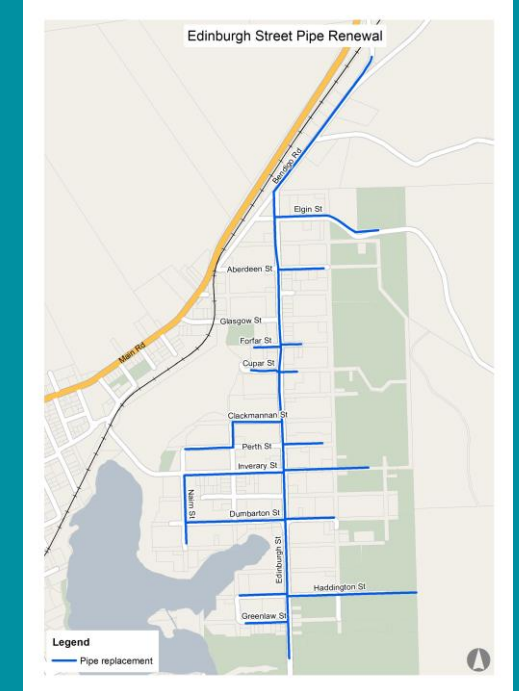
# EDINBURGH STREET PIPEWORKS

- Work commenced 15 February 2021
- Completion date estimate June 2021
- 6.5km of pipeline to be replaced
- Cost approximately \$6m
- Work is being fast tracked to eliminate pipework as possible cause of elevated lead levels
