# APPLICATION FORM FOR A RESOURCE CONSENT

The removal of the scheduled oak tree (T402) on our property.

Samuel Ritchie - Valley Arborist  
12 Montague Street  
North East Valley  
Dunedin 9010  
NEW ZEALAND

## Re: Assessment and report on Oak Tree T402

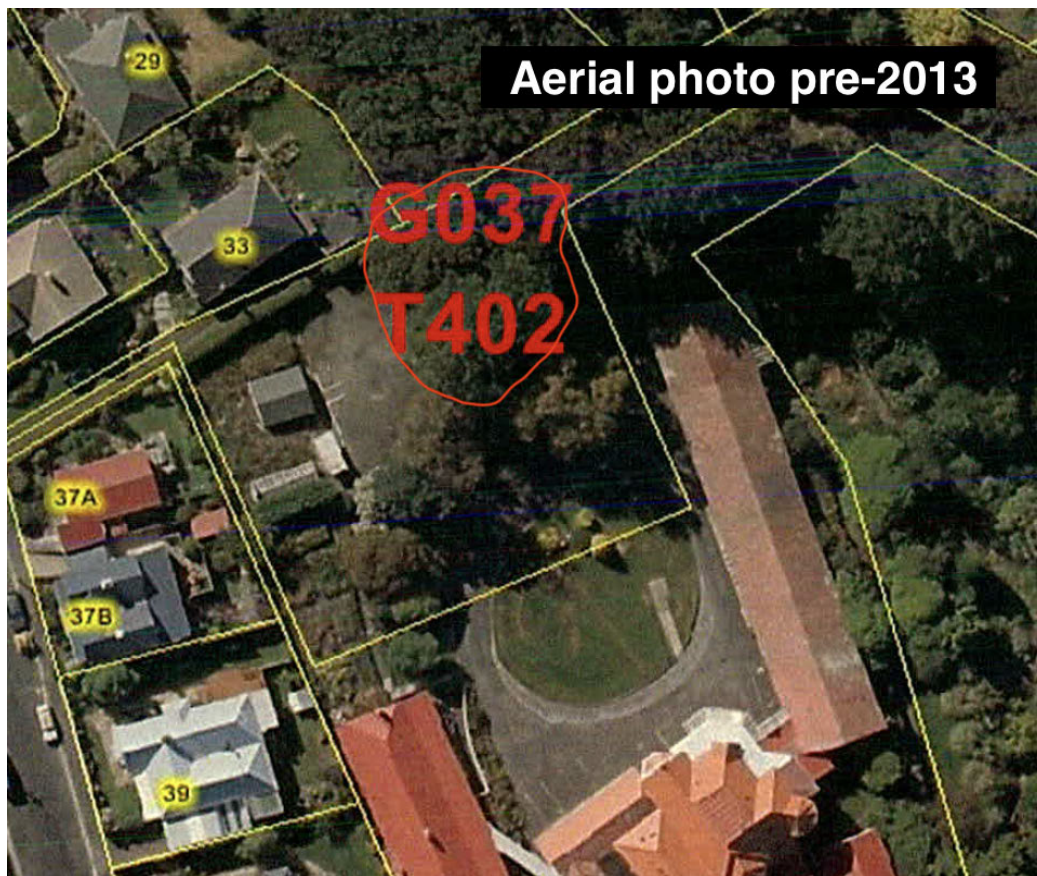
- Prior to 2013, during the existence of the Montecillo War Veterans home, the canopy spread of T402 appears greater than it is now. An aerial photo from prior to 2013 (Figure 1) shows a much larger canopy, particularly in its southern half, when compared to photos after 2013 (Figures 2 and 3). The War Veterans home was demolished by 2013 and it appears by looking at photos of the site from a 2013 report, clearance of vegetation and excavation works for a planned development had started in earnest.

**Figure 1:** Aerial photo showing the old Montecillo Veterans' home buildings, T402, and surrounding vegetation

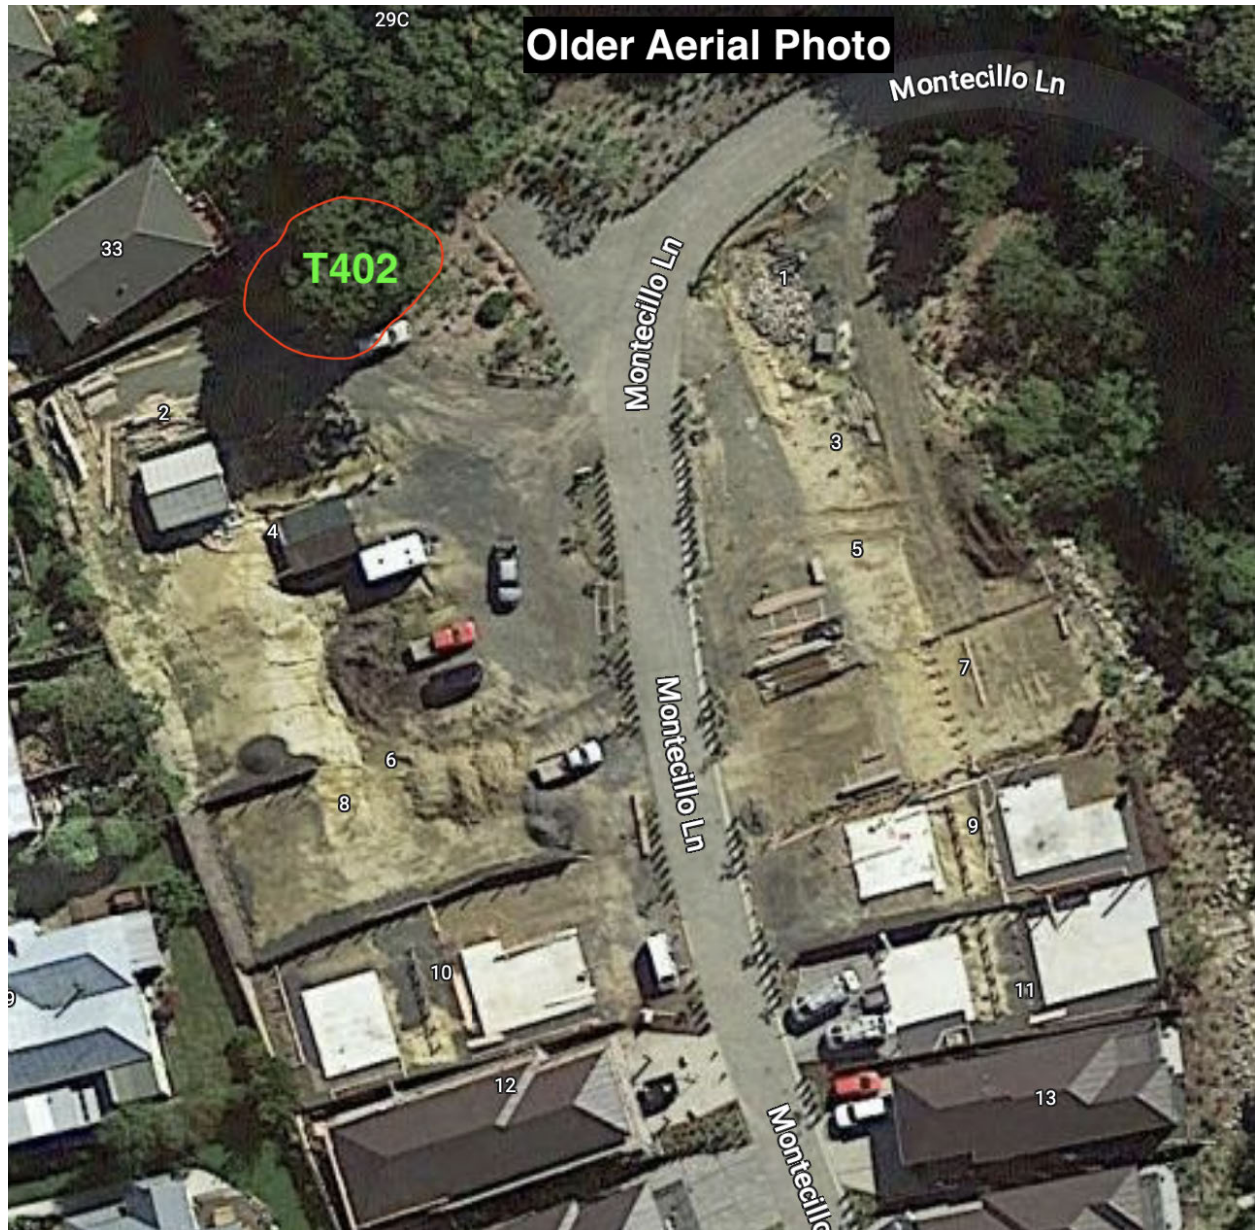
**Figure 2:** An aerial photo taken during the construction of the new subdivision on Montecillo Lane. Note the reduction in the canopy of T402 compared to figure 1 and the earthworks within its vicinity.

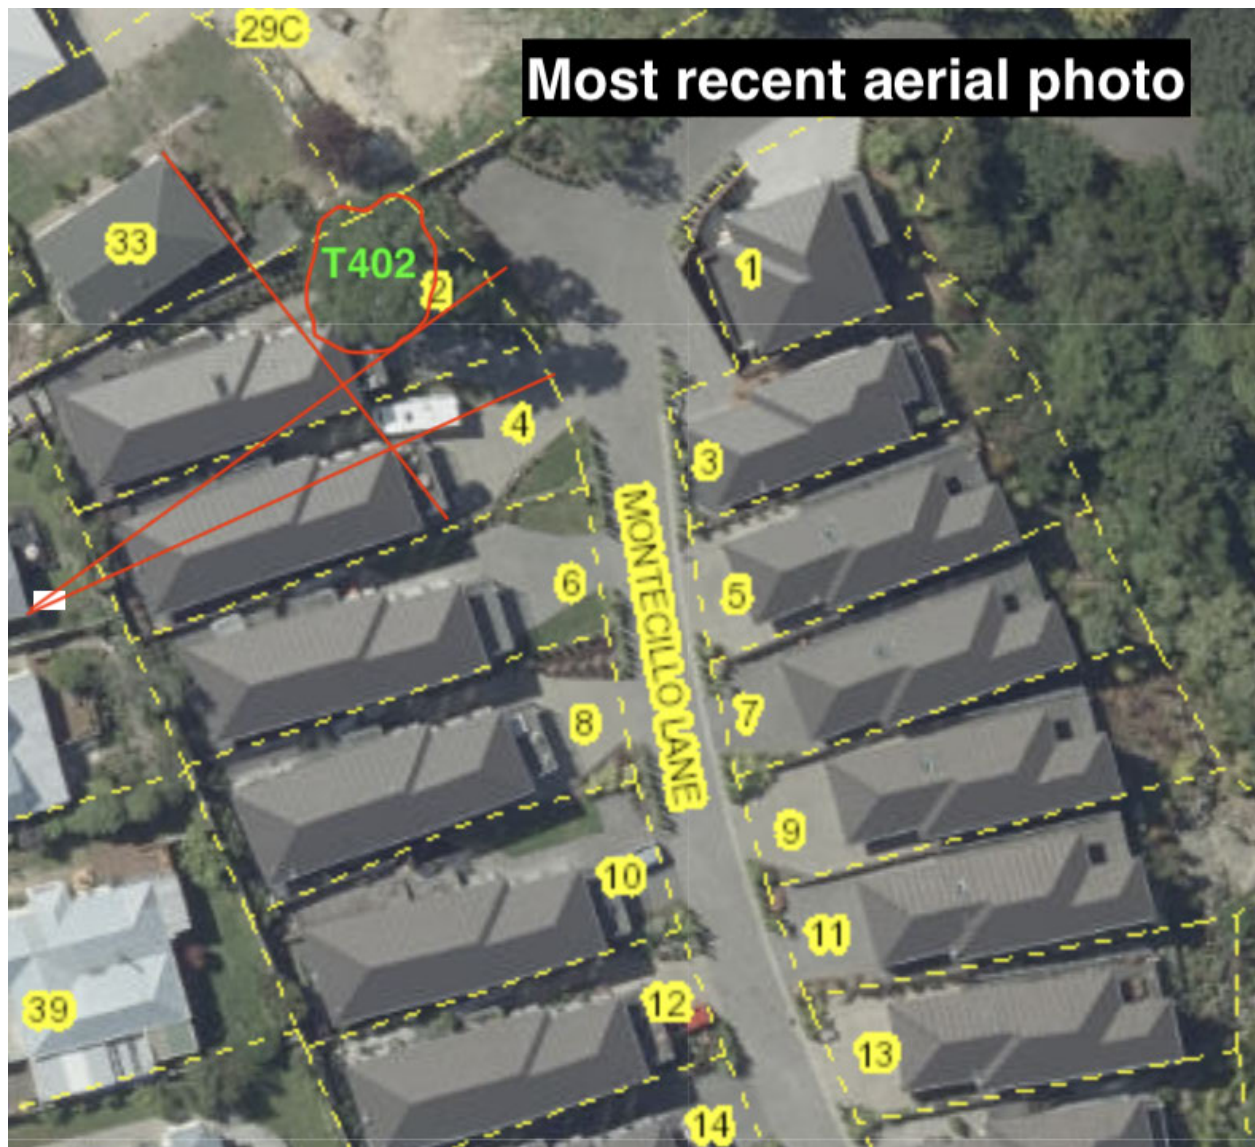
**Figure 3:** Most recent aerial photograph of the area showing the newly completed subdivision.

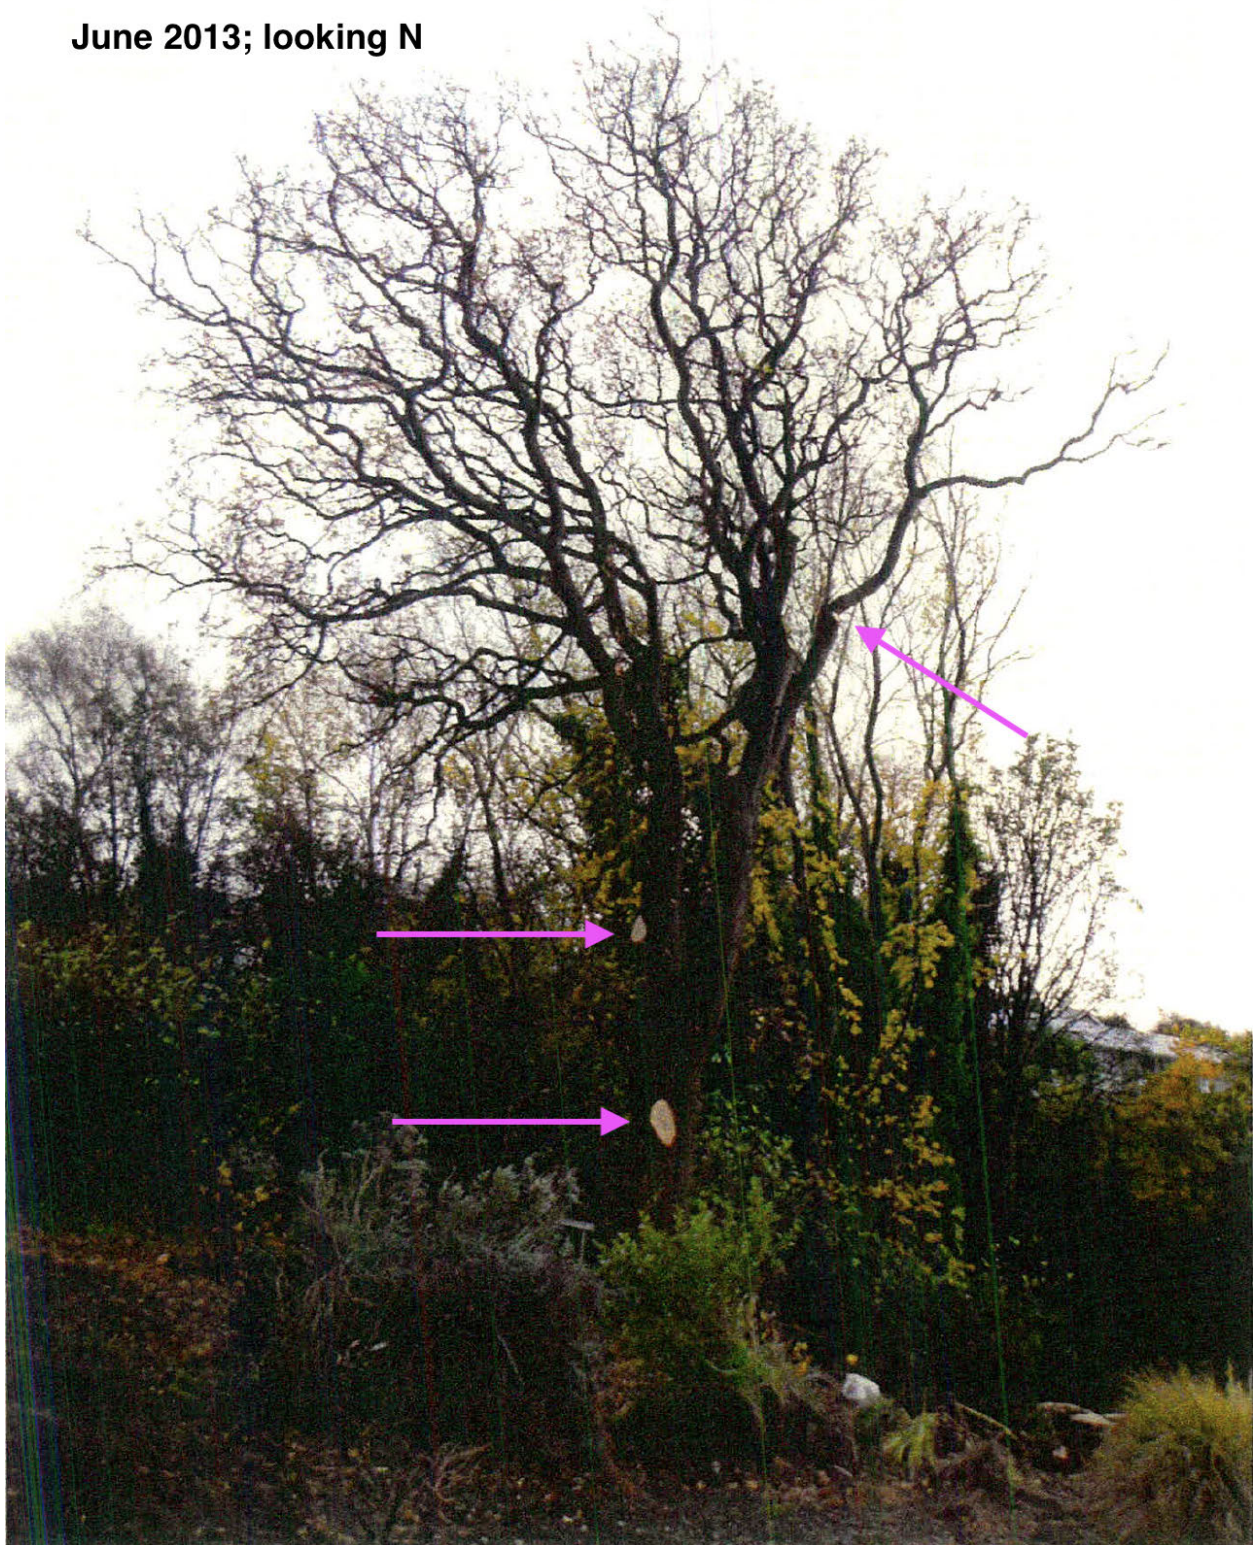
June 2013; looking N

- A June 2013 Arborist's report (Peter Collingwood, Delta Ltd) filed with the consent application has photos which show very fresh large cuts low in the trunk (Figure 4), and a large amount of surrounding vegetation having been cleared, including a large tree 3.5m away to the NE (see figure 5) for which stump removal was planned. This stump has been retained. The report also notes that at sometime in the past, the ground around the base of the tree on the west side had been built up to form, or extend, a parking area, and a retaining wall built and back filled with crusher dust and metal with the tree having been used as part of the retaining wall (see figures 5 and 6), increasing the soil level by approximately 300 - 400mm on that west side at the base of the tree.

**Figure 4:** 2013 Photo of T402 looking north, note the fresh cuts as indicated by the pink arrows.

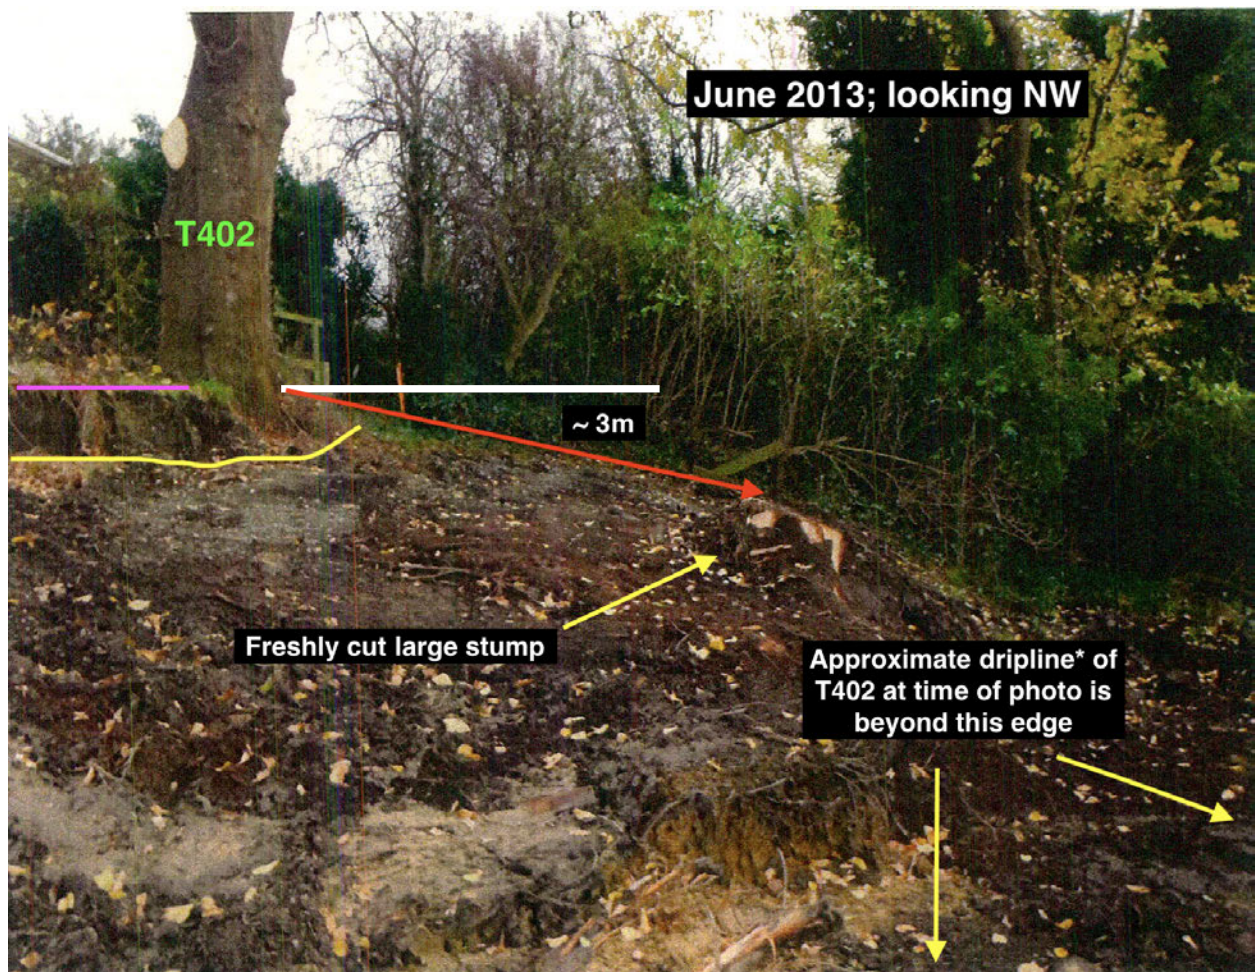
**Figure 5:** View of the ground to the east of T402. Note the excavated ground and the difference in height of ground levels indicated by the pink and yellow lines around the base of T402. Photo credit Peter Collingwood, annotations are my own.

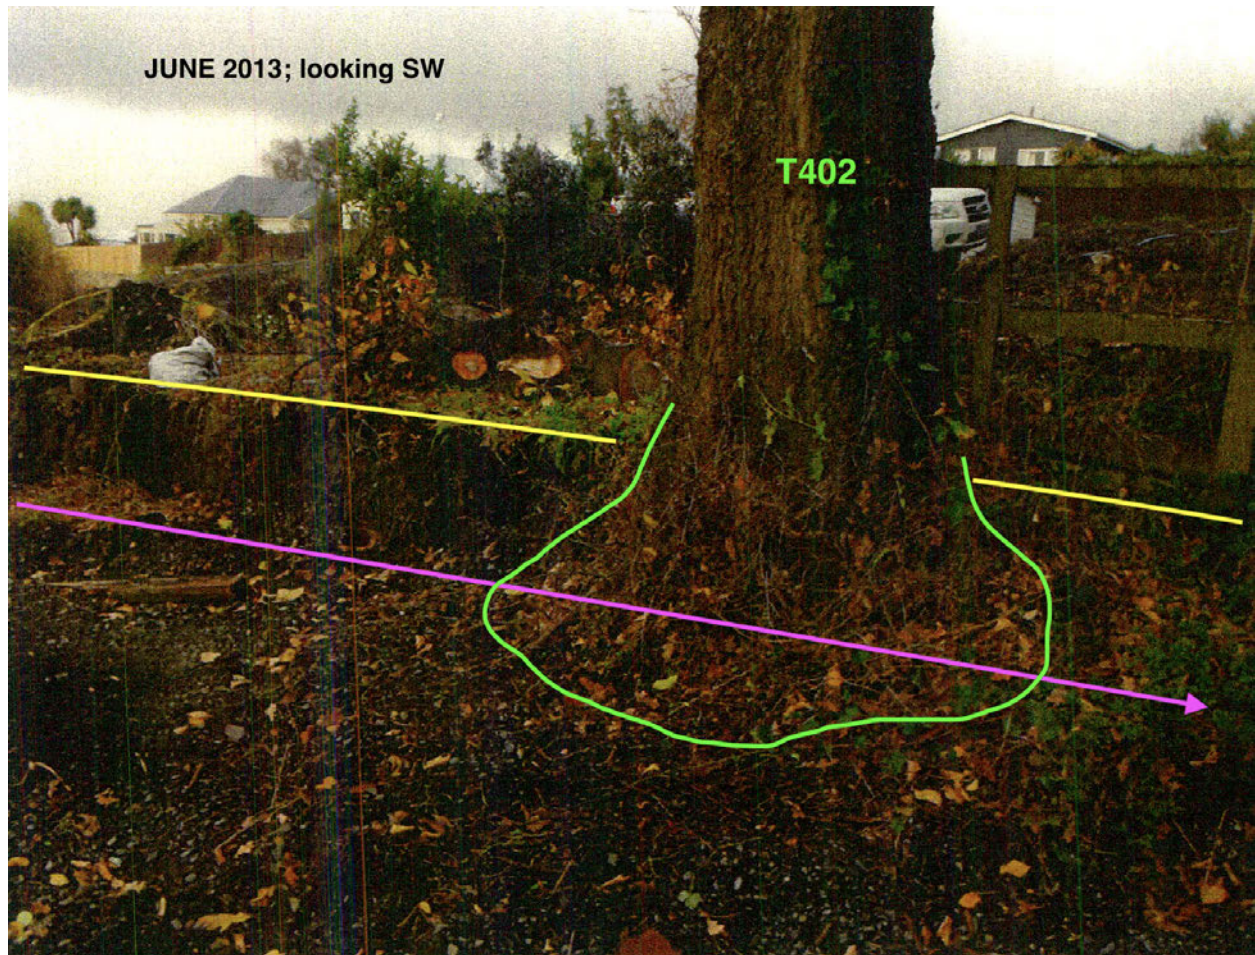
**Figure 6:** 2013 Photo showing the built up ground level on the western side of T402 as indicated by the yellow (higher ground) and pink (lower ground) lines. Green line indicated the approximate root crown of T402. Photo credit Peter Collingwood, annotations are my own.

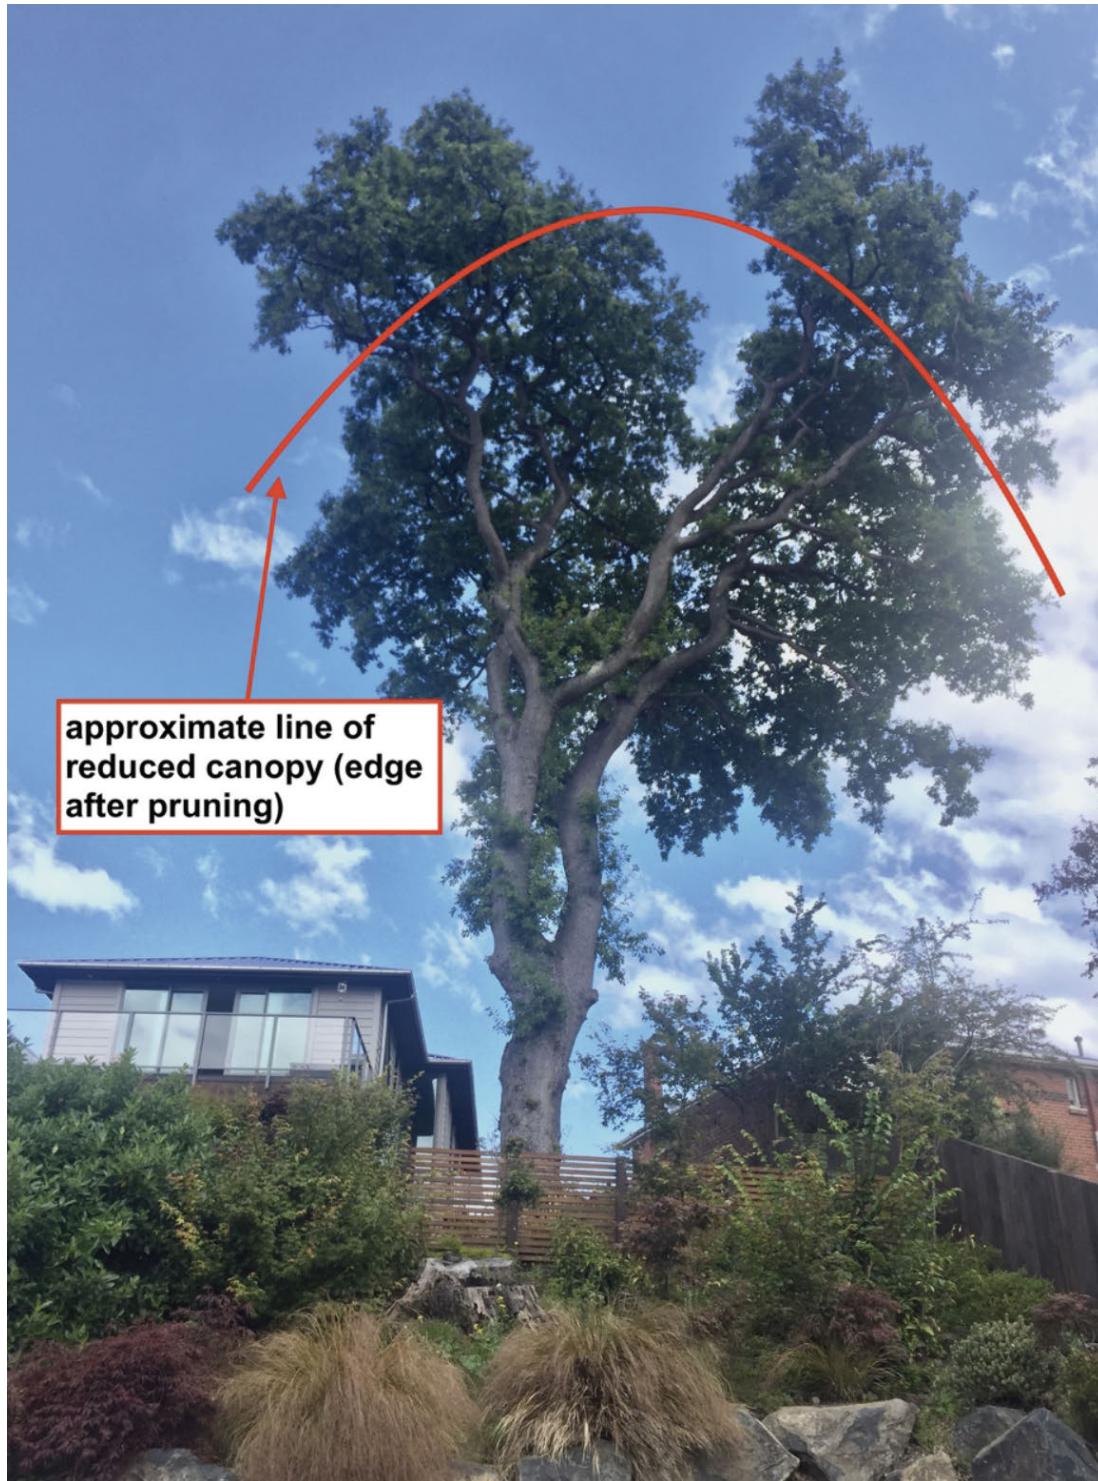
- The crown reduction stipulated in this 2019 consent was argued for on the basis that it would reduce leverage on the tree and presumably reduce the risk of failure, particularly given its top-weighted ('lions tailed') form, its recent exposure (from having sheltering surrounding vegetation cleared), and the issues potentially arising from the disturbances and possible damage to the root system of the tree within the root protection area. It appears from comparison of the tree now with photos of the tree at the time (see photos 7 and 8) that this crown reduction work was not carried out, however wind damage has reduced the north stem to approximately the pruning line stipulated in the report.
- At some point in time, perhaps between 2016 and now, there has been significant pruning work carried out on the tree.

**Figure 7:** 2019 view of T402 from the east, showing shape of crown and recommendation for 30% crown reduction. Compare to figure 8 to see changes over the last 3 years. Photo credit and annotations Mark Roberts.

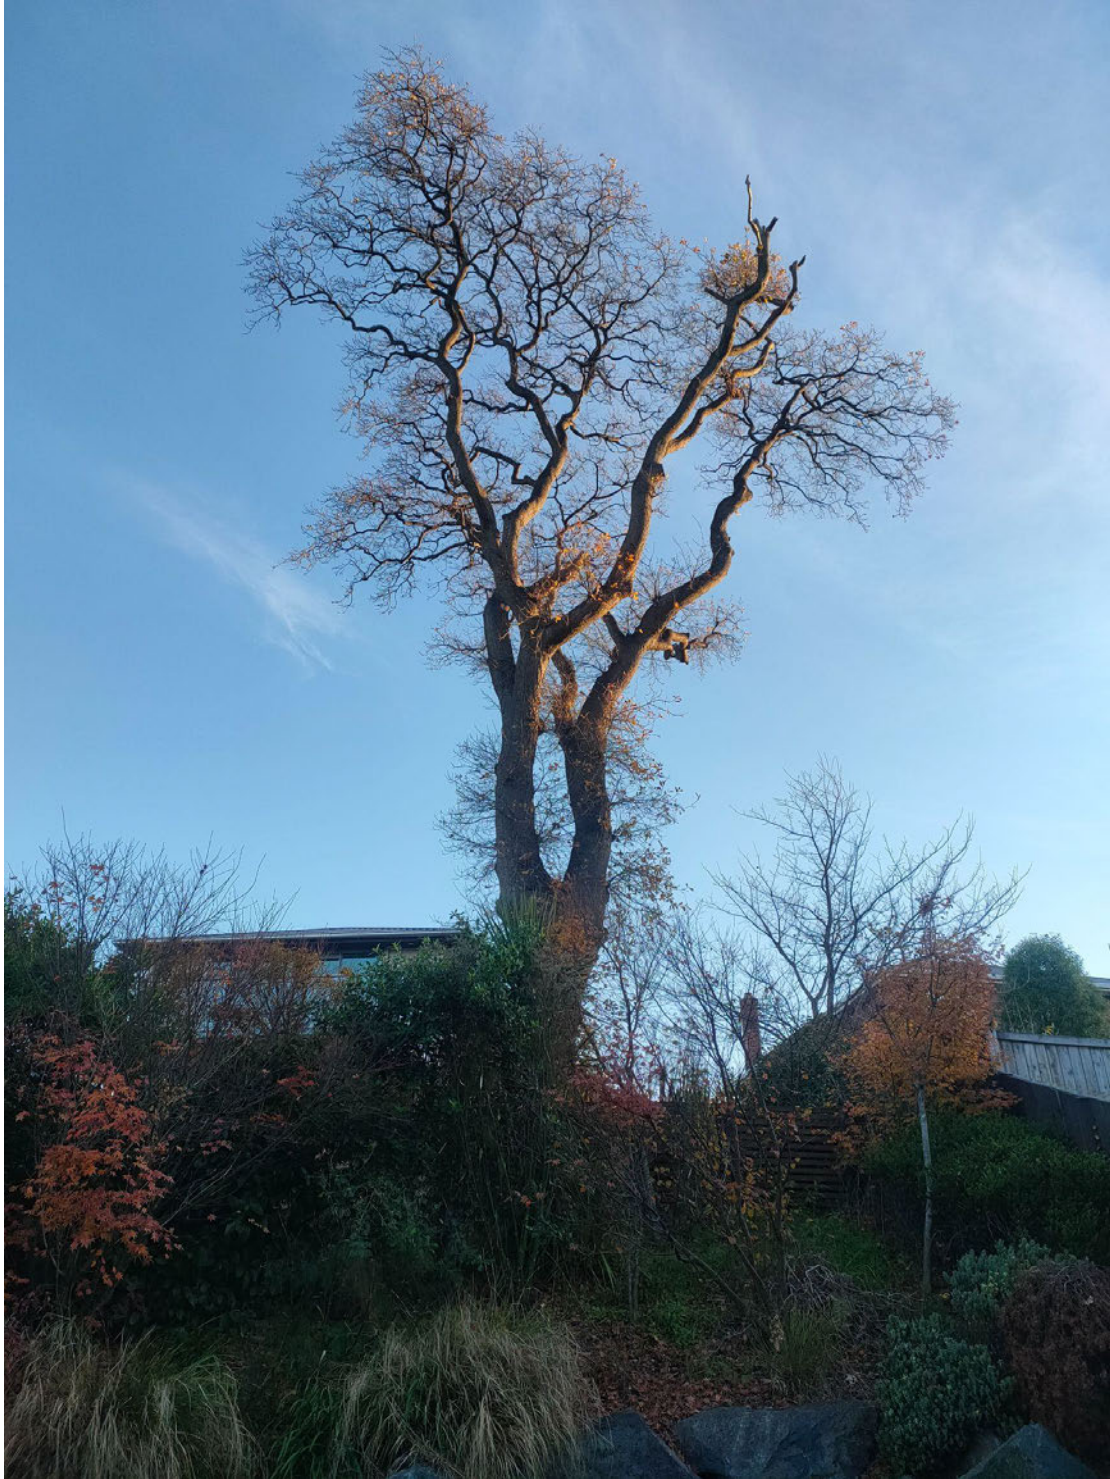
- In general, the tree has a messy, tortured appearance, with 3 or 4 major wind broken stubs (see figure 8), particularly on the NE and W sides, that all appeared to have occurred relatively recently, within the last 5 years. An approximately 150mm branch had recently been broken off by wind and was sitting where it had landed in the garden, but it was unclear from the ground where on the tree it had come from. There are many old pruning cuts both high in the crown and low in the trunk system, and they vary in quality and age; some look as though they have been made in accordance with arboricultural standards, while others do not and are left as stubs or are poorly made. The tree, by wind or by pruning, has had all of its lower branches, large and small, removed to a height of approximately 12m, and therefore growth is concentrated mostly in its uppermost portion, i.e. a 'lion's tail' form. Where there is other growth, it is in the form of numerous epicormic shoots that cover the trunk and main stems (see figure 9).

**Figure 8:** 2023 photo from east showing the current shape of crown; note the loss of the crown on the northern side when compared to figure 7.

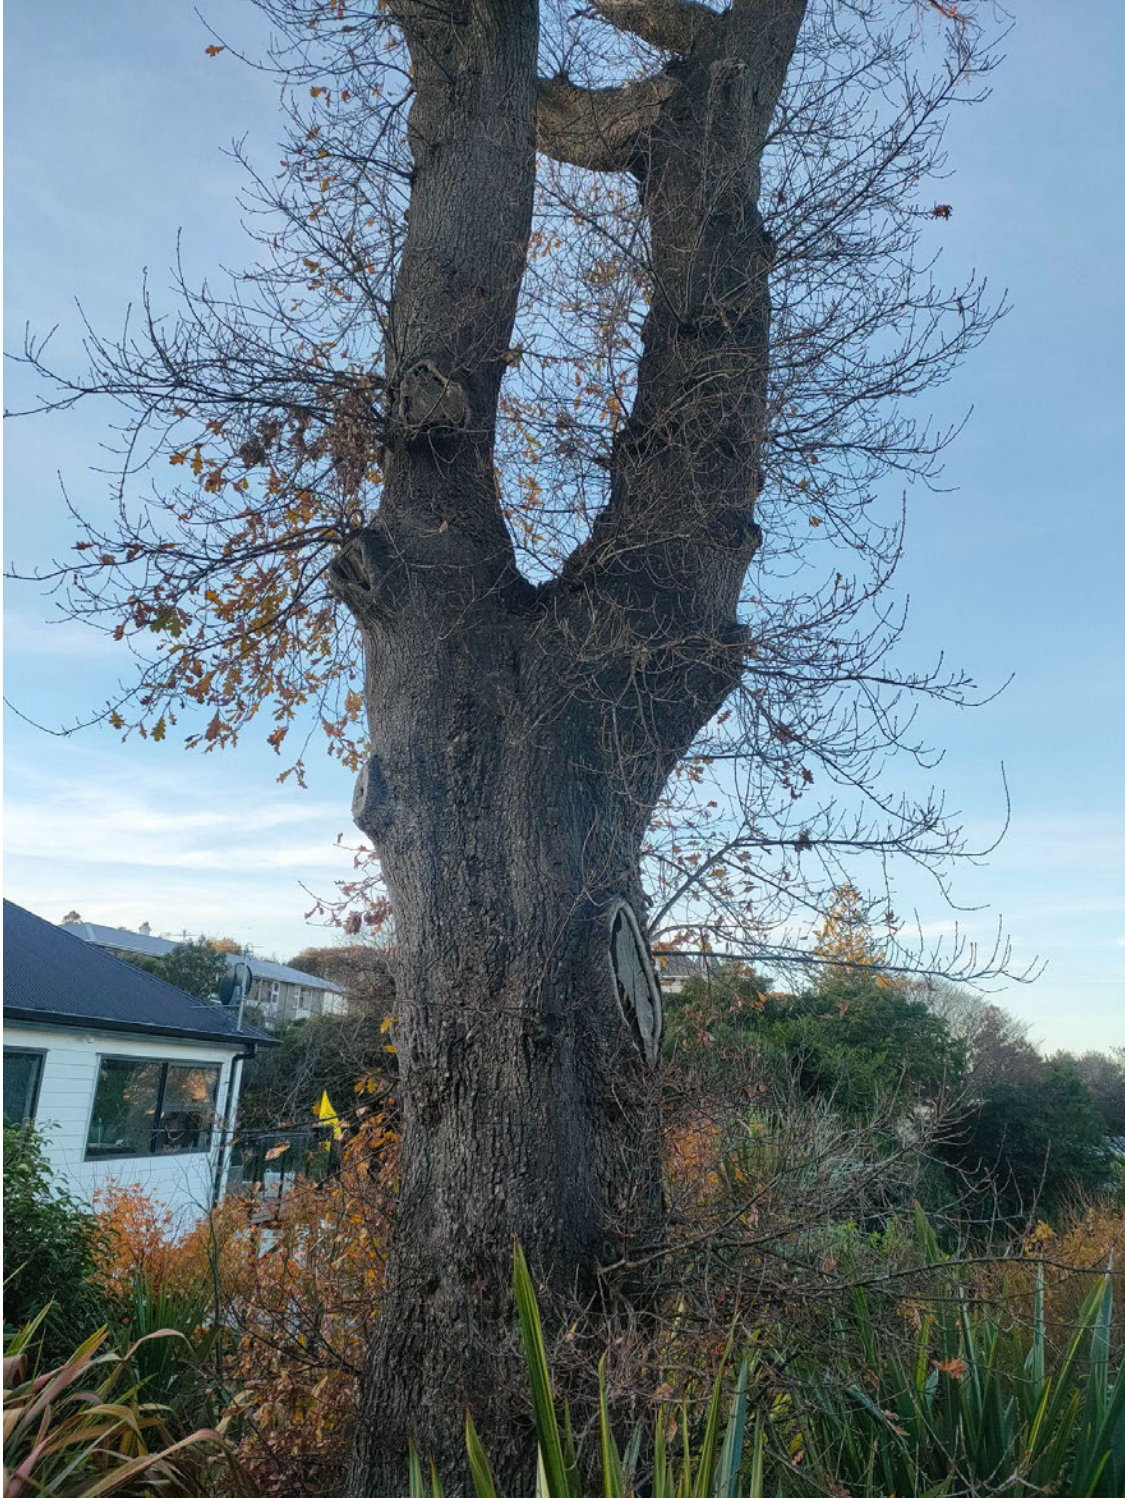
- The tree appeared healthy with normal vitality for its species and age, as indicated by inspection of fallen leaves and leaves on epicormic shoots. There didn't appear to be signs of extensive dieback or decline in the canopy. There are 3 old large cuts in the lower trunk that have not healed over well (see figure 9), and the sapwood portion of the cuts have begun to rot back to form cavities.

**Figure 9:** 2023 photo looking east showing old cuts and cavity development and epicormic growth in the lower trunk of T402.
