APPLICATION FORM FOR A RESOURCE CONSENT

PLEASE FILL IN ALL THE FIELDS

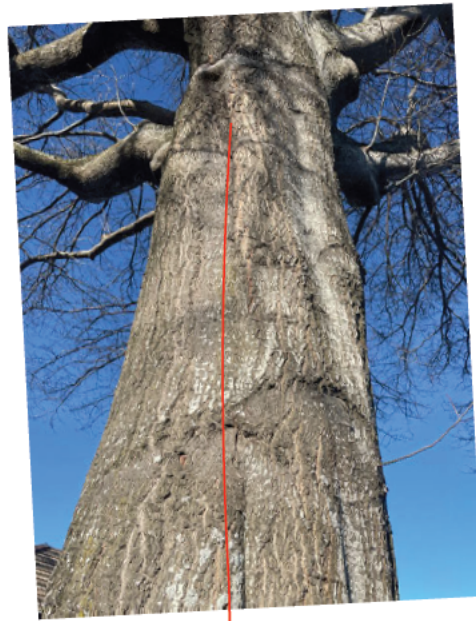
5.0m Spiral Trunk Crack
Pin Oak T666 North face

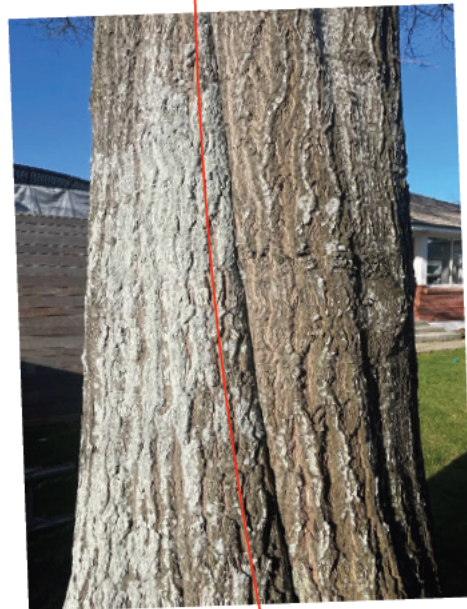
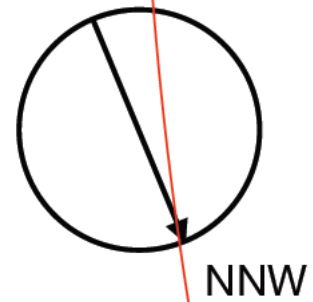
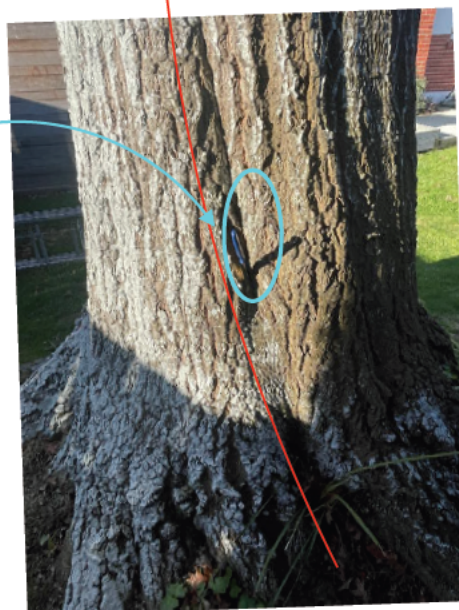
Knife inserted in trunk crack
close to root collar

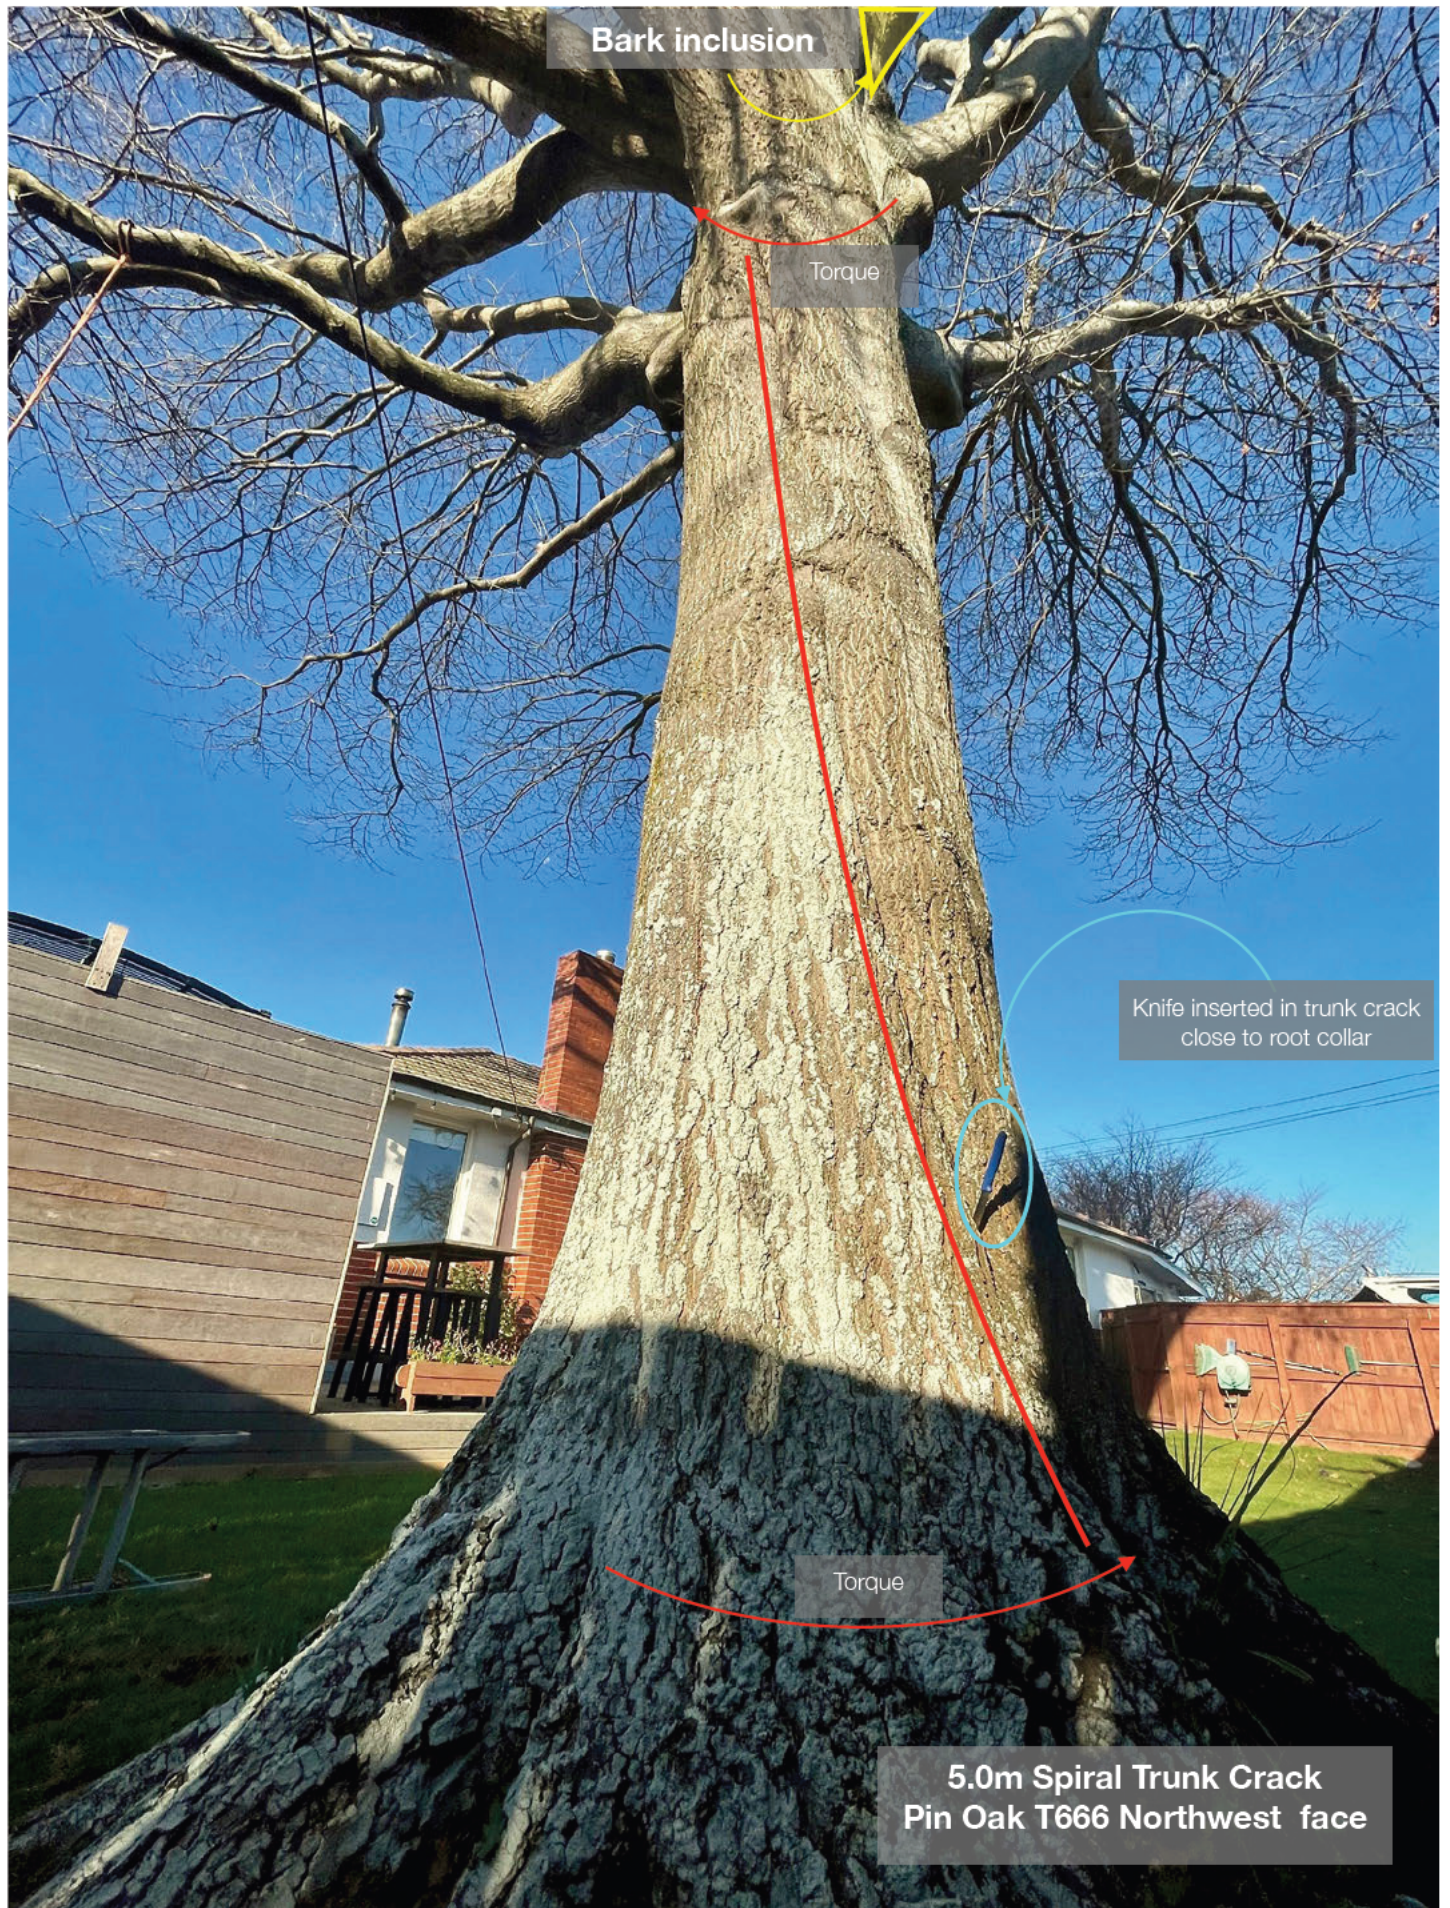
Risk assessment for vertical trunk splits

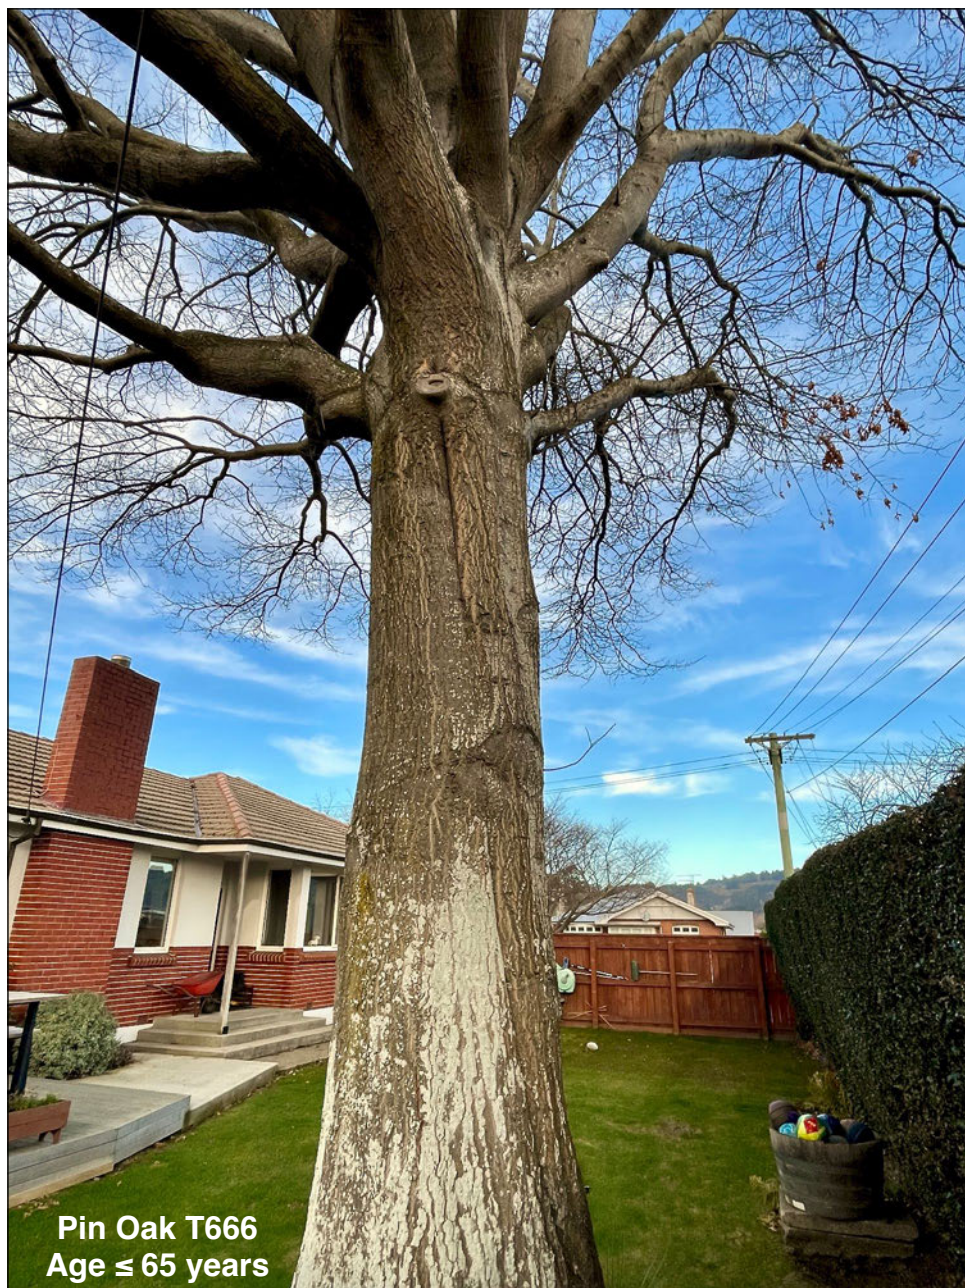
PS George Hepting (USDA forest service pathologist) maintains that '*...pin oak is short-lived, seldom reaching ages over 100 years and diameters of over 3ft. While often planted as a street or shade tree*' (Page 430_Handbook 386)

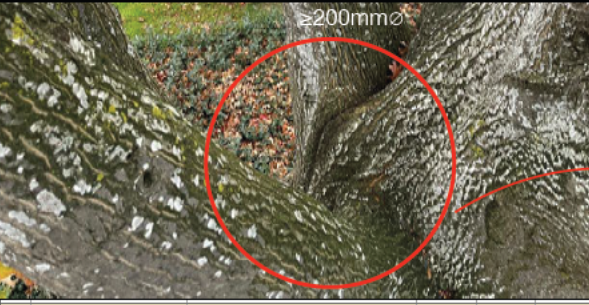
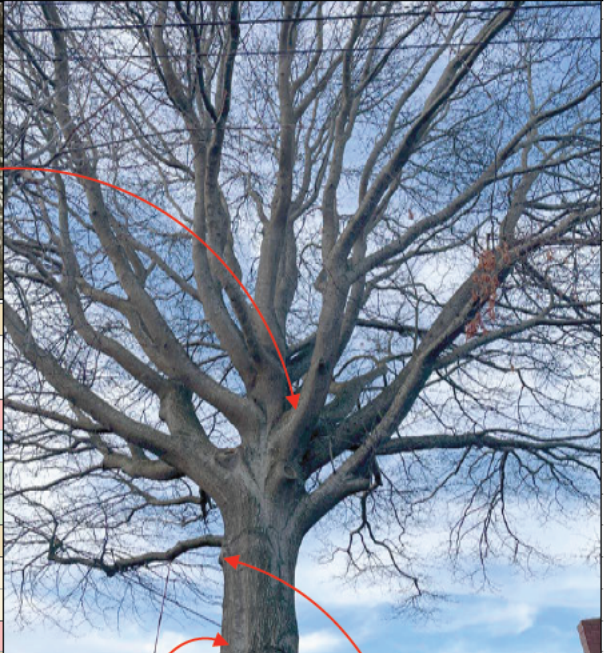
Matrix 1. Likelihood matrix																							
Likelihood	Likelihood of Impacting Target																						
of Failure	Very Low	Low	Medium	High

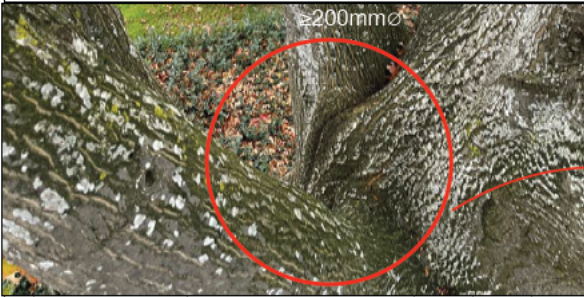
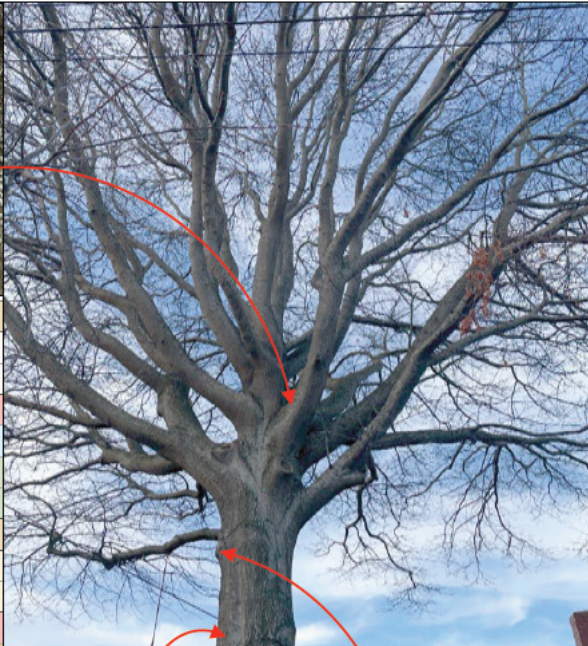
1	Trunk fails	People	80cm	6m	1	NO																		HIGH																																									
2	Trunk fails	Property	80cm	6m	2	NO																		HIGH																																									
10m branch bark included union _ over street utility wires. 5m spiral torsion crack reduces trunk strength in SW gales.
