## **MEMORANDUM**

**To:**                 **Warren Hanley, Resource Planner - Liaison**  
**From:**            **Jean-Luc Payan, Manager Natural Hazards**  
**Date:**             **14/07/2016**  
**Re:**                **Hazards evidence La & RJ Prattley LUC-2016-110**

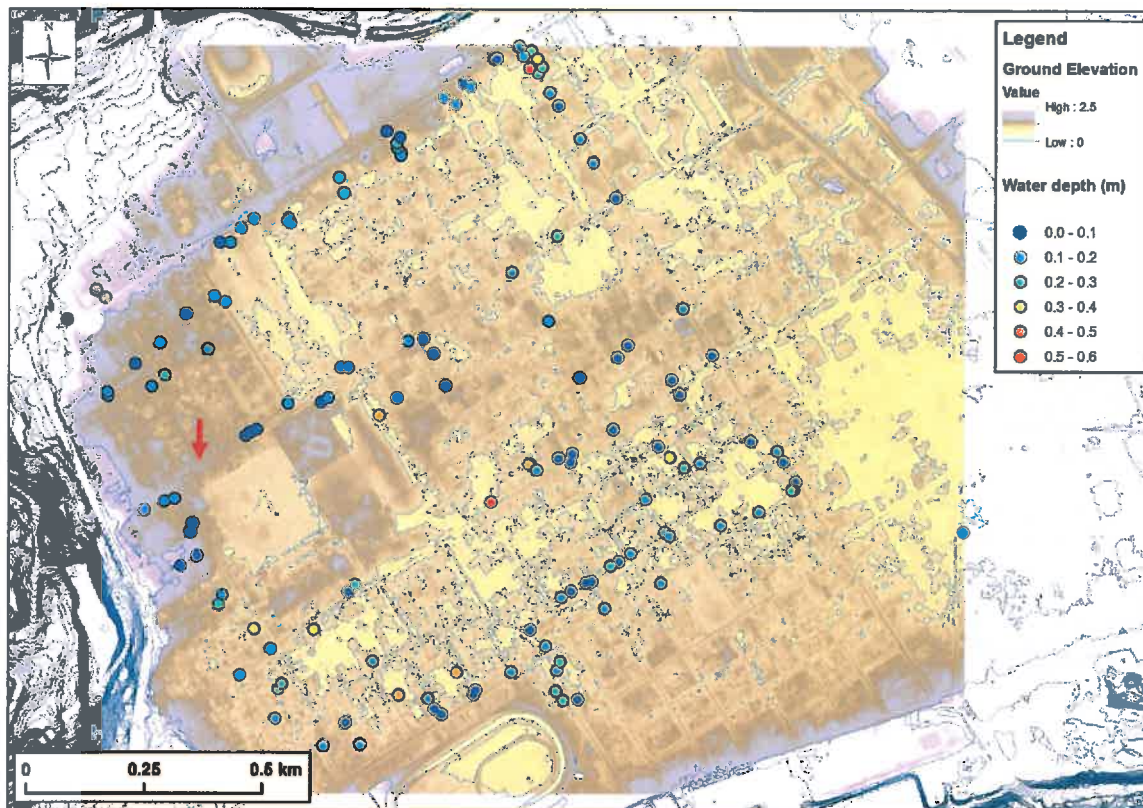
1.     Figure 1 shows the topography in the vicinity of the proposed development site.
2.     Coloured dots on this elevation map depict surveyed flood depths based on debris marks left on fences, power-poles etc. after the June 2015 flood event (ORC, 2015).

3.     The red arrow shows the location of the property (38 Richmond Street) with respect to flood depths, which range from 10 cm to 30 cm in the local area.

**Figure 1.** Map of South Dunedin flat area, showing the maximum depth of above-ground surface ponding during the June 2015 flood. Depths calculated by determining the difference between the elevation of the surveyed debris marks and the underlying ground level at that location. Elevation colour scale shows ground elevation between 0 and 2.5 m above MSL, contour interval is 1 m (ORC, 2015). Red arrow shows location of 38 Richmond Street.

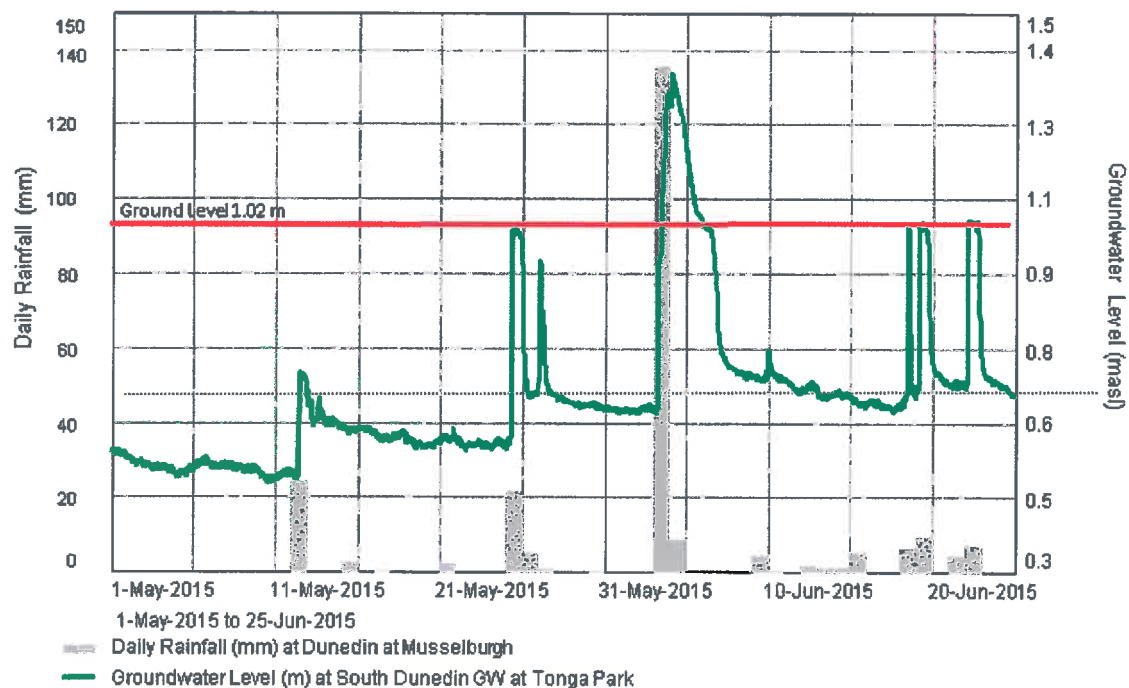
4.     In addition to observed surface flooding, the groundwater in the local area has an average level only ~40 cm below the ground surface (Figure 2).

**Figure 2.** Tonga Park continuous groundwater record from 1 May to 25 June, 2015. Ground level is 1.02 metres above sea level, dashed black line shows average groundwater level, ~40 cm below the ground surface (after ORC, 2015).

15. The stormwater system, even when working at full capacity, cannot be expected to remove all the runoff from the area (ORC, 2016). Groundwater data clearly show a sharp response to rainfall events, and a slow decay back to regular levels (e.g. Figure 2).

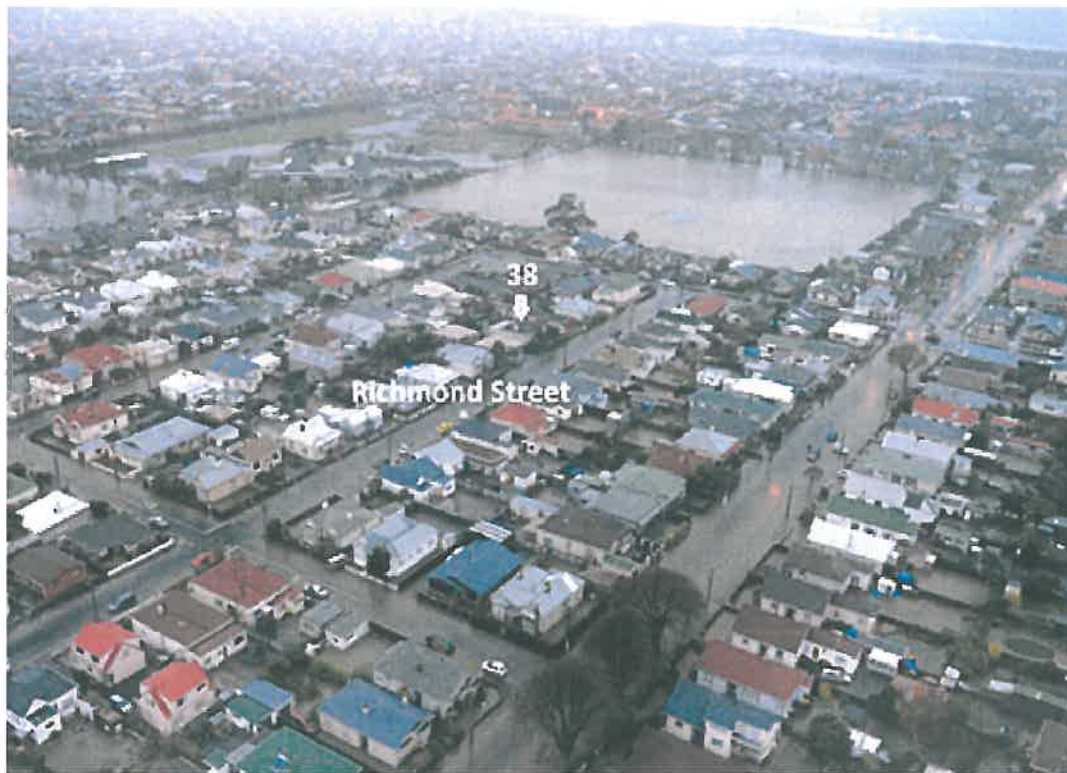
10. There is a tendency for water to pond when the South Dunedin aquifer is at capacity, as was seen in the June 2015 flood event (Figure 3).
11. High tides (which are usually higher than normal during low-pressure storm events) delay gravity drainage of this water to the sea, whether via the stormwater system, or through the South Dunedin aquifer (ORC, 2012a).

**Figure 3.** Annotated aerial photograph showing flooding in relation to 38 Richmond Street. Photo was not necessarily taken during peak of flooding. Source, Otago Daily Times.

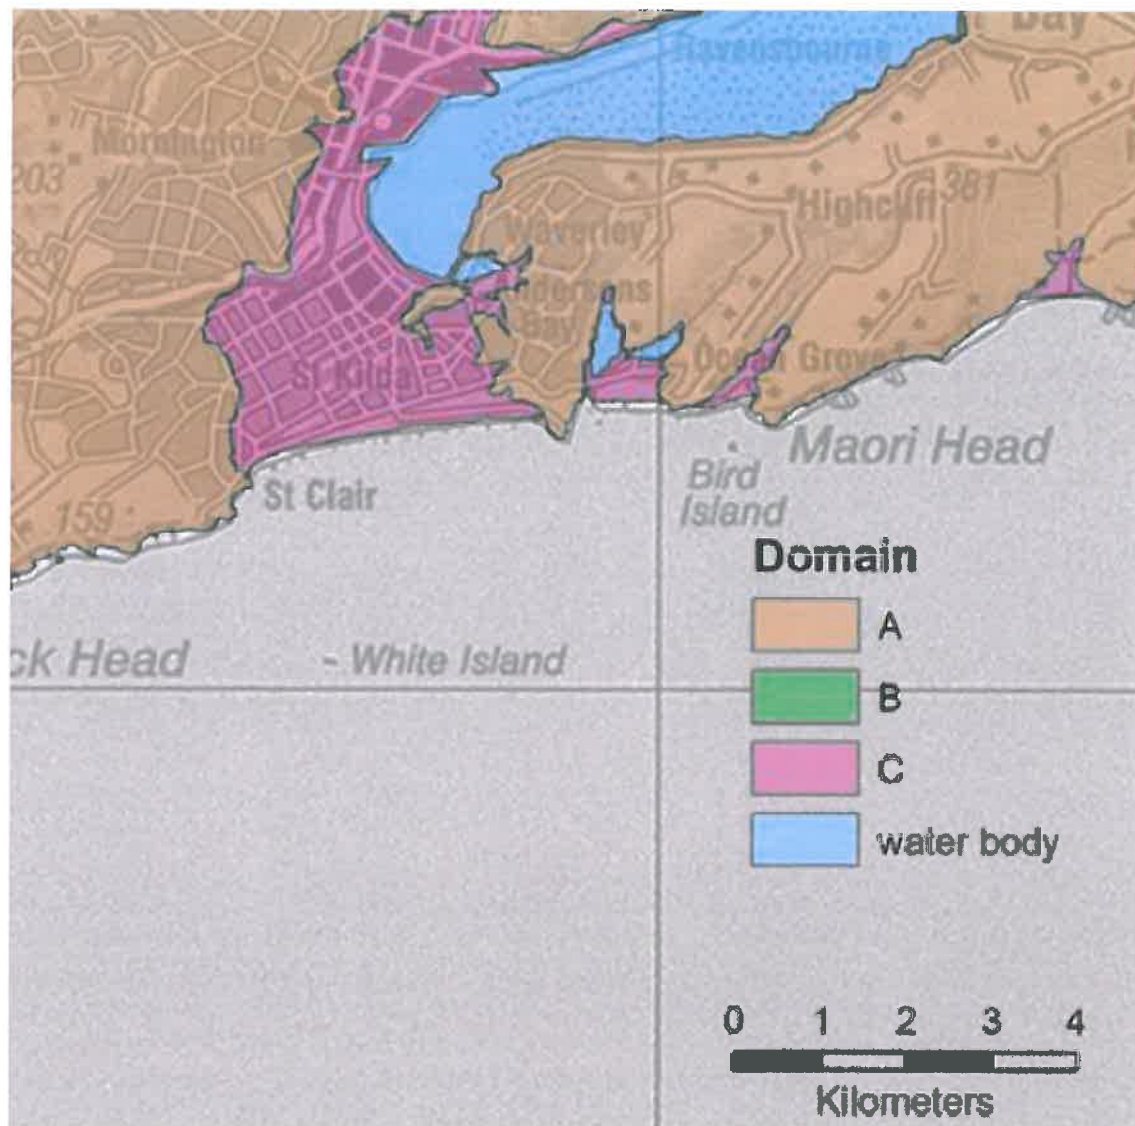
18. ORC has carried out investigations into the susceptibility of different soil types around Otago to liquefaction (Barrell et al., 2014).
19. Figure 4 shows how all of the South Dunedin flat area (including 38 Richmond Street) falls within Domain C. Within Domain C there is a moderate to high likelihood of liquefaction-susceptible materials being present (i.e. poorly consolidated marine and estuarine sediment such as silts and sands, with a high water table).
20. When considered in conjunction with South Dunedin's origins as an estuarine/wetland environment, reclaimed through the addition of sand to raise the level of building foundations, this is an appropriate classification (ORC, 2016).

**Figure 4.** Liquefaction susceptibility in South Dunedin from Barrell et al. (2014).
