Ocean Beach Domain

Desktop Hazards and Geotechnical Assessment

Prepared for:
Dunedin City Council

Prepared by:
Stantec New Zealand

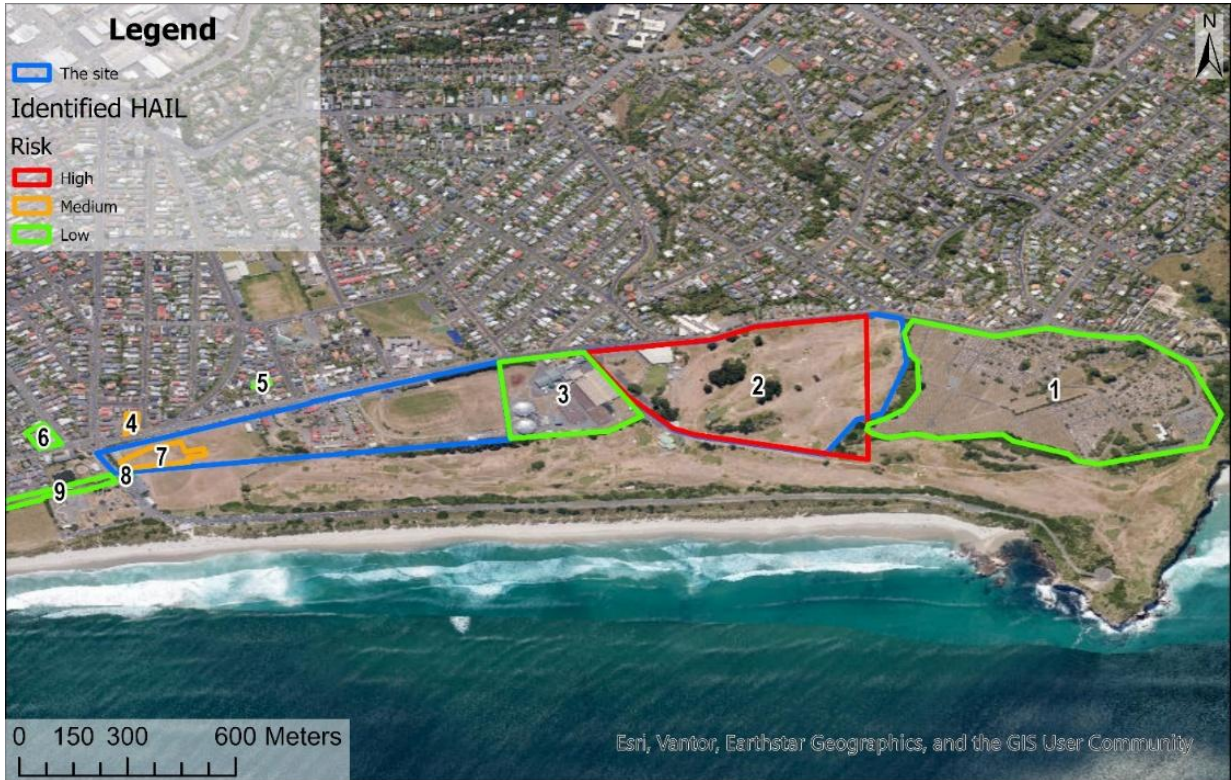
Figure 2-1 Identified HAIL

Based on the historical aerials, the ORC HAIL register, and the site history reviewed, the HAIL activities identified can be summarised and categorised into three broad risk categories – low, medium and high as detailed in Table 2-6 and displayed in Figure 2-1.

Identifier and HAIL tag	Map ID	Risk assessment
Andersons Bay Cemetery (HAIL G1)	1	Low risk Given that the cemetery is located adjacent to the site and down-across hydraulic gradient, this is considered to pose a low risk to the site.
Chisholm Park Landfill (including the former bowling green area) (HAIL G3)	2	High risk Given that the extent and contents of the landfill are unknown and the limited testing carried out, this poses a high risk to the site.
Tahuna Wastewater Treatment Plant (HAIL G6)	3	Low risk Given that this HAIL activity is not located within the site, is across hydraulic gradient, and the soil concentrations reported from the previous investigation, this is considered to pose a low risk to the site.
Victoria Road Motors - 80 Ascot Street (HAIL tags – F4, A13, and F7)	4	Medium risk It is considered unlikely that contamination, if any, in soils to pose a risk to the site given the distance (approximately 35m to the north of the south). However, there is potential for groundwater, if impacted, to flow towards the site. As such, this is considered to pose a medium risk to the site.

17 Culling Street (HAIL tags F4, G4)	5	Low risk Given that this HAIL activity is not located within the site and that the site has undergone remediation, this is considered to pose a low risk to the site.
134 Prince Albert Rd (HAIL tags A17)	6	Low risk Given that this HAIL activity is located at a distance from the site and is across hydraulic gradient, this is considered to pose a low risk to the site.
Area of former houses within Hancock Park (HAIL I)	7	Medium risk Given the age of these houses (pre 1980s), there is the potential for asbestos containing materials (ACM) to have been used in their construction. As such, there is a risk that during demolition and removal of these buildings for ACM material to have impacted soils. As such, this is considered to pose a medium risk to the site.
Pirates Rugby Football Club - 6 John Wilson Ocean Drive (HAIL A17)	8	Low risk Given that the club is located adjacent to the site and down hydraulic gradient, this is considered to pose a low risk to the site.

Ocean Beach Railway (HAIL F6)	9	Low risk Given that the railyard is located down-across gradient and that contamination is not considered likely to migrate, this is considered to pose a low risk to the site.

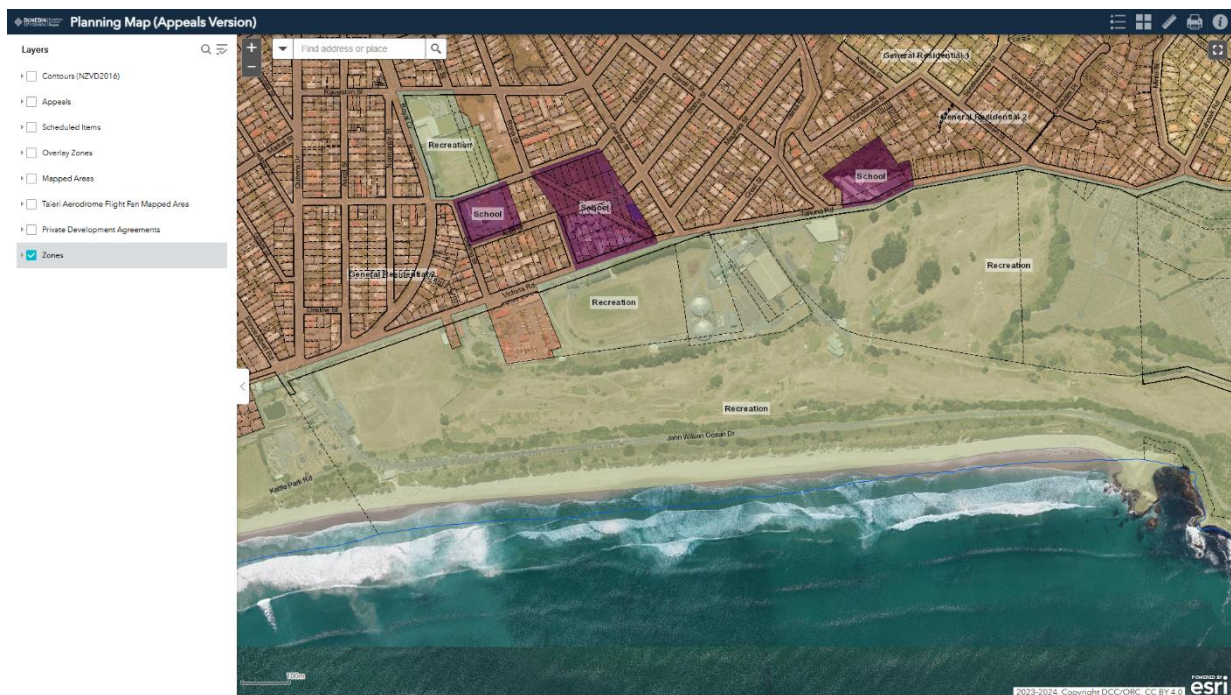
Figure 3-1 District Plan Zoning

Most of the site is zoned as Recreation, apart from the portions occupied by the Holiday Park, and kindergarten for the NZ Gazette.

Although not zoned on the district plan, the 2 areas of interest are bisected by the Tahuna Wate Water Treatment Plant.

No planning assessment has been undertaken as yet, but it is clear that any changes of use to the proposed areas would have a risk of reverse sensitivity to the existing land use surrounding the sites.

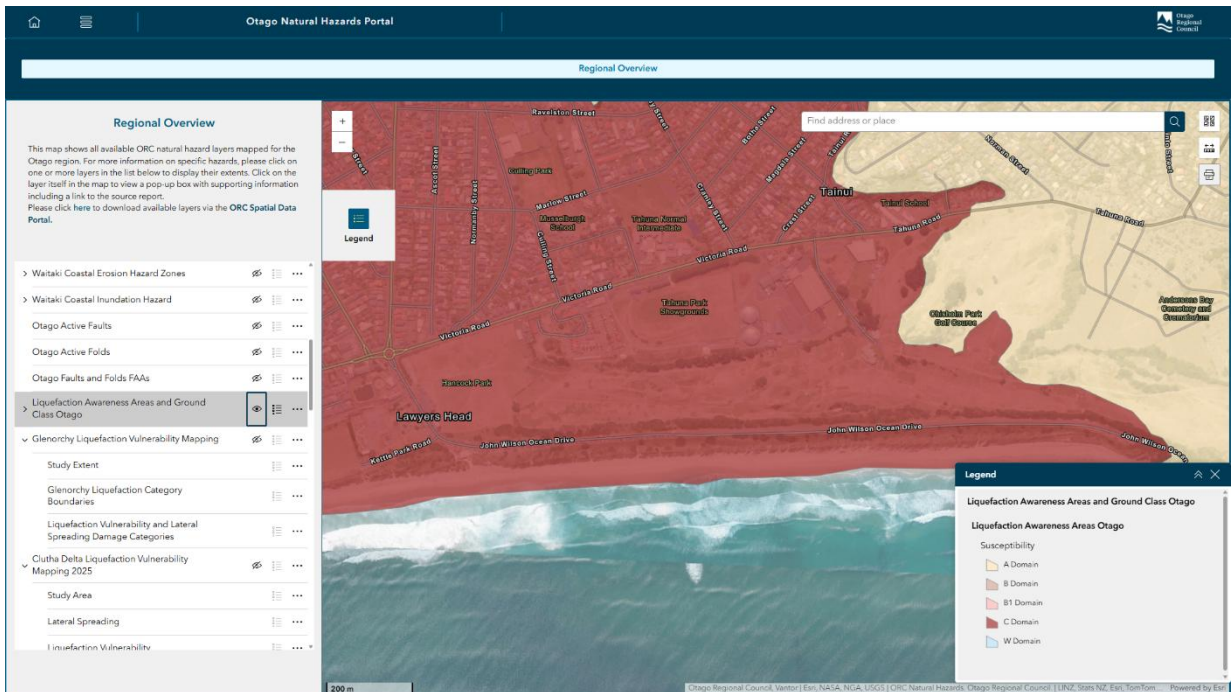
Figure 3-7 ORC Natural Hazards Portal – Liquefaction Awareness Domain C – high likelihood (red)

Since November 29, 2021, the New Zealand Building Code (specifically B1/AS1) requires that all new building consent applications for sites prone to liquefaction in Dunedin include specifically designed foundations. These changes, resulting from the Canterbury earthquake inquiries, ensure that new buildings are strong enough to withstand liquefaction, which causes loss of soil strength.

Construction of new residential dwellings will need specifically designed foundations for buildings on ground identified as liquefaction-prone ground. Current 'deemed to comply' acceptable solutions, such as NZS3604 for foundations, are unlikely to be able to be used".

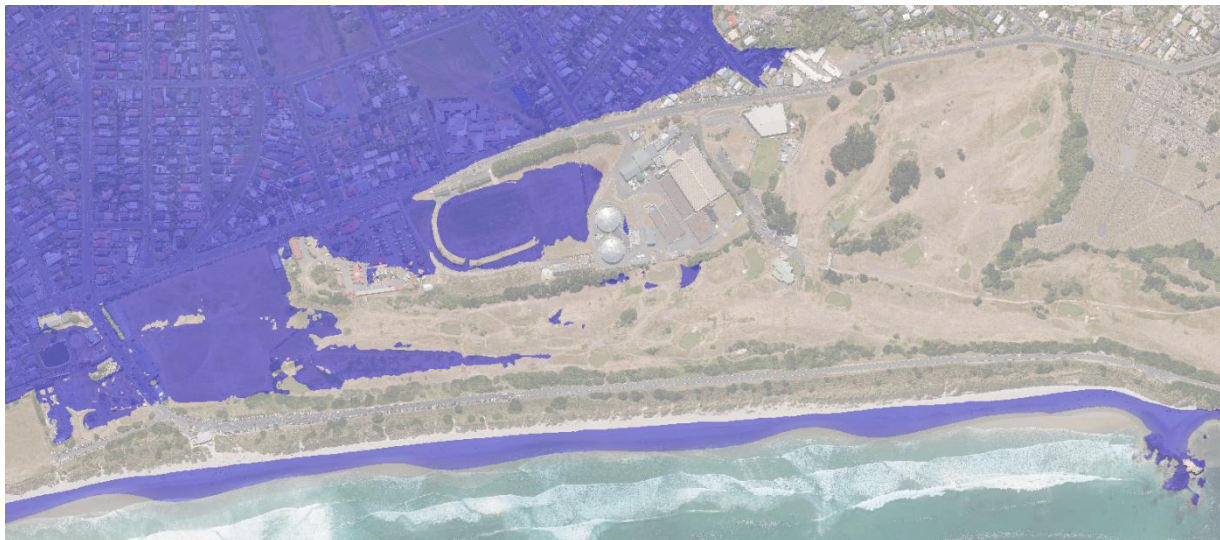
Figure 3-9 Minimum floor level recommendations - Level of 3.13m NZVD2016 in blue.

This document concluded that *the resulting minimum acceptable floor level for a building with a life less than or equal to 2080 is 3.13m NZVD:2016.*

The DCC has ratified this position with a 3.13m minimum floor level, according to long-term sea-level rise/flood risks. Ground at or below 3.13m NZVD is show on the following plan, using topographical LiDAR surface levels from 2021 aerially captured data.

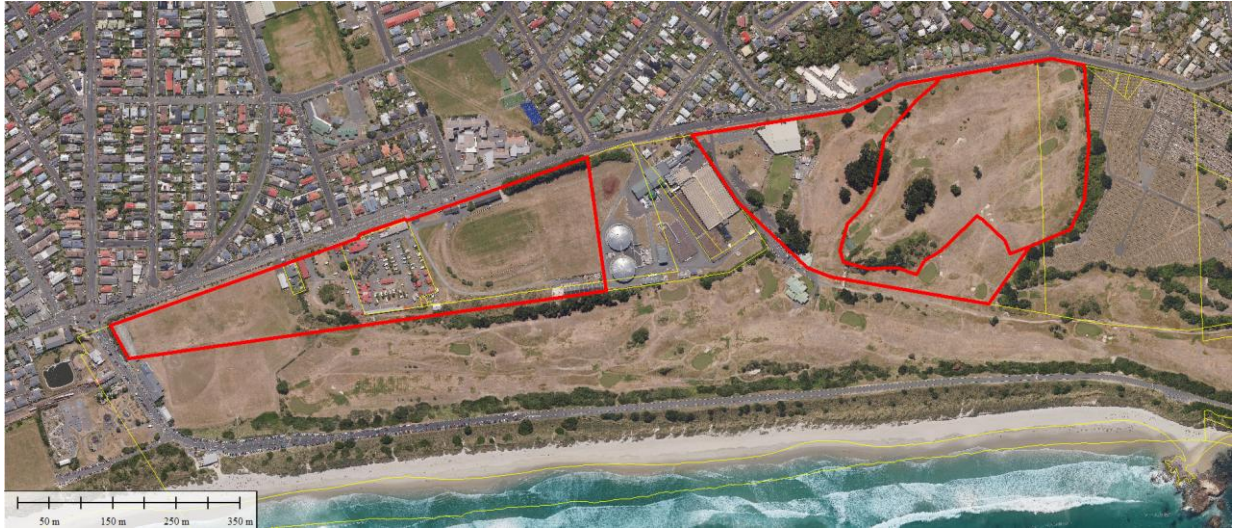
Figure 3-10 Zoning for generalisation of risk.

The site can be broken up into a limited number of zones affected progressively by hazards

The western site has potential flooding associated with sea level rise, requiring minimum floor level requirements (western zone is up to 0.75m below the recommended level of 3.05m MSL NZVD2016)

The potential for liquefaction is a design requirement potentially affecting ground up to 10m above MSL NZVD2016, resulting in the eastern zone being split into two areas, above and below this level.

The entire eastern site is also significantly affected by unconfirmed extents and depths of uncontrolled / un-engineered undifferentiated landfill. Foundation construction on this material would likely be subject to a Section 72 / 73 of the Building Act, as even piled foundations through such material may encounter obstructions within the fill or suffer significant drawdown loading on piles penetrating this material.

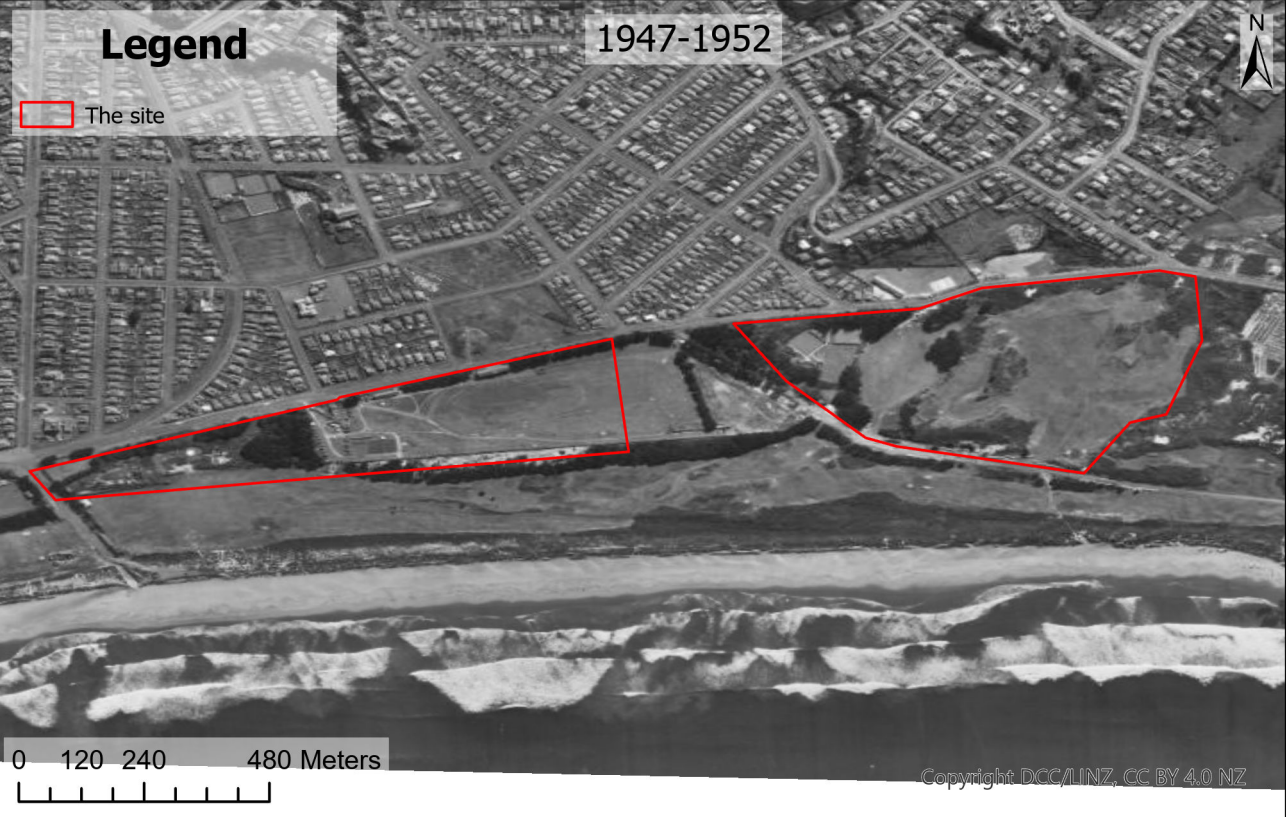
Year	Eastern section	Western section
1947-1952	The eastern section of the site comprises undeveloped land with a golf course and bowling green present. A cemetery is noted directly adjacent to the east.	The western section of the site comprises Tahuna Park, the partially constructed holiday park, and an area of scattered dwellings with probable market garden use.
1958	No significant changes observed within the site. Development of the Tahuna WWTP evident to the west.	The holiday park is noted to have finished construction. The group of dwellings noted within the western section is evident to have a small area of horticultural land use.
1967	Additional structures noted within the bowling green complex.	Group of houses and gardens noted to have been removed and replaced with grassed field.
1975	No significant changes observed.	No significant changes observed.

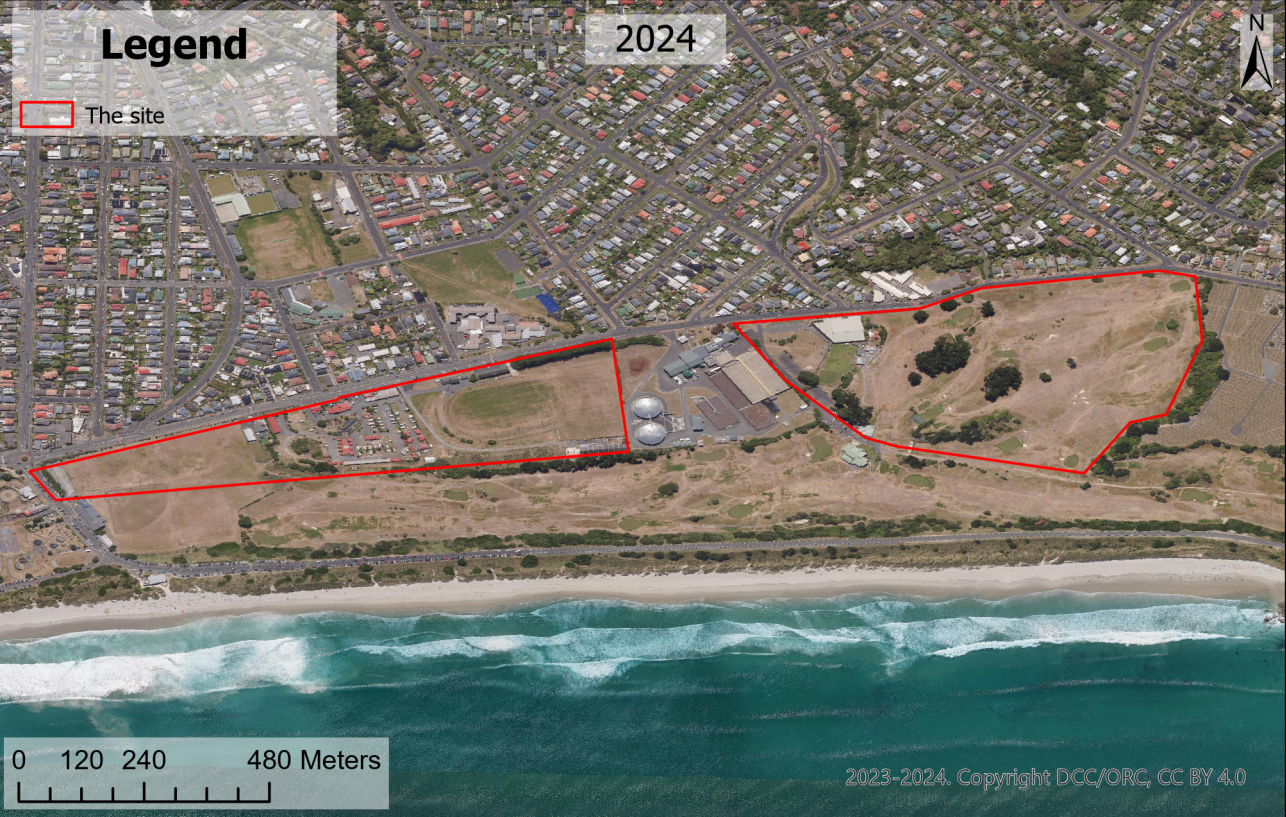
Year	Eastern section	Western section
1985	No significant changes observed.	Removal of vegetation and expansion of holiday park noted.
2000	Construction of lawn bowls stadium noted.	No significant changes observed.
2006-2007	No significant changes noted.	No significant changes observed.
2013	No significant changes noted.	Minor earthworks/disturbances noted at the southern edge of Tahuna Park.
2024	Removal of bowling green lawn and associated buildings observed.	No significant changes observed.
