To:	Dunedin City Council	From:	Edward Guerreiro
		Review:	Lee Paterson
File:	2GP Rezoning sites_ March2022	Date:	March 31, 2022

## SUMMARY

The purpose of this letter is to transmit our assessment the hazards at the requested sites:

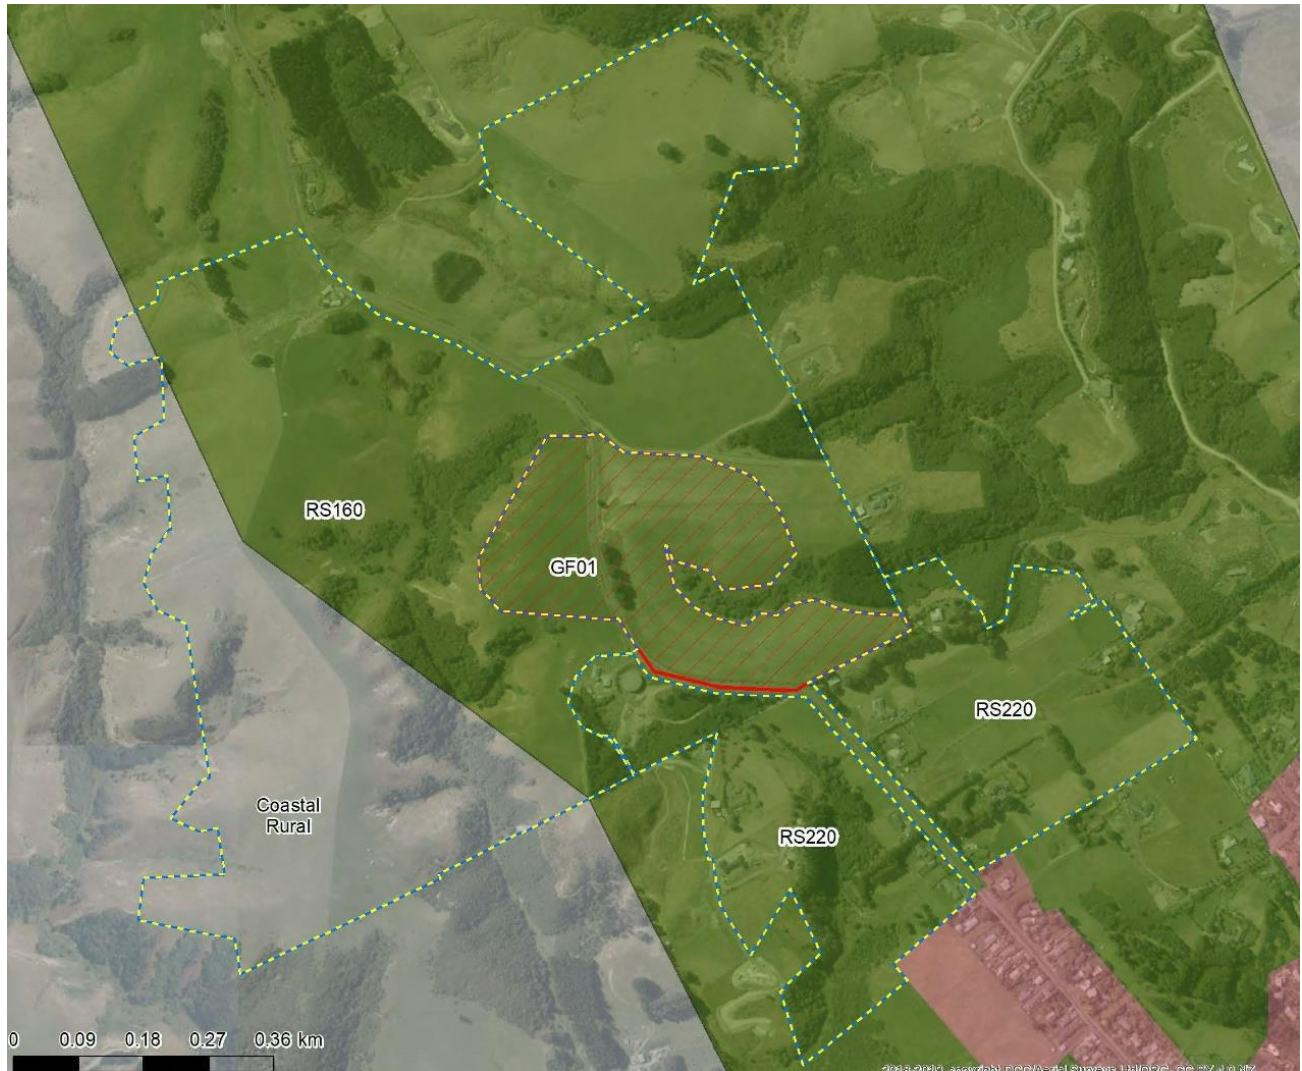
Figure 1 – RS220: 53, 64, 73, 74, 80, 85, 86, 92, 100, 103, 103A, 123, 127 SCROGGS HILL ROAD

The site consists of multiple landslide hazards relating to potential instability of the steep banks and gullies within the site area.

There have been historic landslips within similar geology and slope angles nearby this site. The trigger for these were related to stormwater.

We consider that this site is a **medium level hazard**. This decision is based on the following summary of information:

- There are **medium level hazards** associated with slope instability on the site
  - Global stability of steeper parts of the site appears to be governed by stormwater management and steepness/aspect of the slopes.
  - Geotechnical advice will be required prior to subdivision of this site to confirm the extents of instability and ensure it will not affect any potential lots/structures. This may also identify any offsets that might be required from unstable areas.

Geotechnical assessment will be required to confirm the stability of proposed lots near steep portions of the site. Provided the site is found to be globally stable, some specific earthworks and stormwater management requirements would be applicable for lots on the site. It is likely that removal of trees from the gully areas will exacerbate instability.

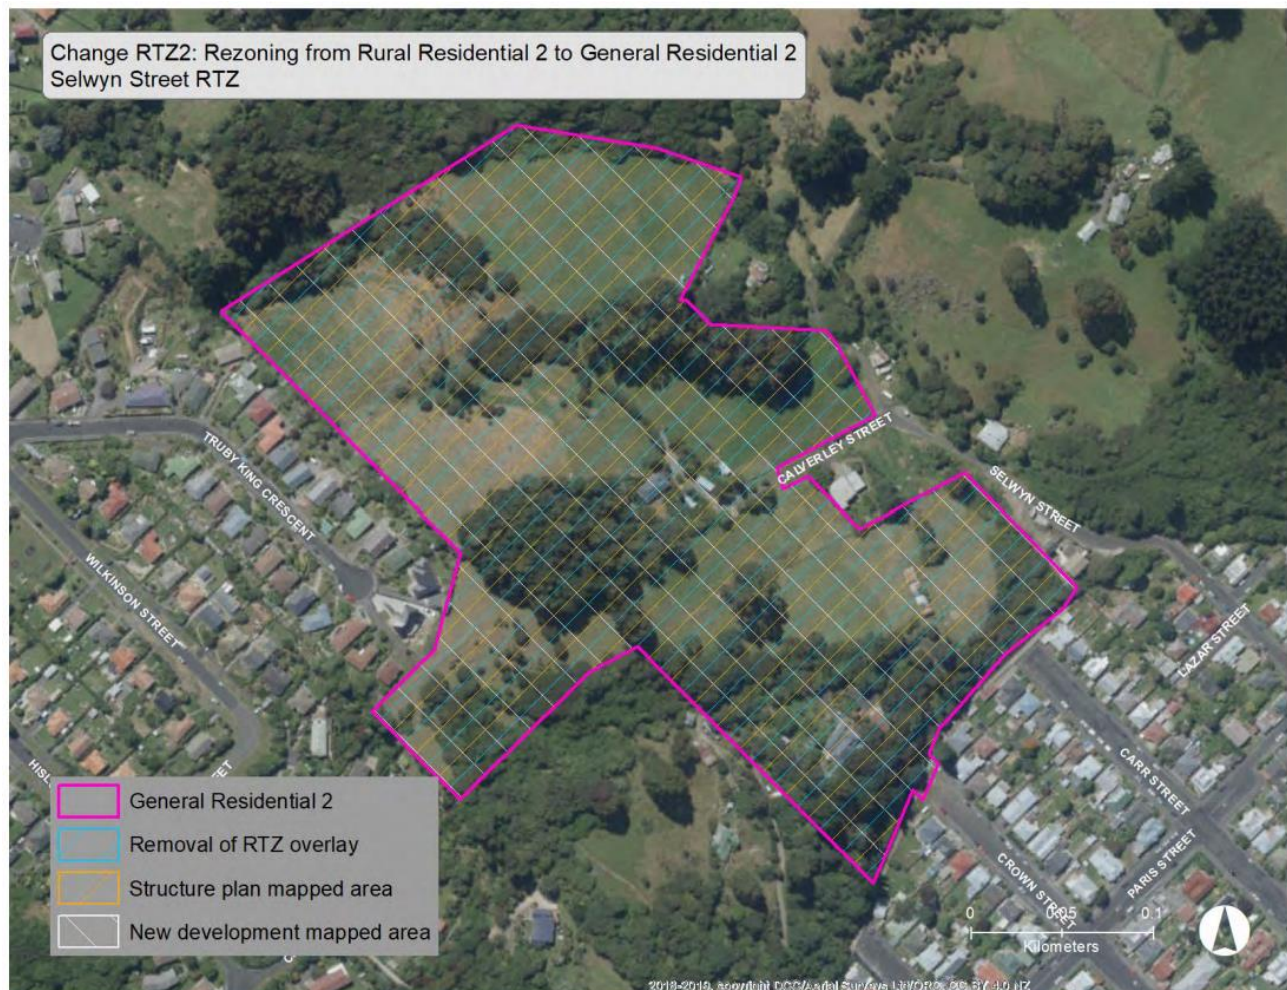
Figure 2 – RTZ2: 87 SELWYN STREET

There are no hazards identified within the hazards register for the proposed area, however there has been historic slips associated with rain events on nearby similar slopes.

We consider that this site is a **high level hazard**. This decision is based on the following summary of information:

- There are **high level hazards** associated with slope instability on the site
  - The majority of the site consists of steep land over 15 degrees, and half the site is over 20 degrees
  - There is previous history of land instability nearby within similar geology and slope angles.
  - Some of the site is within typical stability limits, however there are significant areas of possible instability

Geotechnical assessment will be required to confirm the general stability of the site, especially for the steeper areas. Provided the site is found to be globally stable, requirements for earthworks consent would be normal for the lower lying land sloping by less than 12 degrees within this site.

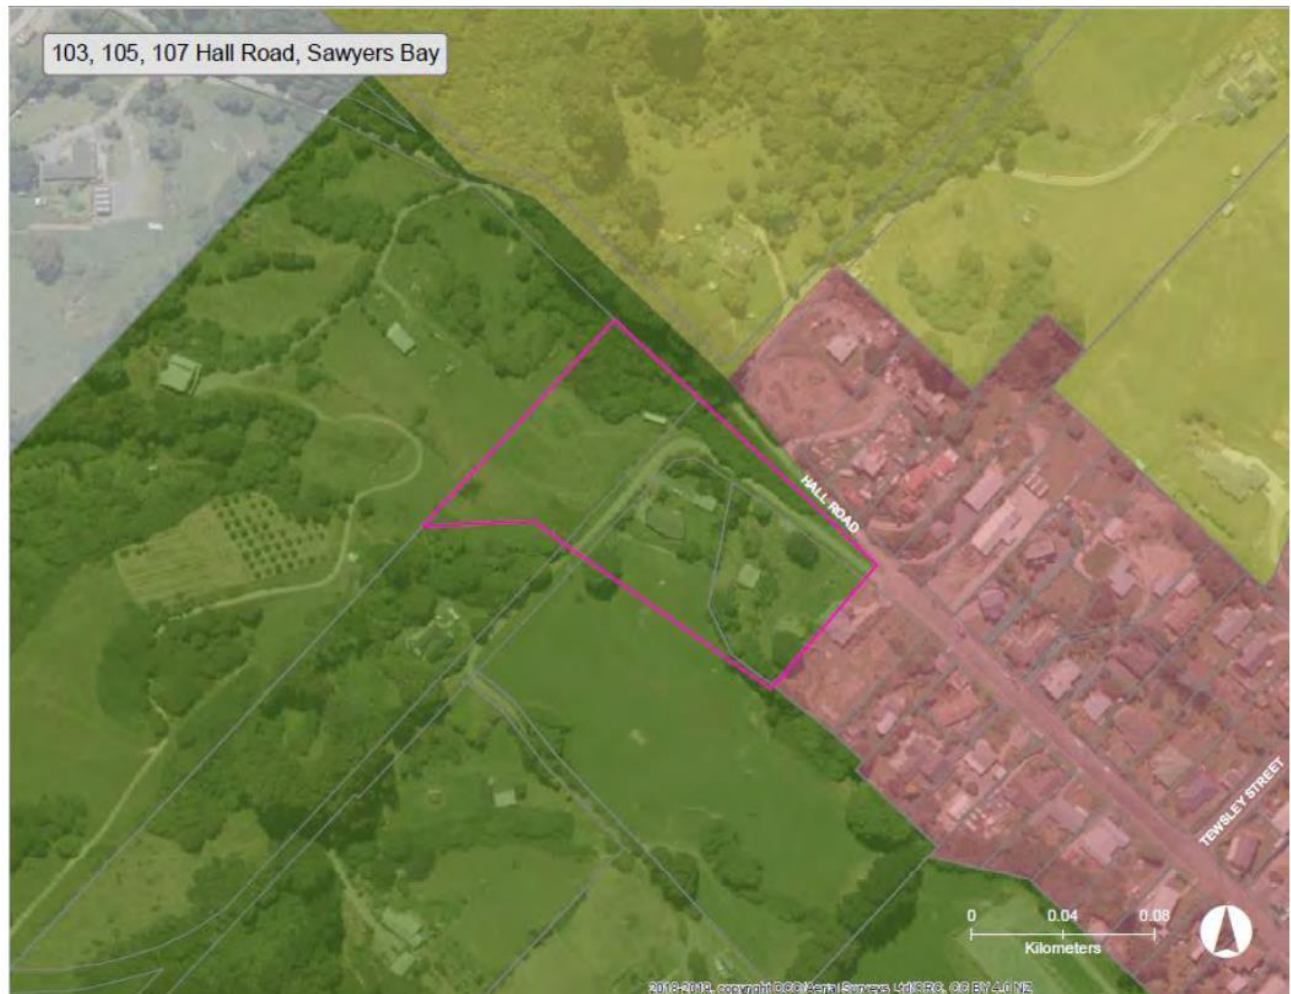
Figure 3 – RS170: PART 103, 105, 107 HALL ROAD, SAWYERS BAY

The land stability hazards above appear to be minor and related to alluvial deposition from flood events. This hazard affects the entire of Sawyers Bay. There are no other hazards on adjacent land that may affect this site.

We consider that this site is a **low hazards level**. This decision is based on the following summary of information:

- There are **no hazards** associated with slope instability
- There are no other listed natural hazards on the site which would affect development

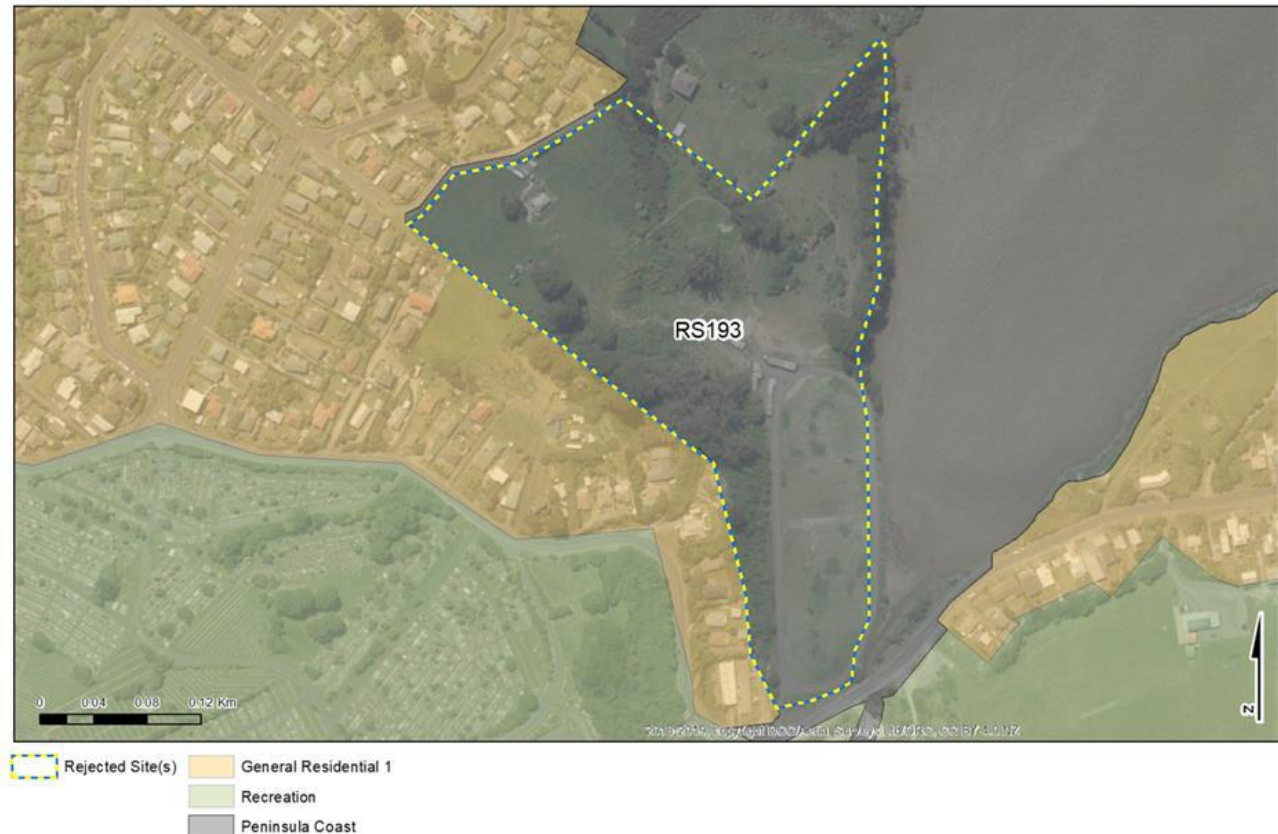
Figure 4 – RS193: 177 TOMAHAWK ROAD

- Hazard ID 10945: Land Stability – Subsidence (Landfill)  
The flat portion of the site adjacent to Tomahawk Lagoon is comprised of a landfill hazard zone. It is unclear whether this is related to landfill or unengineered earth fill.

The liquefaction and landfill hazard zones cover the flat portion of the site adjacent to Tomahawk Lagoon.

Although not listed as a hazard, the slopes are very steep and are likely to present land stability risks with such a dense format such as GR1.

We consider that this site is a **high level hazard** site. This decision is based on the following summary of information:

- There are several **high level hazards** associated with slope instability in the steep portion of the site:
  - Much of the steeper slopes are sloping by over 20 degrees and global stability of the site could be affected by development, especially from earthworks and/or groundwater changes. Any global instabilities would affect multiple potential lots.
  - Geological investigations are required to determine the suitability of the site.
- There is a **high level hazard** associated with liquefaction and landfill on the flat portion of the site
  - The low lying land is unlikely to be suitable for development due to the low-lying nature of the land, potential for liquefaction/lateral spreading into the lagoon, and landfill.

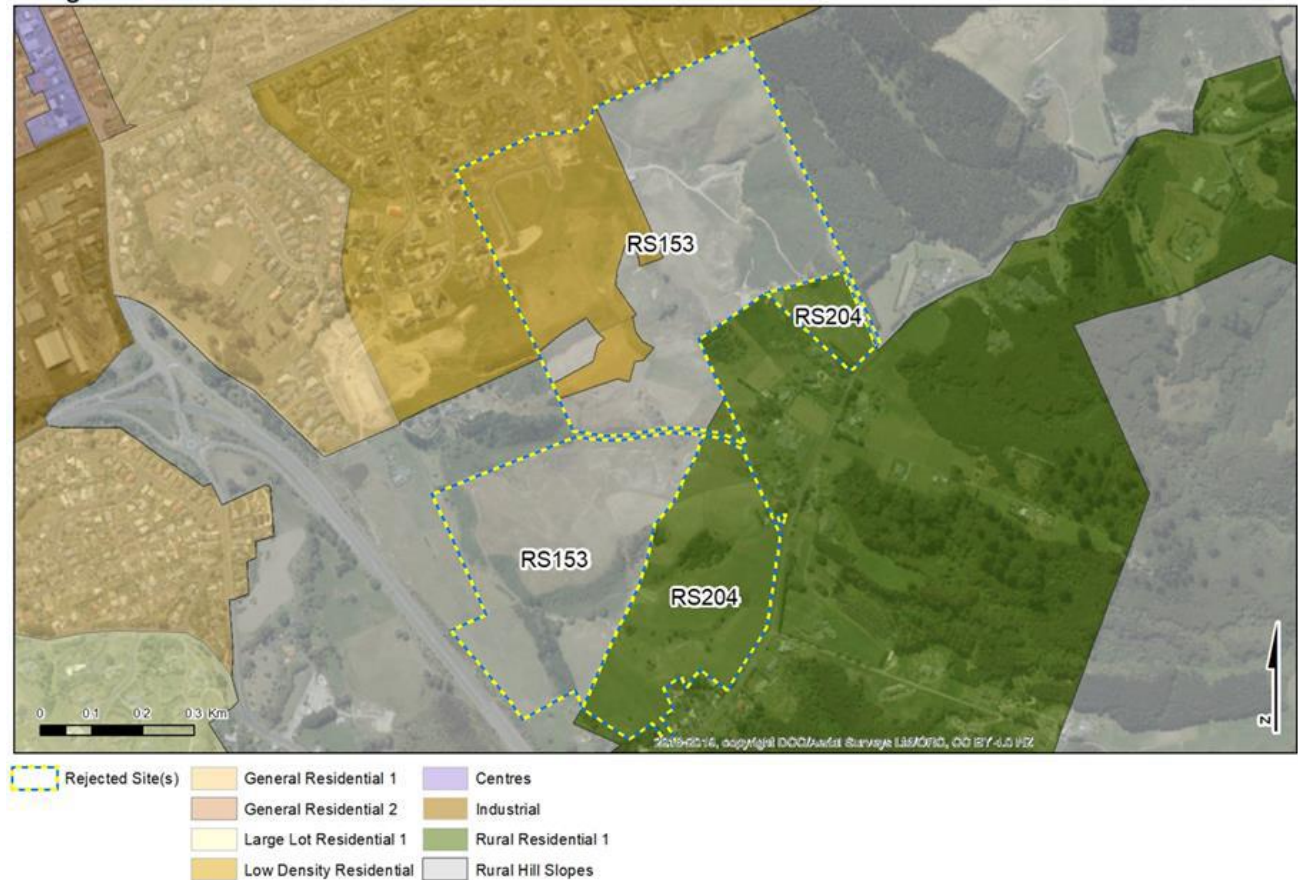
Figure 5 – RS204: 21, 43, 55, 65, 75, 79, AND 111 CHAIN HILLS ROAD

There are land instability hazards within the site and mapped historic landslides within nearby slopes. These are typically within steeper slopes of the same geology. Although the risk of land stability hazard is not excluded from this site, it is likely to be localized to steep slopes around gullies.

We consider that this site is a **low to medium level hazard**. This decision is based on the following summary of information:

- There are **low level hazards** associated with slope instability on the site in slopes less than 12 degrees adjacent to Chain Hills Road:
  - Much of the site itself is within typical stability limits.

- There are **medium level hazards** associated with slope instability within gully features:
  - Stability of steeper parts of the area appears to be uncertain (on slopes greater than 15 degrees). In some areas, the site is steep and with prehistoric landslide features that require geotechnical assessment.

Geotechnical assessment will be required to confirm the stability of the gullies across the site. Provided the site is found to be globally stable, requirements for earthworks consent would be normal for low angled lots (<15 degrees) within this area.

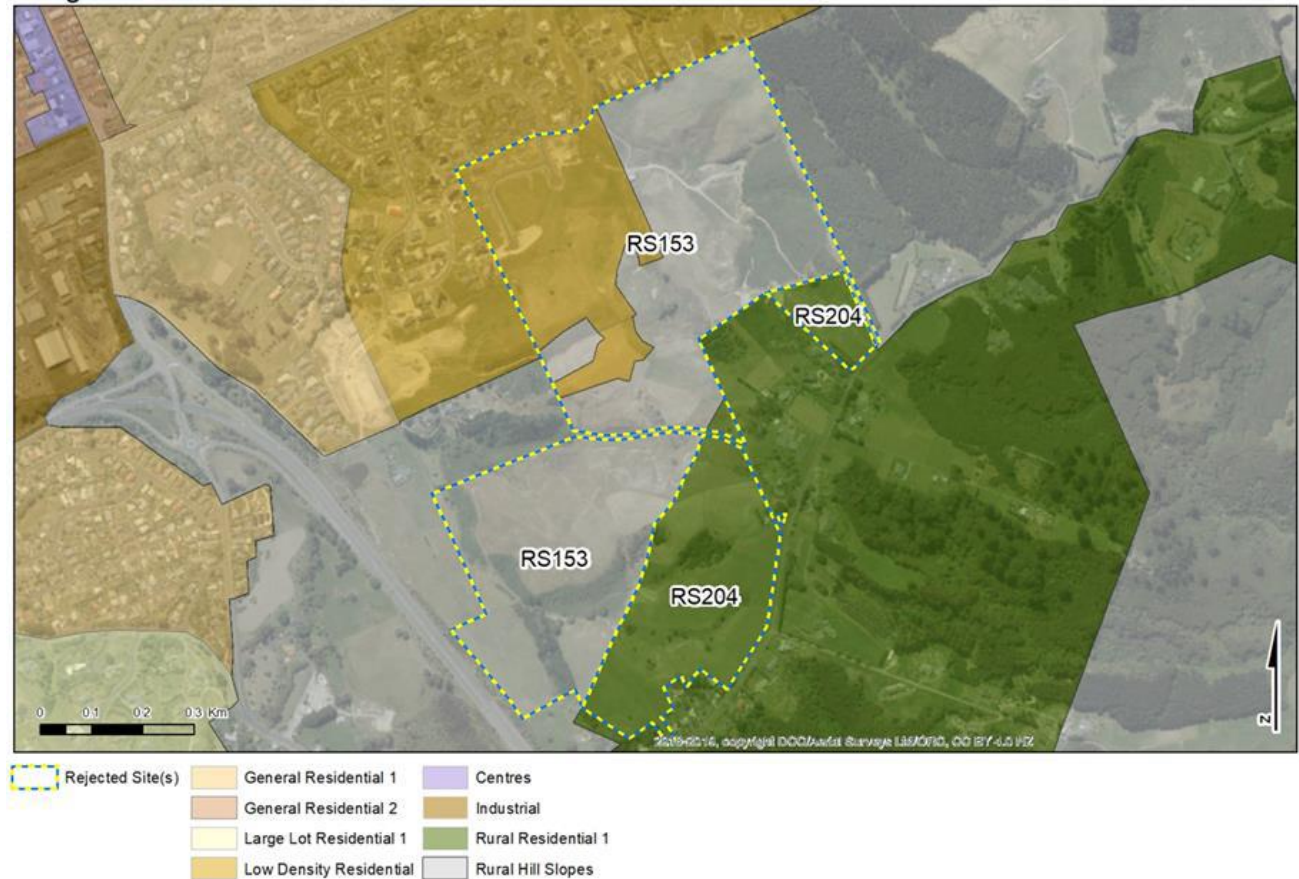
Figure 6 – RS153: 77 and 121 Chain Hills Road and 100 Irwin Logan Drive

There are land instability hazards within the site and mapped historic landslides within nearby slopes. There are also obvious locations of localized surface movement/erosion evident in the aerial photographs. Some of these appear to have been planted out to prevent further erosion/land movement.

We consider that this site is a **medium level hazard**. This decision is based on the following summary of information:

- There are **medium level hazards** associated with slope instability:
  - Most of the site consists of undulating terrain with steep slopes over 15 degrees. In some areas, the site is steep and with prehistoric landslide features that require geotechnical assessment.
  - Geotechnical advice will be required prior to subdivision of this site to confirm the extents of any instabilities and ensure the proposed subdivision layout will not limit the ability to address these hazards. This may also identify any offsets that might be required from unstable slopes

Geotechnical assessment will be required to confirm the stability of the gullies across the site. Provided the site is found to be globally stable, requirements for earthworks consent would be normal for low angled lots (<15 degrees) within this area.

We do not anticipate that this site will be generally unstable, though much of it will be unsuitable for structures. Geotechnical advice will need to identify building platforms and lot layouts/sizes that will work with the terrain features and not confuse the ability to address these hazards.

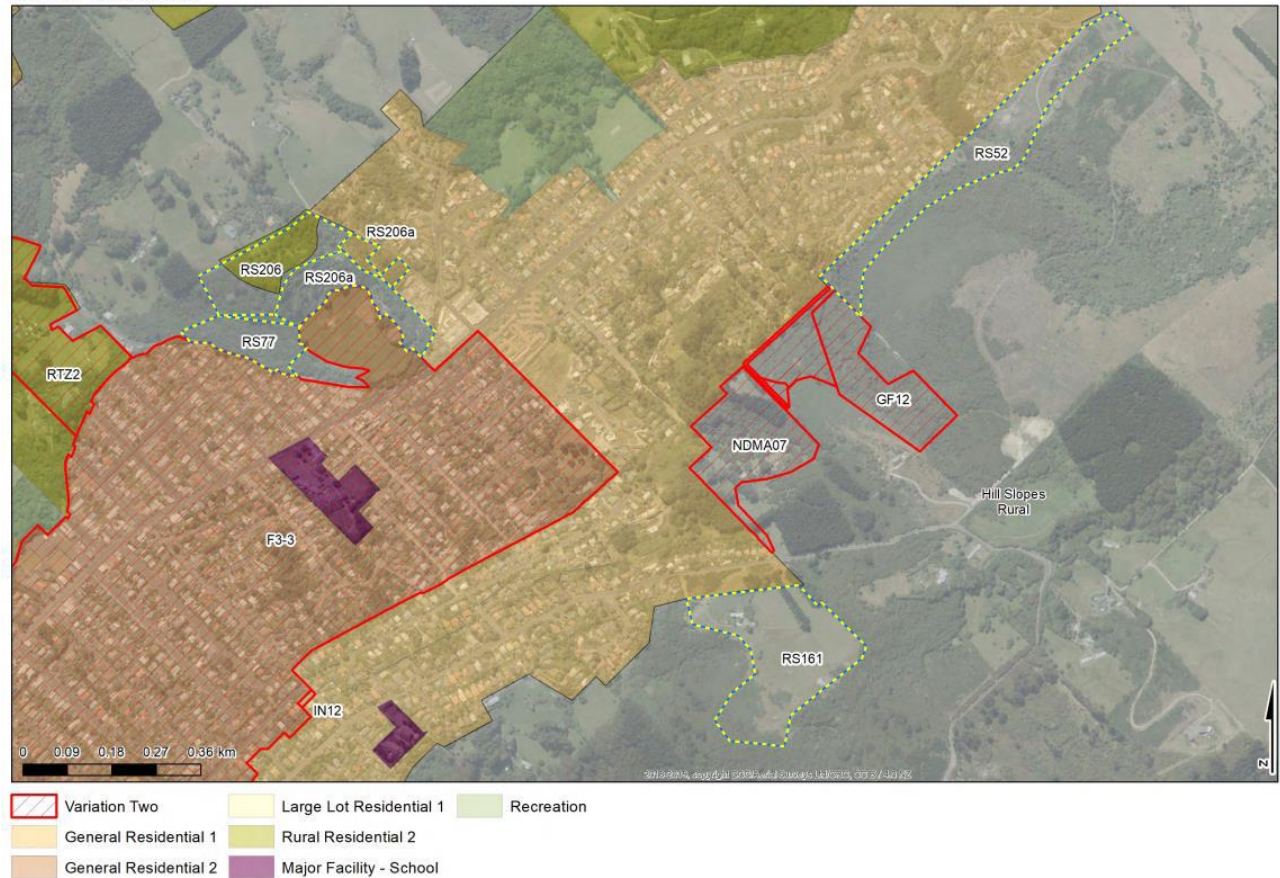
Figure 7 – RS161: PART 210 SIGNAL HILL ROAD

There are no hazards on this site or adjacent land that may affect this site within the hazards register.

We consider that this site is a **low hazard level**. This decision is based on the following summary of information:

- There are **low hazards** associated with slope instability within the proposed area. The area appears to have been explicitly chosen to avoid the steeper slopes surrounding the site.

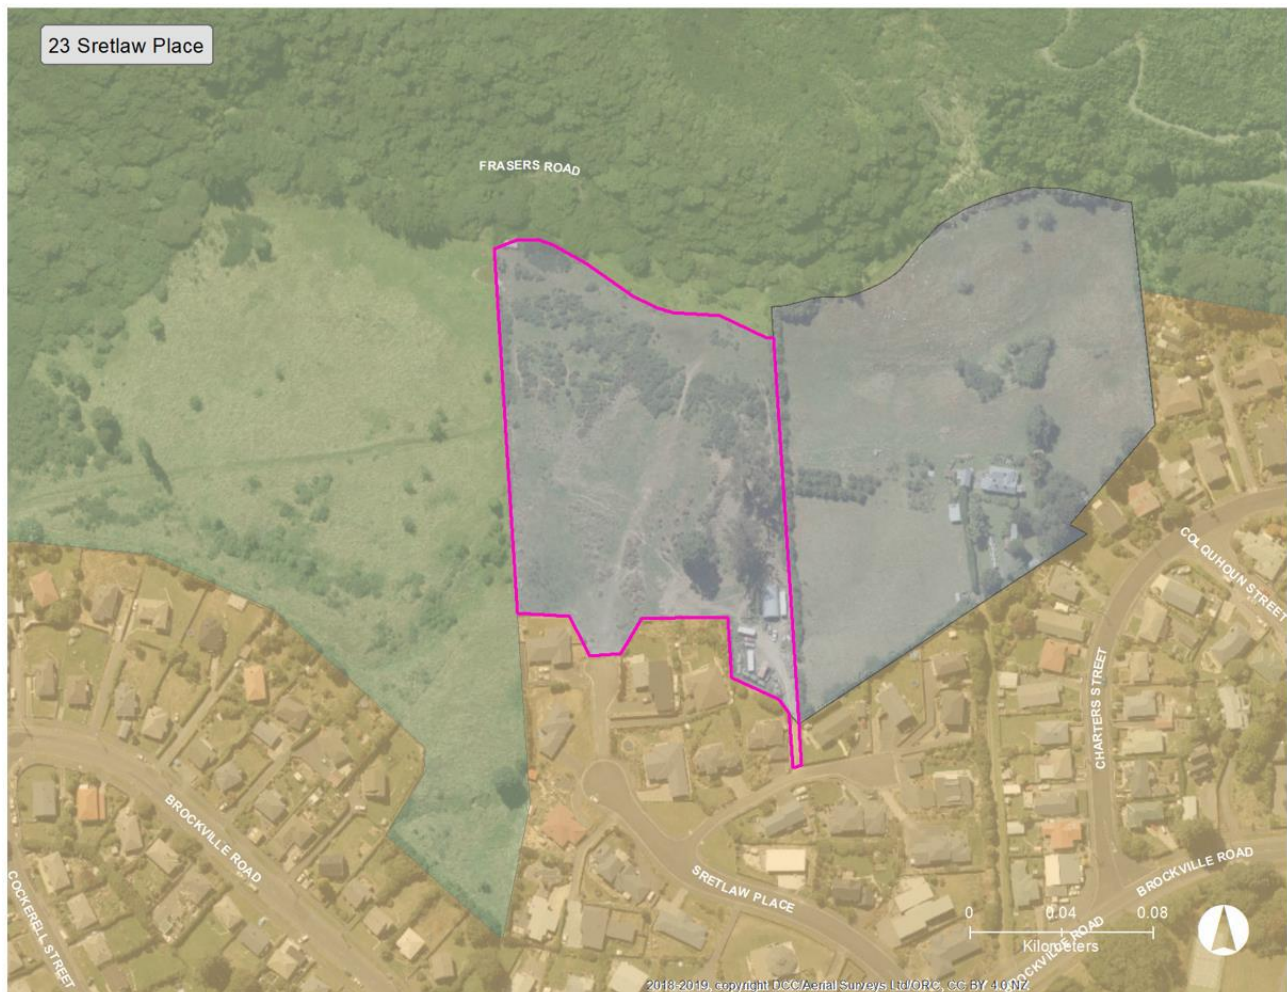
Figure 8 – RS110: 23 SRETLAW PLACE

The above land stability hazards indicate that the site has some landslide debris from an ancient uphill landslide. There are also nearby slopes on adjacent lots with existing land instability. We found historical maps with land stability awareness zones that extend into the site.

We consider that this site is a **low to medium level hazard**. This decision is based on the following summary of information:

- The site slope angles are moderate, and there appears to be no significant landslides on the site. However,
- There are several sources of information to suggest the site has been inundated with landslide debris and affected by landslides from other lots. We consider the site to have **medium level hazards** associated with slope instability.
- Geotechnical advice will be required prior to subdivision of this site to confirm the extents of any instabilities and ensure the proposed subdivision layout will not limit the ability to address these hazards. This may also identify any offsets that might be required from unstable slopes or landslide debris.

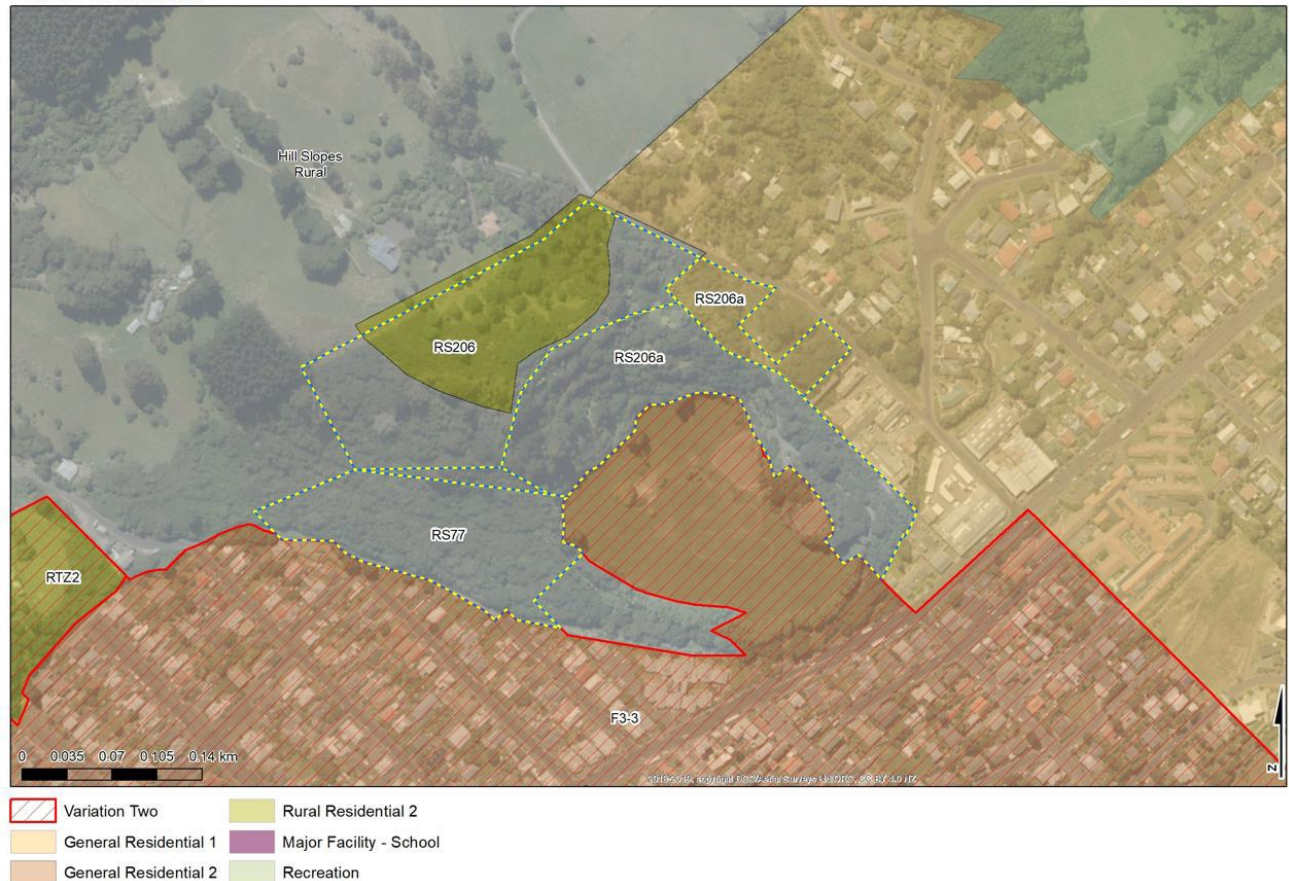
Figure 9 – RS206, RS206a, RS77: Part 35 and 43 Watts Road, Part 109 North Road

Both hazards on the site are associated with the eastern boundary of the site to Watts Rd. There was a historic slip associated with a rain event on the bank of this site.

There is also a large hazard associated with the historic quarry activity in the middle of the sites.

We consider that this site is a **high level hazard**. This decision is based on the following summary of information:

- There are **high level hazards** associated with slope instability on the site
  - Most of the site consists of steep land over 20 degrees
  - There is previous history of noted land instability on the eastern slopes of the site
  - Some of the site is within typical stability limits (there is a small flat area on 43 Watts Rd), however the majority of the land has significant areas of possible instability

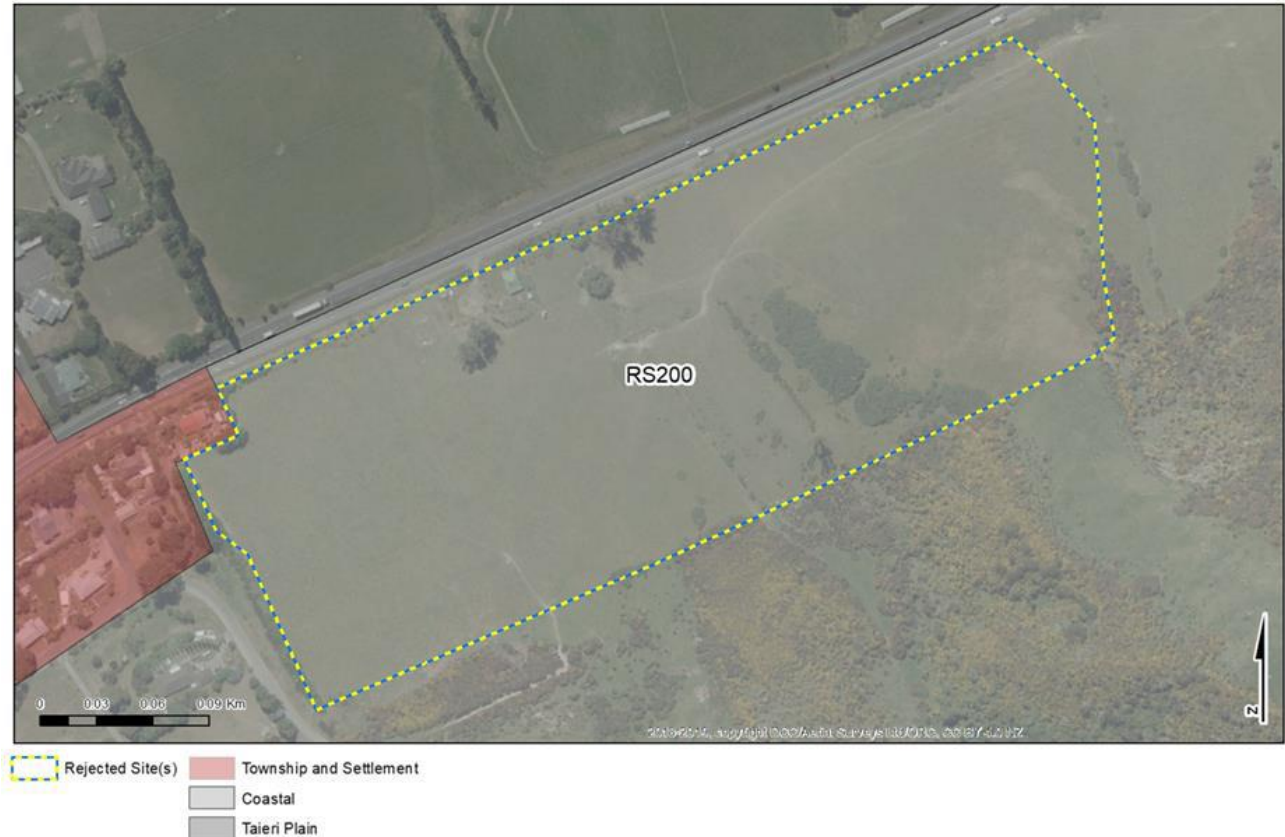
Figure 10 – RS200: 489 EAST TAIERI-ALLANTON ROAD

All the hazards are relating to flood and liquefaction associated with weak floodplain alluvium on the lower lying portion of the site. This is no different than many other locations within Allanton and is controlled using engineering design for foundations and guidelines for minimum floor levels.

We consider that this site is a **low hazard level**. This decision is based on the following summary of information:

- There are **low level hazards** associated with flood hazard on the site:
  - The site lies within flood hazard overlays that are typically mitigated through minimum floor levels implemented at the time of subdivision.
  - The site contains a important watercourse that are more than minor and affect neighboring land. It is unlikely that anyone will build on the lowest portion of the site, however, further assessments of stormwater management and offsets from the watercourse would be required to ensure any development does not have adverse effects.

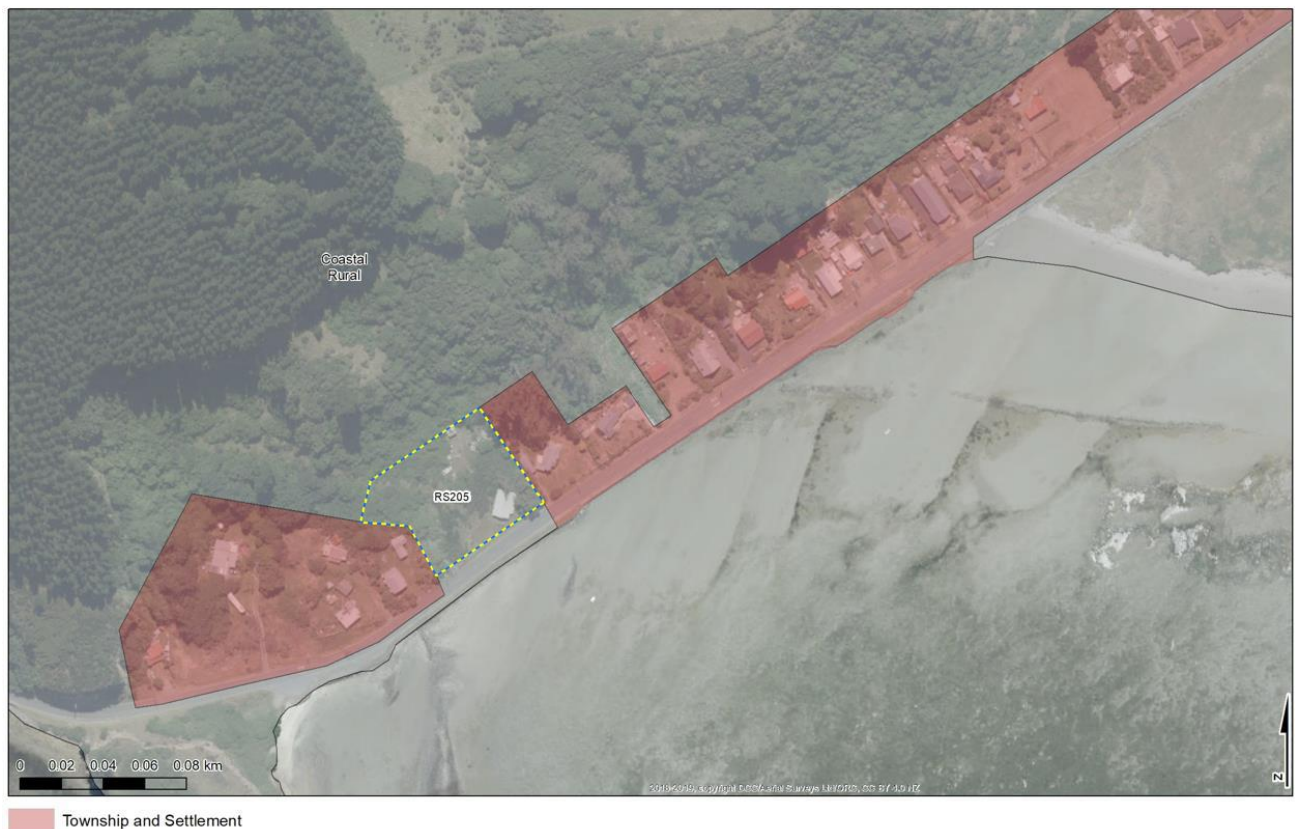
Figure 11 – RS205: 761 Aramoana Road

Whilst the only hazard identified for the lot is regarding liquefaction, there is significant hazards from rockfall from the erosional faces behind the site. Geolink has provided a report on this some 10+ years ago.

We consider that this site is a **low hazard level** in the context of a T&S proposed zoning, considering the rest of the waterfront is also T&S zoned. However, we consider the site to have a **high hazard level** for future development.

There is a rockfall hazard from the slopes above and a Geotechnical assessment suggesting rockfall impaction in this area is possible. Further engineering assessment will be required to identify the safety of this area to be suited for further development with regards to rockfall and liquefaction.

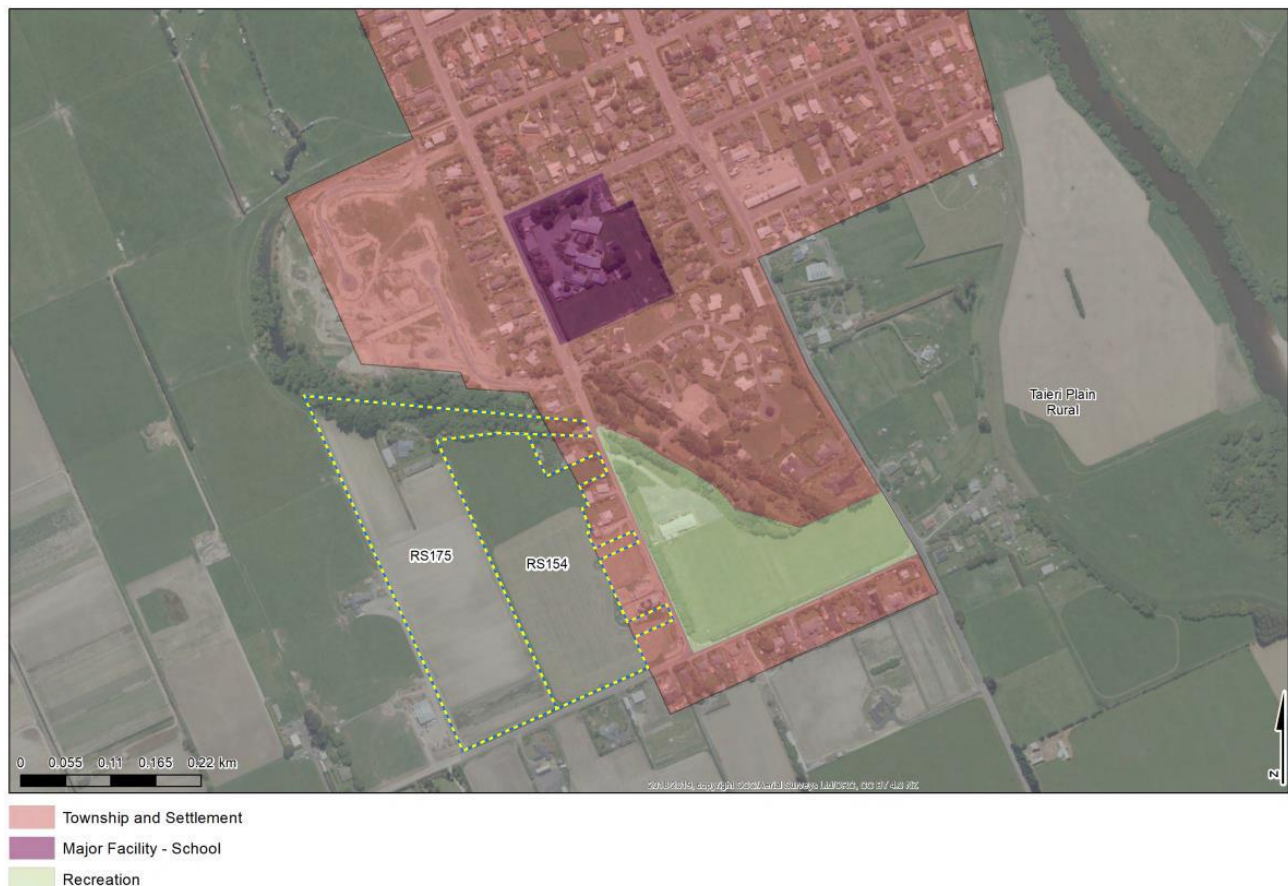
Figure 12 – RS154: 91 AND 103 FORMBY STREET

All the hazards are relating to flooding and liquefaction associated with weak floodplain alluvium. This is no different than many other locations within Outram and is controlled using engineering design for foundations and guidelines for minimum floor levels.

We consider that this site is a **low hazards level**. This decision is based on the following summary of information:

- There are **low level hazards** associated with flood hazard on the site:
  - The site lies within flood hazard overlays that are typically mitigated through minimum floor levels implemented at the time of subdivision

Minimum floor levels will be required to be set for any subdivision within the proposed area. A stormwater assessment may be required to confirm the flooding hazard of the adjacent stream and cumulative effects of filling large areas with respects to neighboring lots. The result of this assessment might be that development in this area will necessitate additional floor level requirements, floodbanks, or stormwater detention.

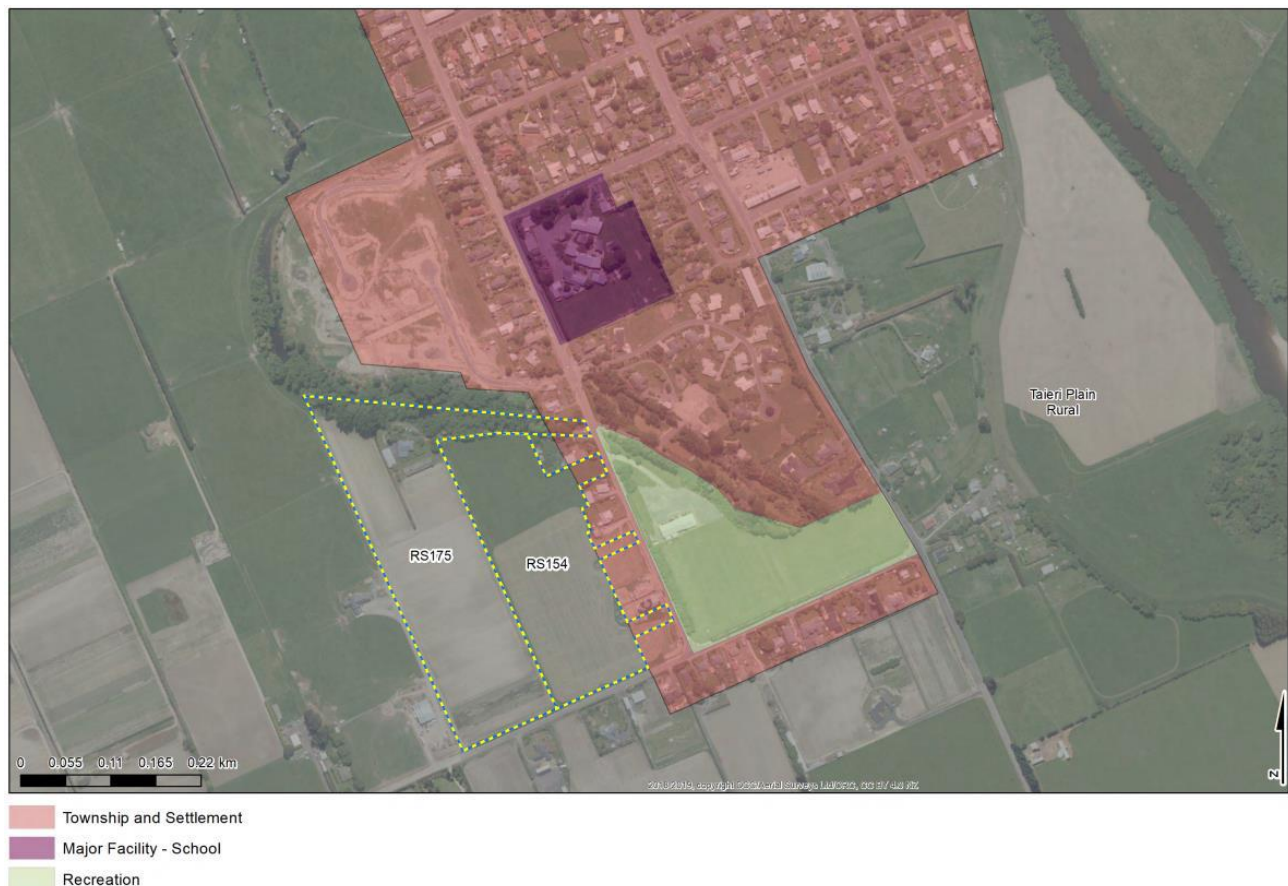
Figure 13 – RS175: 85 Formby Street

All the hazards are relating to flooding and liquefaction associated with weak floodplain alluvium. This is no different than many other locations within Outram and is controlled using engineering design for foundations and guidelines for minimum floor levels.

We consider that this site is a **low hazards level**. This decision is based on the following summary of information:

- There are **low level hazards** associated with flood hazard on the site:
  - The site lies within flood hazard overlays that are typically mitigated through minimum floor levels implemented at the time of subdivision

Minimum floor levels will be required to be set for any subdivision within the proposed area. A stormwater assessment may be required to confirm the flooding hazard of the adjacent stream and cumulative effects of filling large areas with respects to neighboring lots. The result of this assessment might be that development in this area will necessitate additional floor level requirements, floodbanks, or stormwater detention.
