To:	Dunedin City Council	From:	Edward Guerreiro
		Review:	Lee Paterson
File:	2GP Rezoning sites_ March2022	Date:	May 6, 2022

## SUMMARY

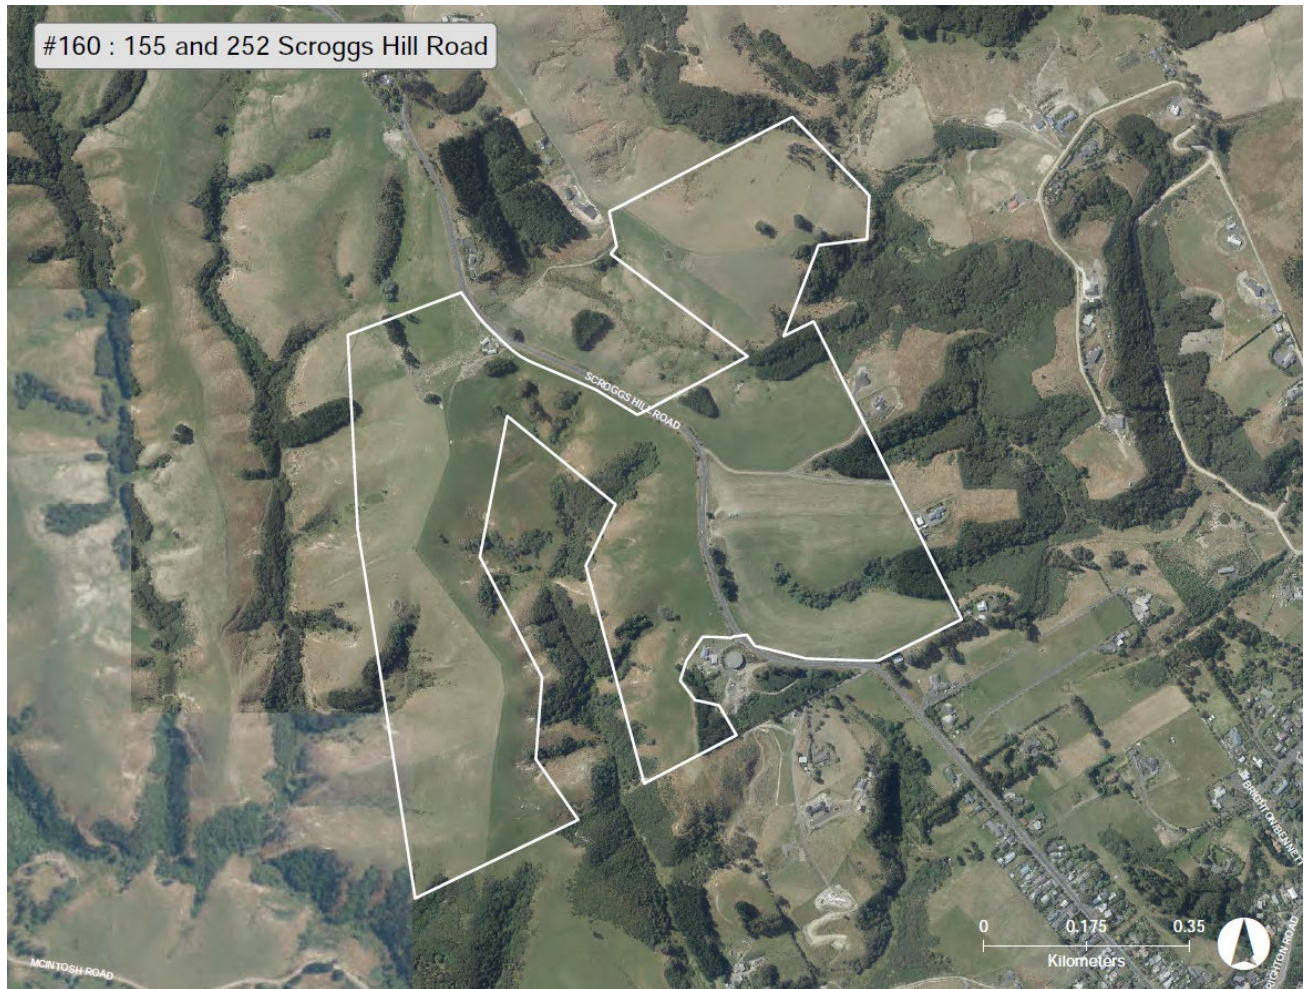
Figure 1 – 155 and 252 Scroggs Hill Road Site

The proposed site is indicated in Figure 1. The site is located within undulating Otago Schist hills above Brighton.

The underlying lithology is generally globally stable at steep slope angles ( $<26^\circ$ ), however is subject to weakness under certain conditions and slope angles. Excavation within lower schist slopes can

We consider that this site is a **medium level hazard**. This decision is based on the following summary of information:

- There are **medium level hazards** associated with slope instability on the site
  - Global stability of steeper parts of the site appears to be governed by stormwater management and steepness/aspect of the slopes.
  - Geotechnical advice will be required prior to subdivision of this site to confirm the extents of instability and ensure it will not affect any potential lots. This may also identify any offsets that might be required from unstable areas.

Geotechnical assessment will be required to confirm the stability of any proposed lots. Provided the site is found to be globally stable, some specific earthworks and stormwater management requirements would be applicable for lots on the site. It is likely that removal of trees from the gully areas will exacerbate instability.

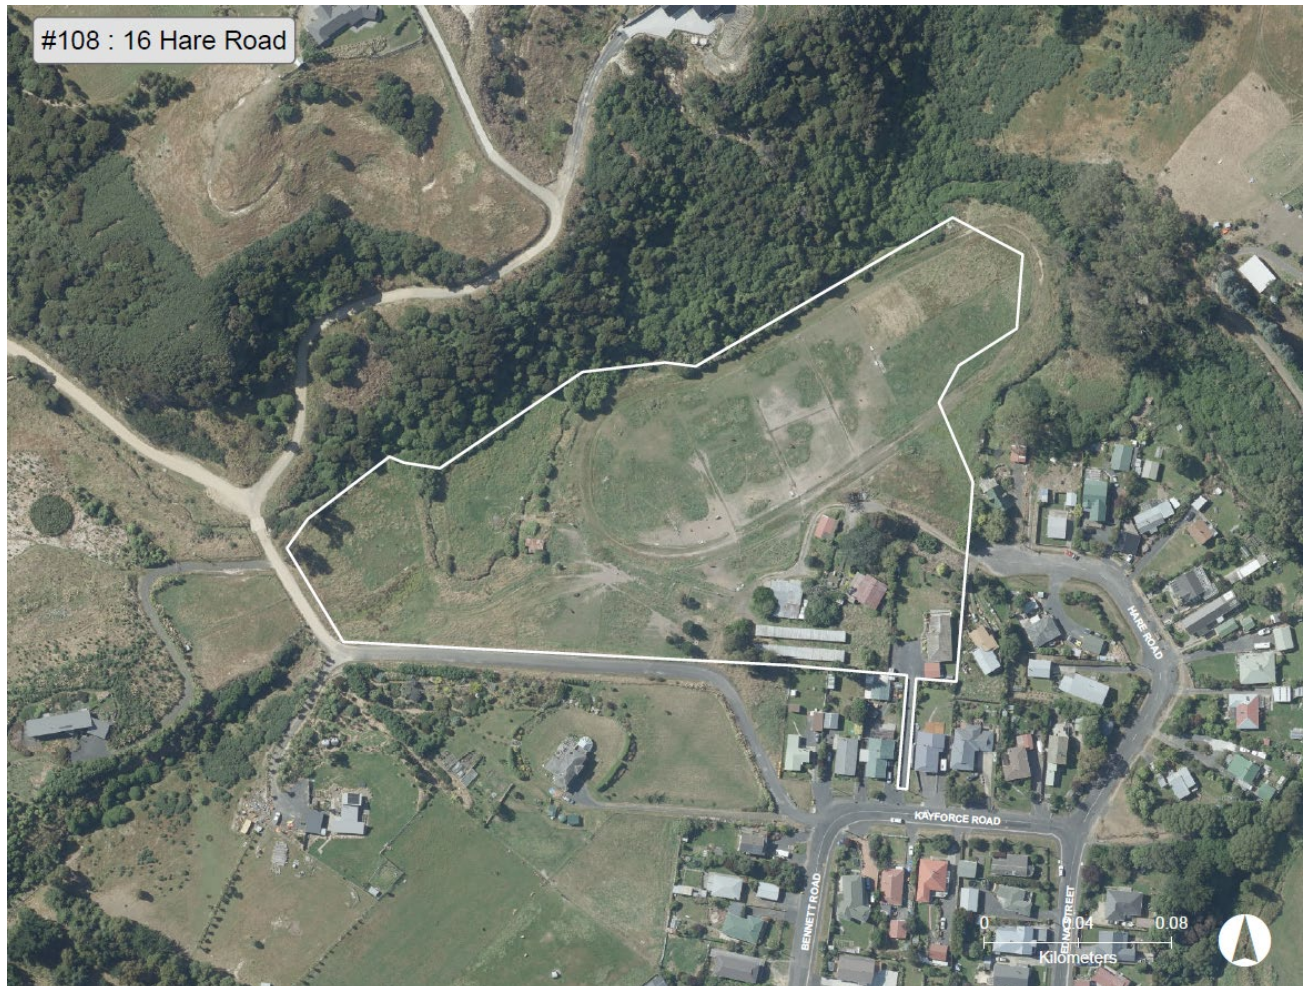
Figure 3 – 16 Hare Road Site

Although not directly a hazard, the underlying soils are relatively young, and as a result may be loose / lower strength. This will affect foundation design.

The steep schist slopes along the northern boundary are heavily vegetated and unlikely to present a slope stability hazard if left untouched. Excavation into the toe of this slope will require geotechnical input.

The land stability hazard affects the land towards the northern boundary of the proposed area and is not considered a hazard for the whole site.

All the hazards relating to liquefaction and alluvial material are associated with weak floodplain alluvium. This is no different than many other locations along Hare Rd and is controlled using engineering design for foundations.

The submission claims that Taylor Creek floods during severe weather events and inundates the proposed rezoning site. This is valuable local information and influences our recommendation for the original assessment for the site to be increased from a **low level hazards** to **medium level hazards** site.

- There are **medium level hazards** associated with stormwater and flooding from Taylor Creek.
  - Flood hazard assessments are required to identify suitability (or not) of the site for higher density development. The specific assessments would be required to confirm the extents and impacts of flooding, especially in relation to potential landslides further impeding Taylor Creek. It is likely that hazard mitigation will require extensive earthworks to develop the lower lying land within this site.

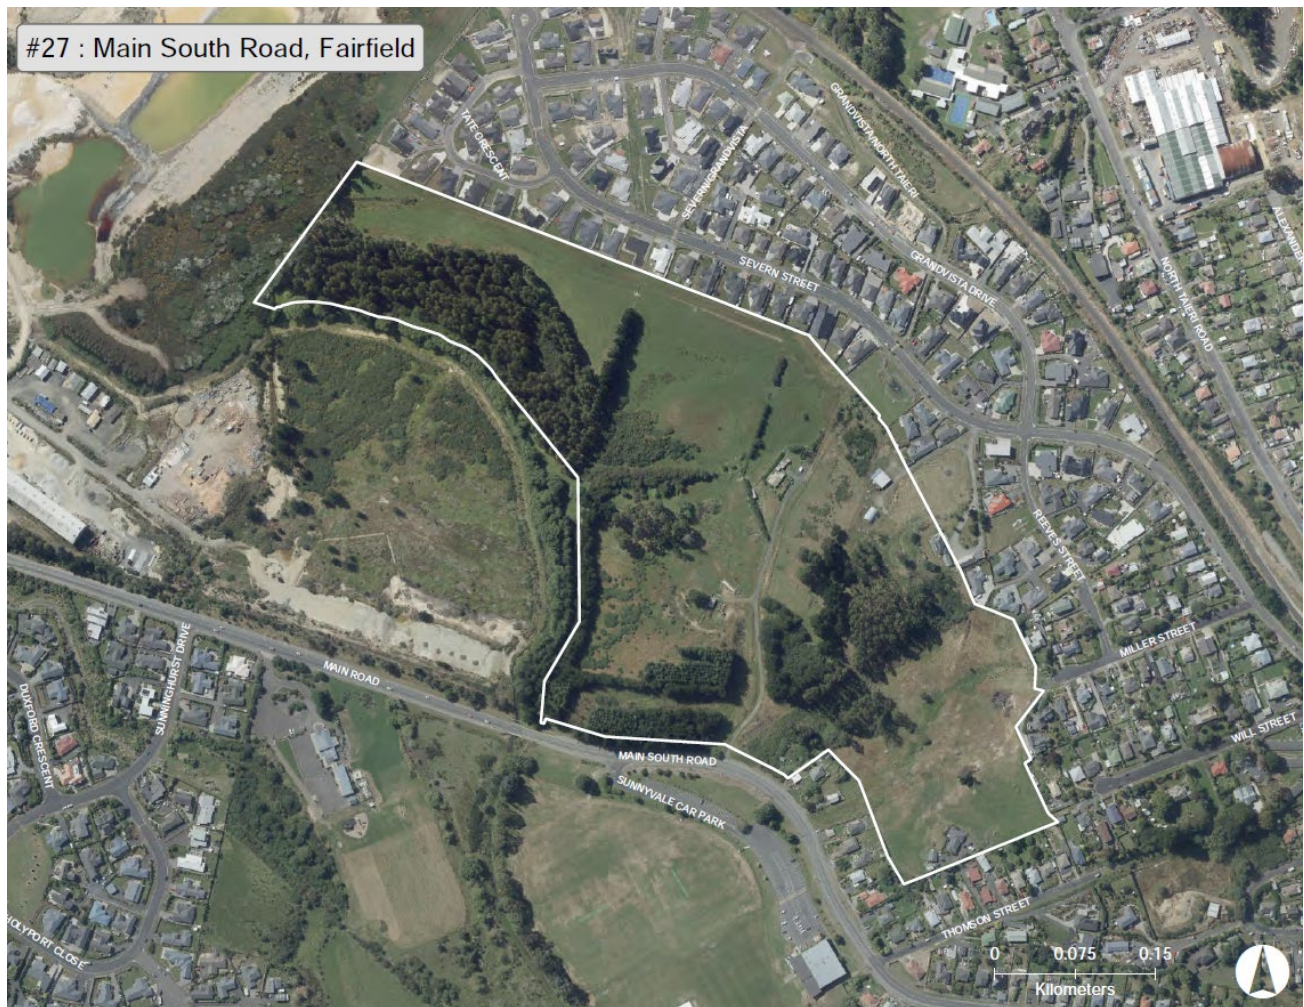
Figure 4 – Main South Road Site

The proposed site is indicated in Figure 4. The site is located west of the historic Abbotsford landslides.

The steepest part of the site is located within the vegetated embankment with consistent slopes of 20-26 degrees. Earthworks within this area may cause significant large scale instability within the uphill lots off Severn St and Tate Cres.

Abbotsford Mudstone is known for its susceptibility to groundwater and earthworks and historic large-scale instabilities. The material typically become unstable at slopes of over 15 degrees, however there have been several cases of instabilities within slopes of less than 12 degrees. An example of this is the historic Abbotsford motorway landslide within the same geology. Excavation of the toe of the slope caused a global landslip within land sloping by less than 12 degrees.

It is noted that an area within the eastern wing of the site has this landslide hazard. There is a "swampy area" and possible recent land instability in this area.

Adjacent to the previous hazard, there is an area within the eastern half of the site containing this mapped pre-historic landslide.

We consider that this site is a **high level hazard** site. This decision is based on the following summary of information:

- There are several **high level hazards** associated with slope instability and precedent for land instability within similar geology and slope angles nearby.
  - Global stability of the site could be affected by development, especially from earthworks and/or groundwater changes. Any global instabilities would be large to massive in scale and affect multiple potential lots.

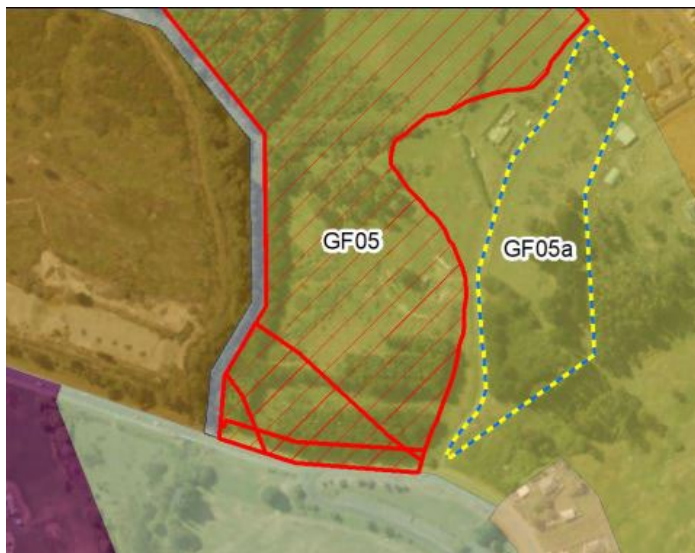
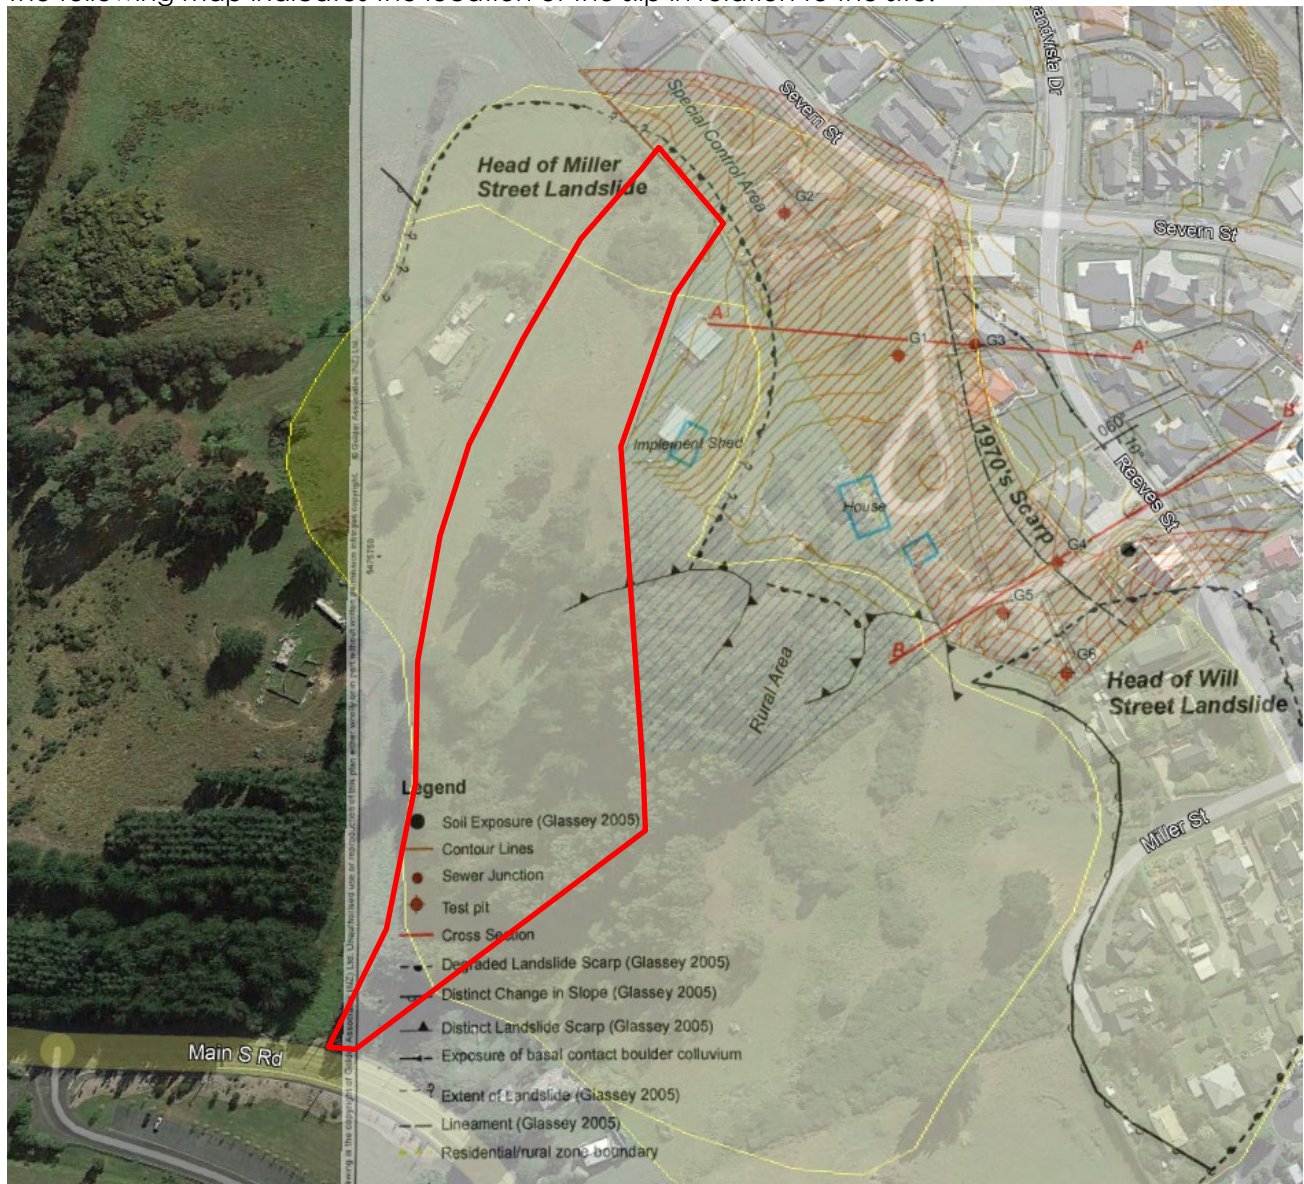
- Submission S204.001 seeks to rezone the area marked GF05a with a restriction of the establishment of only one dwelling.

We consider that the hazard level for this adjacent site is **high**. The site is located entirely within the Miller Street landslide with distinct head scarps from historic landslide features as recent as 1970s. It is

The following map indicates the location of the slip in relation to the site.

We recommend that specific geotechnical advice is sought before any zone changes in this area. From our desktop assessment, the site appears to be unsuitable for any subdivision or reduction in lot sizes where there are massive landslips present. Detailed site investigations would need to be undertaken to support any development proposals in this area.

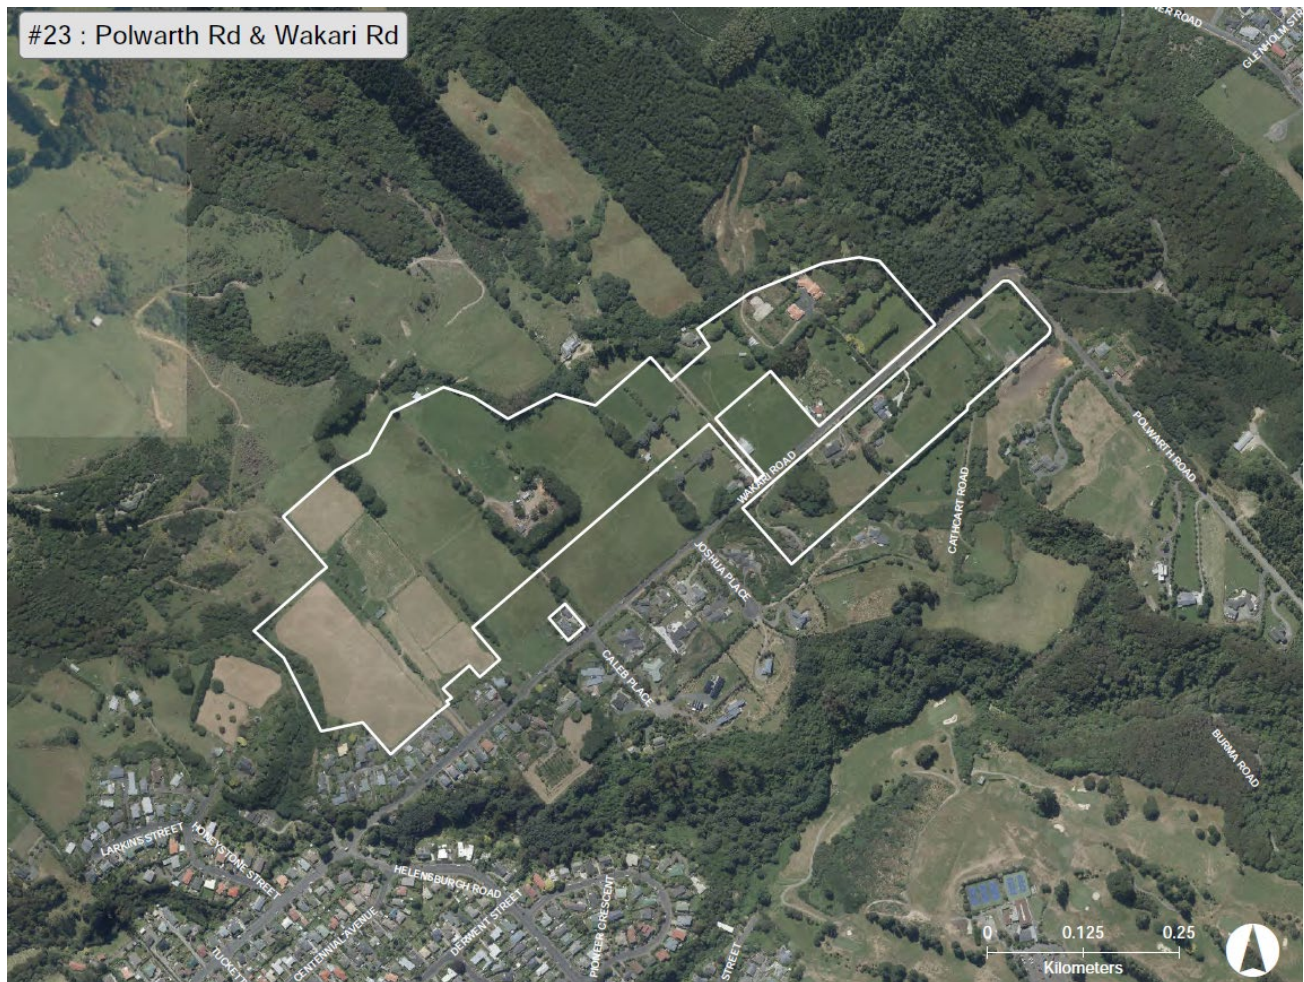
Figure 5 – Polwarth Road & Wakari Road Site

The proposed site is indicated in Figure 5. The site is located within undulating volcanic terrain.

The underlying lithology is generally globally stable at moderately steep slope angles (<20°), unless over-excavated or subject to weathering / ground water. Instability is generally limited to the overlying superficial deposits (loess). In this case, there are no slope stability hazards associated with the geology or sloping terrain.

The land stability hazard only affects a minute corner of the proposed area and is not considered a hazard for the site. There are no other hazards on adjacent land that may affect this site.

We consider that this site is a **low hazards level**. This decision is based on the following summary of information:

The area of concern is relatively minor and would have been addressed through the subdivision process anyway. The addition of the flood hazard does not elevate the hazard level for the site and it remains a **low hazards level**. The risk of flooding in this area is an engineering issue that would be addressed through offsets from the creek or fortifying the banks. The adjustment of the boundary isn't necessary to address the risk.

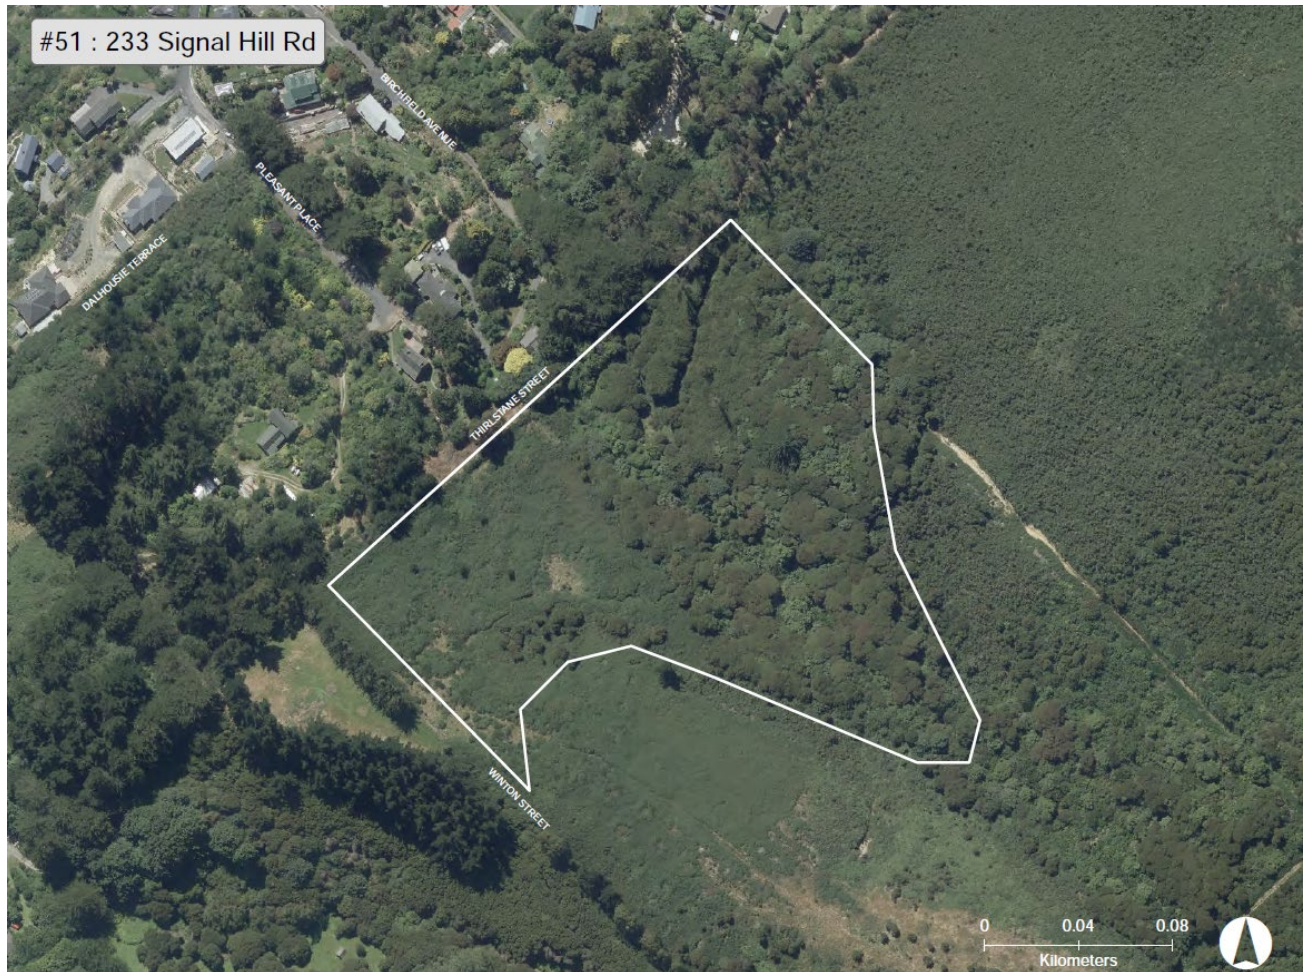
Figure 6 – 233 Signal Hill Road Site

The proposed site is indicated in Figure 6. The proposed site area follows around the base of the steep slopes around Signal Hill.

We consider that this site is a **low-to-medium hazard level**. This decision is based on the following summary of information:

- There are **low hazards** associated with slope instability within the red highlighted area, however excavation into the toe of the steep slopes may exacerbate slope instability.
- There are **medium level hazards** associated with slope instability within the wider area:
  - There are possibly sensitive slopes of up to 35 degrees within the proposed area that may become unstable with excavation and improper stormwater management.
- There are **medium level hazards** associated with stormwater within the wider area:
  - There is a well defined watercourse running through the proposed area, particularly through the main "flat" section of the site. Although the land in the gully is less steep, there are other hazards associated with stormwater management and associated erosion and land stability.

It is possible that excavation into the steeper slopes within the proposed area may cause instability uphill, or within the watercourse.

The site is a **medium hazard** site, which indicates that challenges will exist, and engineering design will be required for development of the site. The concerns presented by the public are in line with our original concerns where we stated *"there are possibly sensitive slopes of up to 35 degrees within the proposed area that may become unstable with excavation and improper stormwater management"*, and *"...geotechnical investigation and assessments of the adjacent slopes is required to confirm the extents of the readily developable land"*.

Our original reservations have been validated by the submissions and we recommend that no change is made to the current hazard level of the site. However, the development of this slope is will likely be dictated by geotechnical and stormwater constraints, rather than simply optimizing the boundaries for maximum geometric efficiency.

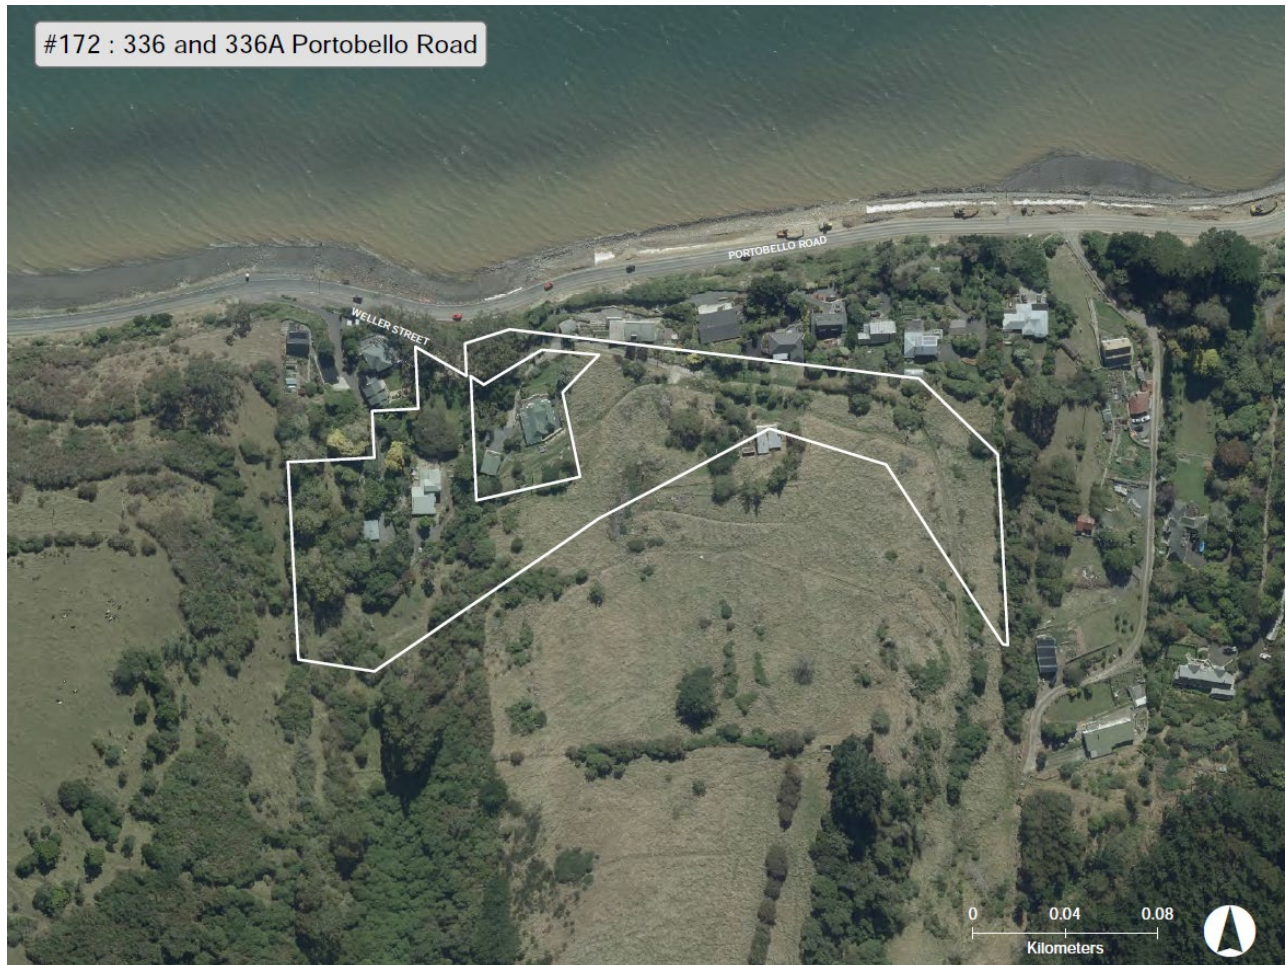
Figure 7 – 336 and 336A Portobello Road Site

The proposed site is indicated in Figure 7. The site is located on the sedimentary foothills of a volcanic formation.

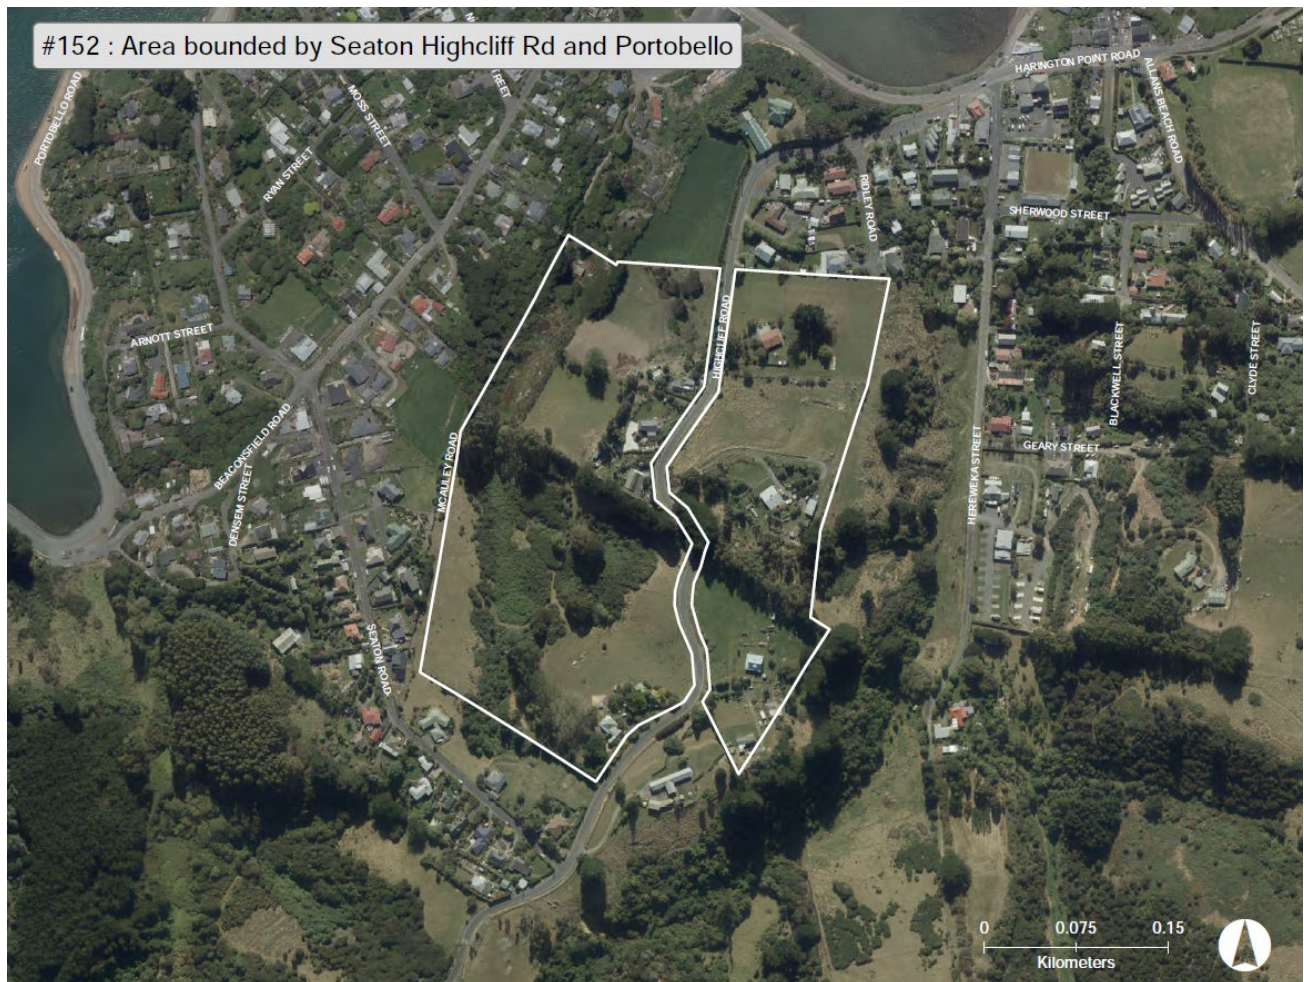
Figure 8 – Area Bounded By Seaton Highcliff Rd And Portobello Sites

The proposed site is indicated in Figure 8. The site is located within the “Peninsula Landslide” area.

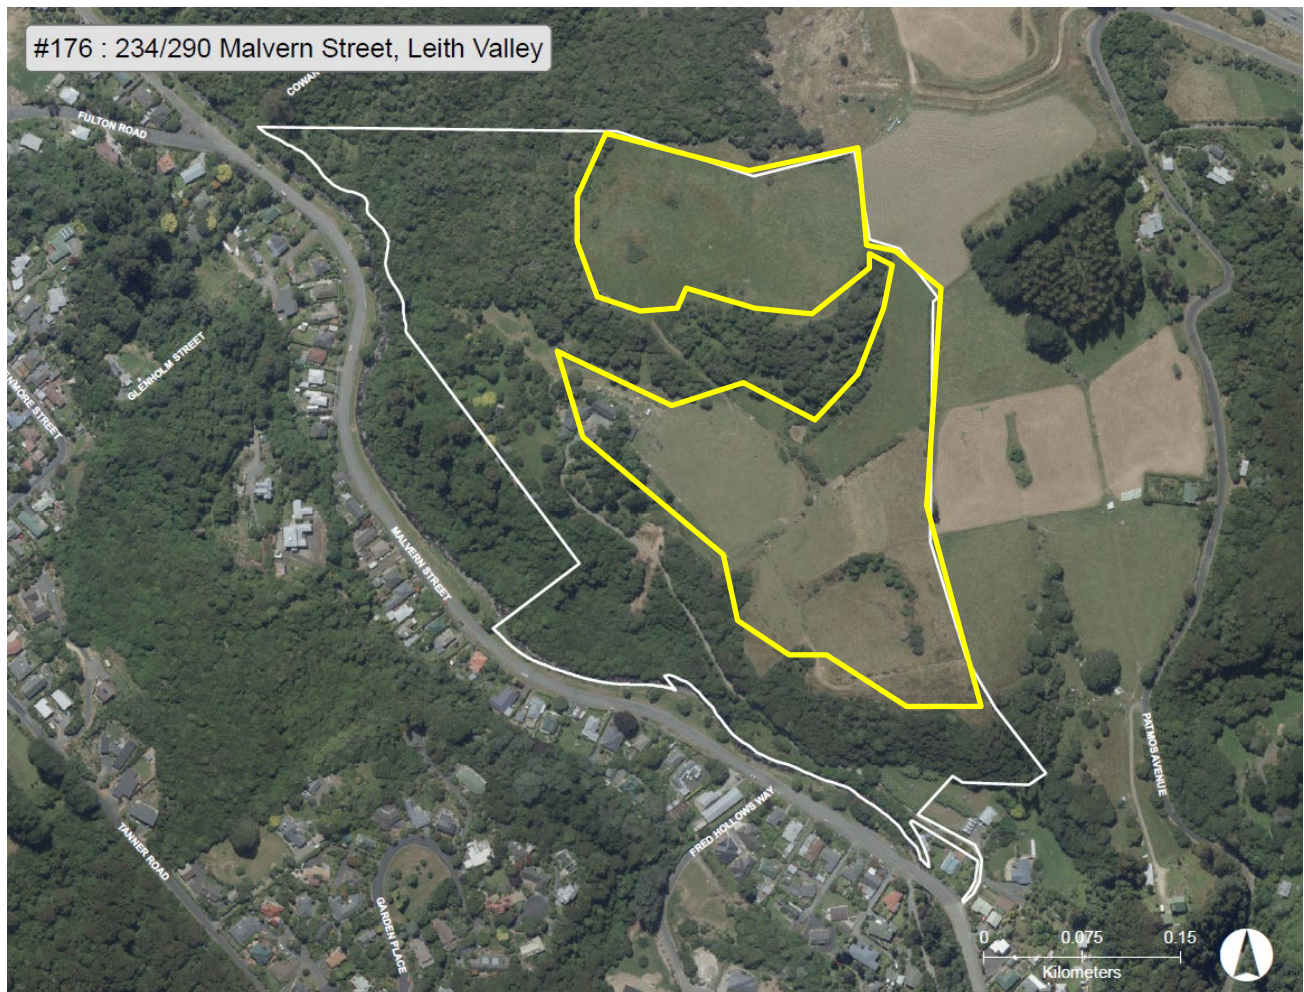
Figure 9 – 234/290 Malvern Street, Leith Valley Sites (yellow outline indicates slopes of less than 20 degrees)

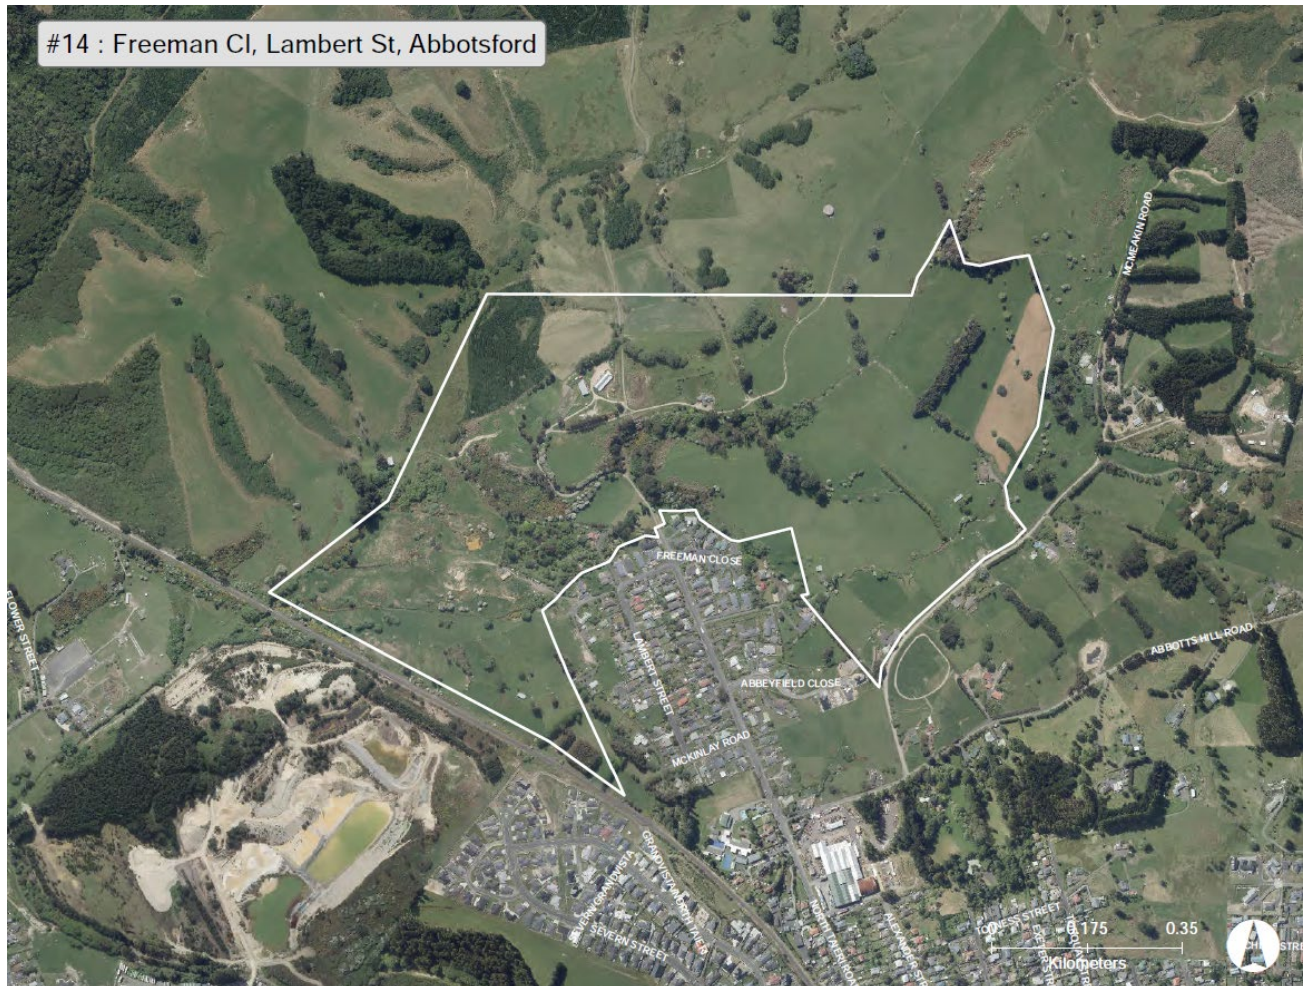
Figure 10 – Freeman Cl, Lambert St, Abbotsford Site

The proposed site is indicated in Figure 10. The site is located North and West of historic Abbotsford landslides.
