# Arboricultural Report

## Application to remove scheduled tree T014 (LUC-2024-460)

Prepared for: Finn Campbell, Dunedin City Council

Prepared by: Mark Roberts, Roberts Consulting Ltd

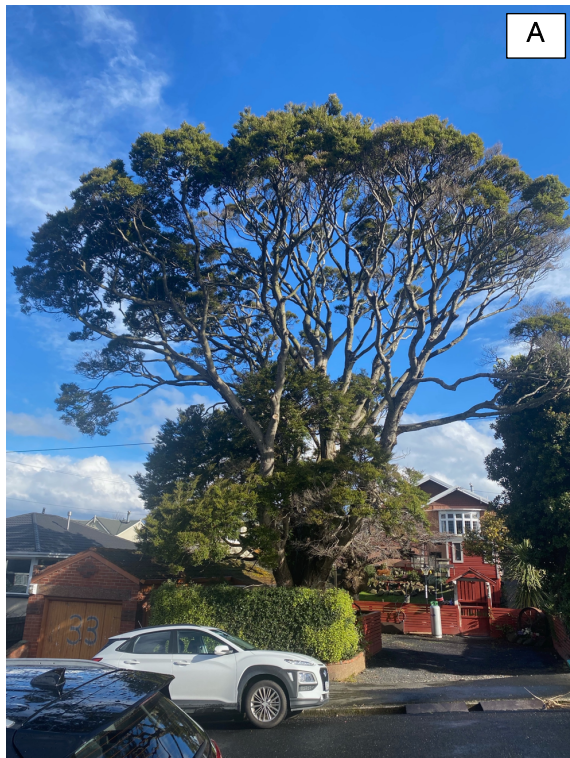
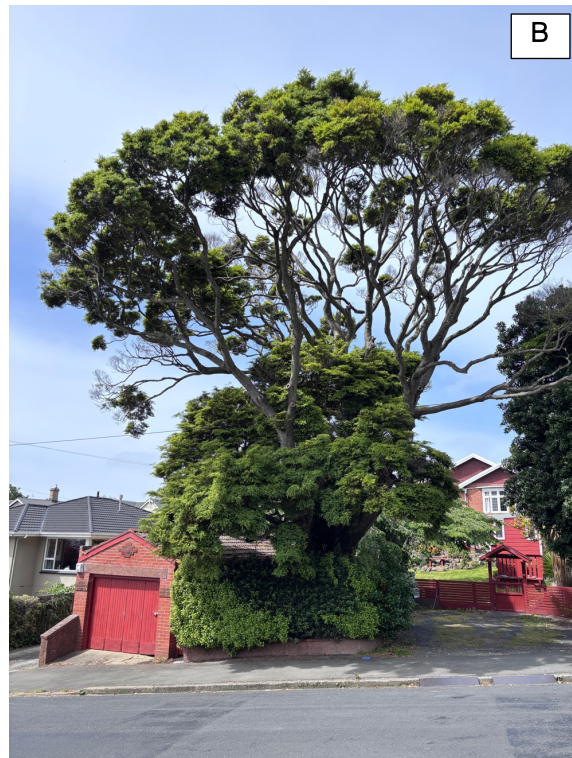
- 1.3.1 The tree is looking possibly healthier in terms of vigour and vitality than at any of my previous assessments (image one).

**Image one:** Comparative images of scheduled beech tree T014 showing the thickness and distribution of foliage. Image **A** taken on September 10, 2021, image **B** taken on December 2, 2024.

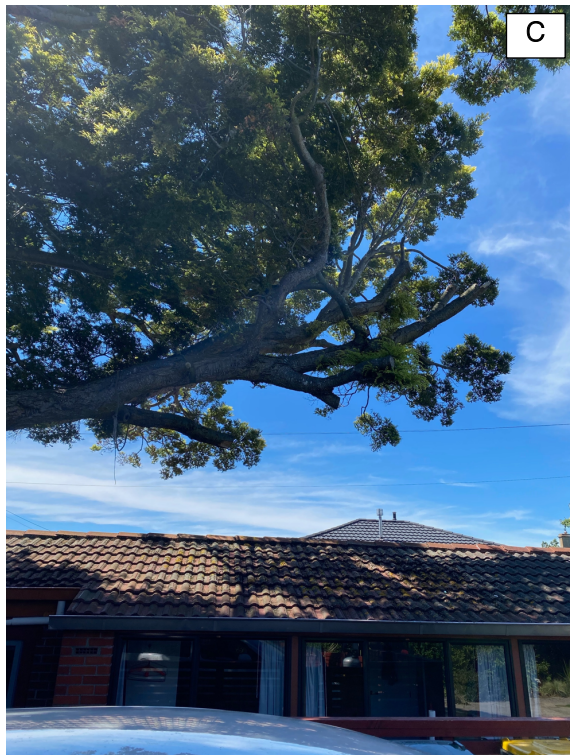
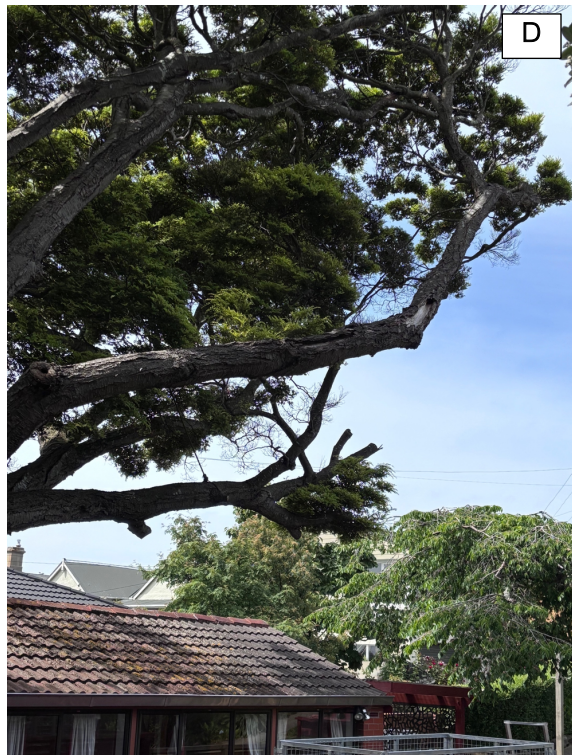
- 1.3.2 There is dead wood in the tree, but no more (perhaps even slightly less) than was noted in November 2020, September 2021, June 2023, August 2023, mentioned in June 2022 (image two).
  - 1.3.3 The tree was in reasonable health, it had good vigour and vitality. The amount of deadwood in the tree appears to be stable, and despite the poorly positioned, degraded, and un-functioning cable supports, the tree appears to be structurally sound.
-

- 5.1 The tree has not had any of the recommended maintenance carried out on it and as a result, some of the previously identified dead and dying branches have fallen from the tree.

**Image Two:** Comparative images of scheduled beech tree T014 so the declining limbs on the southern side of the tree. Image **C** taken 26 November, 2020, image **D** taken on December 2, 2024.
