# **Andy Carr**

**Director | Carriageway Consulting Limited**

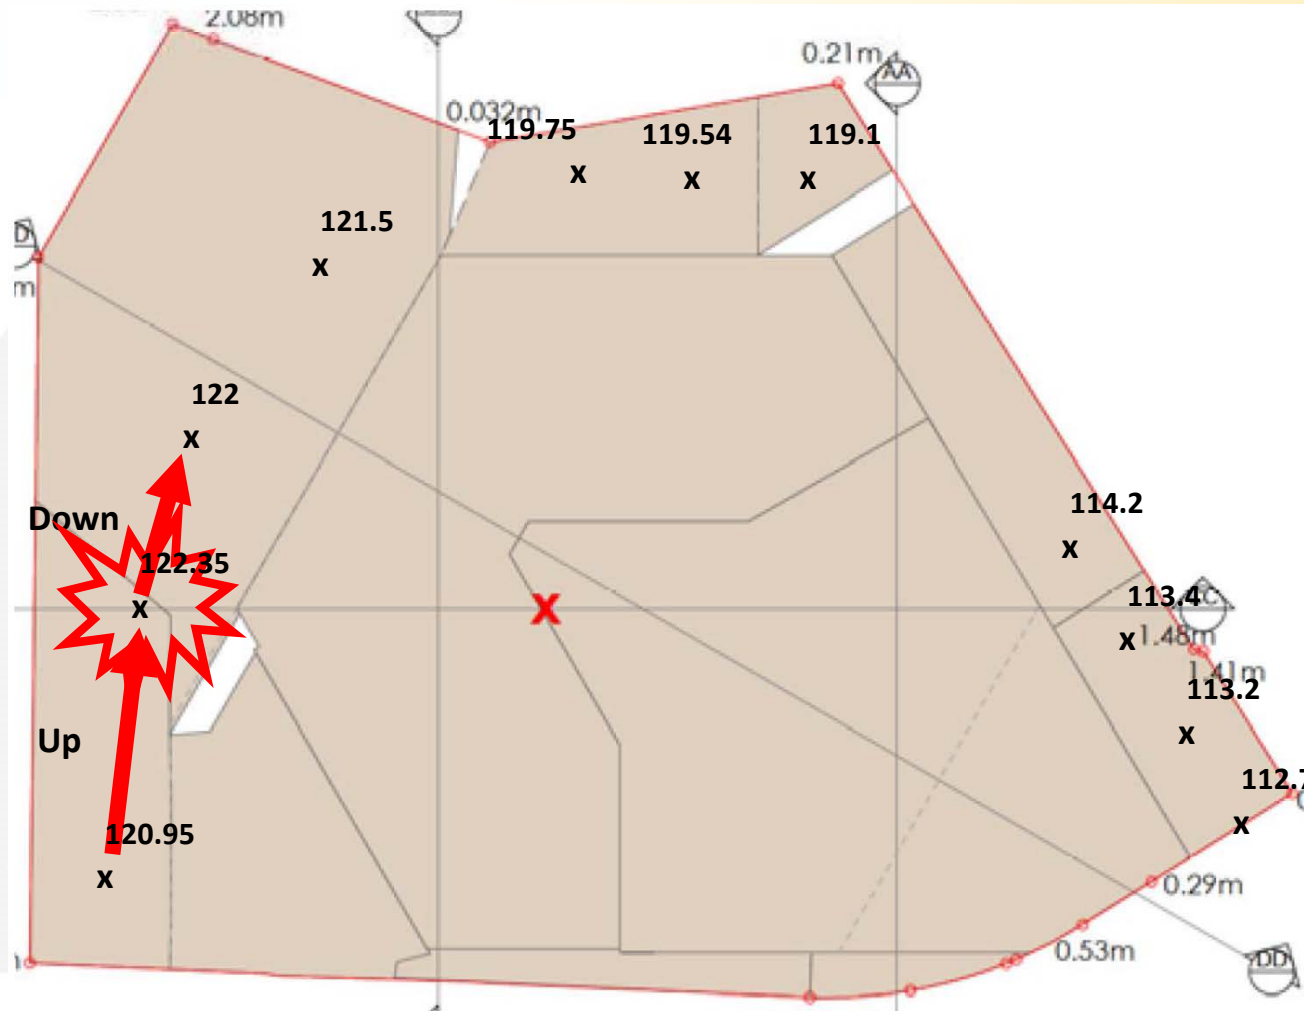
# Summit Grade

Applicant's plan shows 1 in 11 uphill, changes to 1 in 30 downhill

So total change in angle is 7.1 degrees, which equates to an overall change of gradient of 1 in 8.05

Problem: The maximum change of grade for a coach is 1 in 10.4 and for a service vehicle is 1 in 16 – otherwise they scrape or get jammed

So porte cochere remains unusable by coaches and service vehicles

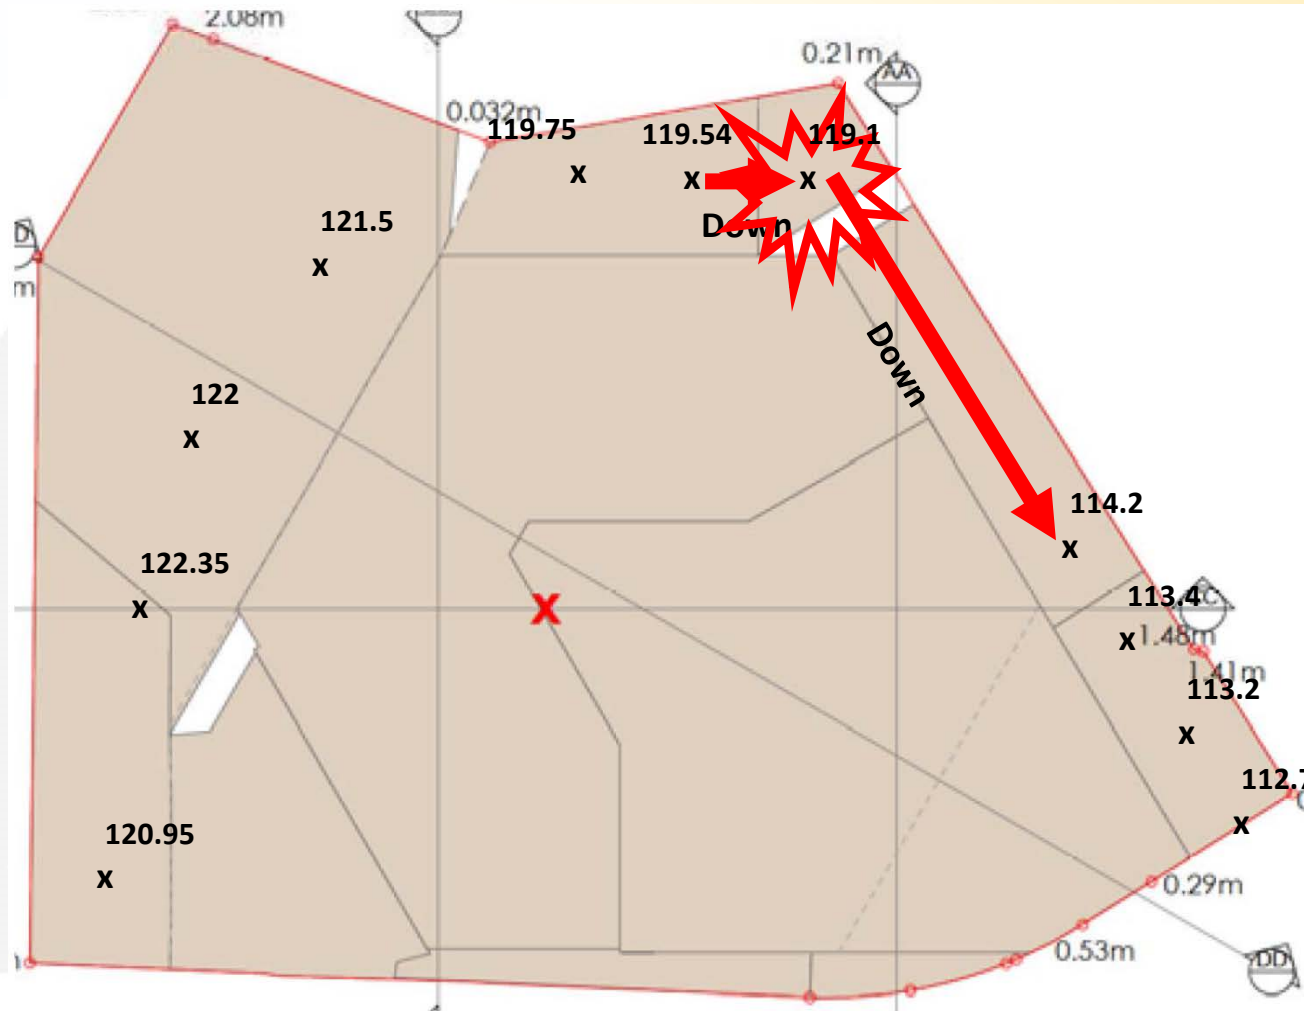
# Second Summit Grade

Applicant's plan shows 1 in 11 downhill, changes to 1 in 6 downhill

So total change in angle is 4.3 degrees, which equates to an overall change of grade of 1 in 13.4

Problem: The maximum change of grade for a service vehicle is 1 in 16 – otherwise they scrape or get jammed

So service vehicles are unable to get to the loading bay

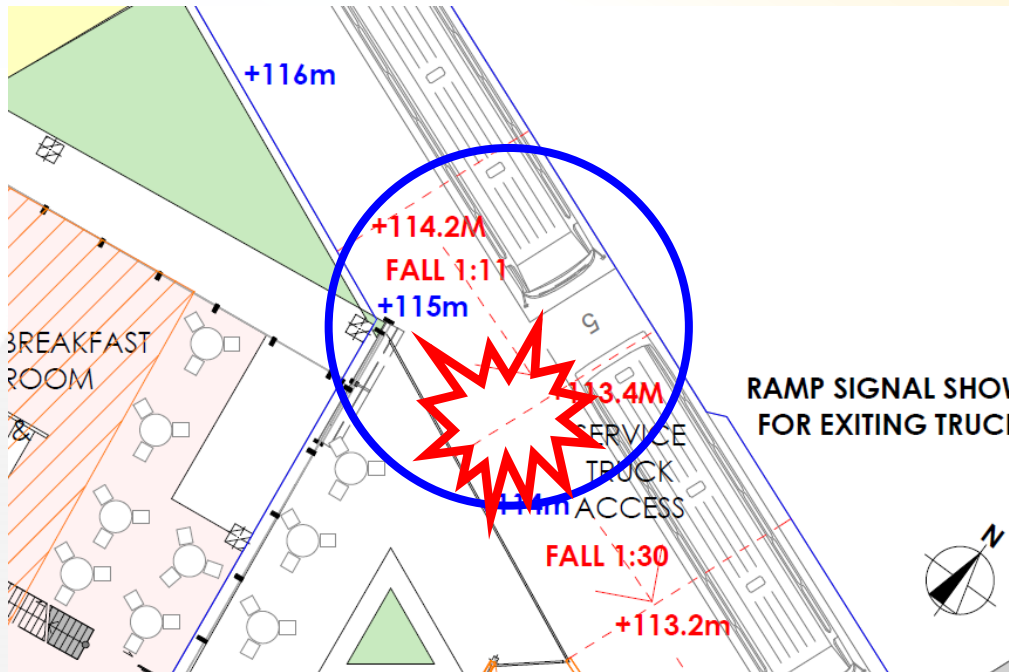
# Miscalculation of Gradient

Change in level from 114.2m to 113.4m (0.8m) over a distance of 7m

Equates to a gradient of 1 in 8.8 **not** 1 in 11 as shown

So total change in angle is 4.6 degrees, which equates to an overall change of grade of 1 in 12.5

Problem: The maximum change of grade for a service vehicle is 1 in 16 – otherwise they scrape or get jammed

So service vehicles are unable to get to the loading bay

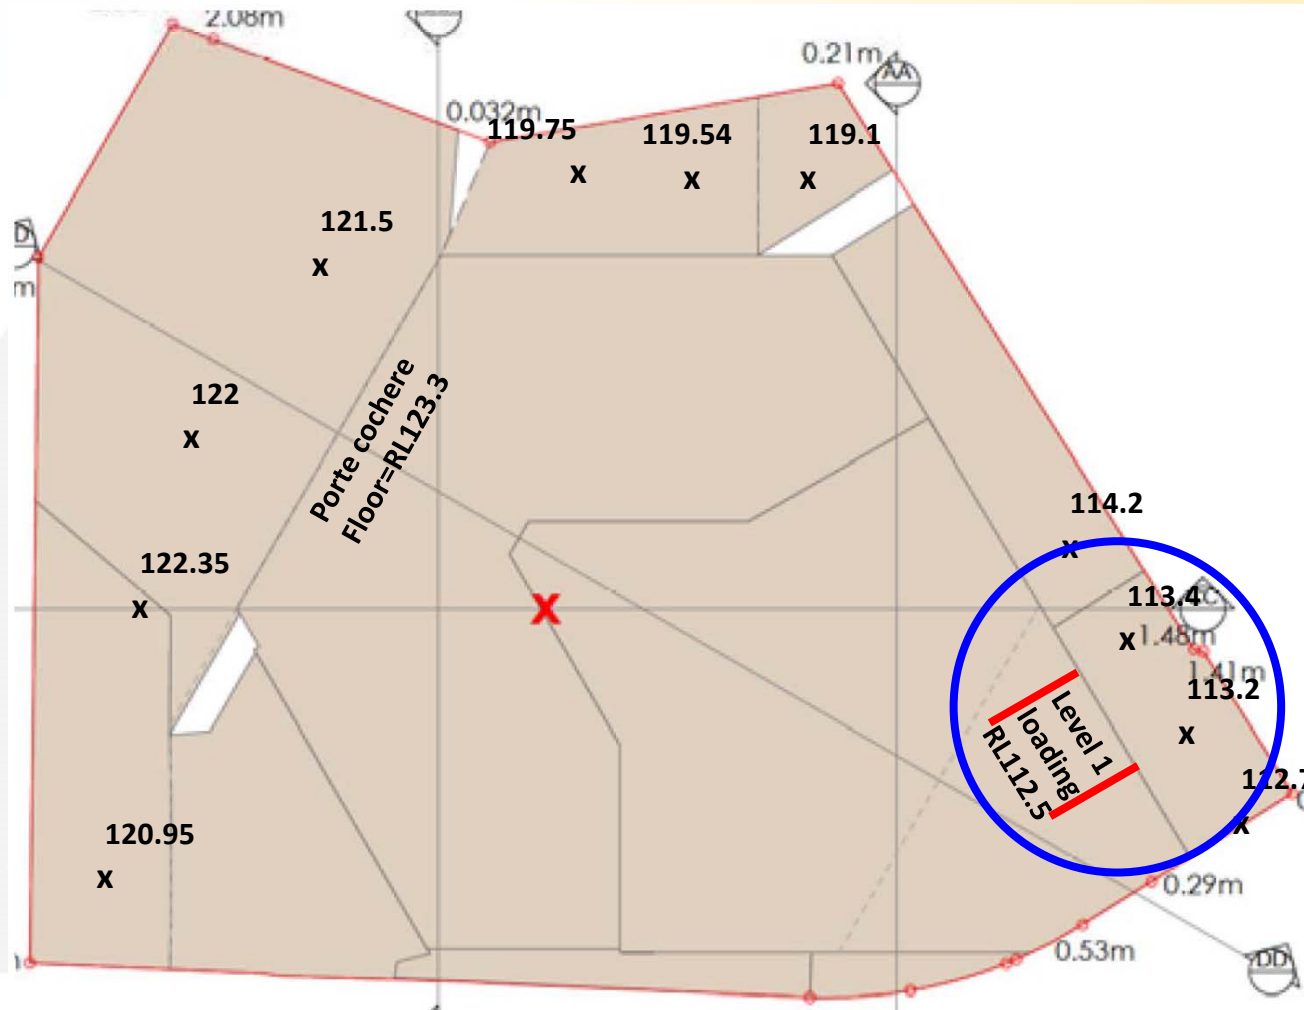
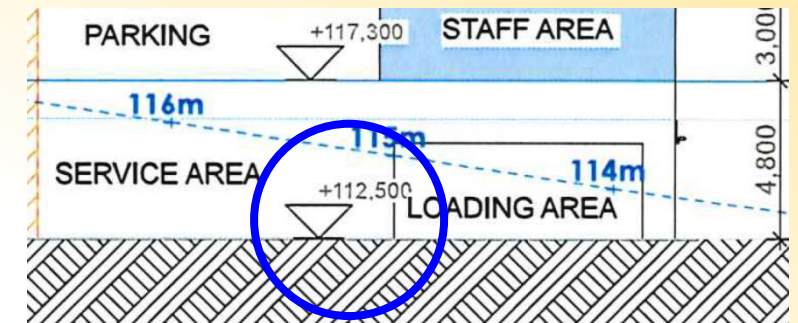
# Loading Bay Access

Problem: Levels shown on perimeter road are at least 0.7m higher than the level shown on plan of cross-section

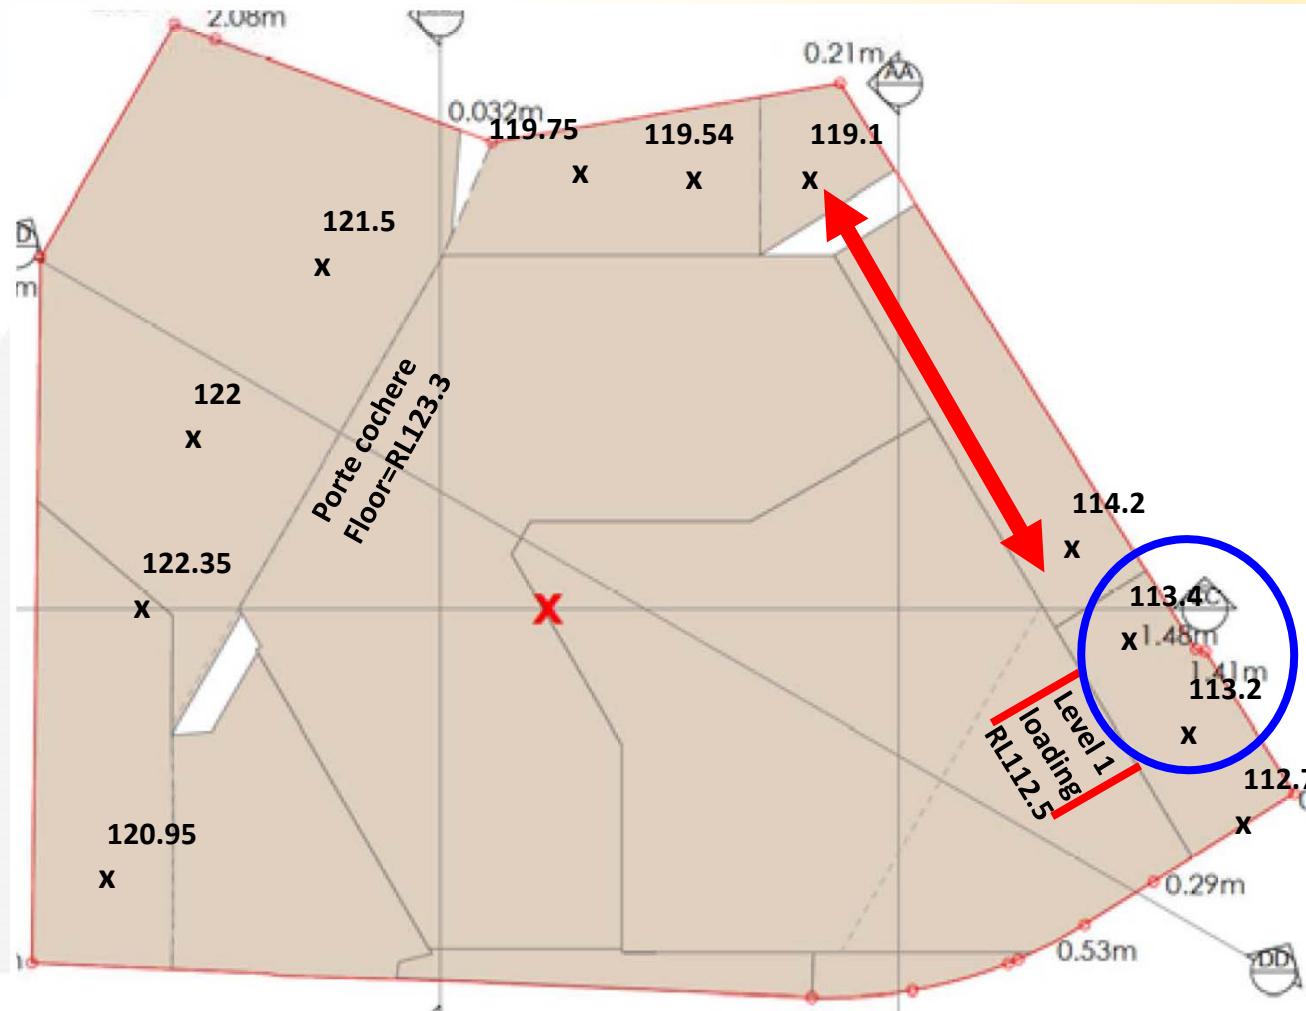
# Level of Loading Bay (Option 1)

If the loading bay is at RL112.5 as cross-section plan shows, then the adjacent perimeter road needs to be lower

To do this, the gradient of the roadway needs to be steeper

The plans show that this is already 1 in 6

It would need to change to 1 in 5.3

Coaches and service vehicles cannot traverse a gradient of more than 1 in 6.5

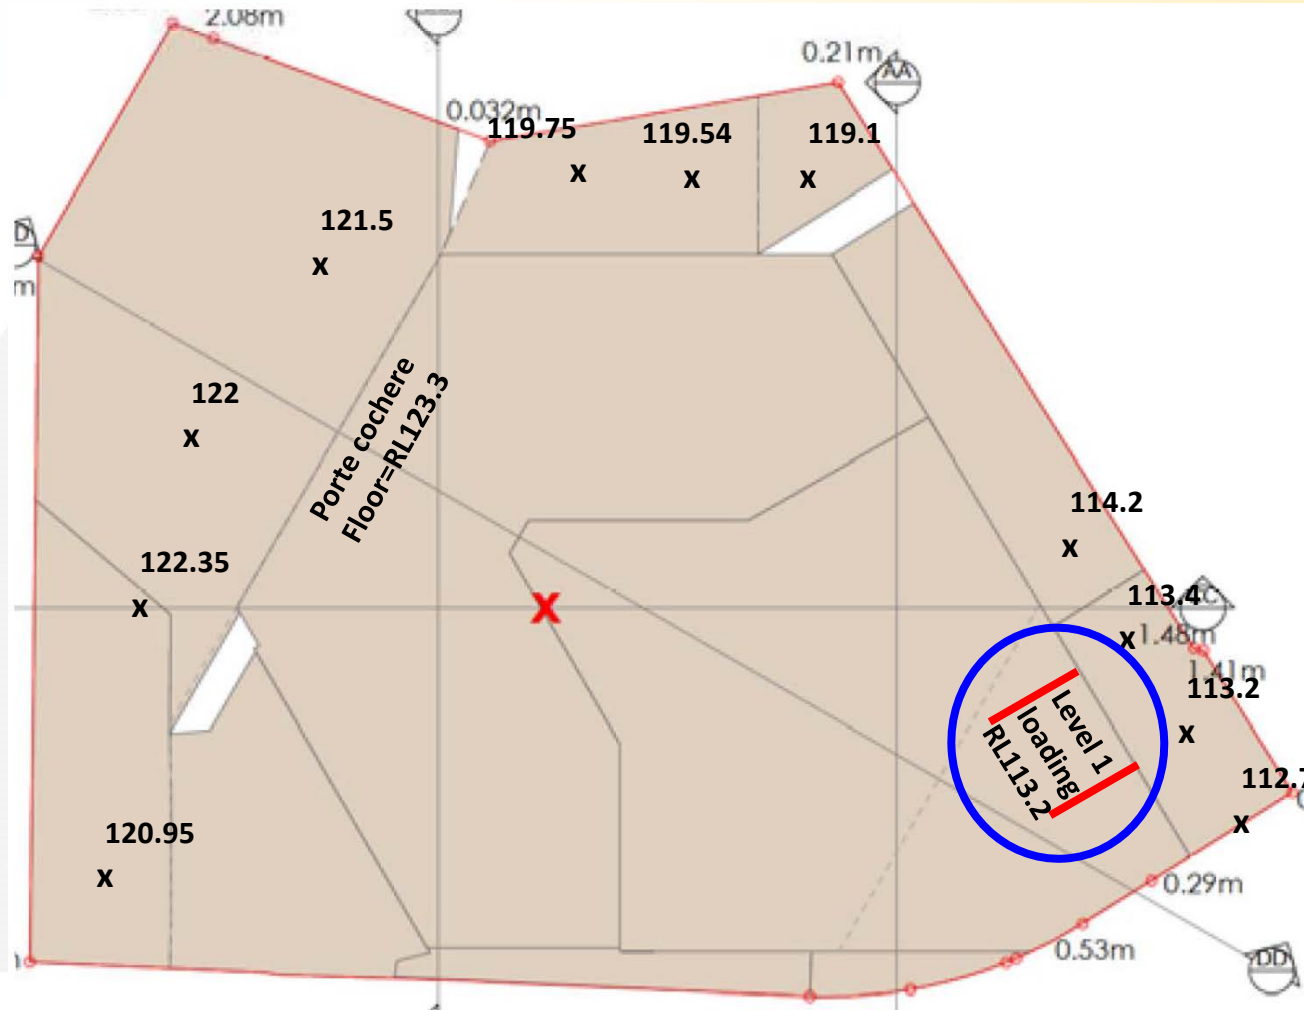
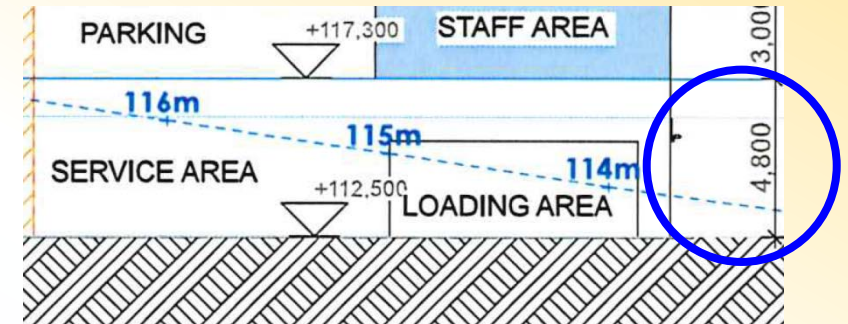
# Level of Loading Bay (Option 2)

Loading bay could be elevated to the perimeter road (RL113.2)

However, cross-section plan shows 4.8m height clearance provided in loading bay at RL112.5

With the loading bay at RL113.2, this reduces to 4.1m, which is insufficient for a truck

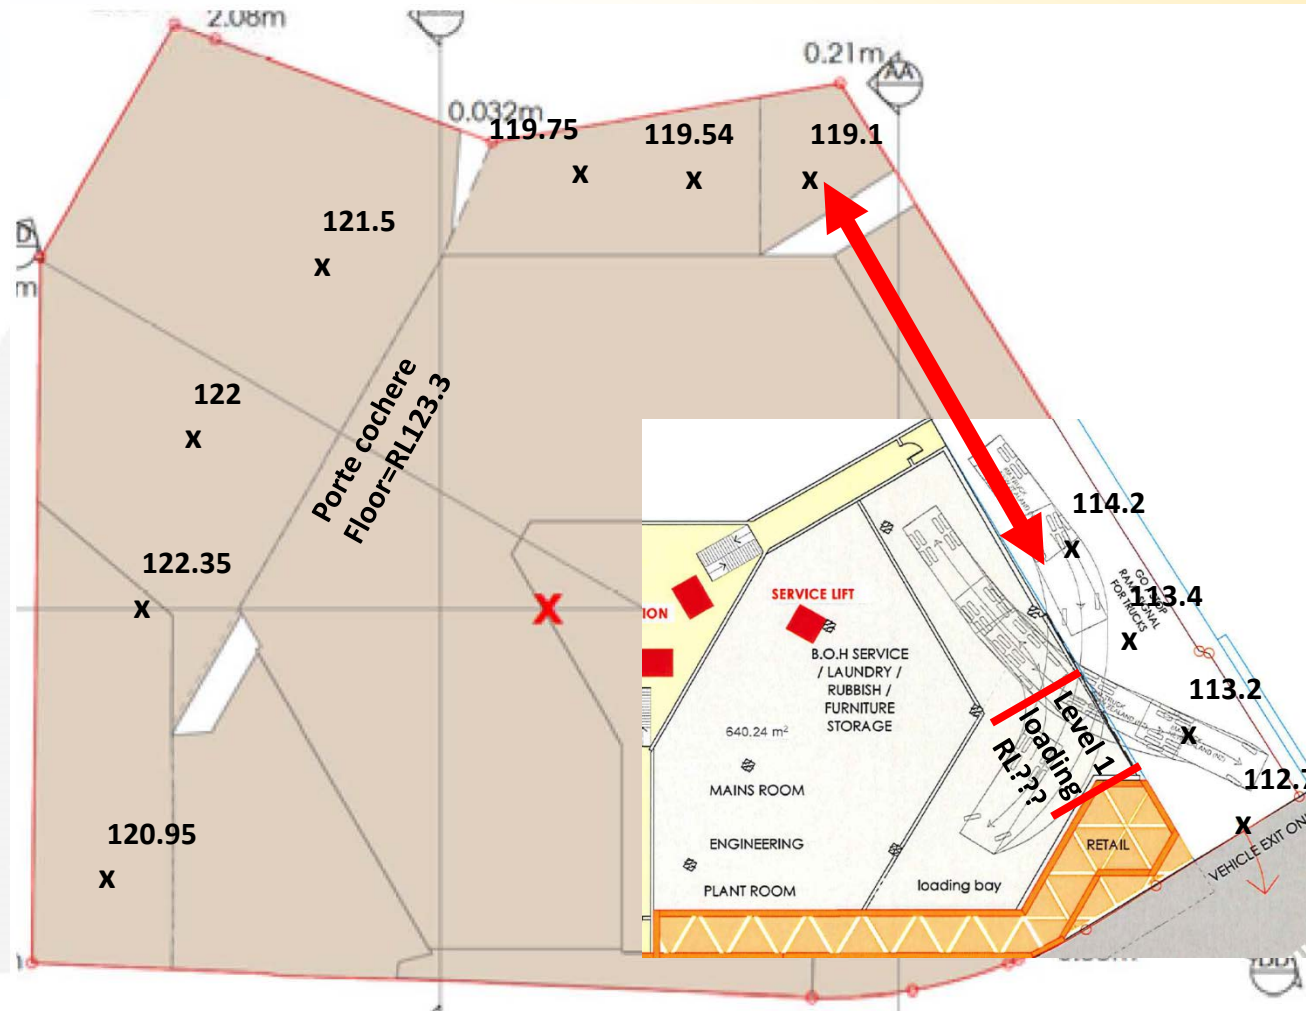
# Applicant's Swept Paths at the Loading Bay

Applicant's own swept paths show the trucks entering the loading bay on the steeper part of the perimeter road (1 in 8.8)

Truck would have severe crossfall with risk of toppling

So this part of the roadway needs to be flatter

Therefore the gradient of the preceding part of the roadway needs to be steeper

But it is already 1 in 6 and steeper than coaches and service vehicles can traverse

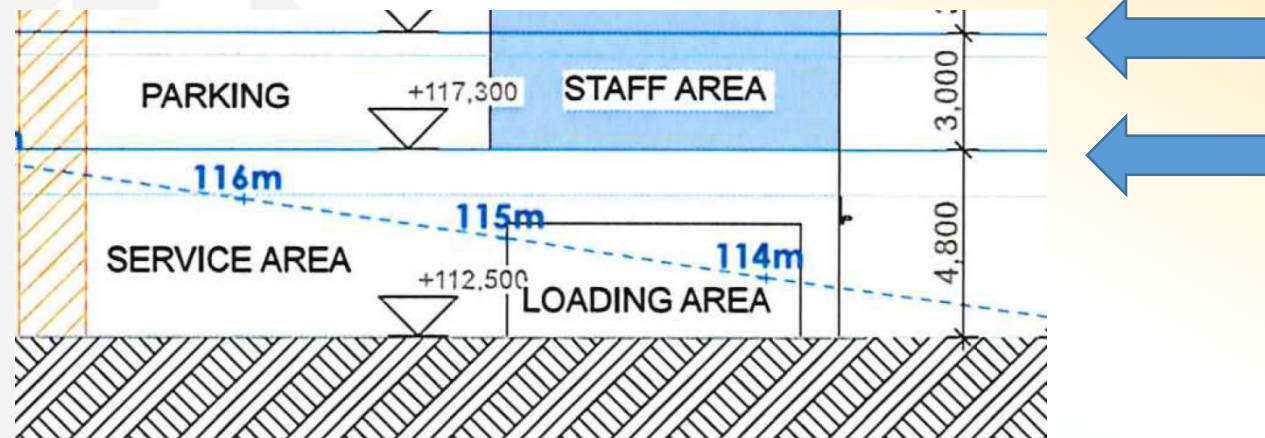
- The cross-section plan makes no allowance for the thickness of the floor itself

- AS2890.2:2002 requires a height clearance of 4.5m for trucks
- The applicant's plans even without any adjustments mean that the floor thickness can be no greater than 0.3m

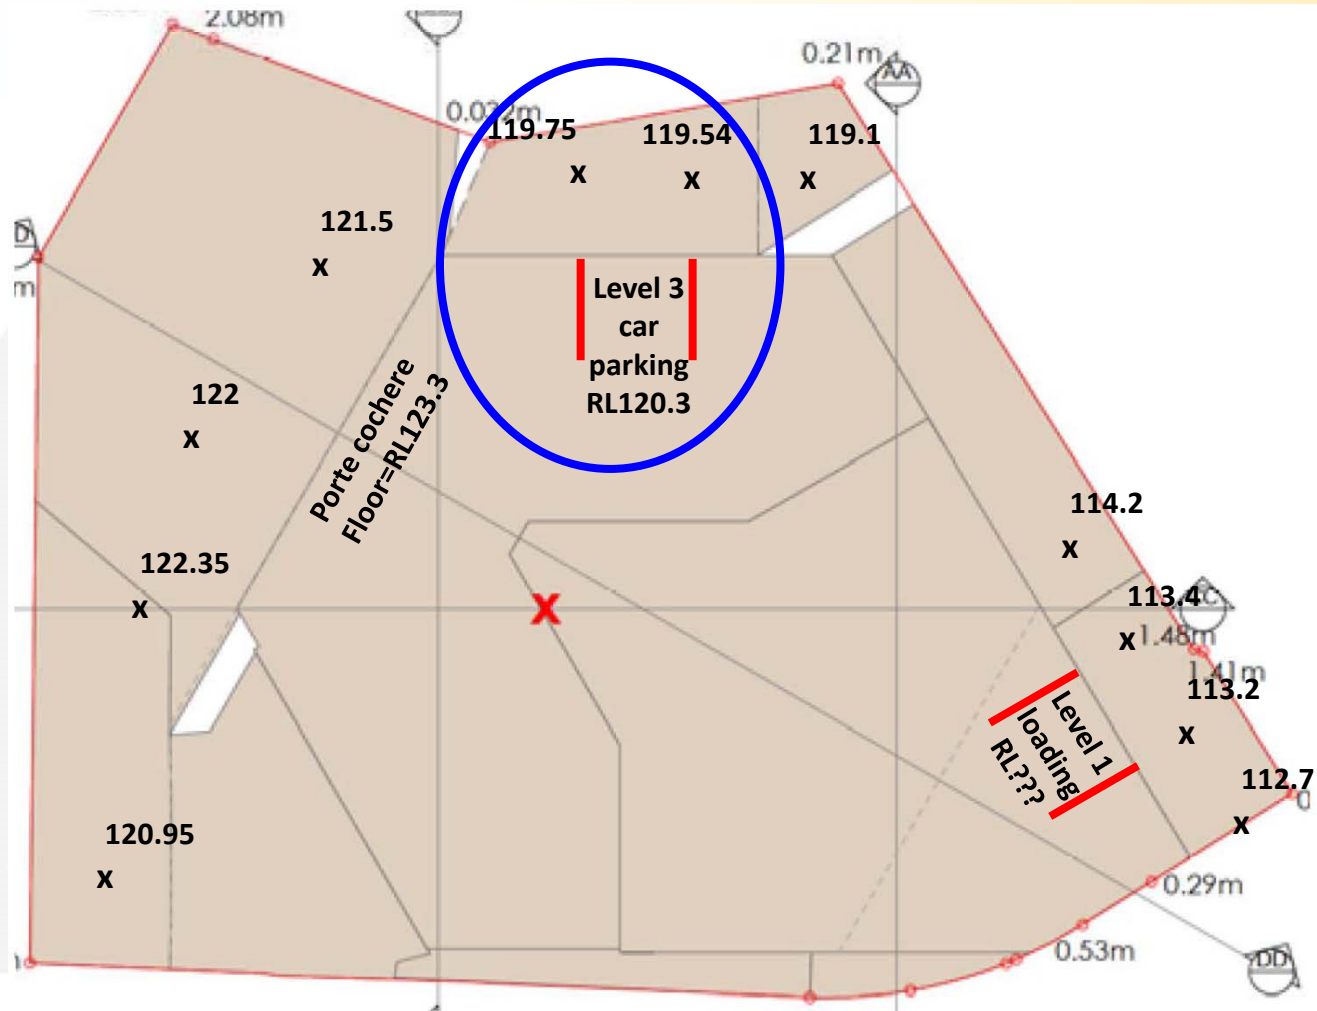
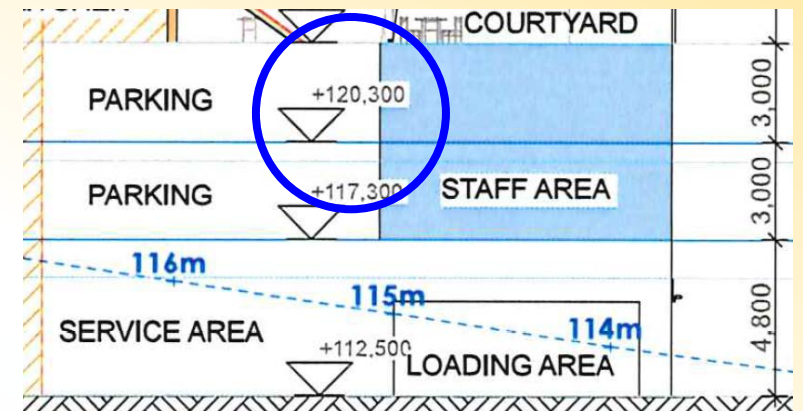
# Car Park Access

Problem: Levels shown on perimeter road are at least 0.55m lower than the level shown on plan of cross-section

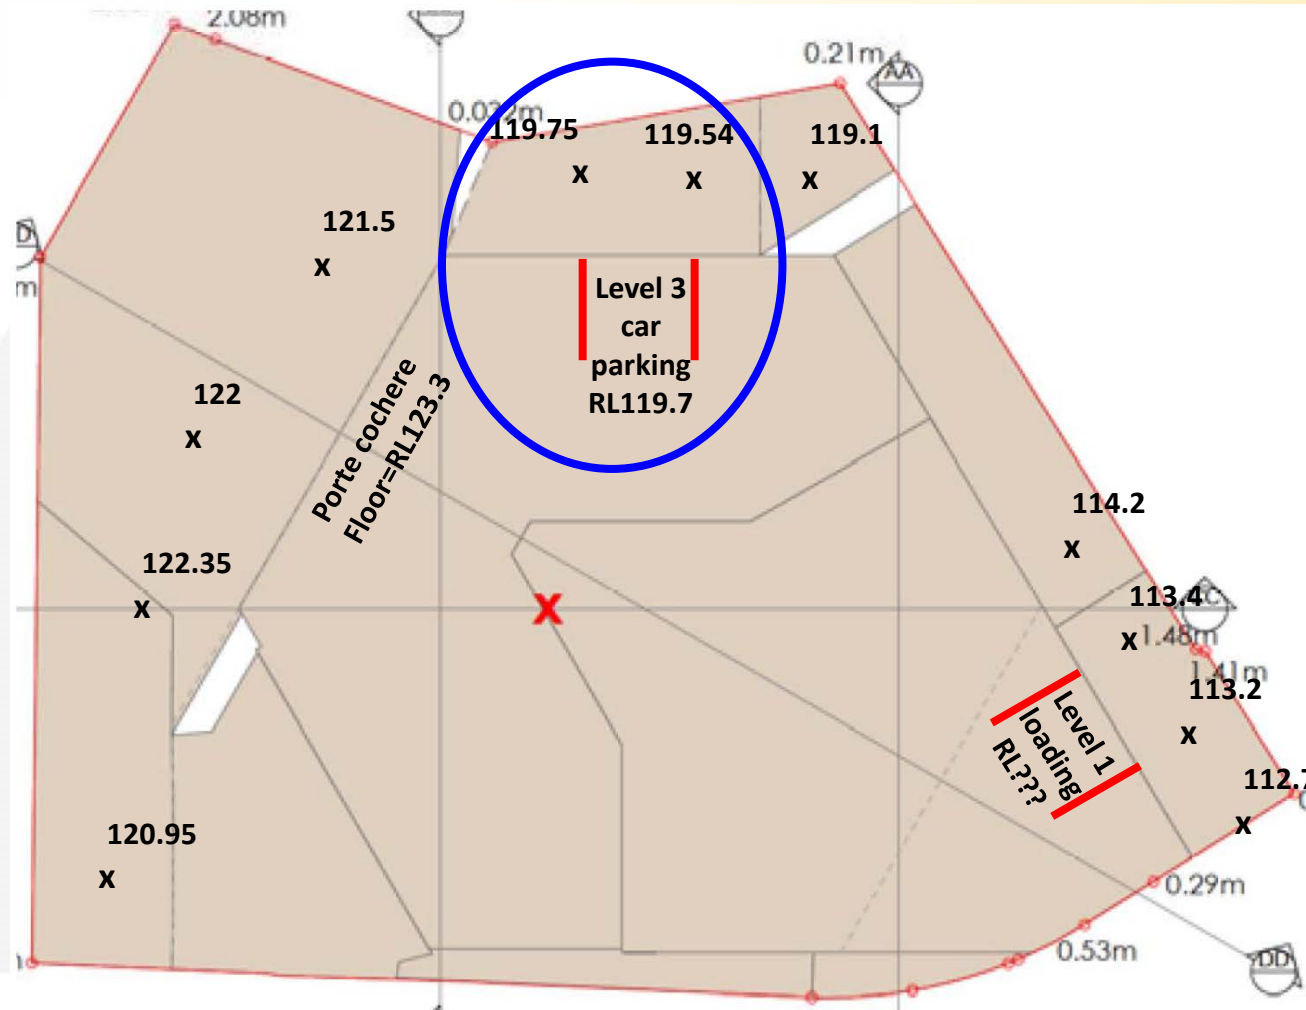
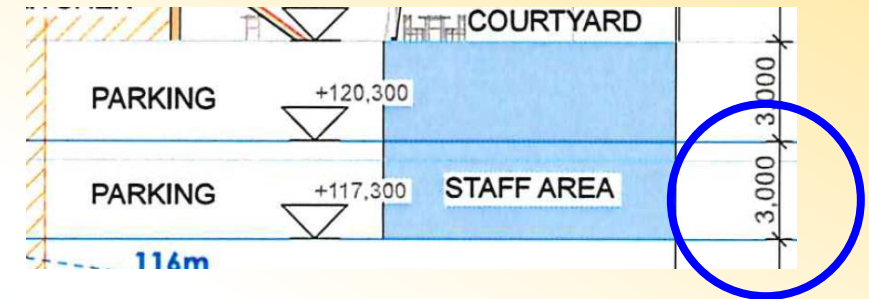
# Level of Car Park (Option 1)

If the level of the car parking is reduced by 0.55m to match the roadway then the height clearance of car parking below reduces to 2.45m

This means headroom of lower level would be 2.15m (allowing 0.3m floor depth) which is too low for cars

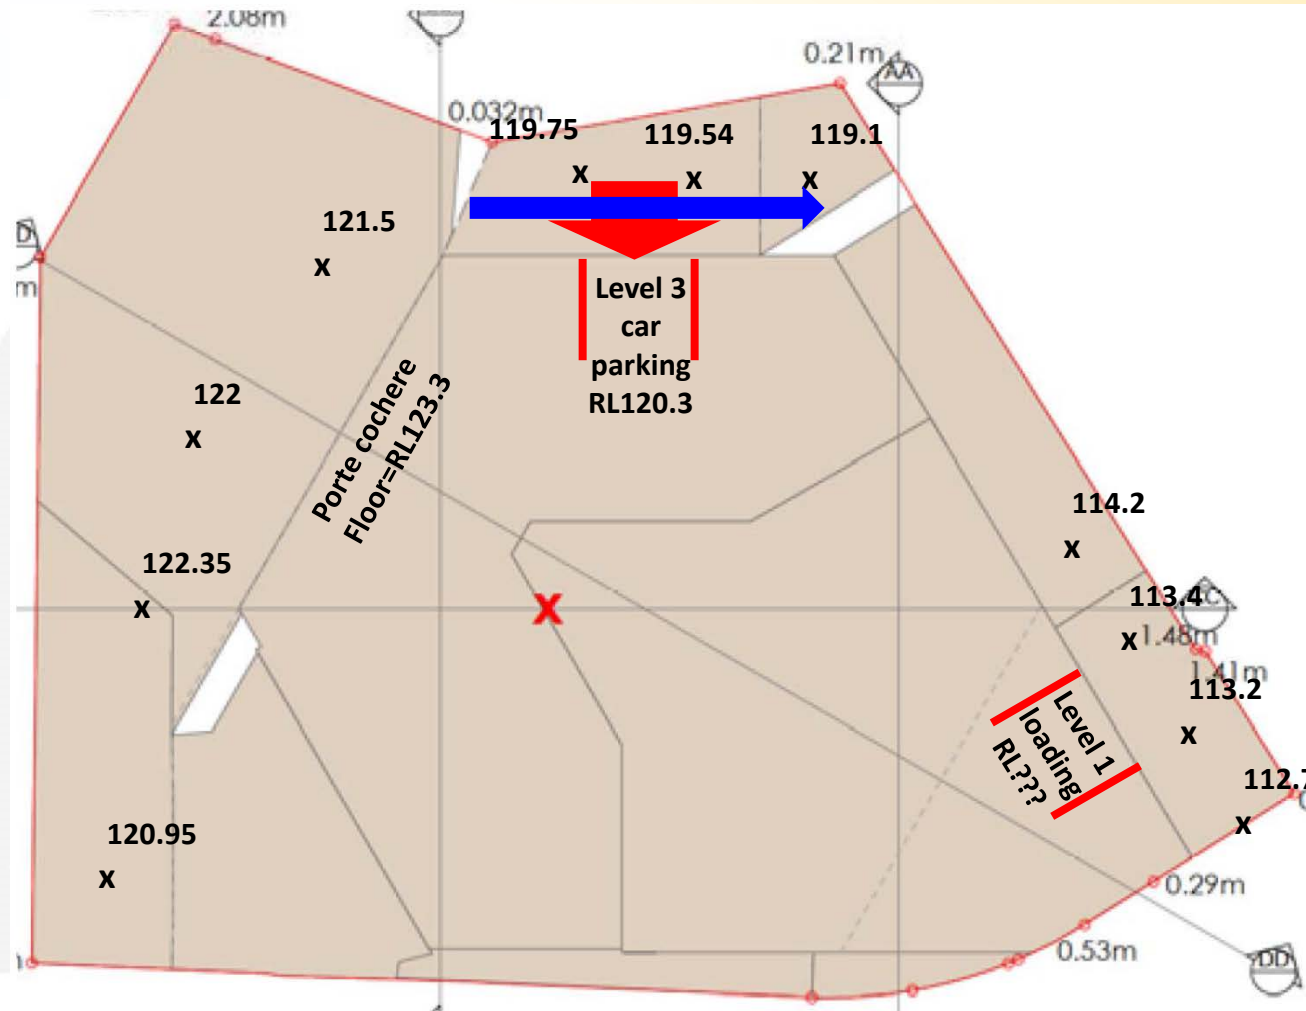
# Level of Car Park (Option 3)

If levels were retained then a ramp could be created up to the car parking level

Ramp gradient would be 1 in 6.5 and usable by cars

But would mean a 1 in 6.5 crossfall for coaches and service vehicles

Coaches and service vehicles could not traverse this

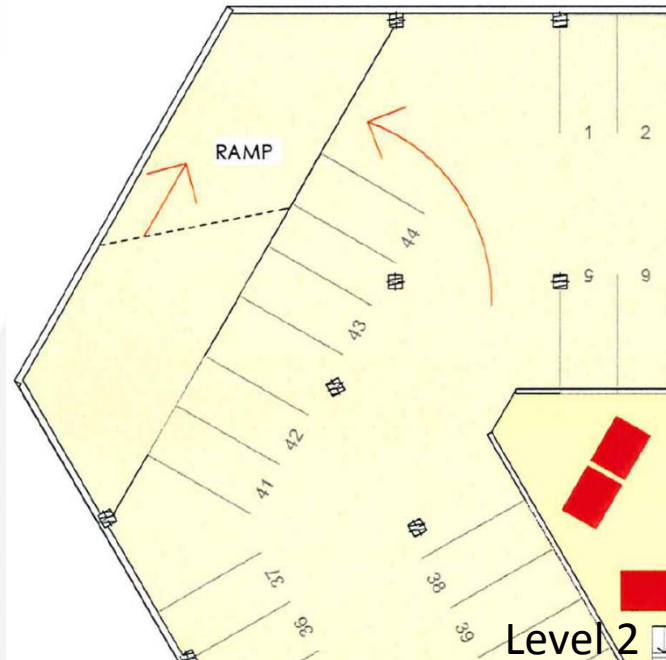
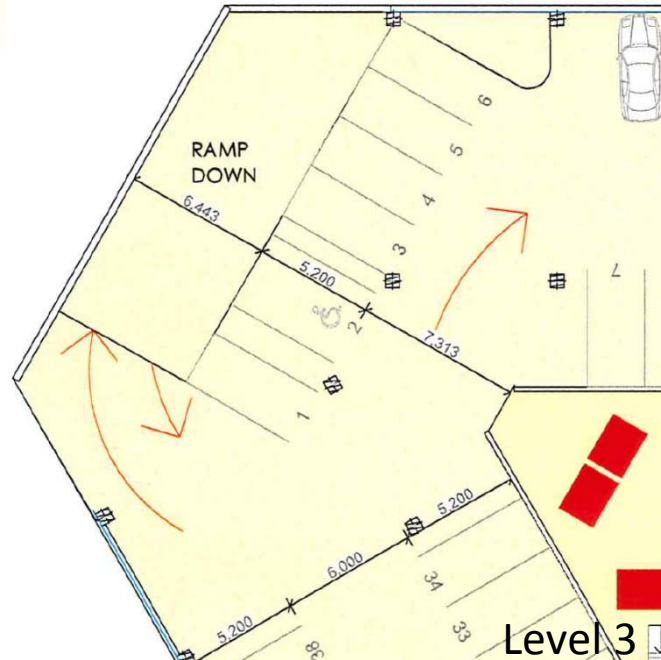
# Internal Ramp in Car Park

Length of ramp is 11.5m

Required change in height between floors is 3.0m

Therefore gradient is 1 in 3.8

So transition ramps needed or cars will scrape bodywork or get jammed

Problem: Main part of ramp at 1 in 3 is much greater than Standards permit

Ramp must therefore be:

- 2m at 1 in 6.7 (transition)
- 7.5m at 1 in 3
- 2m at 1 in 8 (transition)

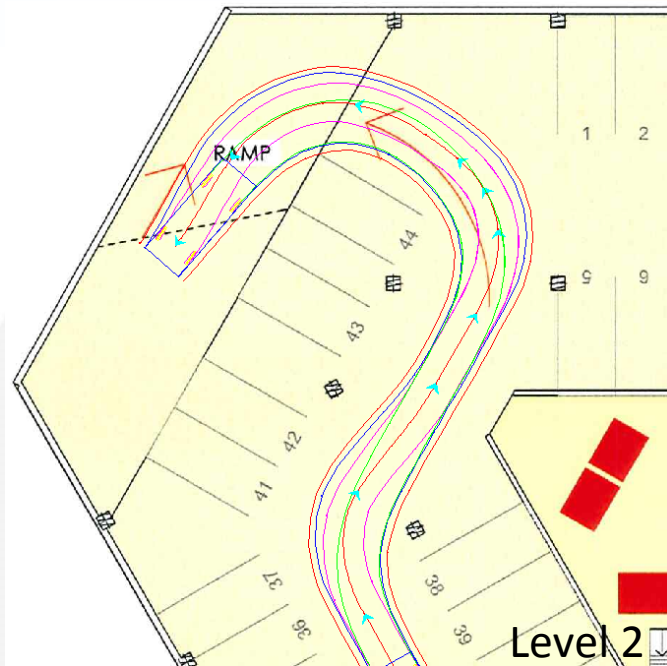
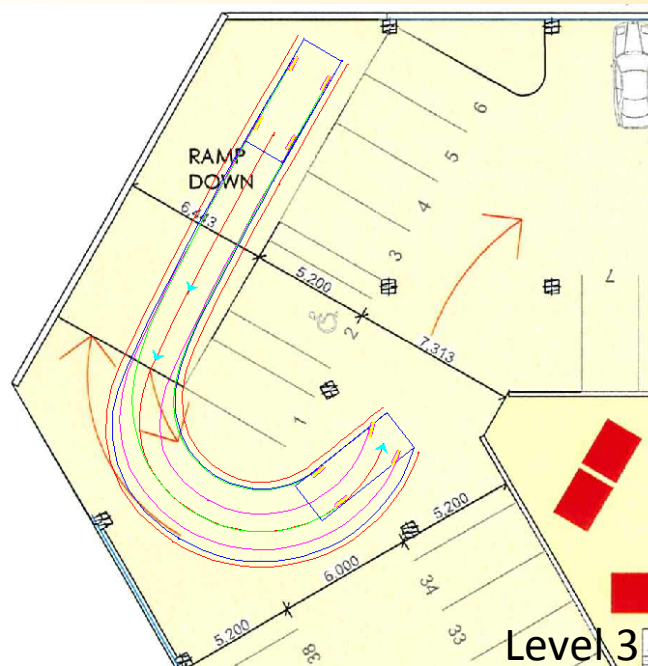
# 'Best Case' Swept Paths of Vehicles on Ramp

Car travelling up ramp on minimum radius occupies the full ramp width

Even if it could move to the side, it requires the full width to turn at the top

Therefore ramp and approaches can only operate as a single traffic lane

No robust controls proposed on ramp, so high potential for one car to encounter another

Valets would need to reverse on the ramp and around a blind corner

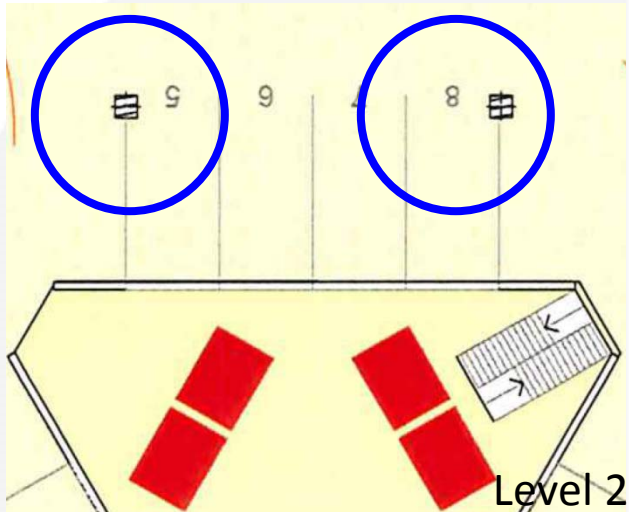
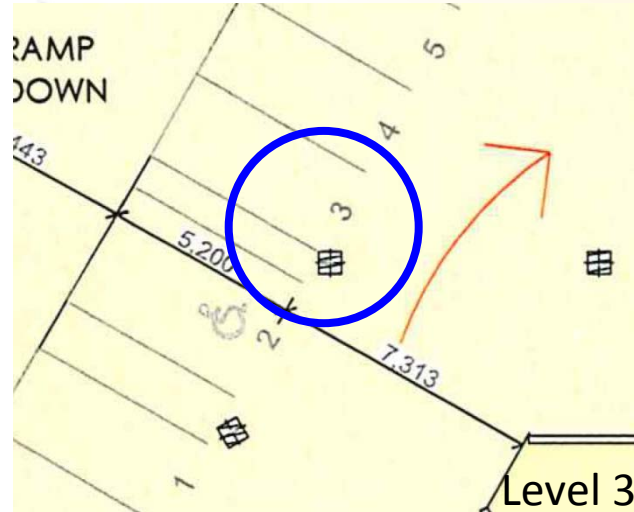
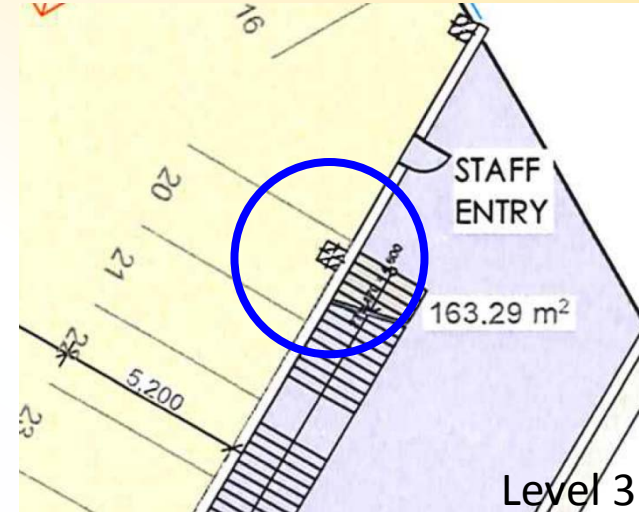
# Other Issues (1)

Unusable car parking spaces shown on plans (7 in total)
